## CONSULTANTS REPORT

The required work relates to serious water ingress due to failure in the existing membrane which needs to be attended to as a matter of urgency, located in the front east block of the school. (east wing the roof above R23: 6th Class, R22: Library and R21:5th Class as well as main staircase to a fire escape is contained on the top floor of this section) . These are important rooms and access routes that are in active use and the water ingress in these areas is a hazard.

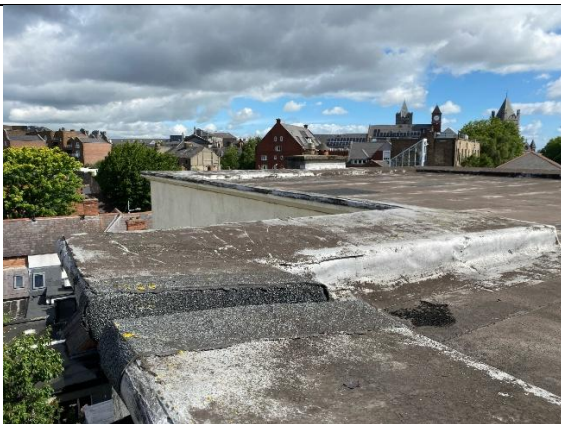
*Figure 1: Overview of area of roof in need of work including chimney, note the patch repairs at the outlet*

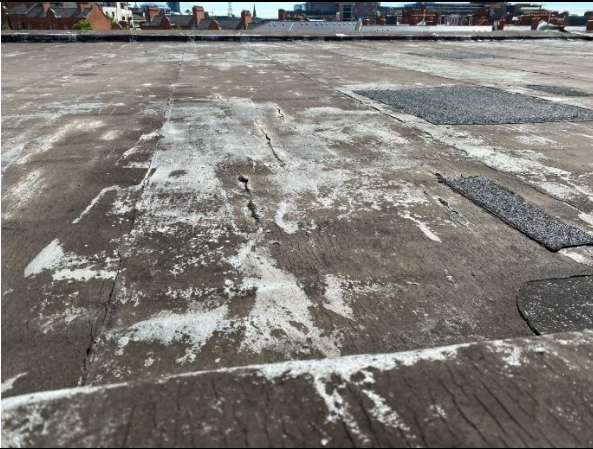
*Figure 2: Existing roofing felt – evidence of blistering and surface pitting, thermal cracking, and advanced UV degradation across the roof deck. Torch-on felt patches have assisted in slowing down the failure but has not prevented additional water ingress. Repairs are no longer working. The surrounding asphalt/felt substrate is too degraded, brittle, and porous to hold a watertight seal.*

As active leaks continue notwithstanding the patch repair, this indicates that the surrounding roof membrane has reached end of service life. The old felt is brittle and failing. Any further minor patch repairs would represent a waste of funds. A complete strip-out and provision of a new waterproofing layer is the appropriate permanent solution. As the roof does not have insulation, we strongly recommend that c.150mm polyurethane insulation is also provided with the roof repair works. The insulation will also assist in providing a good surface for the new roof membrane and help to reduce the risk of condensation and mould growth internally. Due to the ongoing water ingress there is an increased risk that the leaks will require decanting of sections of the building which the Board of Mgmt wish to avoid by undertaking the emergency works.

- Erect scaffolding with handrail around the perimeter of the roof to ensure safe access.
- Remove and dispose of existing roofing membrane.
- Hire a boom lift to remove debris and transport new materials to roof level.
- Clean and prime the existing roof deck.
- Install new waterproofing system: 3mm torch-on underlay with 4mm torch-on cap sheet.
- Lay 2mm separation layer
- Install 150mm rigid insulation -tapered to outlets
- Apply two layers of torch-on membrane to all flashings and upstands.
- Supply and fit black PVC trim to roof perimeter
- Redress and seal all rainwater outlets.

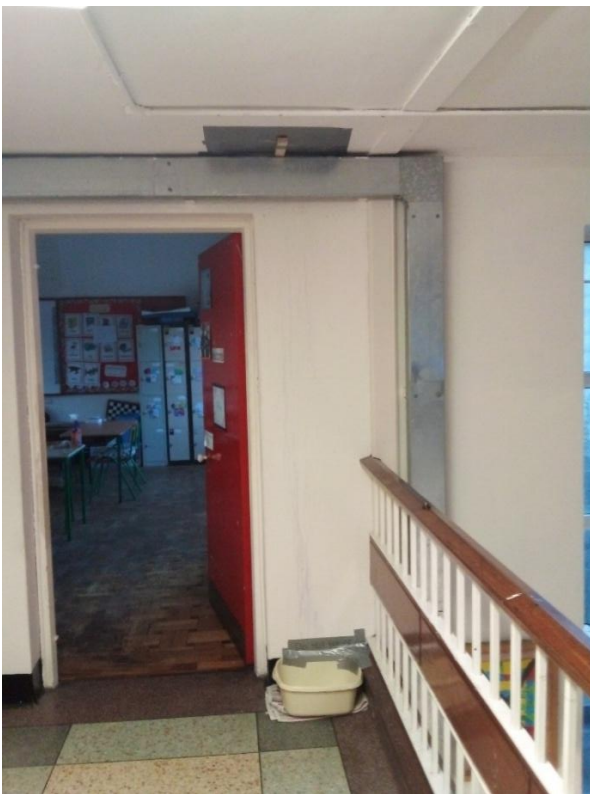
*Figure 3: Evidence of destructive impact of the flat roof failure inside the school building. Active water ingress entering a main corridor right outside a classroom door and stairwell landing.*

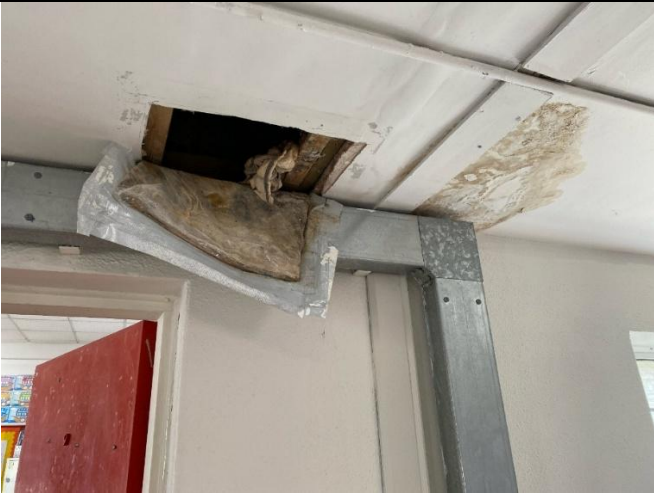
*Figure 4: rainwater from the leaking roof has saturated the ceiling fabric. The sagging and deep staining indicate that this section of the ceiling is being damaged by water ingress. The active leak tracks directly alongside the main galvanized electrical/services trunking, increasing health & safety, and fire hazard risks for occupants.*

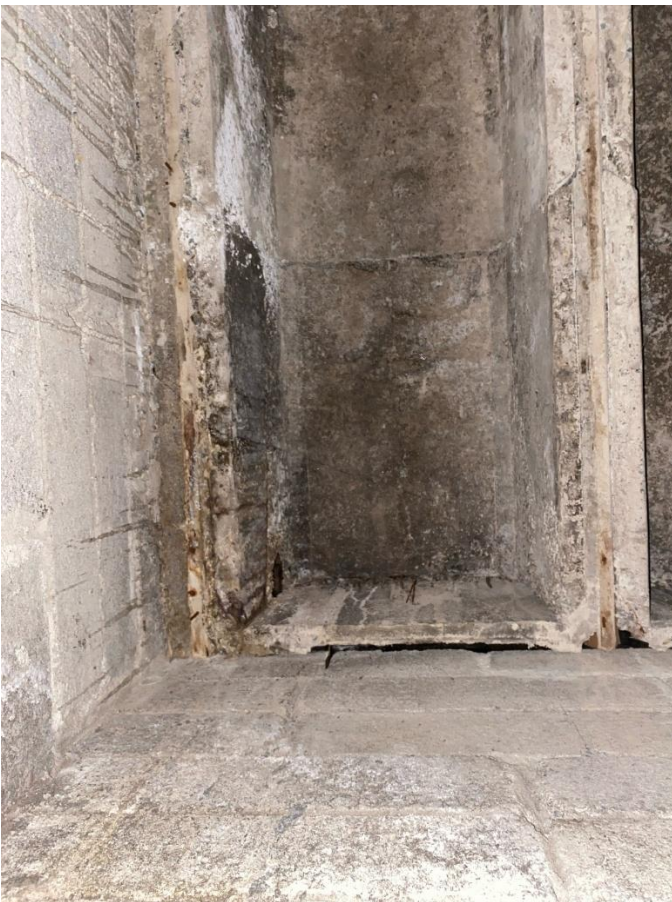
*Figure 5: water ingress from failure of roofing felt is dripping down and saturating ceiling underneath. Photo taken from removed area of ceiling looking up toward underside of concrete roof. Note the staining and mould from condensation due to lack of insulation in the roof*
