# SJK Engineering & Surveying Ltd.

**Client:** HSE South Capital and Estates,

**Premises:** Ballyseedy House, Ballyseedy, Tralee, Co. Kerry V92RX49

**Report:** This report is based on a visual only and did not entail the opening up of works which had been fully or substantially completed, were inaccessible or otherwise obscured from view on the said date of inspection of the 9<sup>th</sup> of July 2026. No planning documents were available to me on the day of my inspection.

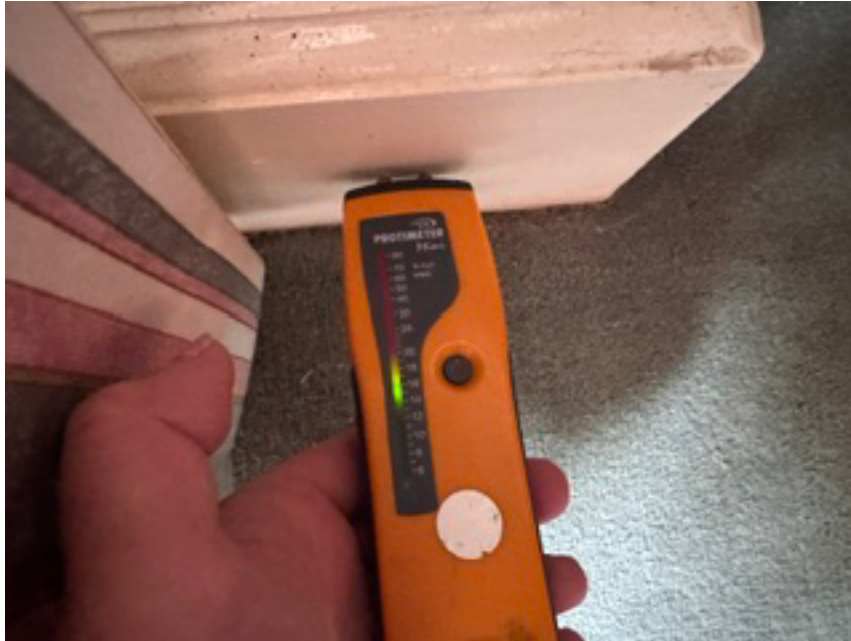
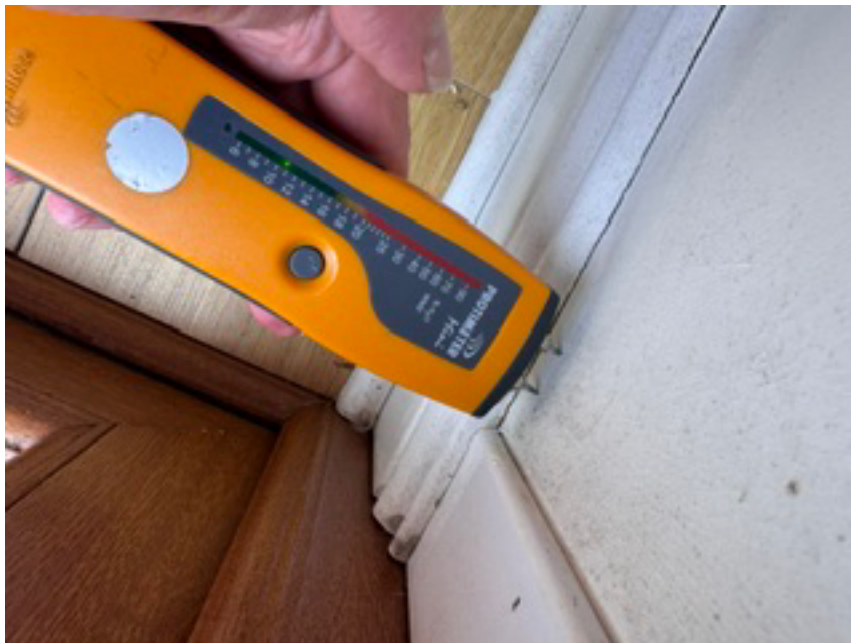
Skirting when tested are dry

The ground floor has floor finishes in place, and all areas are structurally visually in good condition.

The ground floor is reasonable level but not fully level and if new floor coverings were to be installed in the future some repairs to levels at some locations would be required. Also, if new floor coverings were to be installed, I would recommend that the existing concrete surface is suitably treated to prevent the risk of any moisture ingress from the floors.

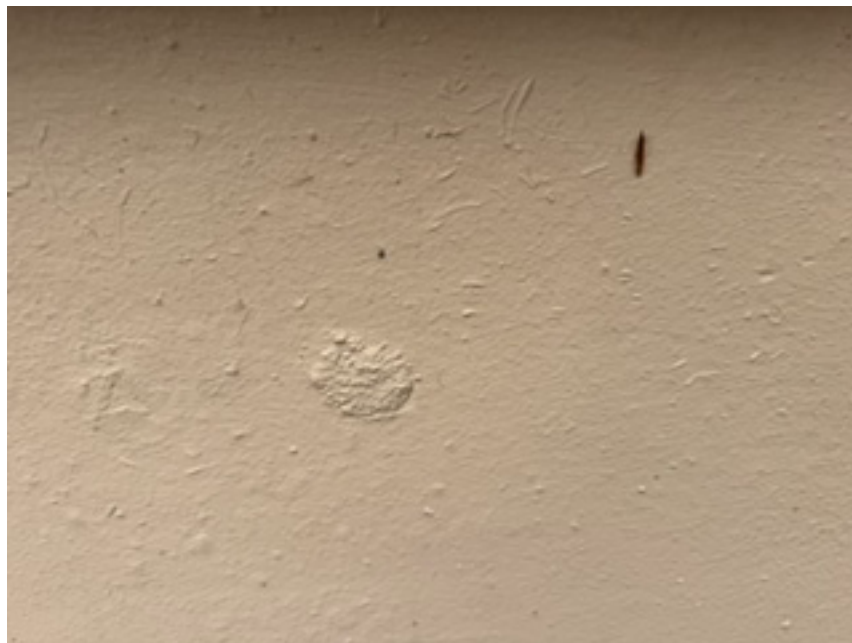
There are visible signs that the cavity might have been pumped as part of previous improvement works.

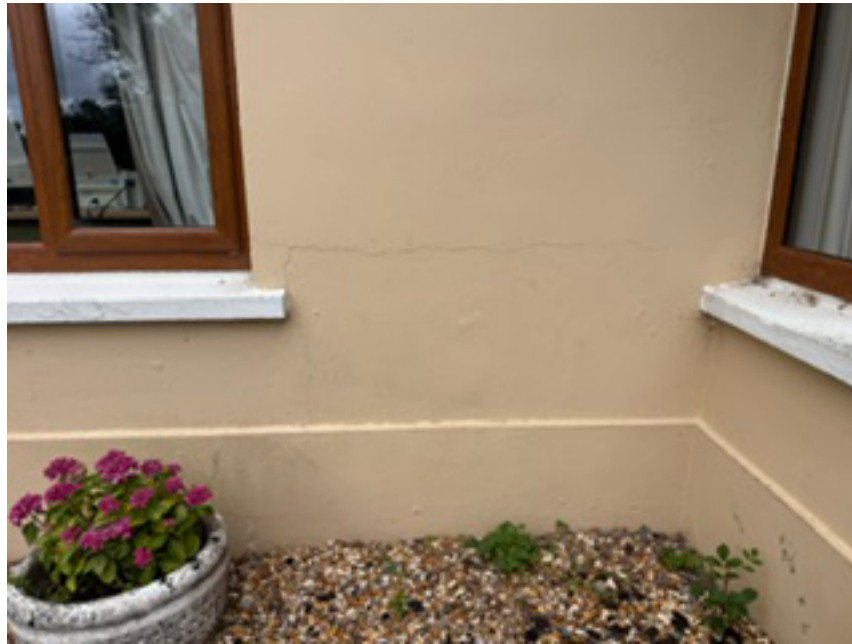
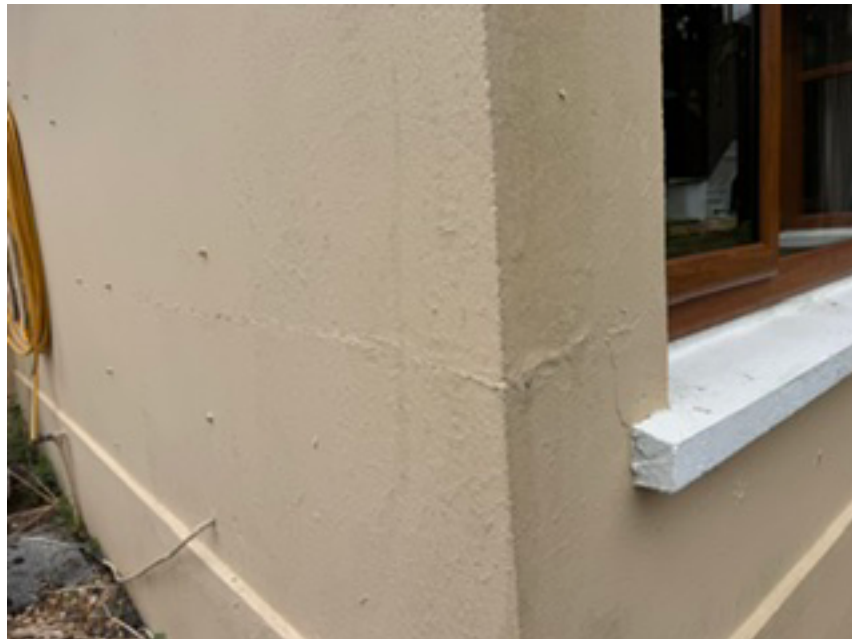
- Slight plaster crack at front left corner.

The cracks that are present are not a structural concern in their present condition. I would recommend that some improvement works be undertaken to improve the structural integrity of the roof which in turn will remove the risk of horizontal pressure being incorrectly applied to the external walls which can result in cracking as identified above at high levels on the external walls.

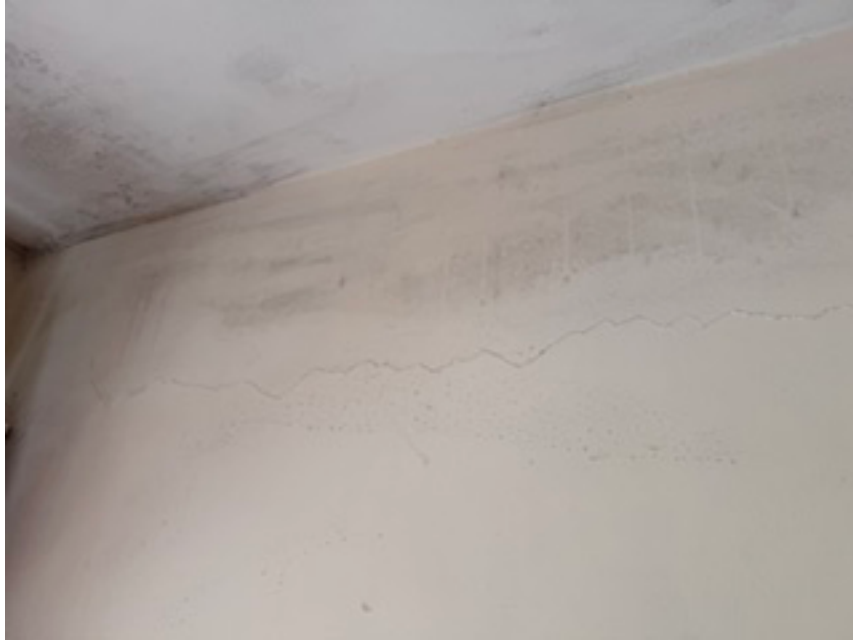
- Slight plaster crack internally at this front left corner location.

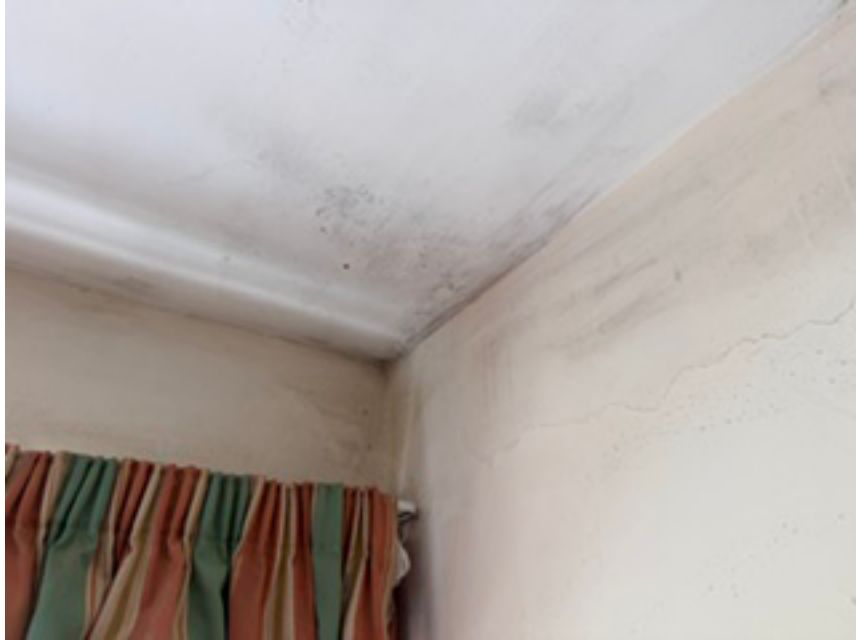
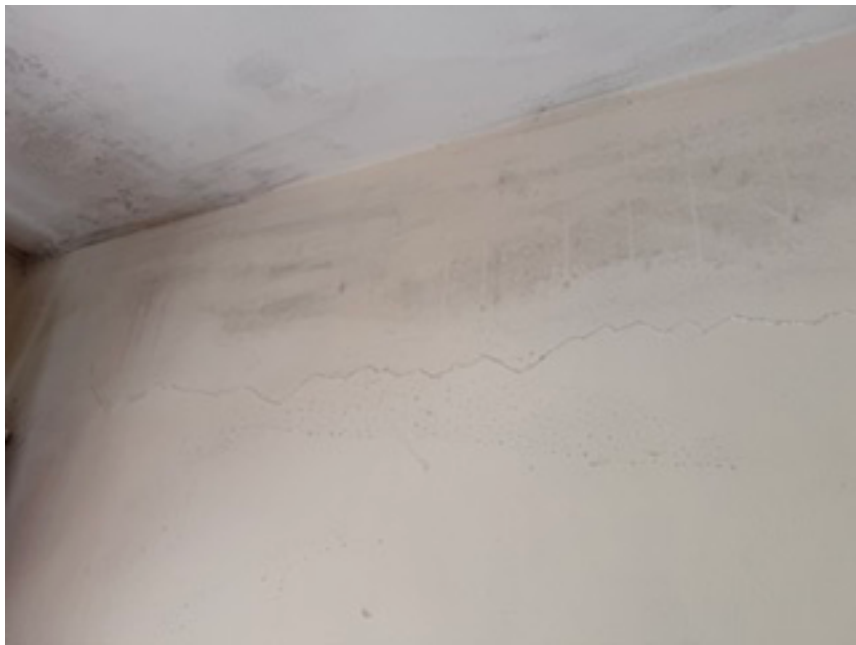
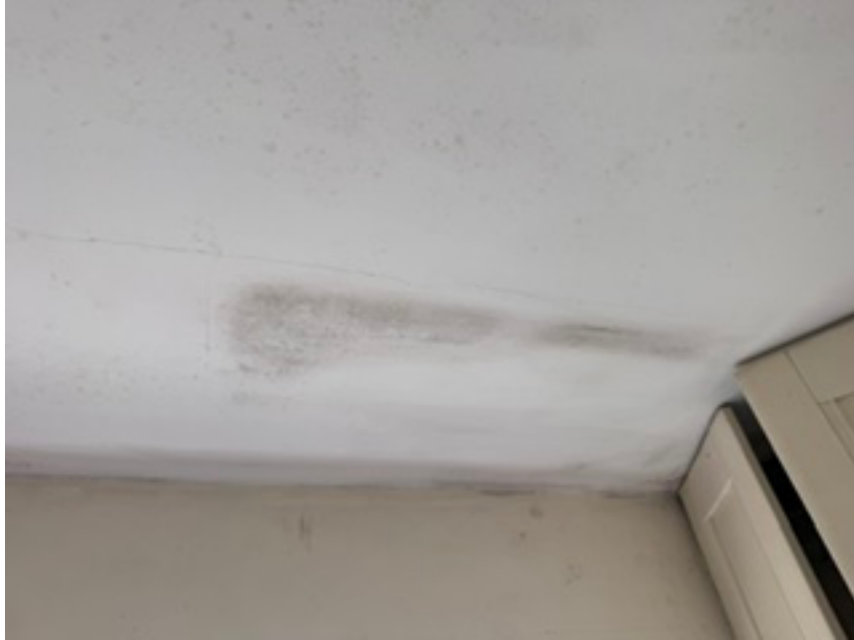
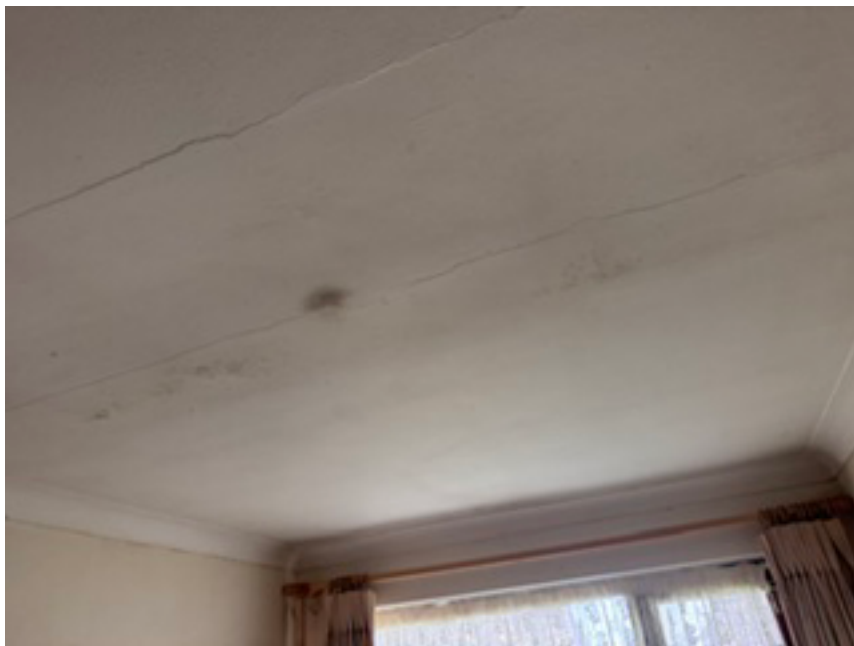
There are extensive issues with fungus attack in the dwelling on walls and ceilings.

If there was a RH of 70 to 85% in the property there would be significant problems with mould growth on the walls and ceilings, which is occurring in the dwelling. This might have occurred from the dwelling not being ventilated / insulated property and the risks are increased if moisture in the dwelling is high. The fungus growth should be treated, and the house should be kept ventilated. If the problem returns, then improvement works should be considered to improve the thermal properties of the dwelling.

There are no wall vents installed to the habitable rooms as per the requirements of Part F of the Building Regulations where improvement works should be considered / undertaken especially as the thermal values of the dwelling appear to have been improved.

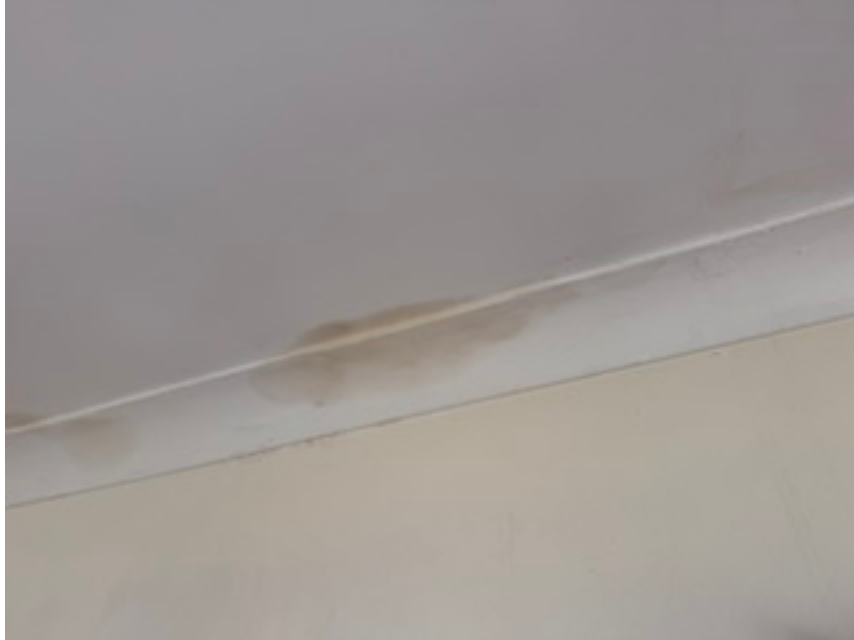
Moisture attack visible at chimney stack locations

The chimneys are of brickwork construction which increases the risk of moisture ingress issues. Leadwork has visible signs of repair. Further investigation works and repairs to the stacks should be undertaken to repair any issues that might be present. If the stacks are to be used the flues should be cleaned / inspected to ensure that re lining of the flues are not required. Any flue not in use should be suitably vented / protected.

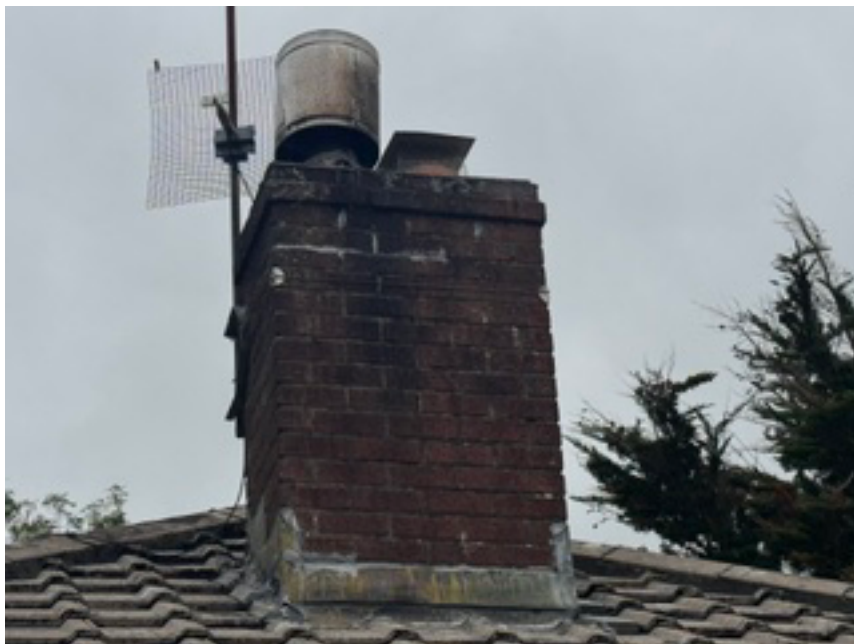
Aerial on left hand chimney should be removed / re located

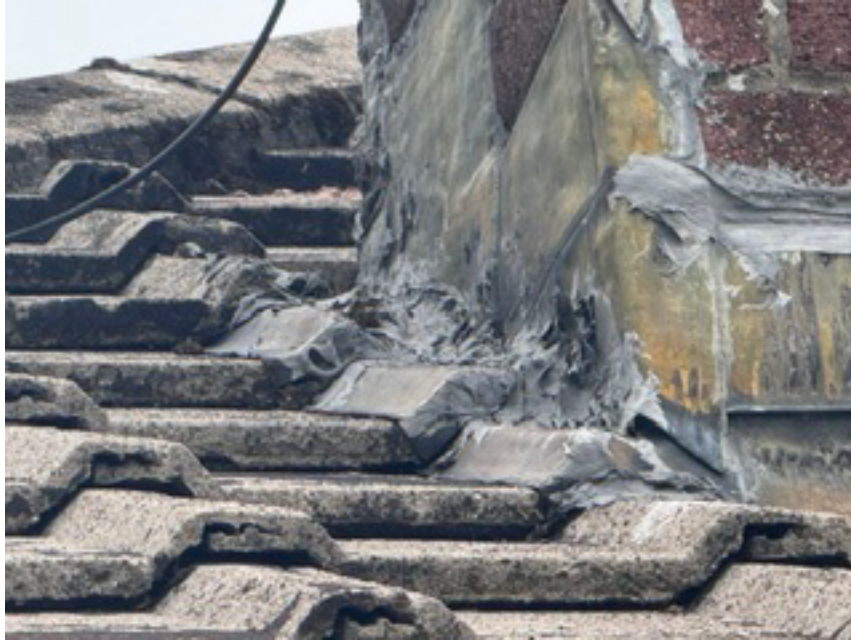
**Evidence of repairs to leadwork at each chimney**

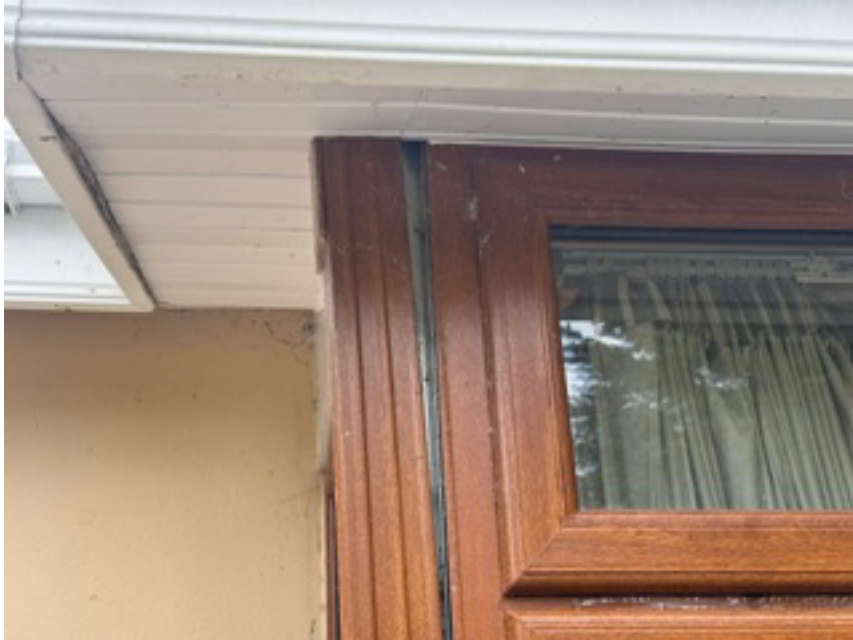
PVC cladding to structural pole is failing at front and needs repair.

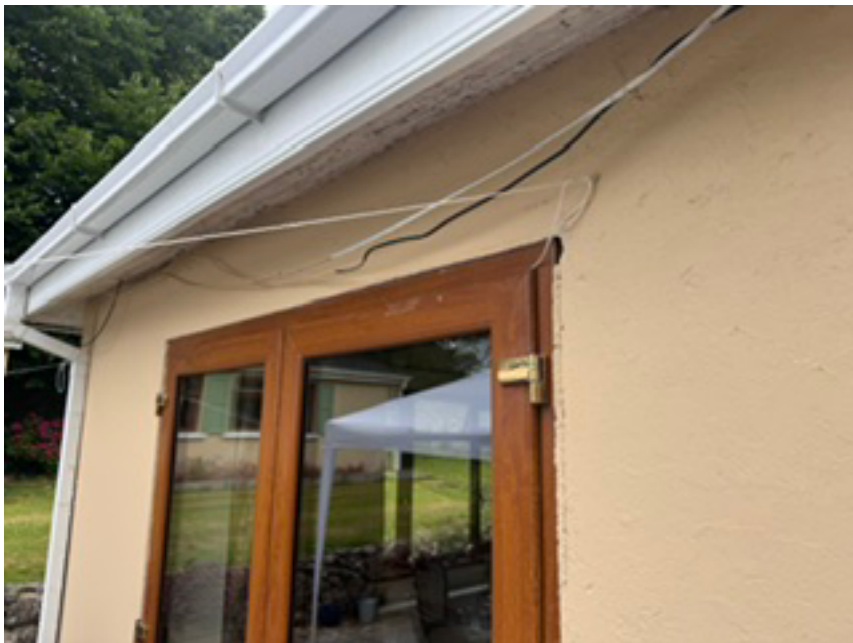
The gable doors are not installed correctly at cavity wall location and repairs / improvement works at this location should be undertaken.

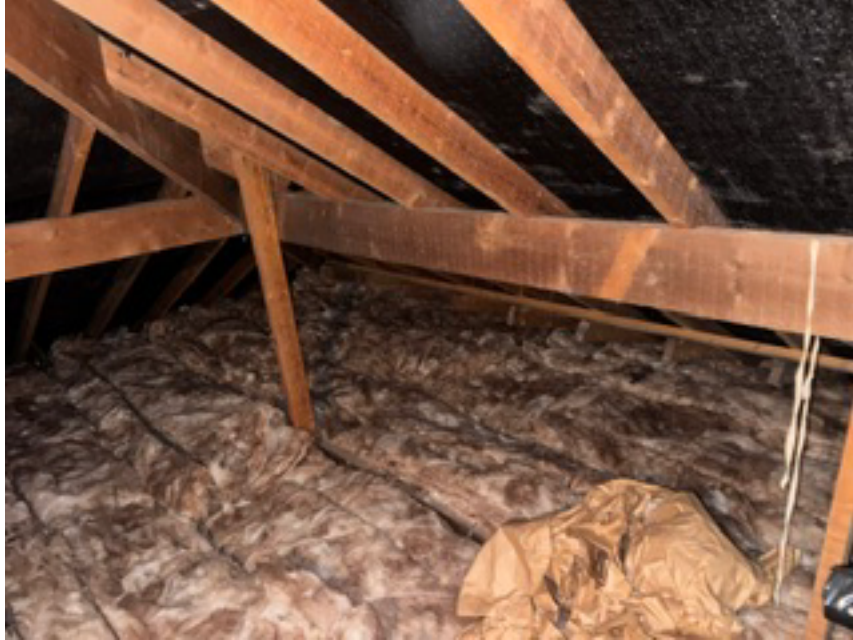
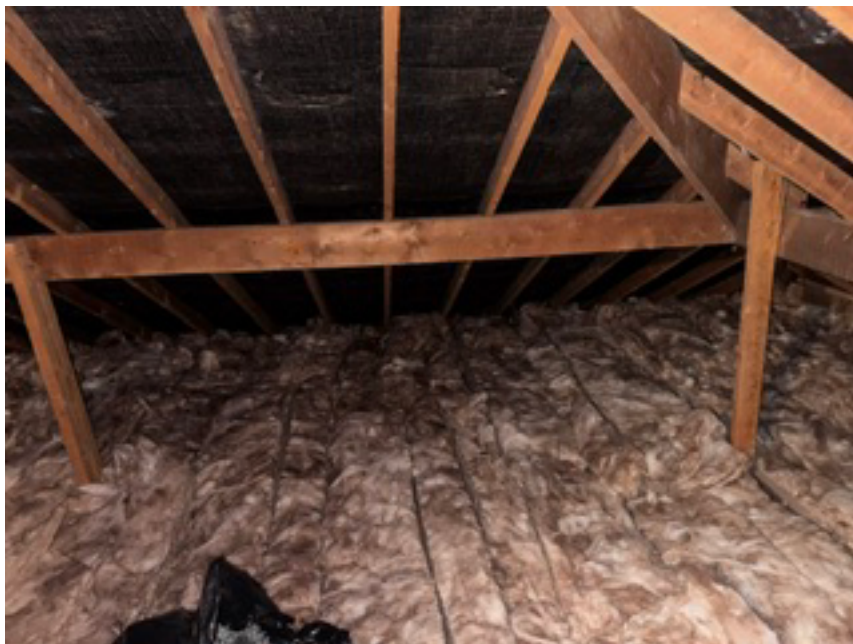
Lack of support to purlins should be improved to improve the structural integrity of the roof

The purlins are poorly supported where improvement works should be considered / undertaken as part of any future works to the dwelling. At some locations there is a lack of collars where improvement works should be considered. The joists are not available for inspection.

I would recommend that some additional supports are installed vertically under the hip / valley rafters to give some additional support to these rafters.

The issues with a lack of support that is in place to the roof structure creates a situation where loadings might be incorrectly applied to the load bearing walls and I would recommend that the structure of the roof is suitably improved as briefly outlined above to remove this risk. All structural improvement works should be supervised by a suitably qualified engineer.

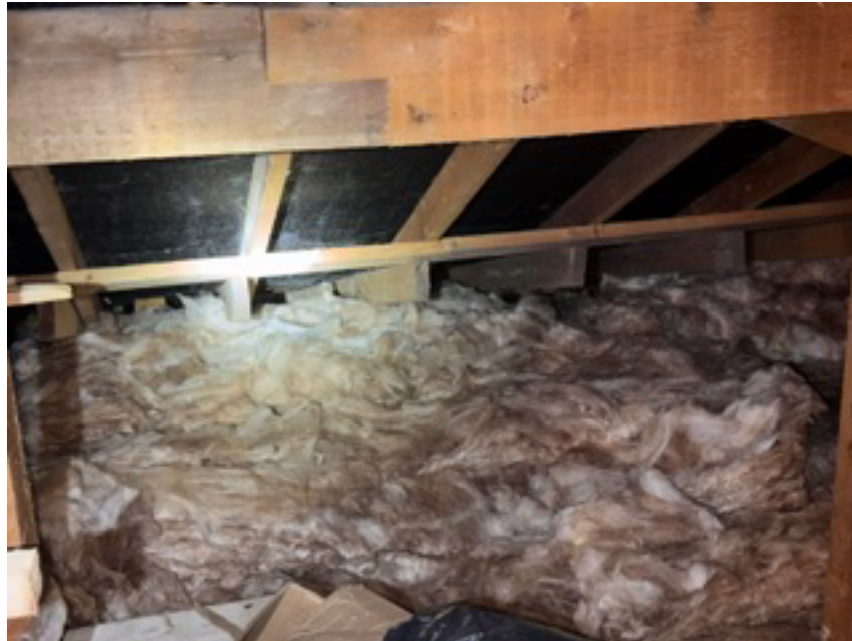
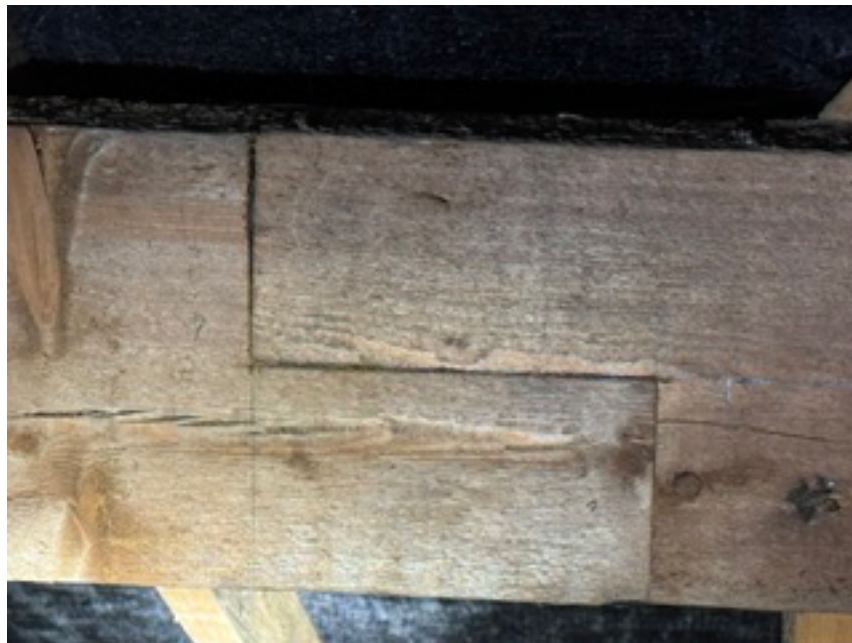
The joists on the purlins are visually in good condition and visually structurally the roof is generally in good condition.

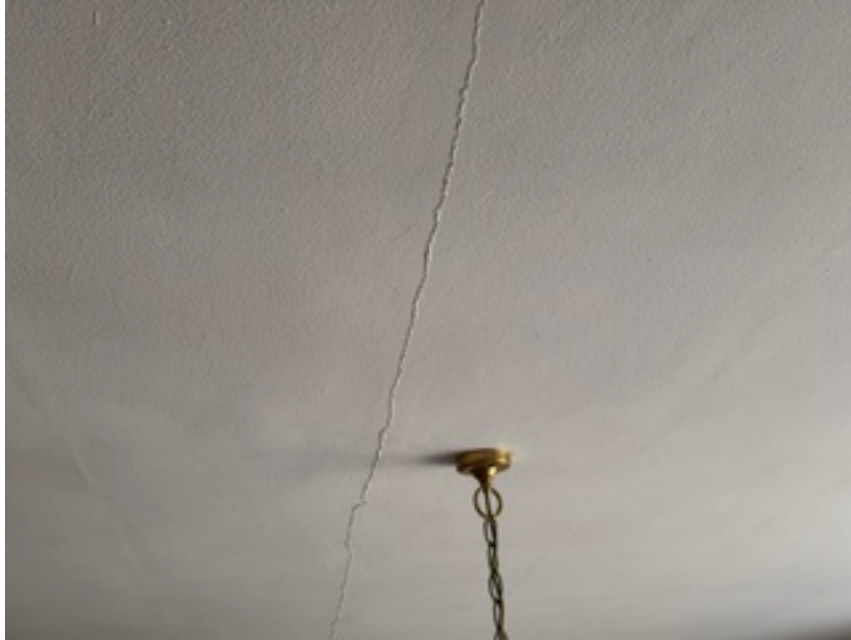
There are plaster cracks present on ceilings which might be related to loads being poor transferred to the joists creating moving / cracks in the ceilings which is not a structural concern, but where again improvement works to ensure that all supports for the purlins are being correctly supported at joist level might be required.

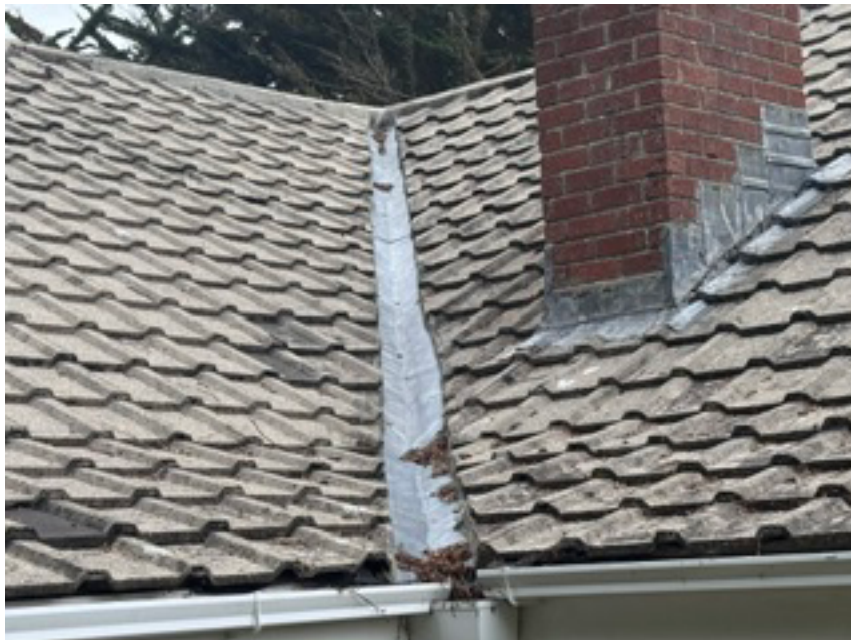
**Lead on valley at rear have very few laps on the lead which will increase the risk of creep / cracking and failure of the leadwork**

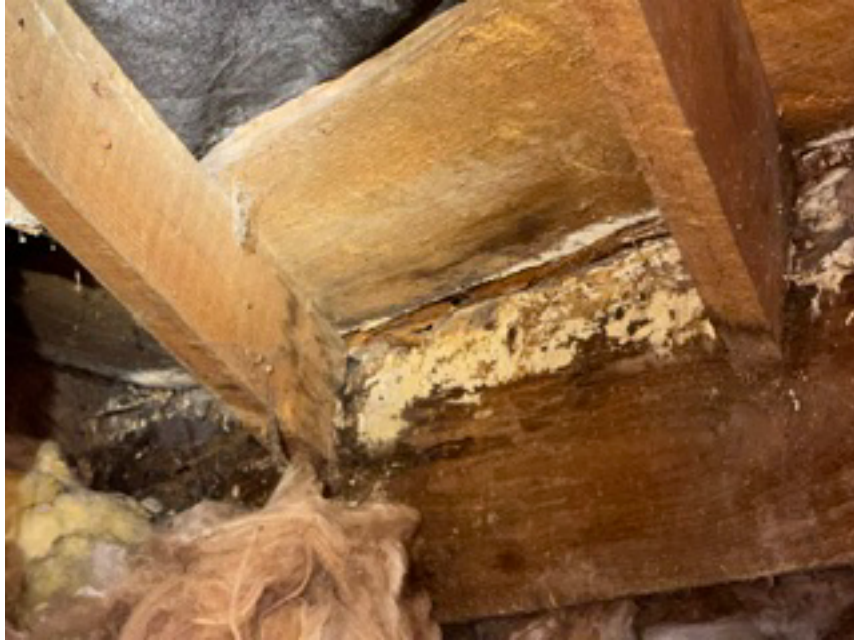
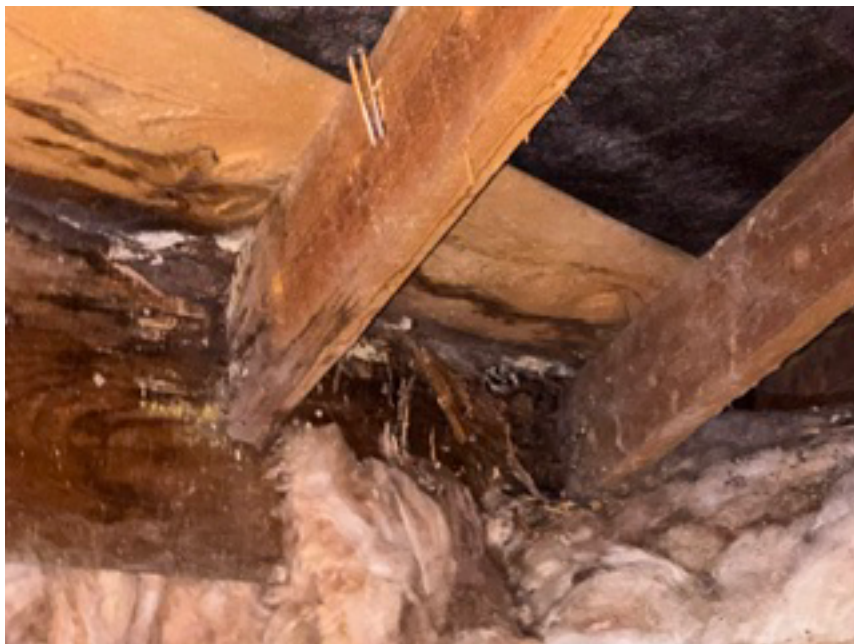
The valley at this location is damaged / decayed and structural repairs at this location are required

Repairs / improvement works to the chimney stacks and structural repairs to the rear valley of roof are required.

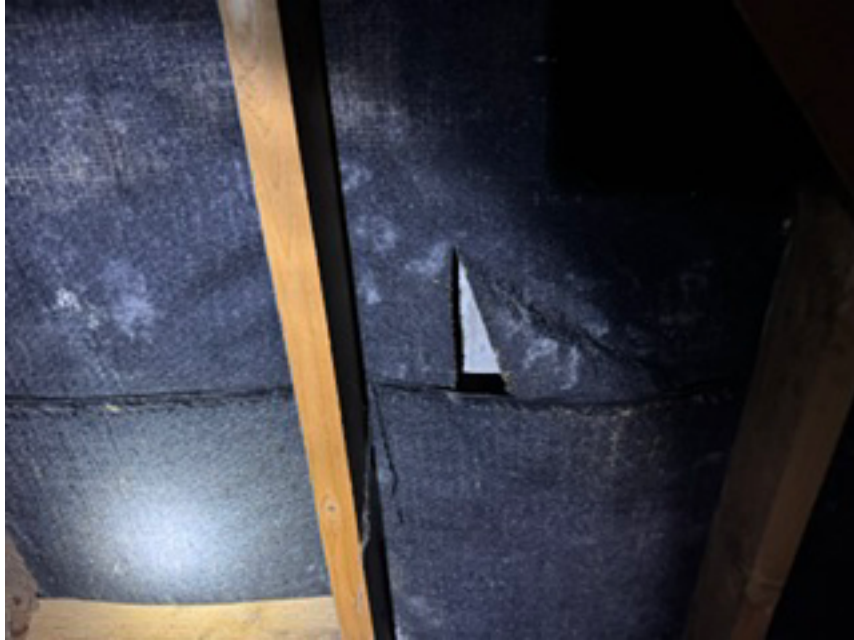
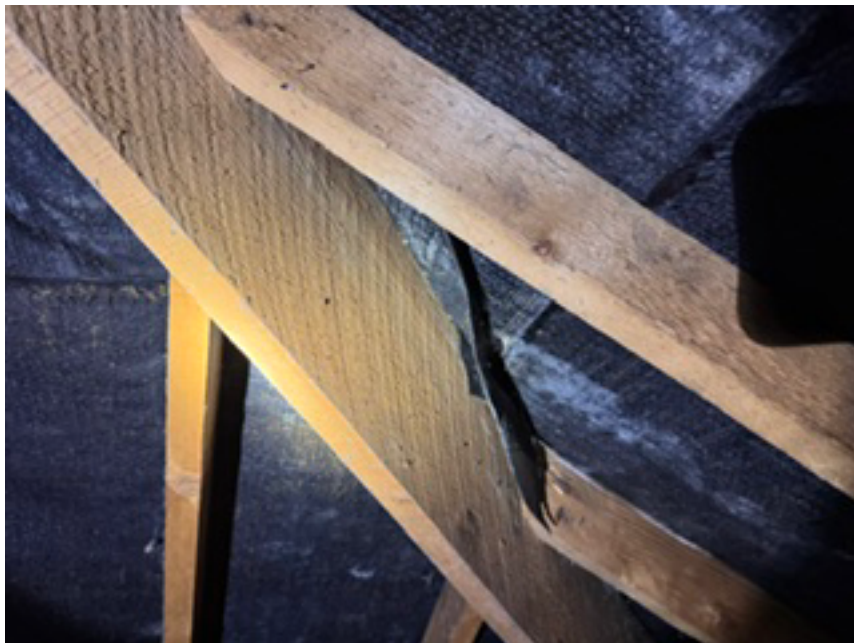
Felt on the roof is generally in good condition except for tears / issues at left side of dwelling where repairs / improvement works are required.

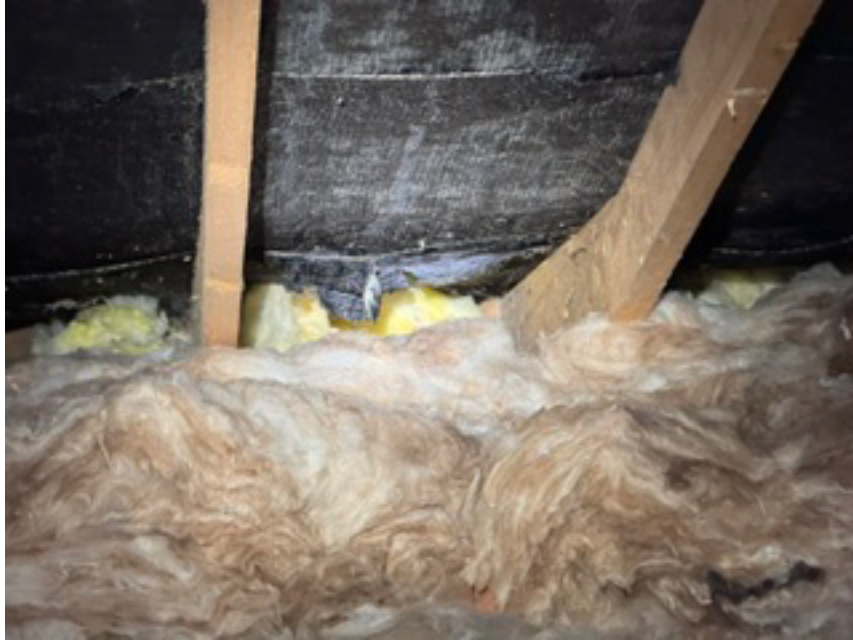
The attic has insulation in place where improvement works should be investigated at eaves locations. During these works the felt at these locations should be inspected as there is a risk that the felt at these flat / eaves locations might be suffering from decay and might be damaged.

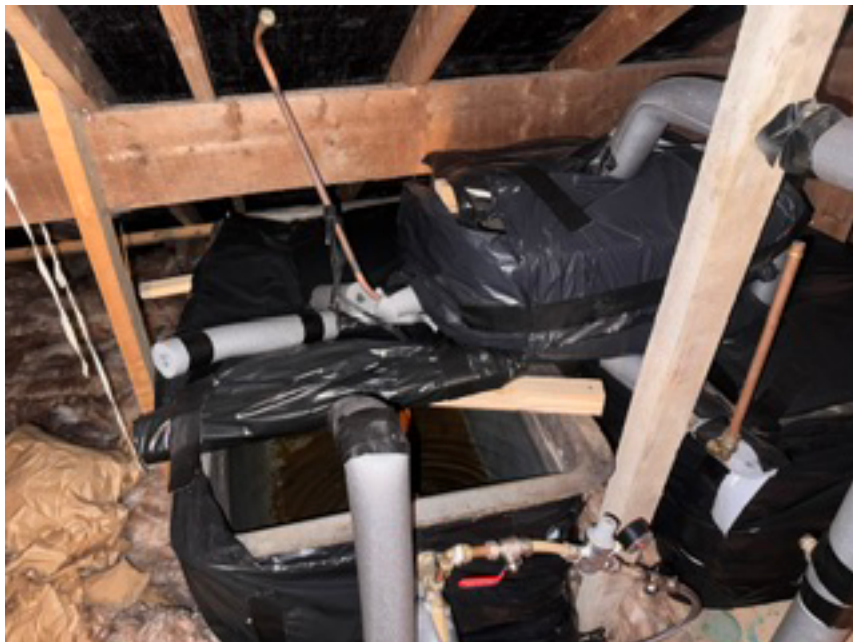
Water tanks are covered and insulated for protection and all pipework's appear to be lagged at areas that can be inspected.

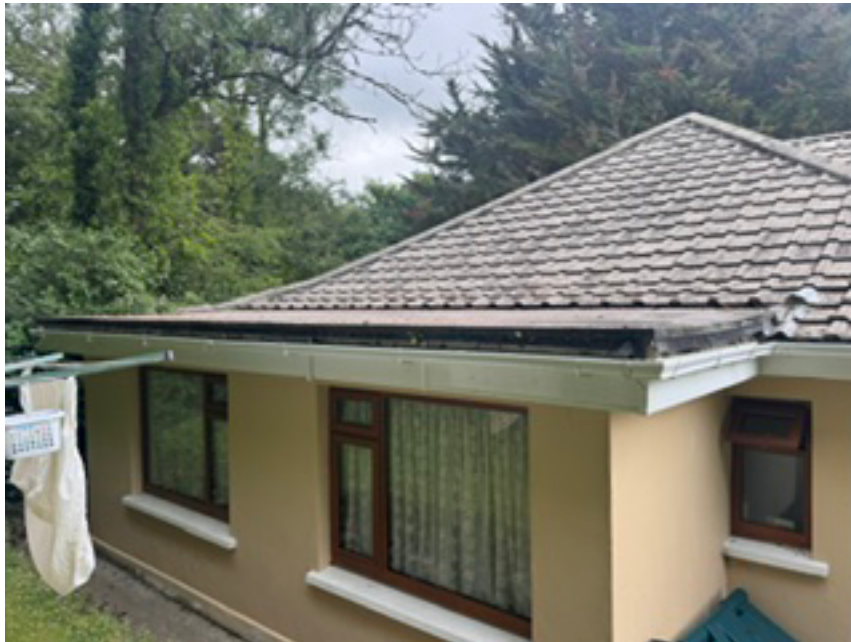
Flat roof to rear of dwelling the condition of which cannot be visually inspected. Fungus attack at this location internally is a sign of a lack of insulation and there will be a risk that these flat roof sections will require upgraded works when they are exposed in full as part of future renovation works to the dwelling.

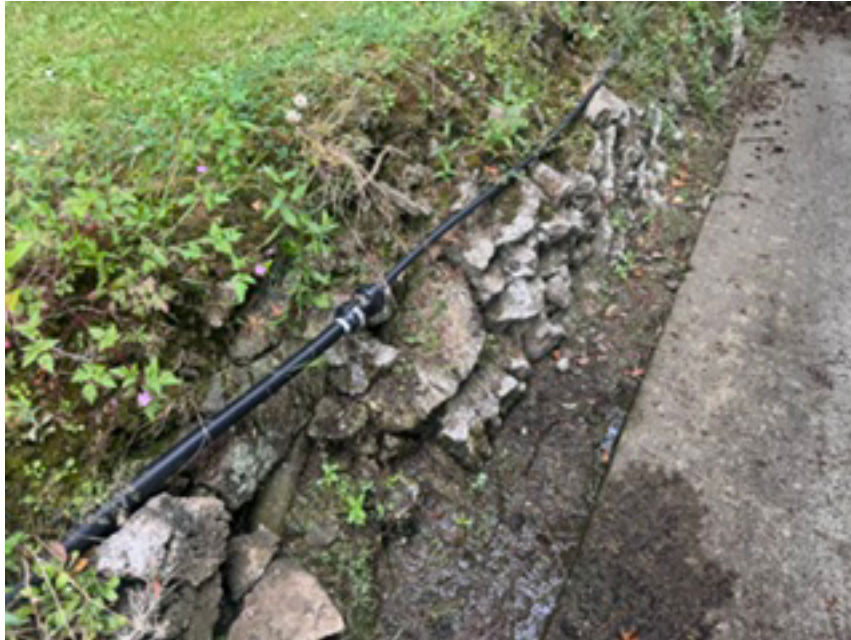
Water pipe exposed at rear of dwelling is large for a single dwelling and is leaking at the joint. All water pipes should be inspected / tested as part of future works to qualify the condition of the pipework's installed.

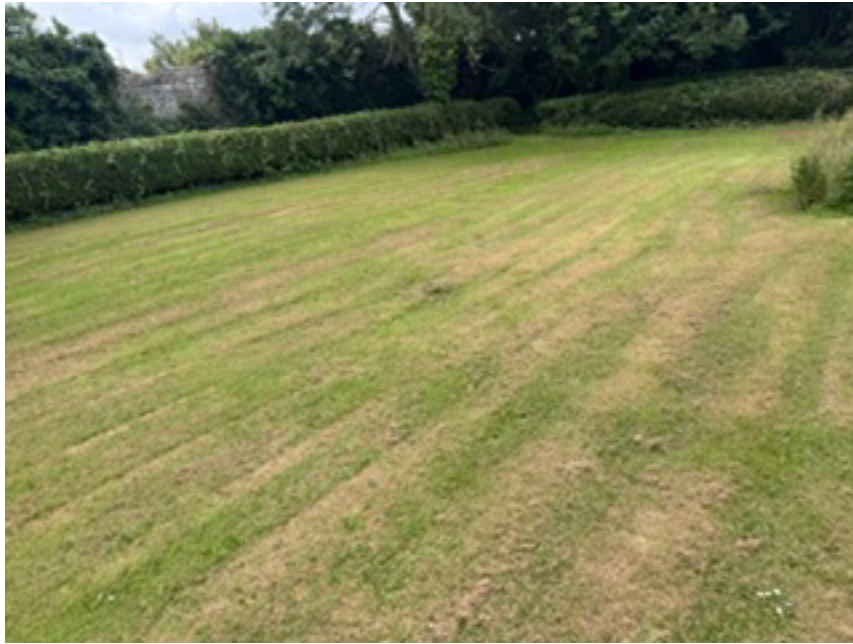
Foul system is discharged to a septic tank which we believe is located in the front lawn but is not visible and cannot be inspected.

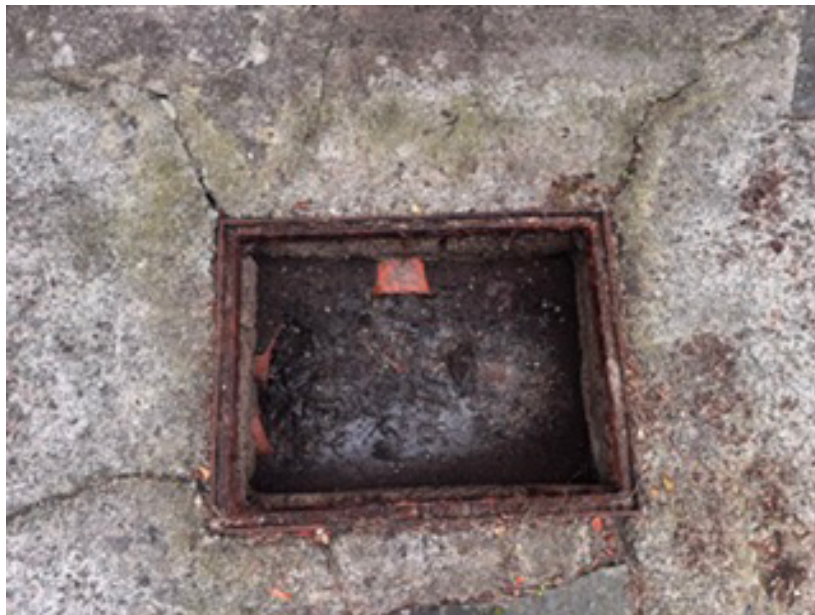
**Manhole at rear is full of effluent and cover needs repair**

I believe that that the drainage system that serves the dwelling will have to be upgraded as part of any future works to the property and planning permission for these works will be required.

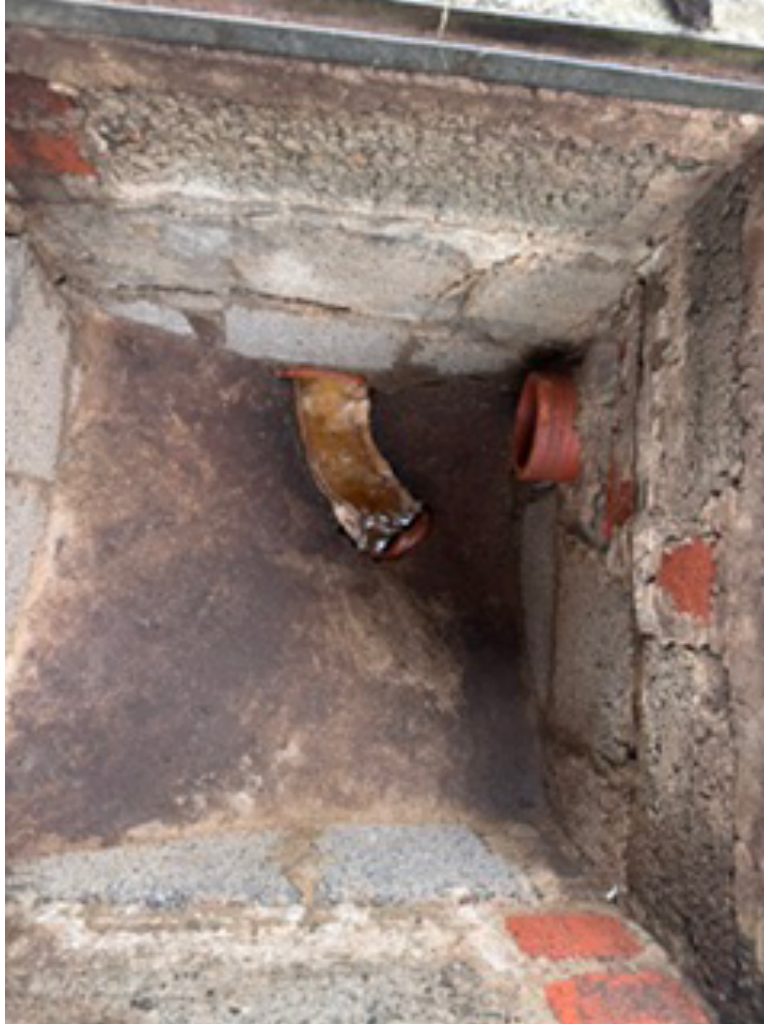
Manhole at front right corner is backed up and holding effluent

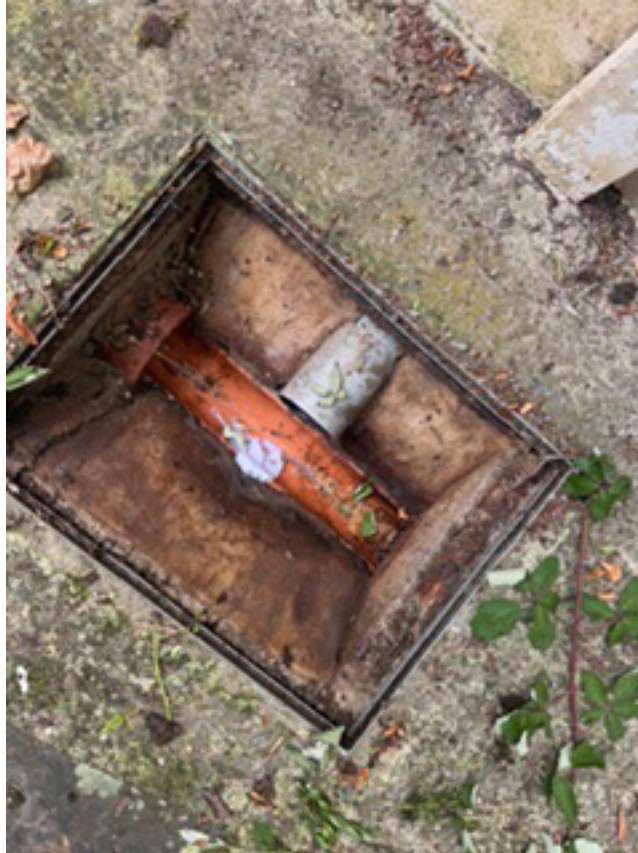
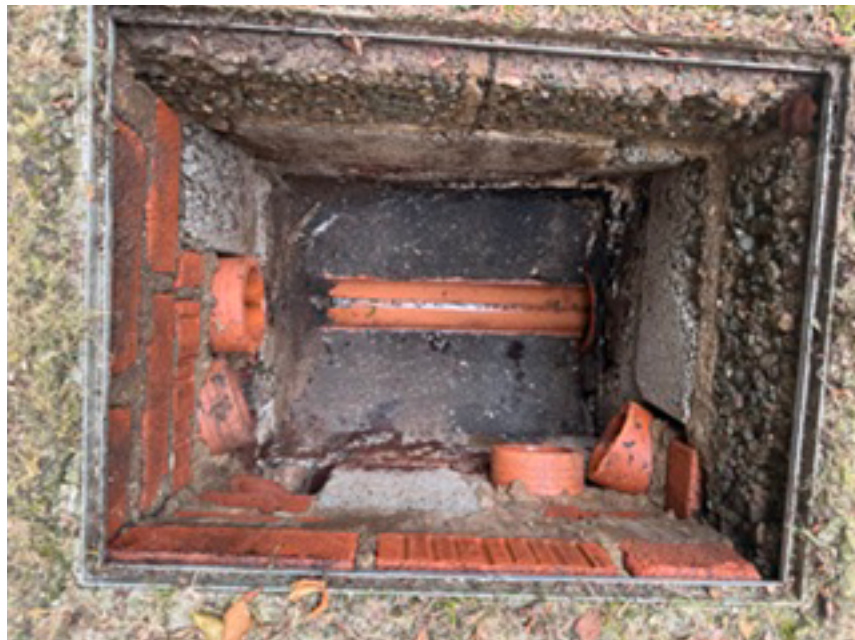
Higher manholes on right gable are clear and clean

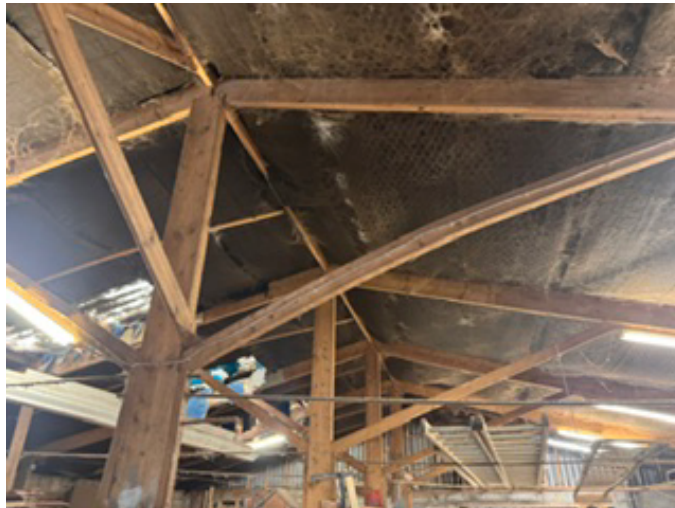
This shed has timber roof supports and single skin sheeting on roof. The structure of the shed is not fire protected which is a fire risk for the commercial unit. A survey of this unit was not undertaken, and the structure of this unit will need to be inspected / improved for the proposed future use of the unit.
