### **SURVEY, SAMPLING AND ASSESSMENT FOR ASBESTOS CONTAINING MATERIALS**

**Bailieborough Community School**

**CMETB**

**Report Date: September 2025**

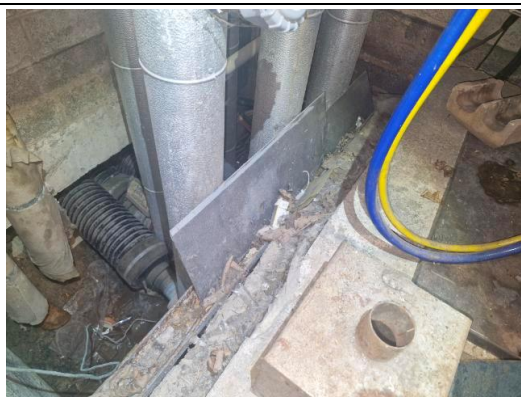
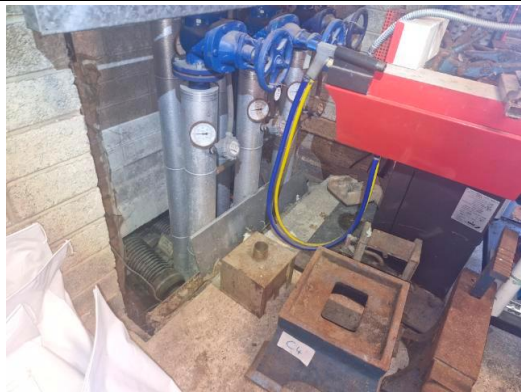
| Bailieborough Community School | | | | | | | |
|---|---|---|---|---|---|---|---|
| Ground Floor Boiler room near pipe work 001 - Loose slates: Cement Product - S003 | 2no | Chrysotile | Medium Damage | 5 | Remove under controlled conditions if works will interfere with the material. | 1 | September 2026 |

| Type | Chrysotile | |
| Material | Loose slates<br>Cement Product | |
| Location | Bailieborough Community School<br>Ground Floor Boiler room near<br>pipe work 001 | |
| Condition | Medium Damage | |

| Type | Chrysotile | |
|---|---|---|
| Recommendation | Remove under controlled<br>conditions if works will interfere<br>with the material. | |

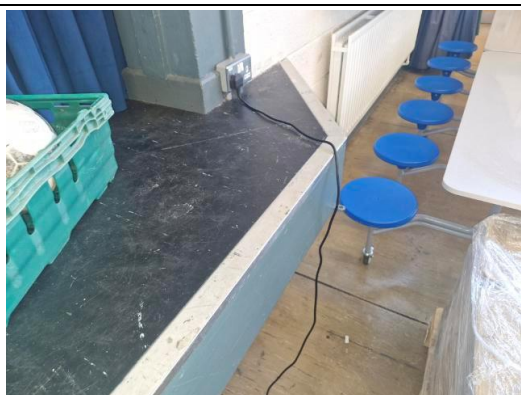
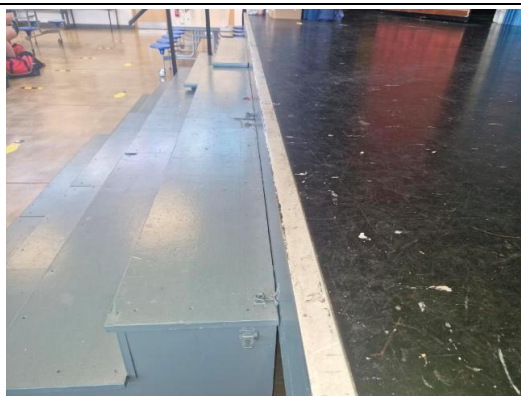
| Bailieborough Community School | | | | | | | |
|---|---|---|---|---|---|---|---|
| Ground Floor GP Hall stage 007 - Step nosing's: PVC / Reinforced Plastics - S005 | 8lin m | Chrysotile | Low Damage | 3 | Remove under controlled conditions if works will interfere with the material. | 1 | September 2026 |

| Type | Chrysotile | |
| Material | Step nosings<br>PVC / Reinforced Plastics | |
| Location | Bailieborough Community School<br>Ground Floor GP Hall stage 007 | |
| Condition | Low Damage | |

| Type | Chrysotile | |
|---|---|---|
| Recommendation | Remove under controlled<br>conditions if works will interfere<br>with the material. | |

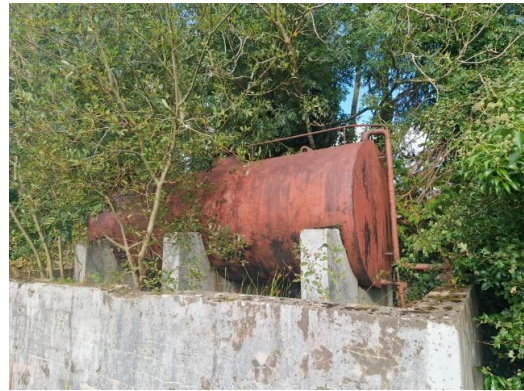
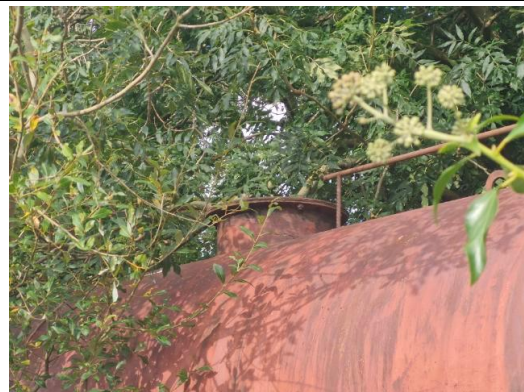
| Oil tank 2 | | | | | | | |
|---|---|---|---|---|---|---|---|
| External Tank lid 027 - Rope seal: Woven Product - Presumed | 1lin m | Chrysotile | Low Damage | 5 | Remove under controlled conditions if works will interfere with the material. | 1 | September 2026 |

| Type | Chrysotile |
|---|---|
| Condition | Low Damage |

| Type | Chrysotile |
|---|---|
| Recommendation | Remove under controlled conditions if works will interfere with the material. |

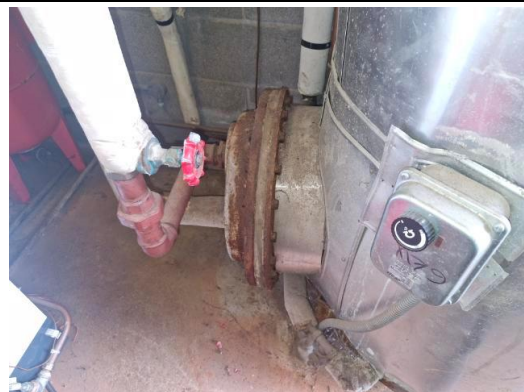
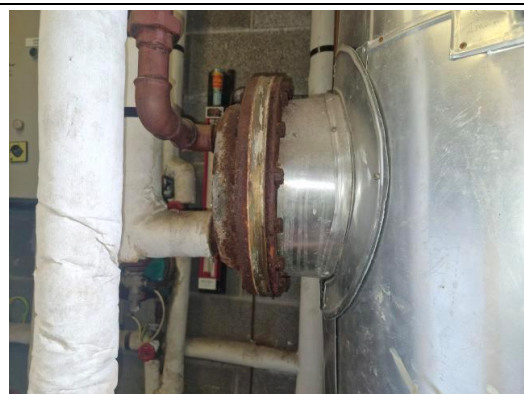
| Location and Use of Material | Quantity (Approx.) | Asbestos Type | Condition | Material Assessment | Recommended Action | Priority Assessment | Next Assessment |
|---|---|---|---|---|---|---|---|
| Ground Floor Boiler room 016 - Water tank gaskets: Gaskets (compressed) - S010 | 4no | Chrysotile | Medium Damage | 5 | Remove under controlled conditions if works will interfere with the material. | 1 | September 2026 |

| Type | Chrysotile |
| Material | Water tank gaskets<br>Gaskets (compressed) |
| Condition | Medium Damage |

| Type | Chrysotile |
|---|---|
| Recommendation | Remove under controlled conditions if works will interfere with the material. |

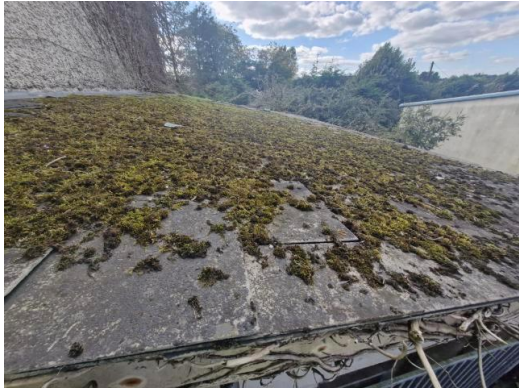
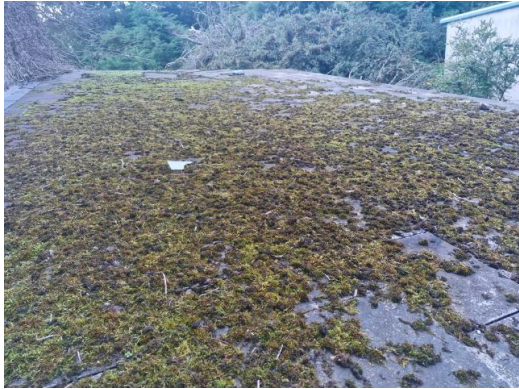
| Location and Use of Material | Quantity (Approx.) | Asbestos Type | Condition | Material Assessment | Recommended Action | Priority Assessment | Next Assessment |
|---|---|---|---|---|---|---|---|
| External Laundry building 022 - Rear lean too roof slates: Cement Product - S014 | 25m <sup>2</sup> | Chrysotile | Low Damage | 4 | Remove under controlled conditions if works will interfere with the material. | 1 | September 2026 |

| Type | Chrysotile | |
| Material | Rear lean too roof slates<br>Cement Product | |
| Location | Laundry Building<br>External Laundry building 022 | |
| Condition | Low Damage | |

| Type | Chrysotile | |
|---|---|---|
| Recommendation | Remove under controlled conditions if works will interfere with the material. | |

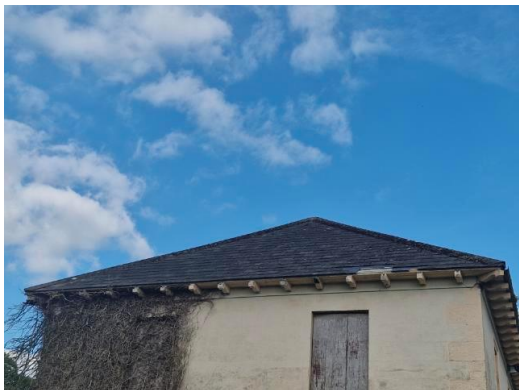
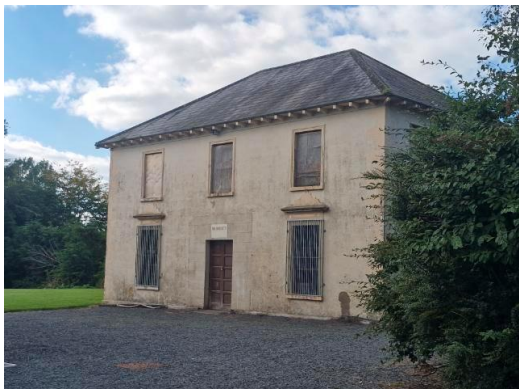
| Location and Use of Material | Quantity (Approx.) | Asbestos Type | Condition | Material Assessment | Recommended Action | Priority Assessment | Next Assessment |
|---|---|---|---|---|---|---|---|
| External Laundry Building Main roof 026 - Slates to side hip and possibly the rear: Cement Product - Strongly Presumed | Non quantifiable | Chrysotile | Medium Damage | 5 | Remove under controlled conditions if works will interfere with the material. | 1 | September 2026 |

| Type | Chrysotile | |
| Material | Slates to side hip and possibly the rear<br>Cement Product | |
| Location | Laundry Building<br>External Main roof 026 | |
| Condition | Medium Damage | |

| Type | Chrysotile | |
|---|---|---|
| Recommendation | Remove under controlled conditions if works will interfere with the material. | |
