### **SURVEY, SAMPLING AND ASSESSMENT FOR ASBESTOS CONTAINING MATERIALS**

**Beech Hill College  
Dublin Rd  
Co. Monaghan  
H18P997**

**CMETB**

**Report Date: September 2025**

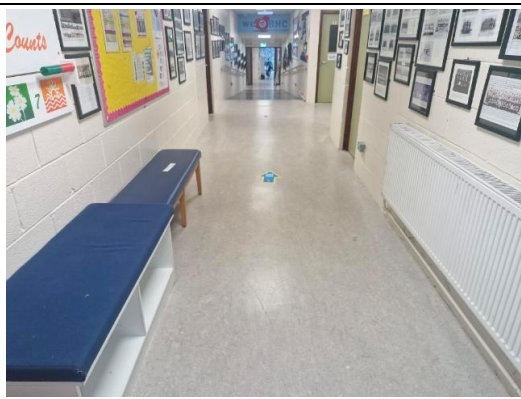
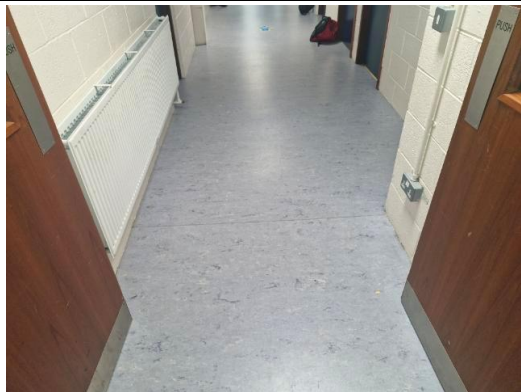
| Type | Chrysotile | |
| Material | Mastic beneath lino and screed<br>Bituminous Product | |
| Location | Beech Hill College<br>Ground Floor Corridors and<br>common areas 001 | |
| Condition | Low Damage | |
| Risk | Very Low | |

| Type | Chrysotile | |
|---|---|---|
| Recommendation | Remove under controlled<br>conditions if works will interfere<br>with the material. | |

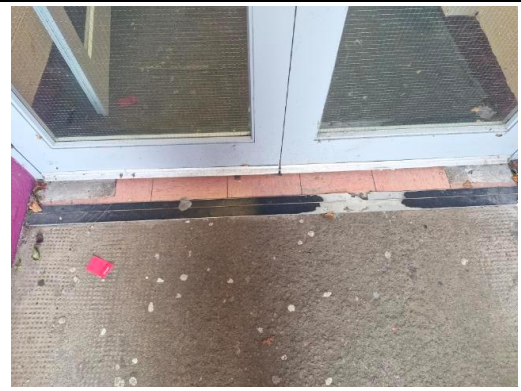
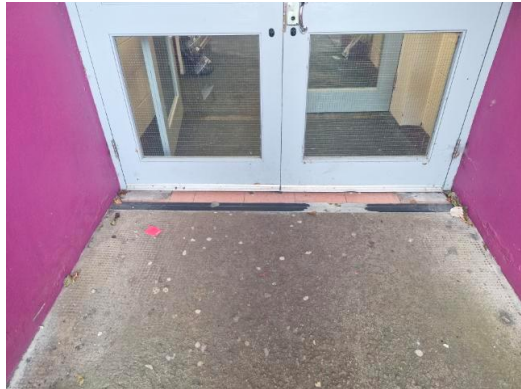
| Type | Chrysotile | |
|---|---|---|
| Sample No. | S007 | |

| Type | Chrysotile | |
| Material | Step nosings<br>PVC / Reinforced Plastics | |
| Location | Beech Hill College<br>Ground Floor Corridor exit doors<br>001 | |
| Condition | Medium Damage | |

| Type | Chrysotile | |
|---|---|---|
| Recommendation | Remove under controlled<br>conditions if works will interfere<br>with the material. | |

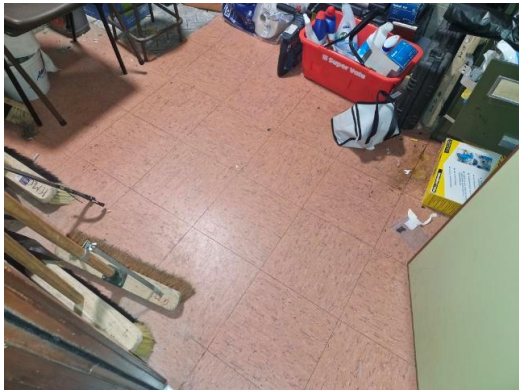
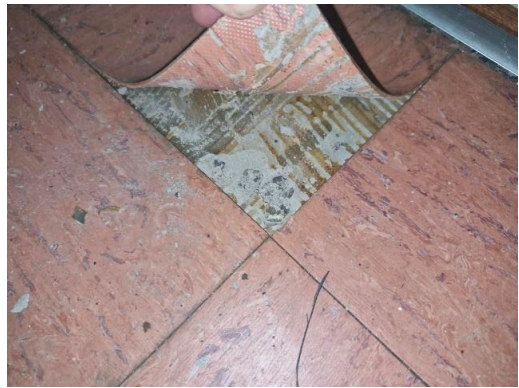
| Type | Chrysotile | |
|---|---|---|
| Sample No. | S001 | |

| Type | Chrysotile | |
| Material | Mastic on the floors beneath vinyl floor tiles and screed Bituminous Product | |
| Location | Beech Hill College Ground Floor Stores 003 | |
| Condition | Good Condition | |

| Type | Chrysotile | |
|---|---|---|
| Recommendation | Remove under controlled conditions if works will interfere with the material. | |

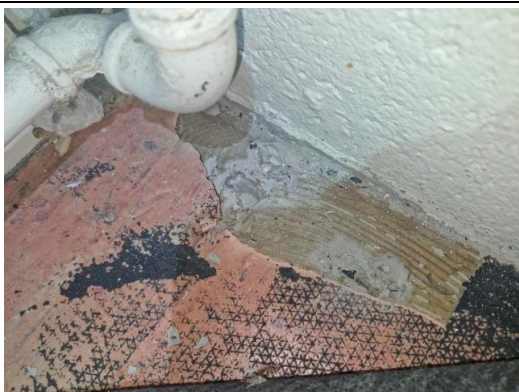
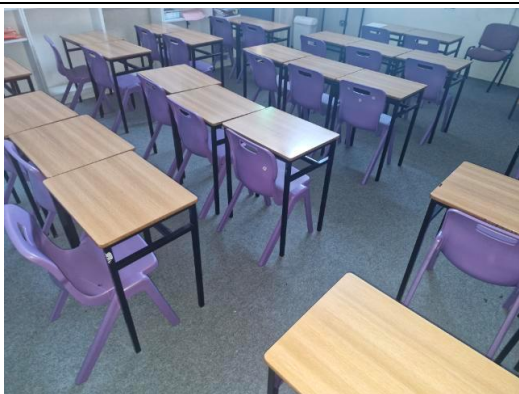
| Type | Chrysotile | |
|---|---|---|
| Sample No. | S002 | |

| Type | Chrysotile | |
| Material | Mastic beneath vinyl floor tiles,screed and carpet Bituminous Product | |
| Location | Beech Hill College Ground Floor Classrooms 004 | |
| Condition | Low Damage | |

| Type | Chrysotile | |
|---|---|---|
| Recommendation | Remove under controlled conditions if works will interfere with the material. | |

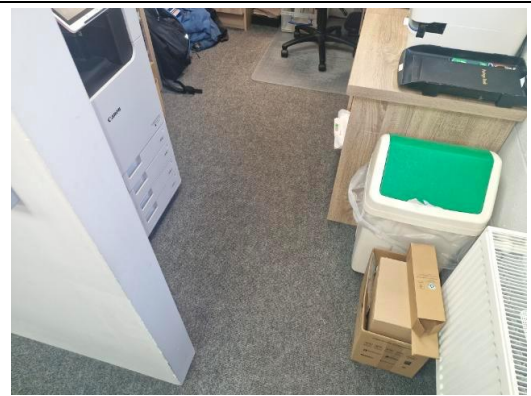
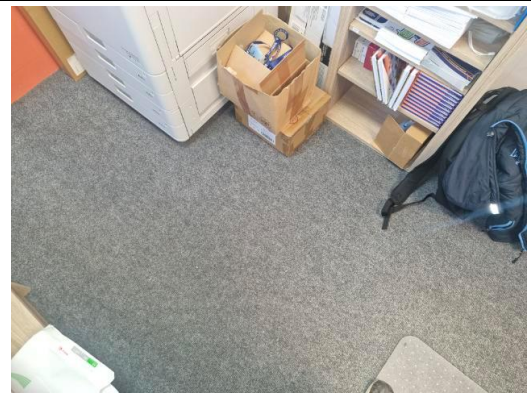
| Type | Chrysotile |
|---|---|
| Condition | Low Damage |
| Risk | Very Low |

| Type | Chrysotile |
|---|---|
| Recommendation | Remove under controlled conditions if works will interfere with the material. |

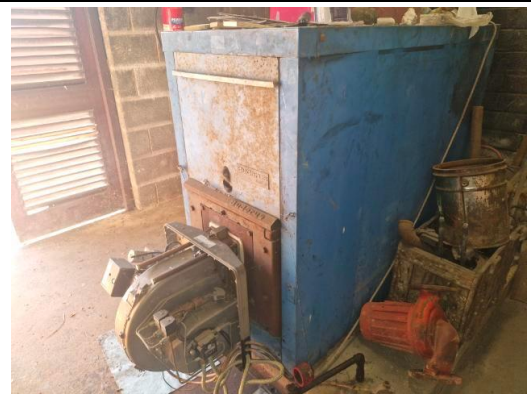
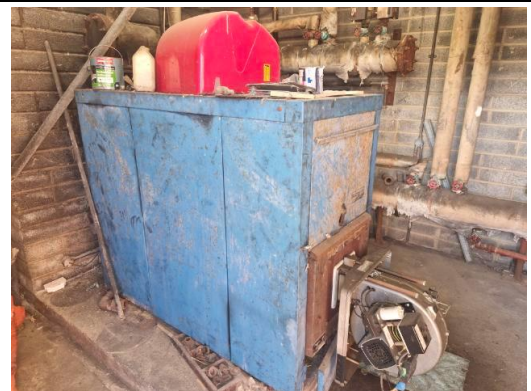
| Type | Chrysotile |
| Material | Boiler unit internals<br>Woven Product |
| Condition | Medium Damage |
| Risk | Low |

| Type | Chrysotile |
|---|---|
| Recommendation | Remove under controlled conditions if works will interfere with the material. |

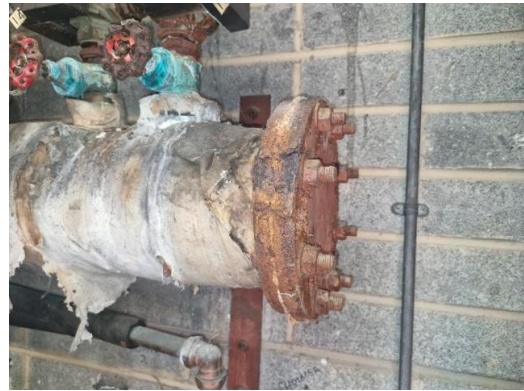
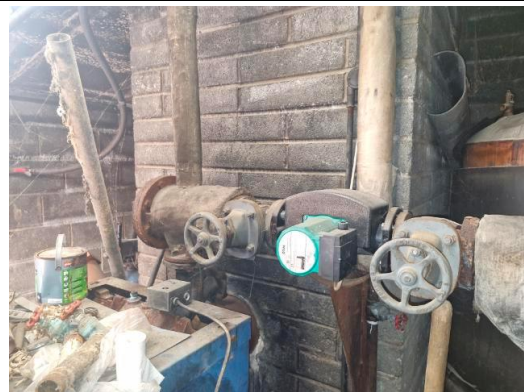
| Type | Chrysotile |
|---|---|
| Condition | Low Damage |
| Risk | Very Low |

| Type | Chrysotile |
|---|---|
| Recommendation | Remove under controlled conditions if works will interfere with the material. |

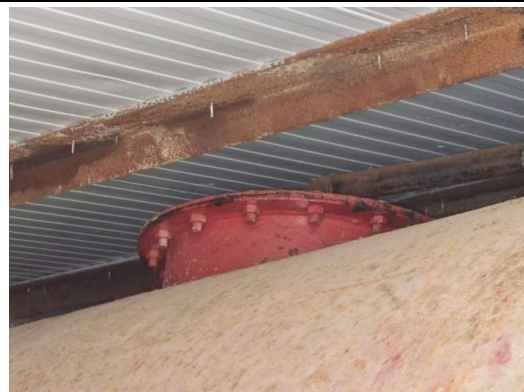
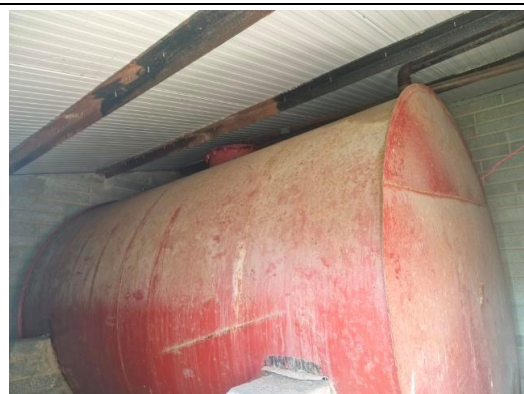
| Type | Chrysotile |
| Material | Rope seal to the lid<br>Woven Product |
| Condition | Low Damage |
| Risk | Low |

| Type | Chrysotile |
|---|---|
| Recommendation | Remove under controlled conditions if works will interfere with the material. |

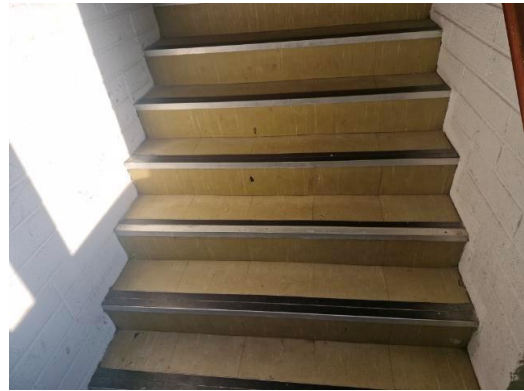
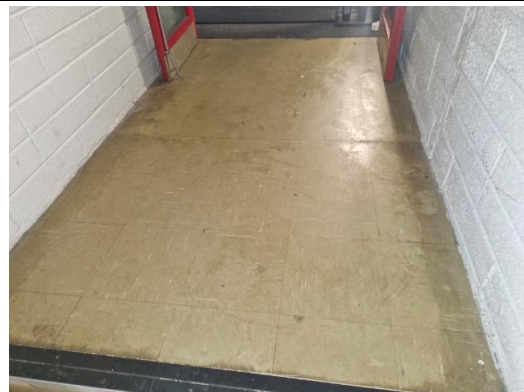
| Type | Chrysotile |
|---|---|
| Condition | Low Damage |
| Risk | Very Low |

| Type | Chrysotile |
|---|---|
| Recommendation | Remove under controlled conditions if works will interfere with the material. |

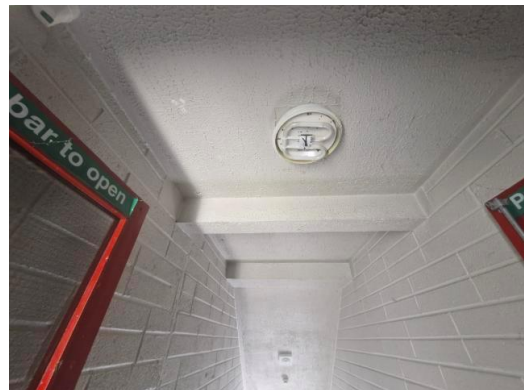
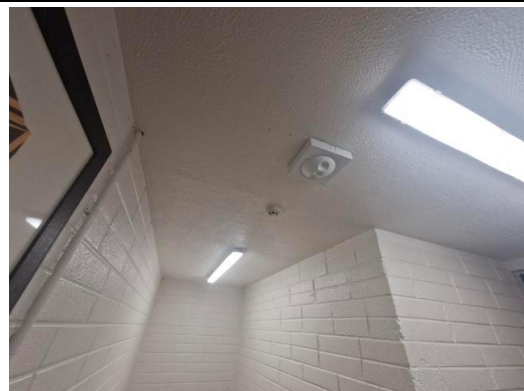
| Type | Chrysotile |
| Material | Insulation boards<br>Insulating Board |
| Condition | Low Damage |
| Risk | Low |

| Type | Chrysotile |
|---|---|
| Recommendation | Remove under controlled conditions if works will interfere with the material. |

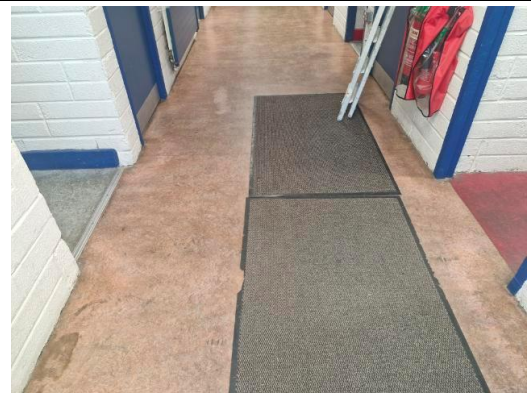
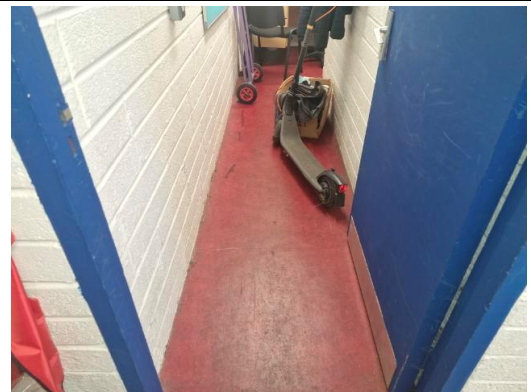
| Type | Chrysotile |
|---|---|
| Condition | Low Damage |
| Risk | Very Low |

| Type | Chrysotile |
|---|---|
| Recommendation | Remove under controlled<br>conditions if works will interfere<br>with the material. |

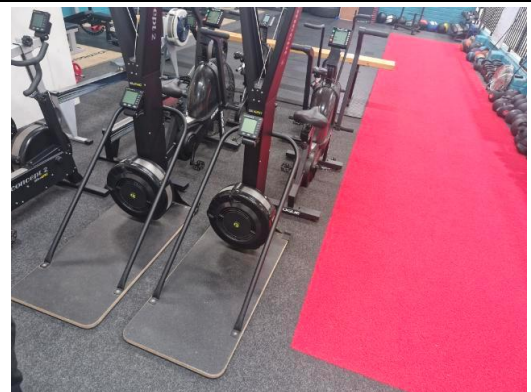
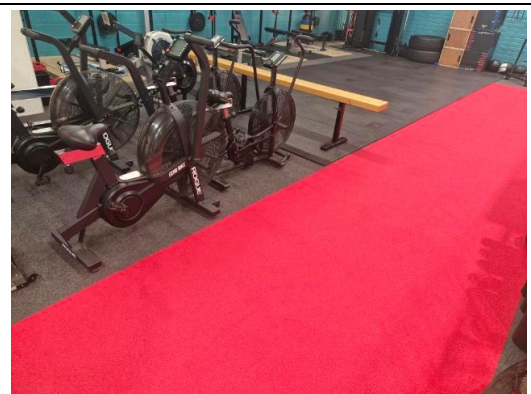
| Type | Chrysotile |
| Material | Mastic beneath carpet and<br>screed<br>Bituminous Product |
| Condition | Low Damage |
| Risk | Very Low |

| Type | Chrysotile |
|---|---|
| Recommendation | Remove under controlled<br>conditions if works will interfere<br>with the material. |

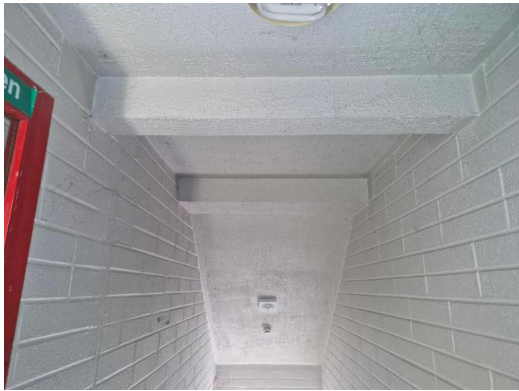
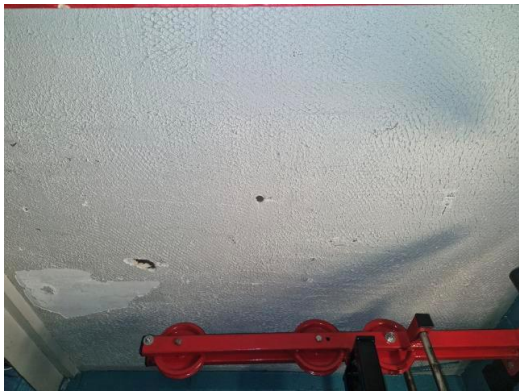
| Sample No. | S005 | |

| Type | Chrysotile | |
| Material | Textured coating | |
| Location | Sports hall<br>Ground & 1st Floor Staircase and mezzanine 011 | |
| Condition | Low Damage | |

| Recommendation | Remove under controlled conditions if works will interfere with the material. | |
