### **SURVEY, SAMPLING AND ASSESSMENT FOR ASBESTOS CONTAINING MATERIALS**

**Breifne College  
Cootehill Road  
Cullies  
Co. Cavan**

**BOM Breifne College**

**Report Date: June 2023**

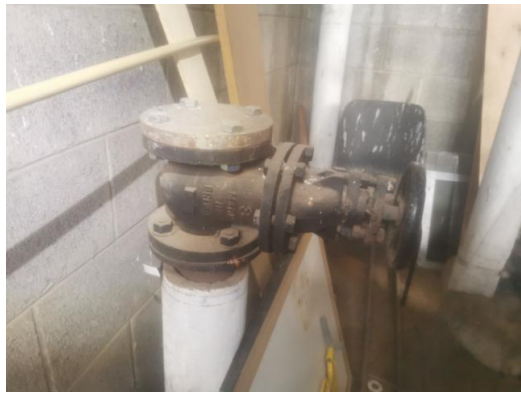
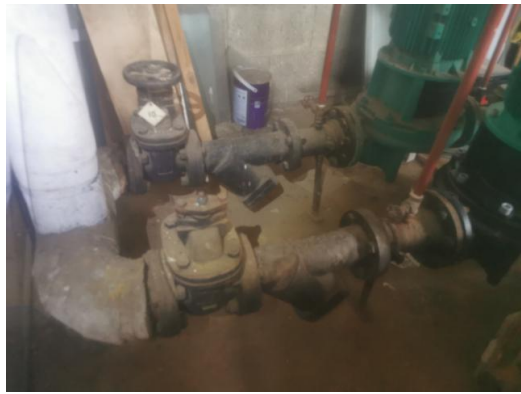
| Breifne College | | | | | | | |
|---|---|---|---|---|---|---|---|
| Ground Floor Boiler room 004 - Old pipe flange gaskets: Gaskets (compressed) - S006 | 26no | Chrysotile | Medium Damage | 5 | Remove under controlled conditions. | 1 | June 2024 |

| Type | Chrysotile | |
|---|---|---|
| Material | Old pipe flange gaskets<br>Gaskets (compressed) | |
| Location | Breifne College<br>Ground Floor Boiler room 004 | |
| Condition | Medium Damage | |

| Type | Chrysotile | |
|---|---|---|
| Recommendation | Remove under controlled conditions. | |

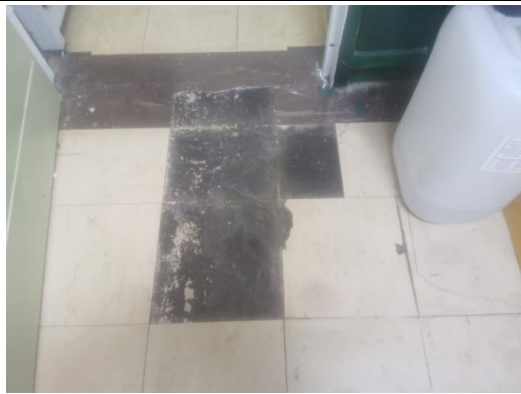
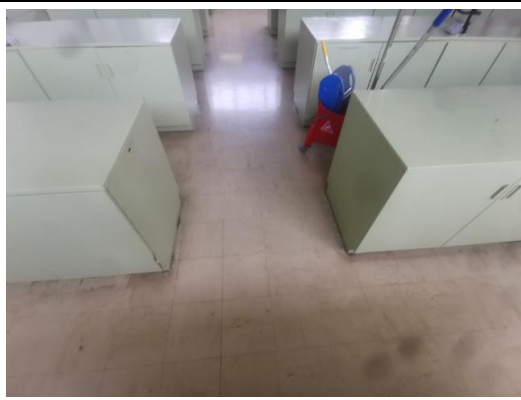
| Breifne College | | | | | | | |
|---|---|---|---|---|---|---|---|
| Ground Floor Science labs and prep rooms 005 - Mastic to vinyl floor tiles: Bituminous Product - S007 | 200m <sup>2</sup> | Chrysotile | Medium Damage | 5 | Remove under controlled conditions. | 1 | June 2024 |

| Type | Chrysotile | |
|---|---|---|
| Material | Mastic to vinyl floor tiles<br>Bituminous Product | |
| Location | Breifne College<br>Ground Floor Science labs and<br>prep rooms 005 | |
| Condition | Medium Damage | |

| Type | Chrysotile | |
|---|---|---|
| Recommendation | Remove under controlled conditions. | |

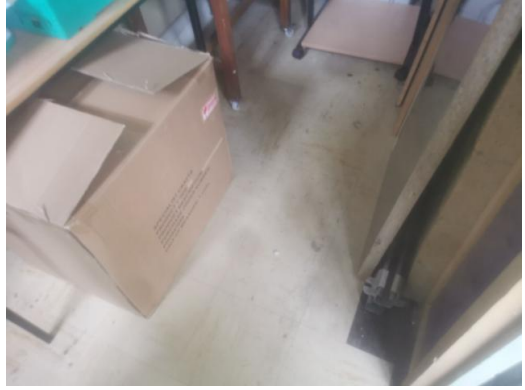
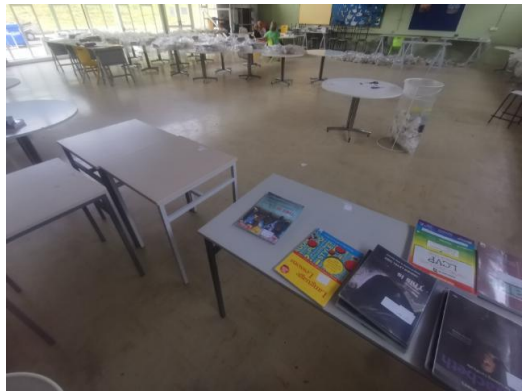
| Breifne College | | | | | | | |
|---|---|---|---|---|---|---|---|
| Ground Floor Room 3a and 3b and stores 007 - Mastic to vinyl floor tiles: Bituminous Product - S011 | 160m <sup>2</sup> | Chrysotile | Low Damage | 4 | Remove under controlled conditions. | 1 | June 2024 |

| Type | Chrysotile | |
|---|---|---|
| Material | Mastic to vinyl floor tiles<br>Bituminous Product | |
| Location | Breifne College<br>Ground Floor Room 3a and 3b<br>and stores 007 | |
| Condition | Low Damage | |

| Type | Chrysotile | |
|---|---|---|
| Recommendation | Remove under controlled conditions. | |

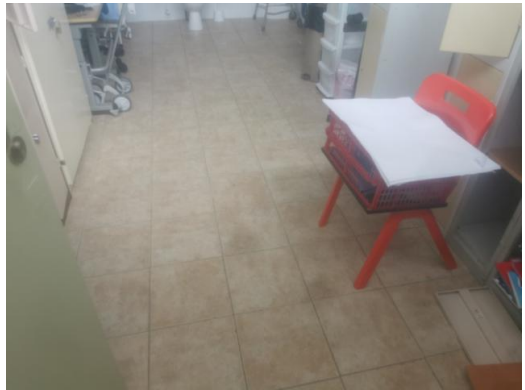
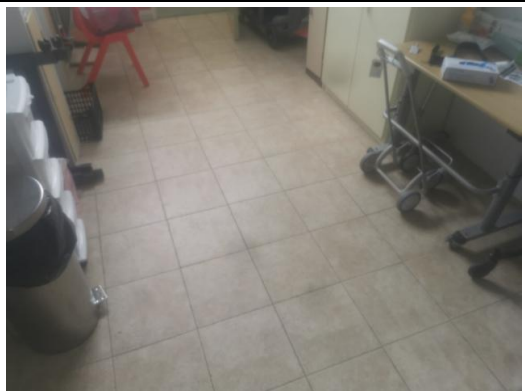
| Breifne College | | | | | | | |
|---|---|---|---|---|---|---|---|
| Ground Floor Disabled WC 011 - Mastic to vinyl floor tiles beneath ceramic tiles: Bituminous Product - Strongly Presumed | | Chrysotile | Low Damage | 4 | Remove under controlled conditions. | 1 | June 2024 |

| Type | Chrysotile | |
|---|---|---|
| Material | Mastic to vinyl floor tiles beneath<br>ceramic tiles<br>Bituminous Product | |
| Location | Breifne College<br>Ground Floor Disabled WC 011 | |
| Condition | Low Damage | |

| Type | Chrysotile | |
|---|---|---|
| Recommendation | Remove under controlled conditions. | |

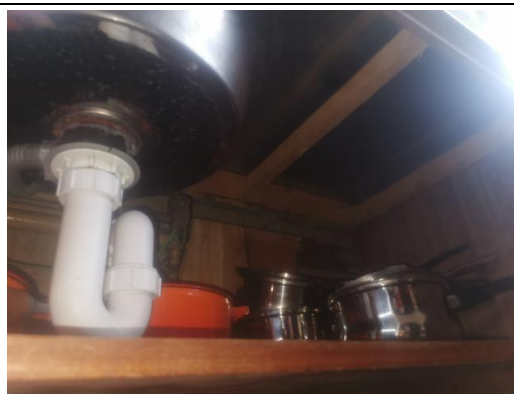
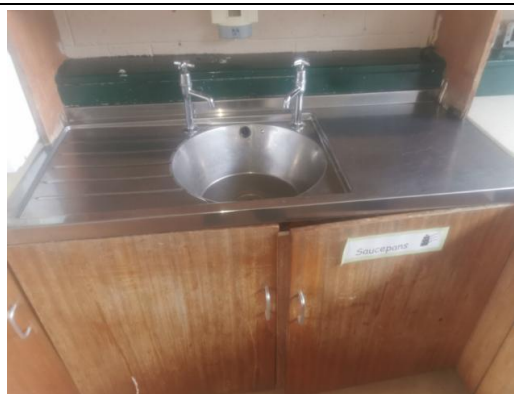
| Type | Chrysotile |
|---|---|
| Condition | Medium Damage |

| Type | Chrysotile |
|---|---|
| Recommendation | Remove under controlled<br>conditions. |

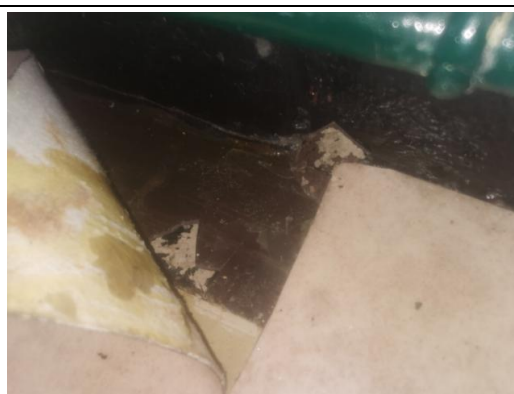
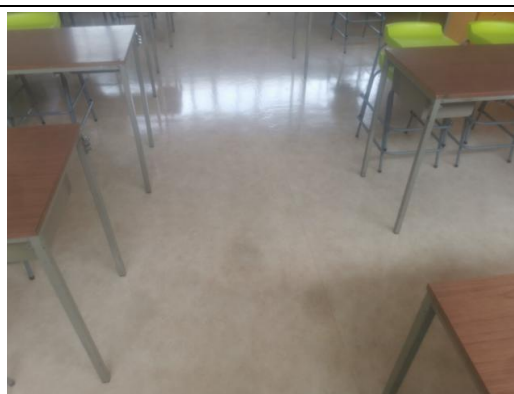
| Type | Chrysotile |
|---|---|
| Material | Mastic to vinyl floor tiles beneath<br>lino<br>Bituminous Product |
| Condition | Medium Damage |

| Type | Chrysotile |
|---|---|
| Recommendation | Remove under controlled<br>conditions. |

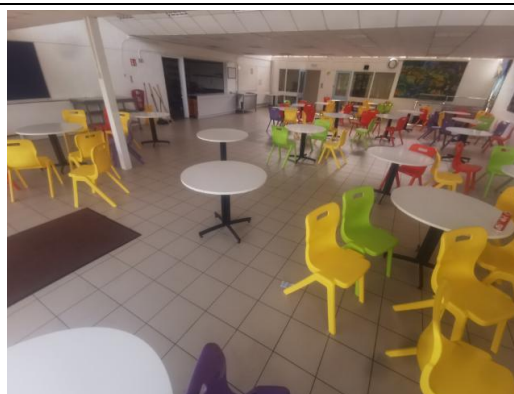
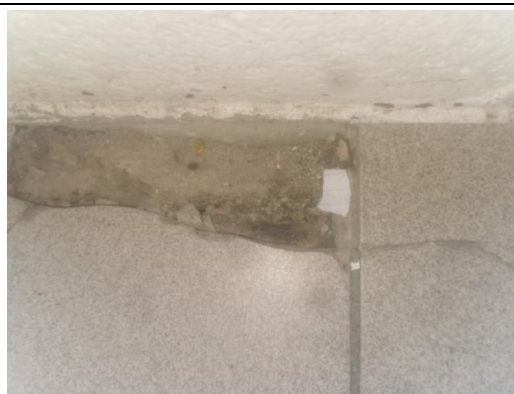
| Type | Chrysotile |
|---|---|
| Condition | Medium Damage |

| Type | Chrysotile |
|---|---|
| Recommendation | Remove under controlled conditions. |

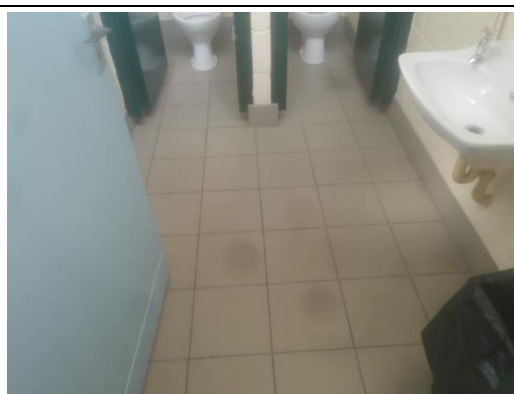
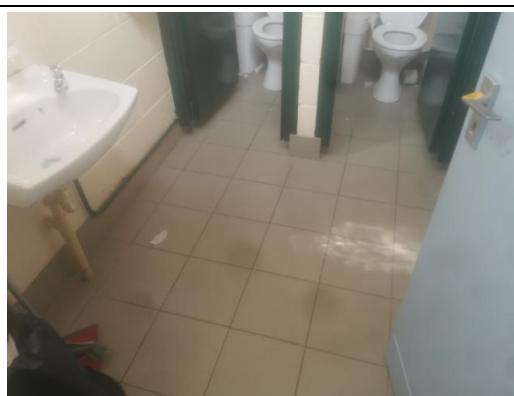
| Type | Chrysotile |
|---|---|
| Material | Mastic to vinyl floor tiles beneath ceramic tiles<br>Bituminous Product |
| Condition | Low Damage |

| Type | Chrysotile |
|---|---|
| Recommendation | Remove under controlled conditions. |

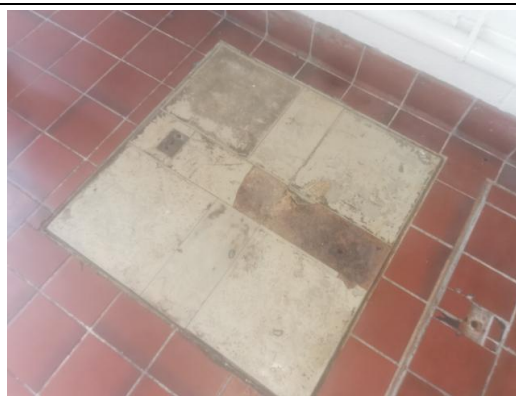
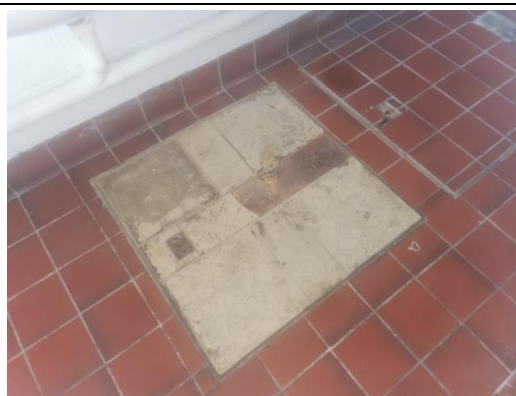
| Type | Chrysotile |
|---|---|
| Condition | High Damage |

| Type | Chrysotile |
|---|---|
| Recommendation | Remove under controlled conditions. |

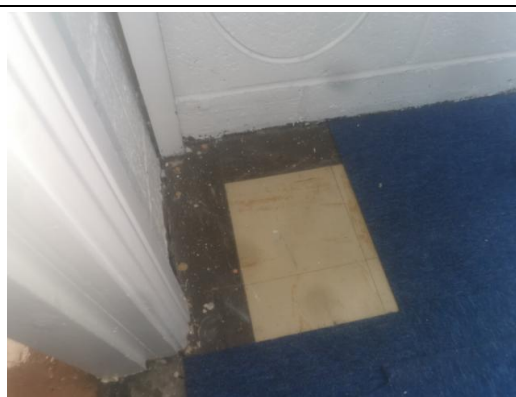
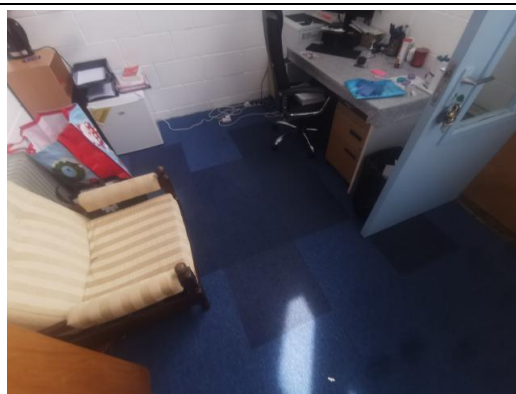
| Breifne College | | | | | | | |
|---|---|---|---|---|---|---|---|
| Ground Floor JCSP Office 018 - Mastic to the floors beneath carpet tiles: Bituminous Product - S018 | 5m <sup>2</sup> | Chrysotile | High Damage | 6 | Remove under controlled conditions. | 1 | June 2024 |

| Type | Chrysotile |
|---|---|
| Material | Mastic to the floors beneath<br>carpet tiles<br>Bituminous Product |
| Condition | High Damage |

| Type | Chrysotile |
|---|---|
| Recommendation | Remove under controlled conditions. |

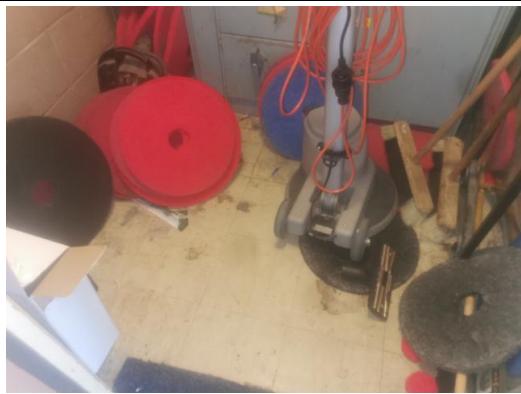
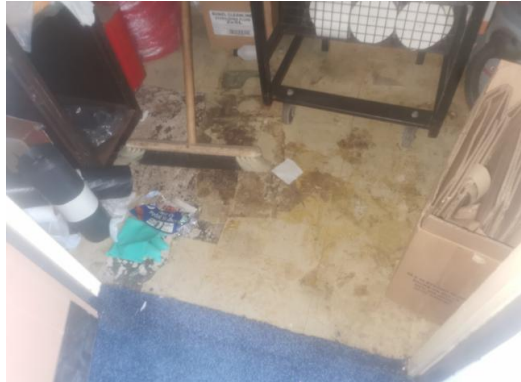
| Breifne College | | | | | | | |
|---|---|---|---|---|---|---|---|
| Ground Floor Switch room and stores 021 - Mastic to vinyl floor tiles: Bituminous Product - S019 | 10m <sup>2</sup> | Chrysotile | High Damage | 6 | Remove under controlled conditions. | 1 | June 2024 |

| Type | Chrysotile | |
|---|---|---|
| Material | Mastic to vinyl floor tiles<br>Bituminous Product | |
| Location | Breifne College<br>Ground Floor Switch room and stores 021 | |
| Condition | High Damage | |

| Type | Chrysotile | |
|---|---|---|
| Recommendation | Remove under controlled conditions. | |

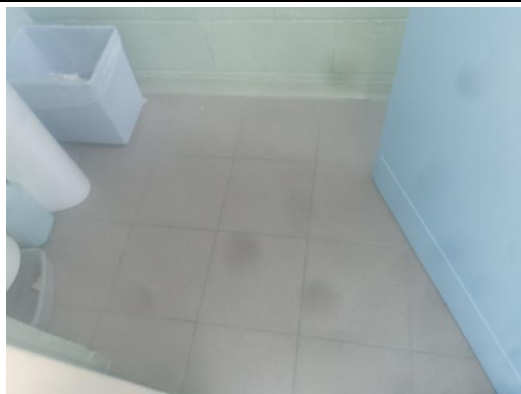
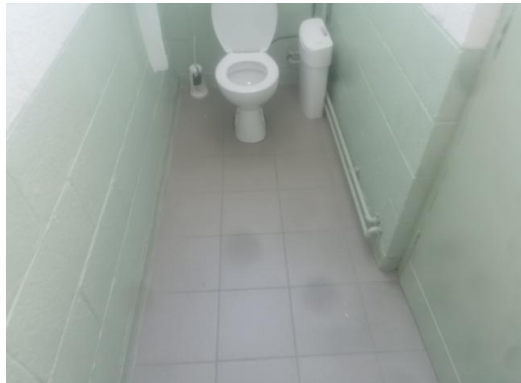
| Breifne College | | | | | | | |
|---|---|---|---|---|---|---|---|
| Ground Floor Staff toilet 022 - Mastic to vinyl floor tiles beneath ceramic tiles: Bituminous Product - Presumed | 4m <sup>2</sup> | Chrysotile | Low Damage | 4 | Remove under controlled conditions. | 1 | June 2024 |

| Type | Chrysotile | |
|---|---|---|
| Material | Mastic to vinyl floor tiles beneath<br>ceramic tiles<br>Bituminous Product | |
| Location | Breifne College<br>Ground Floor Staff toilet 022 | |
| Condition | Low Damage | |

| Type | Chrysotile | |
|---|---|---|
| Recommendation | Remove under controlled conditions. | |

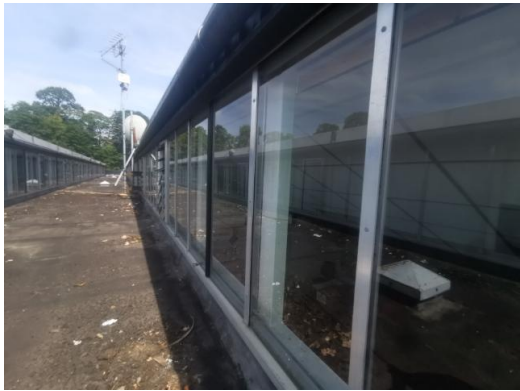
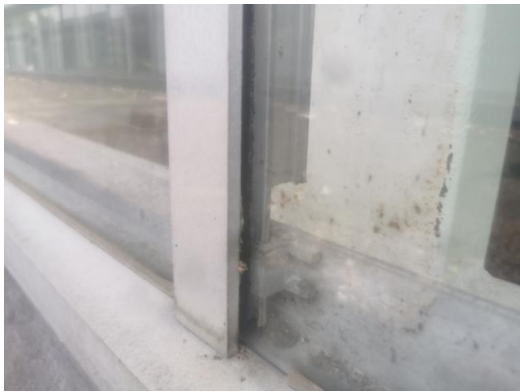
| Breifne College | | | | | | | |
|---|---|---|---|---|---|---|---|
| External High-level glazing 001 - Rope seals to the windows: Woven Product - S001 | All windows | Chrysotile | Medium Damage | 6 | Remove under controlled conditions. | 0 | June 2024 |

| Type | Chrysotile | |
|---|---|---|
| Material | Rope seals to the windows<br>Woven Product | |
| Location | Breifne College<br>External High-level glazing 001 | |
| Condition | Medium Damage | |

| Type | Chrysotile | |
|---|---|---|
| Recommendation | Remove under controlled conditions. | |
