### **SURVEY, SAMPLING AND ASSESSMENT FOR ASBESTOS CONTAINING MATERIALS**

**Loreto College  
Drumkeen  
Co. Cavan**

**CMETB**

**Report Date: September 2025**

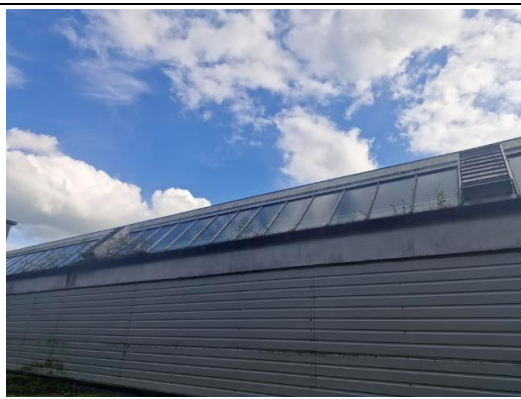
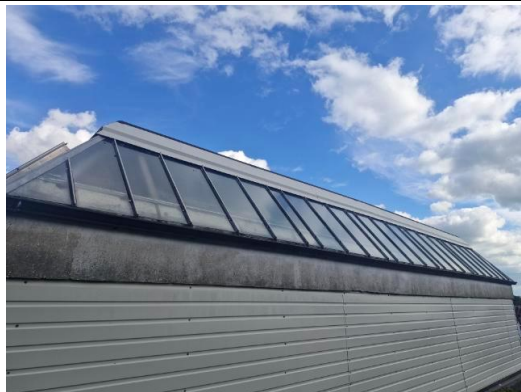
| Type | Chrysotile | |
|---|---|---|
| Location | Building 3<br>External Roof 034 | |

| Building 3 | | | | | | | |
|---|---|---|---|---|---|---|---|
| External Roof 034 - Rope seals to the glazing: Woven Product - Strongly Presumed | Non quantifiable | Chrysotile | Low Damage | 5 | Remove under controlled conditions if works will interfere with the material. | 1 | September 2026 |

| Type | Chrysotile | |
| Material | Rope seals to the glazing<br>Woven Product | |
| Condition | Low Damage | |
| Risk | Low | |

| Type | Chrysotile | |
|---|---|---|
| Recommendation | Remove under controlled conditions if works will interfere with the material. | |

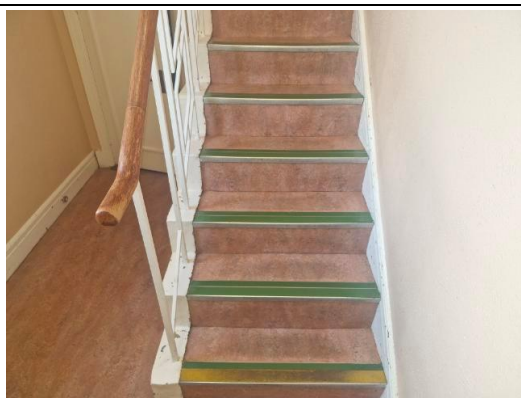
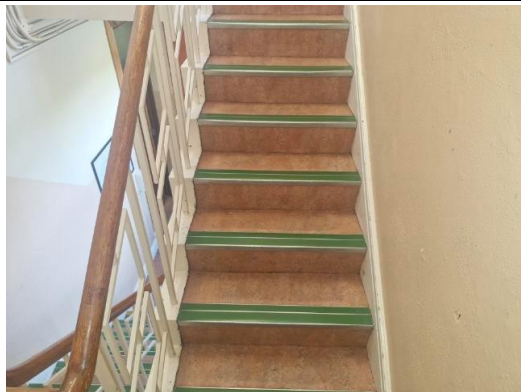
| Type | Chrysotile | |
|---|---|---|
| Location | Original school building<br>Ground, 1st & 2nd floor Staircase 2 022 | |

| Original school building | | | | | | | |
|---|---|---|---|---|---|---|---|
| Ground, 1st & 2nd Floor Staircase 2 022 - Step nosing: PVC / Reinforced Plastics - X009 | 18lin m | Chrysotile | Good Condition | 2 | Remove under controlled conditions if works will interfere with the material. | 1 | September 2026 |

| Type | Chrysotile | |
| Material | Step nosing<br>PVC / Reinforced Plastics | |
| Condition | Good Condition | |

| Type | Chrysotile | |
|---|---|---|
| Recommendation | Remove under controlled conditions if works will interfere with the material. | |

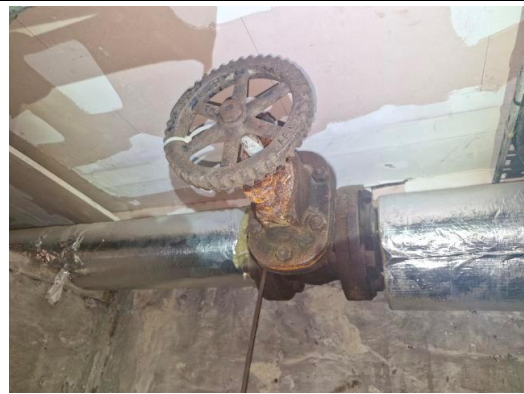
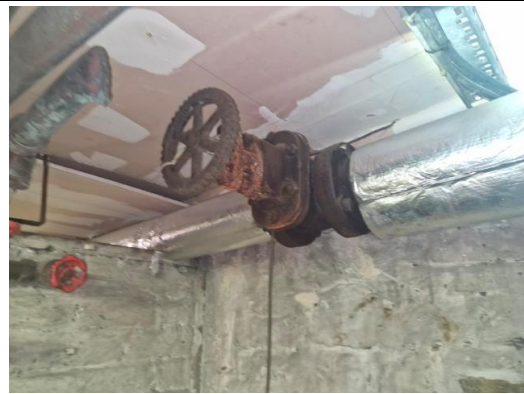
| Original school building | | | | | | | |
|---|---|---|---|---|---|---|---|
| Basement Boiler room 003 - Old type control valve gaskets: Gaskets (compressed) - Presumed | 3no | Chrysotile | Low Damage | 4 | Remove under controlled conditions if works will interfere with the material. | 1 | September 2026 |

| Type | Chrysotile |
|---|---|
| Condition | Low Damage |
| Risk | Very Low |

| Type | Chrysotile |
|---|---|
| Recommendation | Remove under controlled<br>conditions if works will interfere<br>with the material. |

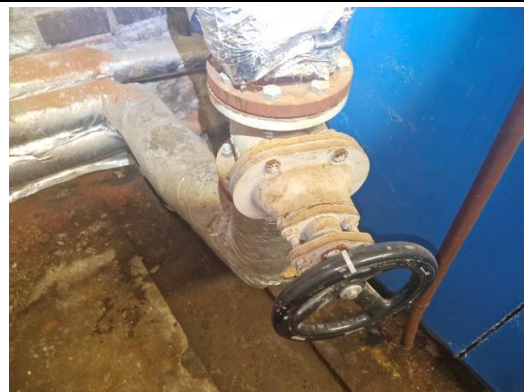
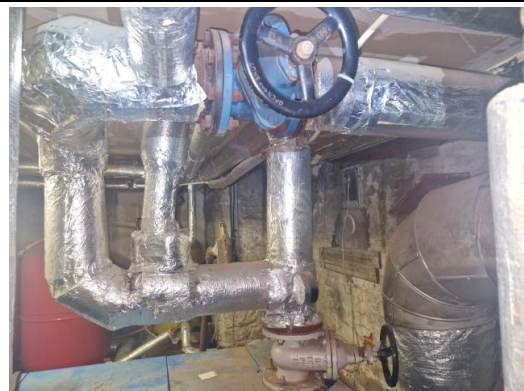
| Original school building | | | | | | | |
|---|---|---|---|---|---|---|---|
| Basement Boiler room 003 - Newer type control valve gaskets: Gaskets (compressed) - Presumed | Non quantifiable | Chrysotile | Low Damage | 4 | Remove under controlled conditions if works will interfere with the material. | 1 | September 2026 |

| Type | Chrysotile |
| Material | Newer type control valve gaskets<br>Gaskets (compressed) |
| Condition | Low Damage |
| Risk | Very Low |

| Type | Chrysotile |
|---|---|
| Recommendation | Remove under controlled<br>conditions if works will interfere<br>with the material. |

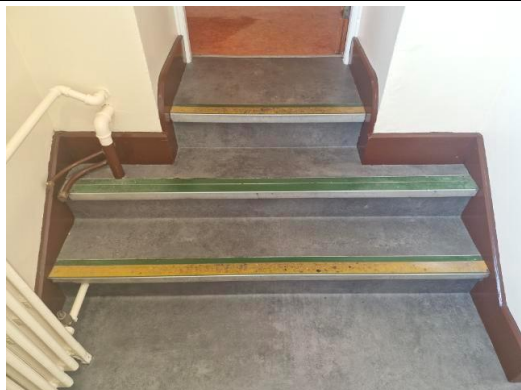
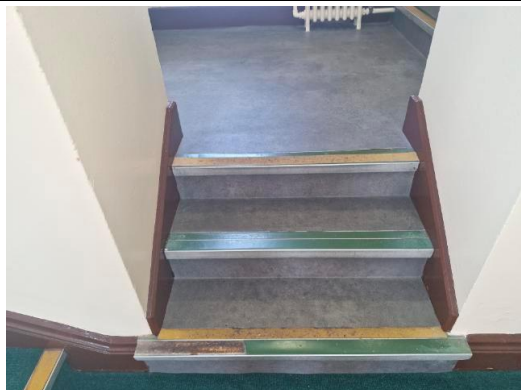
| Type | Chrysotile | |
|---|---|---|
| Location | Original school building<br>2nd Floor Staircase 008 | |

| Original school building | | | | | | | |
|---|---|---|---|---|---|---|---|
| 2nd Floor Staircase 008 - Green step nosing's: PVC / Reinforced Plastics - S009 | 6lin m | Chrysotile | Low Damage | 3 | Remove under controlled conditions if works will interfere with the material. | 1 | September 2026 |

| Type | Chrysotile | |
| Material | Green step nosing's<br>PVC / Reinforced Plastics | |
| Condition | Low Damage | |

| Type | Chrysotile | |
|---|---|---|
| Recommendation | Remove under controlled conditions if works will interfere with the material. | |

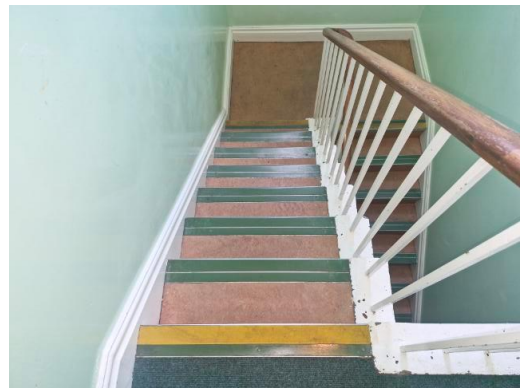
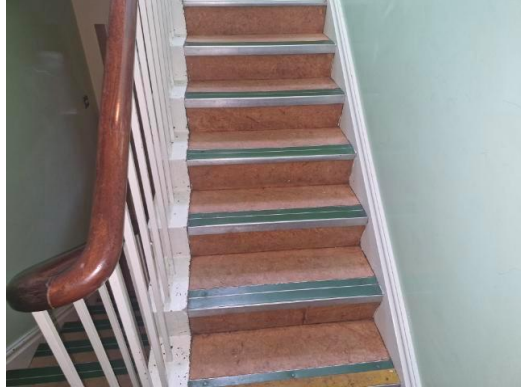
| Type | Chrysotile | |
|---|---|---|
| Location | Original school building<br>Ground, 1st & 2nd Floor Front staircase 009 | |

| Location and Use of Material | Quantity (Approx.) | Asbestos Type | Condition | Material Assessment | Recommended Action | Priority Assessment | Next Assessment |
|---|---|---|---|---|---|---|---|
| Ground, 1st & 2nd Floor Front staircase 009 - Step nosing's: PVC / Reinforced Plastics - X009 | 30lin m | Chrysotile | Good Condition | 2 | Remove under controlled conditions if works will interfere with the material. | 1 | September 2026 |

| Type | Chrysotile | |
| Material | Step nosings<br>PVC / Reinforced Plastics | |
| Condition | Good Condition | |

| Type | Chrysotile | |
|---|---|---|
| Recommendation | Remove under controlled conditions if works will interfere with the material. | |

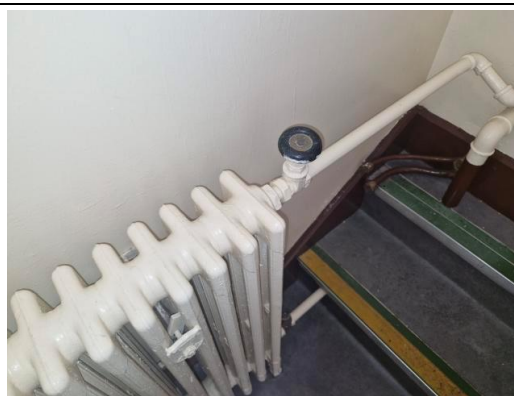
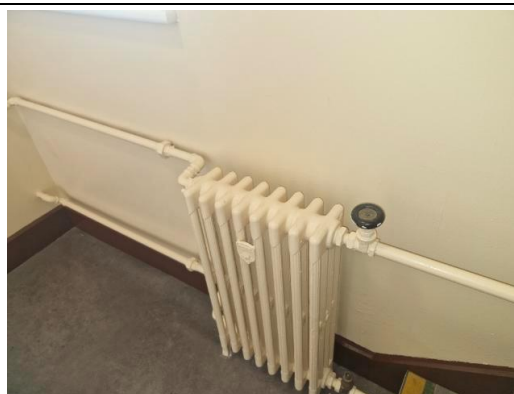
| Location and Use of Material | Quantity (Approx.) | Asbestos Type | Condition | Material Assessment | Recommended Action | Priority Assessment | Next Assessment |
|---|---|---|---|---|---|---|---|
| 2nd Floor Heating system 011 - Radiator knobs: PVC / Reinforced Plastics - Presumed | Throughout | Amosite | Good Condition | 3 | Remove under controlled conditions if works will interfere with the material. | 1 | September 2026 |

| Type | Amosite |
|---|---|
| Condition | Good Condition |
| Risk | Very Low |

| Type | Amosite |
|---|---|
| Recommendation | Remove under controlled conditions if works will interfere with the material. |

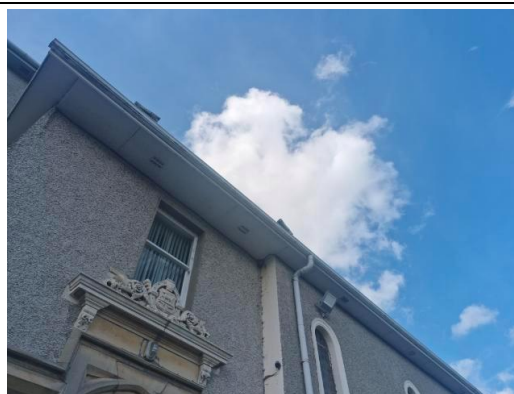
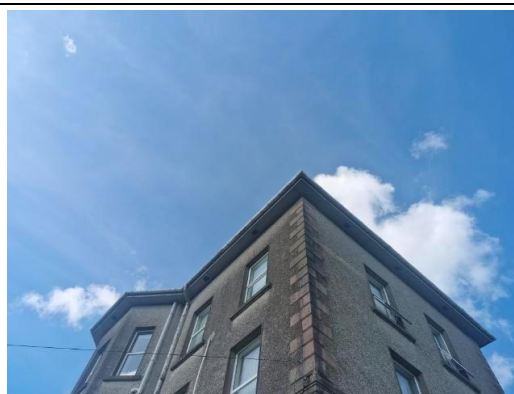
| Location and Use of Material | Quantity (Approx.) | Asbestos Type | Condition | Material Assessment | Recommended Action | Priority Assessment | Next Assessment |
|---|---|---|---|---|---|---|---|
| External Soffit 001 - Cement board: Cement Product - S018 | 200lin m | Chrysotile/Crocidolite | Medium Damage | 7 | Remove under controlled conditions if works will interfere with the material. | 1 | September 2026 |

| Type | Chrysotile/Crocidolite |
| Material | Cement board<br>Cement Product |
| Condition | Medium Damage |
| Risk | Medium |

| Type | Chrysotile/Crocidolite |
|---|---|
| Recommendation | Remove under controlled conditions if works will interfere with the material. |

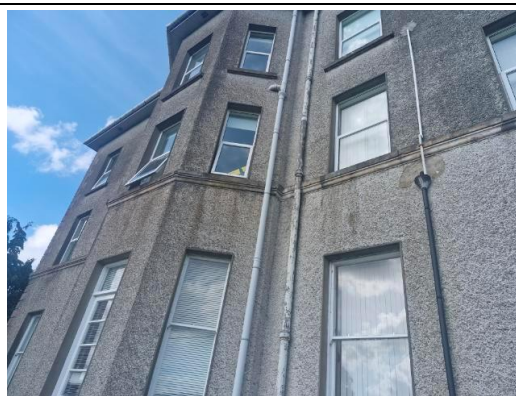
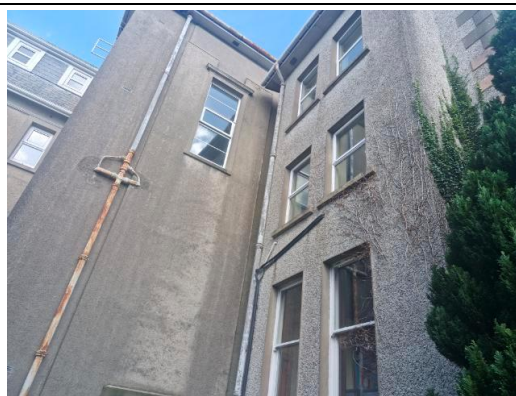
| Location and Use of Material | Quantity (Approx.) | Asbestos Type | Condition | Material Assessment | Recommended Action | Priority Assessment | Next Assessment |
|---|---|---|---|---|---|---|---|
| External Rainwater system 002 - Downpipes: Cement Product - S001 | 60lin m | Chrysotile | Low Damage | 4 | Remove under controlled conditions if works will interfere with the material.. | 1 | September 2026 |

| Type | Chrysotile |
|---|---|
| Condition | Low Damage |
| Risk | Very Low |

| Type | Chrysotile |
|---|---|
| Recommendation | Remove under controlled conditions if works will interfere with the material. |

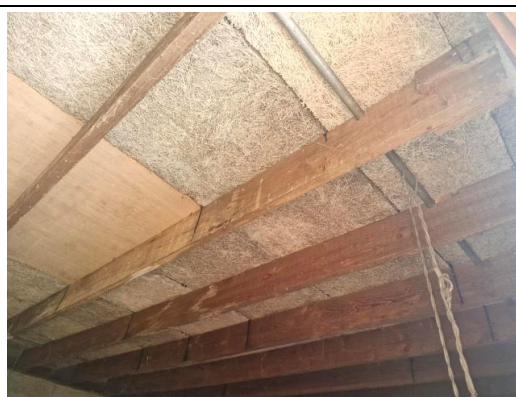
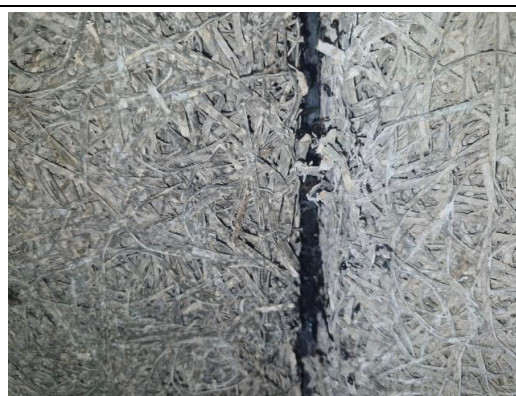
| Location and Use of Material | Quantity (Approx.) | Asbestos Type | Condition | Material Assessment | Recommended Action | Priority Assessment | Next Assessment |
|---|---|---|---|---|---|---|---|
| External Water tank room 011 - Roof felt: Bituminous Product - S012 | 20m <sup>2</sup> | Chrysotile | Low Damage | 4 | Remove under controlled conditions if works will interfere with the material. | 1 | September 2026 |

| Type | Chrysotile |
| Material | Roof felt<br>Bituminous Product |
| Condition | Low Damage |
| Risk | Very Low |

| Type | Chrysotile |
|---|---|
| Recommendation | Remove under controlled conditions if works will interfere with the material. |
