### **SURVEY, SAMPLING AND ASSESSMENT FOR ASBESTOS CONTAINING MATERIALS**

**St Patrick's College  
Cootehill Road  
Co. Cavan  
H12K827**

**CMETB**

**Report Date: September 2025**

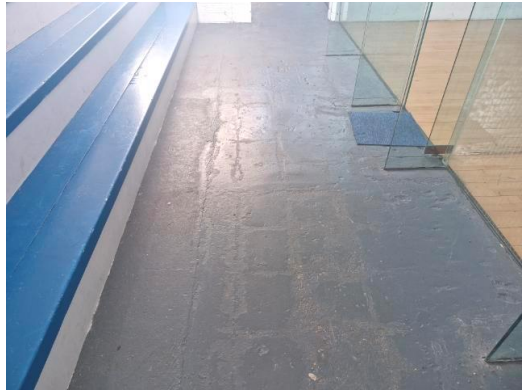
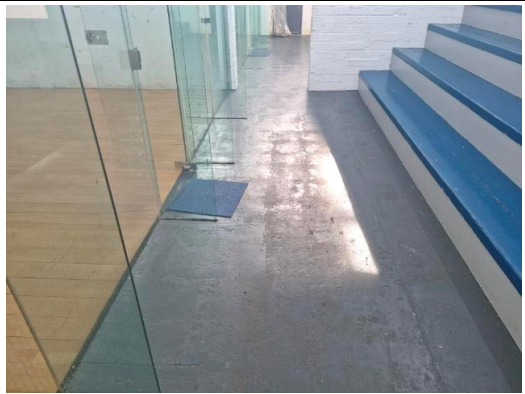
| Location | Handball complex building<br>Ground Floor Handball court floor 014 | |

| Handball complex building | | | | | | | |
|---|---|---|---|---|---|---|---|
| Ground Floor Handball court floor 014 - Mastic under paint: Bituminous Product - S009 | Non quantifiable | Chrysotile | High Damage | 6 | Remove under controlled conditions if works will interfere with the material. | 1 | September 2026 |

| Type | Chrysotile | |
| Material | Mastic under paint<br>Bituminous Product | |
| Condition | High Damage | |

| Recommendation | Remove under controlled conditions if works will interfere with the material. | |

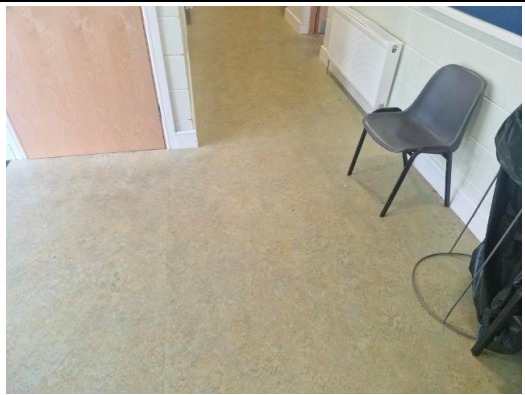
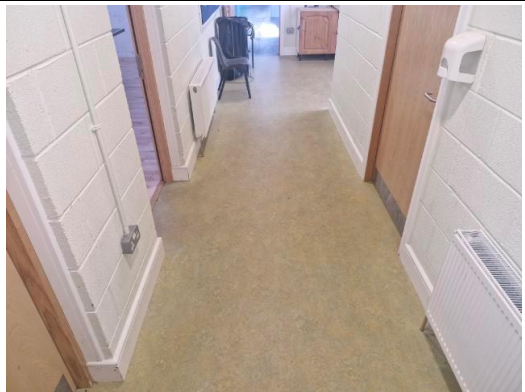
| Location | Handball complex building<br>Ground Floor Corridors 016 | |

| Handball complex building | | | | | | | |
|---|---|---|---|---|---|---|---|
| Ground Floor Corridors 016 - Mastic on the floors beneath lino and screed: Bituminous Product - P009 | Non quantifiable | Chrysotile | Low Damage | 4 | Remove under controlled conditions if works will interfere with the material. | 1 | September 2026 |

| Type | Chrysotile | |
| Material | Mastic on the floors beneath lino and screed<br>Bituminous Product | |
| Condition | Low Damage | |

| Recommendation | Remove under controlled conditions if works will interfere with the material. | |

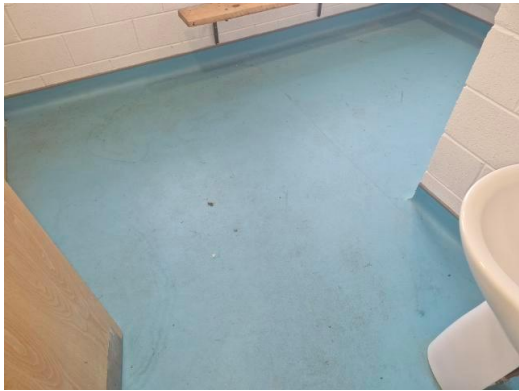
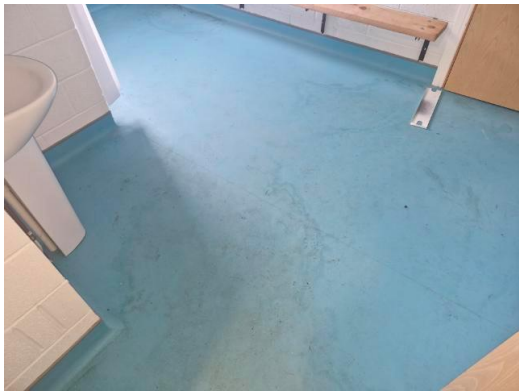
| Type | Chrysotile | |
|---|---|---|
| Location | Handball complex building<br>Ground Floor Rooms 017 | |

| Handball complex building | | | | | | | |
|---|---|---|---|---|---|---|---|
| Ground Floor Rooms 017 - Mastic on the floors beneath lino and screed: Bituminous Product - Presumed | Non quantifiable | Chrysotile | Low Damage | 4 | Remove under controlled conditions if works will interfere with the material. | 1 | September 2026 |

| Type | Chrysotile | |
| Material | Mastic on the floors beneath lino and screed<br>Bituminous Product | |
| Condition | Low Damage | |

| Type | Chrysotile | |
|---|---|---|
| Recommendation | Remove under controlled conditions if works will interfere with the material. | |

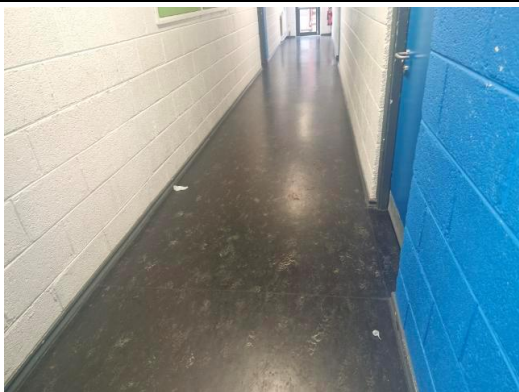
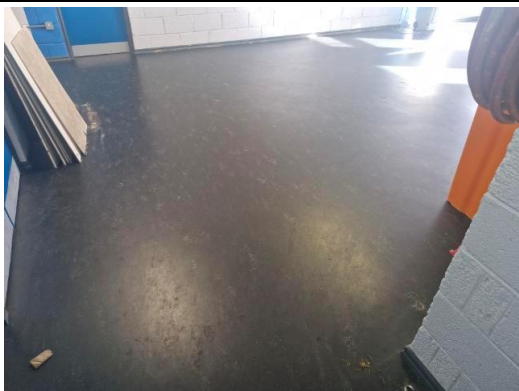
| Type | Chrysotile | |
|---|---|---|
| Location | St Augustans building<br>Ground & First Floor Corridors 003 | |

| St Augustans building | | | | | | | |
|---|---|---|---|---|---|---|---|
| Ground & First Floor Corridors 003 - Mastic on the floors beneath lino and screed: Bituminous Product - Presumed | Non quantifiable | Chrysotile | Low Damage | 4 | Remove under controlled conditions if works will interfere with the material. | 1 | September 2026 |

| Type | Chrysotile | |
| Material | Mastic on the floors beneath lino and screed<br>Bituminous Product | |
| Condition | Low Damage | |

| Type | Chrysotile | |
|---|---|---|
| Recommendation | Remove under controlled conditions if works will interfere with the material. | |

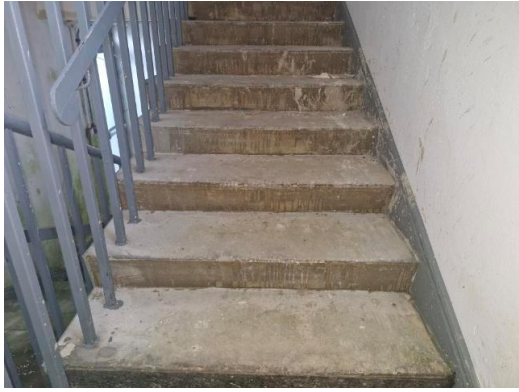
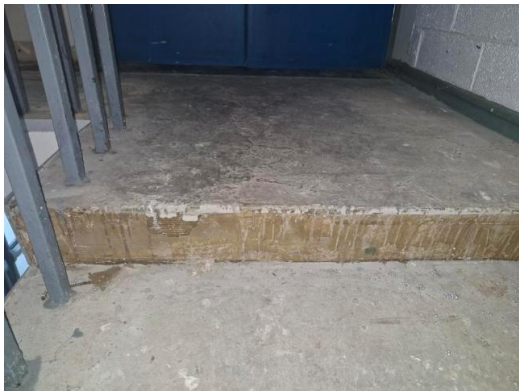
| Type | Chrysotile | |
|---|---|---|
| Location | St Augustans building<br>Ground Floor Emergency exit staircase 005 | |

| St Augustans building | | | | | | | |
|---|---|---|---|---|---|---|---|
| Ground Floor Emergency exit staircase 005 - Vinyl floor tiles: Vinyl Products - S002 | 17lin m | Chrysotile | Medium Damage | 5 | Remove under controlled conditions if works will interfere with the material. | 1 | September 2026 |

| Type | Chrysotile | |
| Material | Vinyl floor tiles<br>Vinyl Products | |
| Condition | Medium Damage | |

| Type | Chrysotile | |
|---|---|---|
| Recommendation | Remove under controlled conditions if works will interfere with the material. | |

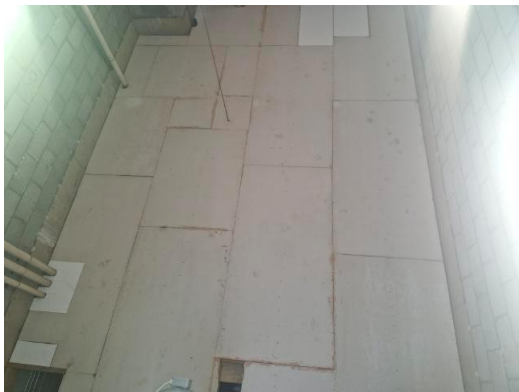
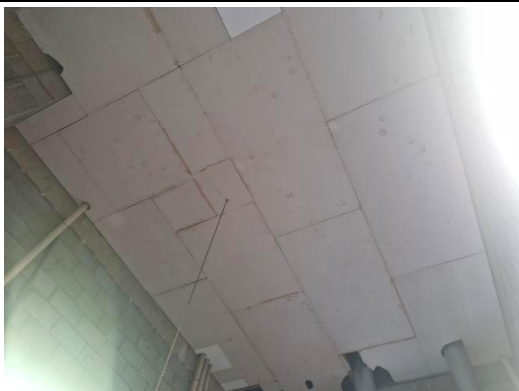
| Type | Amosite | |
|---|---|---|
| Location | St Augustans building<br>Ground Floor Boiler room 008 | |

| St Augustans building | | | | | | | |
|---|---|---|---|---|---|---|---|
| Ground Floor Boiler room 008 - Ceiling boards: Insulating Board - Presumed | 20m <sup>2</sup> | Amosite | High Damage | 8 | Remove under controlled conditions if works will interfere with the material. | 1 | September 2026 |

| Type | Amosite | |
| Material | Ceiling boards<br>Insulating Board | |
| Condition | High Damage | |

| Type | Amosite | |
|---|---|---|
| Recommendation | Remove under controlled conditions if works will interfere with the material. | |

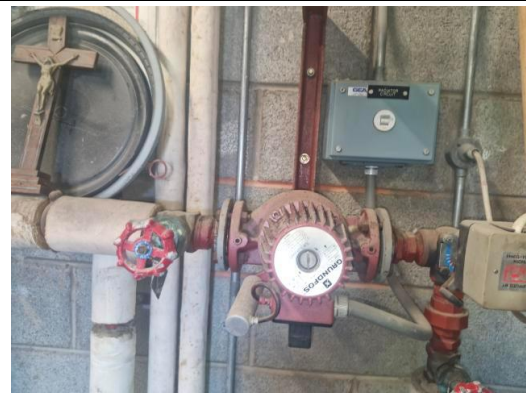
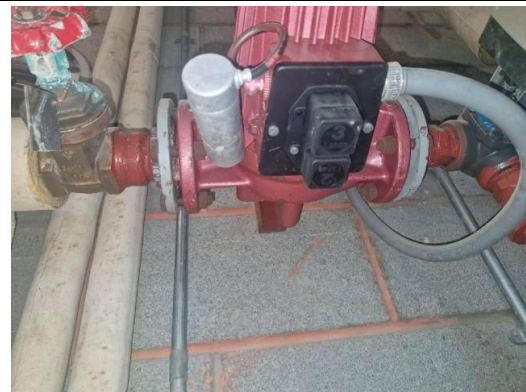
| St Augustans building | | | | | | | |
|---|---|---|---|---|---|---|---|
| Ground Floor Boiler room 008 - Grundfos pump gaskets: Gaskets (compressed) - S006 | 2no | Chrysotile | Low Damage | 4 | Remove under controlled conditions if works will interfere with the material. | 1 | September 2026 |

| Type | Chrysotile |
|---|---|
| Condition | Low Damage |

| Type | Chrysotile |
|---|---|
| Recommendation | Remove under controlled conditions if works will interfere with the material. |

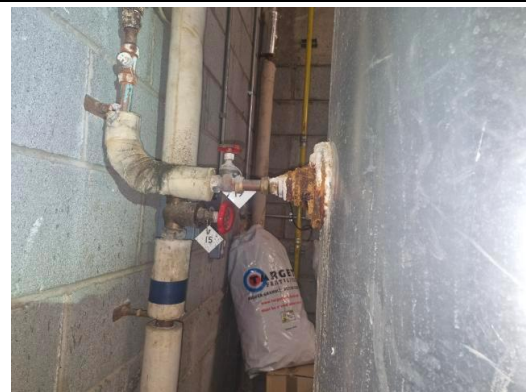
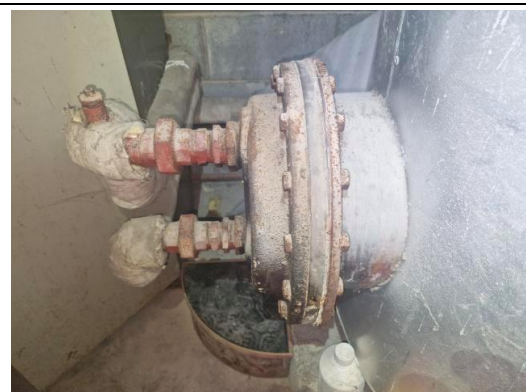
| St Augustans building | | | | | | | |
|---|---|---|---|---|---|---|---|
| Ground Floor Boiler room 008 - Water tank gaskets: Gaskets (compressed) - S007 | 2no | Chrysotile | Medium Damage | 5 | Remove under controlled conditions if works will interfere with the material. | 1 | September 2026 |

| Type | Chrysotile |
| Material | Water tank gaskets<br>Gaskets (compressed) |
| Condition | Medium Damage |

| Type | Chrysotile |
|---|---|
| Recommendation | Remove under controlled conditions if works will interfere with the material. |

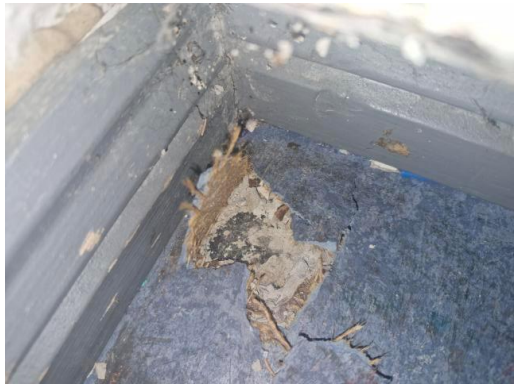
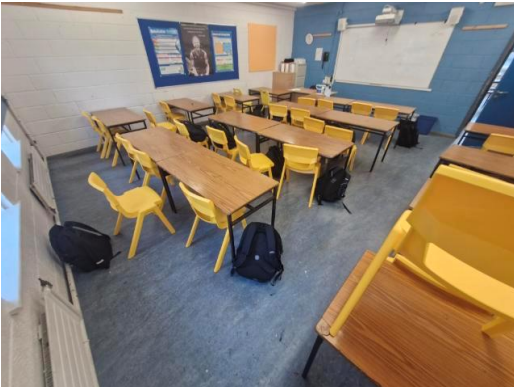
| Type | Chrysotile | |
|---|---|---|
| Location | St Augustans building<br>Ground & First Floor Classrooms and rooms 010 | |

| St Augustans building | | | | | | | |
|---|---|---|---|---|---|---|---|
| Ground & First Floor Classrooms and rooms 010 - Mastic on the floors beneath lino and screed: Bituminous Product - S008 | Non quantifiable | Chrysotile | Low Damage | 4 | Remove under controlled conditions if works will interfere with the material. | 1 | September 2026 |

| Type | Chrysotile | |
| Material | Mastic on the floors beneath lino and screed<br>Bituminous Product | |
| Condition | Low Damage | |

| Type | Chrysotile | |
|---|---|---|
| Recommendation | Remove under controlled conditions if works will interfere with the material. | |

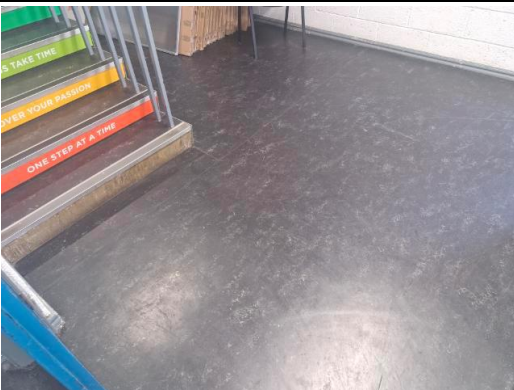
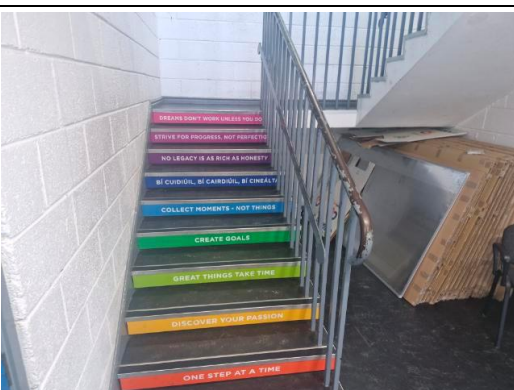
| Type | Chrysotile | |
|---|---|---|
| Location | St Augustans building<br>Ground & First Floor Staircase 011 | |

| St Augustans building | | | | | | | |
|---|---|---|---|---|---|---|---|
| Ground & First Floor Staircase 011 - Mastic on the floors beneath lino and screed: Bituminous Product - Presumed | Non quantifiable | Chrysotile | Low Damage | 4 | Remove under controlled conditions if works will interfere with the material. | 1 | September 2026 |

| Type | Chrysotile | |
| Material | Mastic on the floors beneath lino and screed<br>Bituminous Product | |
| Condition | Low Damage | |

| Type | Chrysotile | |
|---|---|---|
| Recommendation | Remove under controlled conditions if works will interfere with the material. | |

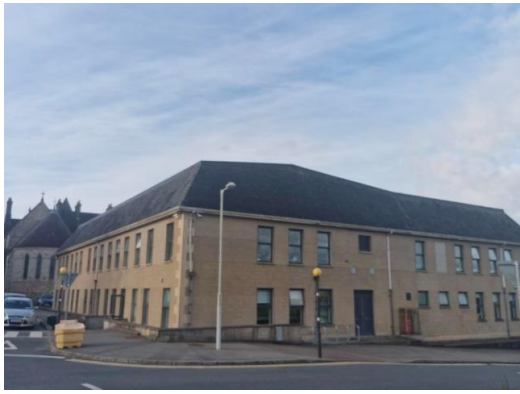
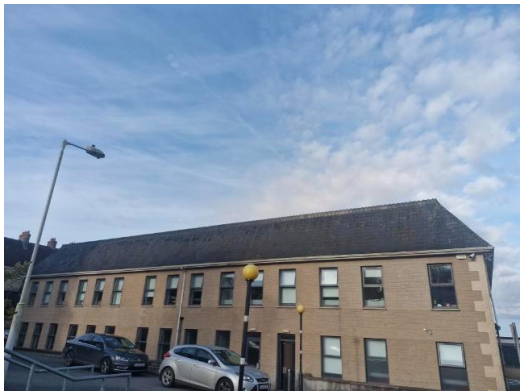
| Type | Chrysotile | |
|---|---|---|
| Location | St Augustans building<br>External Roof 001 | |

| St Augustans building | | | | | | | |
|---|---|---|---|---|---|---|---|
| External Roof 001 - Slates: Cement Product - Strongly Presumed | m <sup>2</sup> | Chrysotile | Medium Damage | 5 | Remove under controlled conditions if works will interfere with the material. | 1 | September 2026 |

| Type | Chrysotile | |
| Material | Slates<br>Cement Product | |
| Condition | Medium Damage | |

| Type | Chrysotile | |
|---|---|---|
| Recommendation | Remove under controlled conditions if works will interfere with the material. | |
