### **SURVEY, SAMPLING AND ASSESSMENT FOR ASBESTOS CONTAINING MATERIALS**

**St. Macartan's College  
Mullaghmurphy Muineachán  
Co. Monaghan  
H18X704**

**CMETB**

**Report Date: October 2025**

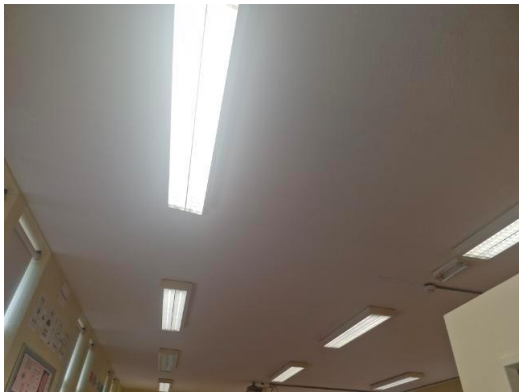
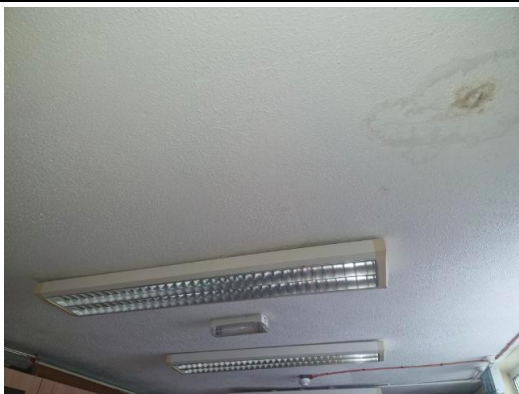
| Flat roof building | | | | | | | |
|---|---|---|---|---|---|---|---|
| Ground Floor Classroom/ science lab 005 - Textured coating on the ceiling: Textured Coating - S006 | Non quantifiable | Chrysotile | Good Condition | 3 | Remove under controlled conditions if works will interfere with the material. | 1 | September 2026 |

| Type | Chrysotile | |
| Material | Textured coating on the ceiling<br>Textured Coating | |
| Location | Flat roof building<br>Ground Floor Classroom/ science lab 005 | |
| Quantity | Non quantifiable (may still remain in other areas or above modern ceilings) | |
| Sample No. | S006 | |
| Condition | Good Condition | |

| Type | Chrysotile | |
|---|---|---|
| Recommendation | Remove under controlled conditions if works will interfere with the material. | |

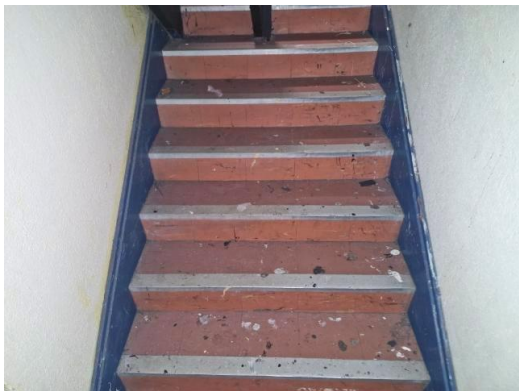
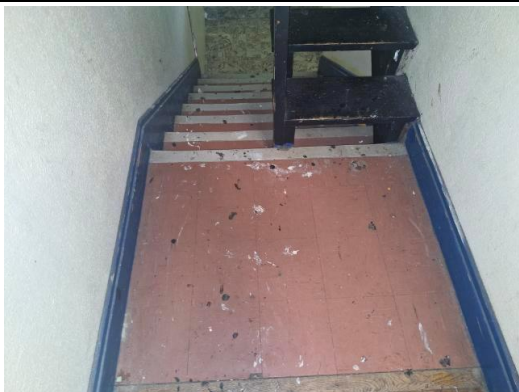
| Flat roof building | | | | | | | |
|---|---|---|---|---|---|---|---|
| Ground Floor Theatre 009 - Staircase vinyl floor tiles and step nosing's: Vinyl Products - S008 | 5m <sup>2</sup> | Chrysotile | Low Damage | 4 | Remove under controlled conditions if works will interfere with the material. | 1 | September 2026 |

| Type | Chrysotile | |
| Material | Staircase vinyl floor tiles and step nosing's<br>Vinyl Products | |
| Location | Flat roof building<br>Ground Floor Theatre 009 | |
| Quantity | 5 m <sup>2</sup> | |
| Sample No. | S008 | |
| Condition | Low Damage | |

| Type | Chrysotile | |
|---|---|---|
| Recommendation | Remove under controlled conditions if works will interfere with the material. | |

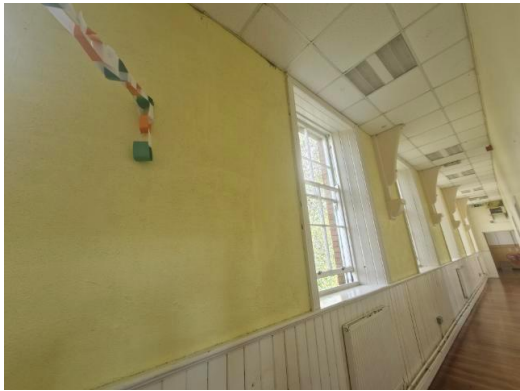
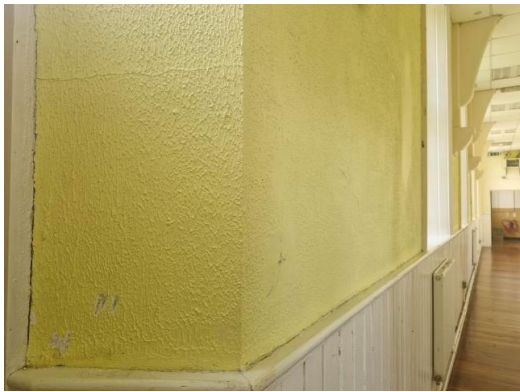
| Original building | | | | | | | |
|---|---|---|---|---|---|---|---|
| 1st Floor Corridor 002 - Textured coating on the walls: Textured Coating - S002 | 35m <sup>2</sup> | Chrysotile | Low Damage | 4 | Remove under controlled conditions if works will interfere with the material. | 1 | September 2026 |

| Type | Chrysotile | |
| Material | Textured coating on the walls<br>Textured Coating | |
| Location | Original building<br>1st Floor Corridor 002 | |
| Quantity | 35 m <sup>2</sup> | |
| Sample No. | S002 | |
| Condition | Low Damage | |

| Type | Chrysotile | |
|---|---|---|
| Recommendation | Remove under controlled conditions if works will interfere with the material. | |

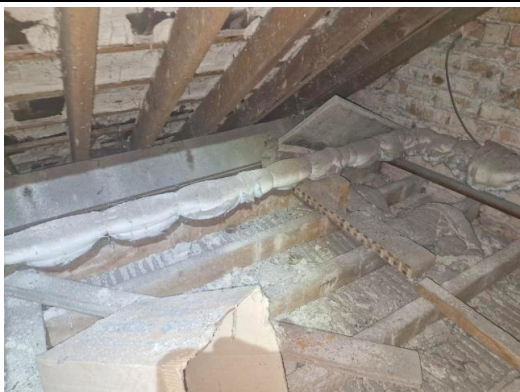
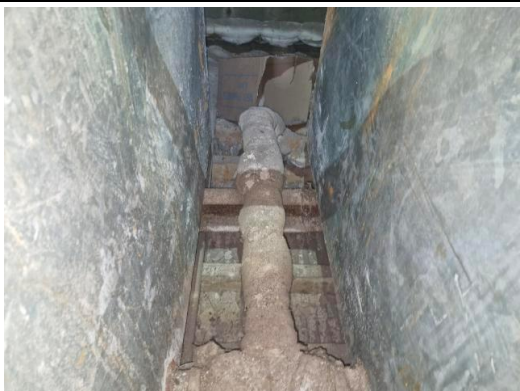
| Original building | | | | | | | |
|---|---|---|---|---|---|---|---|
| 1st Floor Attic 003 - Rope wrapping to the pipe insulation: Woven Product - S004 | Non quantifiable(may still remain in other areas or above modern ceilings) | Chrysotile | Medium Damage | 6 | Remove under controlled conditions if works will interfere with the material. | 1 | September 2026 |

| Type | Chrysotile | |
| Material | Rope wrapping to the pipe<br>insulation<br>Woven Product | |
| Location | Original building<br>1st Floor Attic 003 | |
| Quantity | Non quantifiable | |
| Sample No. | S004 | |
| Condition | Medium Damage | |

| Type | Chrysotile | |
|---|---|---|
| Recommendation | Remove under controlled conditions if works will interfere with the material. | |

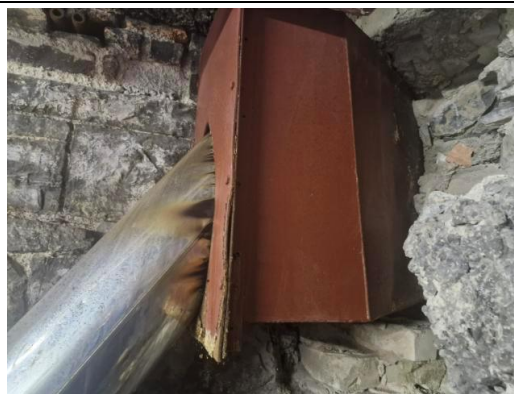
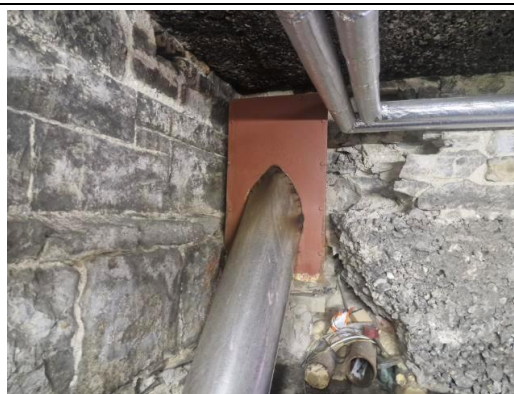
| Original building | | | | | | | |
|---|---|---|---|---|---|---|---|
| Basement Boiler room 001 - Flue rope seals: Woven Product - Presumed | 1no | Chrysotile | Low Damage | 5 | Remove under controlled conditions if works will interfere with the material. | 1 | September 2026 |

| Type | Chrysotile |
|---|---|
| Condition | Low Damage |

| Type | Chrysotile |
|---|---|
| Recommendation | Remove under controlled conditions if works will interfere with the material. |

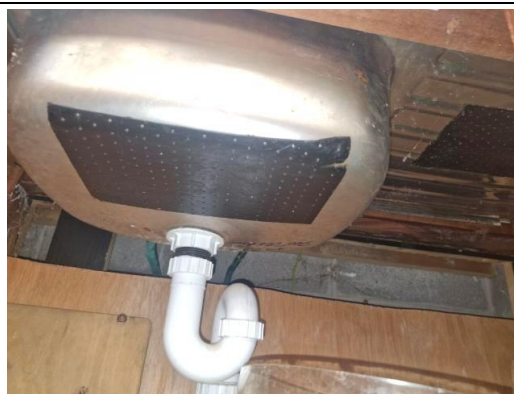
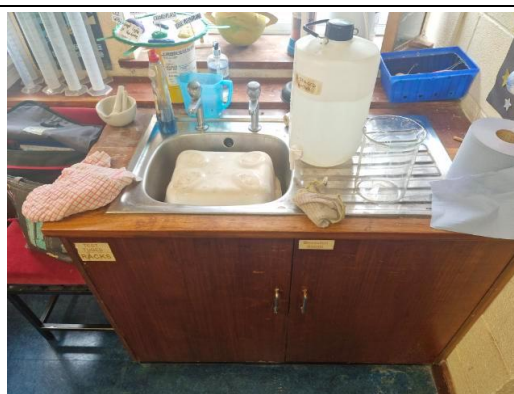
| Pitched roof building | | | | | | | |
|---|---|---|---|---|---|---|---|
| Ground Floor Science lab 018 - Sink heat pads: Bituminous Product - S013 | 2no | Chrysotile | Low Damage | 4 | Remove under controlled conditions if works will interfere with the material. | 1 | September 2026 |

| Type | Chrysotile |
| Material | Sink heat pads<br>Bituminous Product |
| Condition | Low Damage |

| Type | Chrysotile |
|---|---|
| Recommendation | Remove under controlled conditions if works will interfere with the material. |
