# **Asbestos Refurbishment & Demolition Survey (including Sampling and Analysis) for *Oppermann Associates***

**Inver College,  
Cloghvalley Upper,  
Carrickmacross,  
Co. Monaghan**

| Project N°<br>and<br>Revision N° | Report Status | Surveyor | Report Author | Approved by | Issue Date |
|---|---|---|---|---|---|
| A-01910<br>(Revision 1) | Issued | James Howard / Sean<br>Kenny | James Howard | <br>Jonathan Fagan | 07/09/2020 |

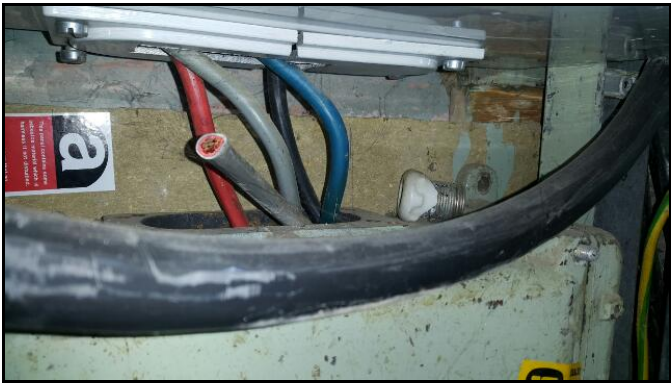
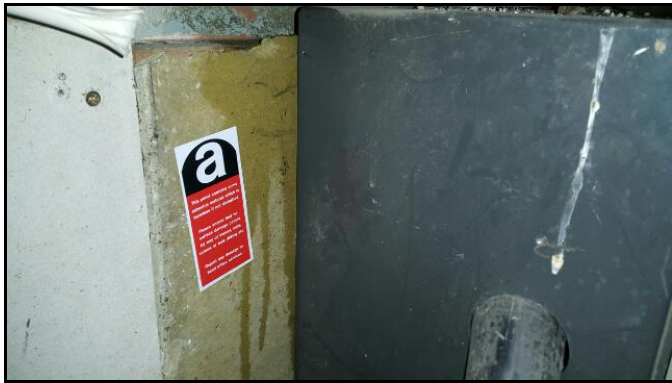
| ROOM NAME / NO.: | 0-001 | | | SAMPLE REF NO.: | S1 | | |

| PRODUCT TYPE: | Cement Product | | | ACCESSIBILITY: | Easy | | |
| FOUND IN: | Electrics | | | | | | |
| ASBESTOS TYPE | NON ASBESTOS | 0 | | EXTENT OF DAMAGE / DETERIORATION | GOOD CONDITION | 0 | |
| | CHRYSTOLE | 1 | ✓ | | LOW DAMAGE | 1 | ✓ |
| PRODUCT TYPE | ASBESTOS REINFORCED COMPOSITES | 1 | ✓ | RECOMMENDED ACTION | REMOVE | | ✓ |

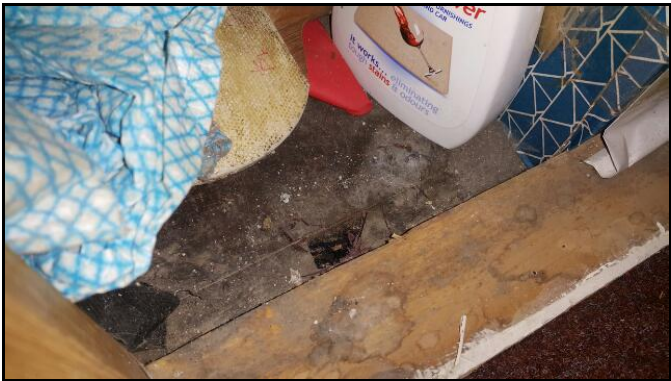
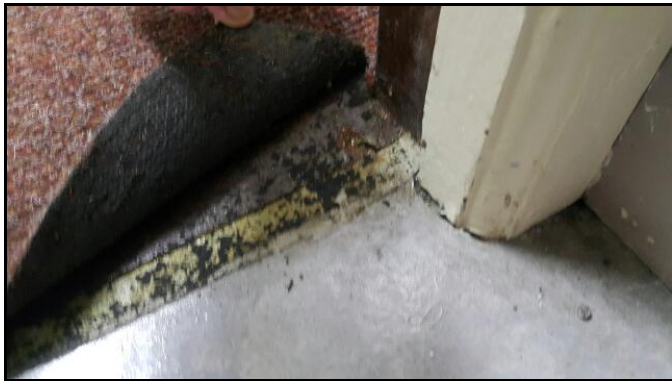
| ROOM NAME / NO.: | 0-002 | | | SAMPLE REF NO.: | S4 | | |

| PRODUCT TYPE: | Vinyl Floor Covering & Bitumen | | | ACCESSIBILITY: | Medium | | |
| FOUND IN: | Floor | | | | | | |
| | CHRYSTOTILE | 1 | ✓ | | LOW DAMAGE | 1 | ✓ |
| PRODUCT TYPE | ASBESTOS REINFORCED COMPOSITES | 1 | ✓ | RECOMMENDED ACTION | REMOVE | | ✓ |

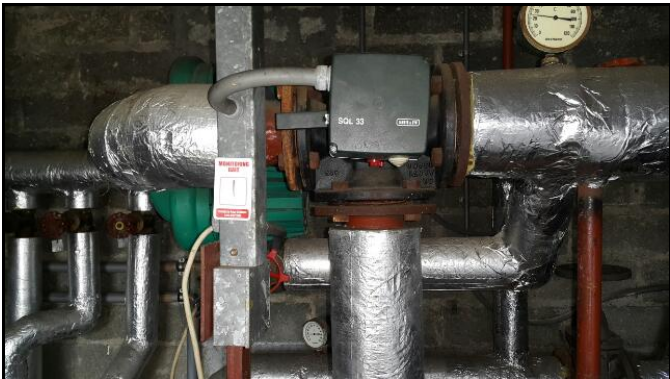
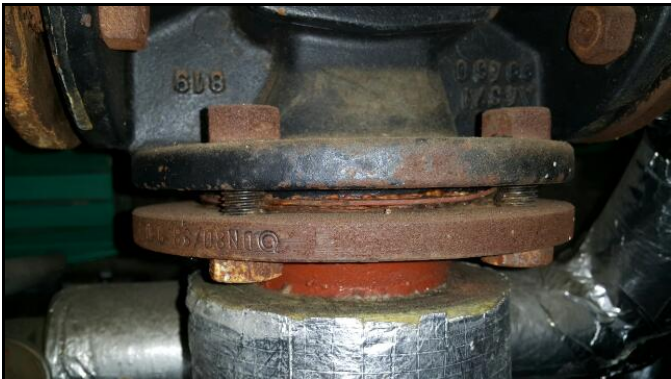
| ROOM NAME / NO.: | 0-044 | | | SAMPLE REF NO.: | S7 | | |

| PRODUCT TYPE: | Gaskets (compressed) | | | | ACCESSIBILITY: | Medium | |
| FOUND IN: | Pipes | | | | | | |
| | CHRYSTOLITE | 1 | ✓ | | LOW DAMAGE | 1 | ✓ |
| PRODUCT TYPE | ASBESTOS REINFORCED COMPOSITES | 1 | | RECOMMENDED ACTION | REMOVE | | ✓ |

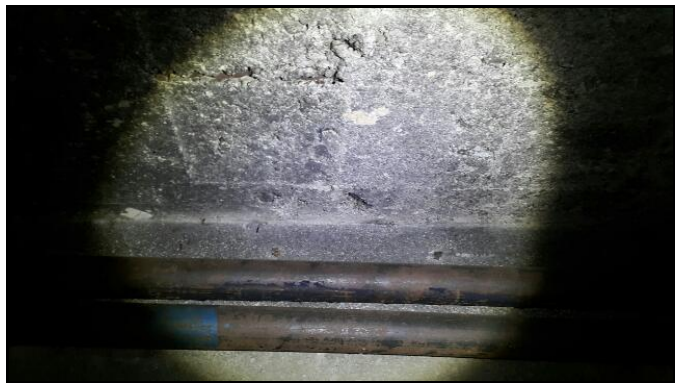
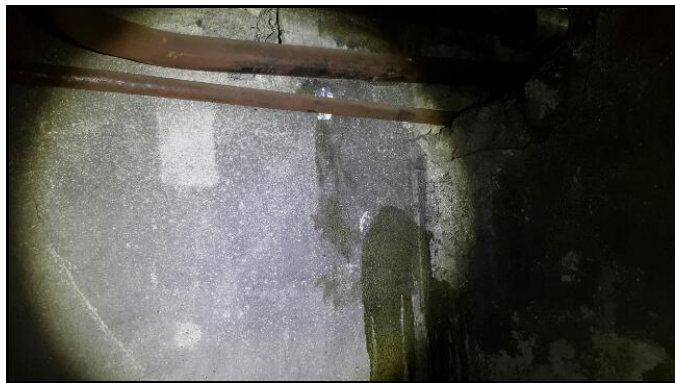
| ROOM NAME / NO.: | -1-001 | | | SAMPLE REF NO.: | S8 | | |

| PRODUCT TYPE: | Thermal Insulation | | | ACCESSIBILITY: | Easy | | |
| FOUND IN: | Walls and ceiling | | | | | | |
| | CROCIDOLITE | 3 | | | HIGH DAMAGE | 3 | ✓ |
| PRODUCT TYPE | ASBESTOS REINFORCED COMPOSITES | 1 | | RECOMMENDED ACTION | REMOVE | | ✓ |

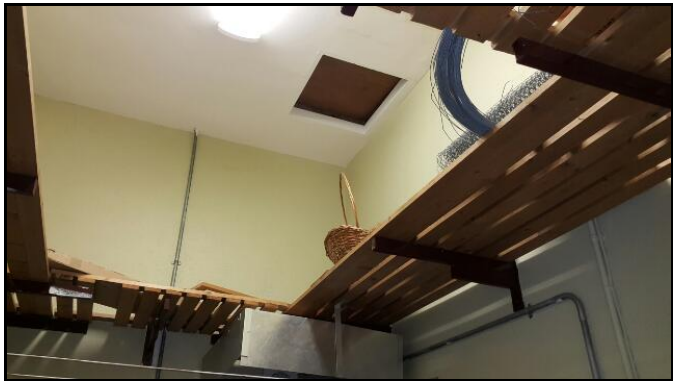
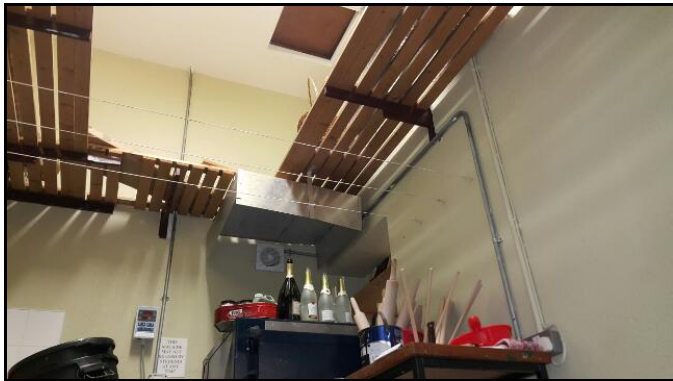
| PRODUCT TYPE: | Unknown | | | ACCESSIBILITY: | No Access | | |
| | CROCIDOLITE | 3 | ✓ | | HIGH DAMAGE | 3 | ✓ |
| PRODUCT TYPE | ASBESTOS REINFORCED COMPOSITES | 1 | | RECOMMENDED ACTION | PRESUME ASBESTOS IS PRESENT UNTIL FURTHER INVESTIGATION | | ✓ |

| Area Surveyed | Sample Number | Location and Use of Material | Asbestos Type | Condition | Accessibility | Extent | Material Risk Assessment Score | Recommended Action |
|---|---|---|---|---|---|---|---|---|
| Void | Presumed | Roof void V-001 - (Unknown) | Chrysotile/Amosite/Crocidolite | High Damage | No Access | Unknown | 12 | Presume asbestos is present until further investigation |

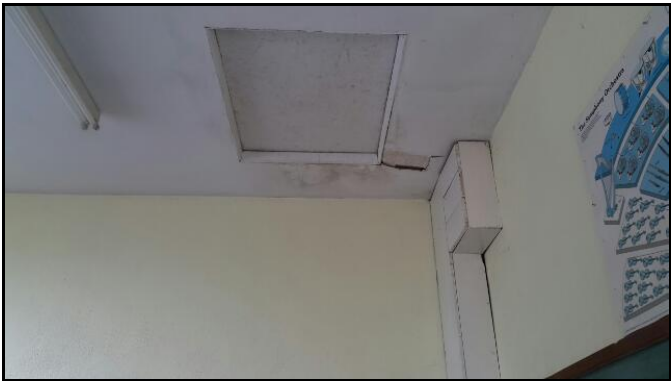
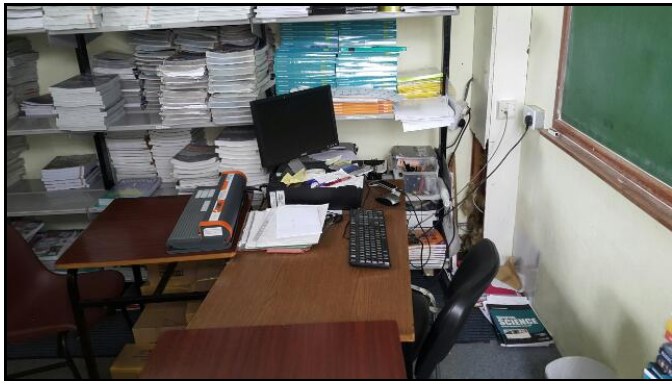
| PRODUCT TYPE: | Unknown | ACCESSIBILITY: | No Access | | | | |
| | CROCIDOLITE | 3 | ✓ | | HIGH DAMAGE | 3 | ✓ |
| PRODUCT TYPE | ASBESTOS REINFORCED COMPOSITES | 1 | | RECOMMENDED ACTION | PRESUME ASBESTOS IS PRESENT UNTIL FURTHER INVESTIGATION | | ✓ |

| Area Surveyed | Sample Number | Location and Use of Material | Asbestos Type | Condition | Accessibility | Extent | Material Risk Assessment Score | Recommended Action |
|---|---|---|---|---|---|---|---|---|
| Void | Presumed | Roof void V-003 - (Unknown) | Chrysotile/Amosite/Crocidolite | High Damage | No Access | Unknown | 12 | Presume asbestos is present until further investigation |

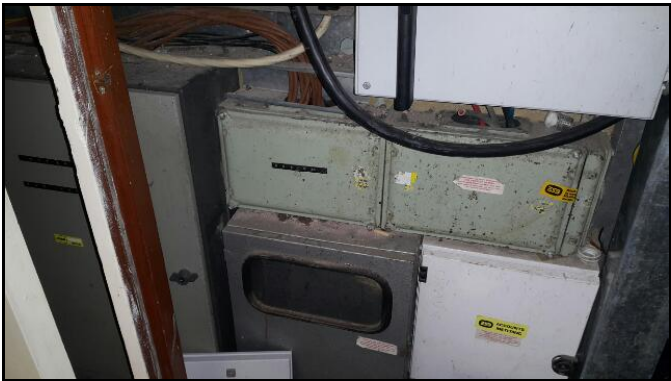
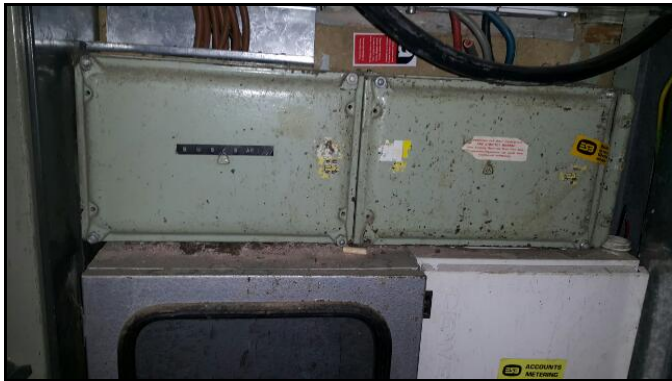
| ROOM NAME / NO.: | 0-001 | | | SAMPLE REF NO.: | Presumed | | |

| PRODUCT TYPE: | Flash Guards | | | ACCESSIBILITY: | Difficult | | |
| FOUND IN: | Electrics | | | | | | |
| | CHRYSTOLITE | 1 | ✓ | | LOW DAMAGE | 1 | ✓ |
| PRODUCT TYPE | ASBESTOS REINFORCED COMPOSITES | 1 | | RECOMMENDED ACTION | REMOVE | | ✓ |

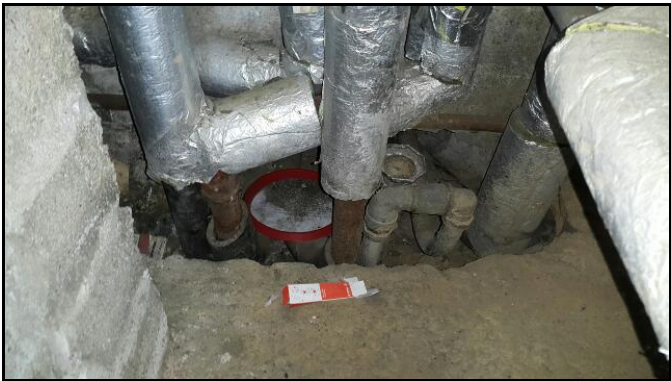
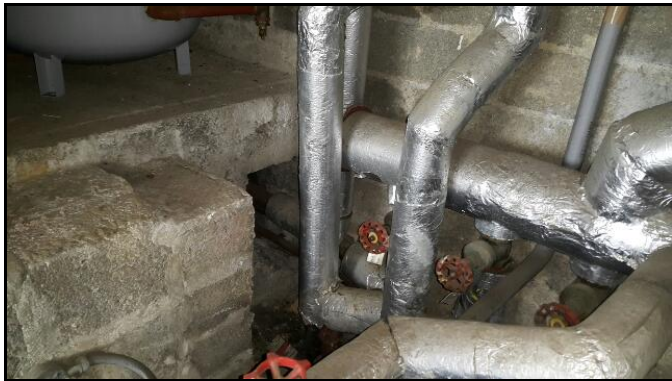
| PRODUCT TYPE: | Unknown | | | ACCESSIBILITY: | No Access | | |
| | CROCIDOLITE | 3 | ✓ | | HIGH DAMAGE | 3 | ✓ |
| PRODUCT TYPE | ASBESTOS REINFORCED COMPOSITES | 1 | | RECOMMENDED ACTION | PRESUME ASBESTOS IS PRESENT UNTIL FURTHER INVESTIGATION | | ✓ |

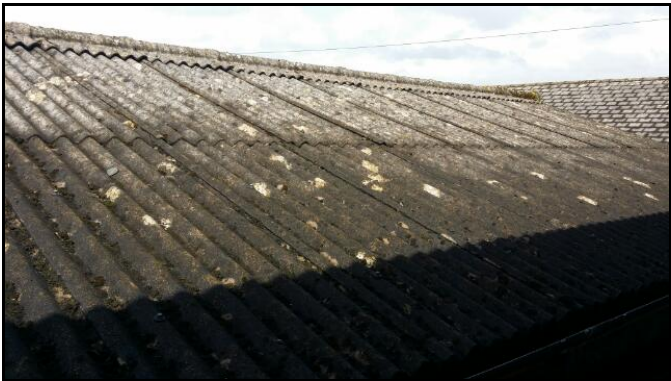
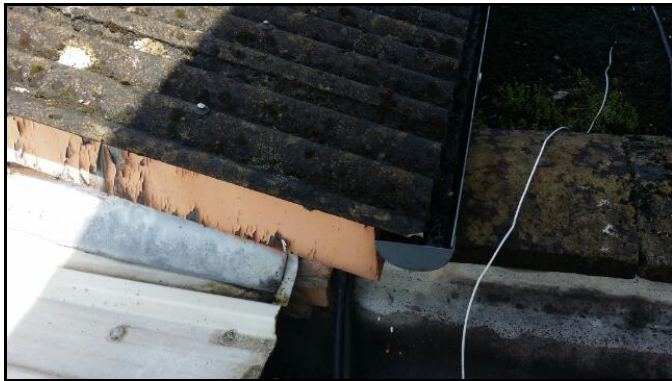
| ROOM NAME / NO.: | 99-007 | | | SAMPLE REF NO.: | S9 | | |

| PRODUCT TYPE: | Cement Product | | | ACCESSIBILITY: | Difficult | | |
| FOUND IN: | Cement Roofing | | | | | | |
| | CHRYSTOTILE | 1 | ✓ | | LOW DAMAGE | 1 | ✓ |
| PRODUCT TYPE | ASBESTOS REINFORCED COMPOSITES | 1 | ✓ | RECOMMENDED ACTION | REMOVE | | ✓ |

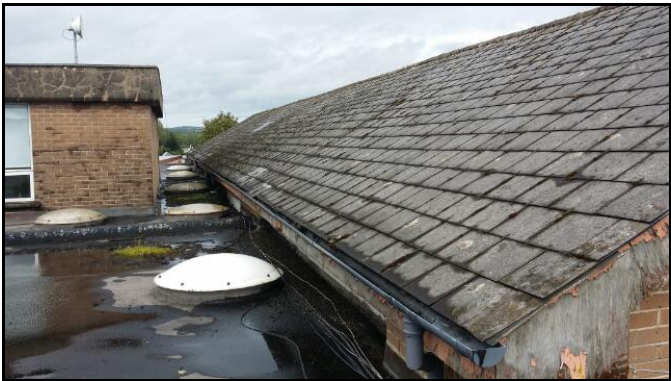
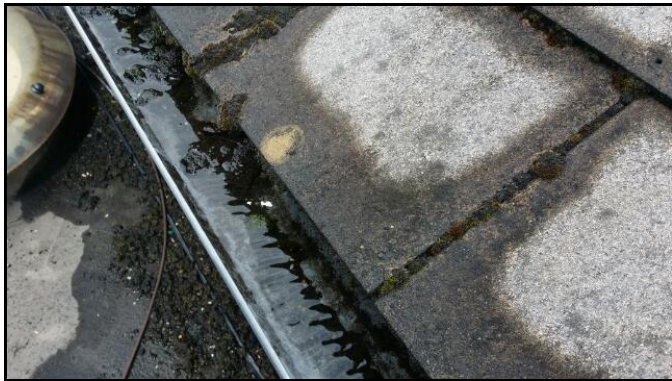
| PRODUCT TYPE: | Cement Slate | ACCESSIBILITY: | Difficult |
| FOUND IN: | Roof | | |
| | | EXTENT OF DAMAGE / DETERIORATION | GOOD CONDITION 0<br>LOW DAMAGE 1<br>MEDIUM DAMAGE 2 ✓<br>HIGH DAMAGE 3<br>LOOSE ASBESTOS 3 |

Cement slate roof to building at rear. Small amount of cement slate repairs all included as contaminated.

| | | RECOMMENDED ACTION | REMOVE ✓<br>REPAIR / SEAL ENCAPSULATE<br>LABEL AND MANAGE |

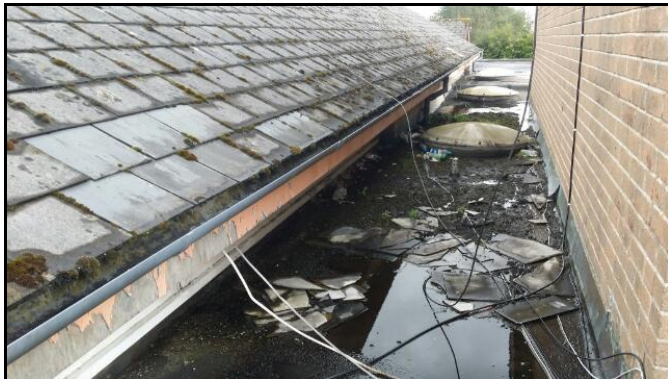
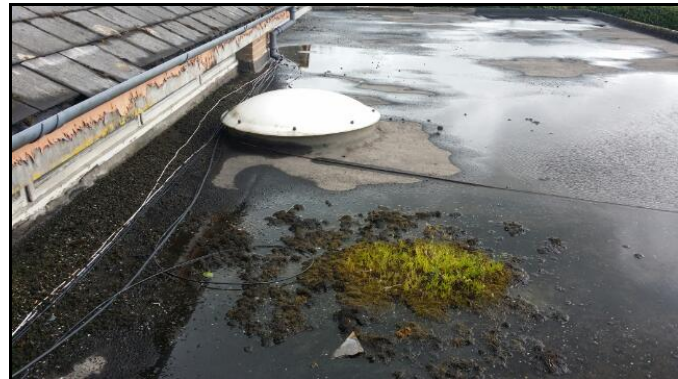
| PRODUCT TYPE: | | Cement Slate | | ACCESSIBILITY: | | Difficult | |
| FOUND IN: | | Debris | | | | | |
| | CROCIDOLITE | 3 | | | HIGH DAMAGE | 3 | ✓ |
| PRODUCT TYPE | ASBESTOS REINFORCED COMPOSITES | 1 | ✓ | RECOMMENDED ACTION | REMOVE | | ✓ |

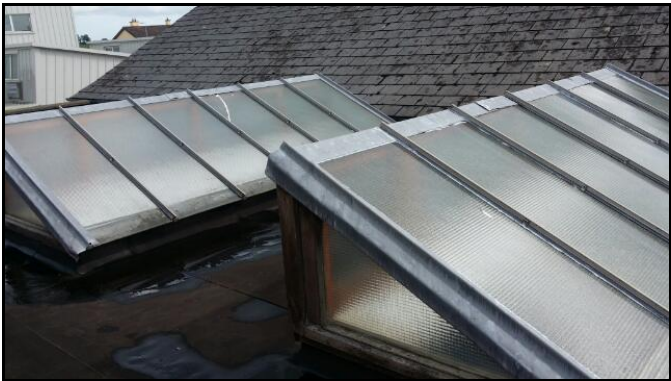
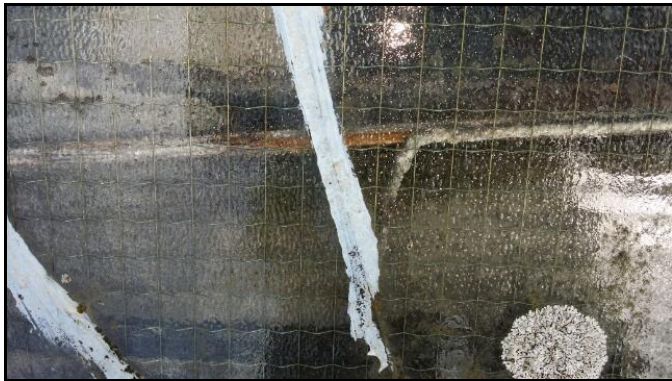
| ROOM NAME / NO.: | 99-010 | | | SAMPLE REF NO.: | S11 | | |

| PRODUCT TYPE: | Rope | | | ACCESSIBILITY: | Difficult | | |
| FOUND IN: | Roof | | | | | | |
| | AMOSITE | 2 | | | MEDIUM DAMAGE | 2 | ✓ |
| PRODUCT TYPE | ASBESTOS REINFORCED COMPOSITES | 1 | | RECOMMENDED ACTION | REMOVE | | ✓ |

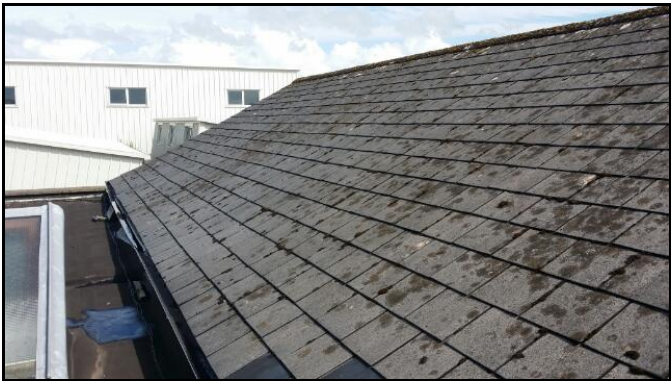
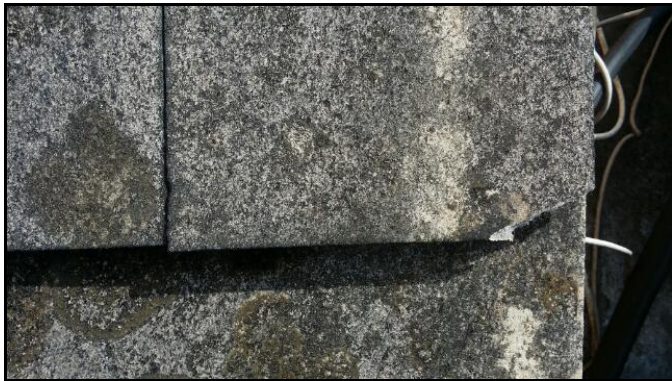
| PRODUCT TYPE: | Cement Slate | ACCESSIBILITY: | Difficult |
| FOUND IN: | Roof | | |
| | | EXTENT OF DAMAGE / DETERIORATION | GOOD CONDITION 0<br>LOW DAMAGE 1<br>MEDIUM DAMAGE 2 ✓<br>HIGH DAMAGE 3<br>LOOSE ASBESTOS 3 |

| | | RECOMMENDED ACTION | REMOVE ✓<br>REPAIR / SEAL ENCAPSULATE<br>LABEL AND MANAGE |

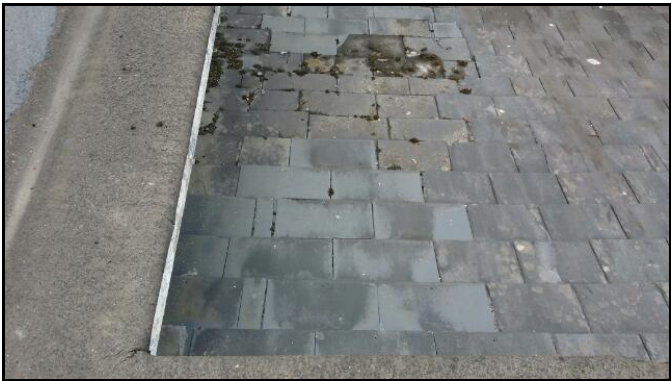
| ROOM NAME / NO.: | 99-012 | | | SAMPLE REF NO.: | S13 | | |

| PRODUCT TYPE: | Cement Slate | | | ACCESSIBILITY: | Difficult | | |
| FOUND IN: | Roof | | | | | | |
| | CHRYSTOTILE | 1 | ✓ | | LOW DAMAGE | 1 | ✓ |
| PRODUCT TYPE | ASBESTOS REINFORCED COMPOSITES | 1 | ✓ | RECOMMENDED ACTION | REMOVE | | ✓ |

Cement slate repairs to natural slate roof.

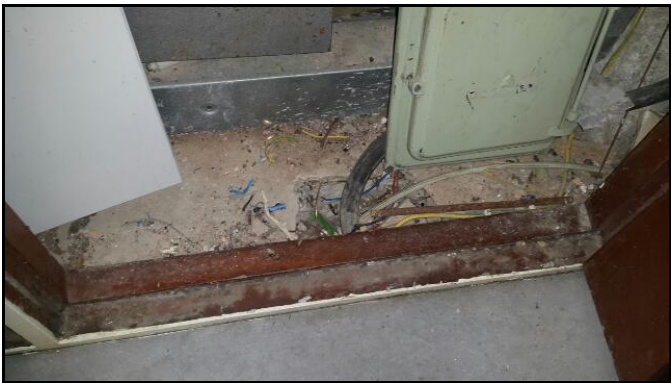
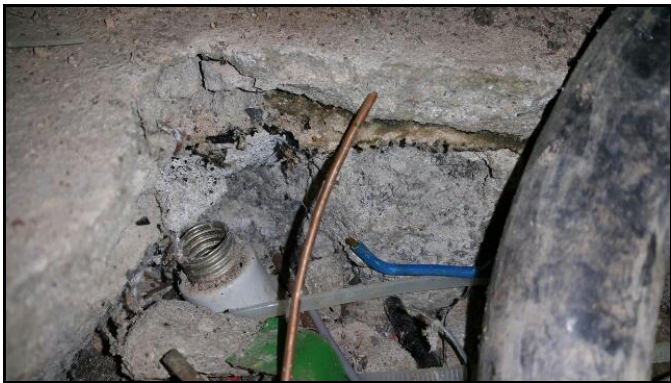
| ROOM NAME / NO.: | 0-001 | SAMPLE REF NO.: | S3 |

| PRODUCT TYPE: | Damp Proof Course | ACCESSIBILITY: | Difficult |
| FOUND IN: | Floor | | |

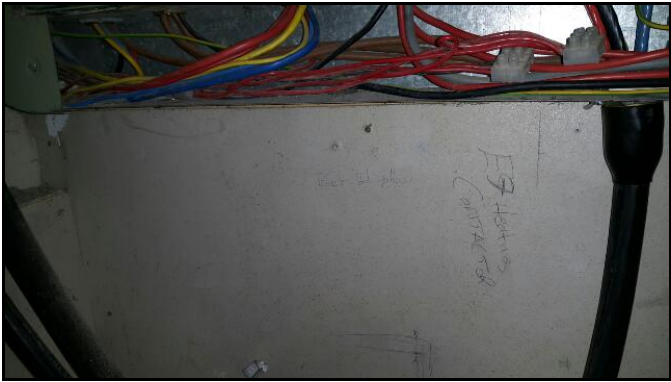
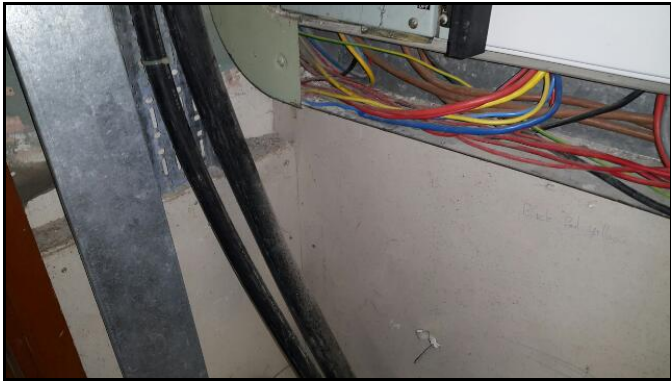
| ROOM NAME / NO.: | 0-001 | SAMPLE REF NO.: | S2 |

| PRODUCT TYPE: | Insulating Board | ACCESSIBILITY: | Easy |
| FOUND IN: | Electrics | | |

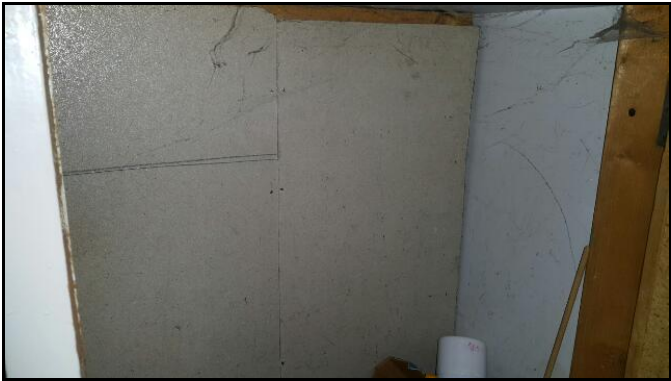
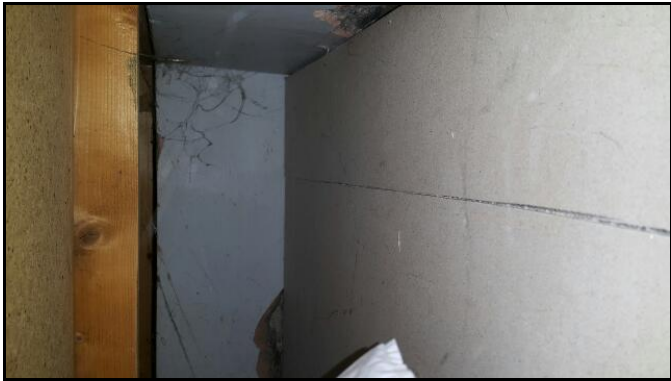
| ROOM NAME / NO.: | 0-002 | SAMPLE REF NO.: | Same As S2 |

| PRODUCT TYPE: | Insulating Board | ACCESSIBILITY: | Easy |
| FOUND IN: | Electrics | | |

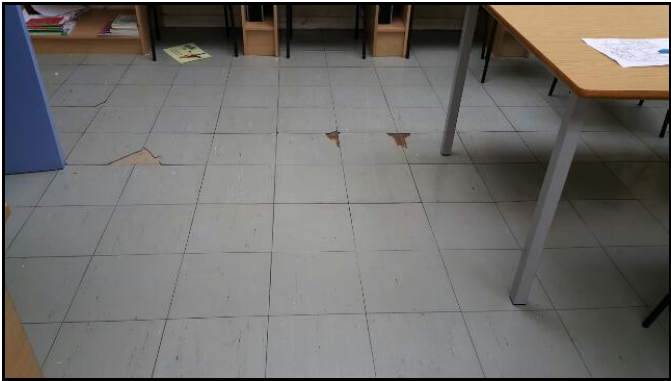
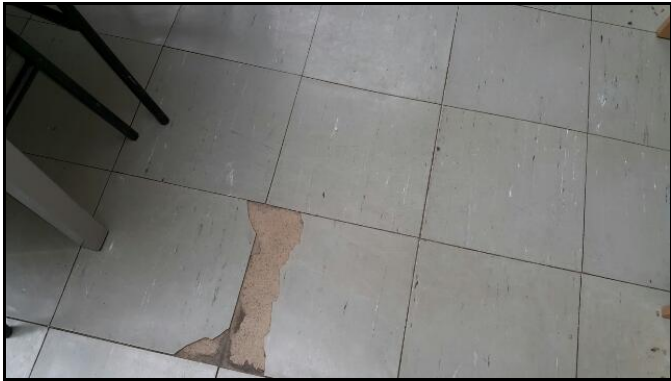
| ROOM NAME / NO.: | 0-027 | SAMPLE REF NO.: | S5 |

| PRODUCT TYPE: | Vinyl Floor Tile | ACCESSIBILITY: | Easy |
| FOUND IN: | Floor | | |

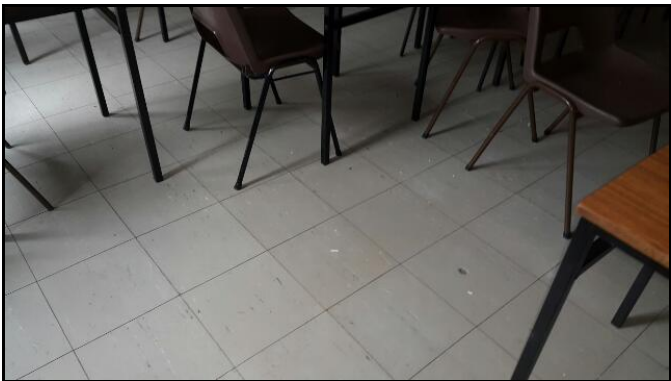
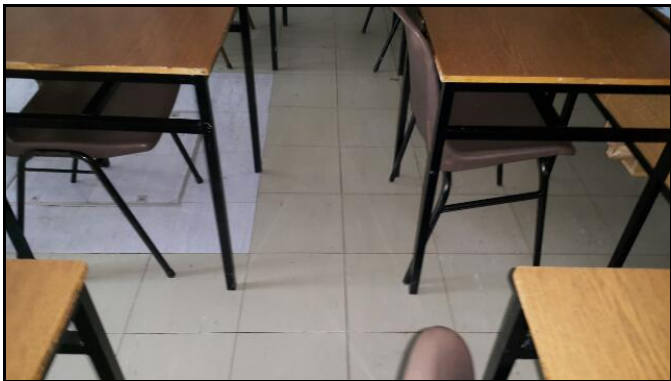
| ROOM NAME / NO.: | 0-028 | SAMPLE REF NO.: | Same As S5 |

| PRODUCT TYPE: | Vinyl Floor Tile | ACCESSIBILITY: | Easy |
| FOUND IN: | Floor | | |

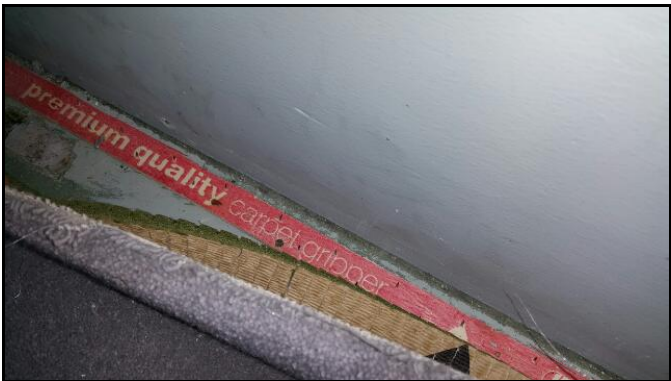
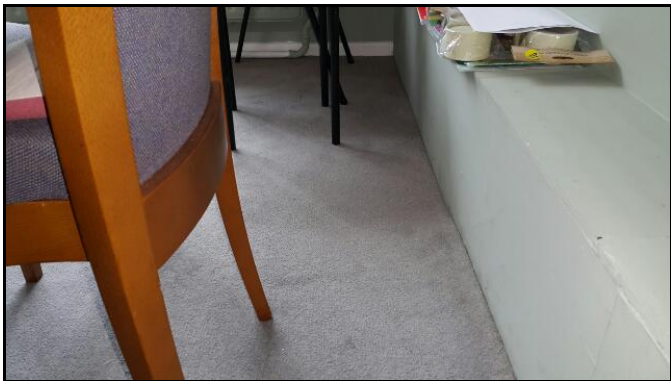
| ROOM NAME / NO.: | 0-037 | SAMPLE REF NO.: | S6 |

| PRODUCT TYPE: | Vinyl Floor Tile | ACCESSIBILITY: | Difficult |
| FOUND IN: | Floor | | |
