## CONSULTANTS REPORT

Scoil Ursula is a large primary school located on Strandhill Road, Sligo (Roll No. 18979F), with a current enrolment of approximately 445 pupils.

At the request of the Board of management a survey was carried out at the school, to inspect both the life safety systems (emergency lighting fire detection and alarm) and the electrical services installations proper.

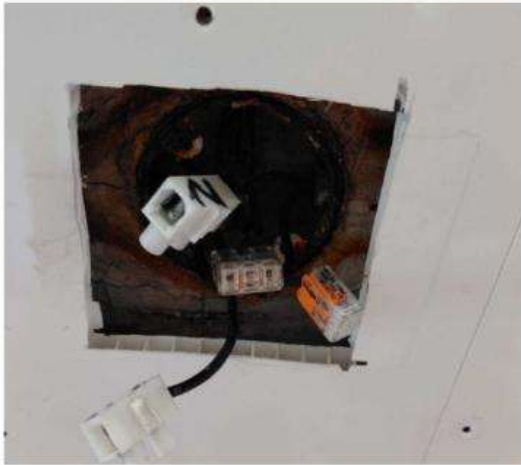
LIGHTING - SCORCHING

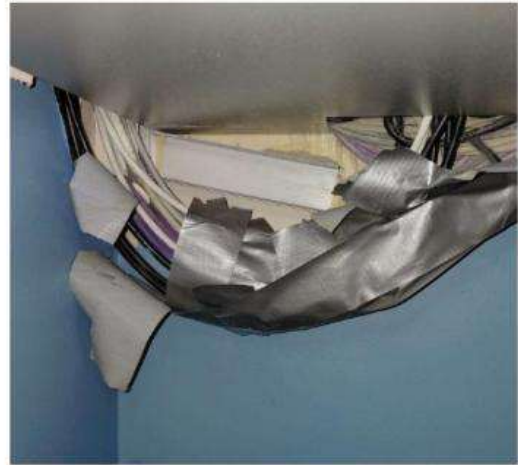
- Open junction points and exposed conductors were observed in ceiling voids and wall cavities where connections have been made without proper junction boxes or protective enclosures.

CABLING EXPOSED

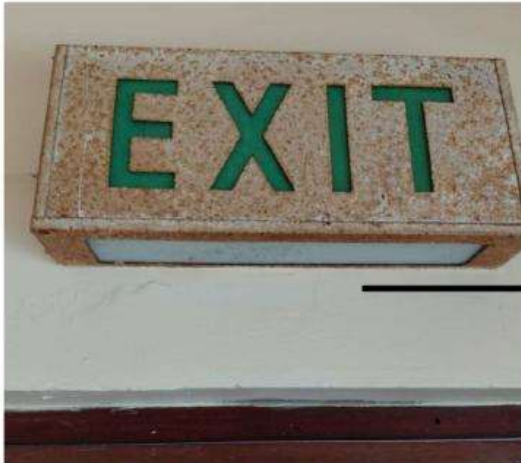
OBSOLETE EML FITTING

To ensure adequate protection is provided to the school. A new system to current standards will be installed, including central test facilities, exit signage, emergency luminaires, cabling, and associated equipment.

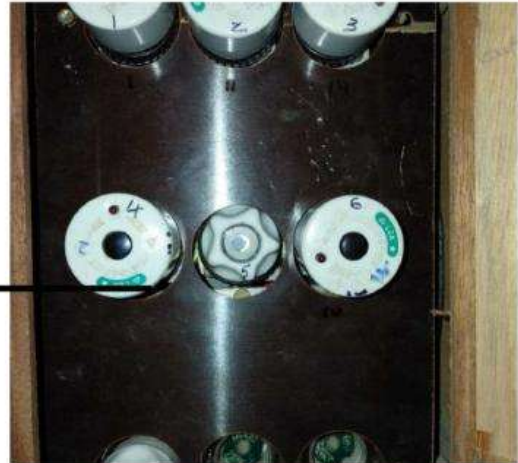
- Multiple legacy fuseboards remain in service, incorporating ceramic rewirable fuses and exposed busbar arrangements that are well beyond modern electrical safety standards.

SDB CERAMIC SCREW-IN FUSES

Retention of existing main board and installation of all new sub-distribution boards, power circuits, sockets, spurs, wiring, containment, and associated electrical infrastructure throughout the buildings.

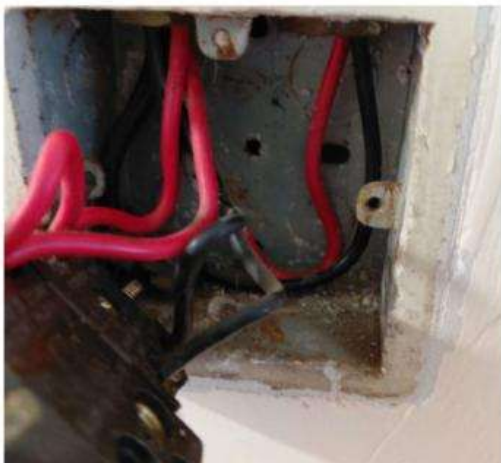
OLD RED & BLACK CABLING

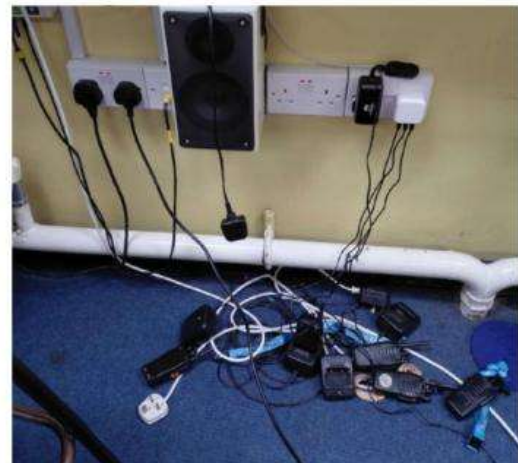
- Extension leads and multi-socket adapters are widely used within classrooms, where they have insufficient fixed socket provision and increasing the risk of overloading and trip hazards.

EXTENSION LEADS

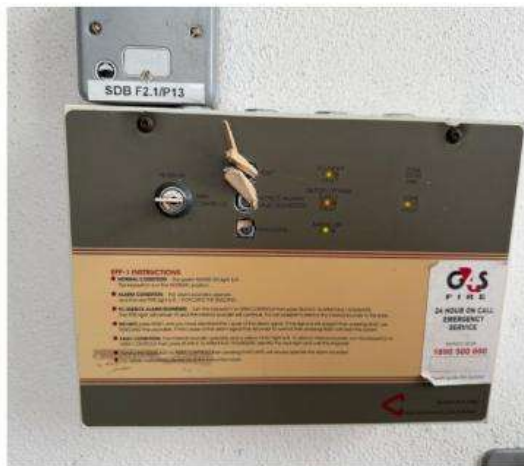
The fire alarm installation at Scoil Ursula was visually inspected as part of our site survey. The system is a conventional, zone-based installation however is no longer in operation (see photograph). The panel shows signs of deterioration, including damaged control components and missing / broken operating switches. There are also mechanical alarm bell sounders and manual “smash glass” call points, which appear to form part of the original installation

**OBSOLETE FDAS PANEL**

It is recommended that a fully addressable fire detection and alarm system be installed in accordance with I.S. 3218; 2024. The proposed upgrade to include:

- New addressable fire alarm control panel.
- Automatic smoke / heat detection throughout classrooms, circulation areas, stores and ancillary spaces.
- New resettable addressable manual call points at final exits and key circulation routes.
- Installation of addressable sounders and sounder/beacons to provide adequate alarm coverage.
- New fire-resistant loop cabling and containment where required.
- Provision of battery backup, fault monitoring and event logging.
- Full commissioning, certification and documentation in accordance with I.S. 3218:2024.

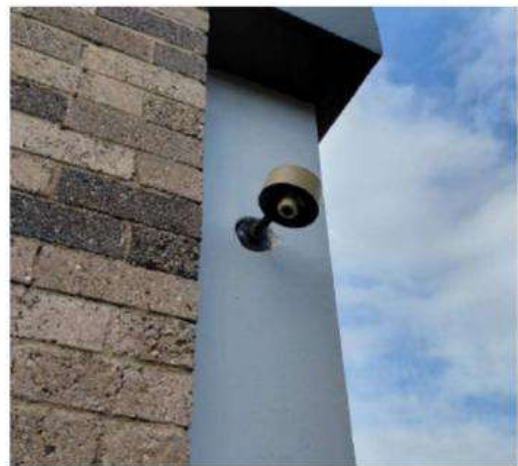
**OBSOLETE EXTERNAL LIGHTING**

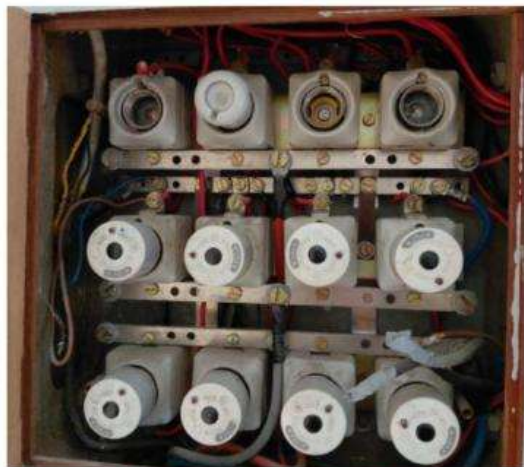
**SDB CERAMIC SCREW-IN FUSES**

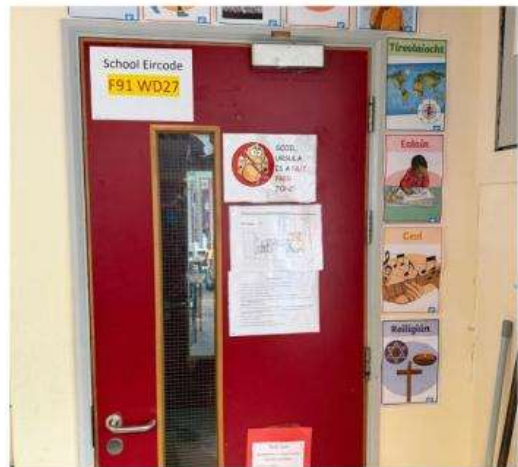
- In a number of areas emergency lighting fittings were not installed above exit doors or over classroom escape routes.
- In addition, no emergency lighting is installed within classroom spaces.
- Limited detection is installed within circulation spaces – a lot of fittings no longer working
- Emergency lighting should provide adequate illumination of escape routes and exit points in the event of power failure. The absence of emergency lighting within classrooms and over exit doors represents a significant life-safety deficiency.
- The existing system therefore requires comprehensive upgrading to ensure that escape routes and occupied spaces are adequately illuminated in accordance with current emergency lighting standards IS3217: 2023

**NO EMERGENCY LIGHTING**

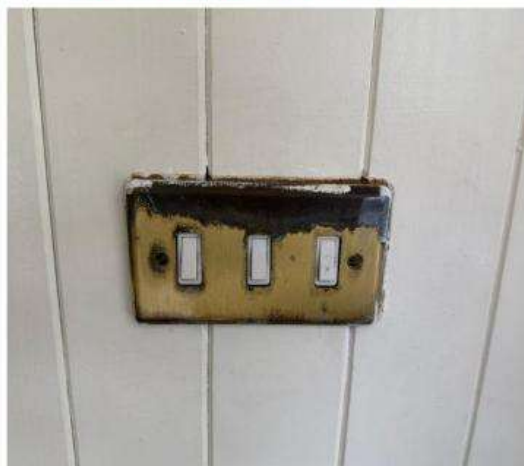
- Three-gang switch plate shows clear burn and heat damage, indicating a previous overheating or fault condition that has not been properly investigated or replaced.

**OVERHEATED SWITCH PLATE**

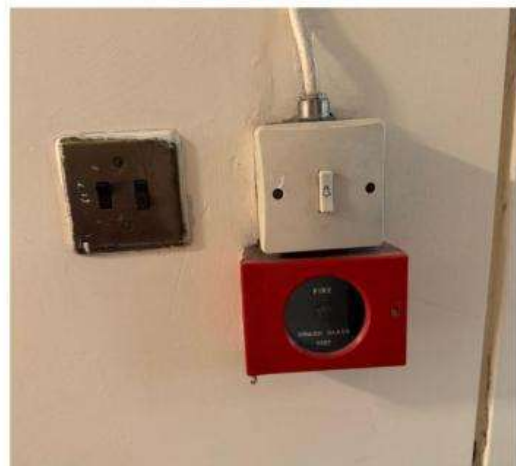
**SWITCHES / MANUAL FIRE CALL POINT**
