# ASBESTOS SURVEY REPORT

**Client:** Cavan County Council.

**Location:** Cavan County Museum Ballyjamesduff Co Cavan.

**Date of Survey:** 26/08/2026  
**Date of Report:** 04/09/2026

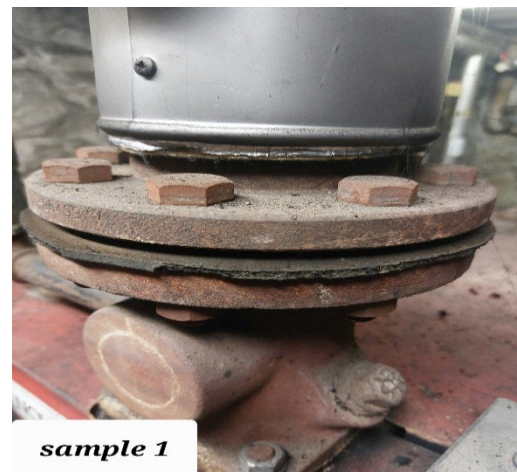
#### Sample 1.

#### Gasket.

A sample was taken here of the Gasket in the boiler room.

The lab results show that Asbestos was not detected in the sample.

**NADIS**

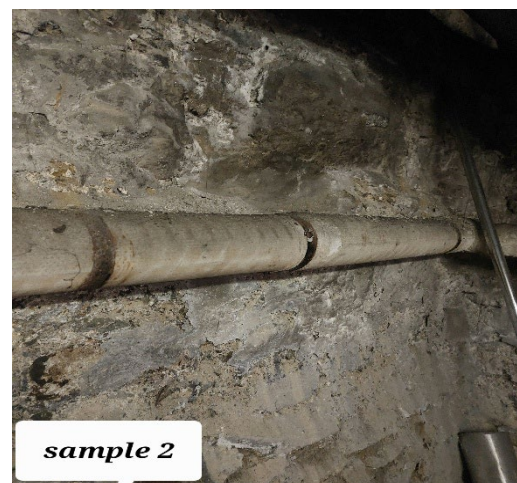
#### Sample 2.

#### Pipe Lagging.

A sample was taken here of the Pipe lagging in the boiler room.

The lab results show that Asbestos was not detected in the sample.

**NADIS**

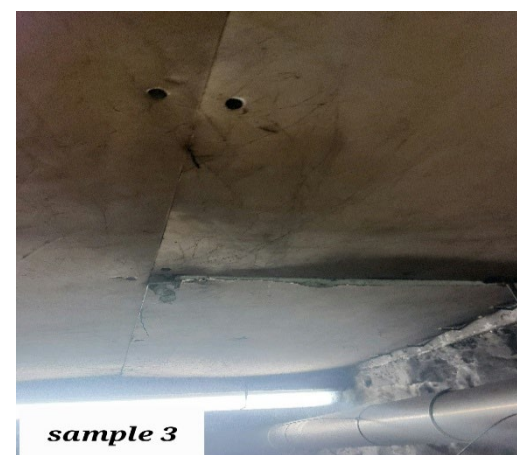
#### Sample 3.

#### Possible AIB .

A sample was taken here of the Possible AIB on the boiler room ceiling.

The lab results show that Asbestos was not detected in the sample.

**NADIS**

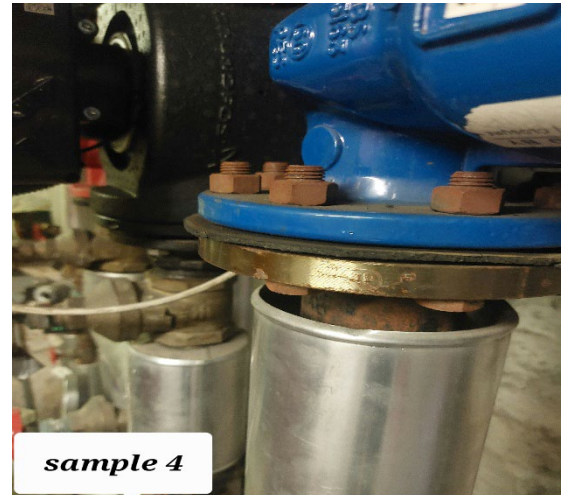
**Sample 4.**

**Gasket .**

A sample was taken here of the Gasket in the boiler room.

The lab results show that Asbestos was not detected in the sample.

**NADIS**

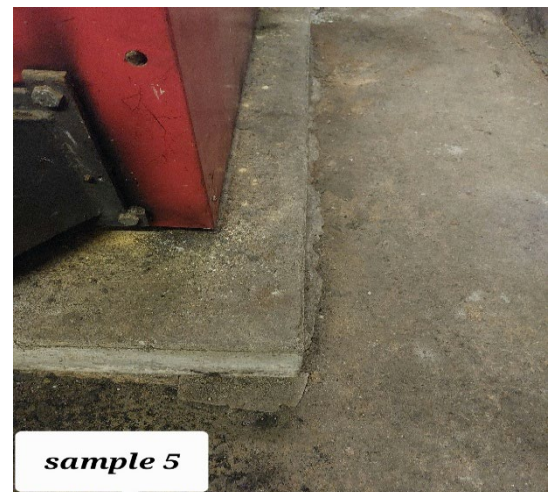
**Sample 5.**

**Concrete Base/Cement Product .**

A sample was taken here of the Concrete base/cement product on the base under the boiler.

The lab results show that Asbestos was not detected in the sample.

**NADIS**

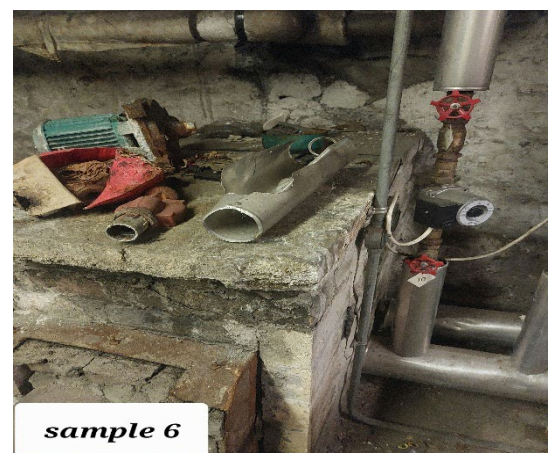
**Sample 6.**

**Smoke Vent/Cement Product .**

A sample was taken here of the Smoke vent/cement product in the boiler room.

The lab results show that Asbestos was not detected in the sample.

**NADIS**

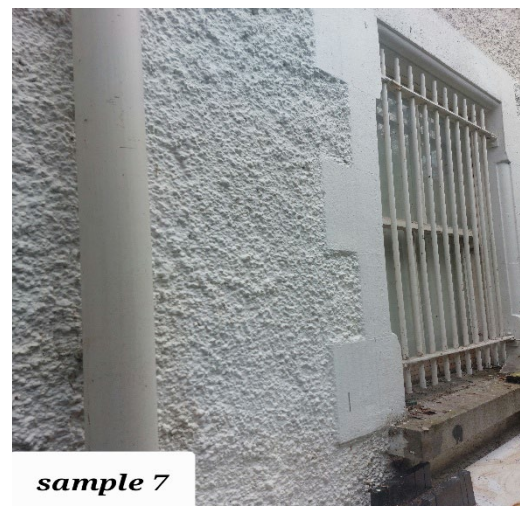
**Sample 7.**

**Texture Coating.**

A sample was taken here of the Texture coating on the external wall .

The lab results show that Asbestos was not detected in the sample.

**NADIS**

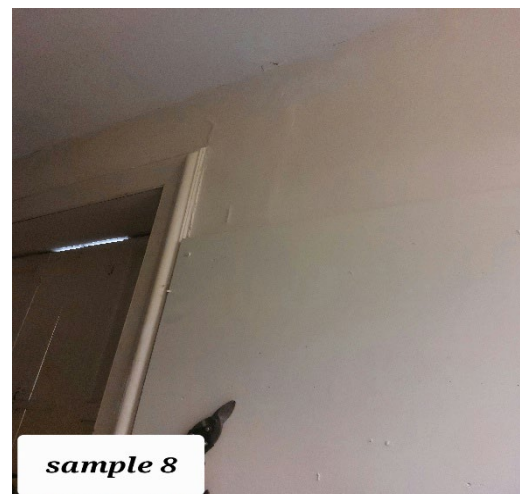
**Sample 8.**

**Texture Coating .**

A sample was taken here of the Texture coating on the wall slab in the store where units are going.

The lab results show that Asbestos was not detected in the sample.

**NADIS**
