# Asbestos Refurbishment Survey Report

Beds Project – Specific Areas  
UHK  
Tralee  
Co Kerry

Health Services Executive Southern Area

**Project 42156C**

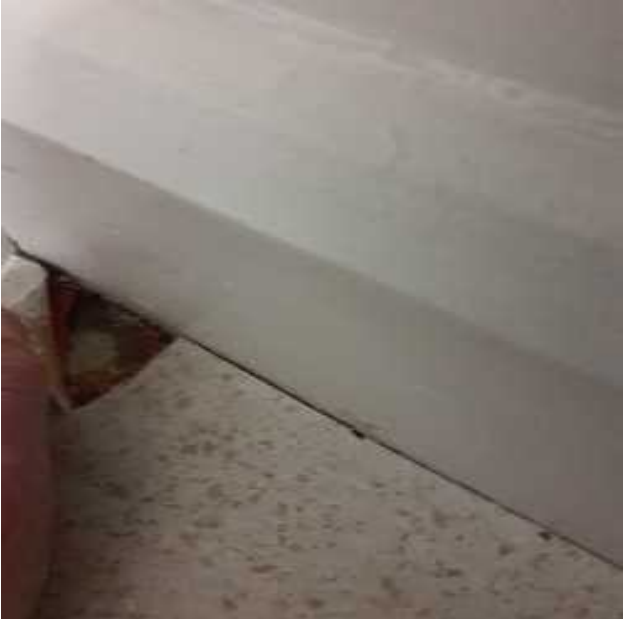
| Location Details : 114404 | | | |

| Location Details : 114404 | | | |
|---|---|---|---|
| Building/Area : | UHK | Sample No. : | RGB20241126002 |
| Room/Section : | G1101 | Confirmation : | Sample Taken |
| Location : | Floor | Access : | Full Access |
| Description : | Floor Tiles | Normal Use : | Hospital |

| Material Risk Assessment : 114404 | | | Risk Rating |
|---|---|---|---|
| Asbestos Type : | Chrysotile | Score | High Risk |
| Type Of Product : | Vinyl floor tile | 1 | Midium Risk |
| Condition : | Low Damage | 1 | Low Risk |
| Quantity : | 13 M2 | | |
| Material Assessment Score : | | 3 | Very Low Risk |

| Recommendations and Notes |
|---|
| <p>Priority 1 : Remove ACM's Prior to Refurbishment or Demolition.</p> |

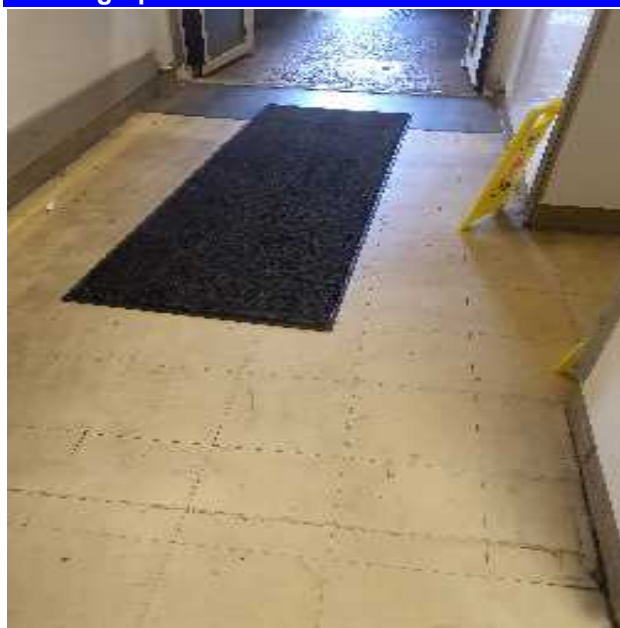
#### Location Details : 114407

Asbestos Type : Chrysotile  
 Type Of Product : Vinyl floor tile  
 Condition : Low Damage  
 Surface Treatment : Composite Materials Containing Asbestos  
 Quantity : 20 M2

Priority 1 : Remove ACM's Prior to Refurbishment or Demolition.

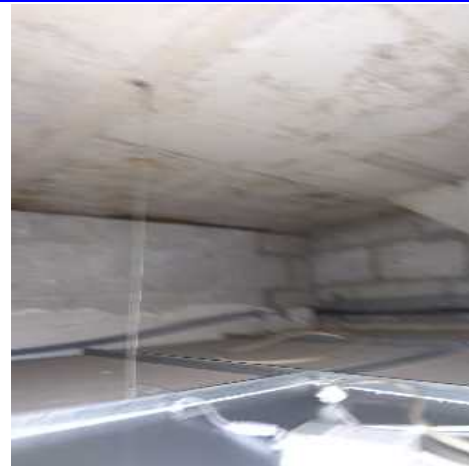
## Location Details : 114399 No Asbestos Found

Building/Area : UHK  
Room/Section : G450  
Location : Ceiling Void  
Description : Solid  
Sample No. :  
Confirmation :  
Access : Full Access  
Normal Use : Hospital  
Recommendations :  
Notes :

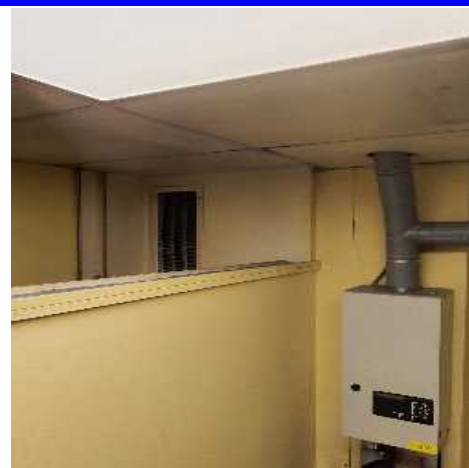
## Location Details : 114400 No Asbestos Found

Building/Area : UHK  
Room/Section : G450  
Location : Floors Walls and Ceiling  
Description : Solid and Plasterboard  
Sample No. :  
Confirmation :  
Access : Full Access  
Normal Use : Hospital  
Recommendations :  
Notes :

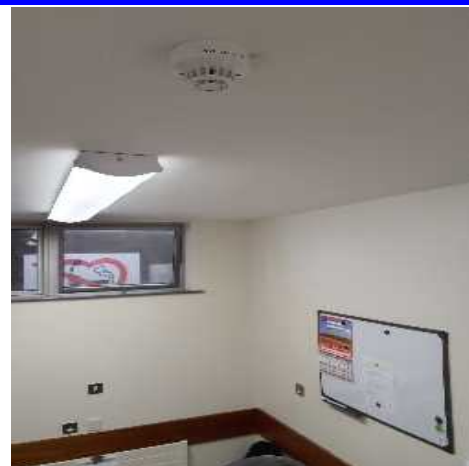
## Location Details : 114401 No Asbestos Found

Building/Area : UHK  
Room/Section : G451  
Location : Floors Walls and Ceiling  
Description : Solid and Plasterboard  
Sample No. :  
Confirmation :  
Access : Full Access  
Normal Use : Hospital  
Recommendations :  
Notes :

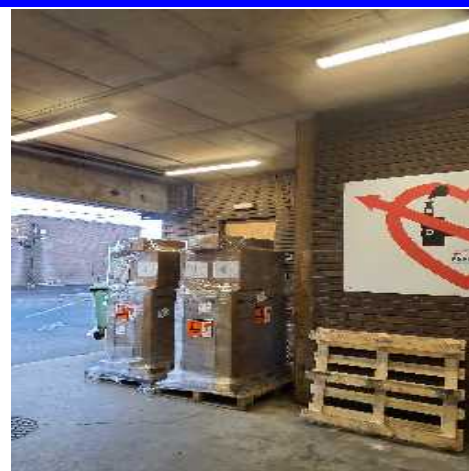
## Location Details : 114402 No Asbestos Found

Building/Area : UHK  
Room/Section : G281  
Location : Floors Walls and Roof  
Description : Solid and Plasterboard  
Sample No. :  
Confirmation :  
Access : Full Access  
Normal Use : Hospital  
Recommendations :  
Notes :

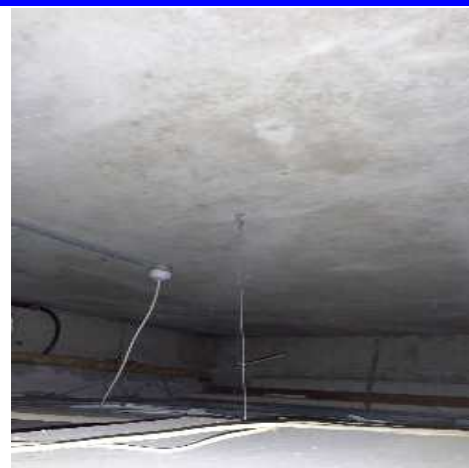
## Location Details : 114403 No Asbestos Found

Building/Area : UHK  
Room/Section : G1101  
Location : Ceiling Void  
Description : Solid  
Sample No. :  
Confirmation :  
Access : Full Access  
Normal Use : Hospital  
Recommendations :  
Notes :

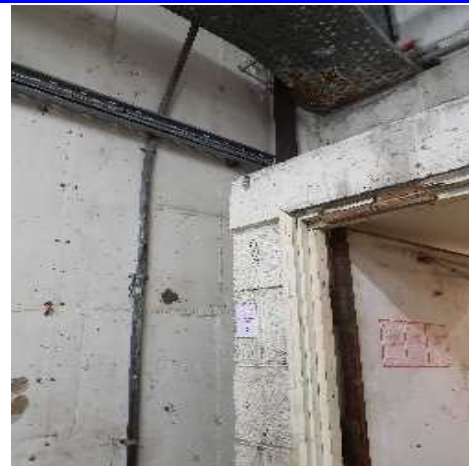
## Location Details : 114405 No Asbestos Found

Building/Area : UHK  
Room/Section : Boiler Room  
Location : Floors Walls and Ceiling  
Description : Solid and Plasterboard  
Sample No. :  
Confirmation :  
Access : Full Access  
Normal Use : Hospital  
Recommendations :  
Notes :

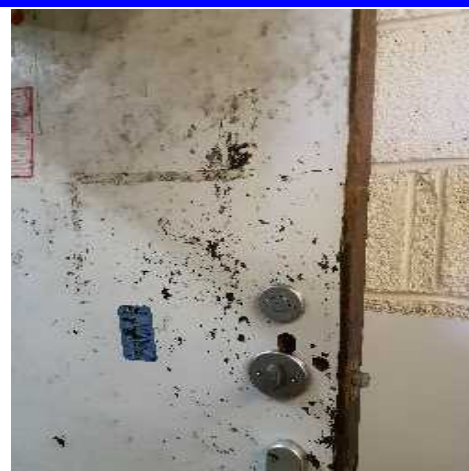
## Location Details : 114406 No Asbestos Found

Building/Area : UHK  
Room/Section : Boiler Room  
Location : Door  
Description : Wood  
Sample No. :  
Confirmation :  
Access : Full Access  
Normal Use : Hospital  
Recommendations :  
Notes :

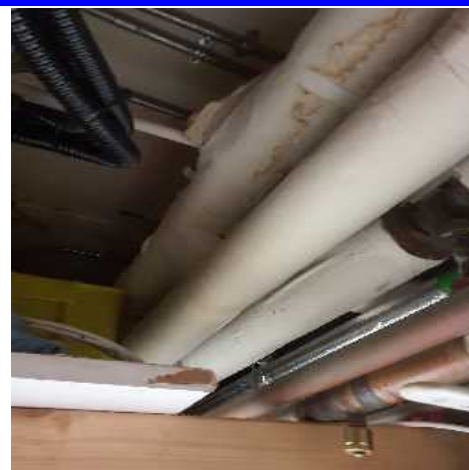
## Location Details : 114408 No Asbestos Found

Building/Area : UHK  
Room/Section : Lobby  
Location : Ceiling Void  
Description : Solid  
Sample No. :  
Confirmation :  
Access : Full Access  
Normal Use : Hospital  
Recommendations :  
Notes : Fabric and MMMF wrap to pipework

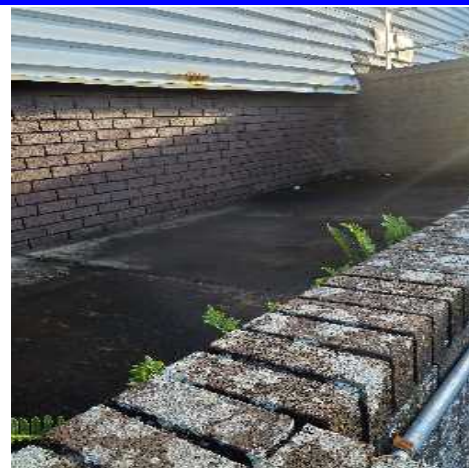
## Location Details : 114409 No Asbestos Found

Building/Area : UHK  
Room/Section : External  
Location : Roof  
Description : Wood  
Sample No. :  
Confirmation :  
Access : Full Access  
Normal Use : Hospital  
Recommendations :  
Notes : Fabric and MMMF wrap to pipework
