# Model Project

Framework Agreement for Construction Design  
Professional Services for Pyrite Remediation Scheme

Project  
**Inspection of  
Notional Building 1,  
Dublin 15.**

Report Title  
**BUILDING CONDITION  
ASSESSMENT IN ACCORDANCE  
WITH IS 398-1:2013**

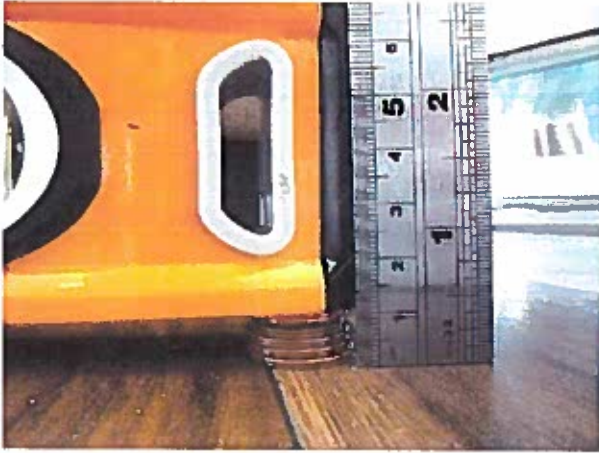
Photo 1

| ELEMENT GROUP | PHOTO REFERENCE | ATTRIBUTE VALUE | OBSERVATION IN ANY ROOM | LOCATION(S) IDENTITY /COMMENTS |
|---|---|---|---|---|
| Ground floor surface level<br>(see floor level survey) | 1 | 8 | Hogging of greater than 10mm (2m spirit level centred on ridge) in Living Room | Living Room |

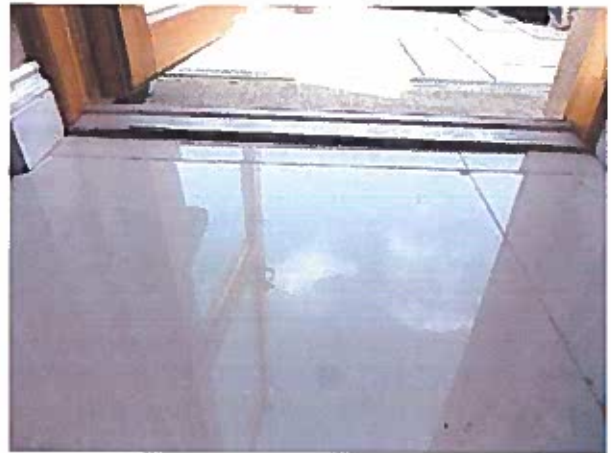
Photo 2

| ELEMENT GROUP | PHOTO REFERENCE | ATTRIBUTE VALUE | OBSERVATION IN ANY ROOM | LOCATION(S) IDENTITY /COMMENTS |
|---|---|---|---|---|
| | 2, 3, 4 | 8 | Upward displacement of more than 2mm at rear door threshold | Utility Room |

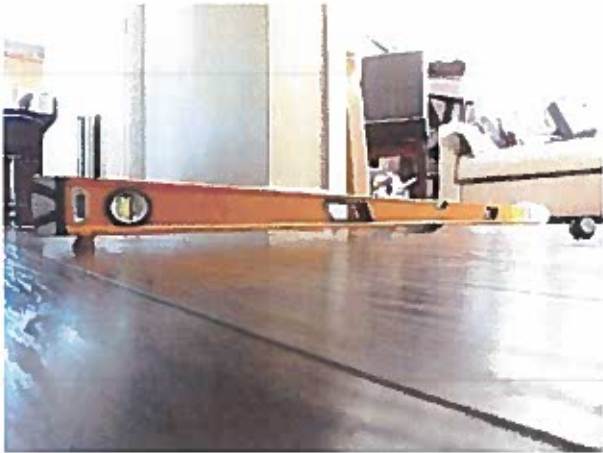
Photo 5

| ELEMENT GROUP | PHOTO REFERENCE | ATTRIBUTE VALUE | OBSERVATION IN ANY ROOM | LOCATION(S) IDENTITY /COMMENTS |
|---|---|---|---|---|
| | 5, 6 | 10 | Upward displacement of 13mm at construction joint at door to study | Hallway / Study |

| Summary Conclusions and sign off template (To be read in accordance with the Table 3.2 – Evaluation of damage and associated sketches and photographs) | | | | |
|---|---|---|---|---|
| A | 5, 6 | Upward displacement of 13mm at construction joint at door to study | Ground Floor Surface Level | 10 |

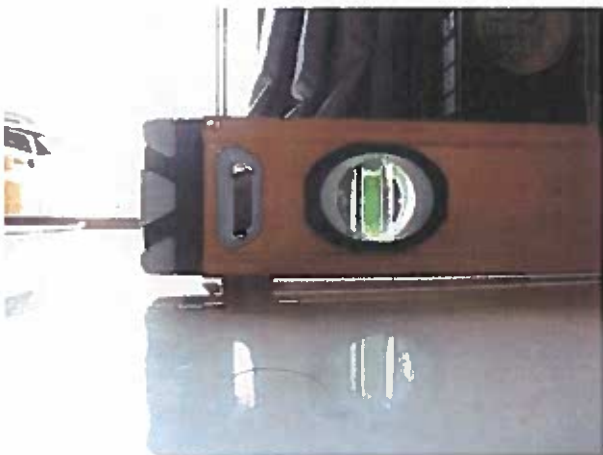
Photo 7

| ELEMENT GROUP | PHOTO REFERENCE | ATTRIBUTE VALUE | OBSERVATION IN ANY ROOM | LOCATION(S) IDENTITY /COMMENTS |
|---|---|---|---|---|
| | 7 | 3 | Hogging of 5mm (2m spirit level centred on ridge) in kitchen / dining. | Kitchen / Dining |

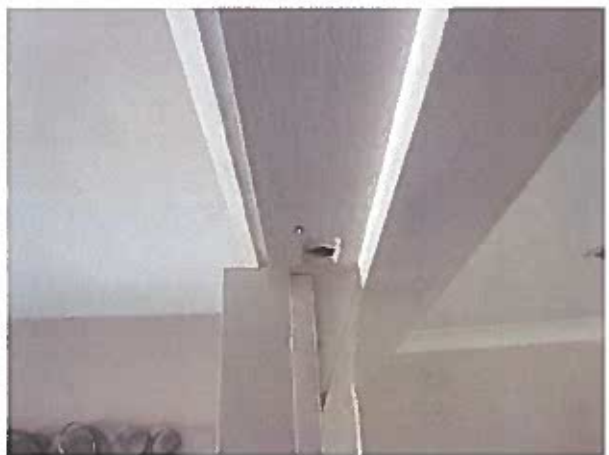
Photo 8

| ELEMENT GROUP | PHOTO REFERENCE | ATTRIBUTE VALUE | OBSERVATION IN ANY ROOM | LOCATION(S) IDENTITY /COMMENTS |
|---|---|---|---|---|
| Fixtures and Fitting | 8, 9, 10, 11, | 6 | Internal double doors between Living Room and Dining Room require significant force to open | Living Room / Dining Room |

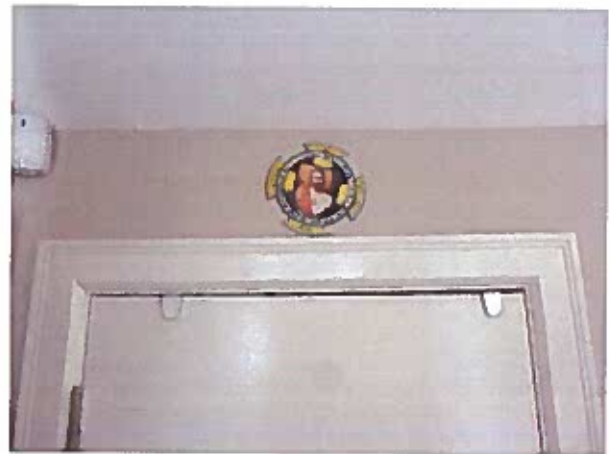
Photo 12

| ELEMENT GROUP | PHOTO REFERENCE | ATTRIBUTE VALUE | OBSERVATION IN ANY ROOM | LOCATION(S) IDENTITY /COMMENTS |
|---|---|---|---|---|
| | 12, 13 | 7 | Upward displacement of staircase | Hallway |

| Summary Conclusions and sign off template (To be read in accordance with the Table 3.2 – Evaluation of damage and associated sketches and photographs) | | | | |
|---|---|---|---|---|
| A | 12, 13 | Upward displacement of staircase | Fixtures and Fittings | 7 |

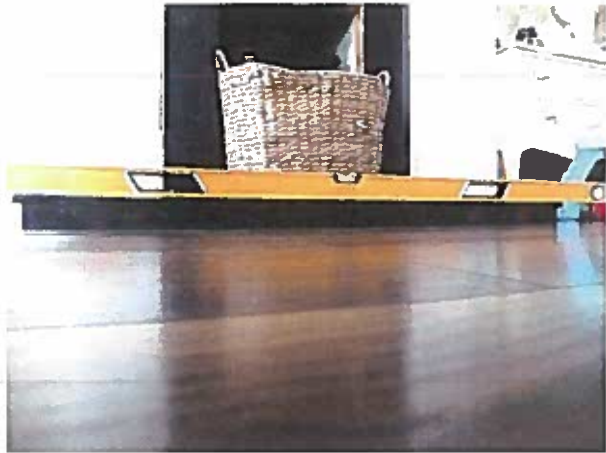
Photo 14

| ELEMENT GROUP | PHOTO REFERENCE | ATTRIBUTE VALUE | OBSERVATION IN ANY ROOM | LOCATION(S) IDENTITY /COMMENTS |
|---|---|---|---|---|
| | 14, 15 | 4 | Upward displacement and cracking of fireplace hearth | Living Room |

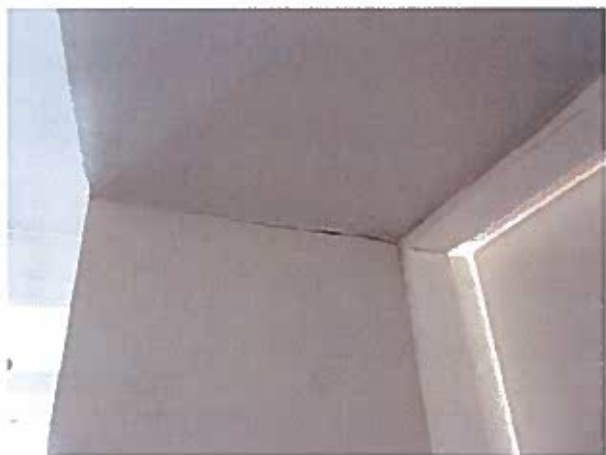
Photo 16

| ELEMENT GROUP | PHOTO REFERENCE | ATTRIBUTE VALUE | OBSERVATION IN ANY ROOM | LOCATION(S) IDENTITY /COMMENTS |
|---|---|---|---|---|
| Walls / Partitions on Ground Floor | 16, 17 | 1 | Horizontal cracking at top lh and top rh corners of reveal to door leading to study. | Hallway |

| Summary Conclusions and sign off template (To be read in accordance with the Table 3.2 – Evaluation of damage and associated sketches and photographs) | | | | |
|---|---|---|---|---|
| A | 16, 17 | Horizontal cracking at top lh and top rh corners of reveal to door leading to study. | Walls / Partitions on Ground Floor Level | 1 |

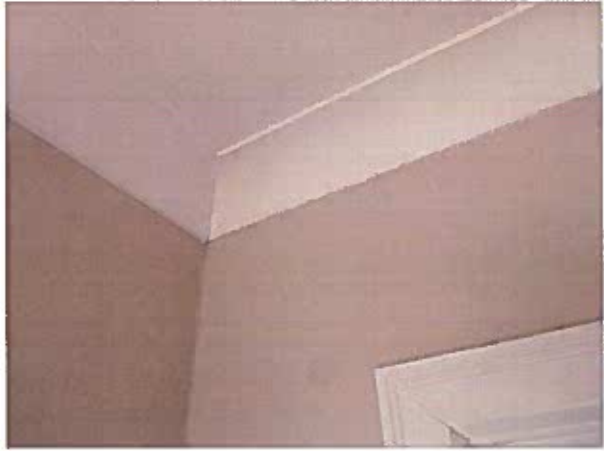
Photo 18

| ELEMENT GROUP | PHOTO REFERENCE | ATTRIBUTE VALUE | OBSERVATION IN ANY ROOM | LOCATION(S) IDENTITY /COMMENTS |
|---|---|---|---|---|
| Ground Floor Ceiling(s) | 18, 19, 20 | 4 | Coving displacement > 2mm at joint in hallway | Hallway |

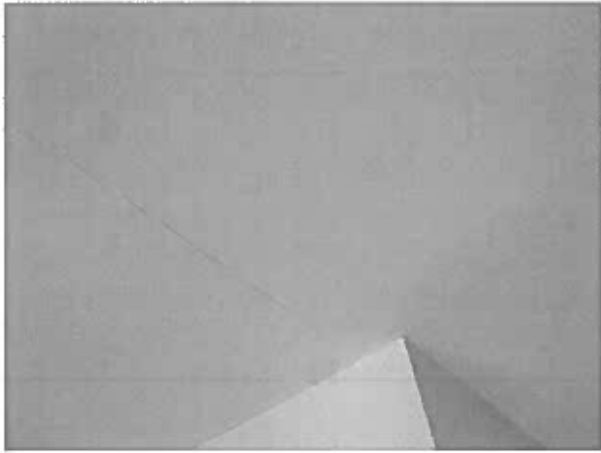
Photo 21

| ELEMENT GROUP | PHOTO REFERENCE | ATTRIBUTE VALUE | OBSERVATION IN ANY ROOM | LOCATION(S) IDENTITY /COMMENTS |
|---|---|---|---|---|
| | 21 | 1 | Cracking to ceiling in kitchen. | Kitchen |

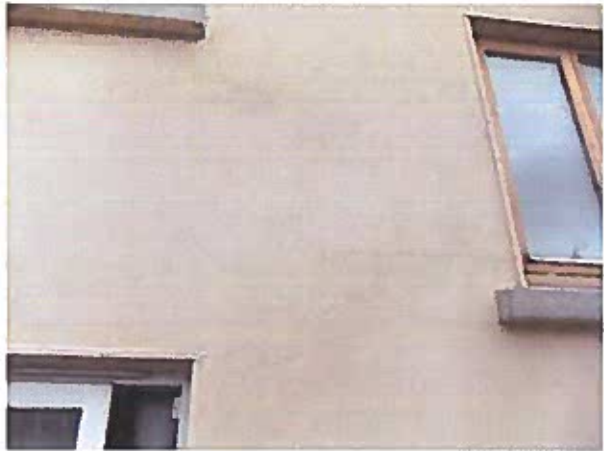
Photo 14

| ELEMENT GROUP | PHOTO REFERENCE | ATTRIBUTE VALUE | OBSERVATION IN ANY ROOM | LOCATION(S) IDENTITY /COMMENTS |
|---|---|---|---|---|
| External | 13, 14 | 2 | 7 no. cracks at corner of doors and windows, diagonal and horizontal from hairline to 0.5mm approx. | Rear Elevation |

| Summary Conclusions and sign off template (To be read in accordance with the Table 3.2 – Evaluation of damage and associated sketches and photographs) | | | | |
|---|---|---|---|---|
| A | 13, 14 | 7 no. cracks at corner of doors and windows, diagonal and horizontal from hairline to 0.5mm approx. | External | 2 |
