SKIBBEREEN STEAM MILL

# INFORMATION PACK

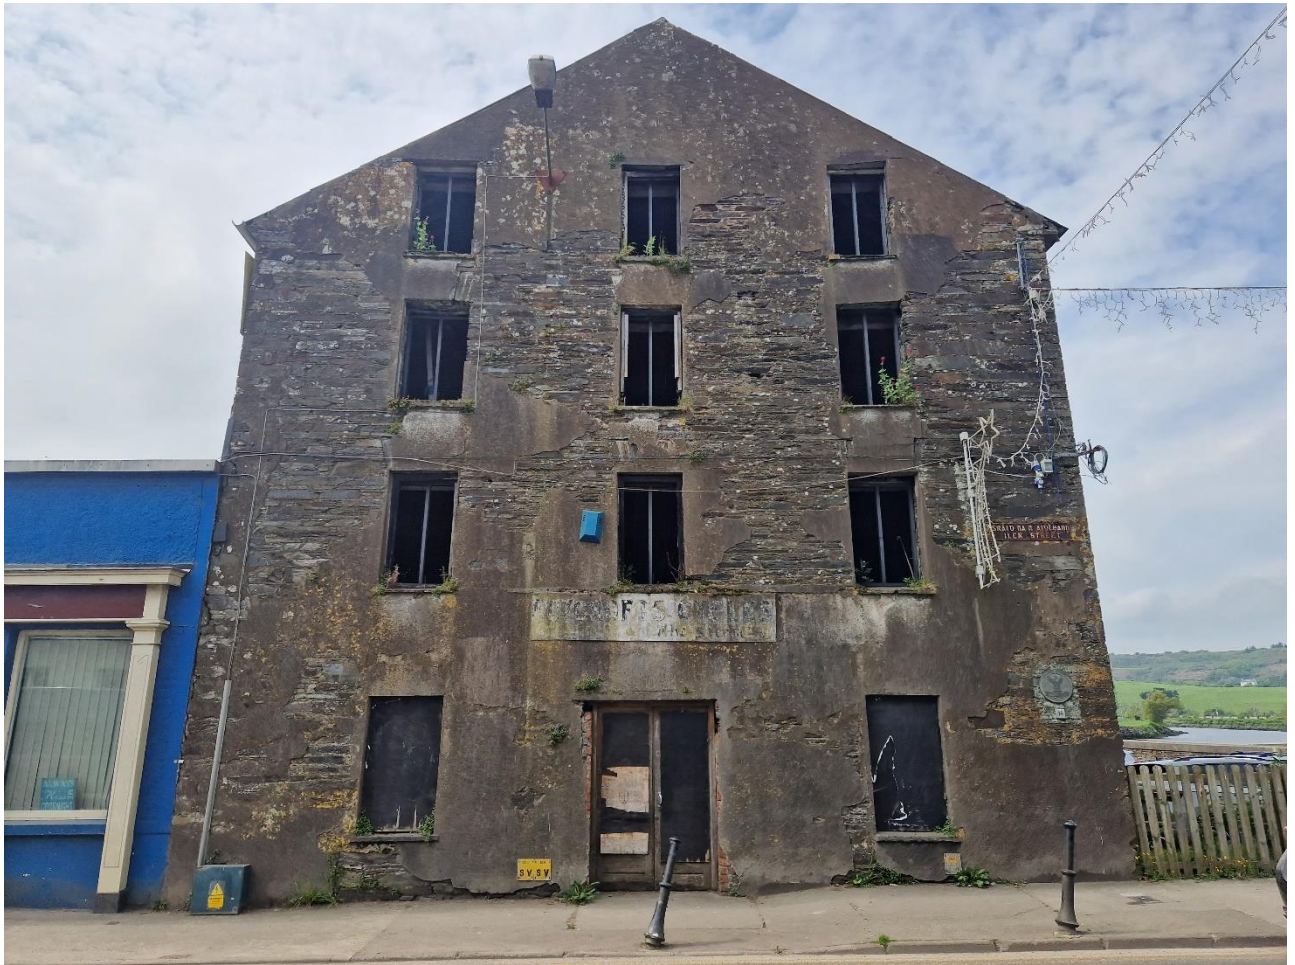
*Figure 4. Shows the main gable fronted elevation of the building. Note that as there are no windows present, water penetrates and decays the lintels. Most lintels on this elevation have decay present.*

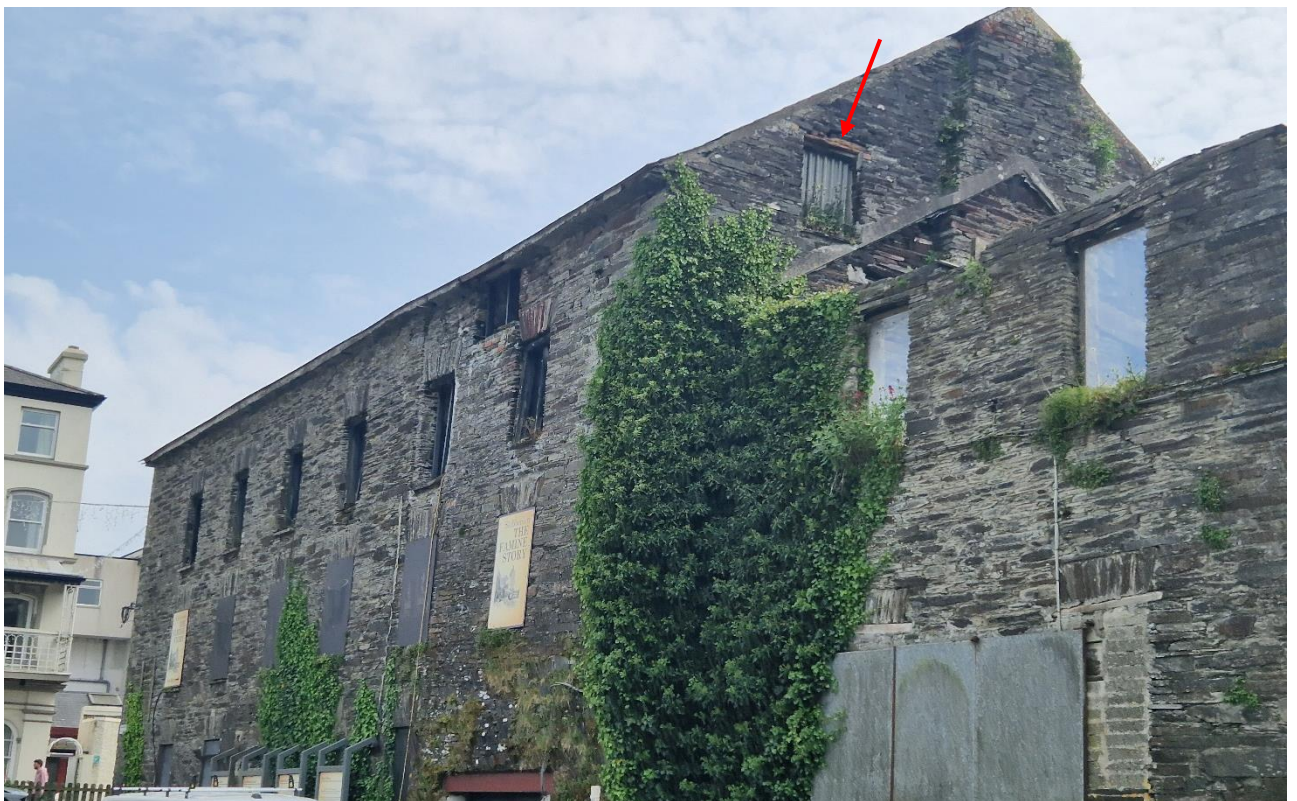
*Figure 6. It highlights the poor condition of the exposed lintel on the north of the west gable that should be replaced.*

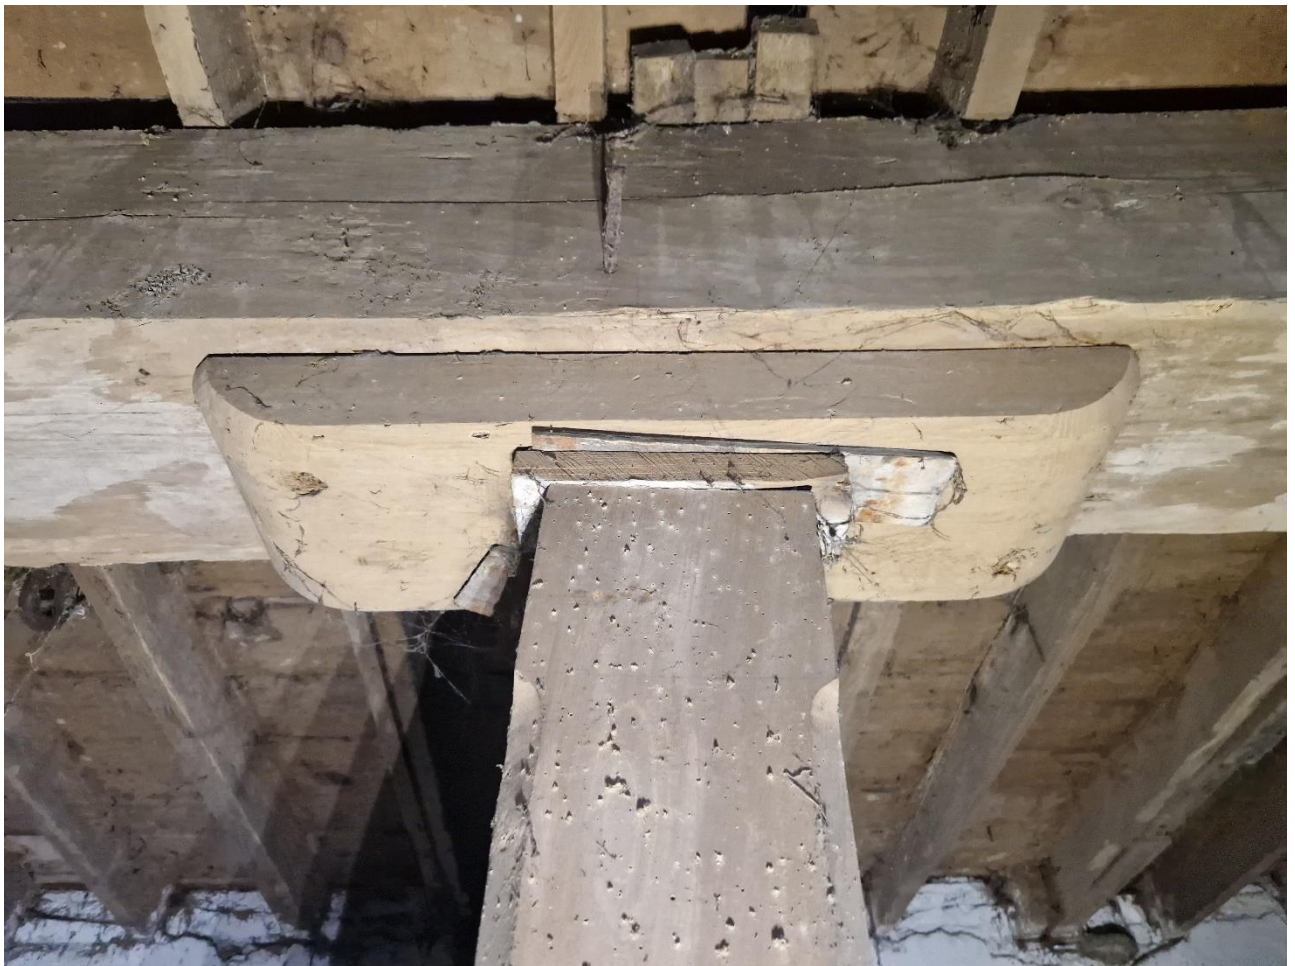
*Figure 8. Shows a typical post arrangement.*

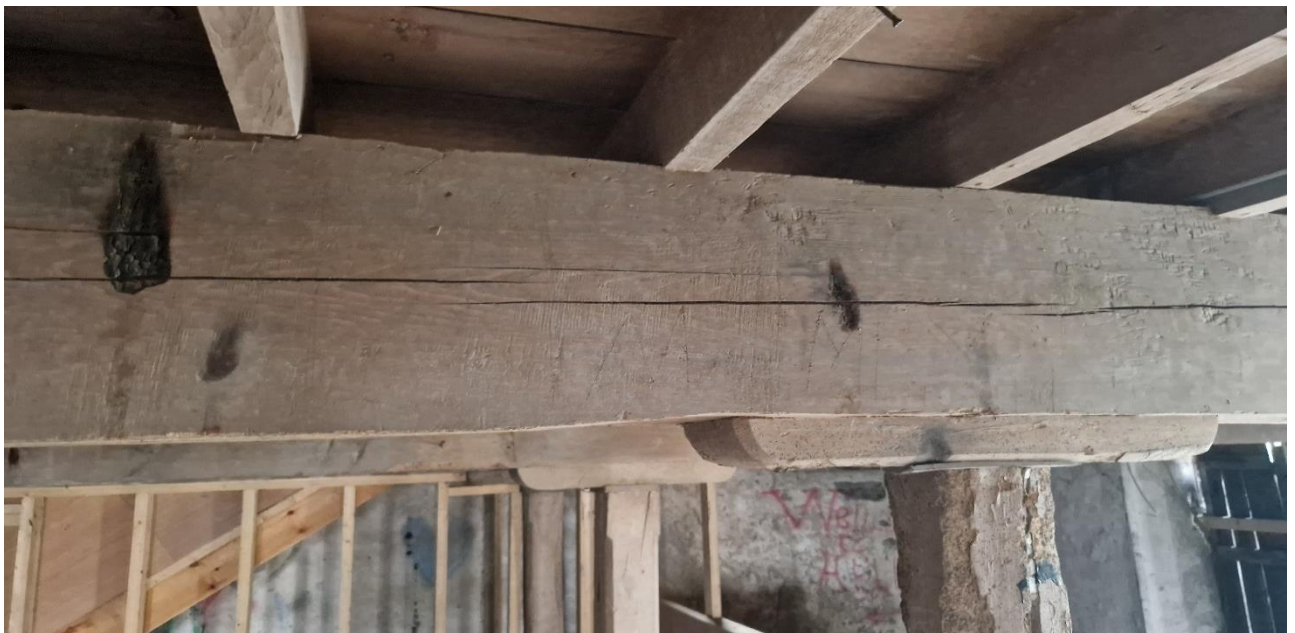
*Figure 13. Shows two of several burn marks present in the building.*

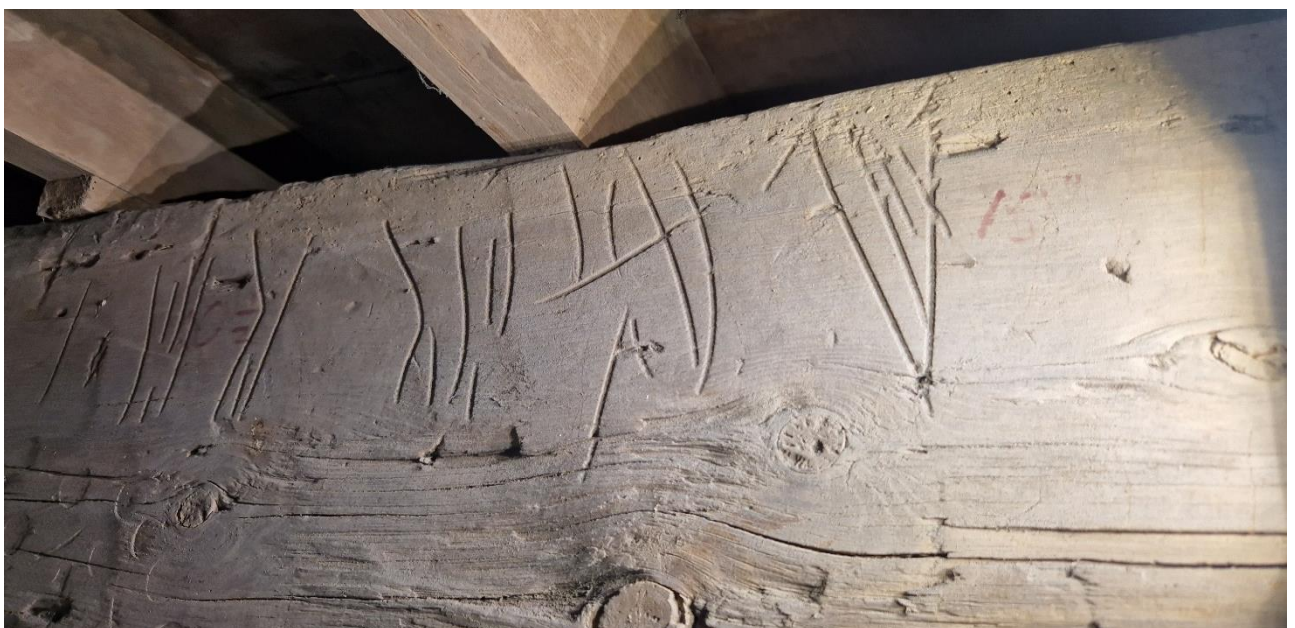
*Figure 14. Shows typical baltic marks visible on some timbers.*

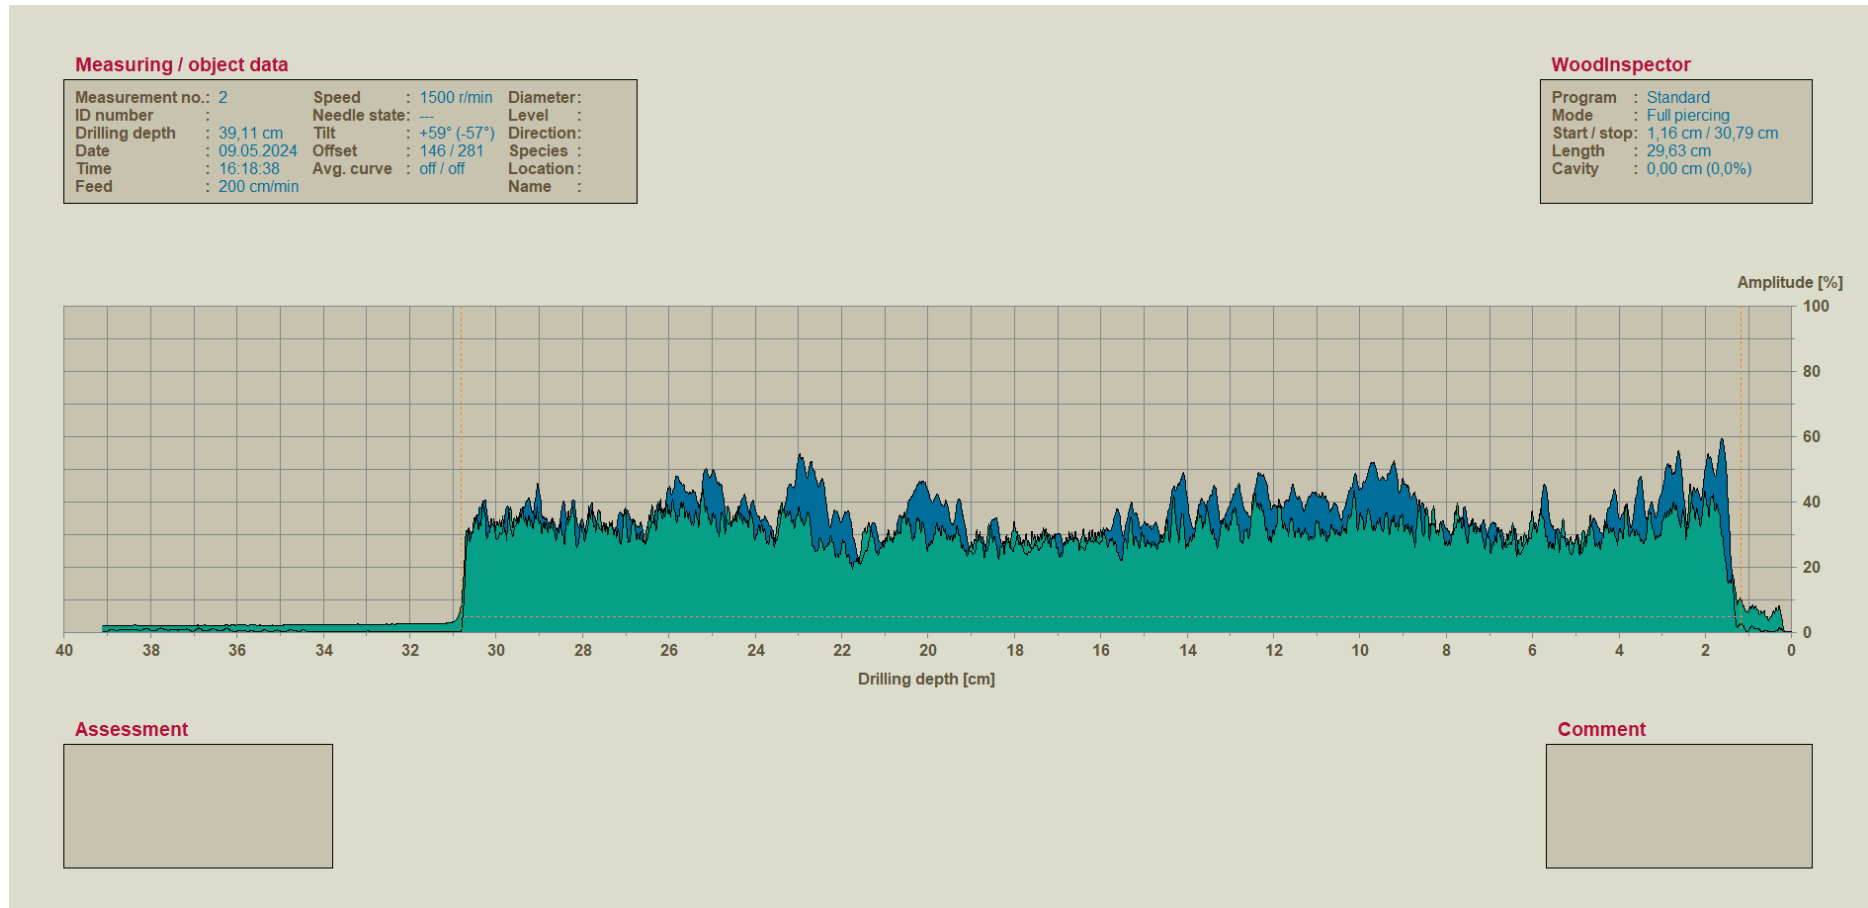
**Measuring / object data**

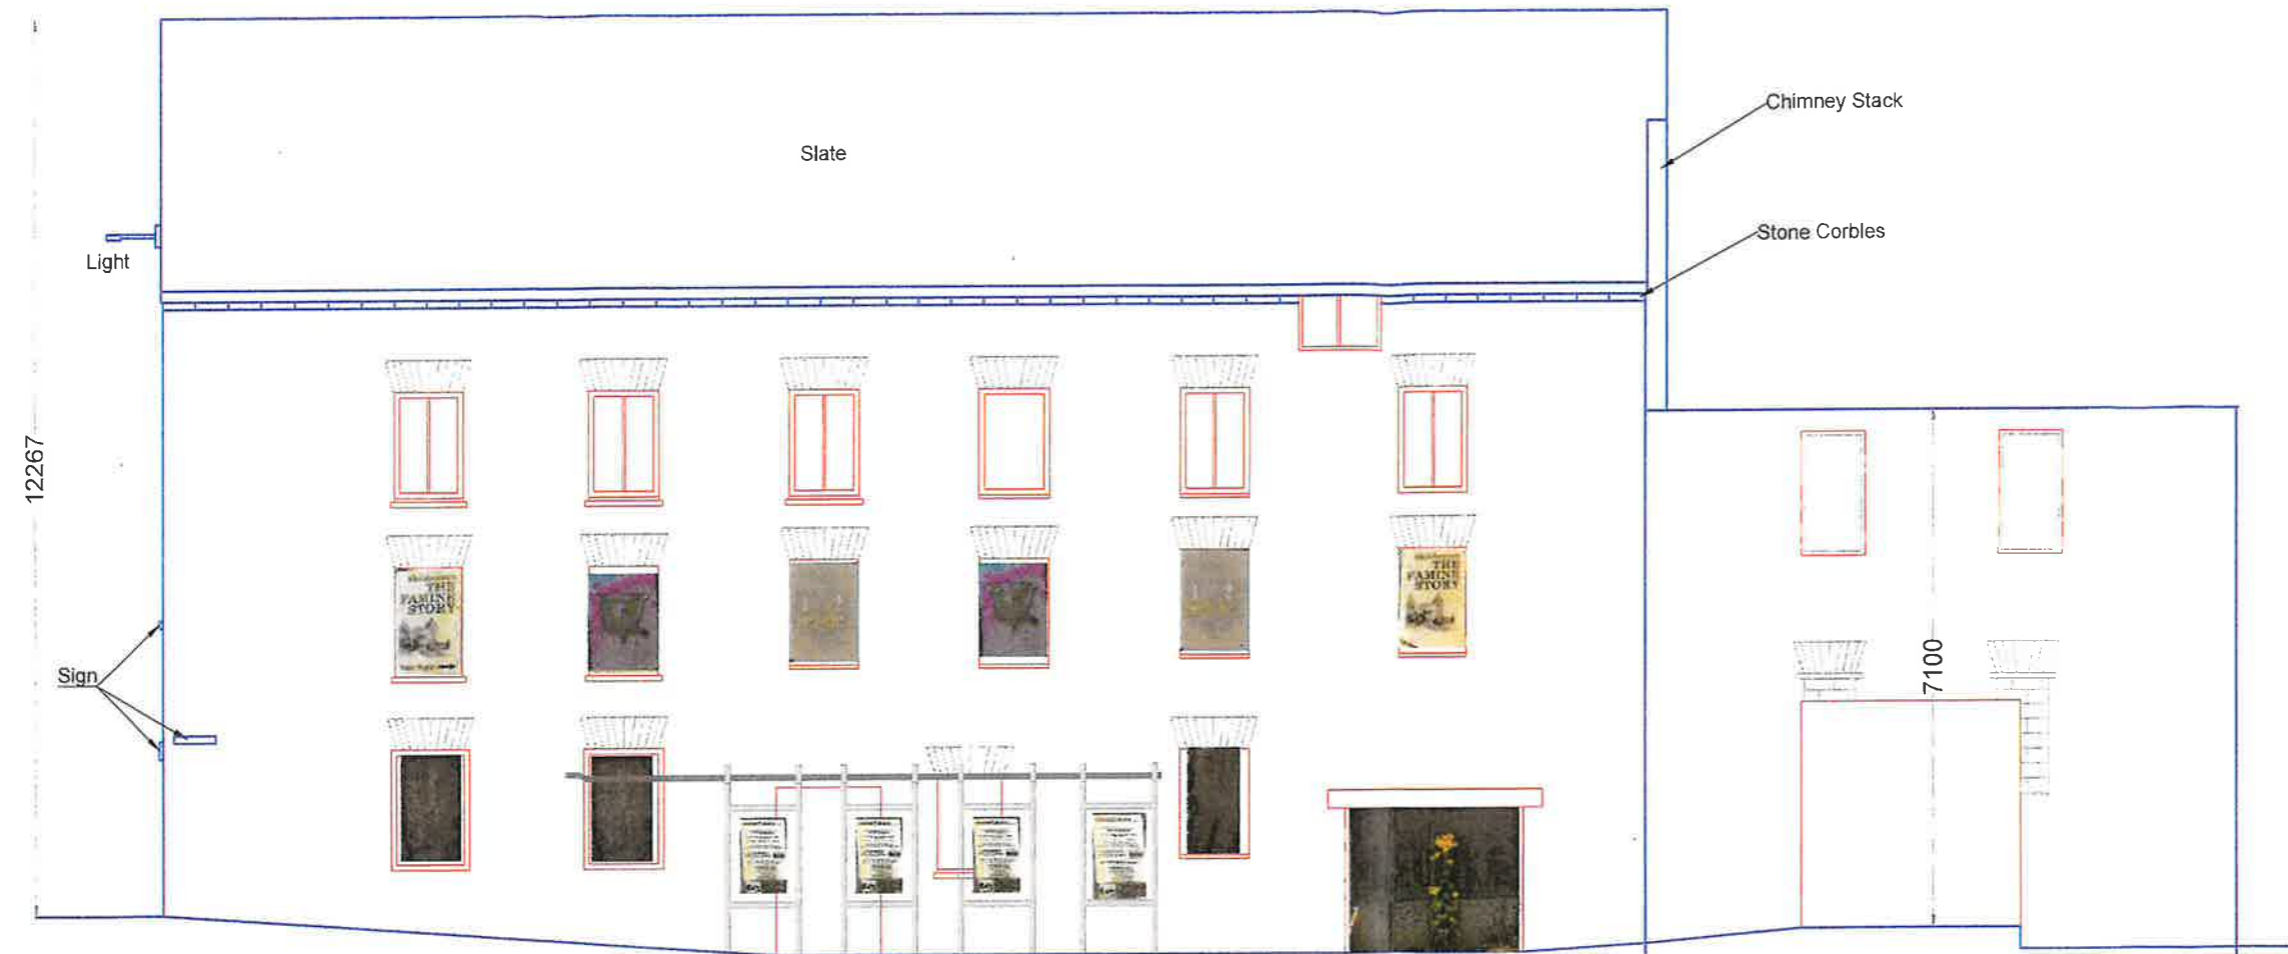
- Notes :**
- Dimensions not to be scaled from drawing.
  - See corresponding plans for door, window, beam and pier schedules.
  - Some of the Stone Corbles are missing in places on the Main Mill Warehouse.
  - The majority of windows are boarded or have information boards placed in the opening.
  - The are information boards placed in a frame on ground floor level bolted to the wall using a railing and set into the ground.
  - GF D3 contains a steel I Beam head on concrete pillars at either end.
  - The second floor windows are metal framed with mesh covering.
  - The roof slates of the Main Mill Warehouse are in reasonable condition.
  - The West Annex was not accessible.

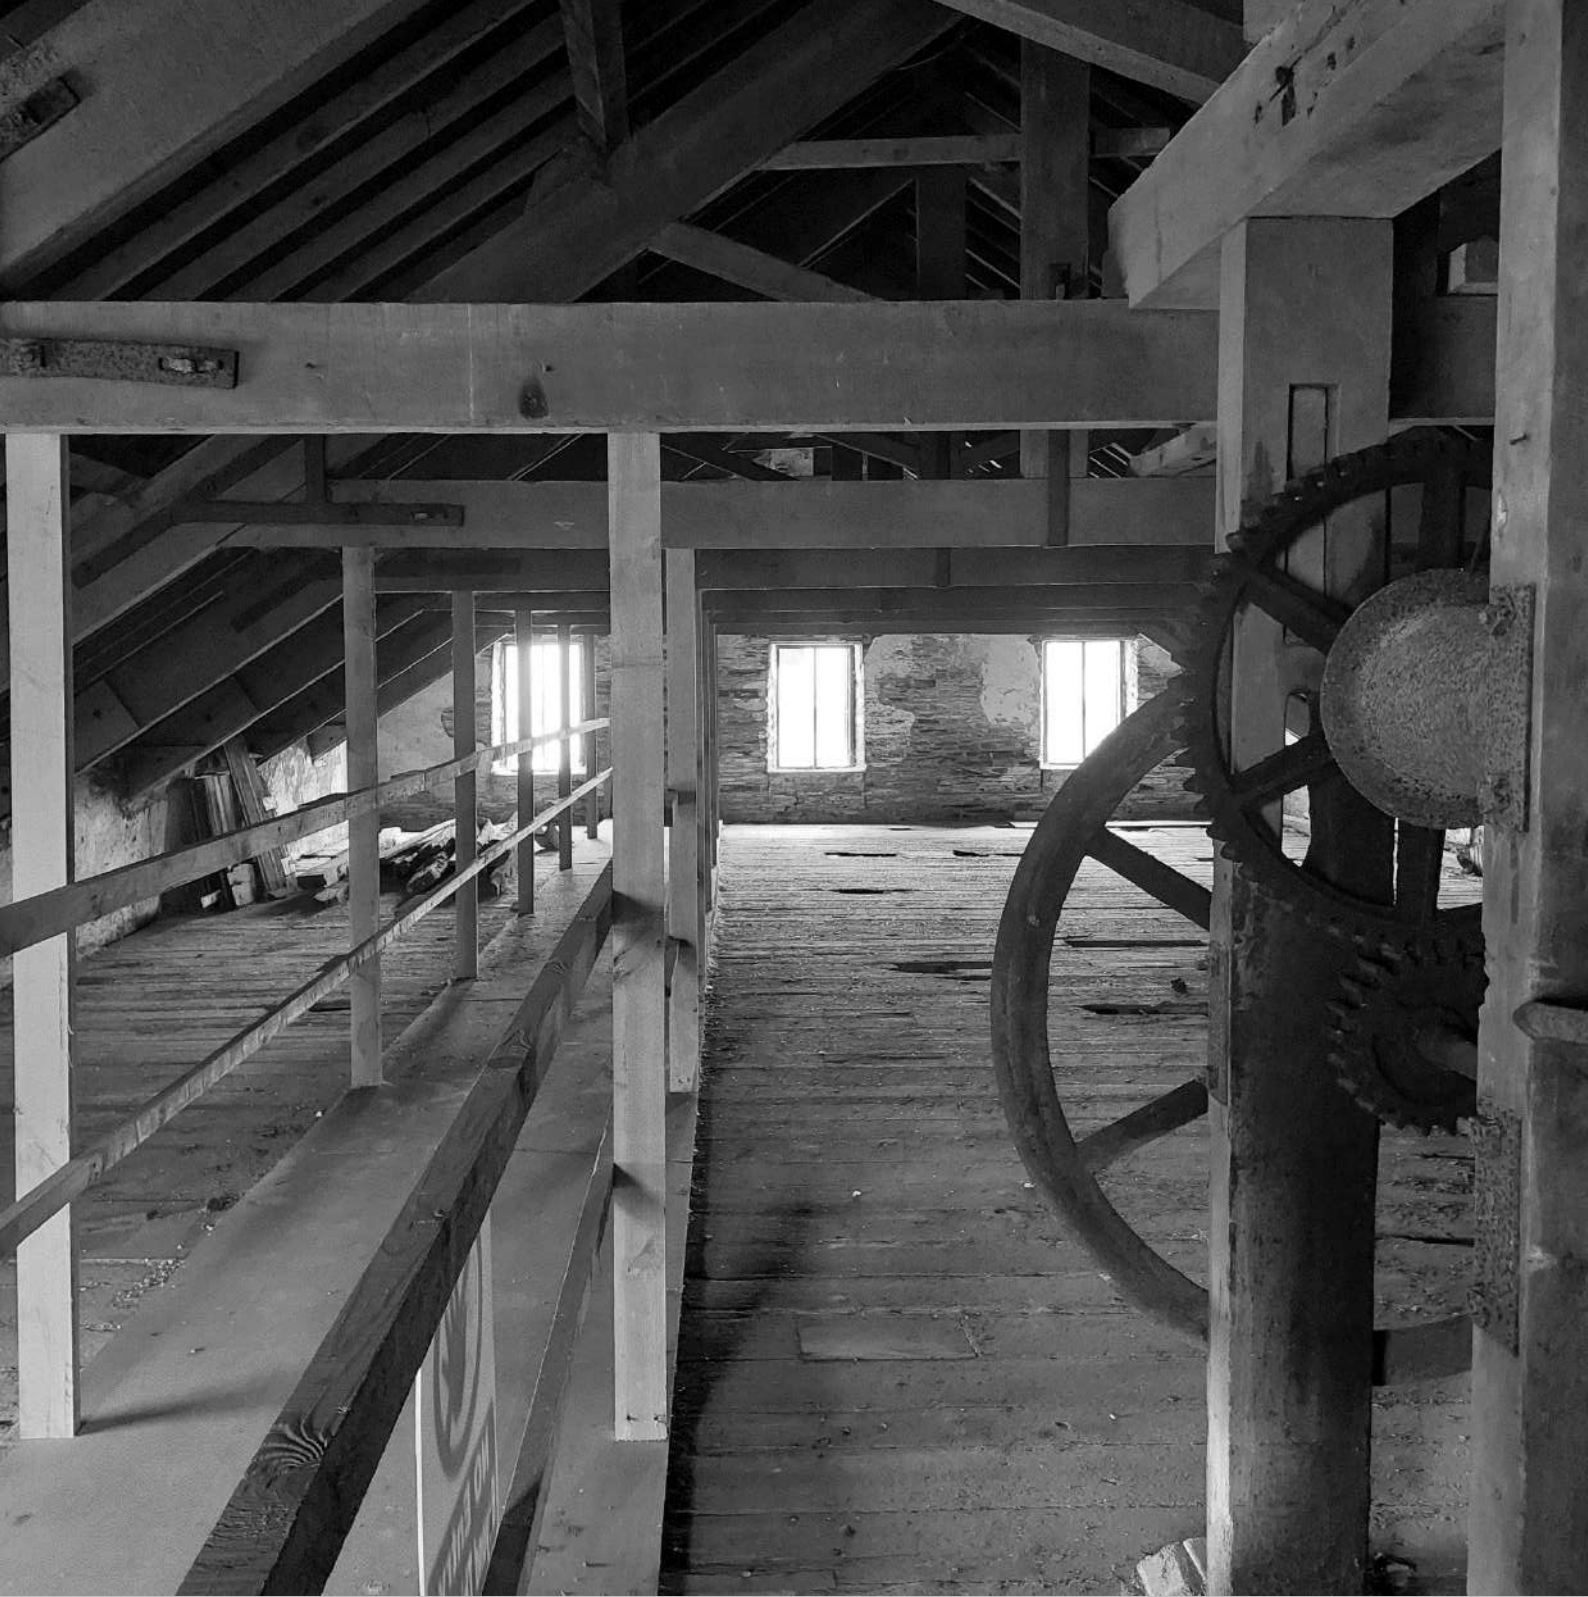
## Part One: Introduction, Methodologies, and Heritage Protection

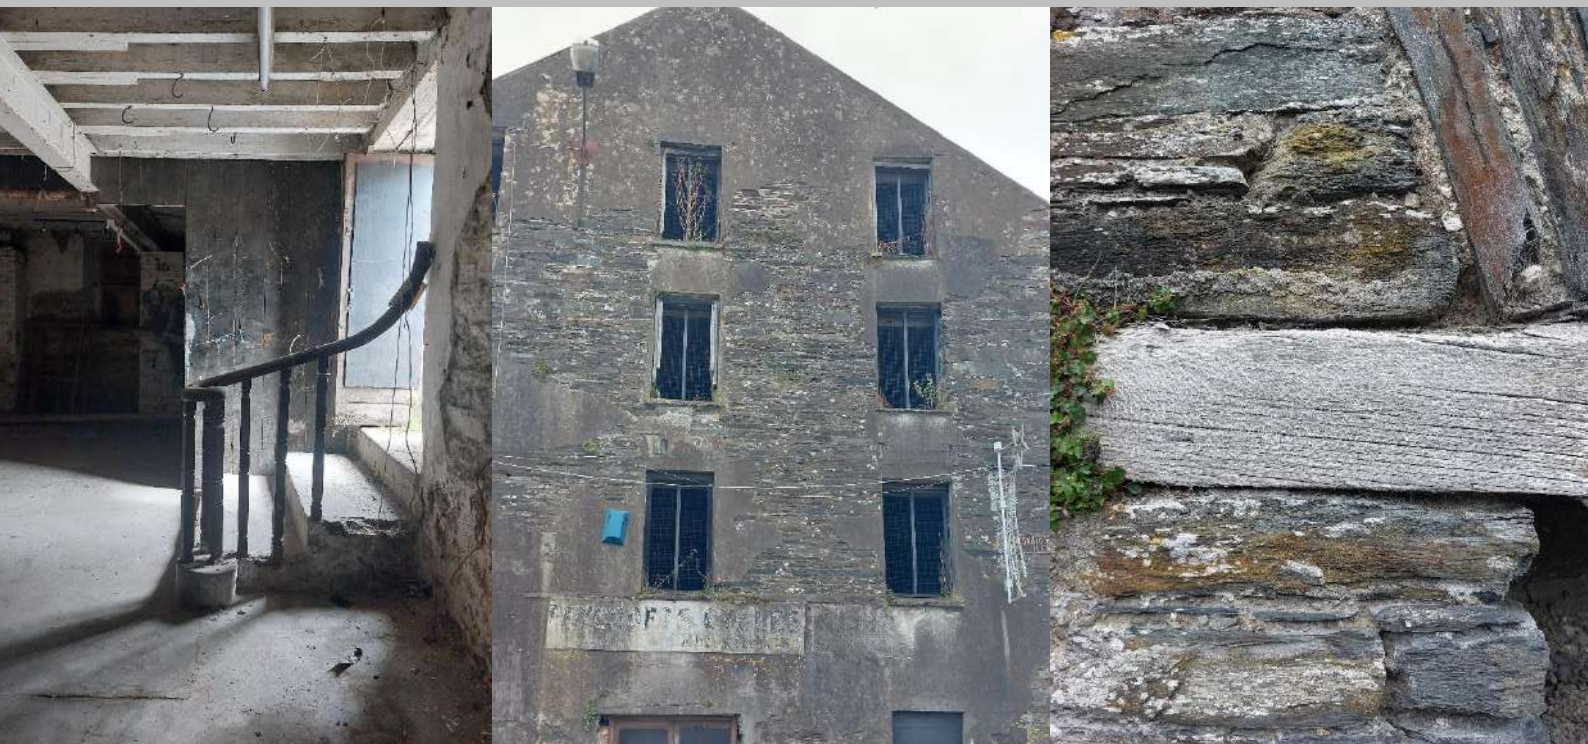
*Fig 1.01: Images of Skibbereen Steam Mill*

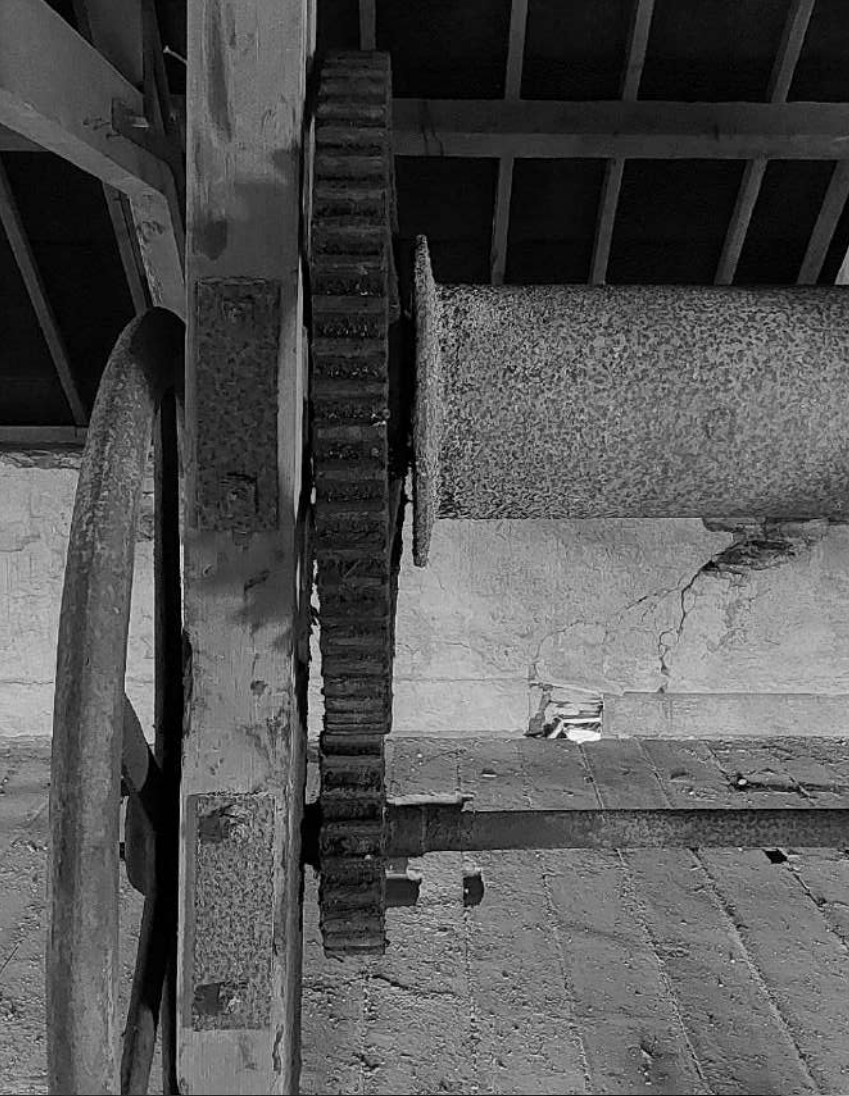
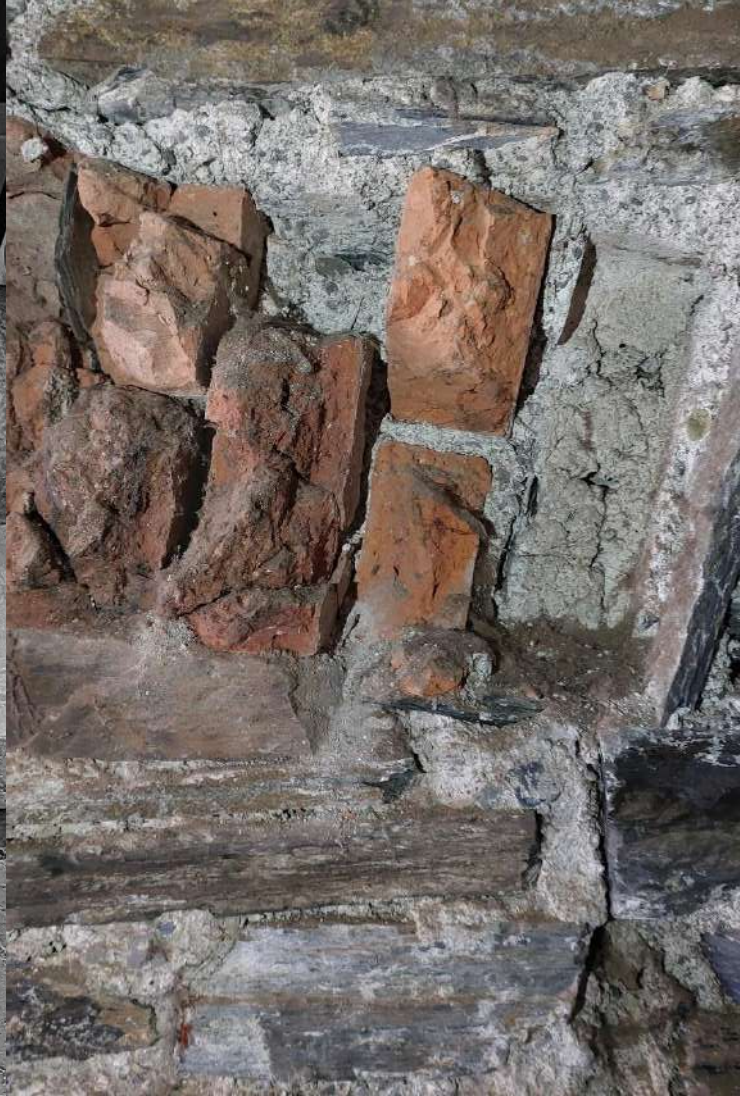
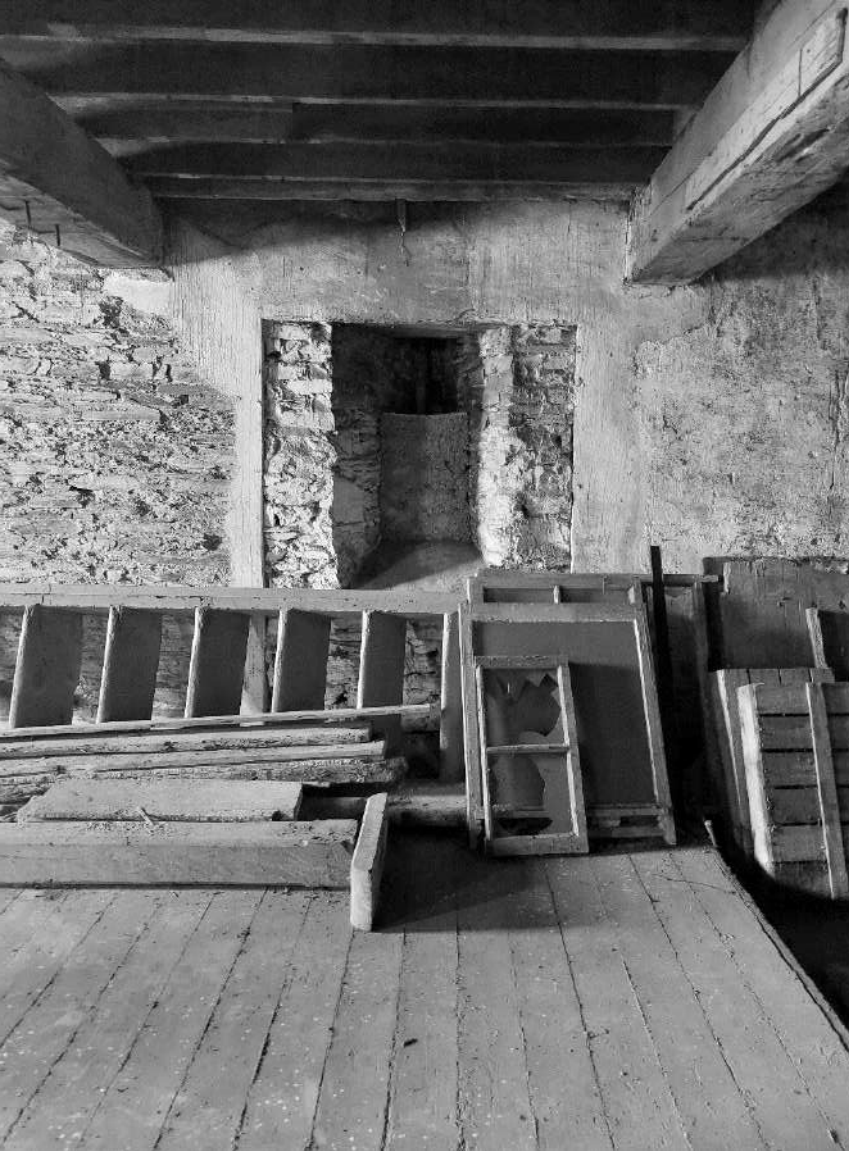
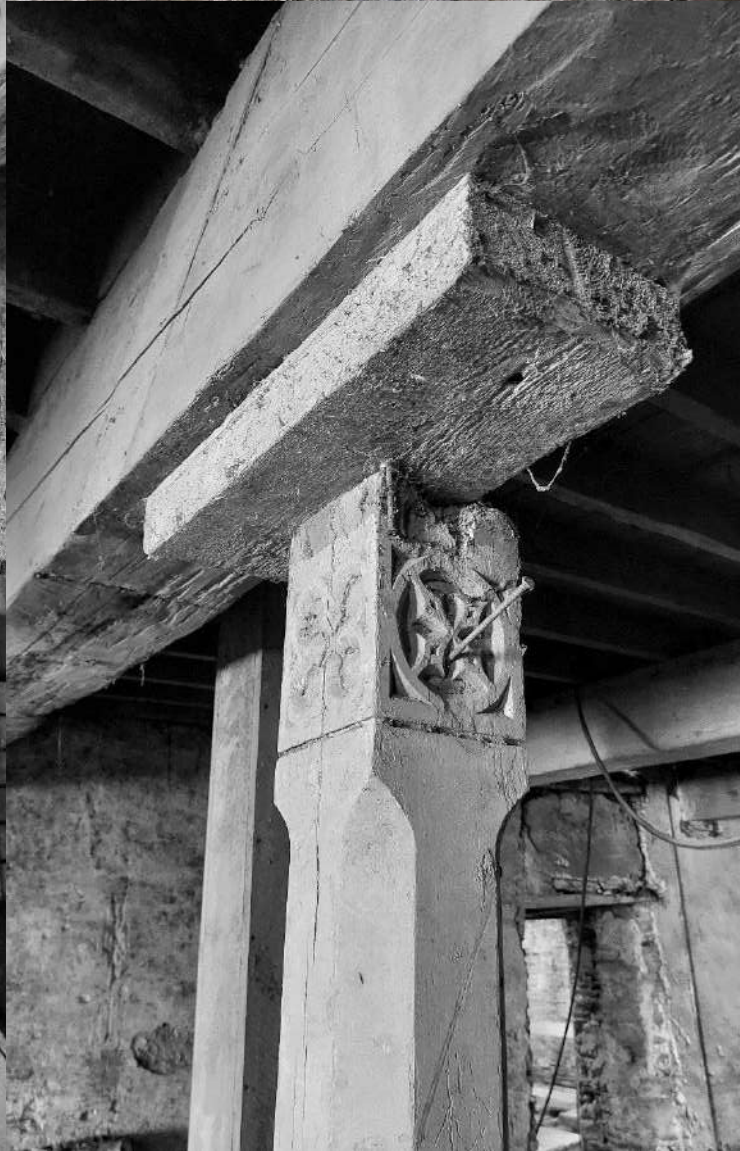
### *National Inventory of Architectural Heritage*

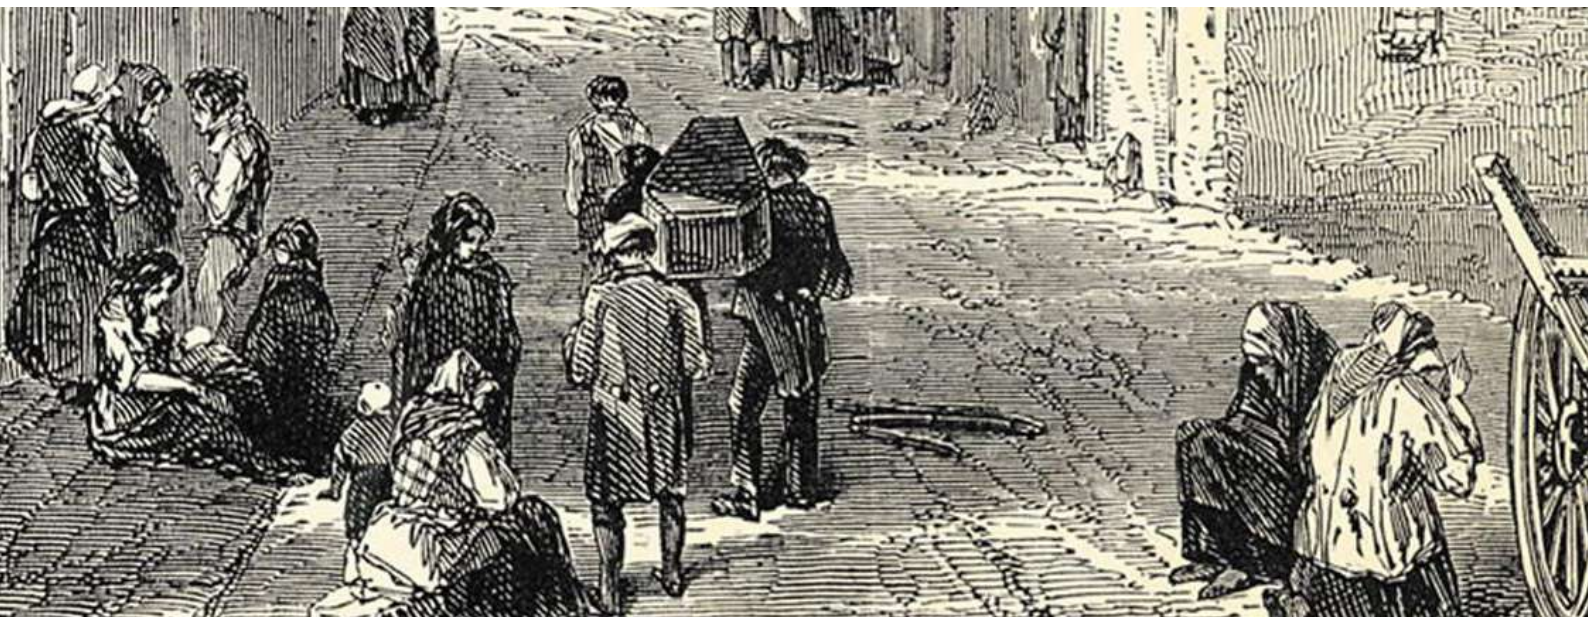
Fig 2.02: Illustration of the famine in Skibbereen

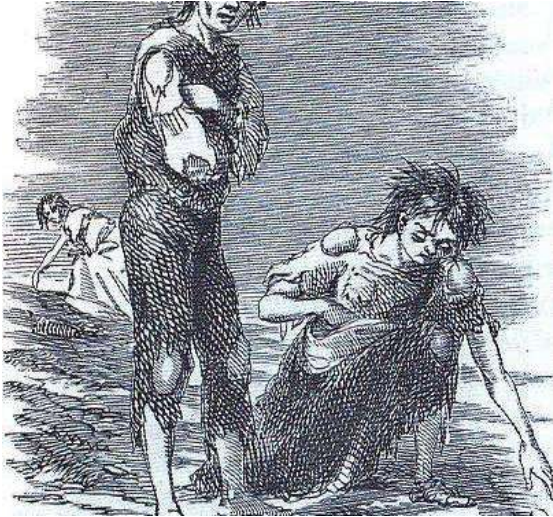
Fig 2.03: James Mahony Famine Illustration, 1847

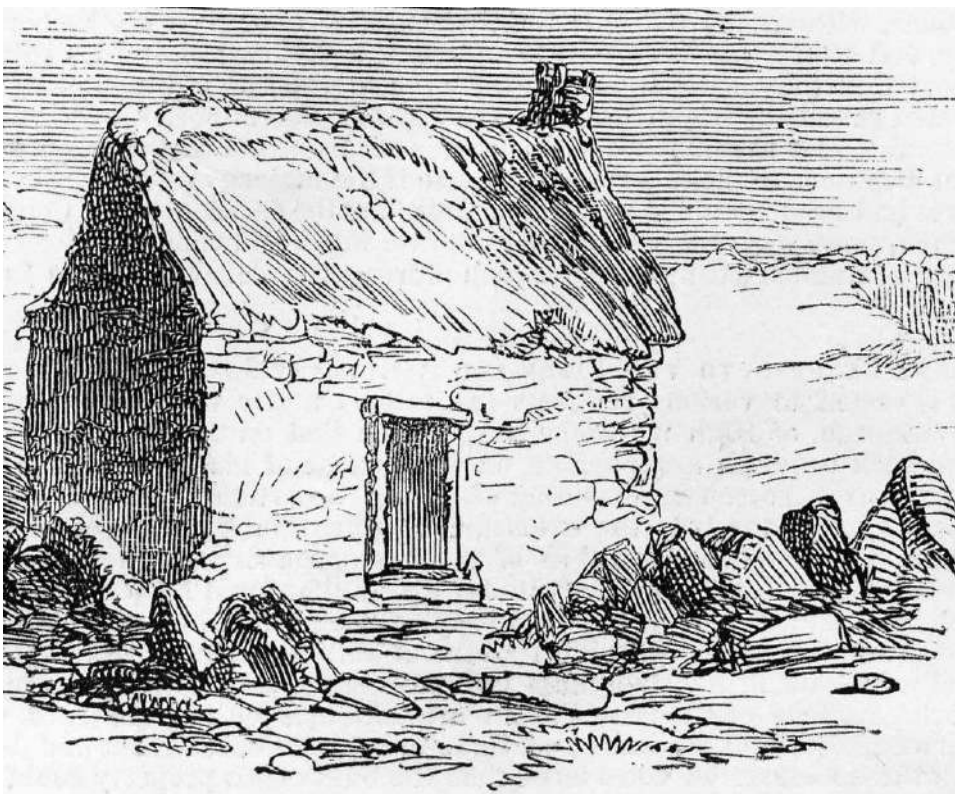
*Fig 2.04: James Mahony Illustration of 4<sup>th</sup> class house, 1847*

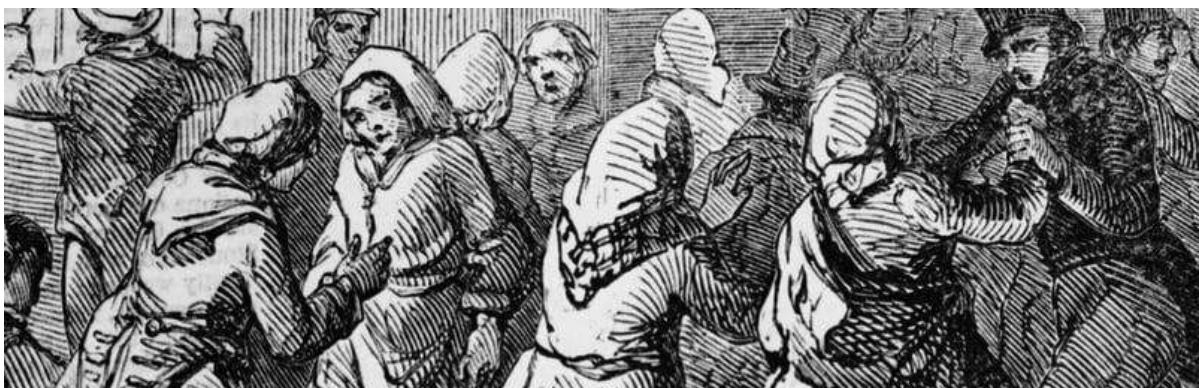
<sup>6</sup> statement of the conditions in Skibbereen was written by the Skibbereen Committee of Gratuitous Relief on February 1<sup>st</sup> 1847.

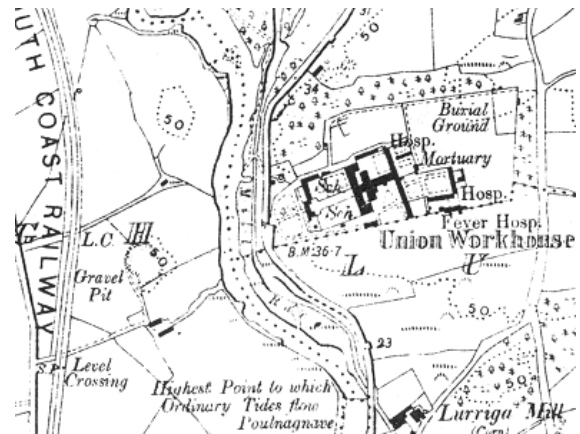
Fig 2.09: (above) Historic OSI map of Skibbereen Workhouse

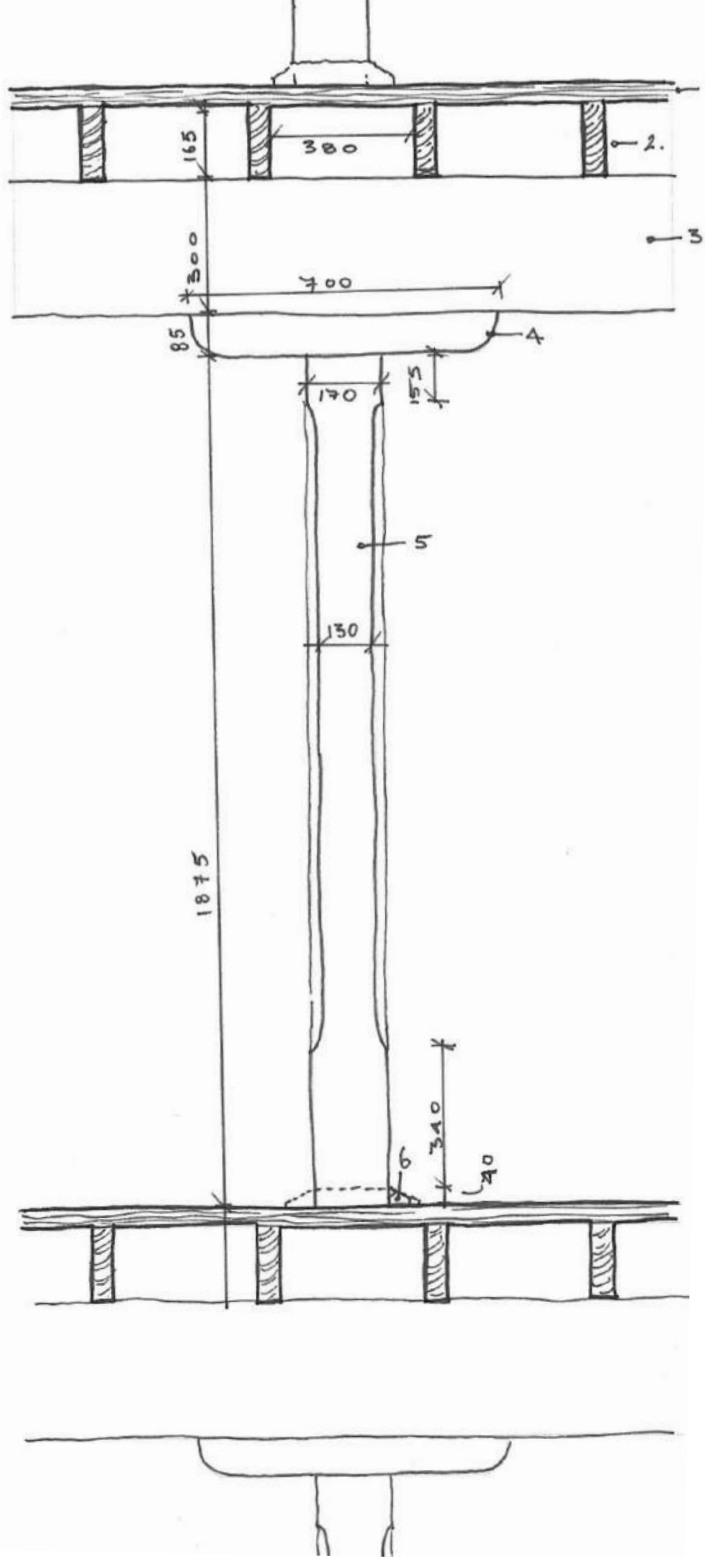
## Part Three: Understanding the Building: Fabric and Analysis, Condition Survey

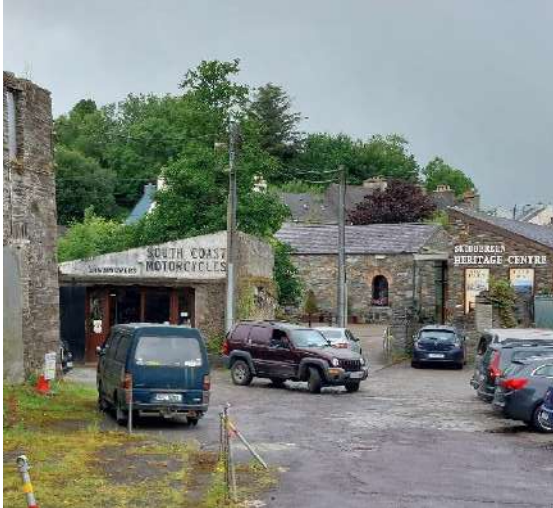
*Fig 3.01: View towards gas works/ heritage centre. Mill to lhs.*

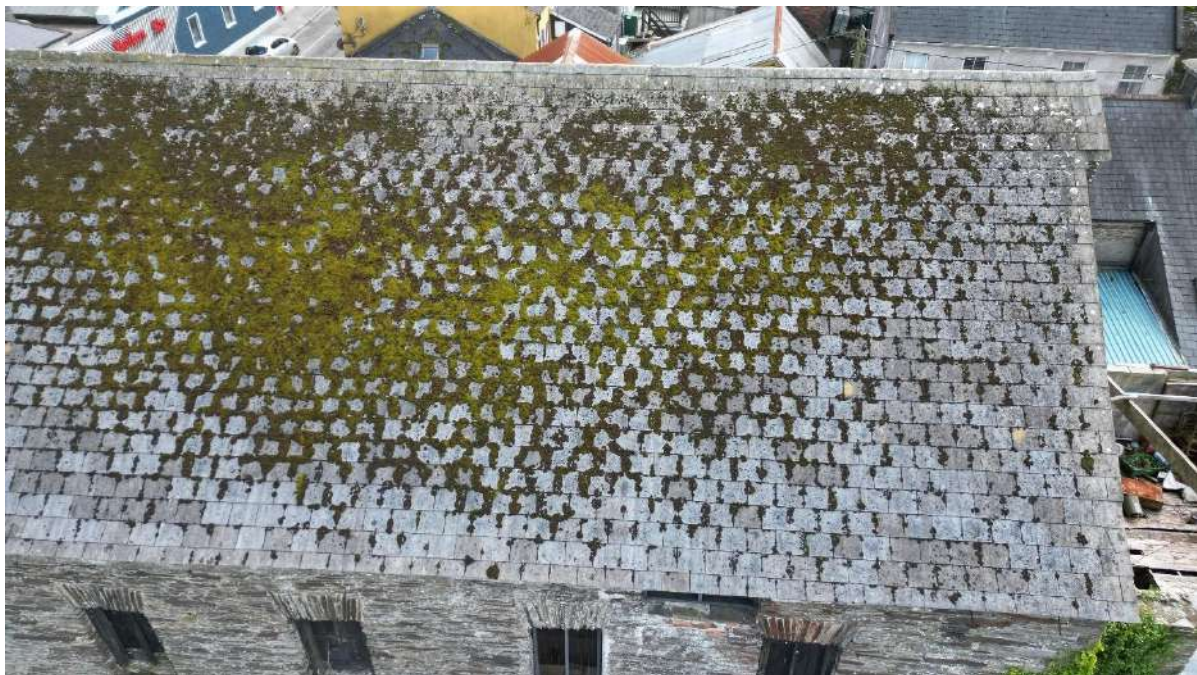
*Fig 3.04: North face of roof of mill.*

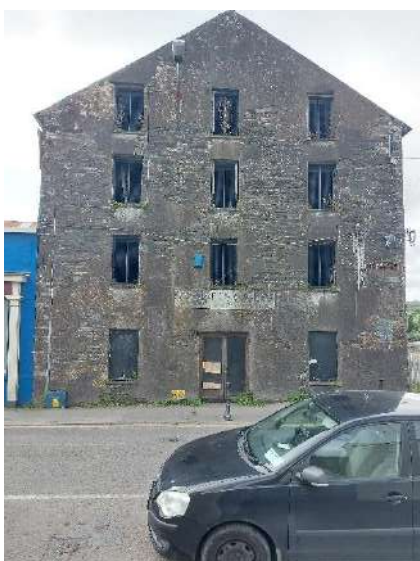
Fig 3.07: East elevation

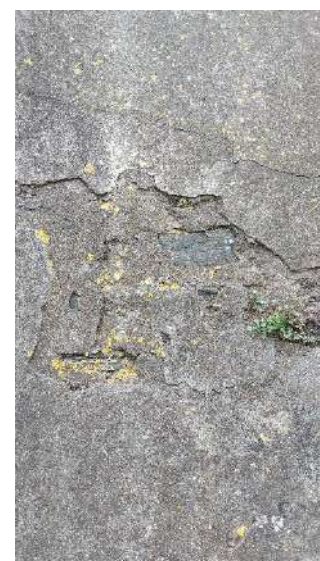
Fig 3.09: Failure of render finish

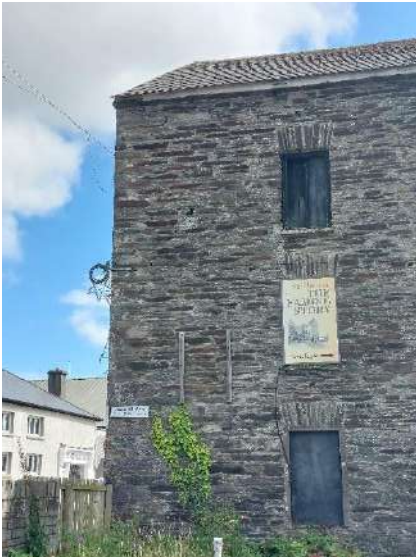
Fig 3.10: North east corner

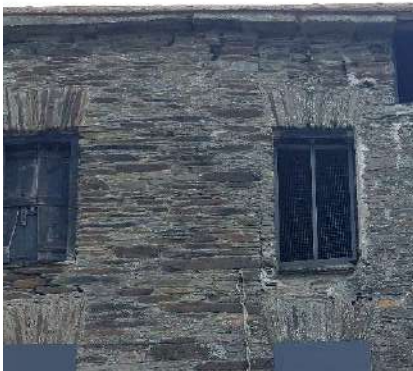
Fig 3.11 Detail of stonework- eroded joints and cracking visible, especially at eaves level

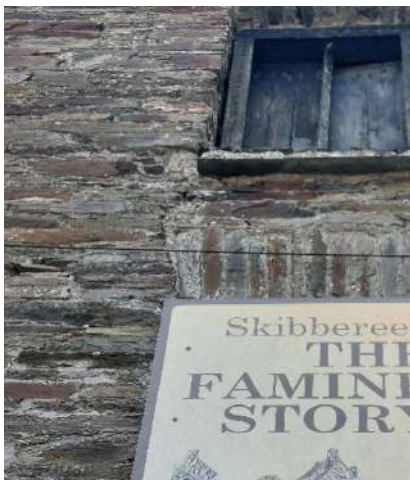
Fig 3.12: Cracking above window

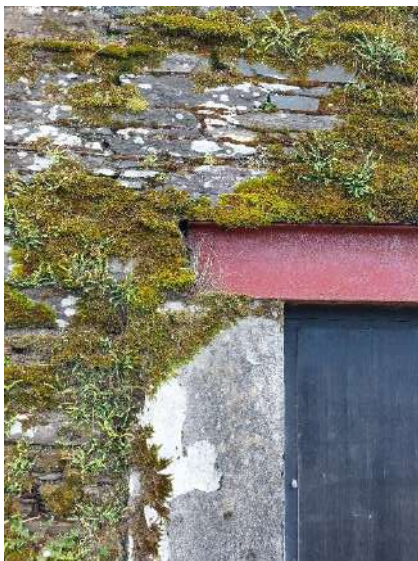
*Fig 3.13 : modern steel lintel and significant moss growth*
