SKIBBEREEN STEAM MILL

# INFORMATION PACK

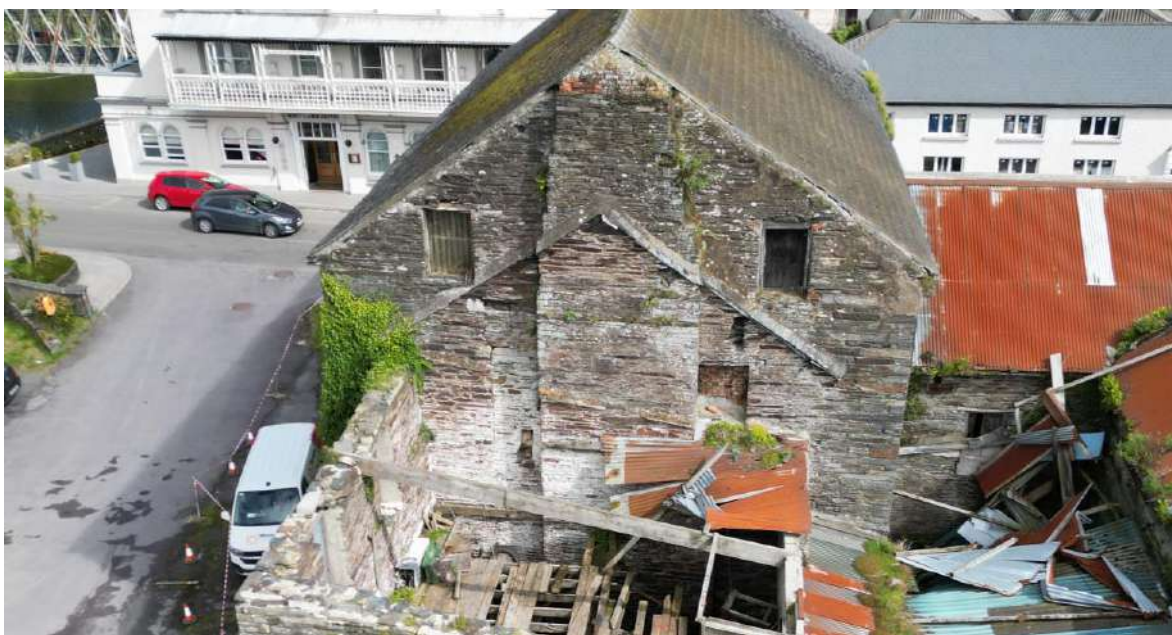
Fig 3.16: West elevation

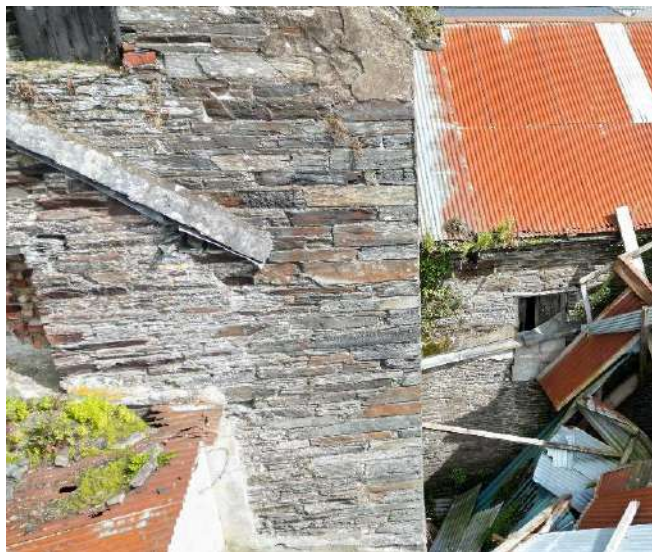
*Fig 3.16: Southwest corner. Some render visible at eaves level. Lead flashing to former roofline visible.*

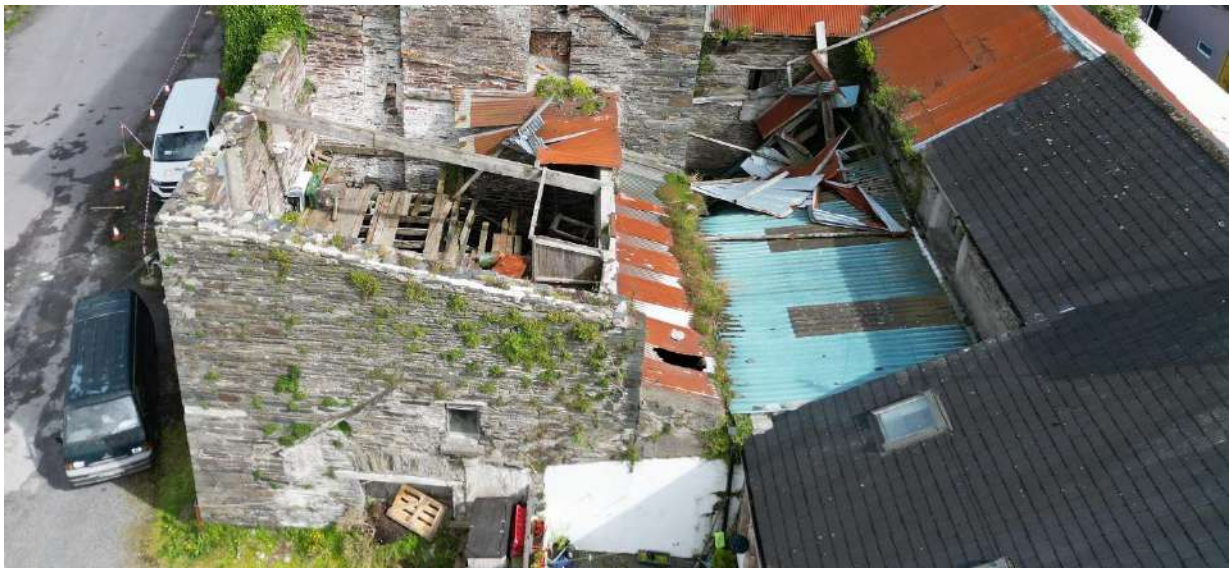
Fig 3.18: View of west annex

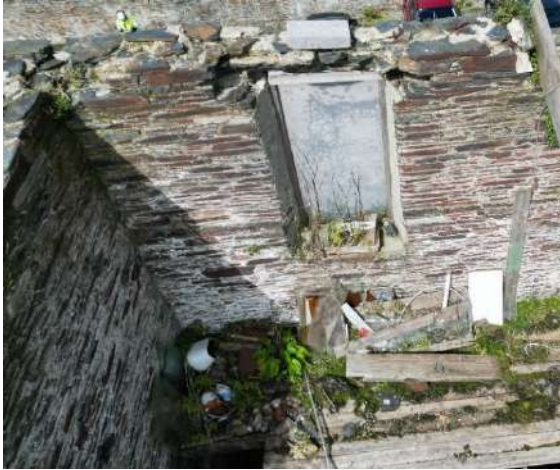
*Fig 3.19: Loose masonry to top of walls*

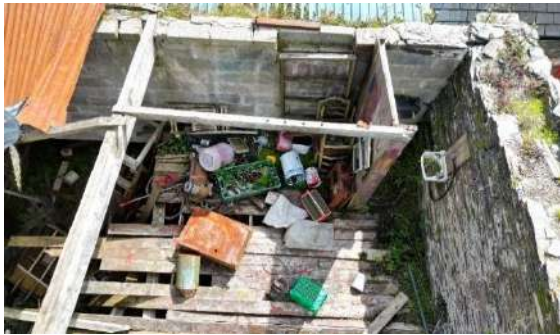
*Fig 3.20: Concrete block wall to south elevation*

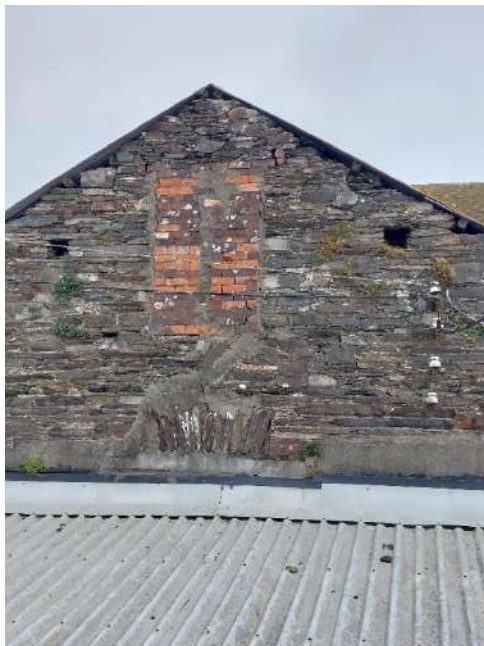
Fig 3.22: South gable wall of south annex

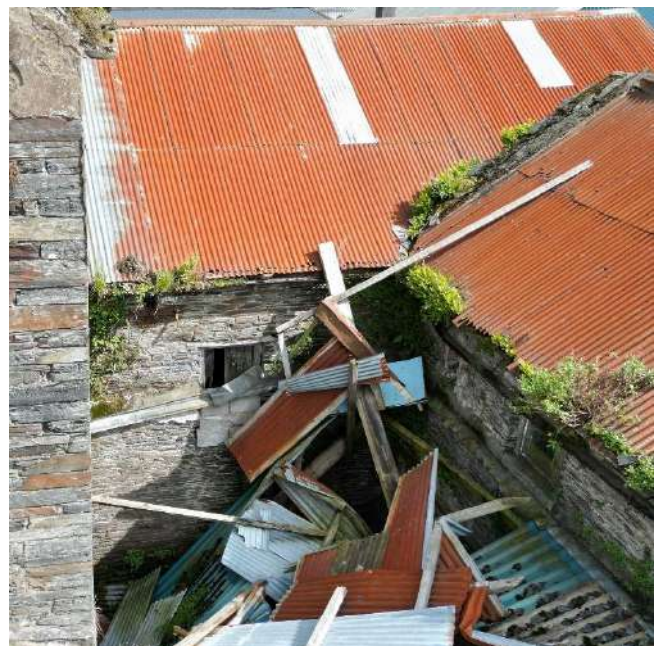
Fig 3.23: West wall of south annex with adjoining failed roof structure

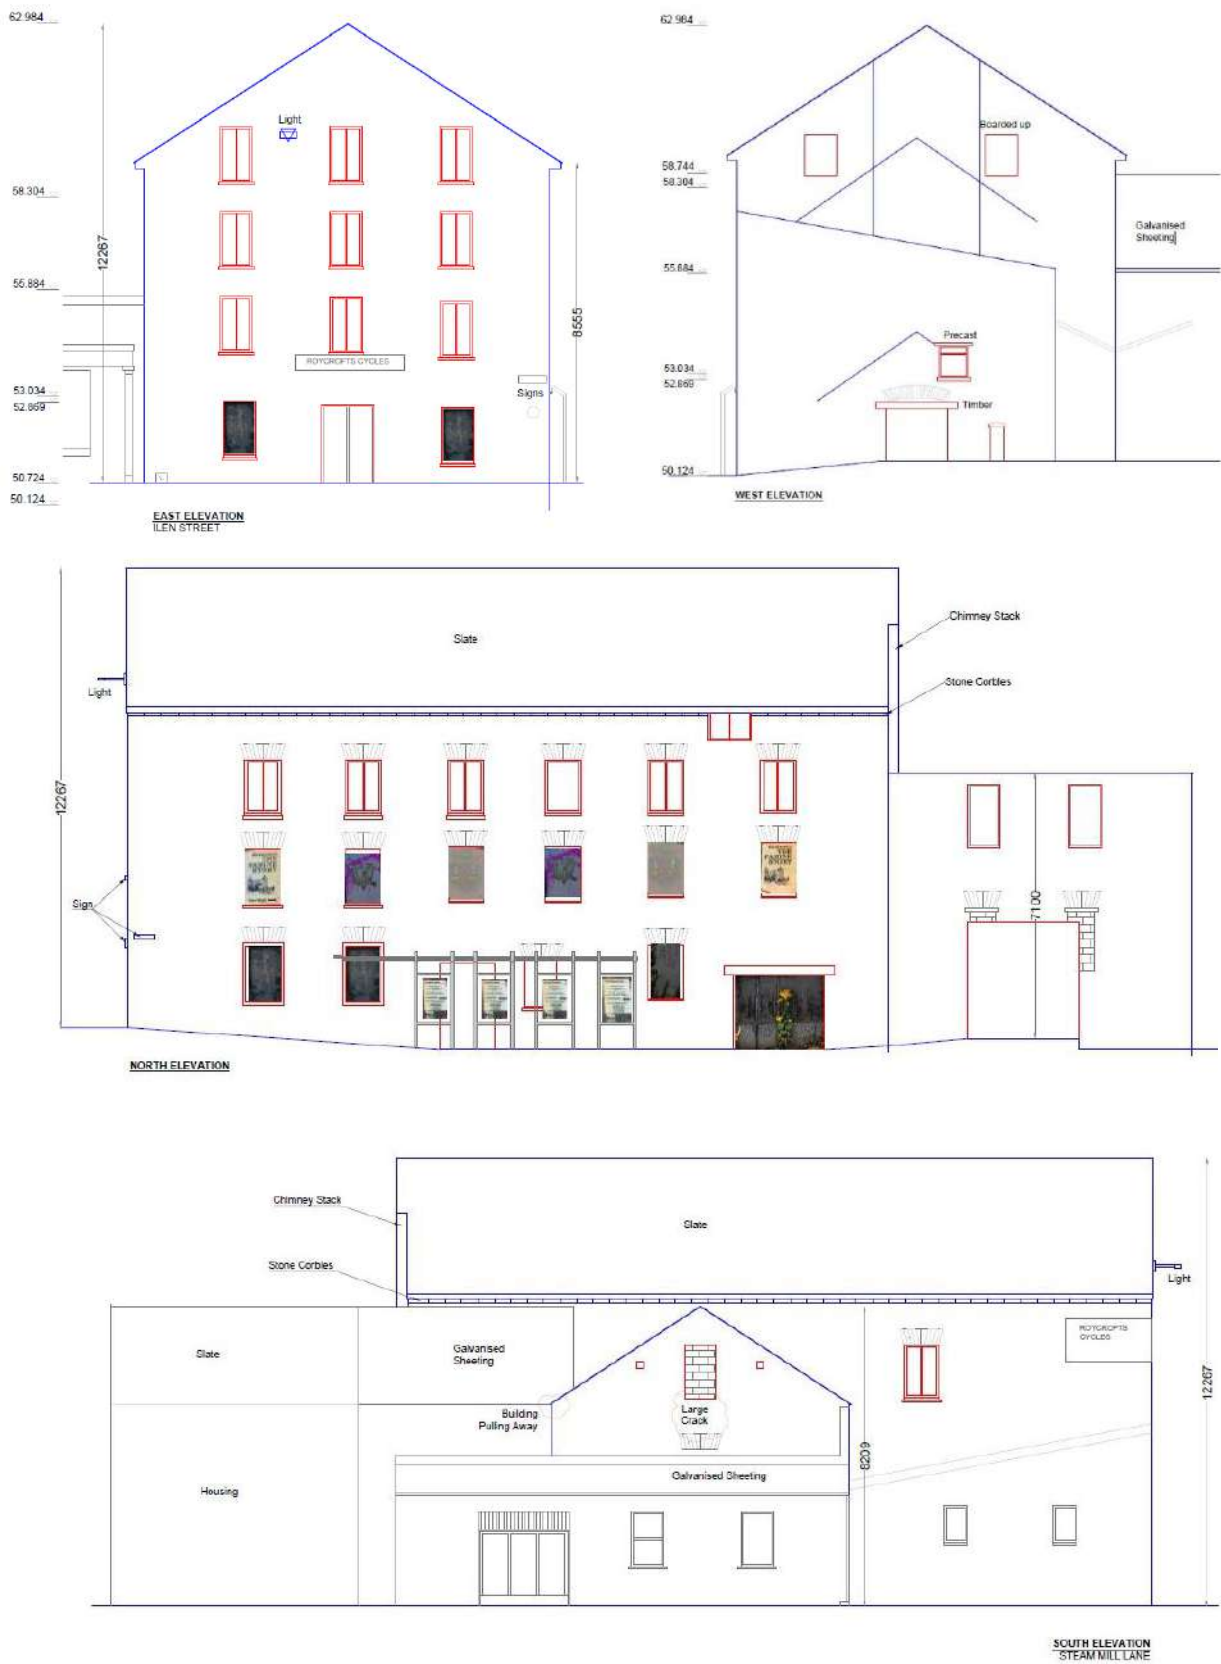
Fig 3.24: Survey Drawings. NTS. See appendix for scaled drawings.

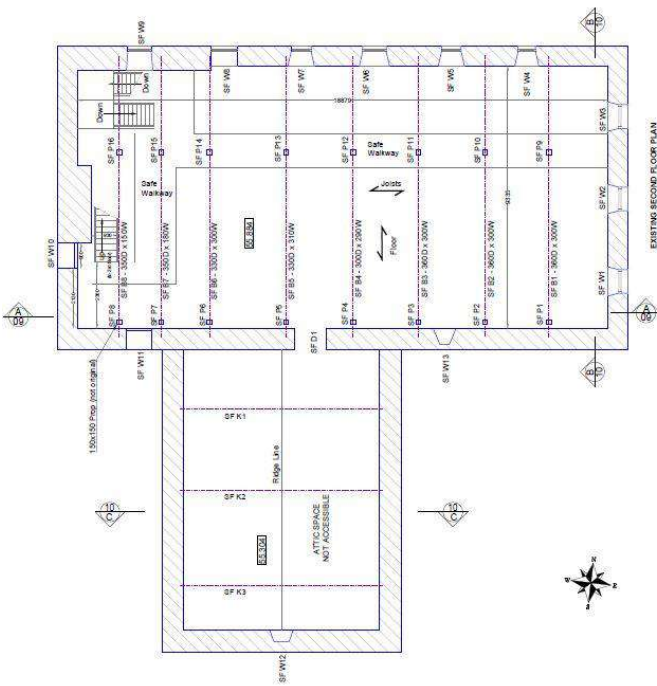
Fig 3.25: First floor plan. NTS.

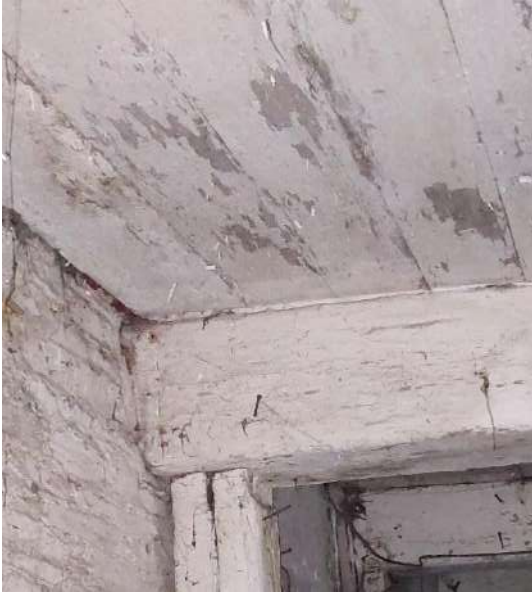
*Fig 3.32: Timber beam embedded in damp external walls to south side of main volume.*

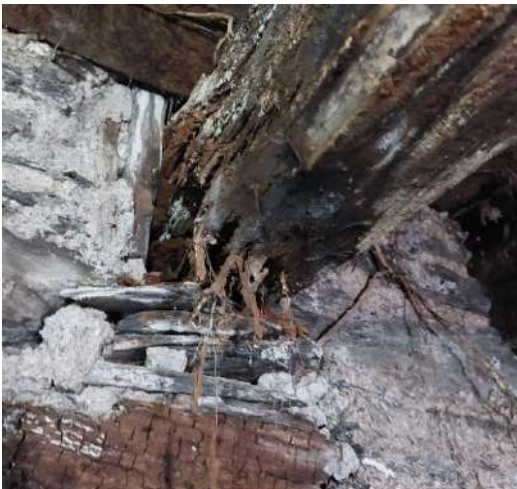
*Fig 3.34: Decayed joist ends in west room*

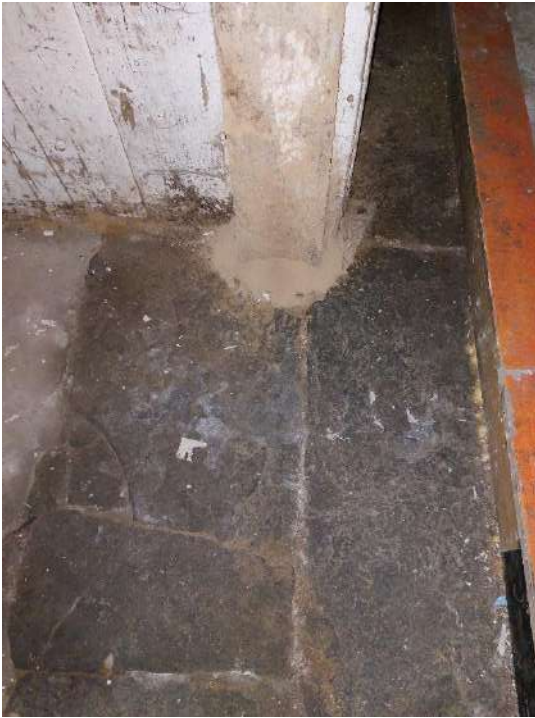
*Fig 3.35: Flagstone to west and of main volume ground floor*

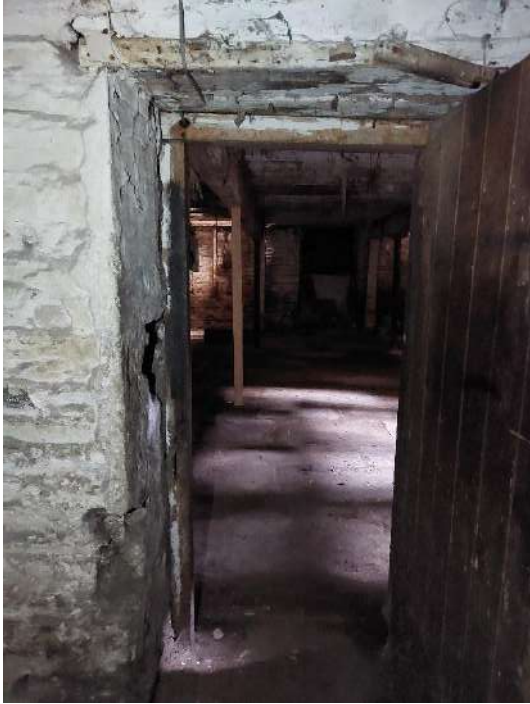
*Fig 3.41: Door into south annex*

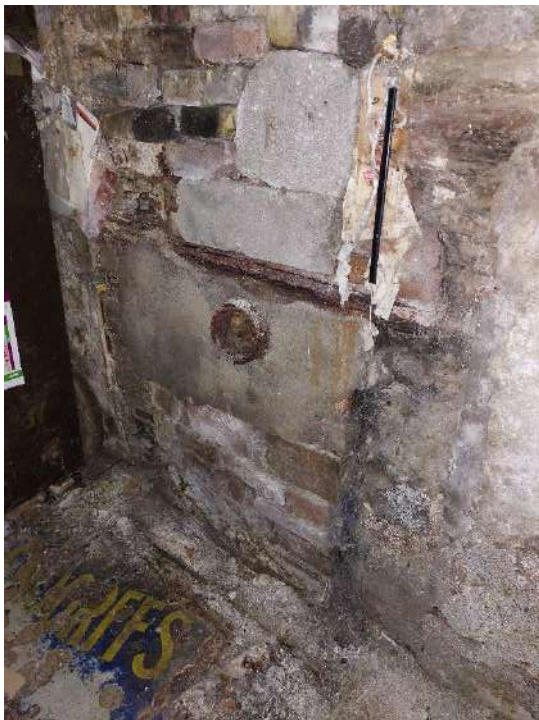
Fig 3.46: Possible former flue / chimney to north wall in shop area.

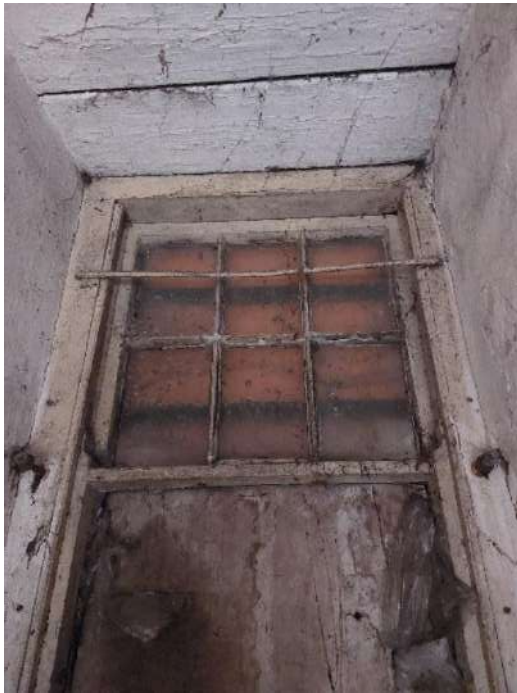
*Fig 3.47: Sliding sash window to north elevation towards east of building.*

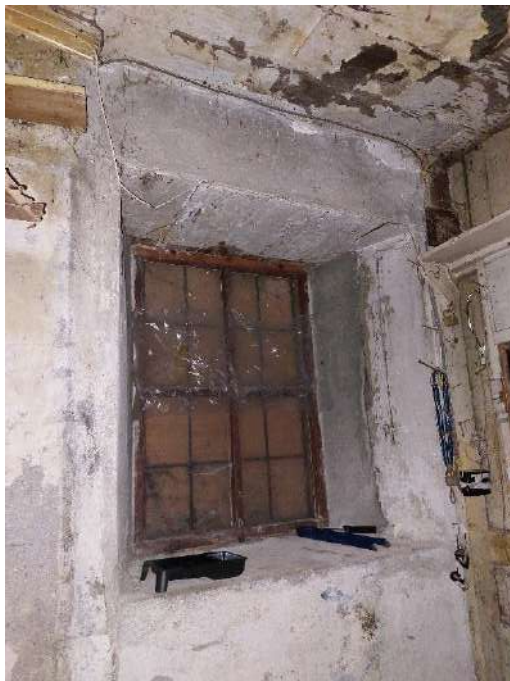
*Fig 3.48: Timber window to shop area (west of building) with concrete construction visible around opening.*

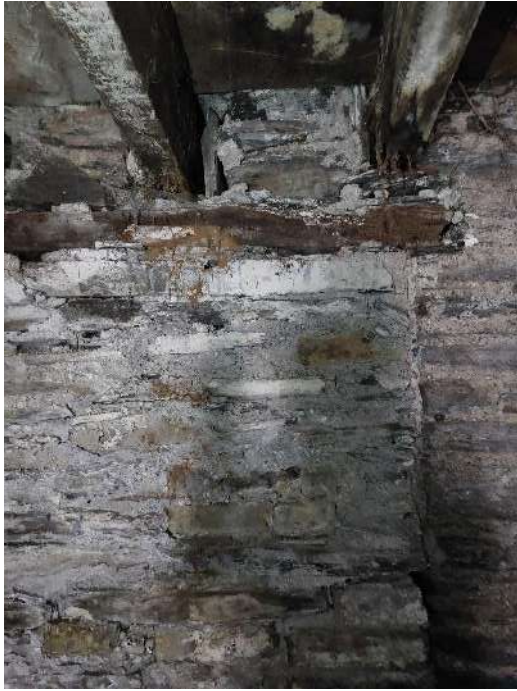
*Fig 3.50: embedded joists and lintel decayed to south elevation of west room.*

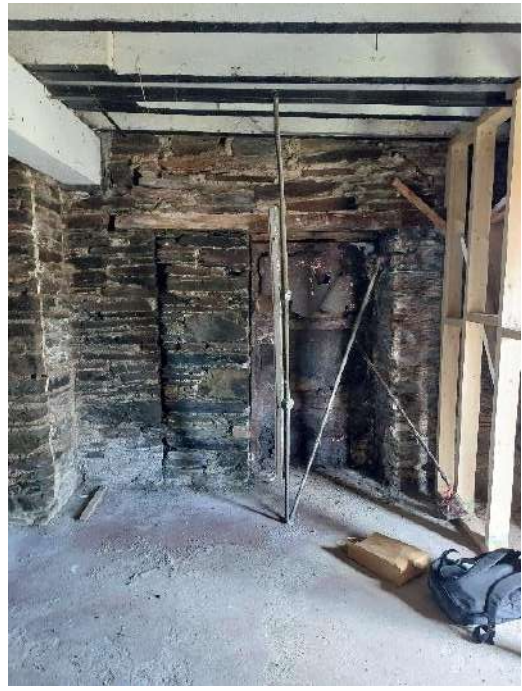
*Fig 3.51: Former opening to west wall partially filled in in stone with decayed timber lintel above.*

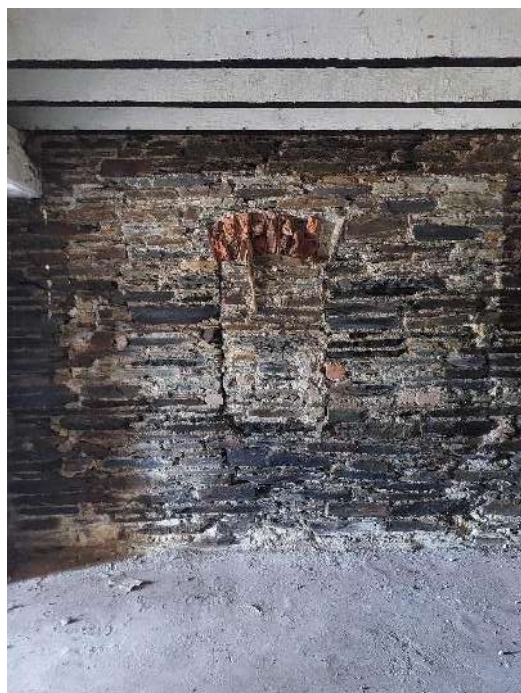
*Fig 3.511: Former window opening into main volume now filled in. Brick arch above with significant spalling visible.*

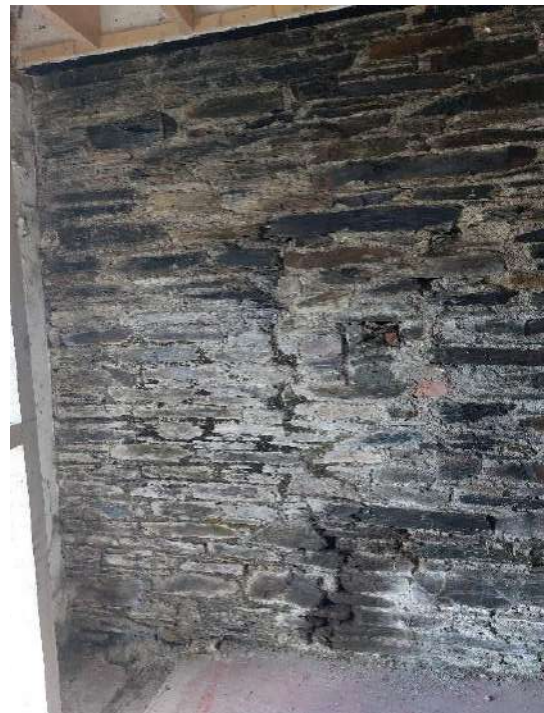
*Fig 3.52: Some cracking visible to partition wall between main volume and west room.*

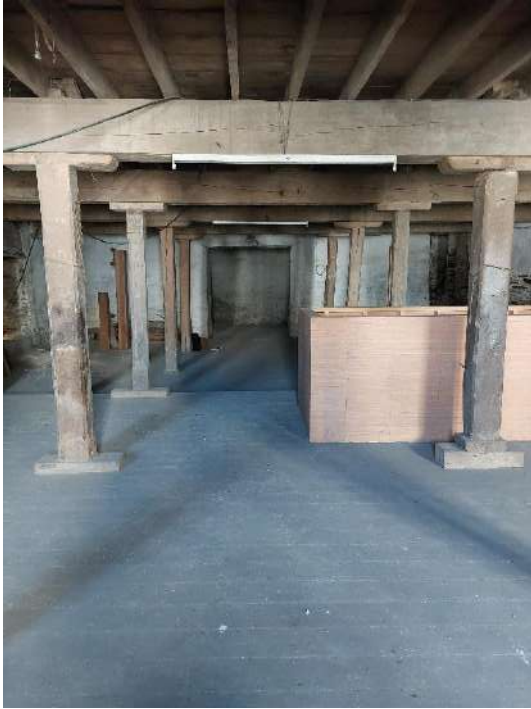
*Fig 3.53: View of first floor facing west*

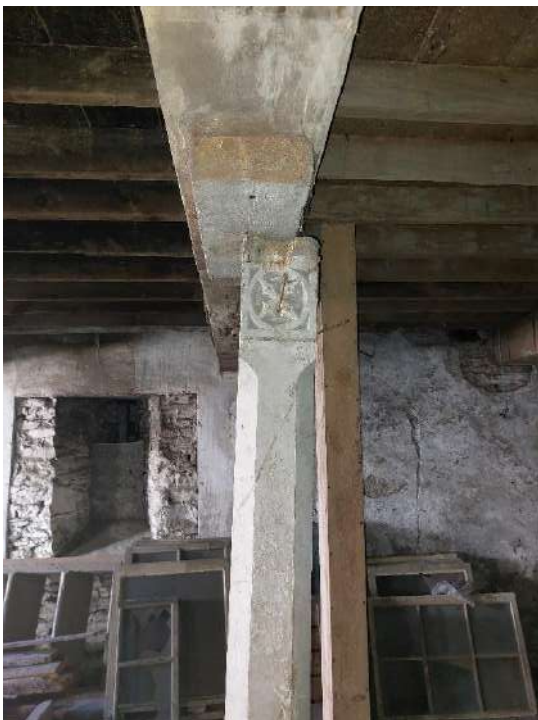
Fig 3.57: Misaligned column possibly from a church.

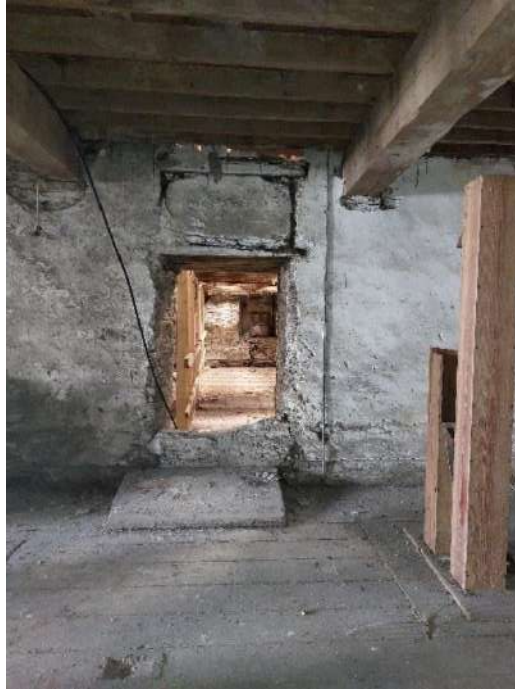
*Fig 3.60: Door opening into south annex with failed lintel above.*

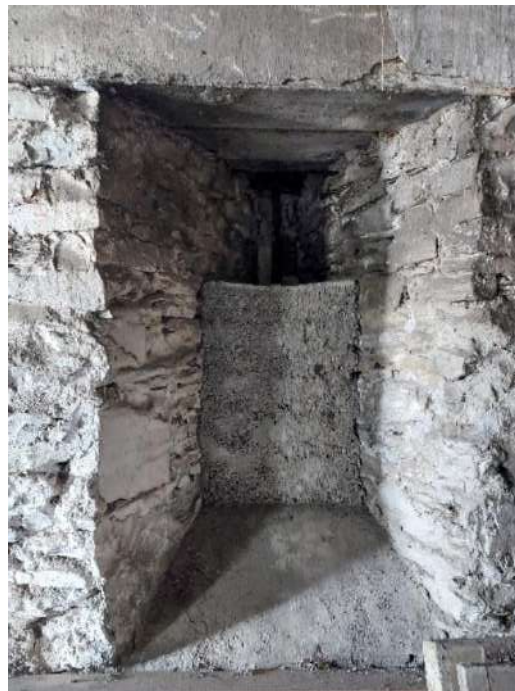
*Fig 3.61: Blocked up window opening to south wall.*

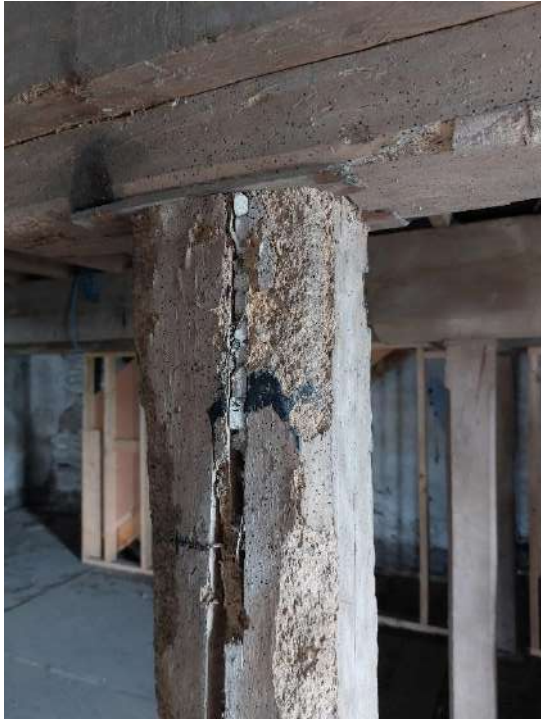
Fig 3.69: Timber beam and column with woodworm damage visible

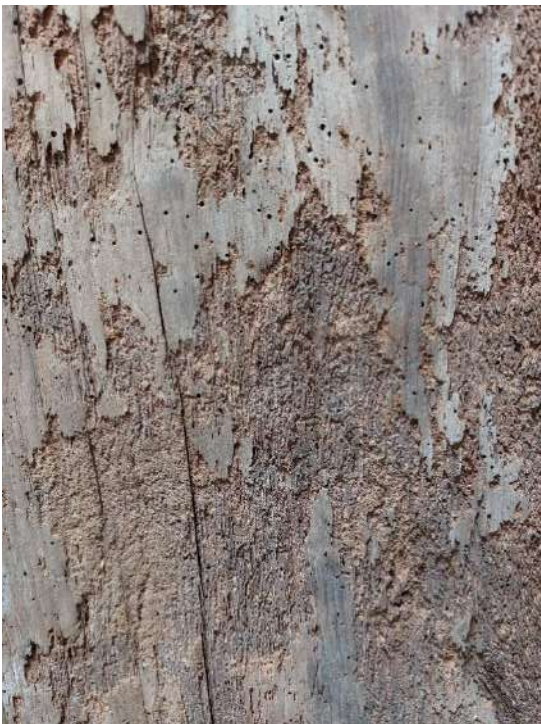
Fig 3.70 Detail of woodworm damage to beam

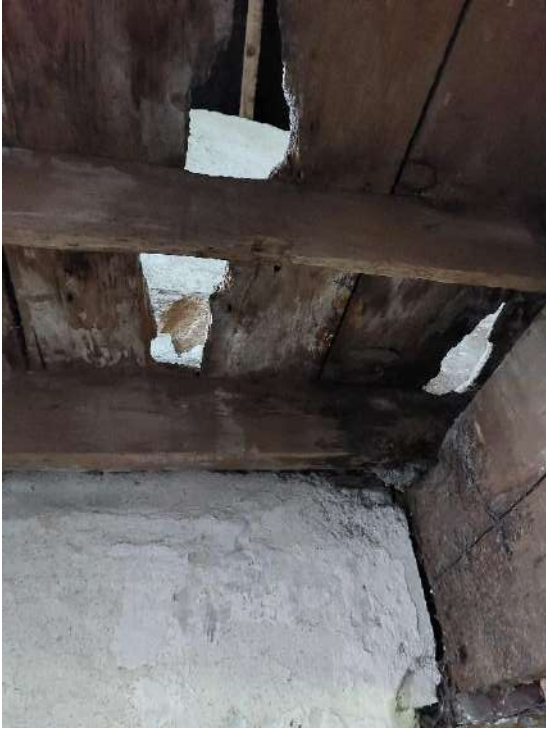
*Fig 3.71: Boards forming ceiling very heavily decayed.*

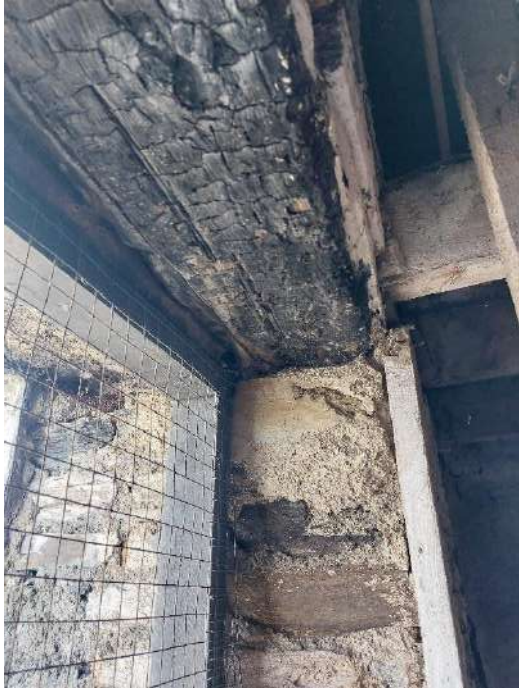
Fig 3.72: Charred timber lintel in east wall

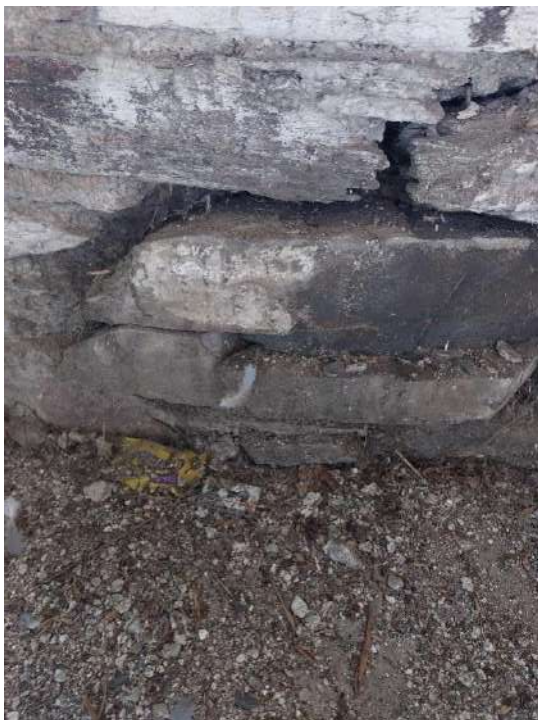
Fig 3.73: Cracking in east wall

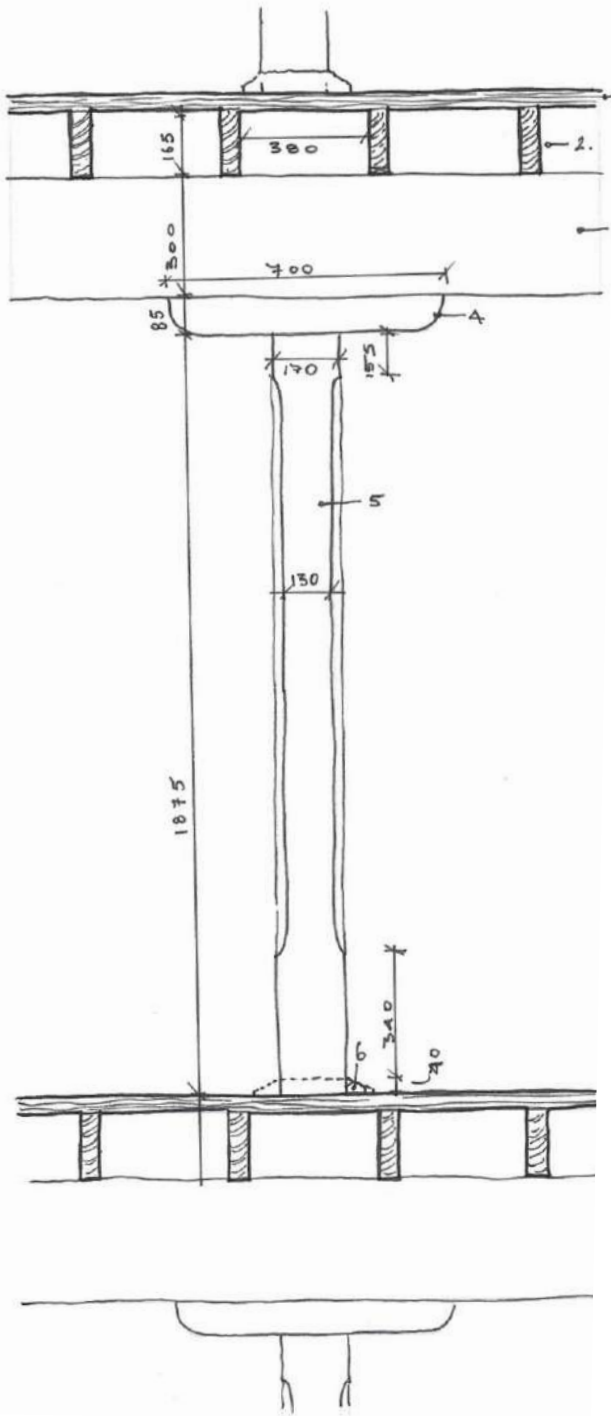
Fig 3.74: Sketch survey of timber structure

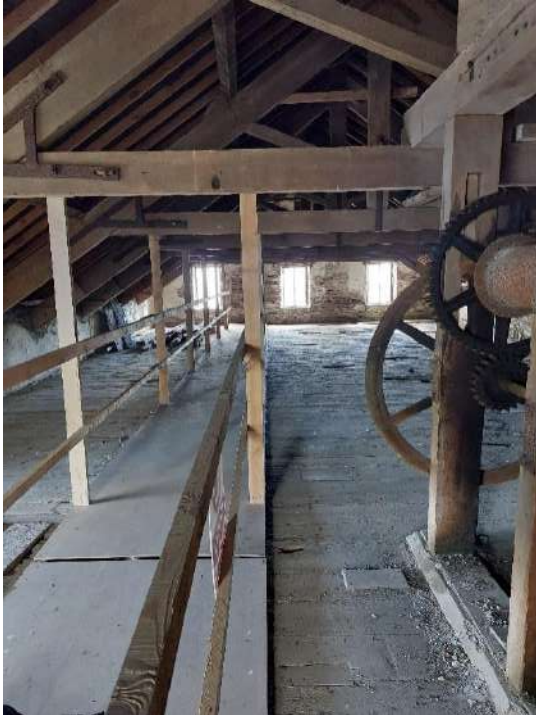
Fig 3.75: View of third floor facing east

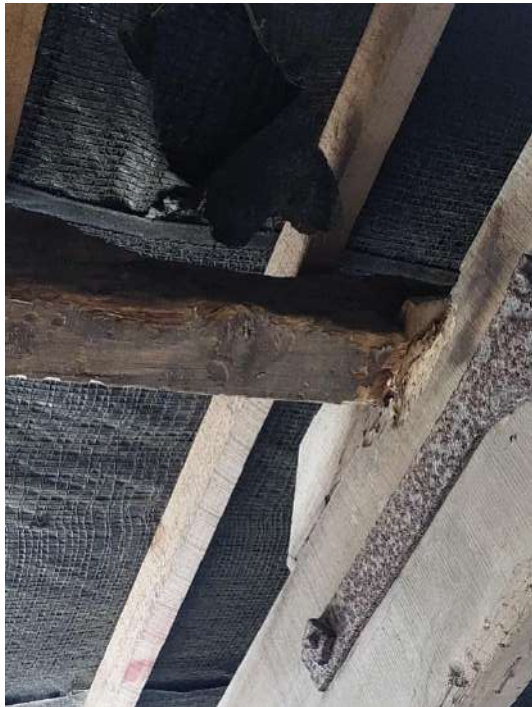
Fig 3.79: Decay visible to roof purlin

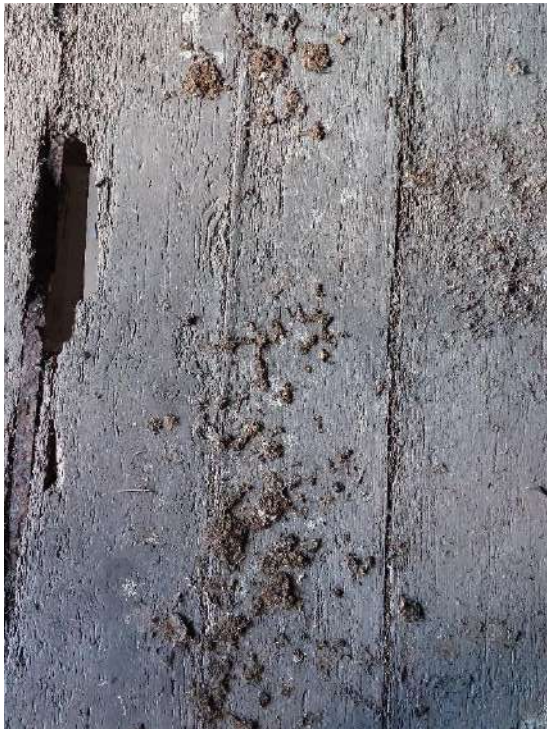
*Fig 3.80: Heavy decay to timber floorboards*

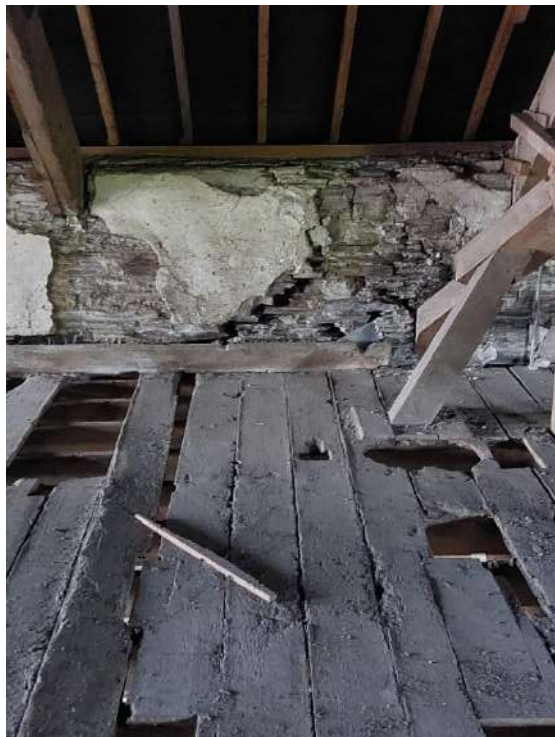
*Fig 3.81: View of cracking to south wall which appears to be associated with the south annex.*

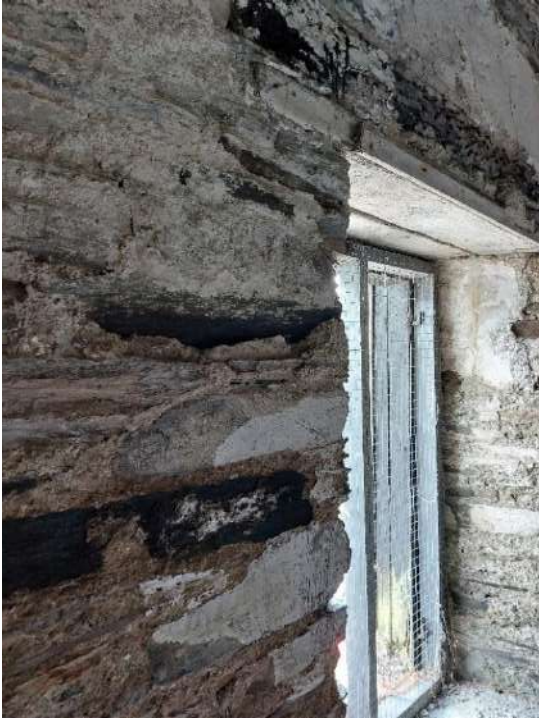
Fig 3.82: View of east wall window opening

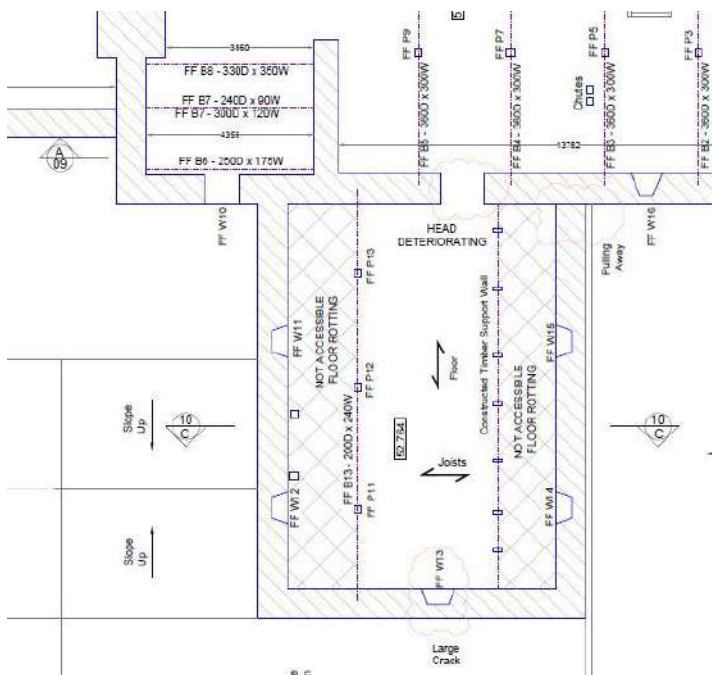
Fig 3.88: Ground floor plan of south annex. NTS

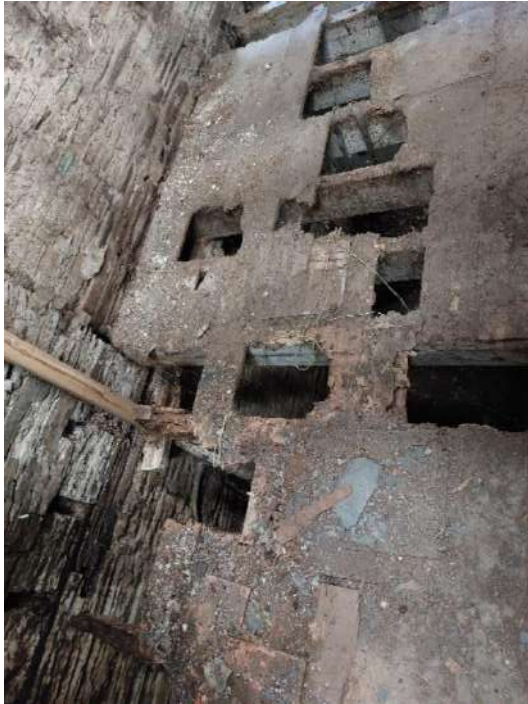
*Fig 3.91. Decayed timber floor finish*

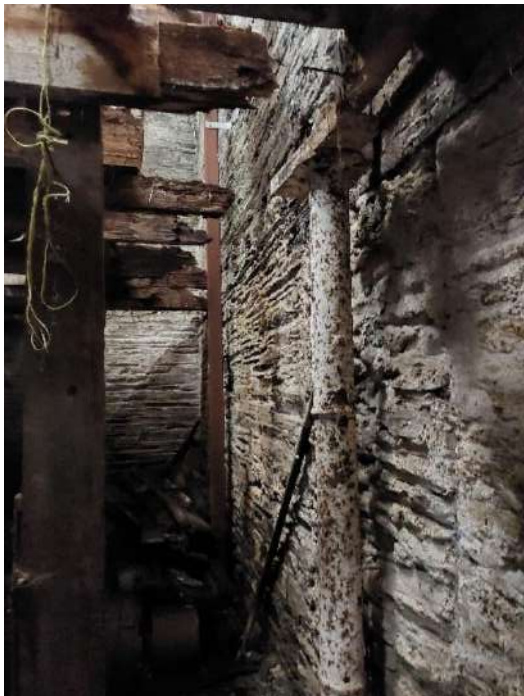
*Fig 3.92. Decayed ends to floor joists along west wall*

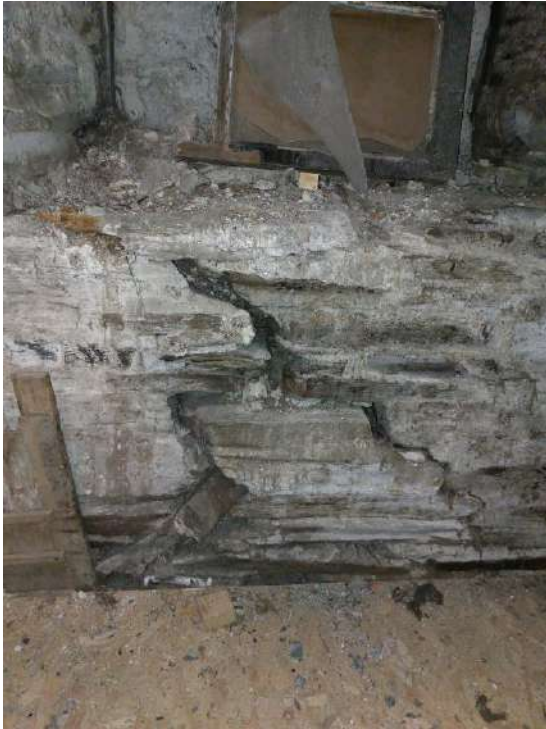
*Fig 3.93. Cracking to south gable wall between openings*

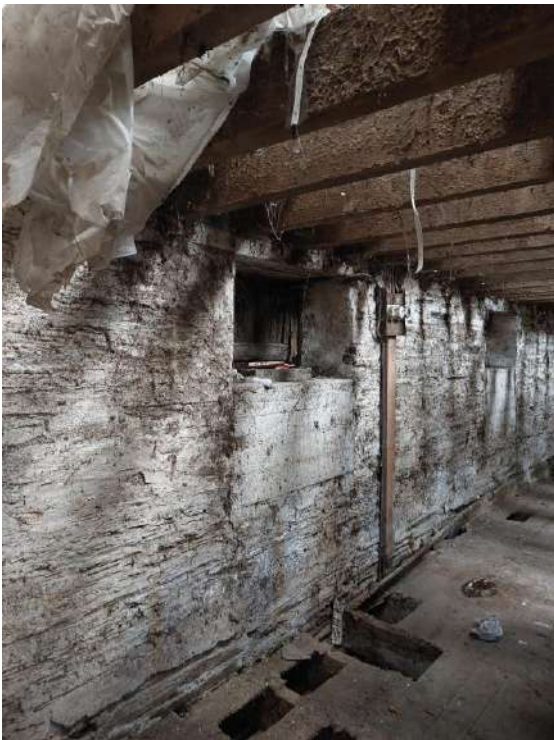
*Fig 3.94: View of east wall*

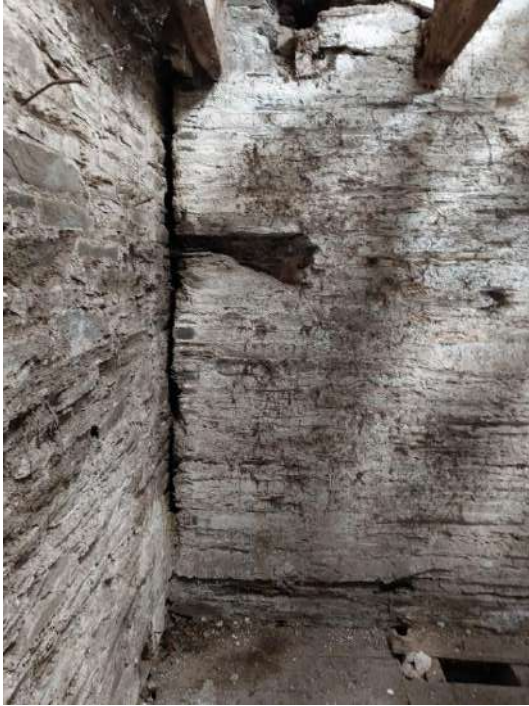
*Fig 3.95: Crack at first floor level between main volume and south annex*

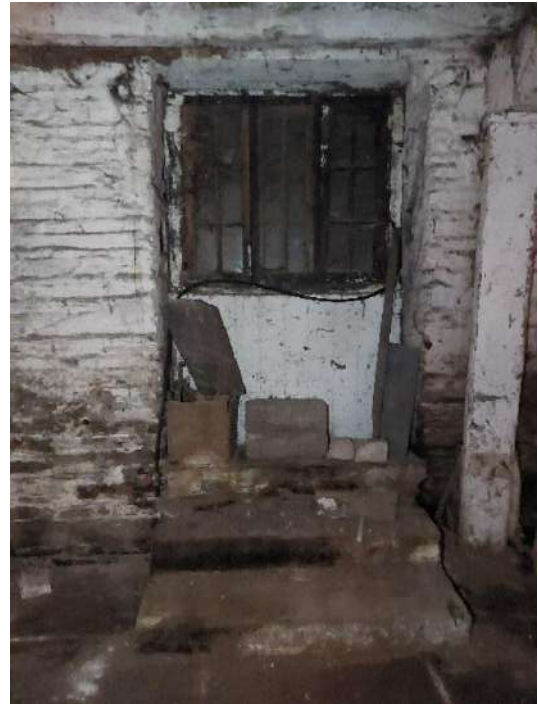
*Fig 3.96: Door opening in south gable wall of annex*

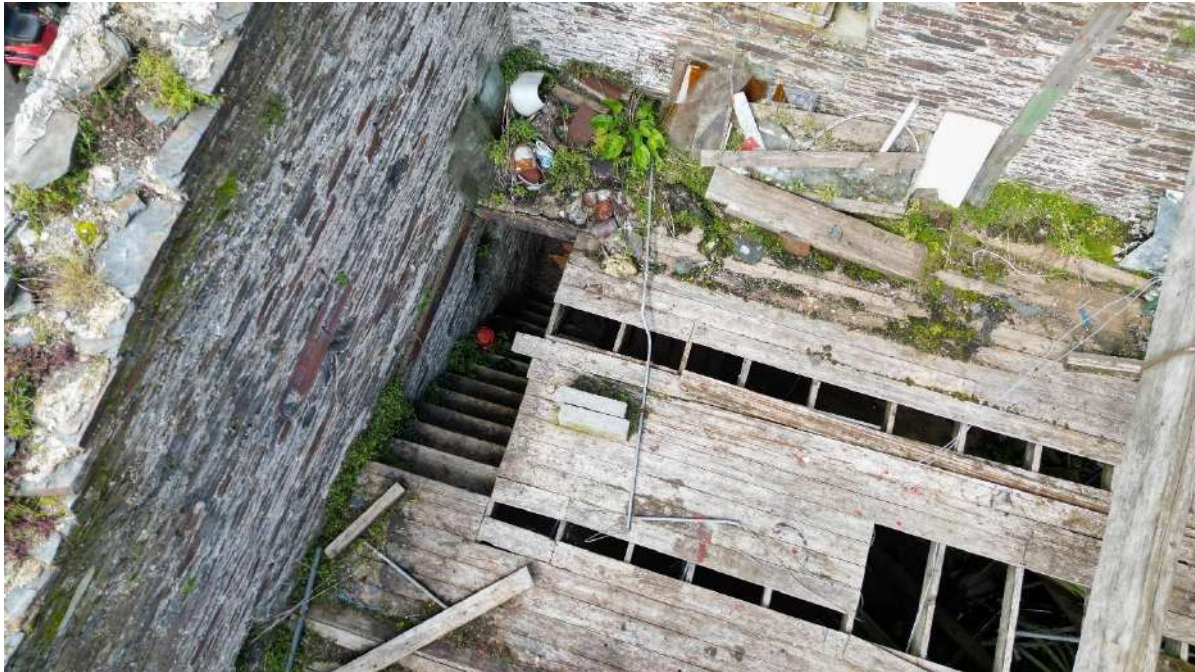
*Fig 3.99. Northwest corner with stairs visible*

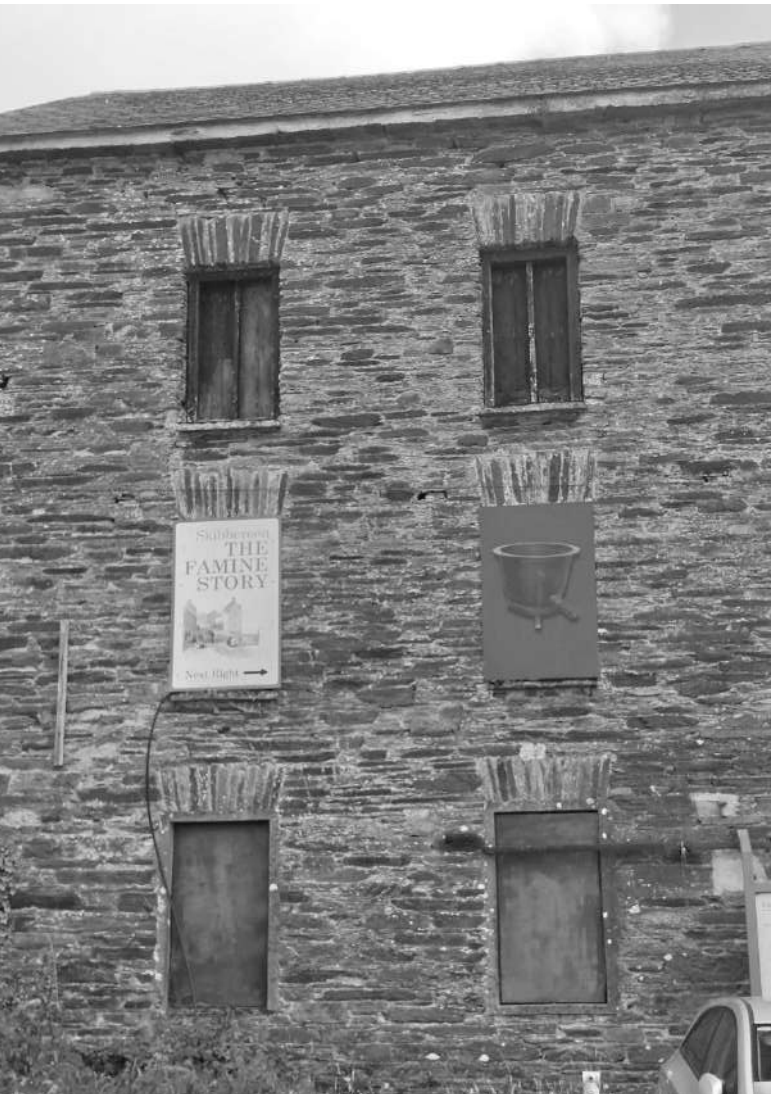
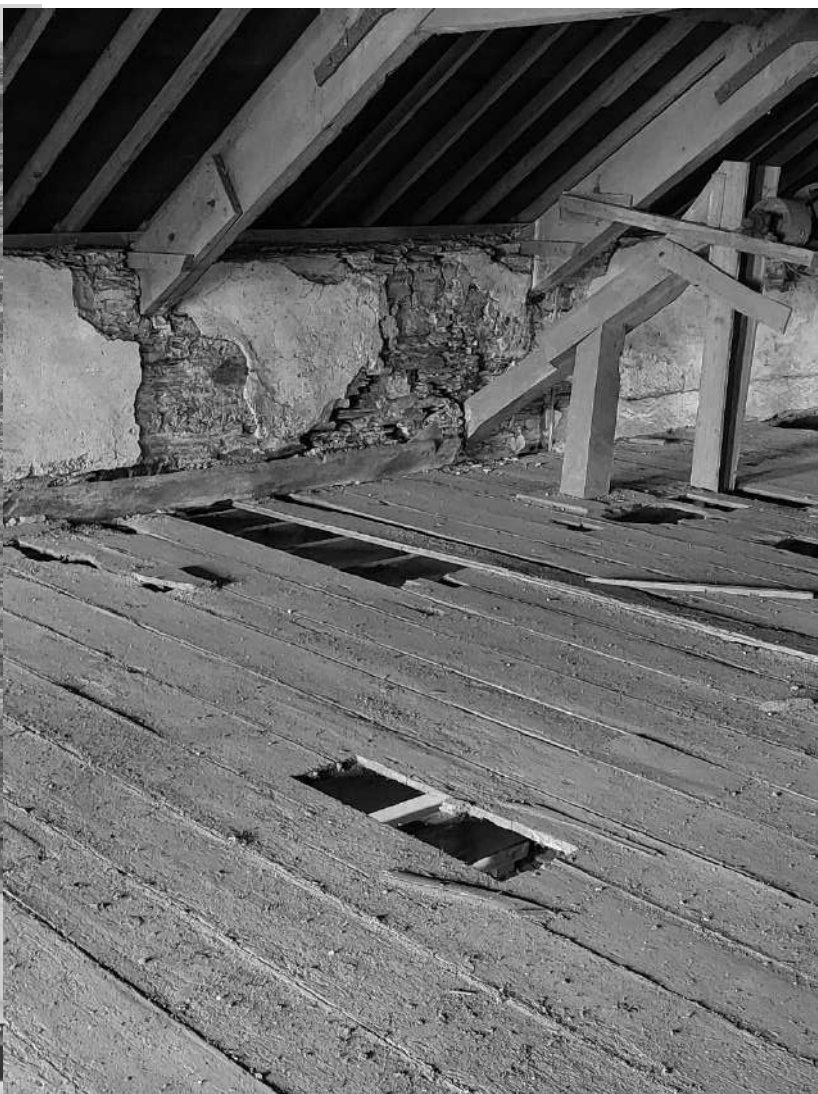
**Part Five: Assessment of Conservation Issues**
