SKIBBEREEN STEAM MILL

# INFORMATION PACK

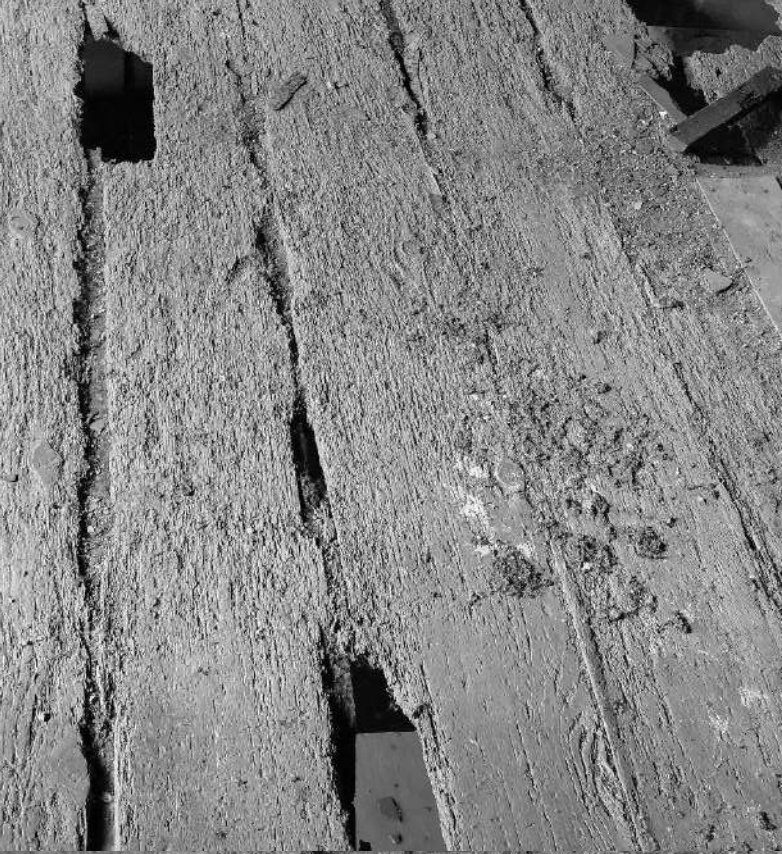
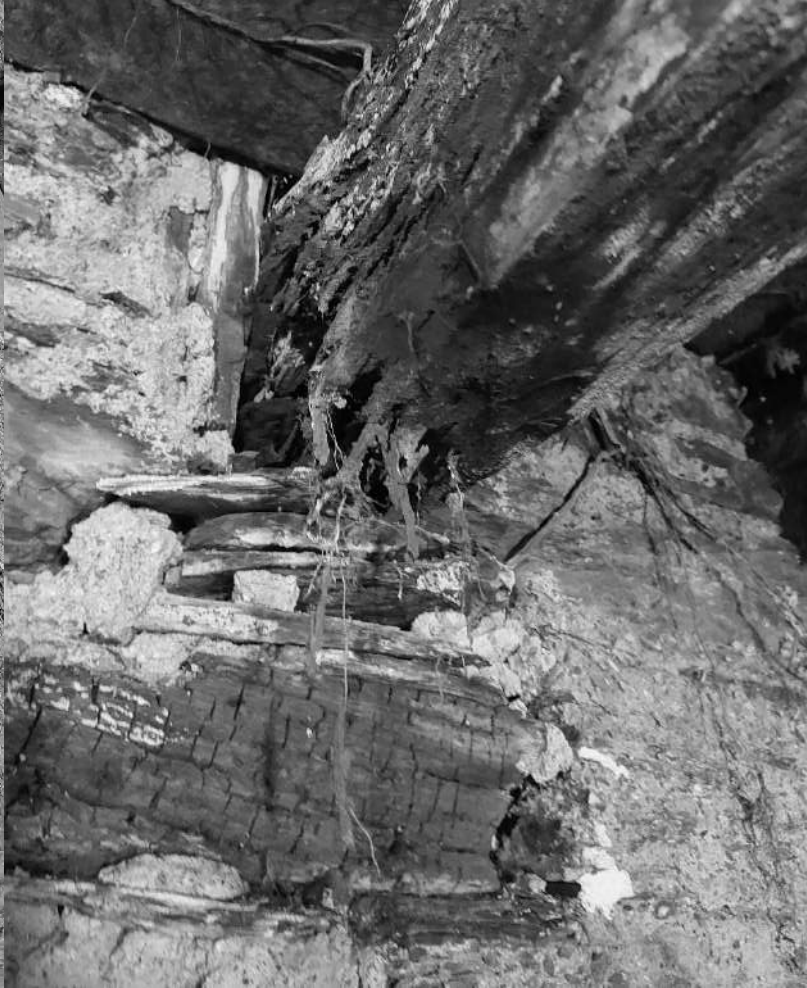
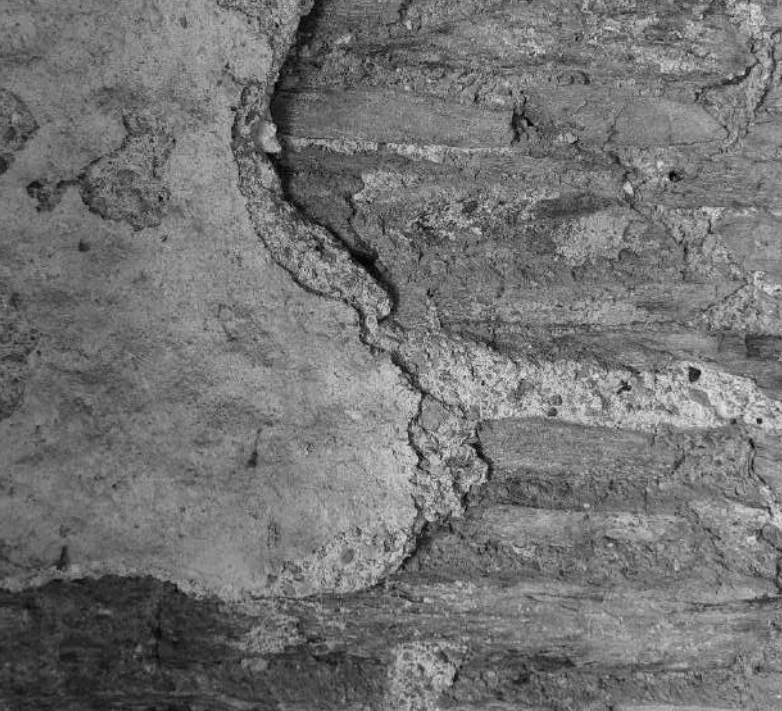
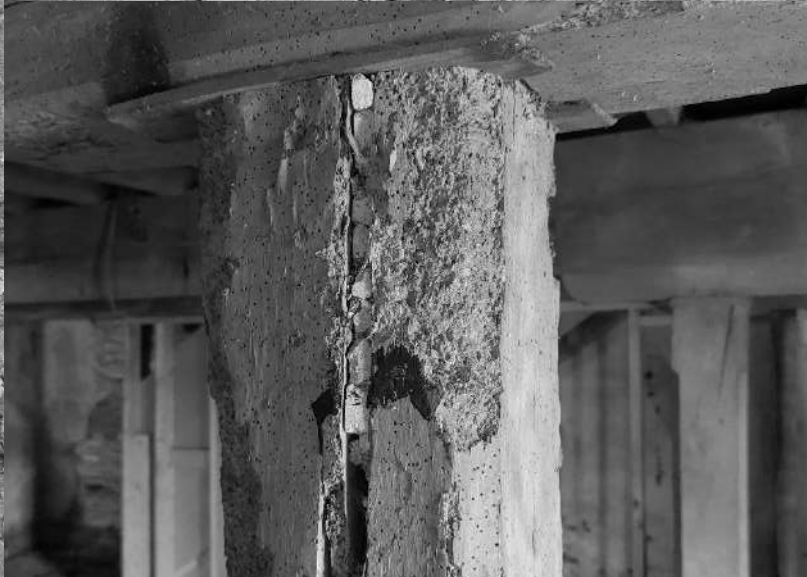
**Part Six: Action Plan**

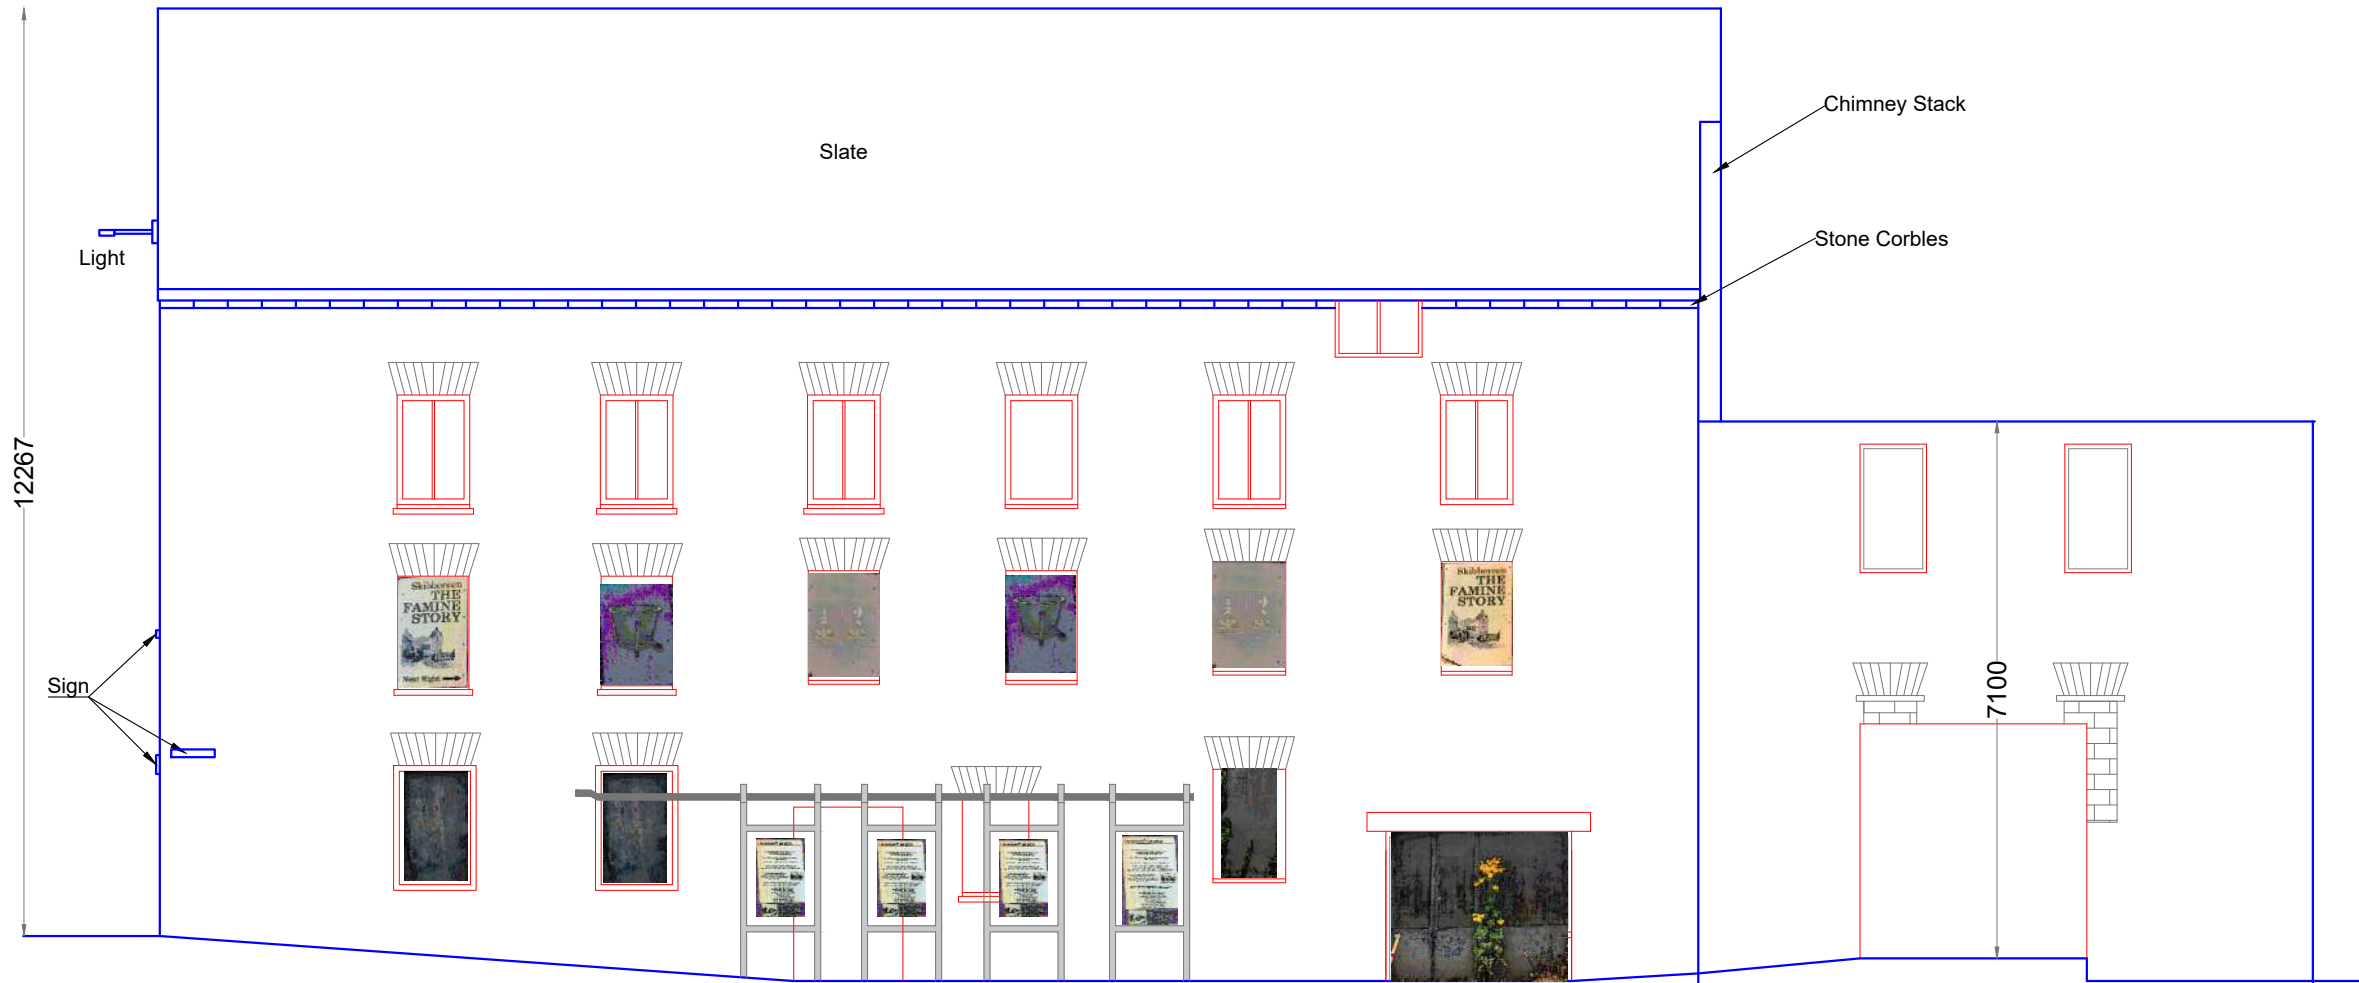
**DRAWING NOT TO BE SCALED**  
 COPYRIGHT: No part of this document may be reproduced or transmitted in any form or stored in any retrieval system of any nature without the written permission of WATERMAN KELLY C.E. as copyright holder except as agreed for use on the project for which the document was originally issued.

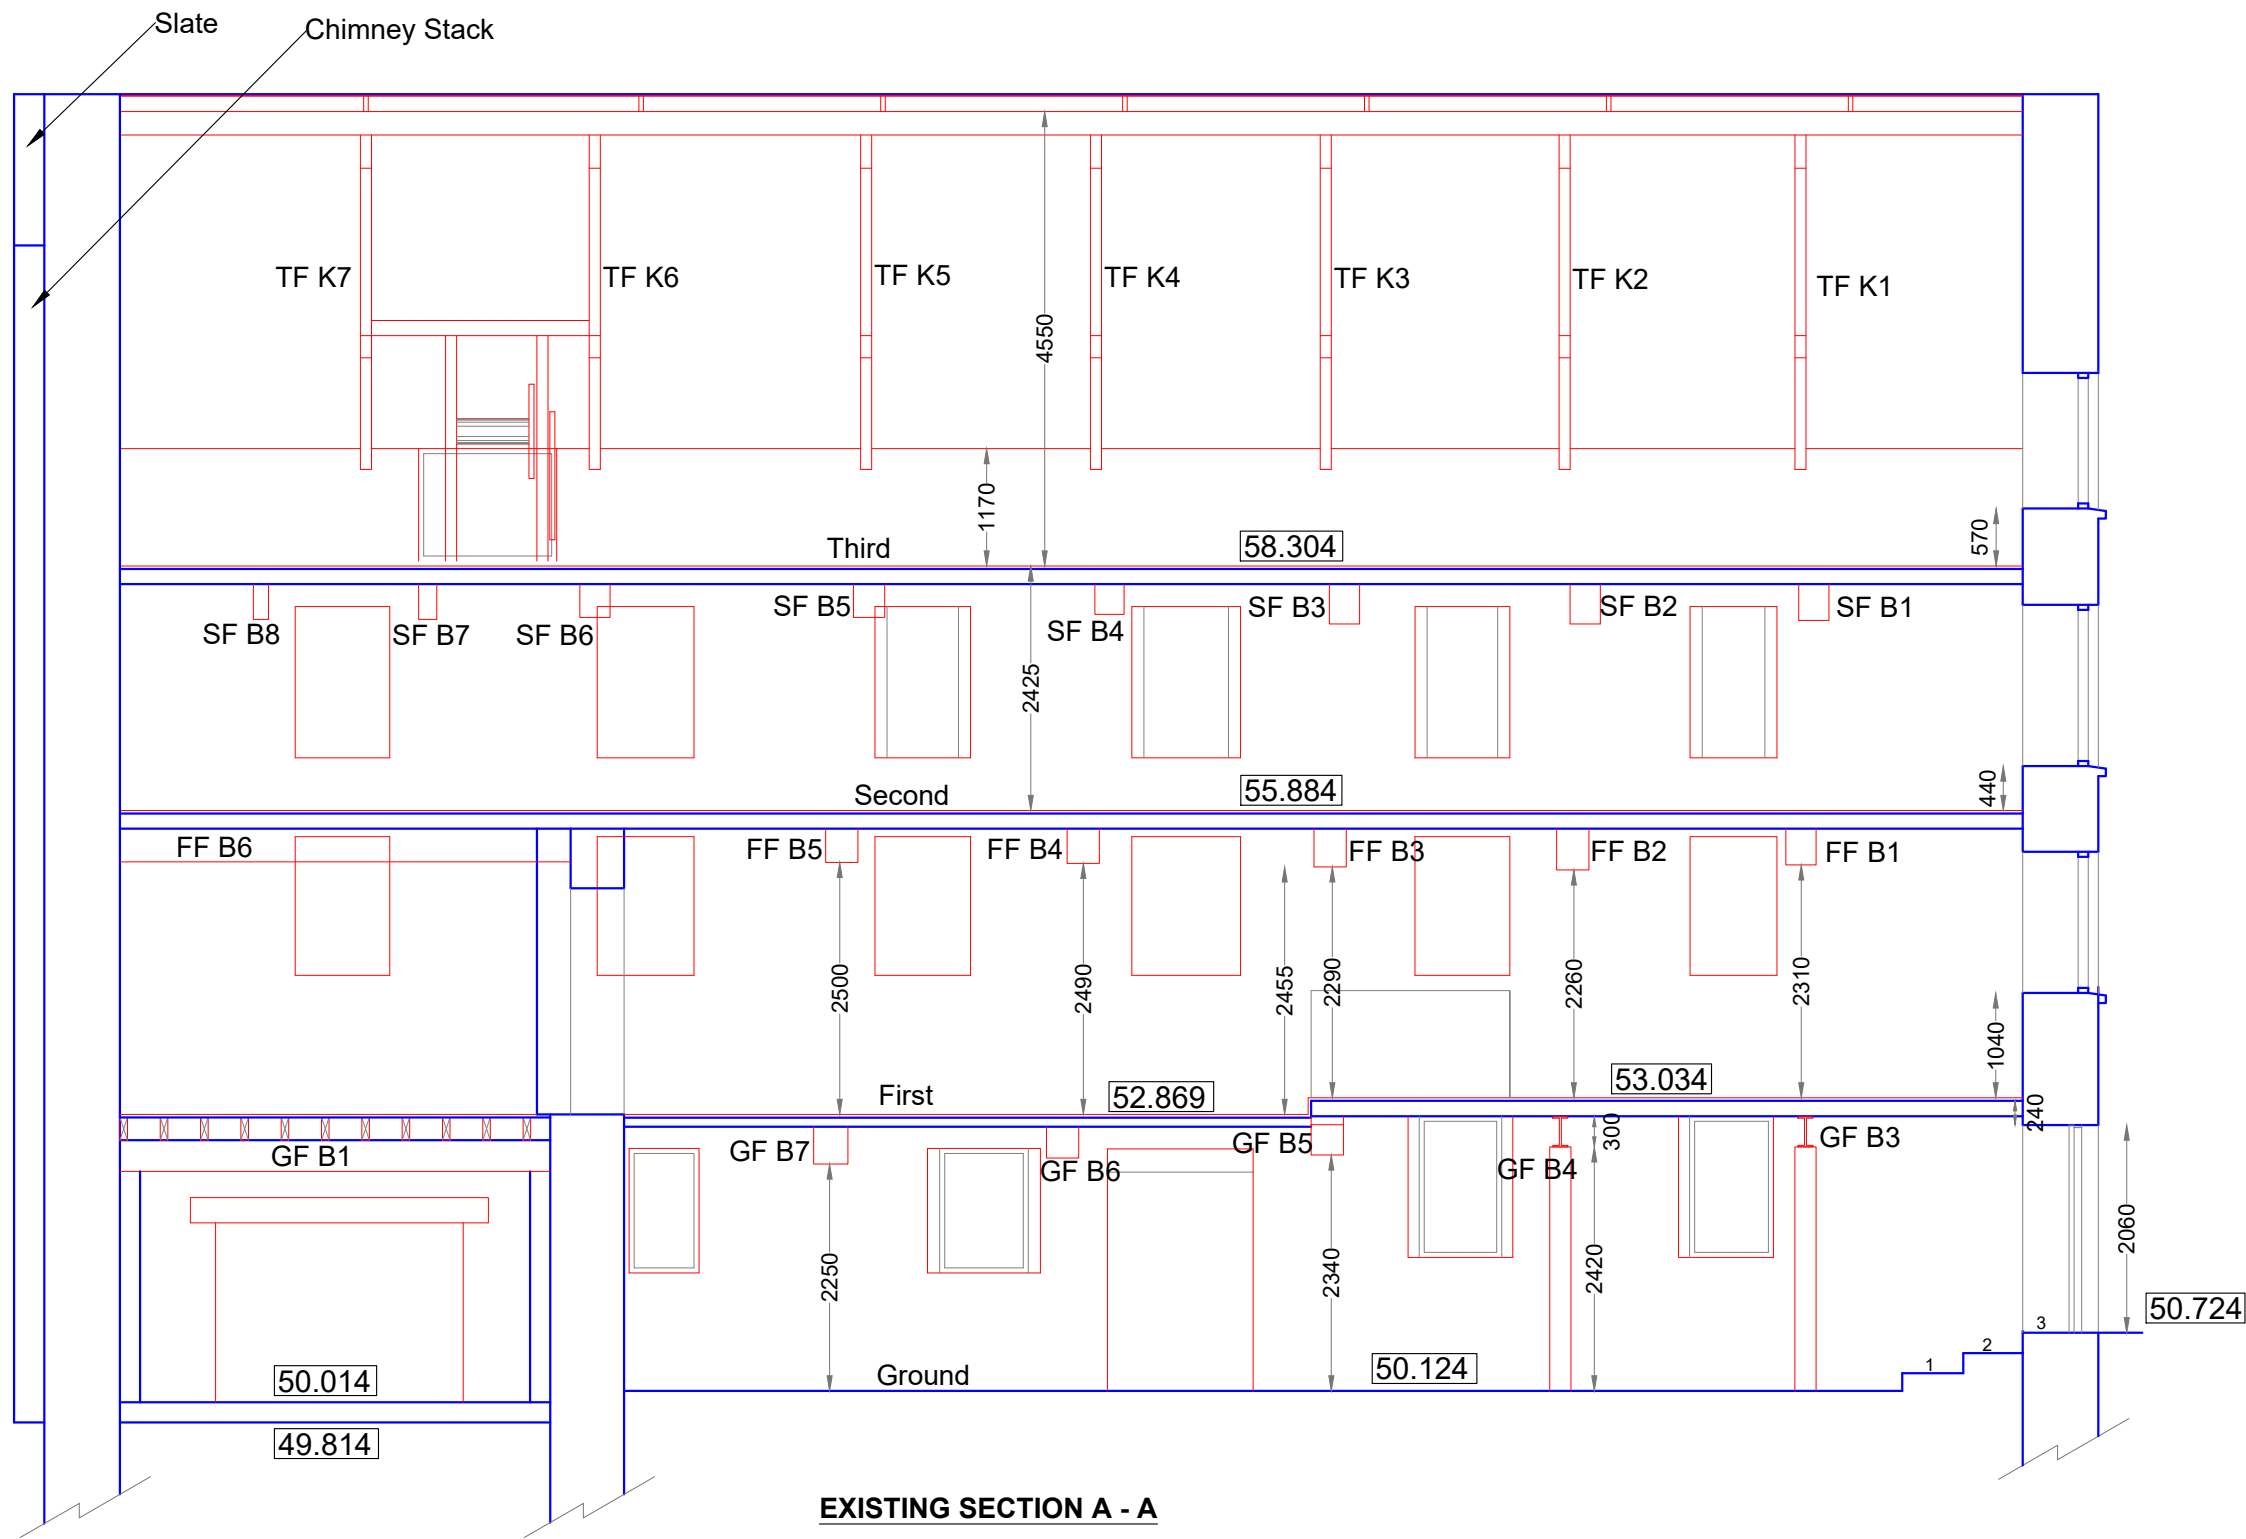
- Notes :**
- Dimensions not to be scaled from drawing.
  - See corresponding plans for door, window, beam and pier schedules.
  - The two beams closest to the door on the East at Ground Floor level have been replaced with steel I beams and placed on brick pier.

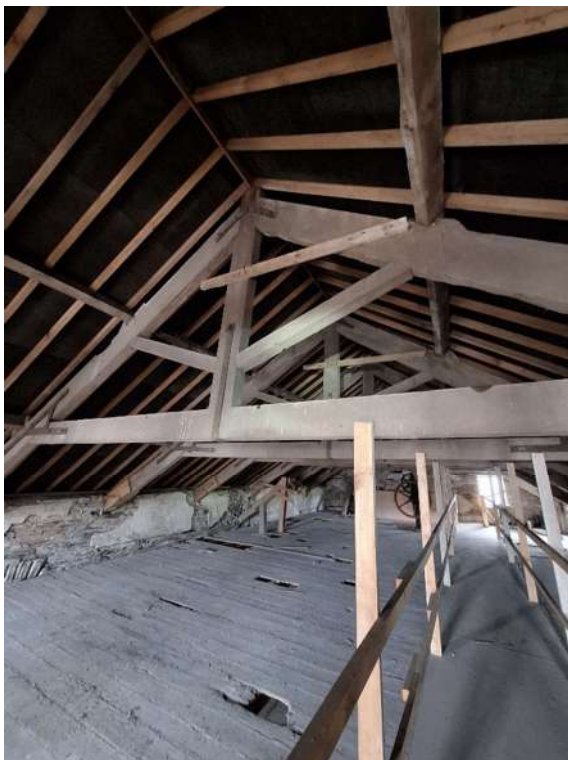
*Photo 5 – Original roof truss*

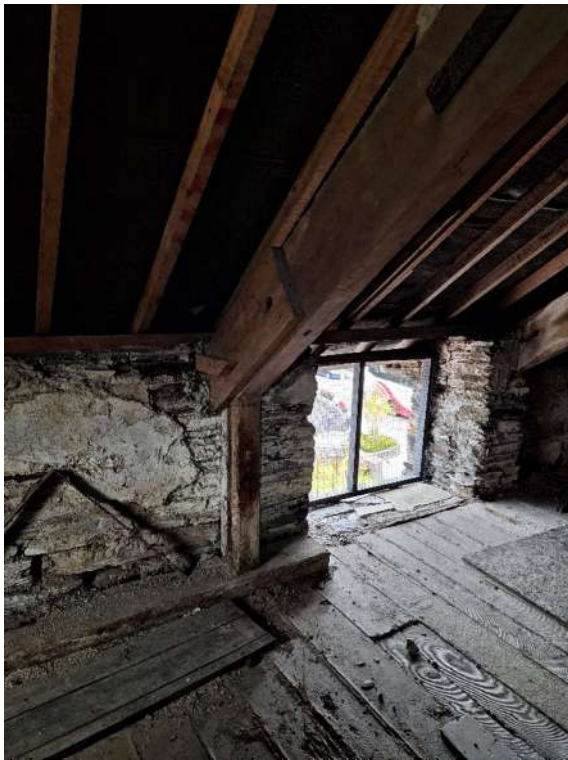
*Photo 6 – Second truss base with damp rot showing on original truss*

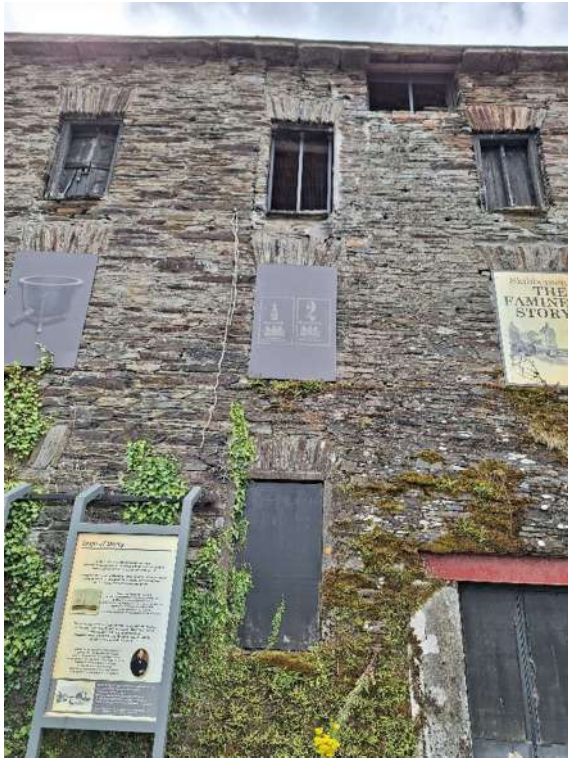
*Photo 8 – Northern facing wall showing capping and opt to roof void*

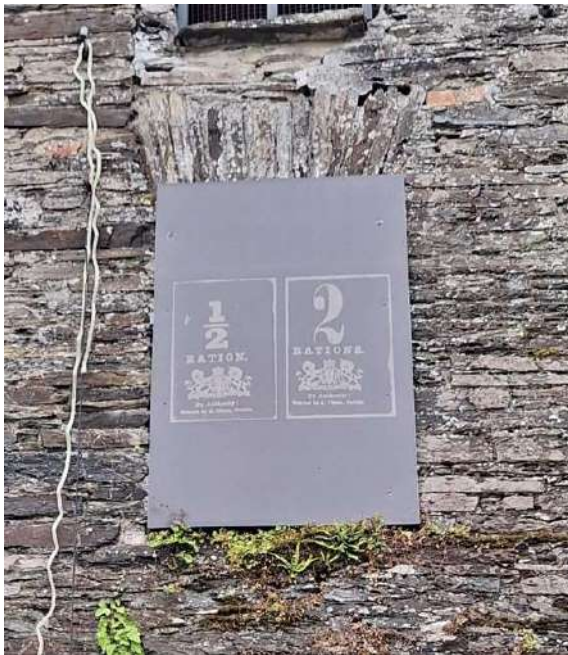
*Photo 9 – Failed window head*

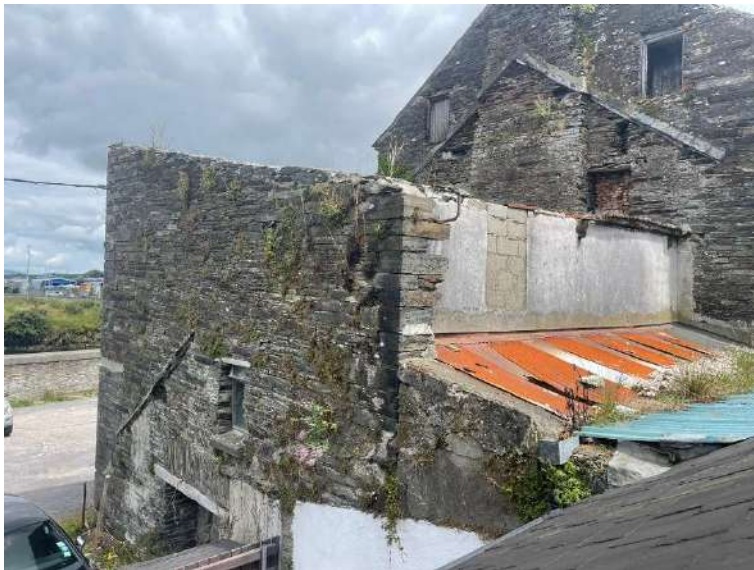
*Photo 10 – West Elevation*

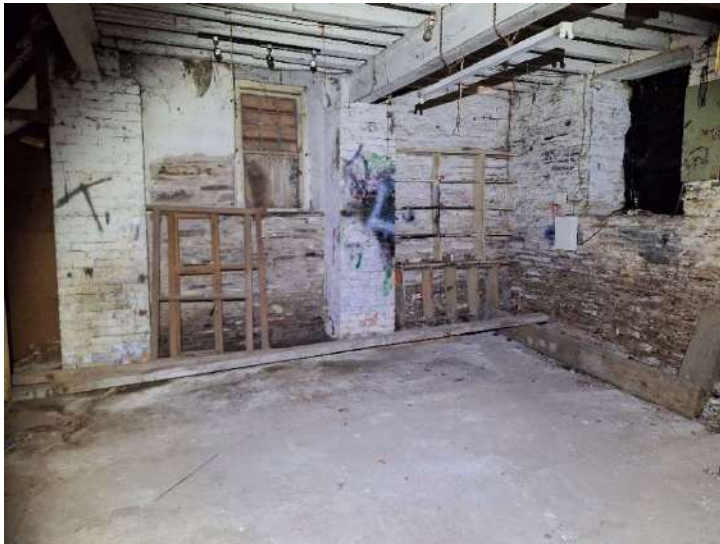
*Photo 11 - Concrete ground floor showing steel beam and brick column supporting first floor*

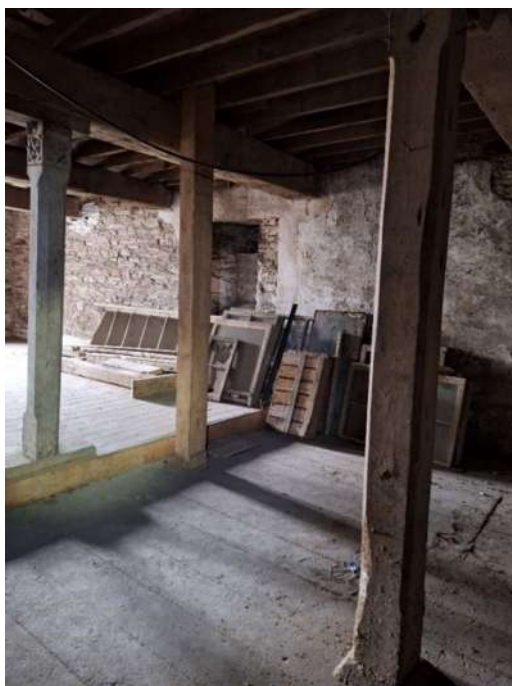
*Photo 12 - First Floor*

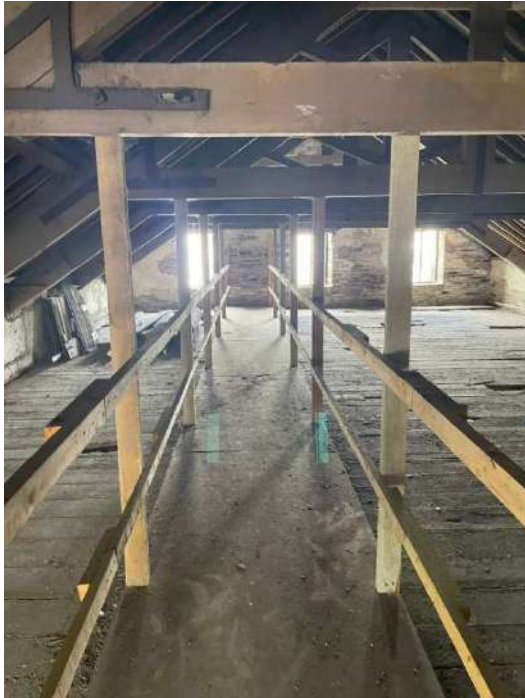
*Photo 15 – Third floor*

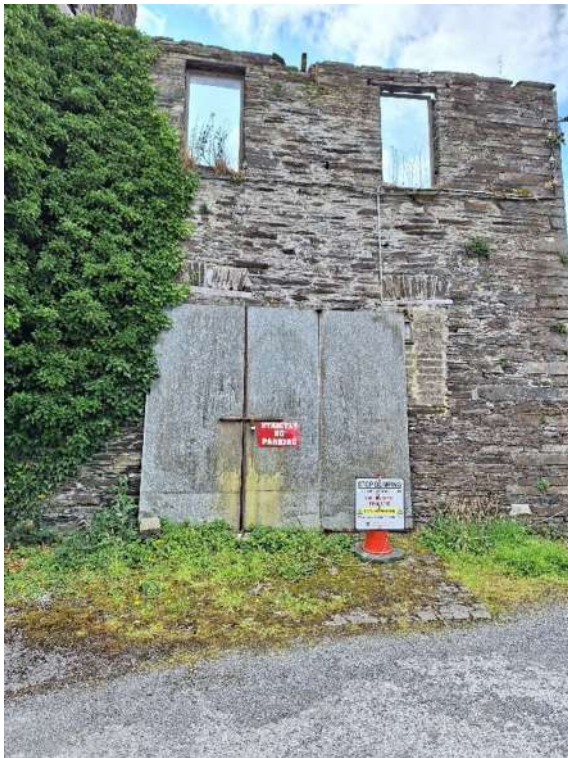
*Photo 16 – West annex*

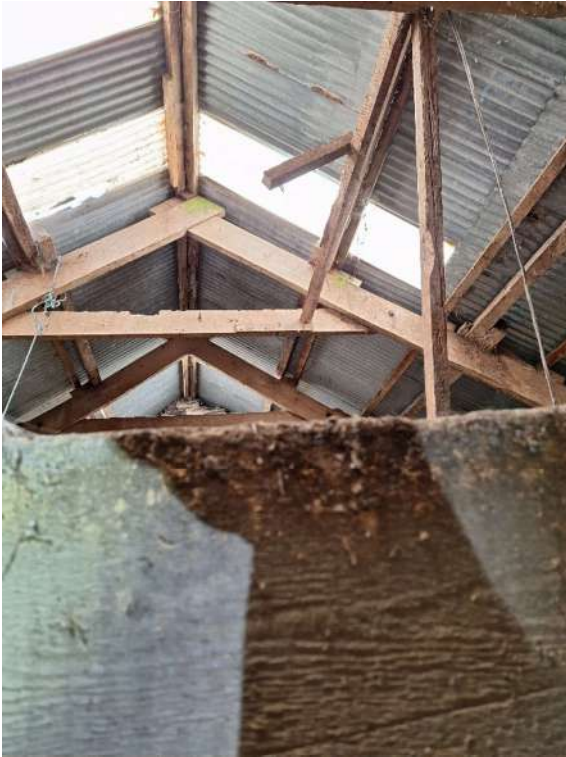
*Photo 17 – Corrugated roof and timber truss*

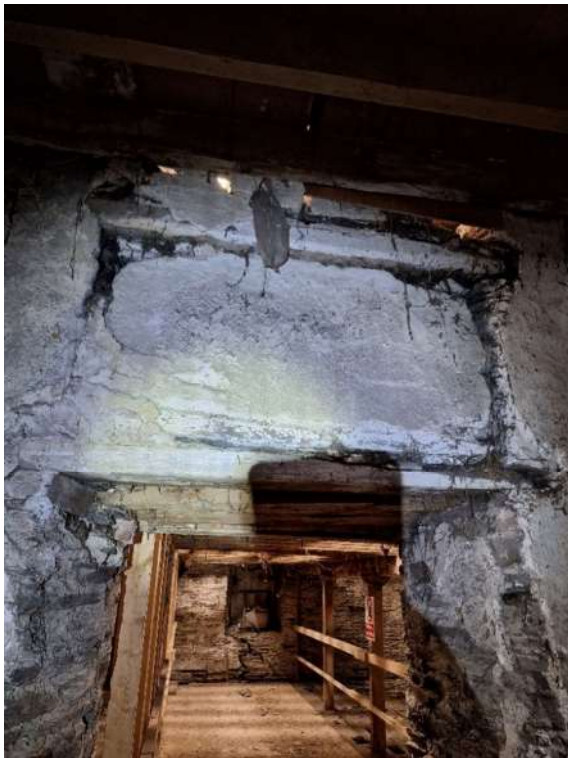
*Photo 18 – Failed lintel*

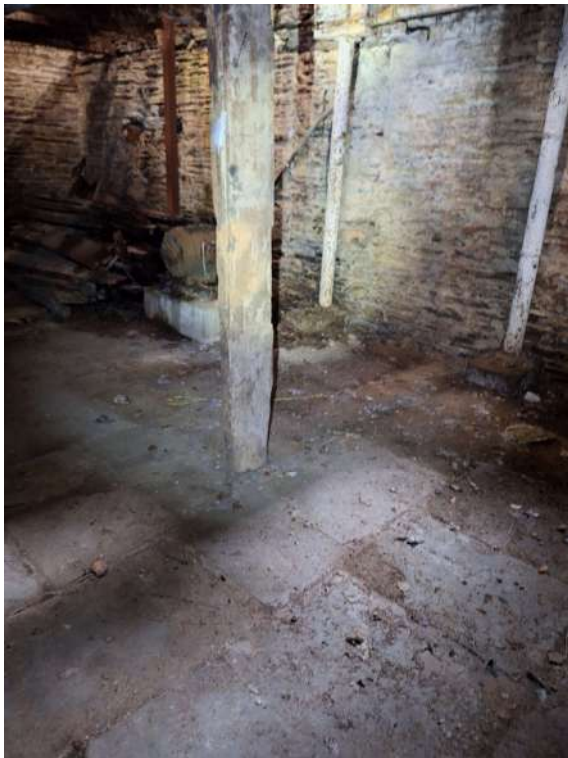
*Photo 20 – Example of condition of timbers*

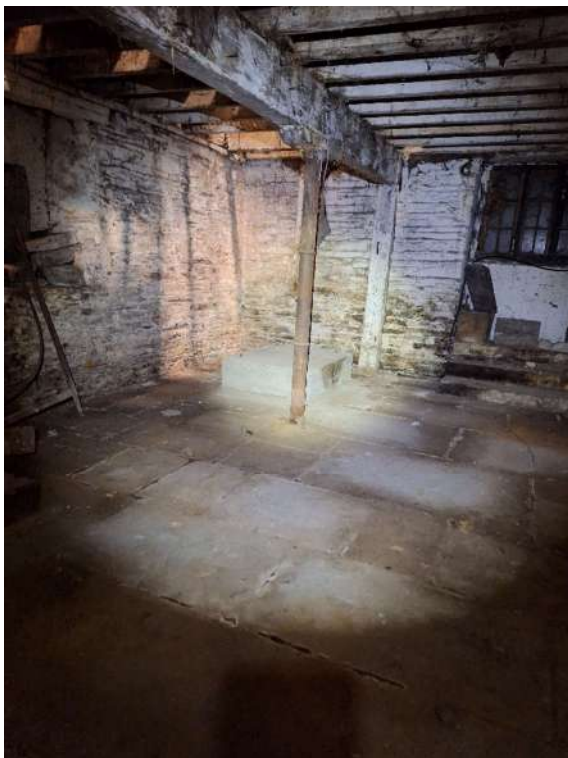
*Photo 21 – Original paving slabs*
