**Conservation Methodology  
on proposed works to the former  
Keshcarrigan Barracks at Keshcarrigan,  
Co. Leitrim**

**Keshcarrigan Development Association**

**Date of Issue 19<sup>th</sup> February 2025**

**Job No. 2506**

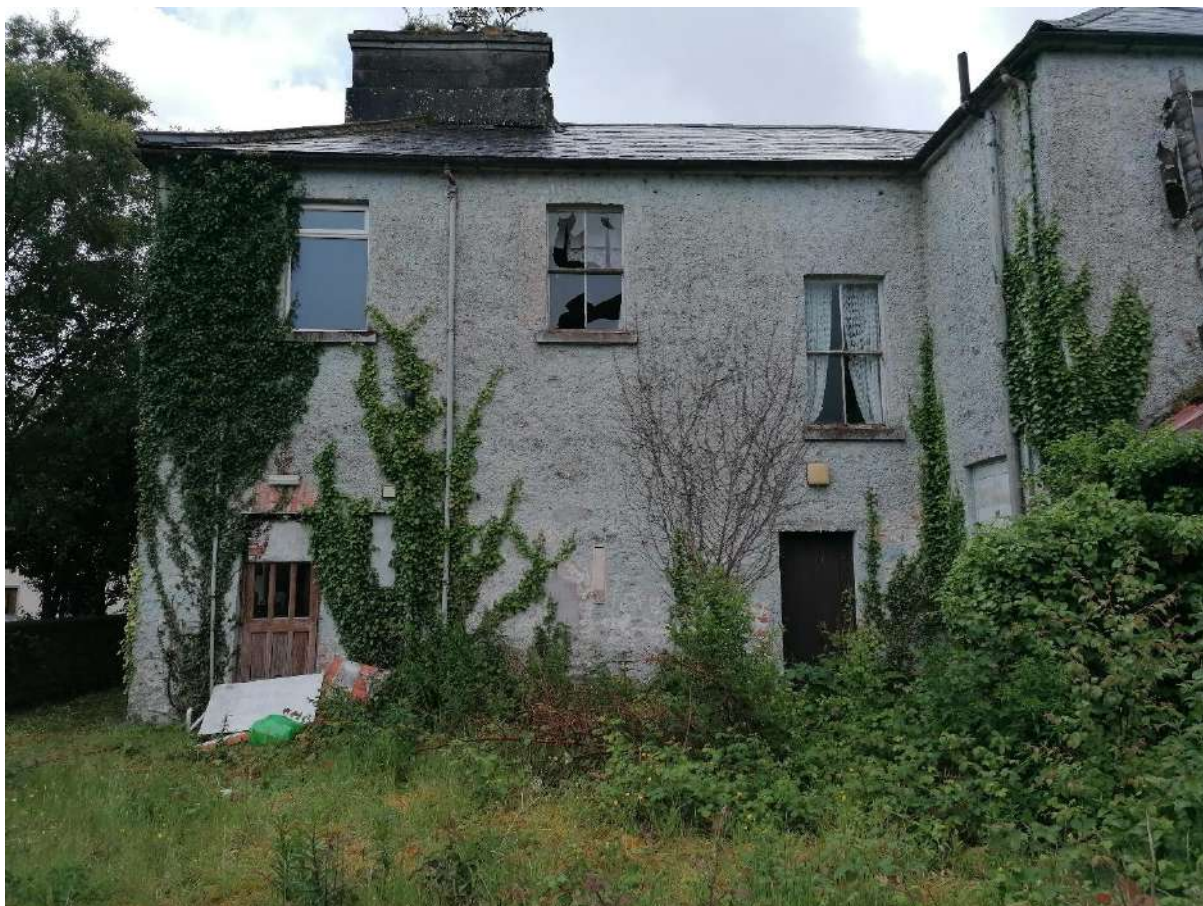
There are notable ivy growths to the rear façade and this should be removed to avoid even further threatening the structural integrity of the building.

*Fig. 3 Rear (North West) elevation*

Treat with appropriate biocide, allowed to die back and then to be removed. Care to be taken to remove all roots and dead growth within the masonry. Limited opening up may be required. Stone elements to be carefully removed to avoid damage and to be reset in lime mortar on completion.

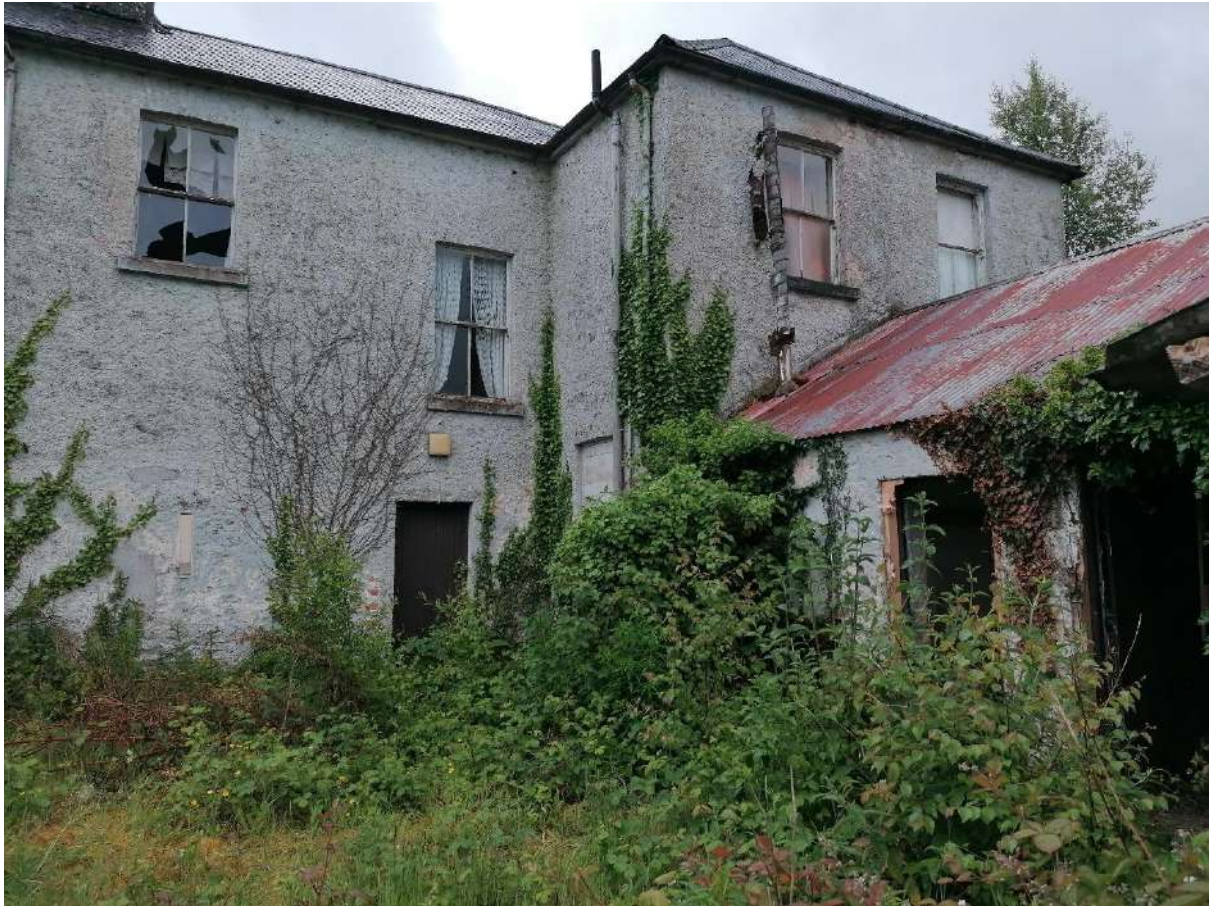
*Fig. 4 Rear (North West) elevation*

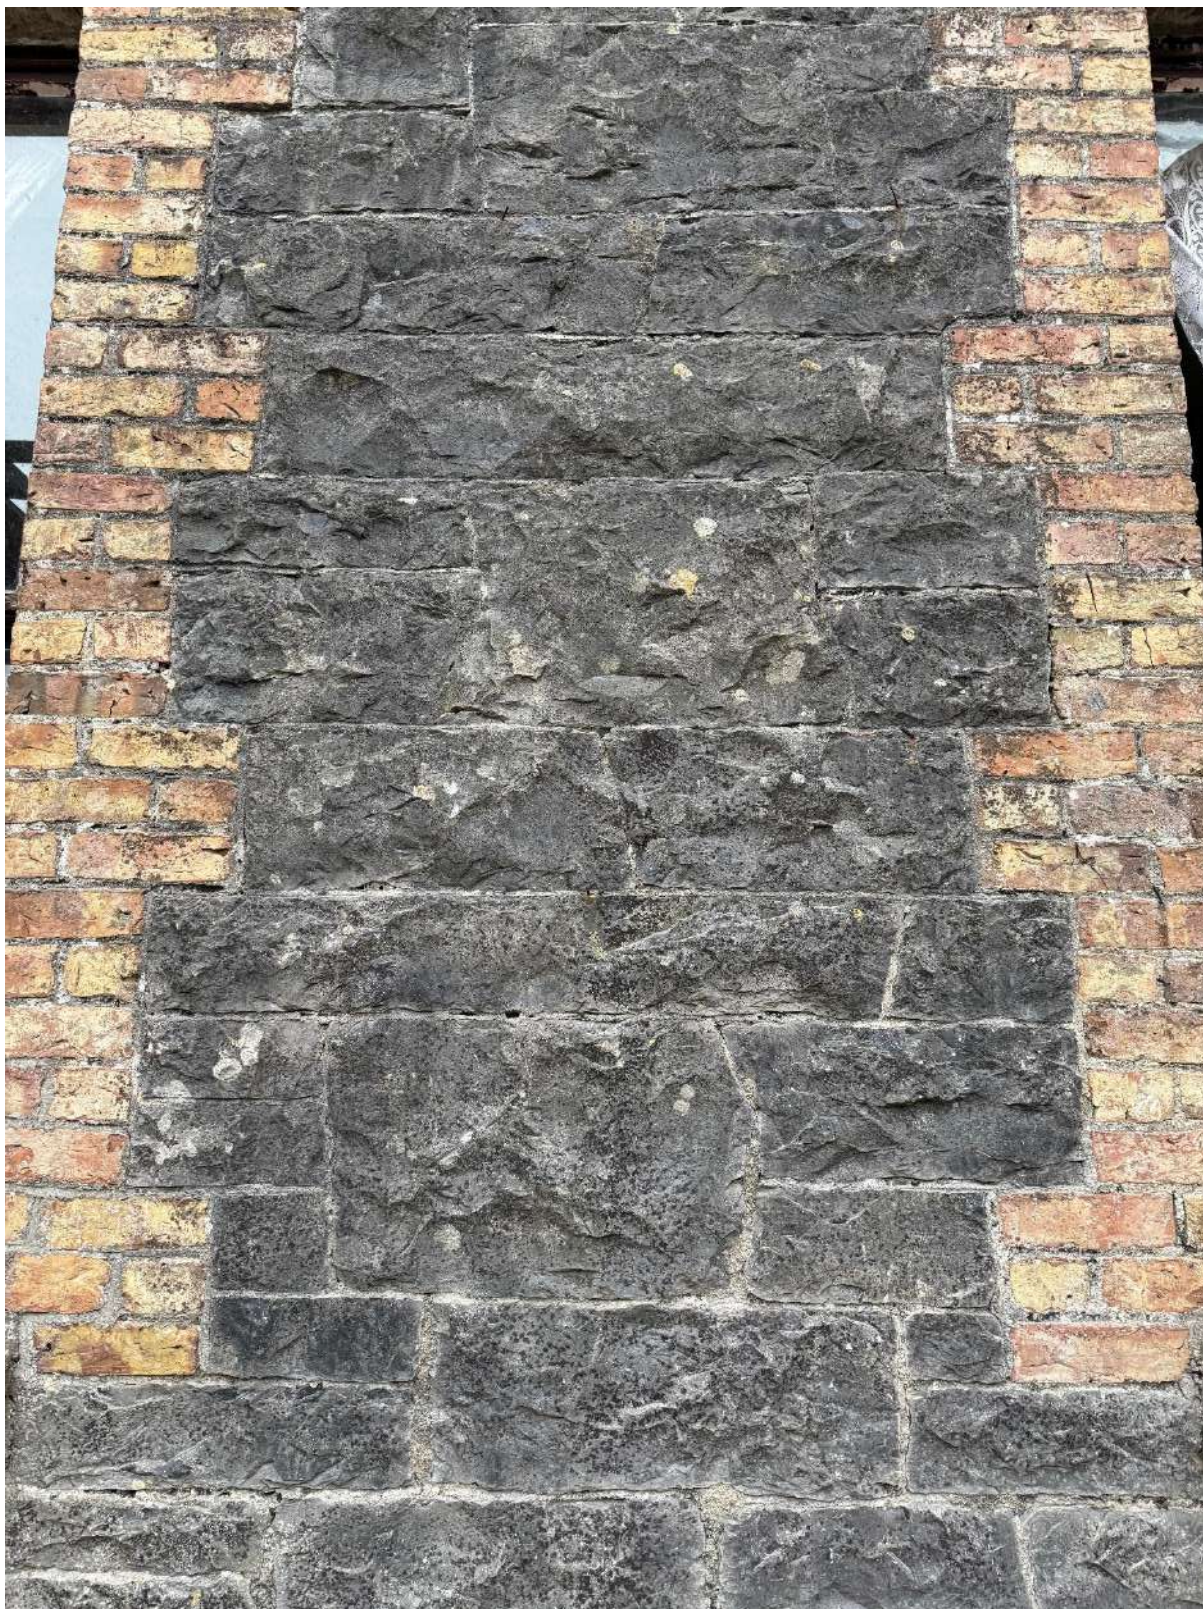
Ashlar sandstone façade to front facades capped with corbel eaves stone, harling render elsewhere. The stonework is generally in good condition. Localized pointing proposed only where dislodged.

The condition of the brickwork to external window & door opes was found to be generally in good condition.

*Fig. 6 Stone & brickwork*

Repointing, where required, is to be carried out in a compatible and appropriate NHL mortar. Where possible, a sample of existing surviving lime mortar should be retained to allow replication. The contractor should allow for getting a sample of the existing mortar analysed facilitating replication of the original mix or a suitable variation as may be appropriate. Prior to implementation, a sample of mortar repair / repointing should be carried out and agreed with the Conservation Architect to demonstrate suitability of mortar, compatibility of colour and finish together with competency of the contractor. The sand is to be well-graded crushed stone with a predominant particle size to match the original mortar. It is to be low in soluble salts having an inert siliceous content greater than 95%. The sand is to be free from clay and other impurities.

Where decayed bricks are uncovered they should be cut out in a way that causes the minimum disturbance to the surrounding sound bricks. Replacement bricks to be sourced & installed that match the original as closely as possible in size, durability, texture and colour. Any replacements should be laid with the same bond, joint size and joint colour as the original. Where the brickwork is patterned or coloured, the replacement bricks should match the pattern and colours of the originals.

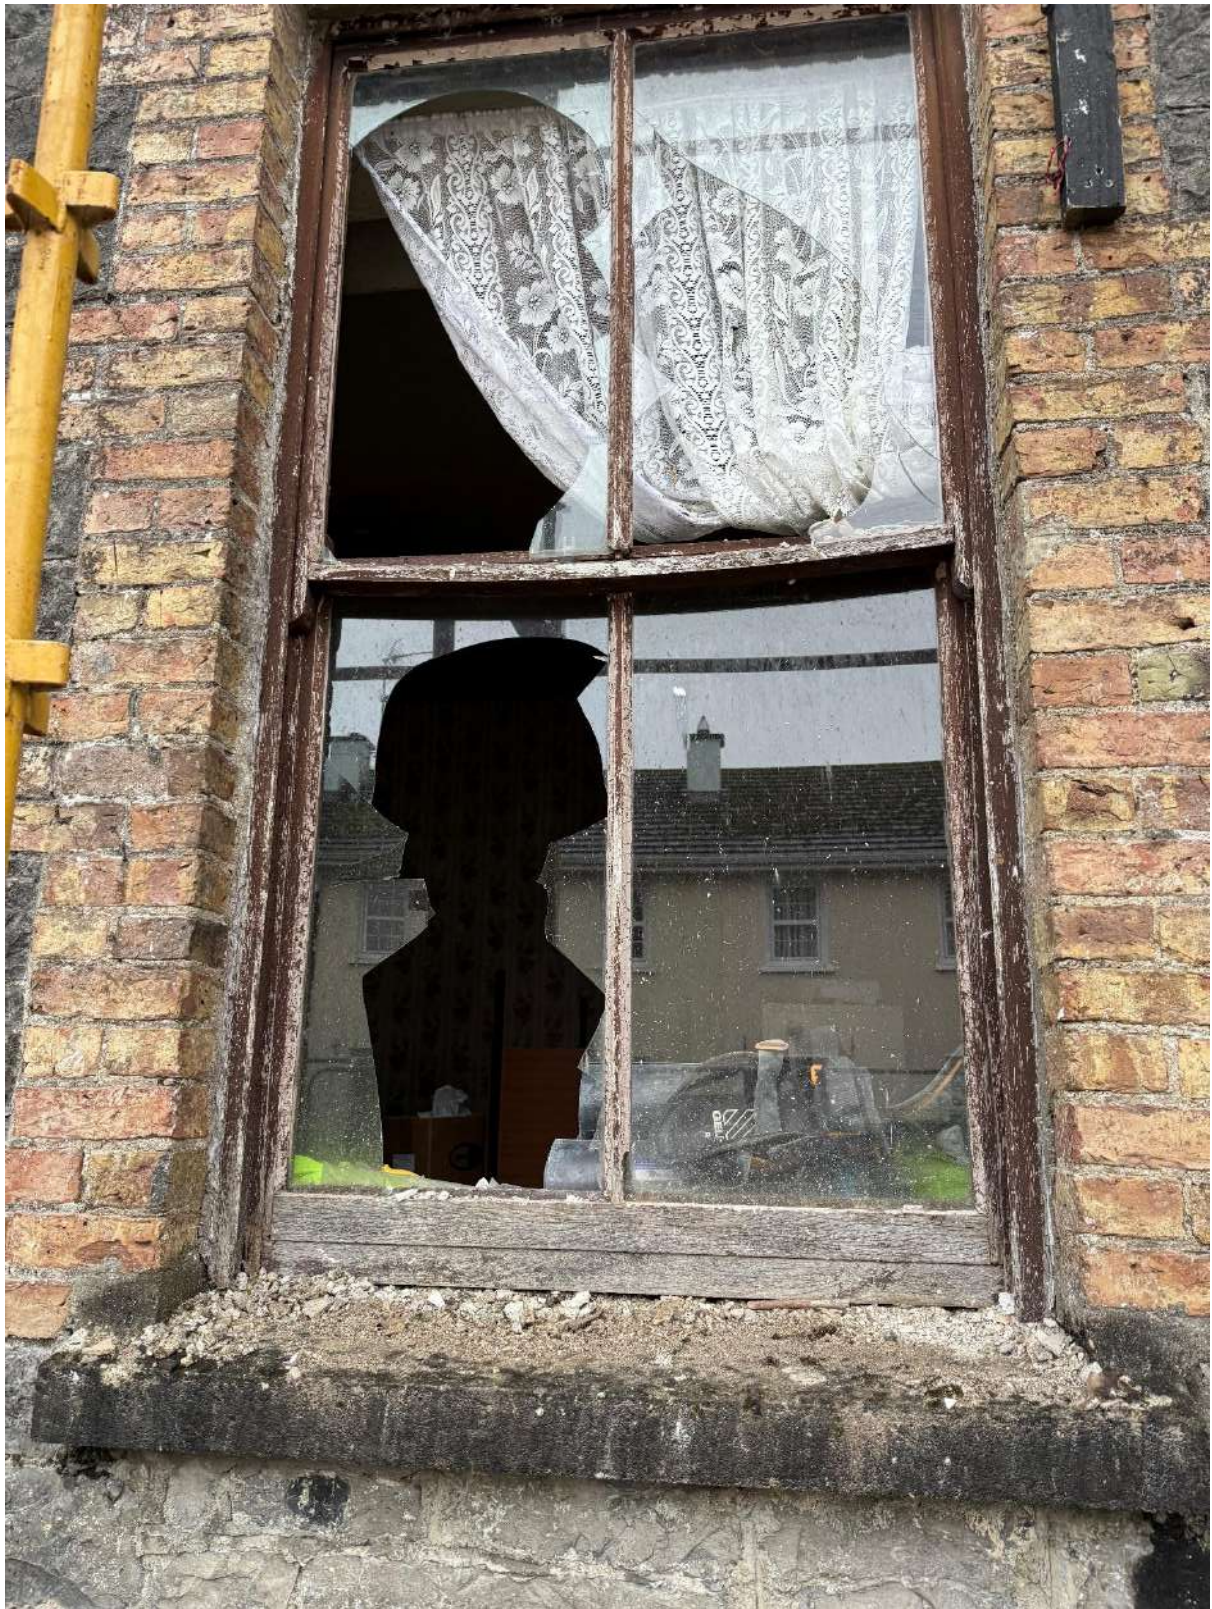
The building contains a mixture of original single glazed sliding sash two over two timber windows, replacement single glazed sliding sash two over two timber windows, replacement pvc framed windows, and replacement hardwood timber doors. Due to inadequate maintenance over the years some of the timber members to the original surviving windows have unfortunately decayed to such an extent that repair is necessary.

*Fig. 7 Replacement timber framed windows to front facade*

It is proposed to remove all non original external windows & doors and install replacement traditional external doors and sash windows complete with a slim-glaze double glazed units (with warm edge spacer), which allows the perimeter margin to be to the minimum and therefore replicate traditional glazing rebates. Whilst details of the original profiles of the sliding sash windows can be recorded and re-created from the surviving windows on the rear façade, sufficient details of external doors were not available at the time of preparation of this Conservation methodology to specify the replacement doors. However the applicant is in the process of gathering old photographs and making these available to the Conservation Architect, which will inform the detailing of the proposed replacement timber doors.

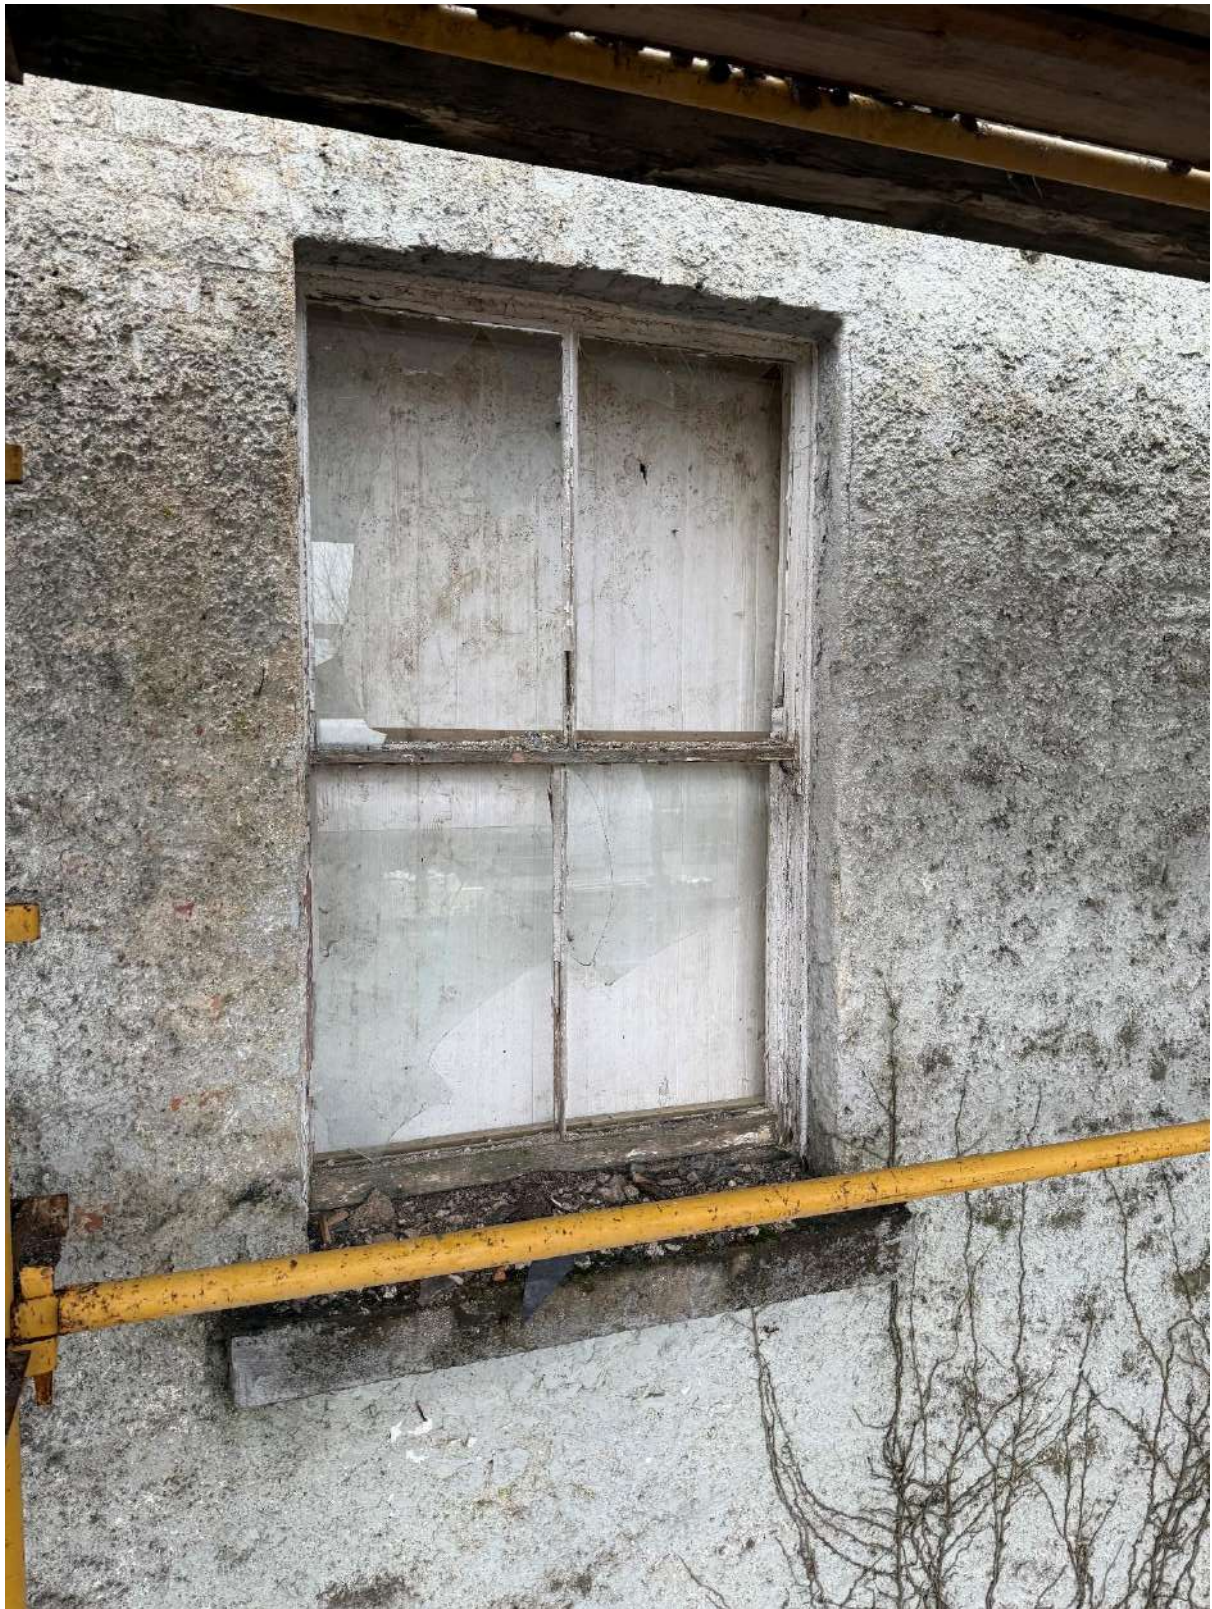
*Fig. 8 Surviving two over two timber framed sash window to rear facade*

It is proposed to carefully restore the surviving original windows as follows:

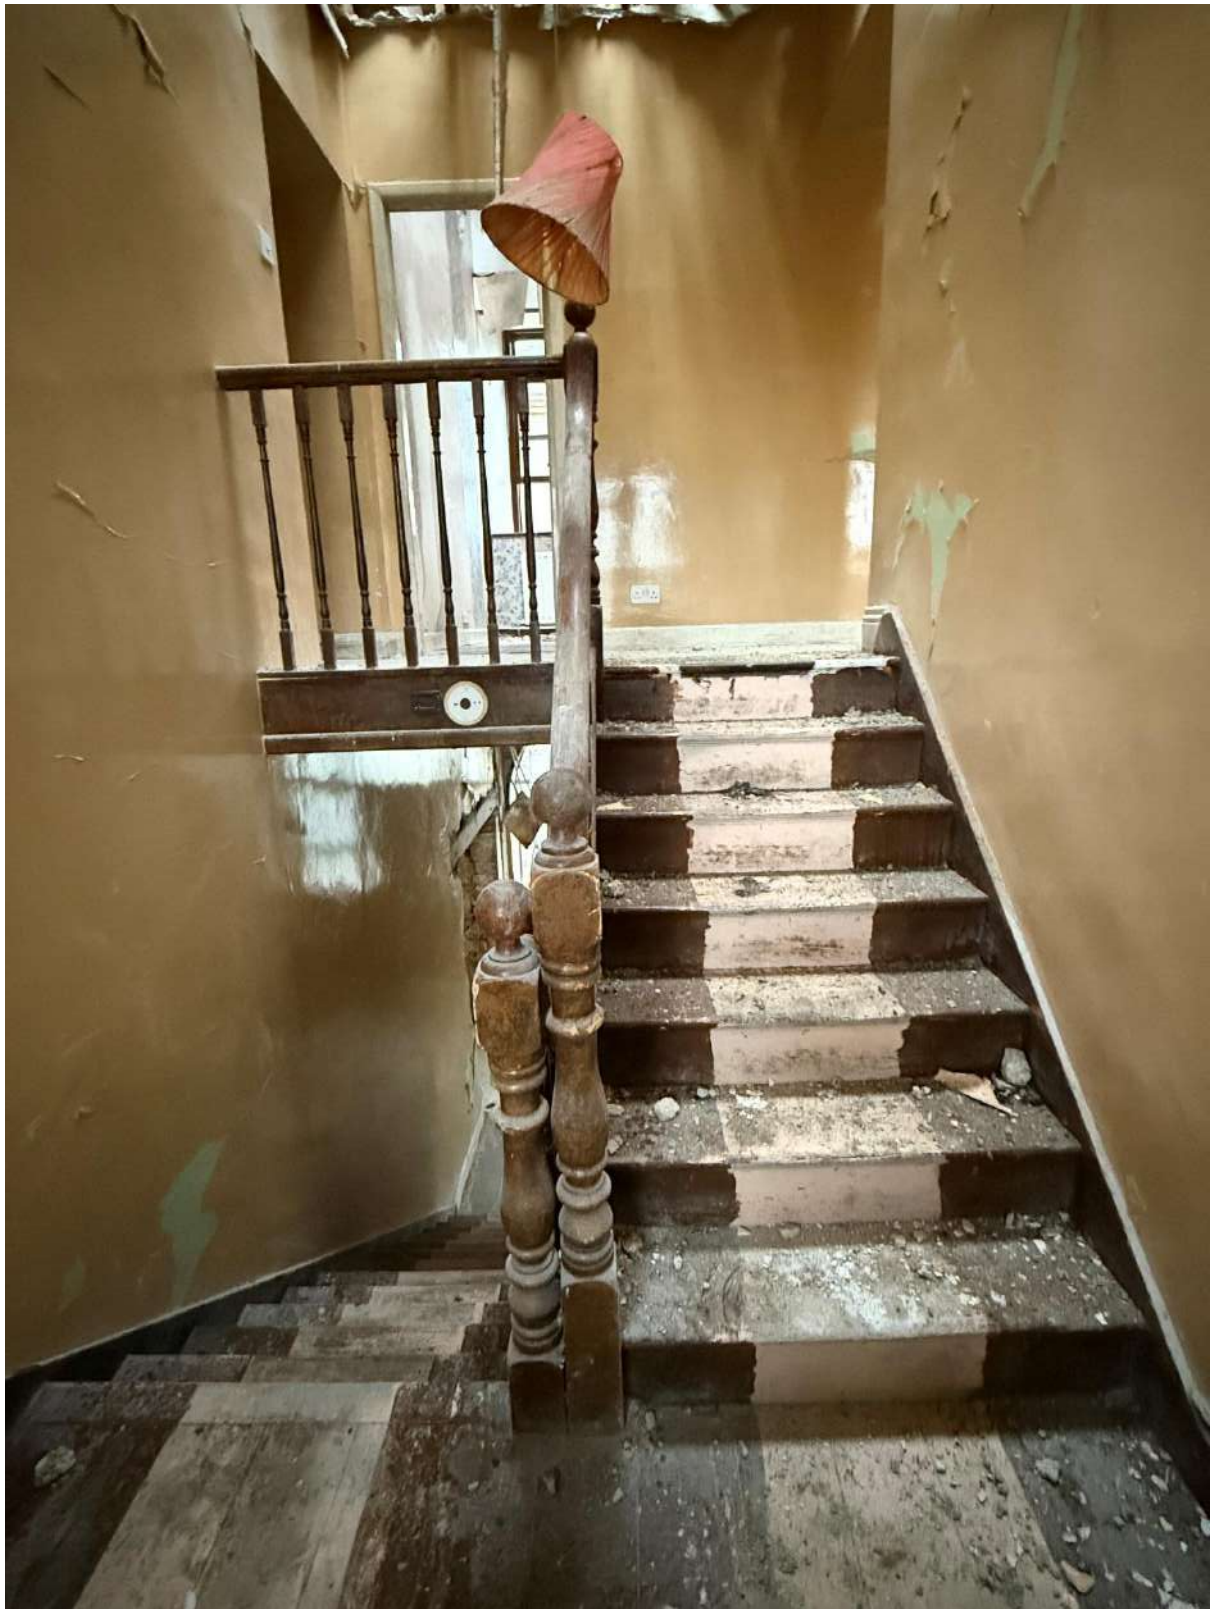
The original timber feature staircase is to be retained and repaired where necessary with matching materials. With the exception of a few damages or missing bannisters the stairs is generally in good repair and only minor works are anticipated.

*Fig. 10 Original stairs*

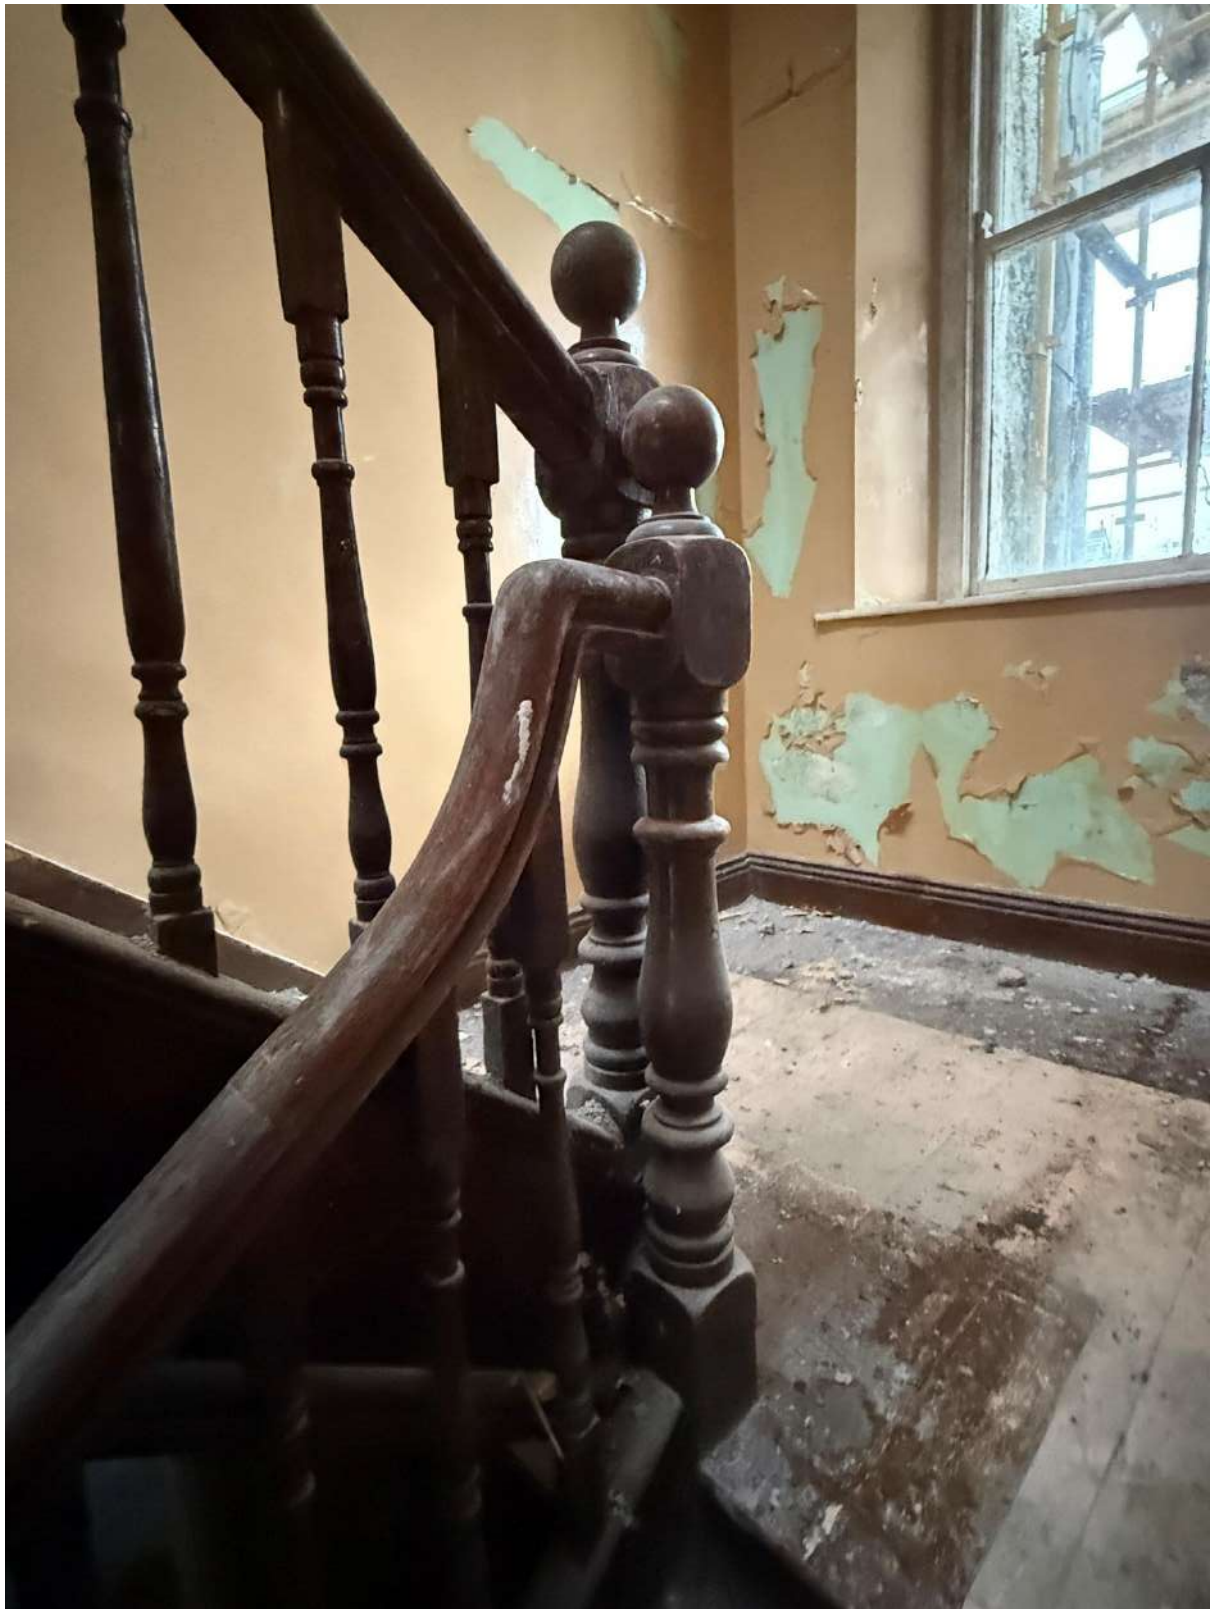
Unfortunately the majority of the internal skirtings were replaced with the exception of the half landing and some rooms on the first floor. Similarly there are no surviving door leafs or architraves.

*Fig. 11 Landing & banister detail to original stairs at half landing*

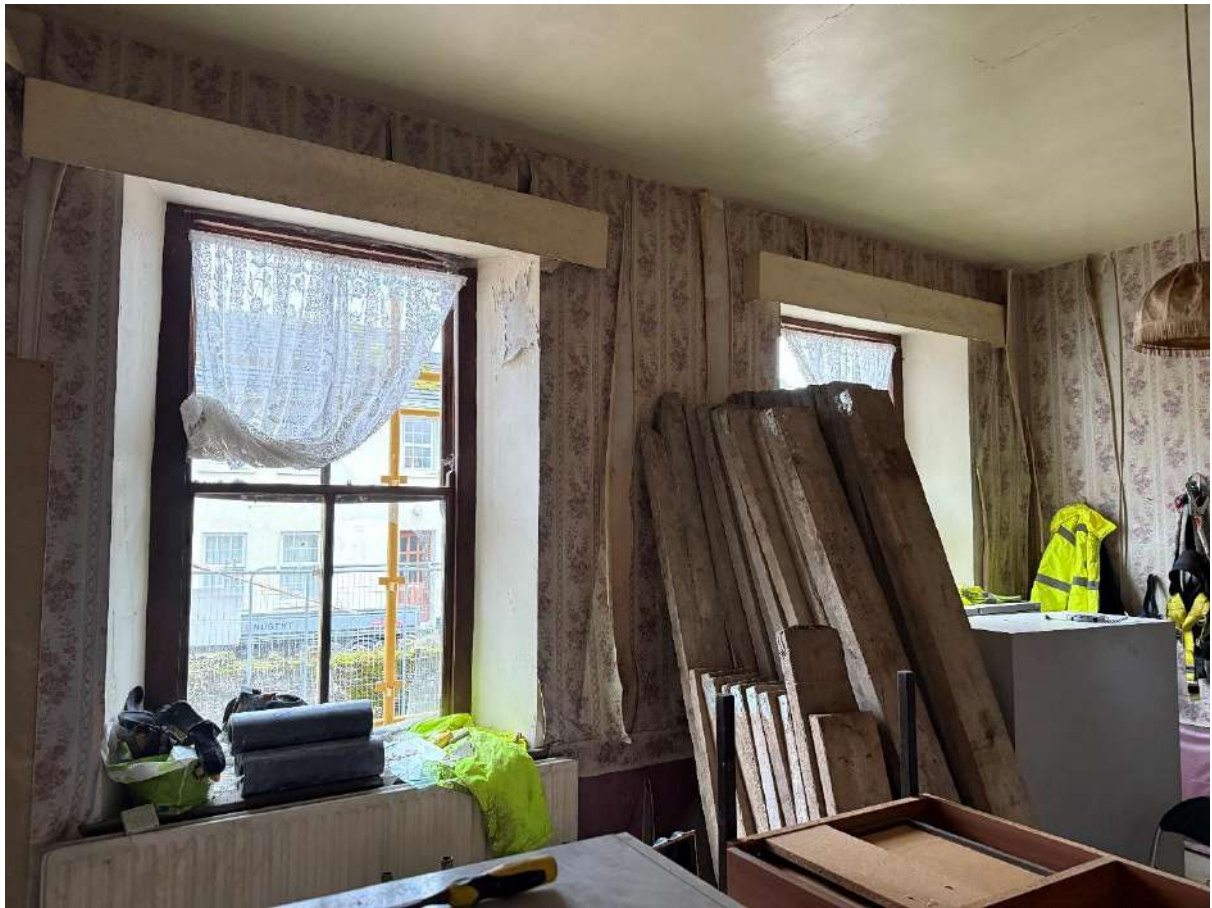
There are no surviving original lath & plaster ceilings. All ceilings were replaced with gypsum plasterboard whilst in use as a Barracks.

*Fig. 12 Typical interior of room showing non-original ceilings & joinery*

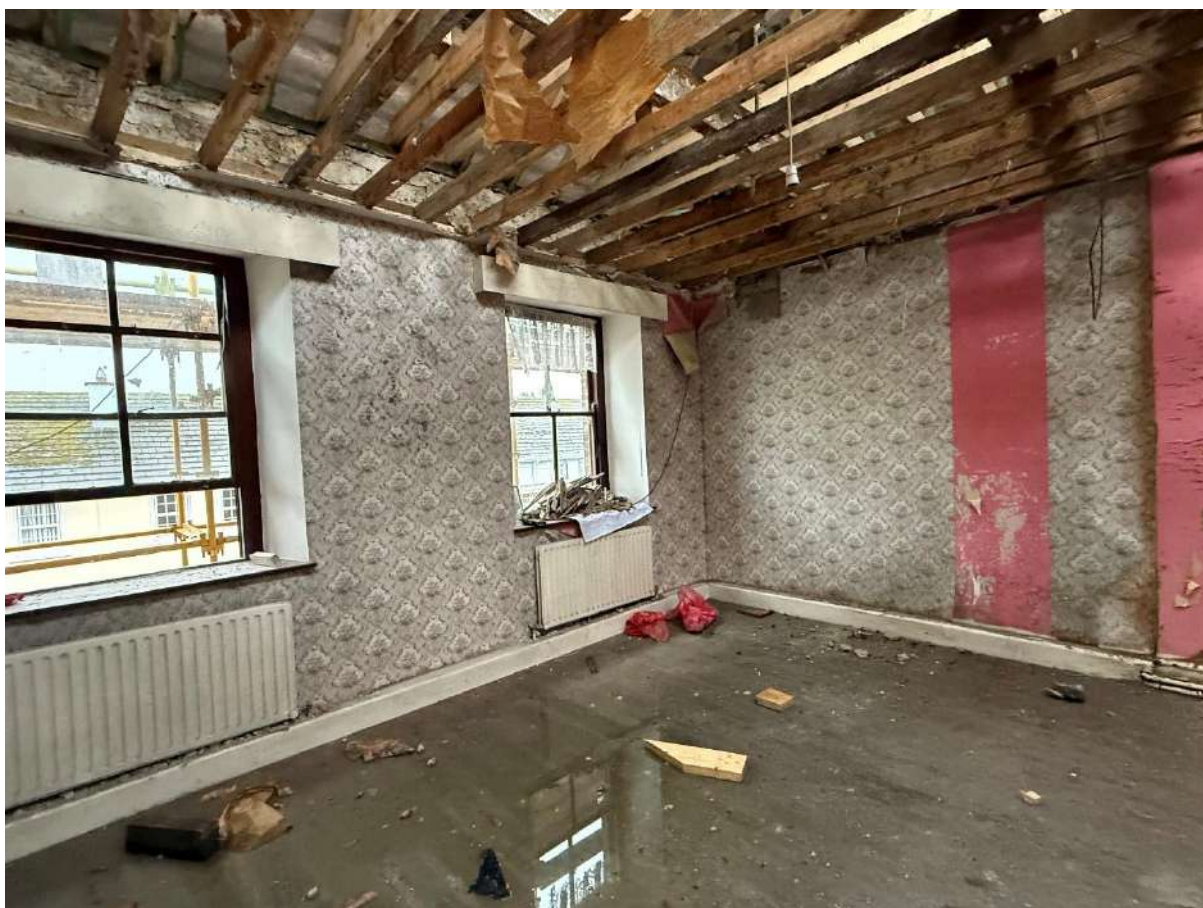
*Fig. 13 First Floor interior of room showing ceilings removed*

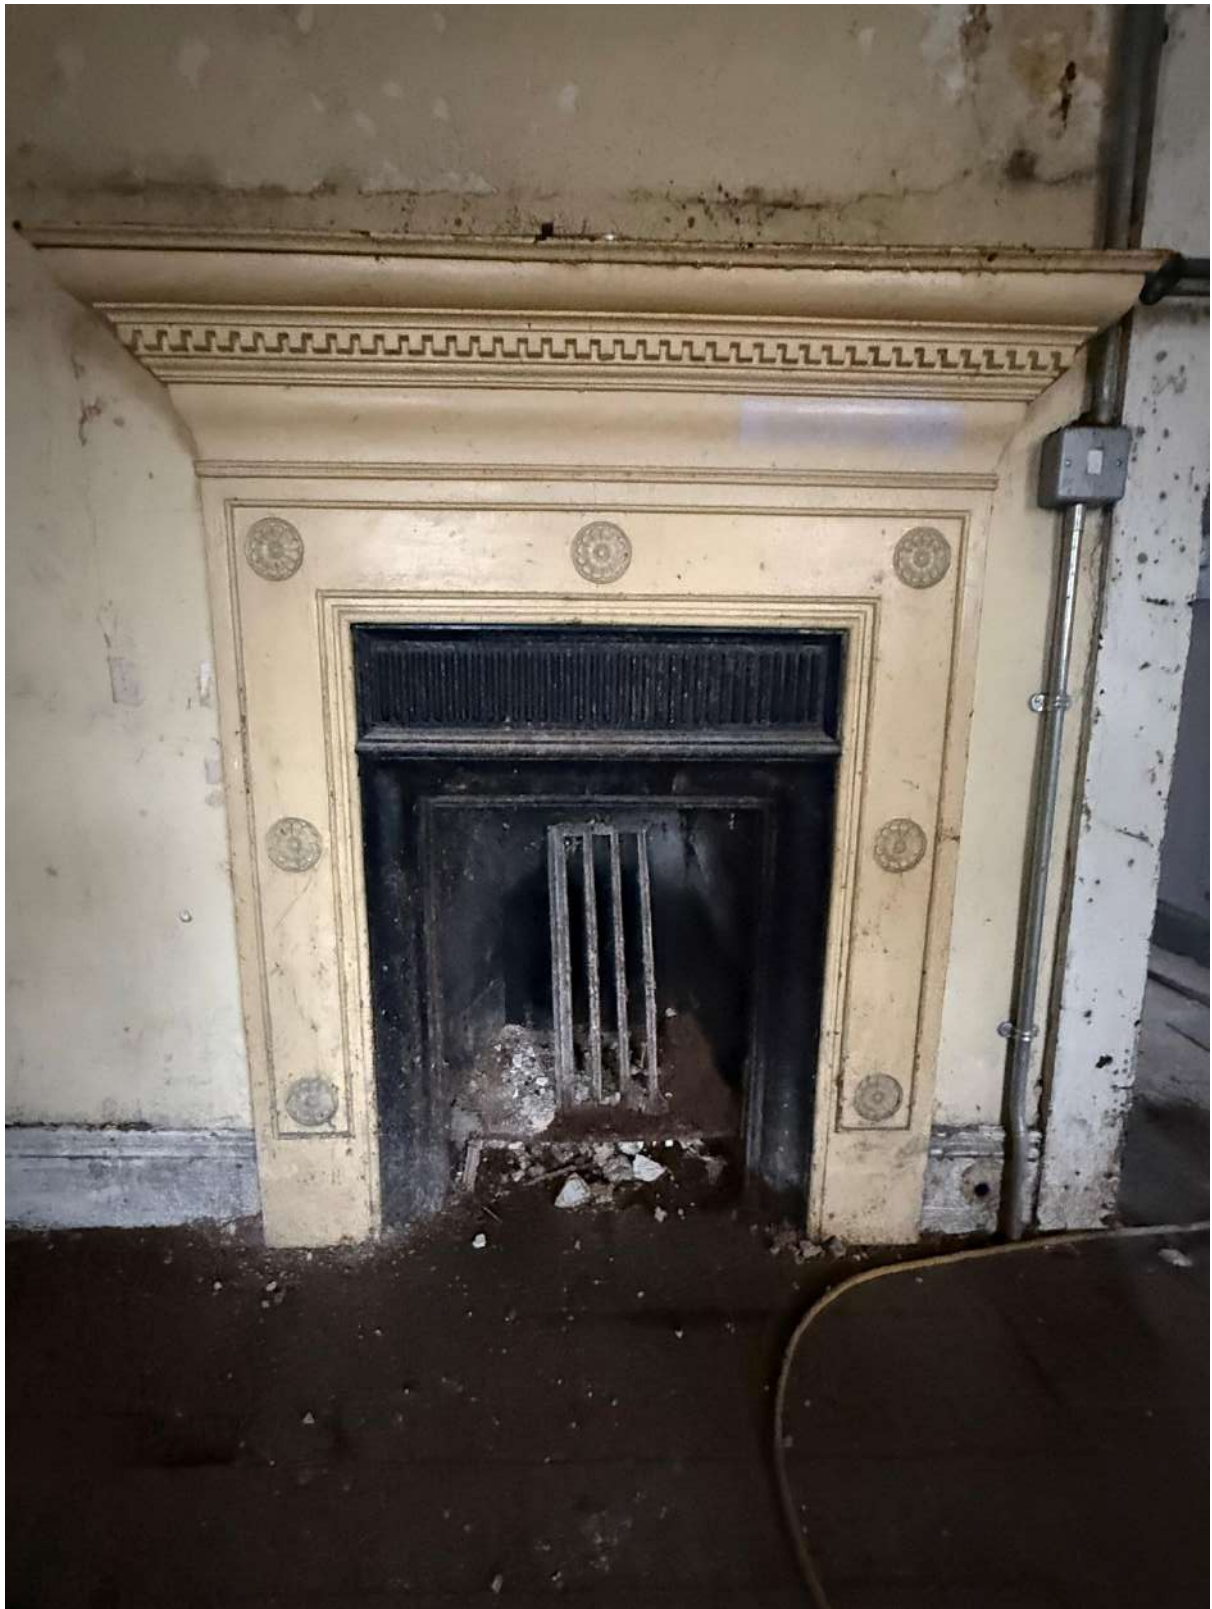
*Fig. 14 Original fireplace to Eastern front room at first floor*

There is one surviving fire surround located in the Eastern room on the First Floor. This should be retained & restored to help preserve the character of the interior.
