## **Heating and Ventilation Services for Aonad 2 Baile an tSagairt, An Spideal, Co. na Gallimhe (An Comisinéir Teanga)**

It is proposed to replace the heating and ventilation plant on the roof of Aonad 2 Baile an tSagairt.

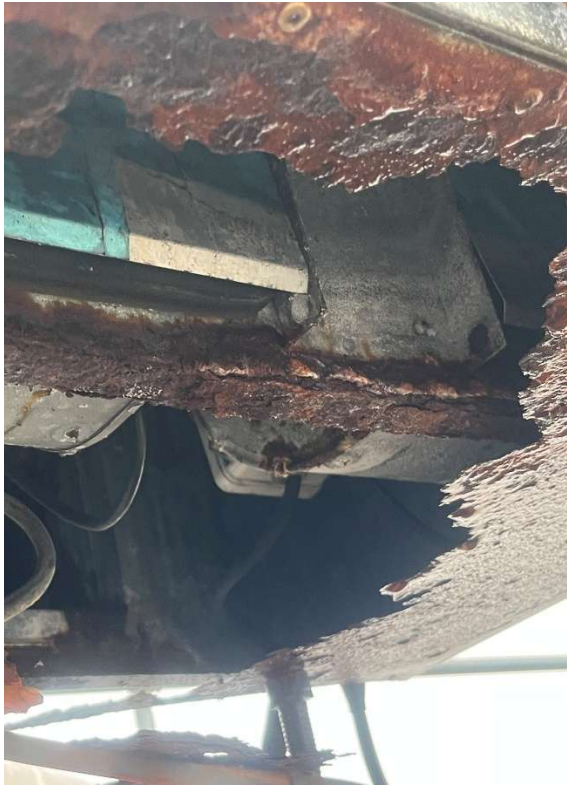
Almost all of the roof plant is approx. 25 years old. It is deteriorating with rust on ducting, rusty air handing units and insulation coming off the ducts.

**Rusty underside of AHU**

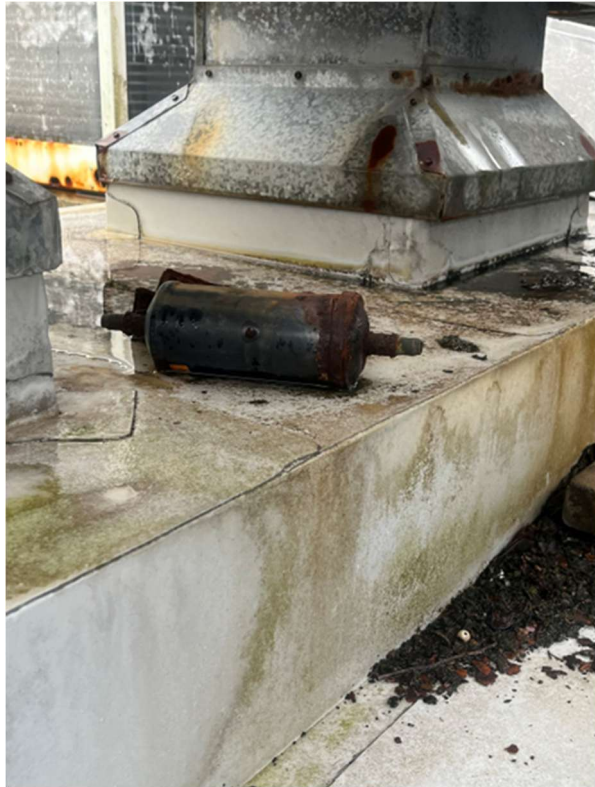
**Rust on galvanised ducting & plant deteriorating**

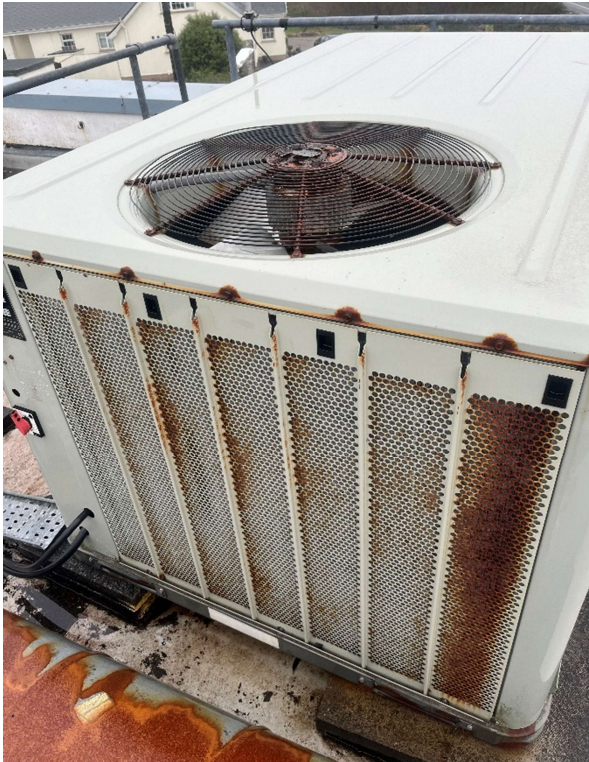
**Rust on AHU & galvanised duct**

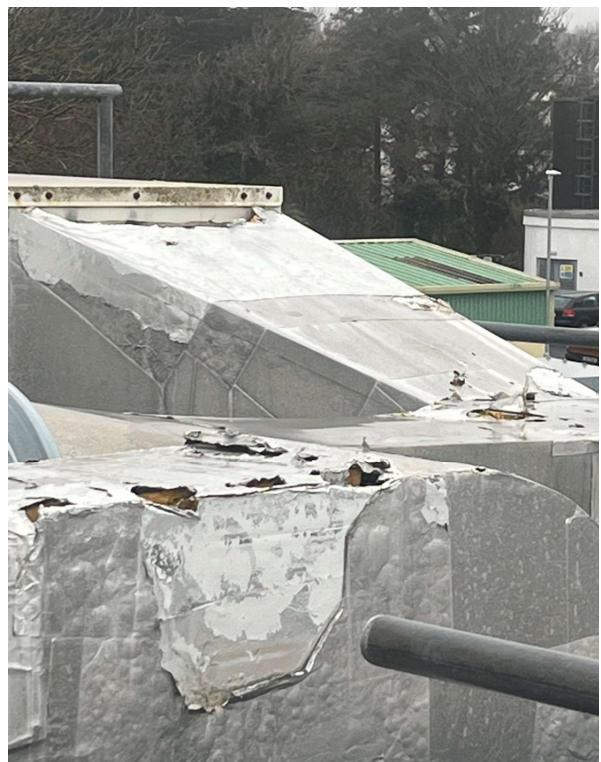
**Insulation around ducts deteriorating**
