**University College Cork**

## **Traffic Management Plan incorporating Risk Assessments**

| Revision | Date | Prepared By | Reviewed By | Approved By |
|---|---|---|---|---|
| Issue 3 | April 2020 | Shane Fleming<br>(This revision only<br>relates to alterations<br>associated with<br>New Hub) | | |

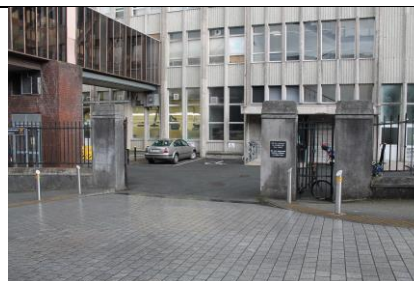
**Gaol Walk Entrance**

At the boiler house area, there is an emergency access entry directly out onto Gaol Cross, which is not used for normal operations.

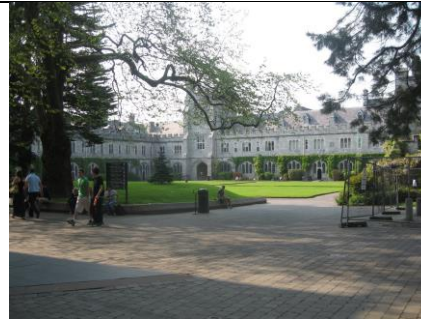
**Main Quad**

This zone features only the following types of traffic – bicycles, pedestrians and wheelchair users.  
This area incorporates the area of lawns and pathways contained within the main quadrangle. The area is generally closed off the motorised traffic.

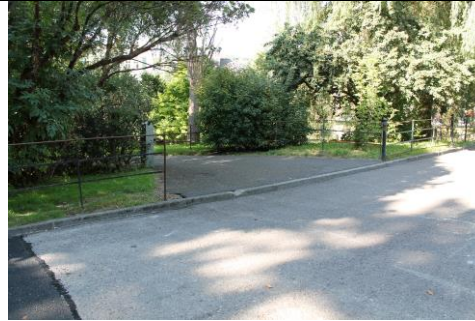
**Kerb at Path to Glucksman**

This zone comprises the paths located at the lower grounds next to the River lee and around the Glucksman Gallery. It is not normally used for motorised traffic, except for UCC vehicles driving to the gallery, using the designated pathway described in Zone M. In general the pathways here are not heavily used by pedestrians compared to other areas of the campus, but they may be used by quite a few members of the public visiting the gallery, including during the summer.

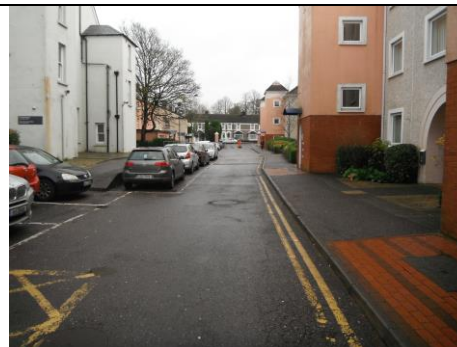
**Road and paths  
between Brighton Villas  
and Castlewhite**

This zone comprises the paths and roadways located adjacent to Brighton Villas, Bloomfield Terrace and Lucan Place, situated between the Western road and the Castlewhite apartments. The roadway between Brighton Villas and Castlewhite is shared by traffic from both areas. The parking spaces are allocated to UCC staff only, controlled by an entrance barrier activated by swipe cards. Summer residents at Castlewhite also have access to parking. There is a pedestrian/cycling thoroughfare which enters the site from the Western Road, which is used by pedestrians and cyclists to access the Aras na Laoi section of campus by means of the pedestrian bridge over the river.

| Hazard/Risk | Photos | Risk Rating Before | | | Existing Controls | Risk Rating After | | | Comments and Further Actions |
|---|---|---|---|---|---|---|---|---|---|
| Interaction between pedestrians and vehicles entering/exiting the vehicular entrance. The pedestrian pathway at the entrance is marked by road-paint. This is partially worn and could be refreshed. | | 2 | 4 | Med | <p>There are barriers in place which slow down and control traffic entering and leaving the site. There are designated walking areas, marked with paint on the ground. Vehicular traffic volumes are low.</p> <p>The pedestrian pathway on the north side of the entrance is separated by bollards.</p> | 1 | 4 | Low | Paint markings are worn at the entrance area and should be refreshed at the entrance and throughout the zone where required. |

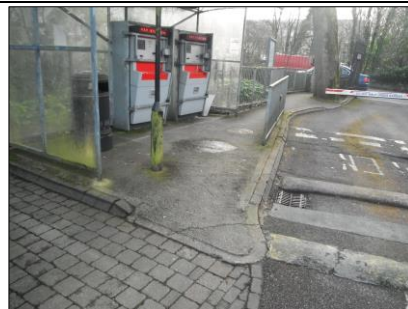
**Pay station.**

The traffic flow is two-way at the entrance but there is a one-way loop around a central island inside the car park.

| Hazard/Risk | | Risk Rating Before | | | Existing Controls | Risk Rating After | | | Comments and Further Actions |
|---|---|---|---|---|---|---|---|---|---|
| Line markings very worn in one-way loop section – leading to the potential hazard of traffic going the wrong direction in the 1-way system | | 1 | 3 | Low | None | 1 | 3 | Low | Consider refreshing line markings |

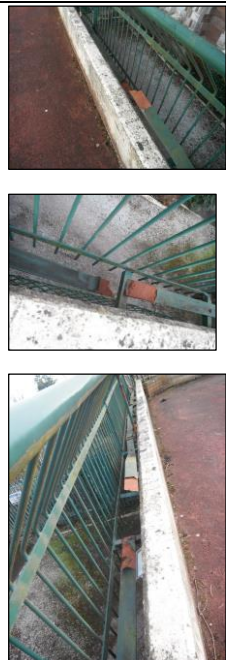
| Hazard/Risk | | Risk Rating Before | | | Existing Controls | Risk Rating After | | | Comments and Further Actions |
|---|--|---|---|---|---|---|---|---|---|
| <p>Hazards associated with damaged railing (railing provides edge protection to car park). The railings are still providing edge protection, but are not in good condition.</p> | | 1 | 4 | Low | None | 1 | 4 | Low | Consider repair of damaged/rusted guardrails. |
