ASBESTOS REFURBISHMENT SURVEY REPORT

Gormanston Camp

Hanger Lean too Building

Project Number
45568

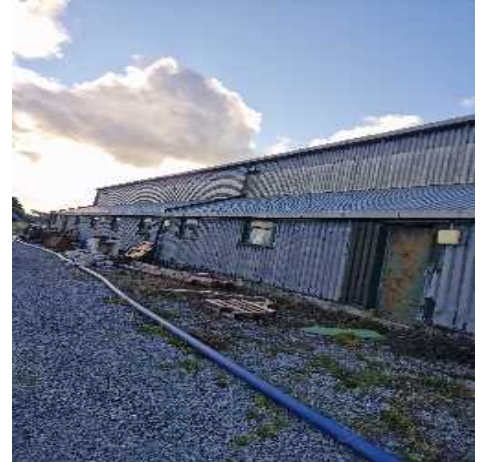
Location Details : 153231 No Asbestos Found

Building/Area :
 Room/Section : External
 Location : Roof and side wall
 Description : Metal cladding mmmf insulation
 Sample No. :
 Confirmation :
 Access : Full Access
 Normal Use :
 Recommendations :
 Notes :

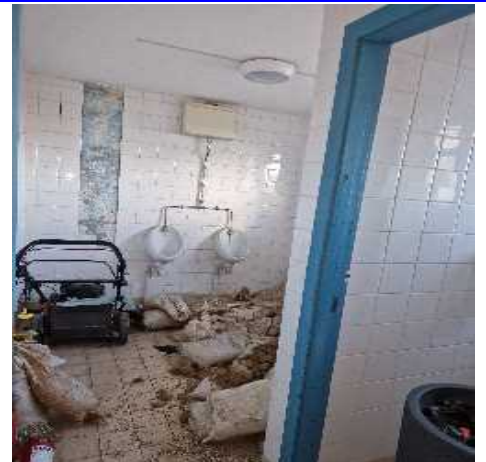
Location Details : 153232 No Asbestos Found

Building/Area :
 Room/Section : Toilet
 Location : Walls floor ceiling
 Description : Ceramics blocks concrete
 Sample No. :
 Confirmation :
 Access : Full Access
 Normal Use :
 Recommendations :
 Notes :

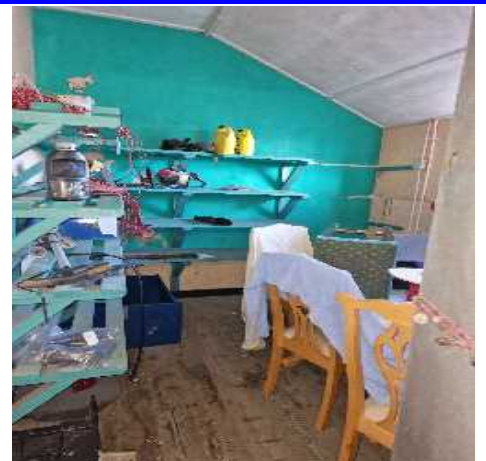
Location Details : 153233 No Asbestos Found

Building/Area :
 Room/Section : Store
 Location : Walls floor ceiling
 Description : Timber blocks concrete
 Sample No. :
 Confirmation :
 Access : Full Access
 Normal Use :
 Recommendations :
 Notes :

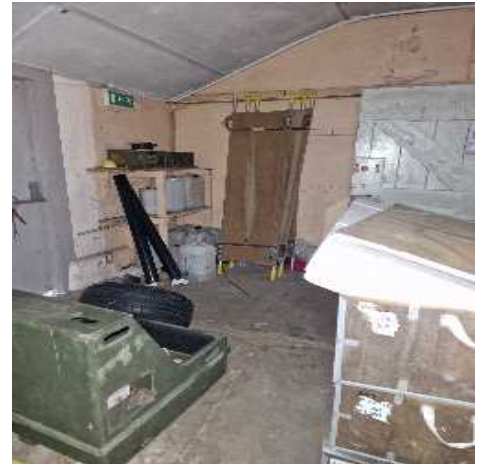
Location Details : 153234 No Asbestos Found

Building/Area :
 Room/Section : Store
 Location : Walls floor ceiling
 Description : Timber blocks concrete
 Sample No. :
 Confirmation :
 Access : Full Access
 Normal Use :
 Recommendations :
 Notes :

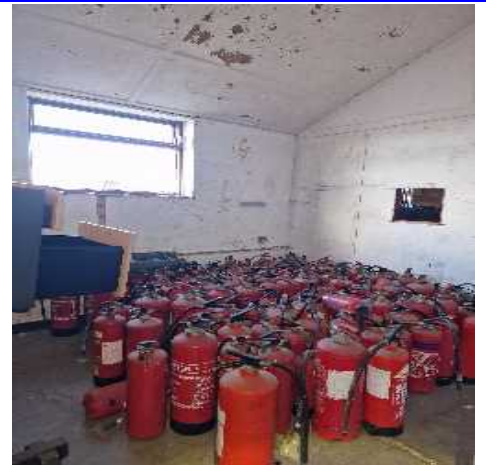
Location Details : 153235 No Asbestos Found

Building/Area :
 Room/Section : Store
 Location : Walls floor ceiling
 Description : Timber blocks concrete
 Sample No. :
 Confirmation :
 Access : Full Access
 Normal Use :
 Recommendations :
 Notes :

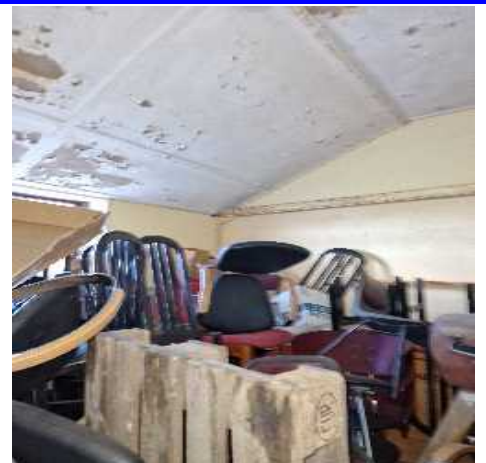
Location Details : 153236 No Asbestos Found

Building/Area :
 Room/Section : Store
 Location : Walls floor ceiling
 Description : Timber blocks concrete
 Sample No. :
 Confirmation :
 Access : Full Access
 Normal Use :
 Recommendations :
 Notes :

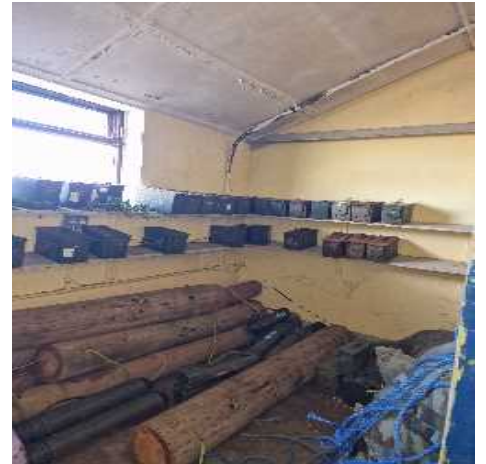
Location Details : 153237 No Asbestos Found

Building/Area :
 Room/Section : Store
 Location : Walls floor ceiling
 Description : Timber blocks concrete
 Sample No. :
 Confirmation :
 Access : Full Access
 Normal Use :
 Recommendations :
 Notes :

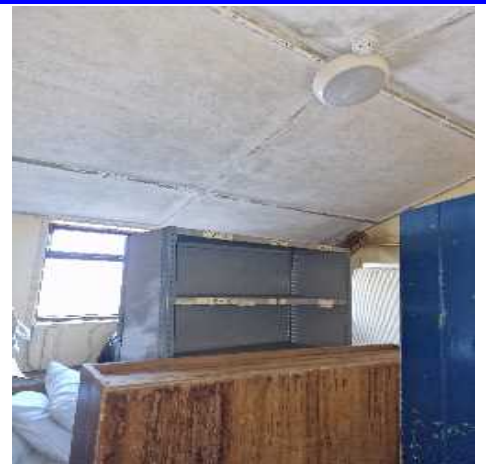
Location Details : 153238 No Asbestos Found

Building/Area :
 Room/Section : Store
 Location : Walls floor ceiling
 Description : Timber blocks concrete
 Sample No. :
 Confirmation :
 Access : Full Access
 Normal Use :
 Recommendations :
 Notes :

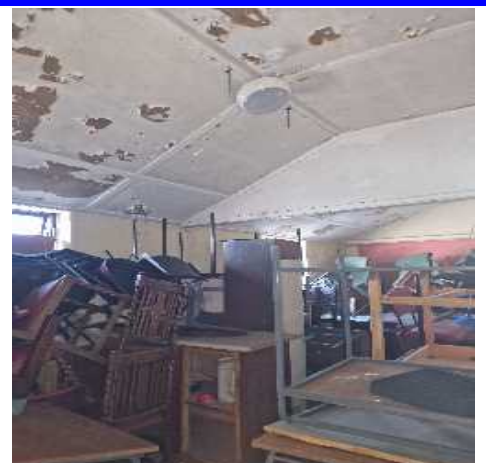
Location Details : 153239 No Asbestos Found

Building/Area :
 Room/Section : Store
 Location : Walls ceiling
 Description : Timber blocks concrete
 Sample No. :
 Confirmation :
 Access : Full Access
 Normal Use :
 Recommendations :
 Notes :

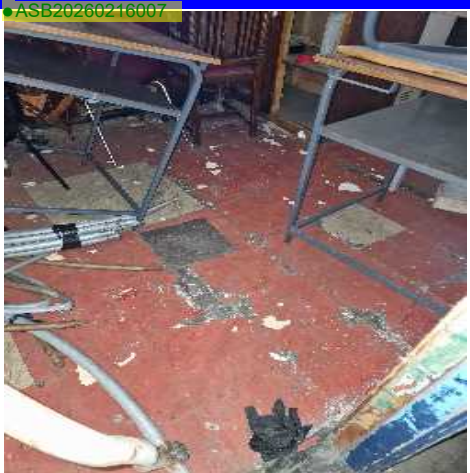
Location Details : 153240 No Asbestos Found

Room/Section : Store

Location : Floor

Description : Red vft

Sample No. : ASB20260216007

Confirmation : Sample Taken

Sample	Description	Asbestos Detected	Asbestos Type
ASB20260216007	Red vft from Store Floor	Not detected
