# An Ecological Impact Assessment of River Lee Riverwalk

Ballymullen to Ballyseedy Wood

12292

March 2009

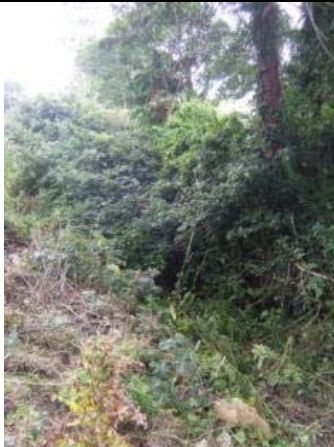
**Plate 9:** WL1 Hedgerow (H2)

**H2:** H2 is a hedgerow that runs north-south and joins the treeline along the River Lee at a right angle on the southern bank. It is a low hedgerow up to 2m in height. Species include Bramble, Hawthorn, Creeping Thistle, Yellow Flag and Hedge Bindweed (*Calystegia sepium*). There is also one tall Ash tree. See Plate 9, Appendix 4.

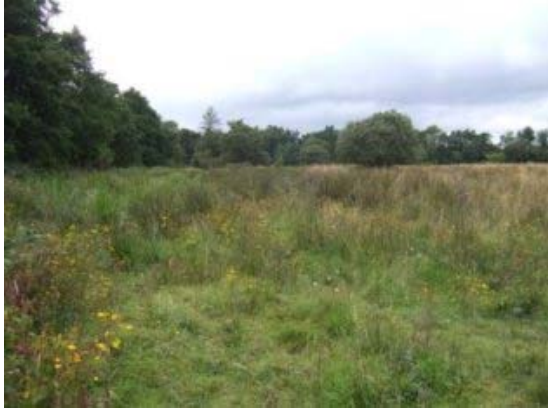
**Plate 13:** GS4 Wet Grassland

At the east end of the study area most of the grassland to the north of the river is Wet Grassland (GS4) (see map, Appendix 1). This predominantly contains Rush species, Yellow Iris and various grasses. There is a good moss layer present including species such as *Rhytidiadelphus* spp. See Plate 13, Appendix 2.

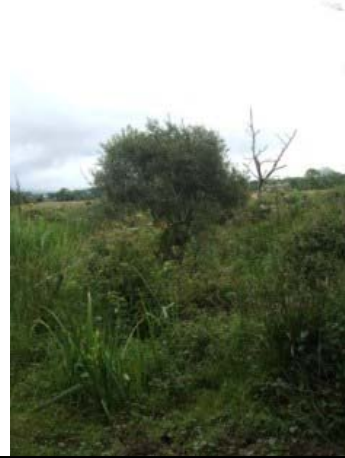
**Plate 14:** FW4 Drainage Ditch (DD1)

**DD1:** At the eastern side of the study area there are two drainage ditches running from the North East leading into the River Lee. These drainage ditches have not been cleared recently. The ditches run through Wet Grassland which borders the ditches. There are also some Grey Willow (*Salix cinerea*), Alder, Bramble, Honeysuckle (*Lonicera periclymenum*) and Common Nettle on the banks. See Plate 14, Appendix 4.

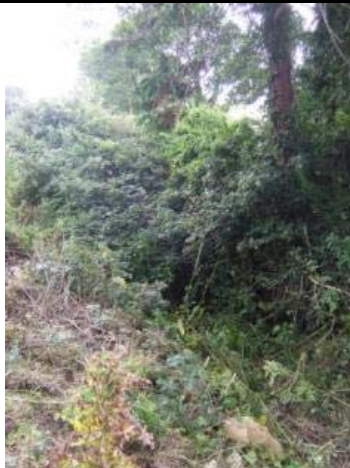
**Plate 15:** FW4 Drainage Ditch (DD2)

**DD2:** At the western side of the study area there is a drainage ditch flowing into the River Lee from the South. It appears that this may originally have been a natural stream however it shows evidence of modification. A pipe has been placed at the end of the drainage ditch where it flows into the River Lee. It is very densely overgrown, resulting in the ditch not being visible other than at the end where the pipe leads to the River. The dense growth consists predominantly of Bramble and Bindweed. On the west side of the ditch is a hedgerow containing Alder, Hawthorn and Leylandii species. See Plate 15, Appendix 4.

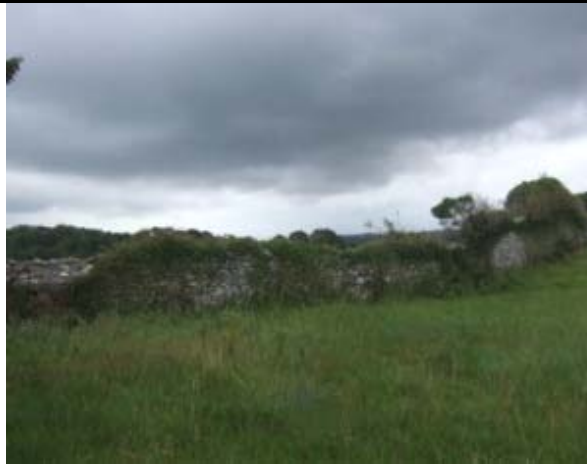
**Plate 16:** BL1 Stone Wall

Towards the eastern end of the study area to the south of the river there is a large old stone wall running along the boundary of Tommy Moynihan's and Tom O'Loughlan's land. The wall is up to 2m high and has been built with some mortar. There is some vegetation on the side and top of the wall. Vegetation includes Ivy, Hartstongue Fern, a young Ash tree, Silky Wall Feather-moss (*Homalothecium sericeum*), Brambles and Dandelion species (*Taraxacum* spp.). See Plate 16, Appendix 4.

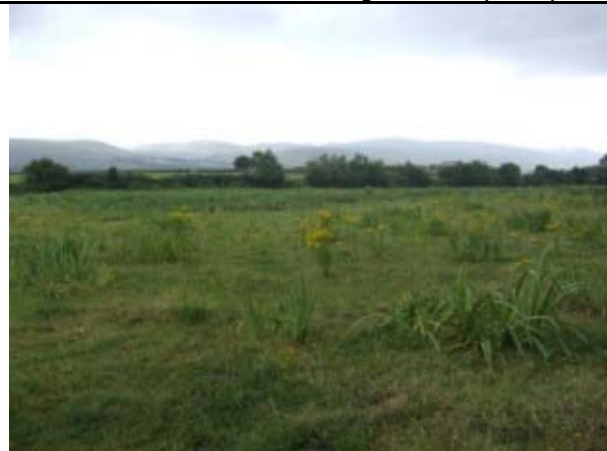
**Plate 17:** GA1 Improved Agricultural Grassland (with patches of wet grassland element)

Most of the grassland to the south of the river is Improved Agricultural Grassland (see map, Appendix 1). These grasslands consist of grasses such as Rye Grass (*Lolium perenne*) and abundant of Ragwort (*Senecio* spp.). Patches of the grasslands have a large quantity of Yellow Iris and Thistles (*Cirsium* spp.); the former species in particular would indicate the presence of a wet grassland element. See Plate 17, Appendix 4.

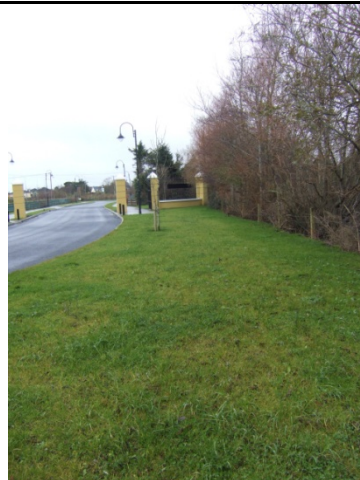
**Plate 18.** GA2 Amenity Grassland adjacent to the WN4 and WN5 woodland near the Griffin Brother's Construction site.

At the western end of the study area there is an entrance to a new housing estate part of which is still under construction. This entrance includes a very recently landscaped lawn. The grassland strip is approximately 4m in width and the sward is dominated by Meadow-grass (*Poa* spp.), Daisy (*Bellis perennis*) and Creeping Buttercup. Other species include Clover (*Trifolium* spp.), Dandelion (*Taraxacum* spp.), Ribwort Plantain (*Plantago lanceolata*) and Sheep's Sorrel (*Rumex acetosella*). See Plate 18, Appendix 4.
