# Appendix A

Job Title: Replacement Modular Buildings at College of FET  
Kilmallock Town Campus.

This project relates to two standalone prefabricated structures as illustrated on the Existing Site Layout Plan below.

Both Prefabs are in poor condition and it is proposed to remove both buildings and replace with a single new Modular Unit constructed to current Building Regulations.

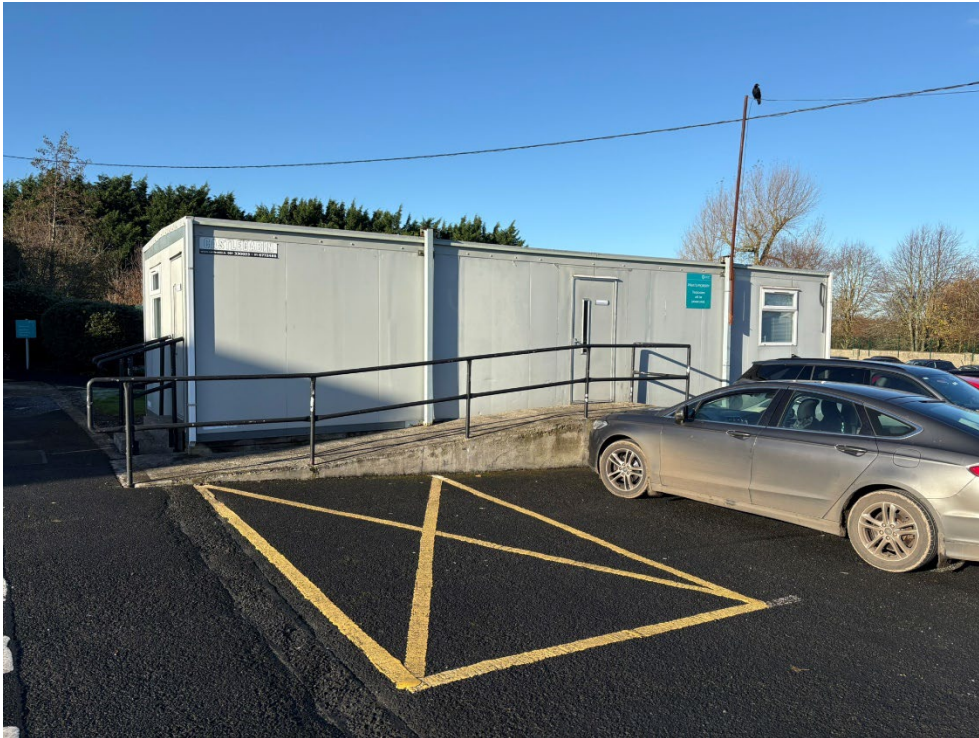
*Exterior of Prefab 01 showing ramp access to one door and stepped access to second door (visible behind ramp to left of image)*

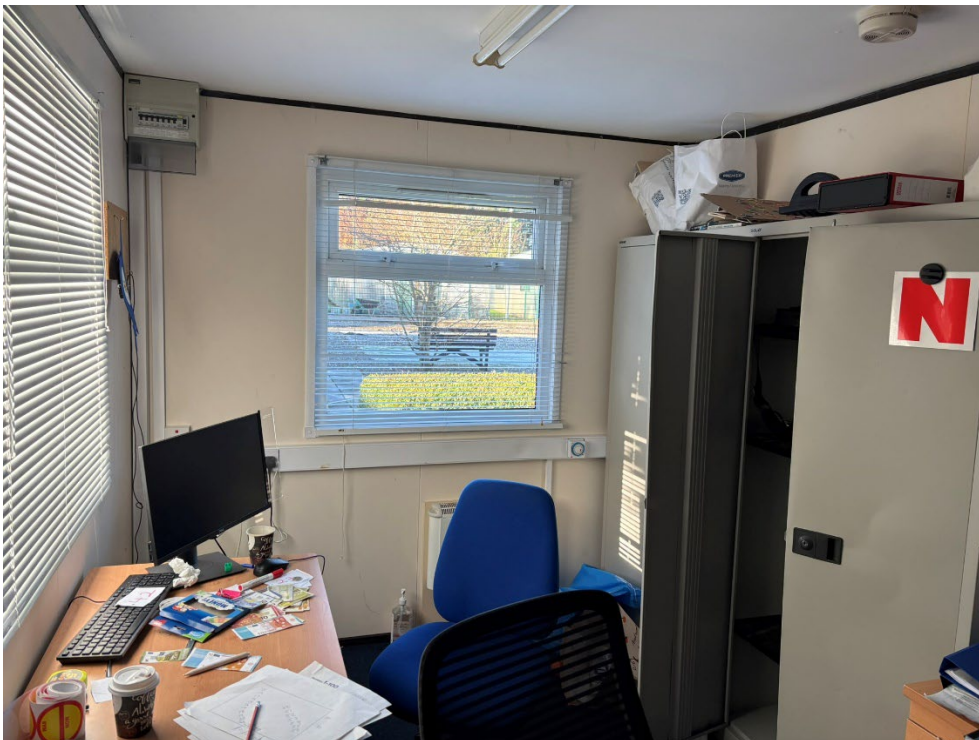
*One to One Meeting Room in Prefab 01. Electric heating visible behind operator chair with time clock above. Room is over heating and has poor ventilation.*

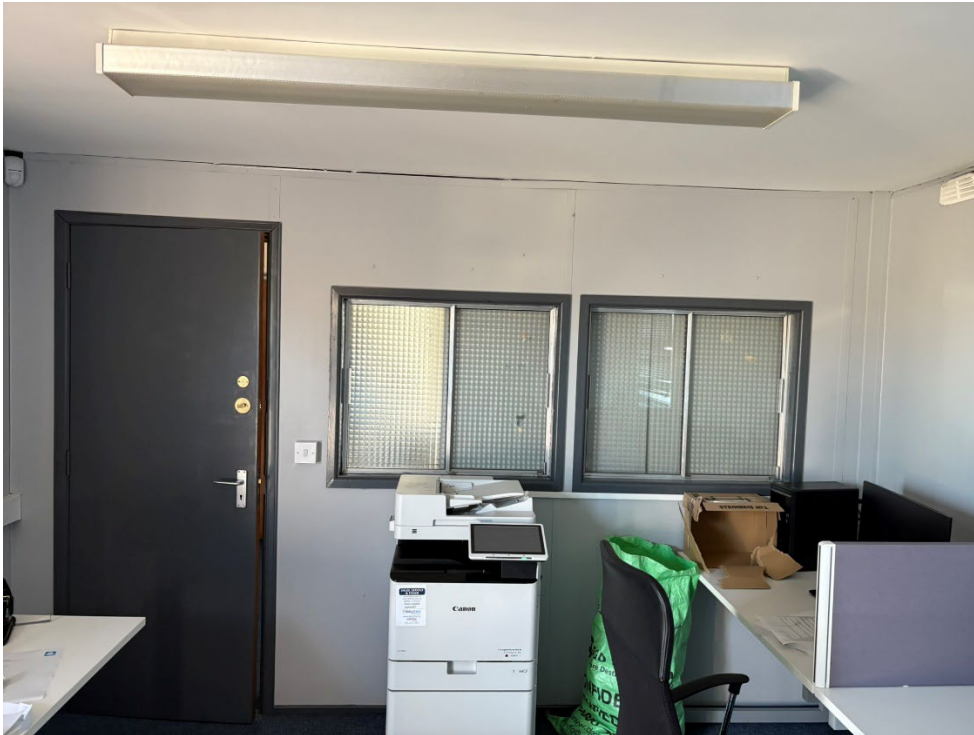
*Administrative Office in Prefab 01, with internal door linking to One to One Meeting Room. Very poor acoustic separation between Office and Meeting Room.*

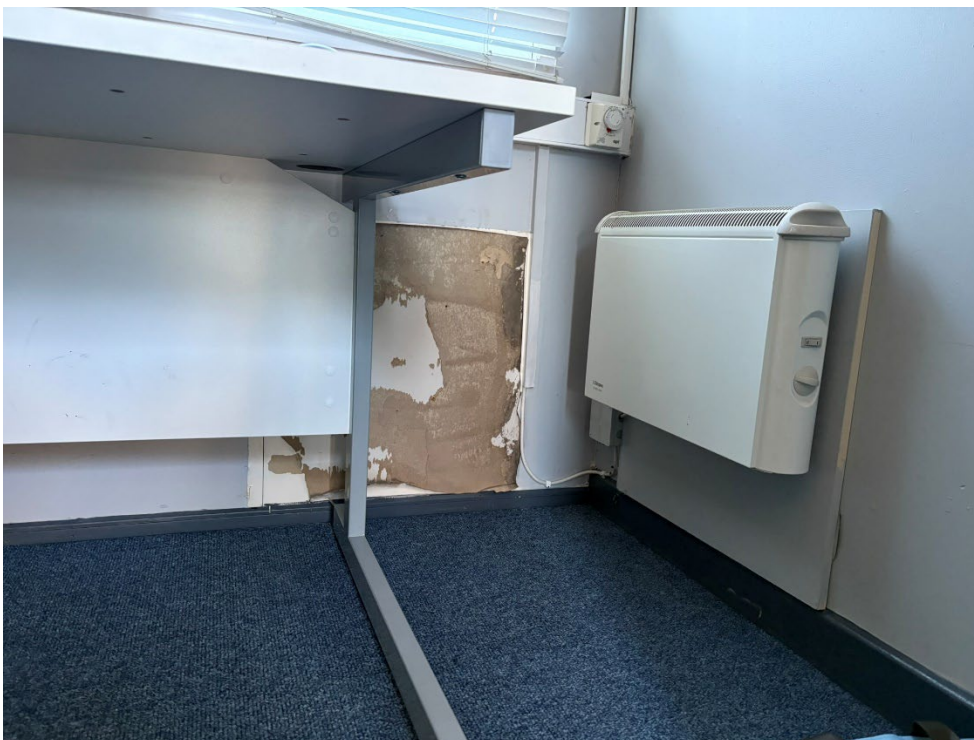
*Deterioration of external wall in Prefab 01. External wall thickness is circa 50mm with minimal insulation. Electric heating*

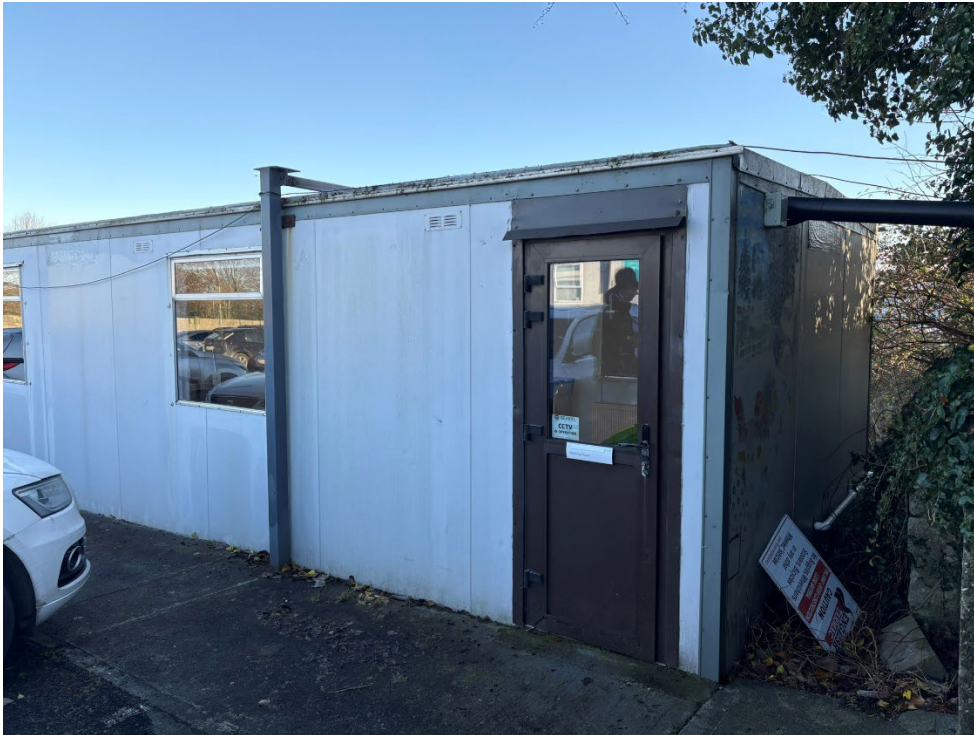
*Exterior of Prefab 02 showing entrance at grade. Inadequate build-up under prefab has led to deterioration of floor joints with the internal floor sagging.*

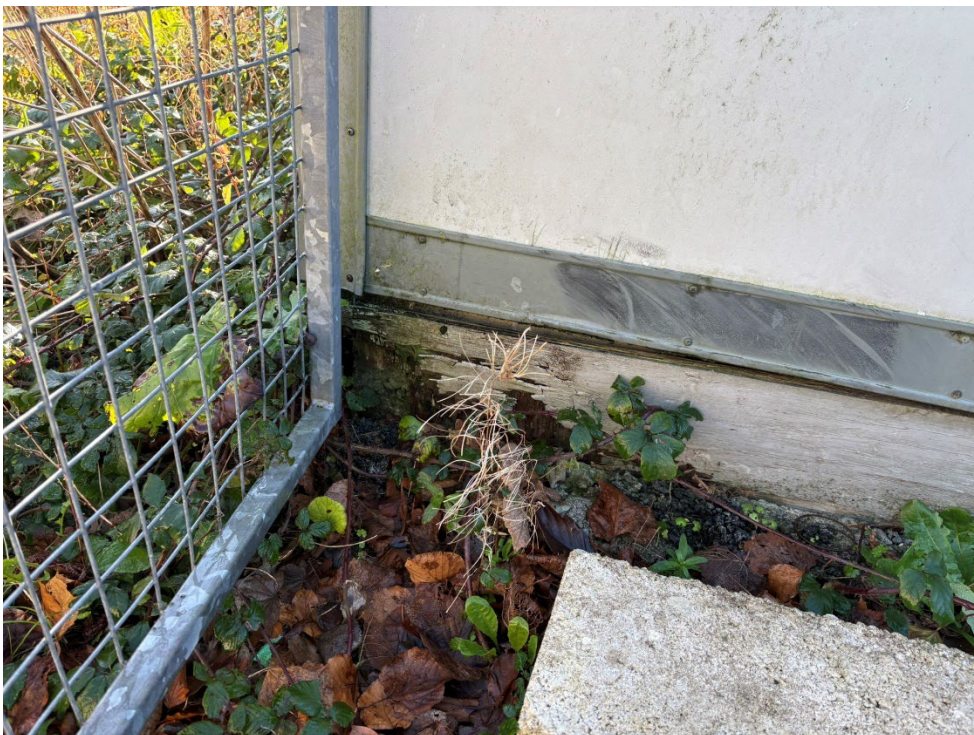
*Deterioration at plinth to Prefab 02*

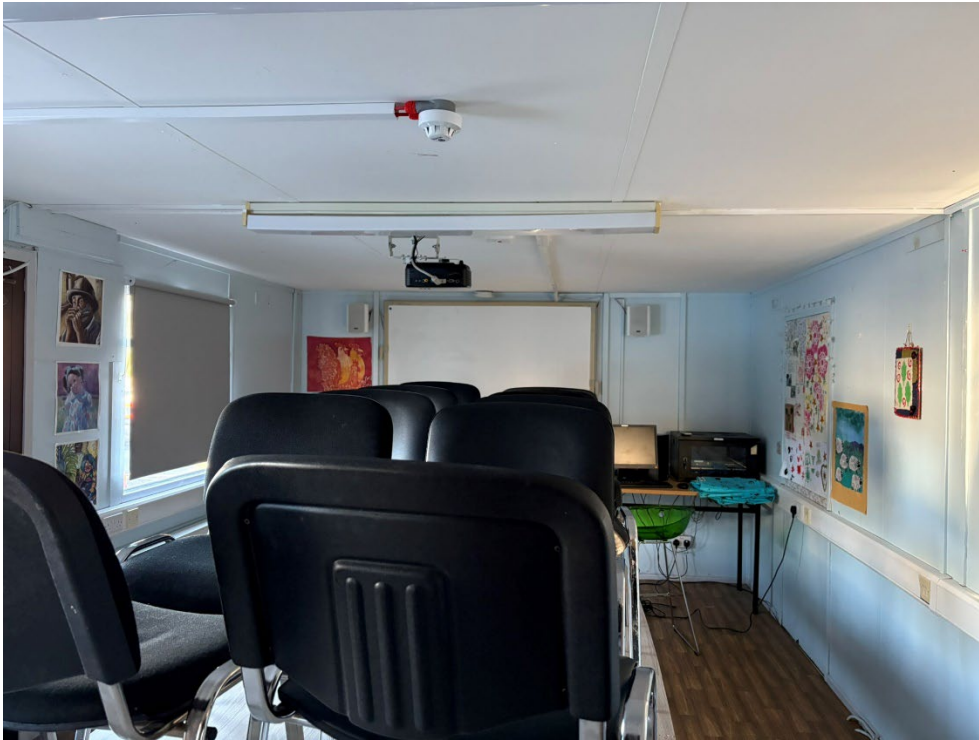
*Former Computer Lab in Prefab 02 no longer in use due to deterioration of the building.*

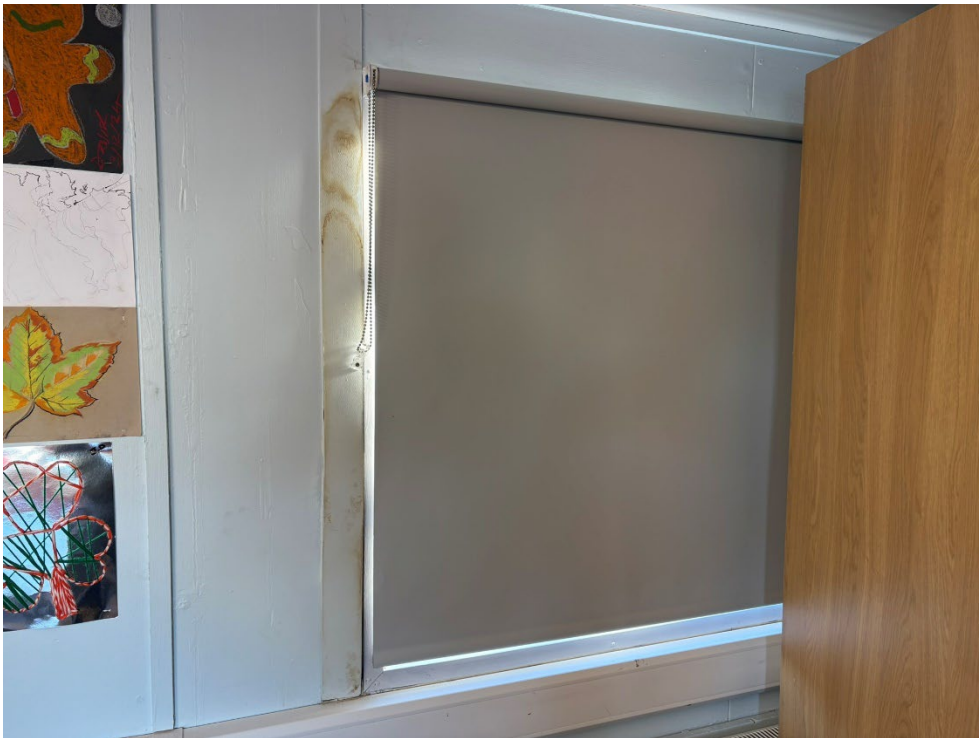
*Discolouration arising from water ingress around windows. External wall thickness is circa 50mm with minimal insulation.*

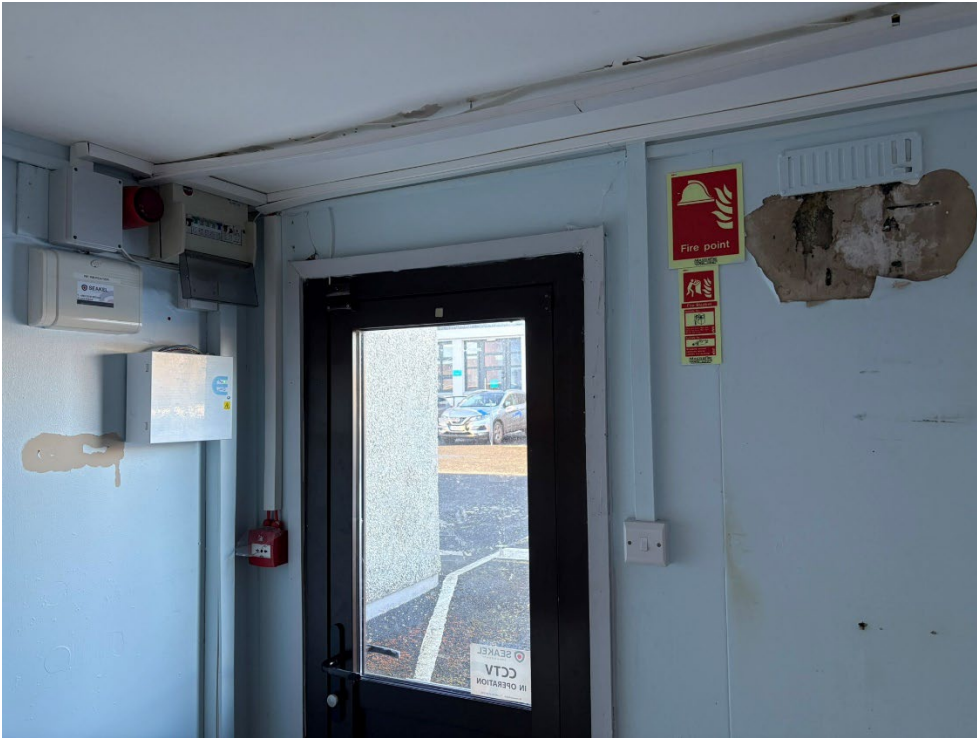
*Deterioration of external wall in Prefab 02. External wall thickness is circa 50mm with minimal insulation.*

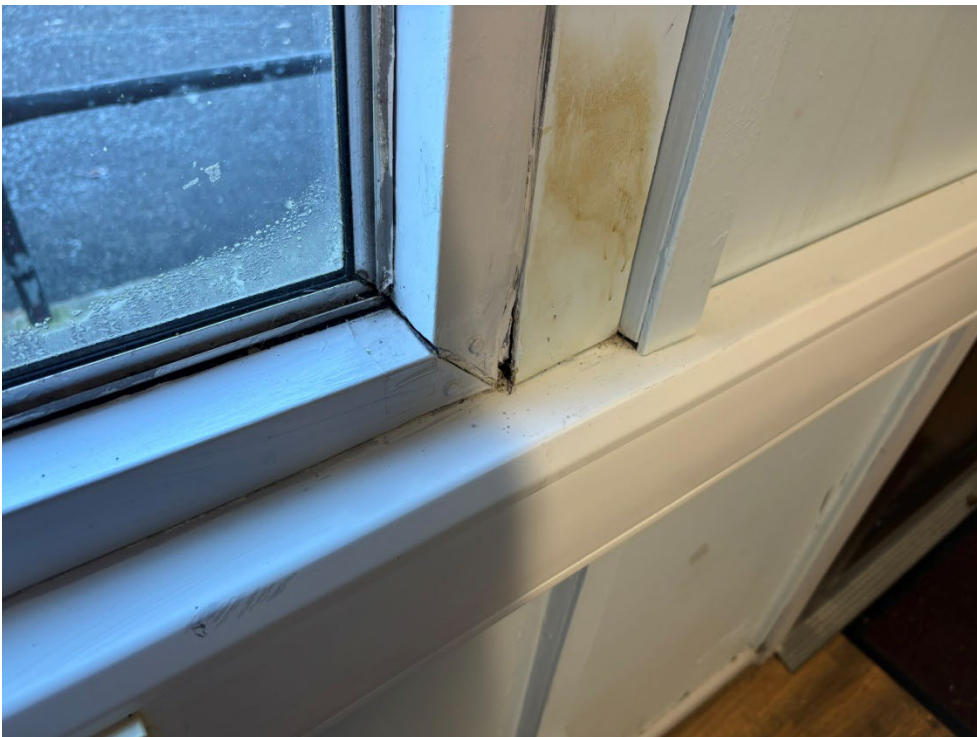
*Windows are single glazed aluminium frames items and together with insubstantial external walls, the thermal performance of Prefab 02 is very poor with high condensation*

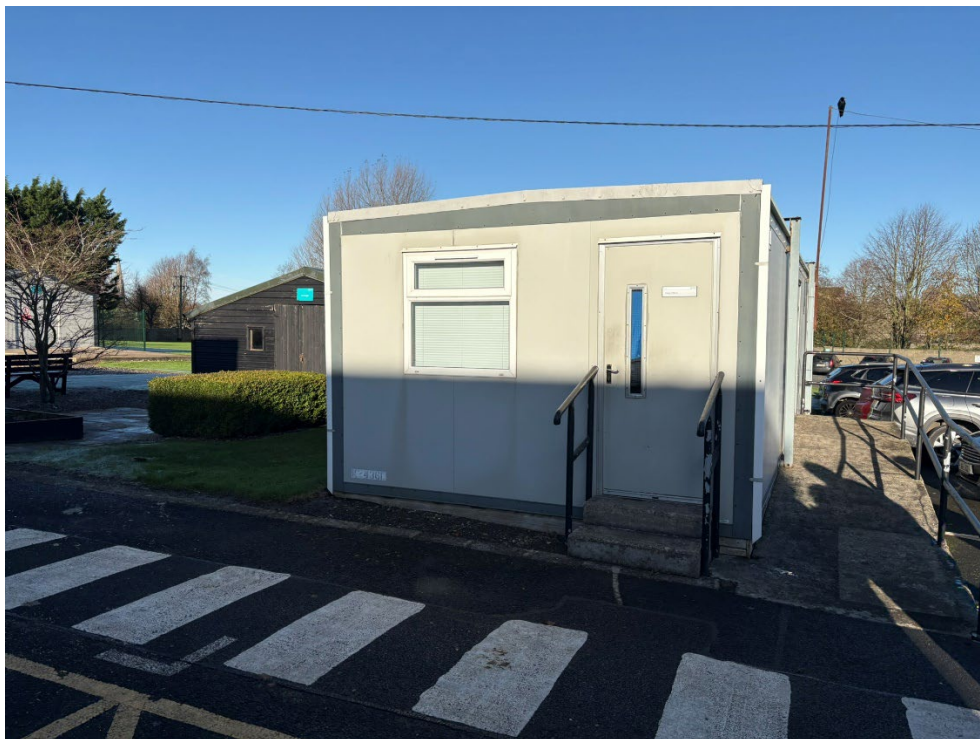
*Gable wall of Prefab 01 and existing timber shed to left. This is the proposed site for the new Modular Building.*

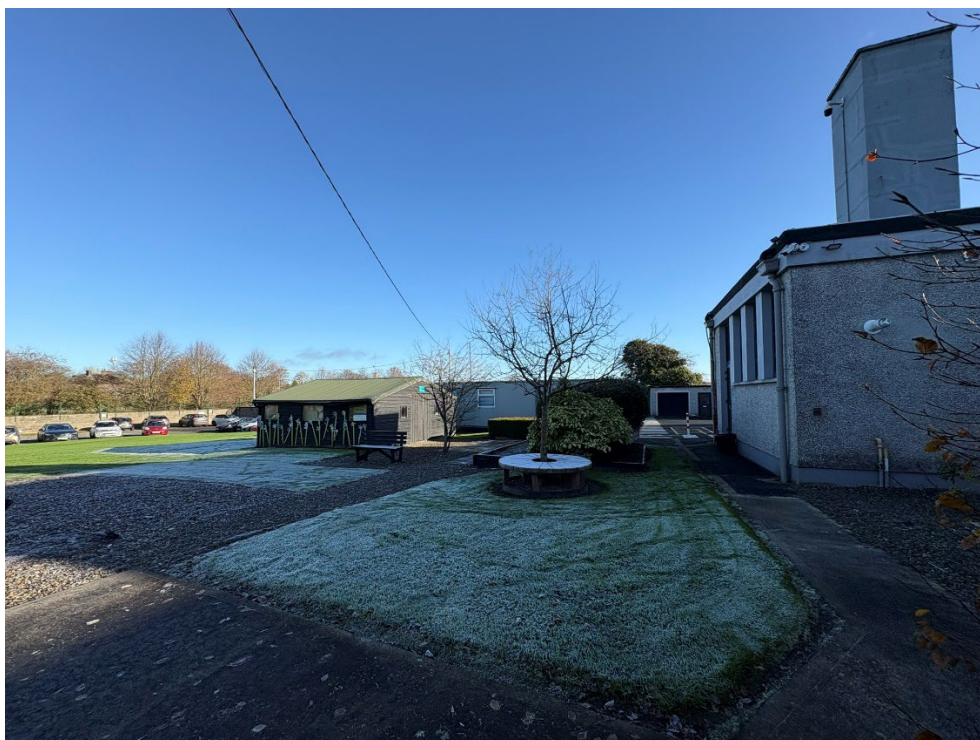
*General view of the proposed site for the new Modular Building. Existing timber shed in foreground with Prefab 01 behind.*

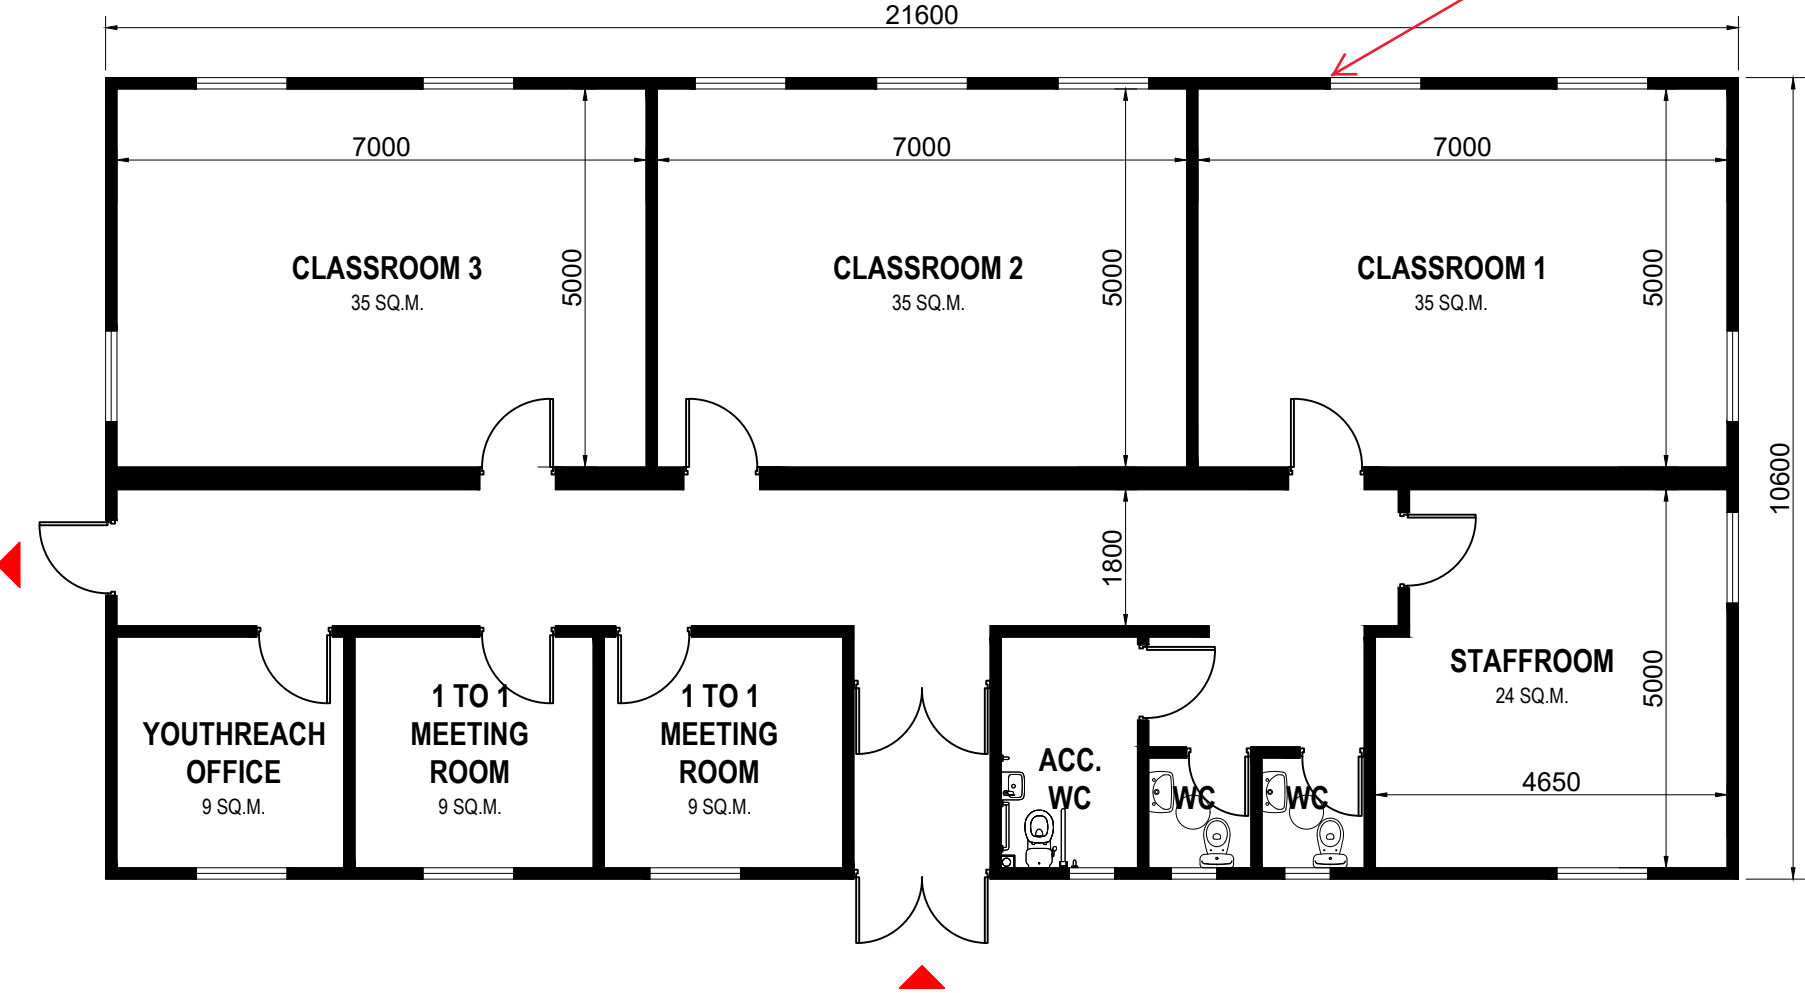
APPENDIX E  
Preliminary Building Layout

Indicative layout of proposed unit other options to be explored and most suitable layout identified in conjunction with the client
