# St. Oliver's CC – EWS 2026 – Building Management System, Heating, Cold Water Services and Roof Replacement Project Preliminary Safety and Health Plan

Date: July 2026

Ref.: 3279/CMcG

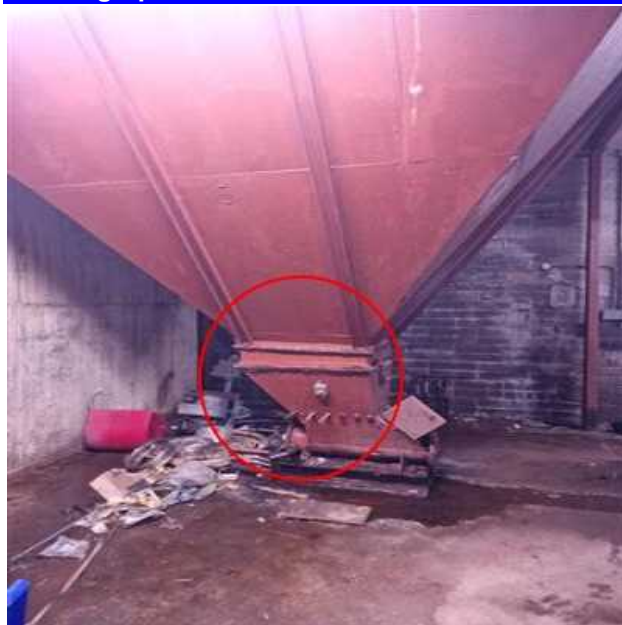
#### Photograph

| Textiles & Paper | | Medium Damage | Gasket | Chrysotile | ASB20260617001 | Sample Taken | 7 | Priority 1 : Remove ACM's Prior to Refurbishment or Demolition. | |

| Condition : Medium Damage | 2 | Medium Risk |

Priority 1 : Remove ACM's Prior to Refurbishment or Demolition.

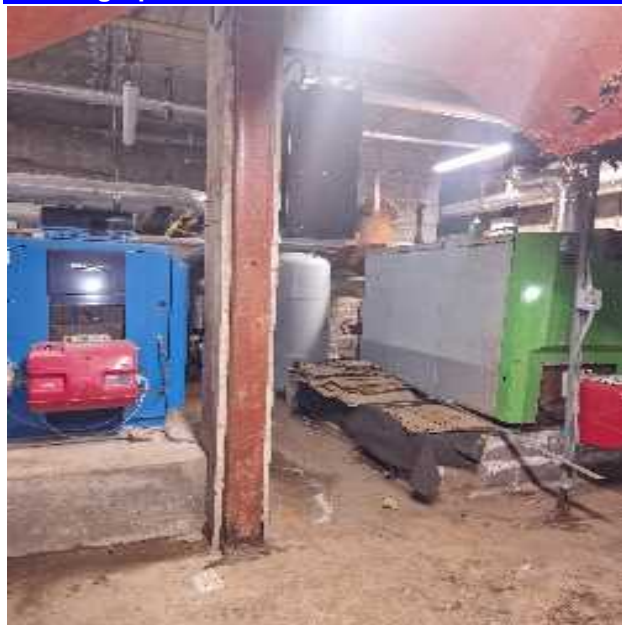
#### Photograph

| Textiles & Paper | | Good Condition | Gasket | Chrysotile | | Presumed | 5 | Priority 1 : Remove ACM's Prior to Refurbishment or Demolition. | |

| Condition : Good Condition | 2 | Medium Risk |

Priority 1 : Remove ACM's Prior to Refurbishment or Demolition.

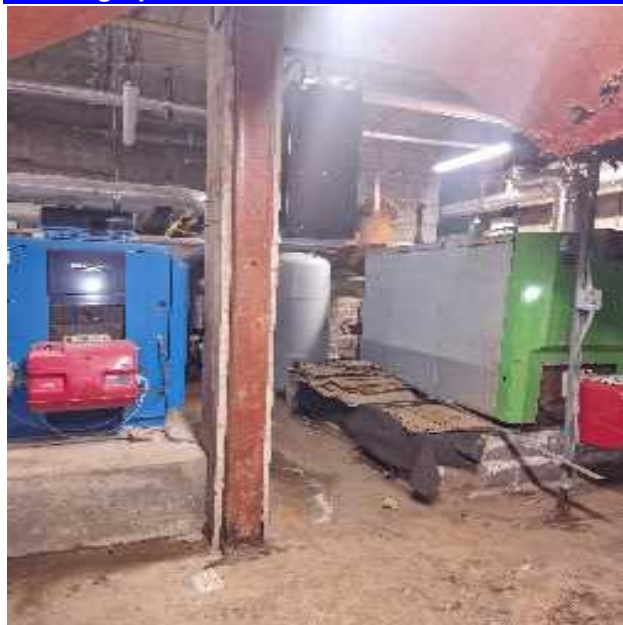
#### Photograph

| Condition : Good Condition | 2 | Medium Risk |

Priority 1 : Remove ACM's Prior to Refurbishment or Demolition.

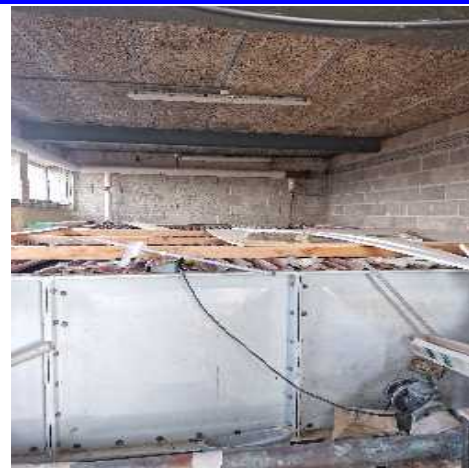
## Location Details : 157061 No Asbestos Found

Building/Area :  
 Room/Section : Tank room  
 Location : Walls floor ceiling  
 Description : Concrete blocks strawboard  
 Sample No. :  
 Confirmation :  
 Access : Full Access  
 Normal Use :  
 Recommendations :  
 Notes :

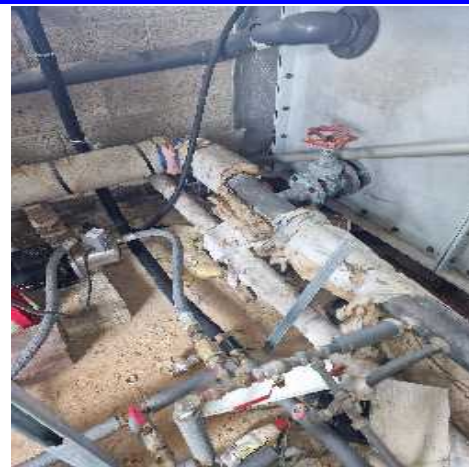
## Location Details : 157062 No Asbestos Found

Building/Area :  
 Room/Section : Tank room  
 Location : Pipe work  
 Description : Mmmf insulation  
 Sample No. :  
 Confirmation :  
 Access : Full Access  
 Normal Use :  
 Recommendations :  
 Notes :

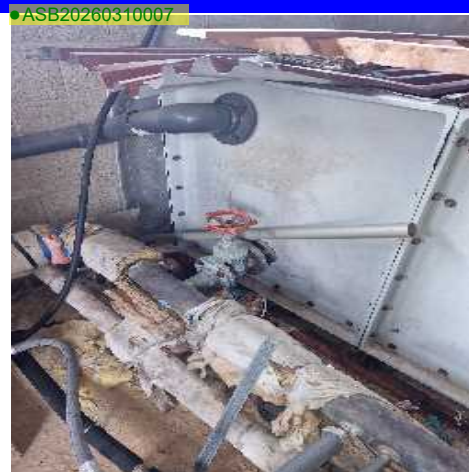
## Location Details : 157063 No Asbestos Found

Building/Area :  
 Room/Section : Tank room  
 Location : Pipe work  
 Description : Gaskets  
 Sample No. : ASB20260310007  
 Confirmation : Sample Taken  
 Access : Full Access  
 Normal Use :  
 Recommendations :  
 Notes :

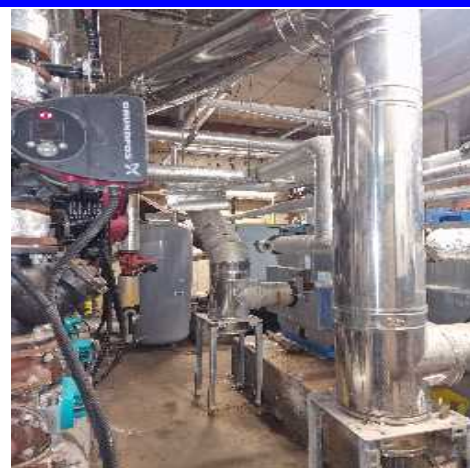
## Location Details : 157064 No Asbestos Found

Building/Area :  
 Room/Section : Plant room  
 Location : Walls floor ceiling  
 Description : Concrete  
 Sample No. :  
 Confirmation :  
 Access : Full Access  
 Normal Use :  
 Recommendations :  
 Notes :

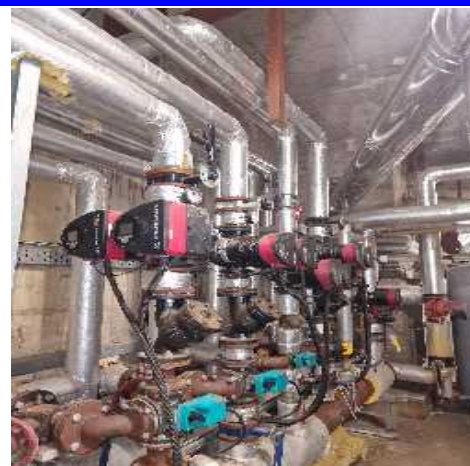
## Location Details : 157065 No Asbestos Found

Building/Area :  
 Room/Section : Plant room  
 Location : Pipe work  
 Description : Mmmf insulation  
 Sample No. :  
 Confirmation :  
 Access : Full Access  
 Normal Use :  
 Recommendations :  
 Notes :

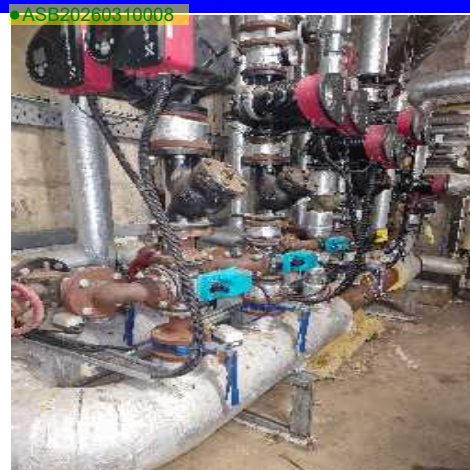
## Location Details : 157066 No Asbestos Found

Building/Area :  
 Room/Section : Plant room  
 Location : Pipe work  
 Description : Gaskets  
 Sample No. : ASB20260310008  
 Confirmation : Sample Taken  
 Access : Full Access  
 Normal Use :  
 Recommendations :  
 Notes :

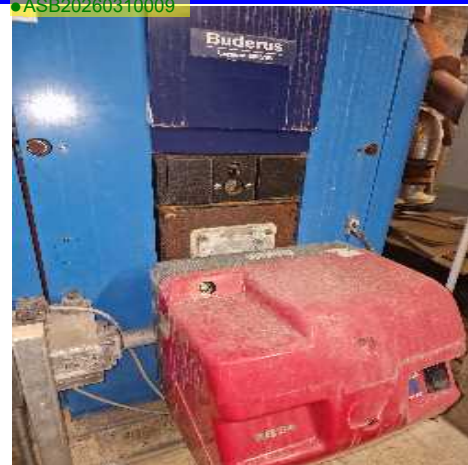
## Location Details : 157067 No Asbestos Found

Building/Area :  
Room/Section : Plant room  
Location : Boiler gasket  
Description : Gaskets  
Sample No. : ASB20260310009  
Confirmation : Sample Taken  
Access : Full Access  
Normal Use :  
Recommendations :  
Notes :

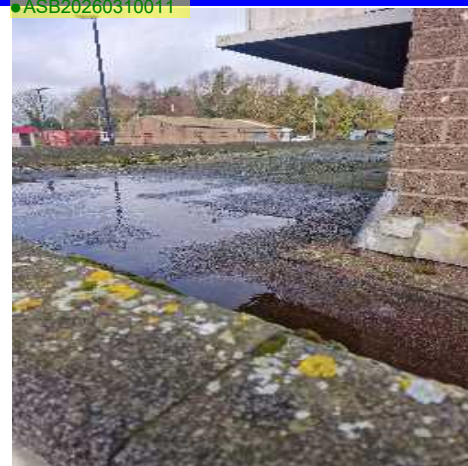
## Location Details : 157070 No Asbestos Found

Building/Area :  
Room/Section : External  
Location : Flat roof  
Description : Bitumen felt  
Sample No. : ASB20260310011  
Confirmation : Sample Taken  
Access : Full Access  
Normal Use :  
Recommendations :  
Notes :

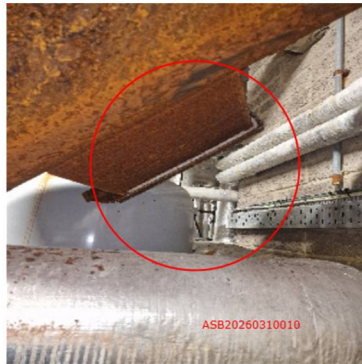
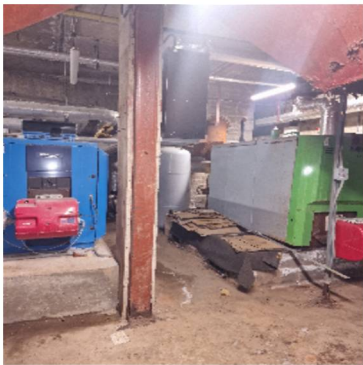
Plant and Boiler Room  
Surveyed
