# National Barrier Mitigation Programme

## Topographic and Bathymetric Survey Appendix J

### Lot 10 – Meath Document Verification Sheet

**File Reference:** NBMP\_08.8.01

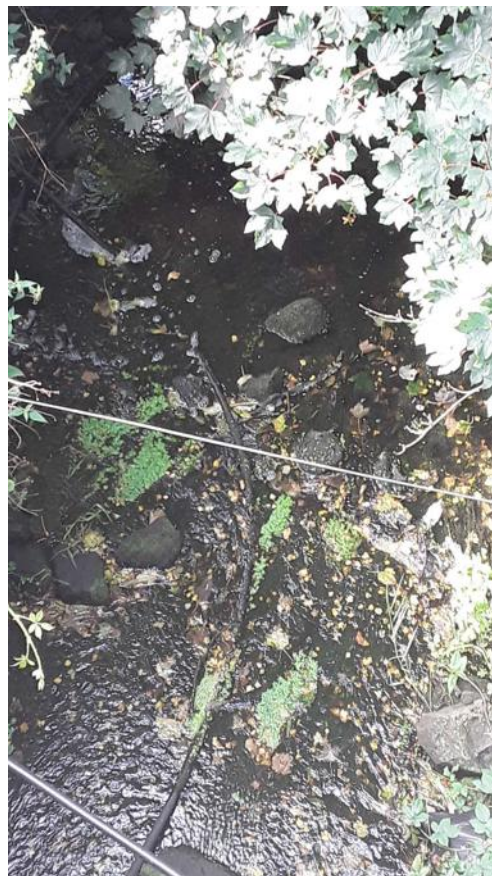
Plate 1 Lady Bridge - Downstream

The Lady Bridge is a bridge apron located on the Dee River in Nobber Co. Meath. This structure is a bridge/box culvert on the Dee River that is on L34401 approx. 300m from Nobber Cemetery. The bridge apron is elevated from the river bed at the downstream face of the bridge/box culvert. There is a 15 degree slope up to the bridge apron and a drop from the bridge apron into river. The culvert is 1.8m wide by 7m long. IFI completed a IBAST assessment in 2022 and has identified this structure as an impassable barrier for Salmon, Salmon smolt, Lamprey, Shad, Pike, Brown Trout and Cyprinids fish species.

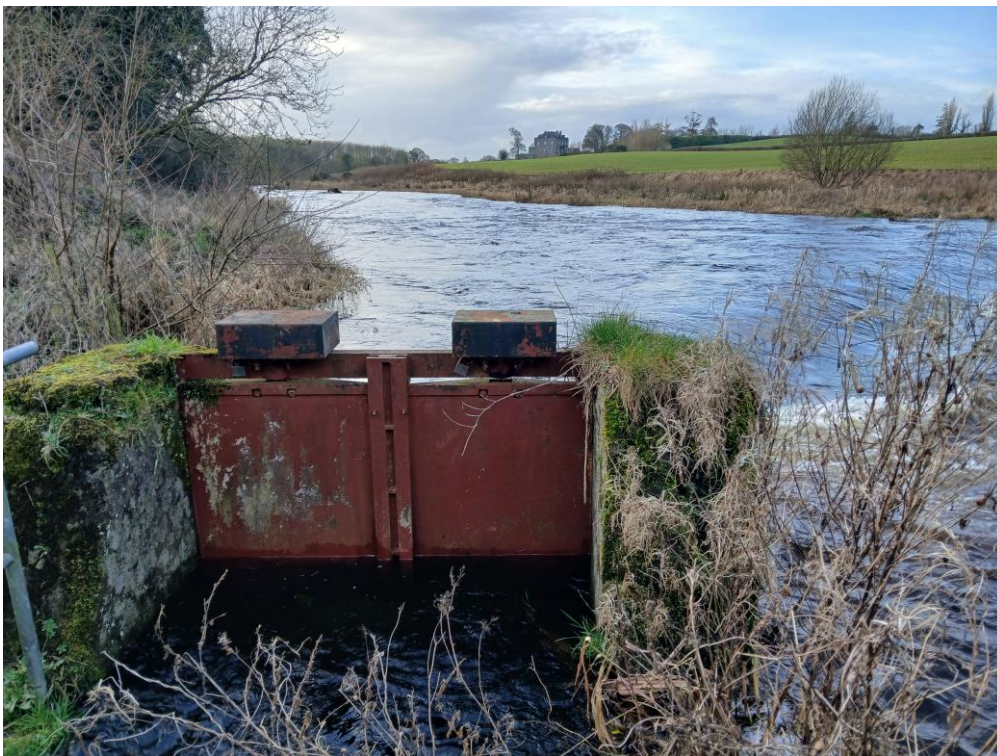
Plate 2 Clavens Bridge Weir - Upstream

The Clavens Bridge Weir is a concrete weir structure on the Blackwater River, in the townland of Rathbrack, Co. Meath. The structure is located within a designated Natura 2000 site River Boyne and River Blackwater SAC 002299 and SPA 004232. The weir has a 45 degree slope, a 0.90m barrier height and a width of 20m long. The weir is also located at an abstraction plant. IFI completed a Tablet Survey 123 report in 2021 that identified this structure as an impassable barrier for shad, lamprey, pike and cyprinids.

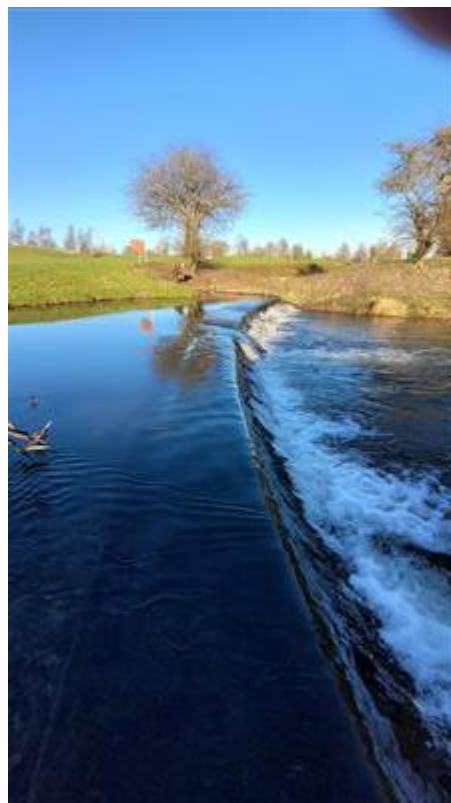
Plate 4 Knightsbrook Weir - Upstream

The Knightsbrook Weir located on the River Knightsbrook in Co. Meath. The existing structure will need some modifications, along with work to the ground and soil around it to facilitate the migration of fish species.

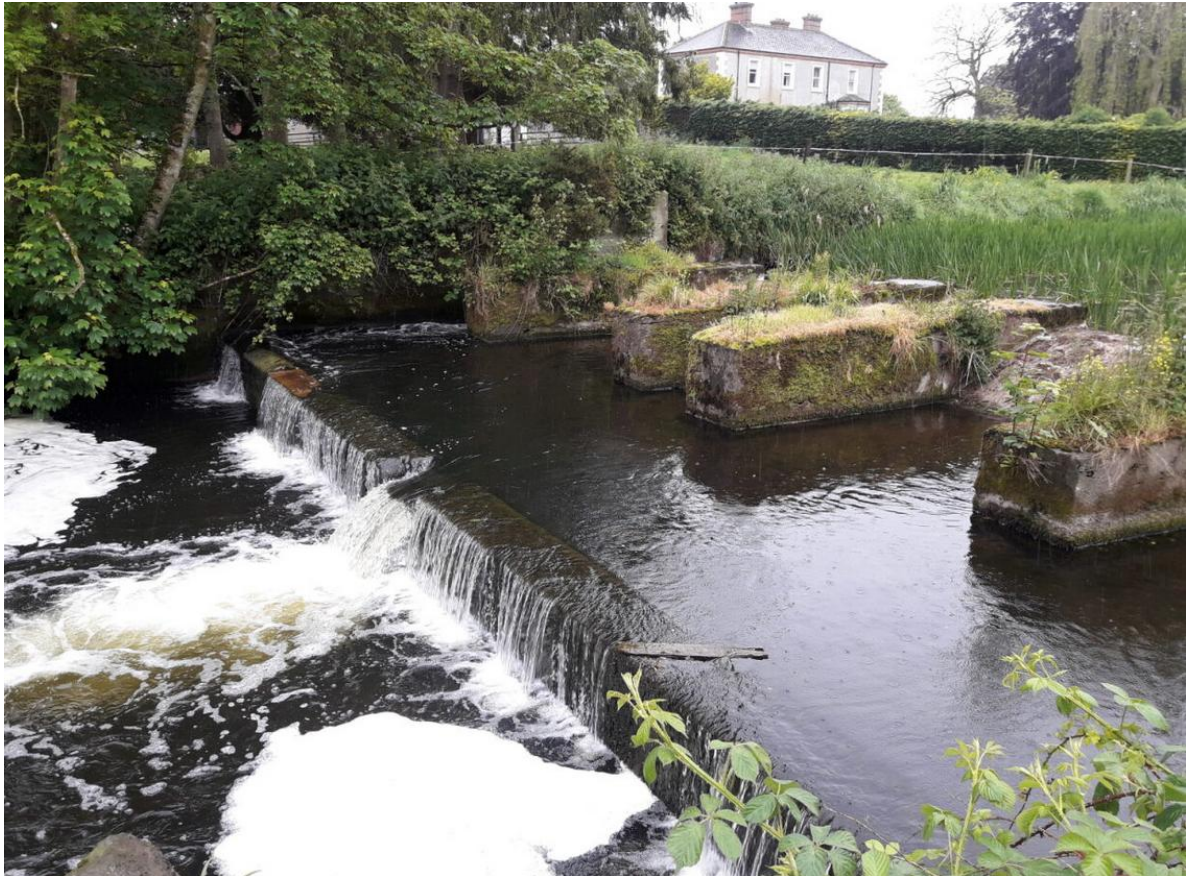
*Plate 6 Mahonstown Weir - Upstream*

The Mahonstown Weir is a mass concrete weir structure on the Moynalty River in townland of Mahonstown, County Meath. The weir is recorded on the NIAH website, though presently in poor condition this weir is representative of nineteenth-century industrial activity. The weir formed a mill pond to the west of the weir. With a hydraulic ram and eel trap, formerly located to the site, this weir formed part of a group of structures relating to Mahonstown House. The weir has a vertical drop of 1.05m and the barrier has a wet width of 9.78m. IFI completed a SNIFFER report in 2018 that identified this structure as an impassable barrier for salmon smolt, shad, lamprey, pike and cyprinids.

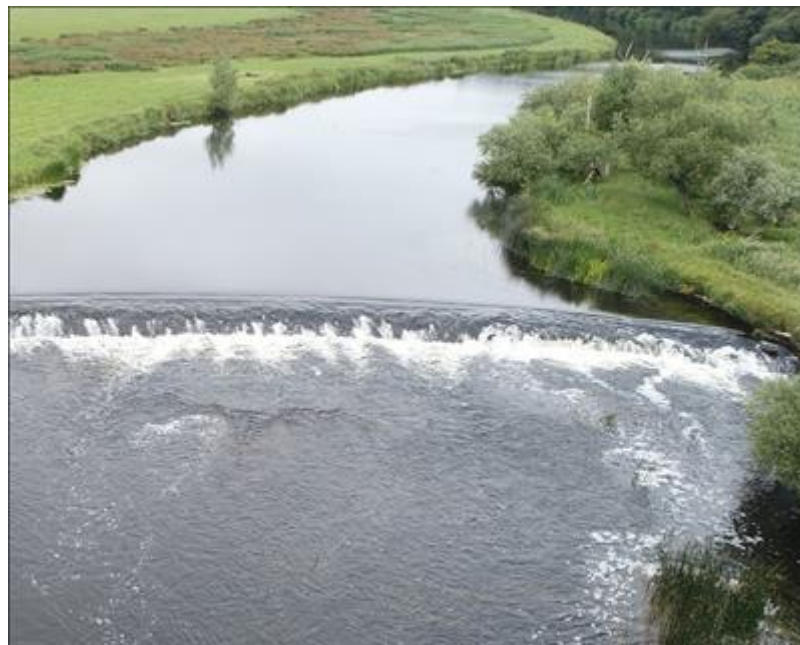
Plate 8 Newgrange Weir – Upstream

The Newgrange Weir is located on the River Boyne in Co. Meath. The existing structure will need some modifications, along with work to the ground and soil around it to facilitate the migration of fish species. The barrier is located in the River Boyne and River Blackwater SAC (002299) and River Boyne and River Blackwater SPA (004232).

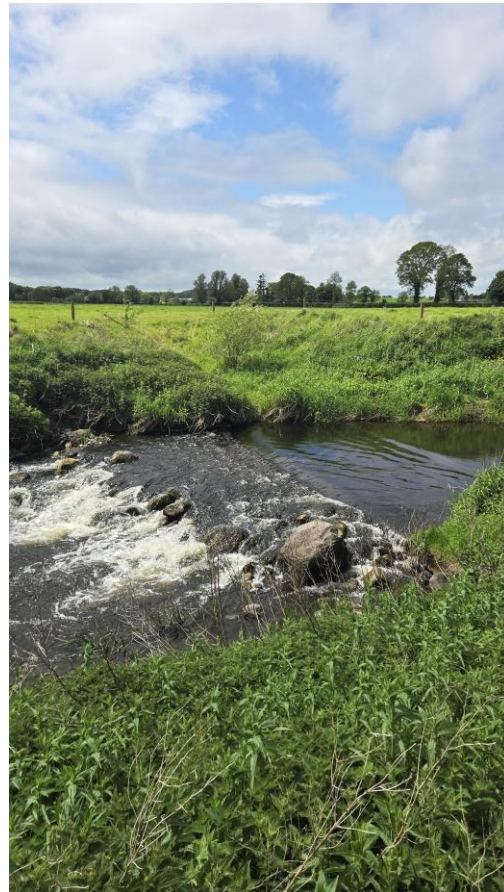
*Plate 12 Balreask Ford - Upstream*

Balreask Ford is located on the Moynalty\_060 River, in Balreask, County Meath. The structure is a mass concrete ford with a barrier height of 0.4m that is built on the river bed. The ford is 5.5m long in the river channel and is located between two fields. The structure restricts fish passage and allows vehicles to drive through the river bed, which presents a dual risk to the integrity of the river habitat. Although the ford enables crossing by animals and farm vehicles, this can deliver sediment and pollutants to the river, particularly where the crossing is part of a farm. Beyond blocking passage, impoundments caused by barriers can elevate water temperatures, adversely affecting cold-water species such as salmonids. Additionally, the structure impedes sediment and nutrient transport, reducing the availability of gravels and fine sediments essential for providing habitat functions for fish such as salmonids and lamprey, and other aquatic organisms and plants throughout their life cycles.
