***S.I. Ltd Contract No: 6571***

Client: Tipperary County Council  
Engineer: Hassett Leyden & Associates  
Contractor: Site Investigations Ltd

**Residential Development,**  
**Cuil Greine, Donohill, Co. Tipperary**  
**Site Investigation**

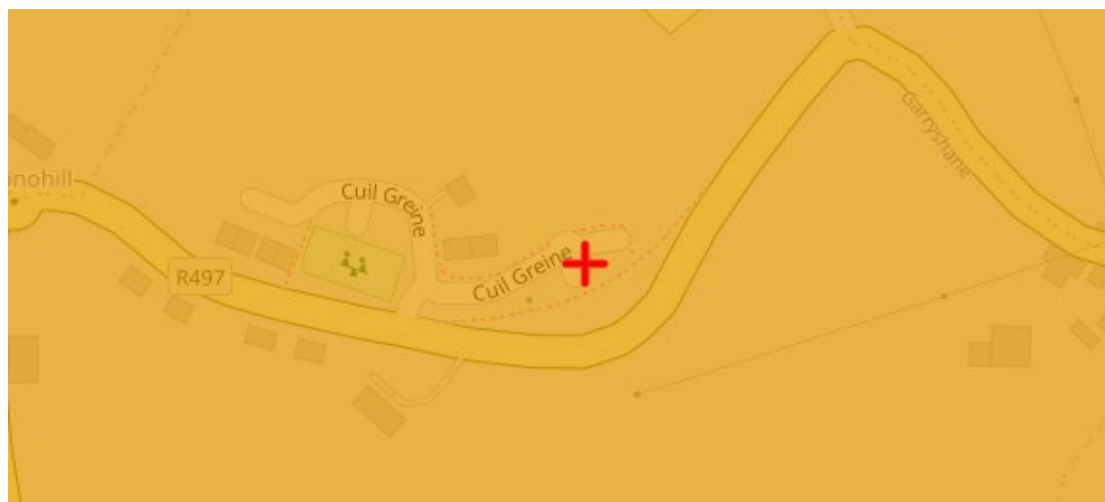
The Environmental Protection Agency (EPA) has recently updated the Radon gas exposure map and this is available to view on the EPA website. This shows the possible exposure to radon gas with the bedrock geology, subsoil geology, soil permeability and aquifer type analysed to produce the map. The map below shows that the site falls in the medium level of 1 in 10 homes are at risk of radon exposure. Measures should be taken in the form of radon protection barriers from radon exposure in the new structures.

EPA map identifying possible Radon exposure.
