# **Preliminary Report on Source Protection**

## **Nephin Valley Group Water Scheme and Levally Lough County Mayo**

**Centre for Freshwater and Environmental Studies**

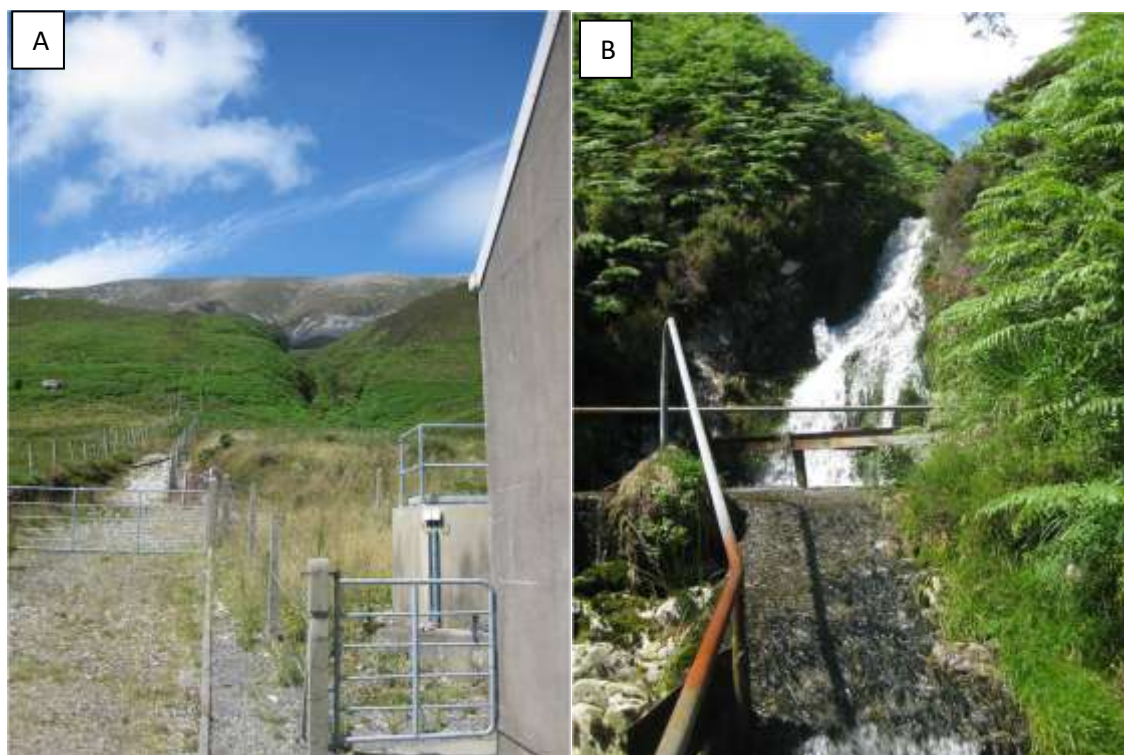
**Figure 1:** Site Location: Nephin Valley GWS, A) water treatment plant to the right of the photo and the mountain stream abstraction point in the background and B) water abstraction point.

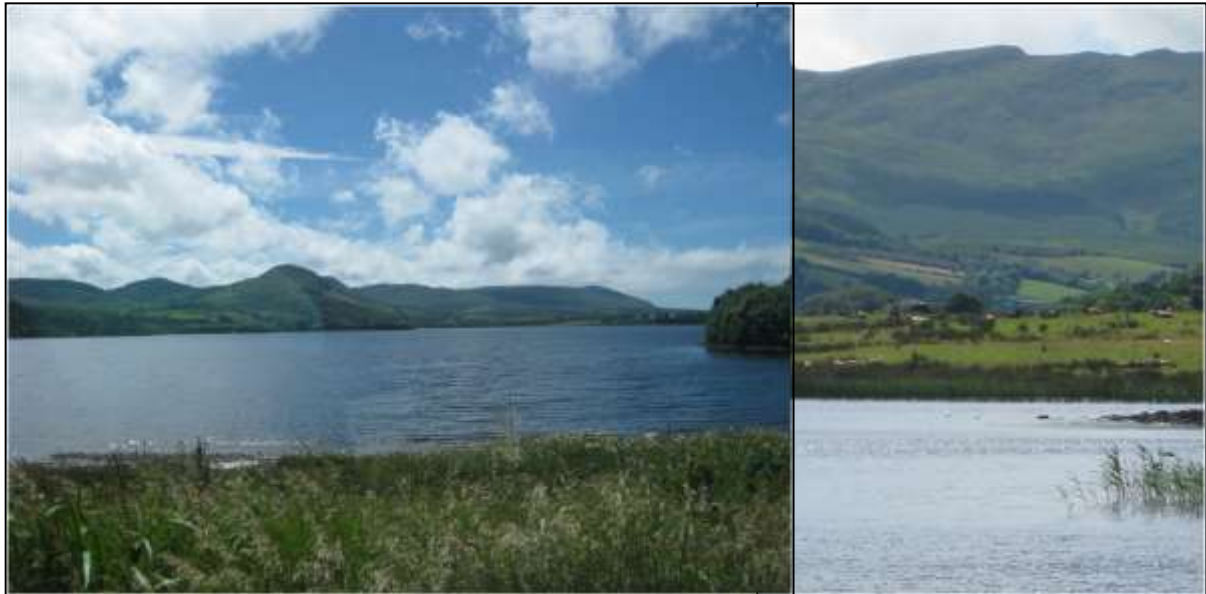
**Figure 2:** A) Levally Lough (potential abstraction point for secondary water source for Nephin Valley GWS). B) Agricultural pressures along the west of the Levally Lough.

Pressures within the Levally Lough catchment are also primarily agricultural, with much of the catchment surrounding Lough and to the west/northwest of the catchment classified by CORINE as pasture and land principle occupied by agriculture. Other pressures within the Levally Lough catchment may include domestic wastewater treatment systems in areas in E and Extreme ground water vulnerability. Elevation is greatest along the east and south of the catchment, reaching a maximum of approximately 340 m in the Cuilmullagh hills to the south of the catchment.
