## Site 3, Kilnavarra Lane, Cavan, Co. Cavan – Site Investigation

Client: Comhairle Contae an Chabháin /  
Cavan County Council

Completed: 5th July 2024

Report No.: OCB23-142

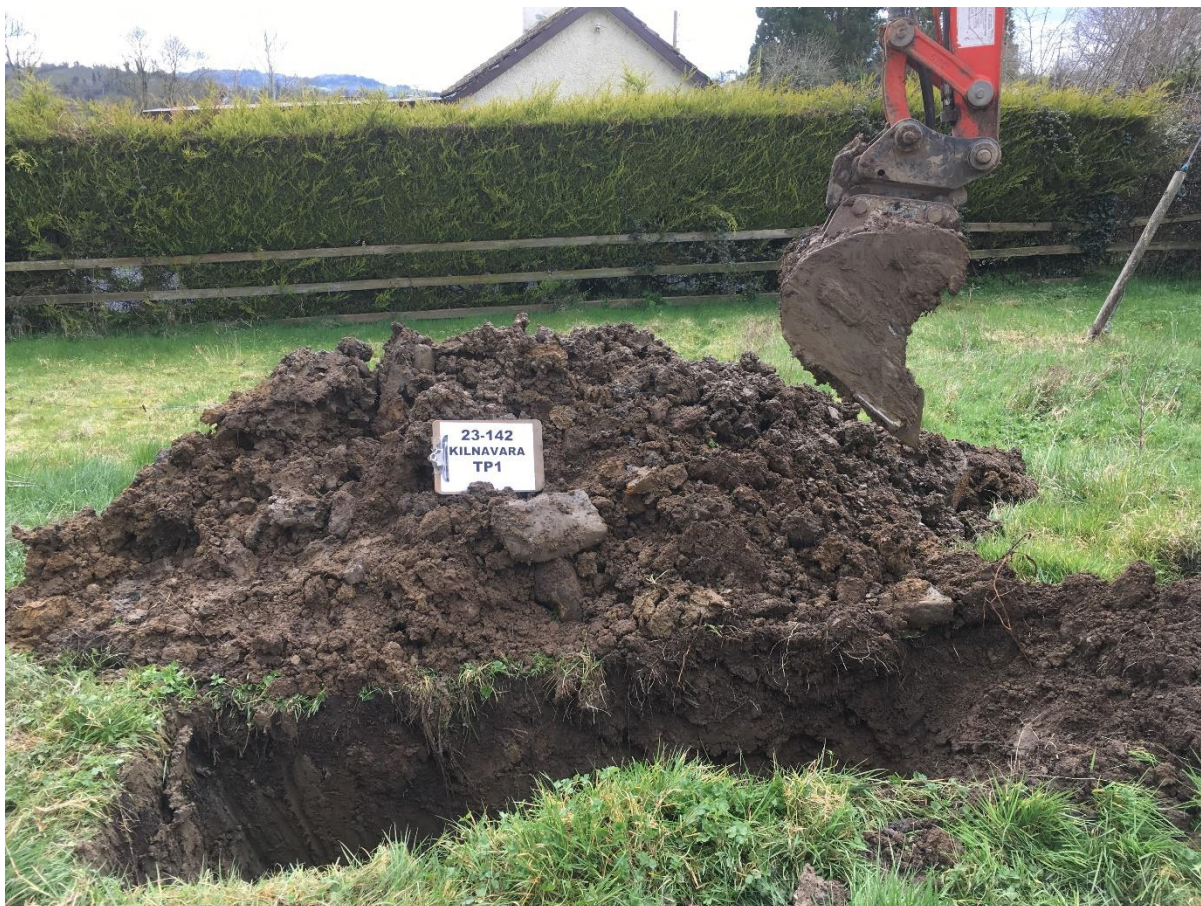
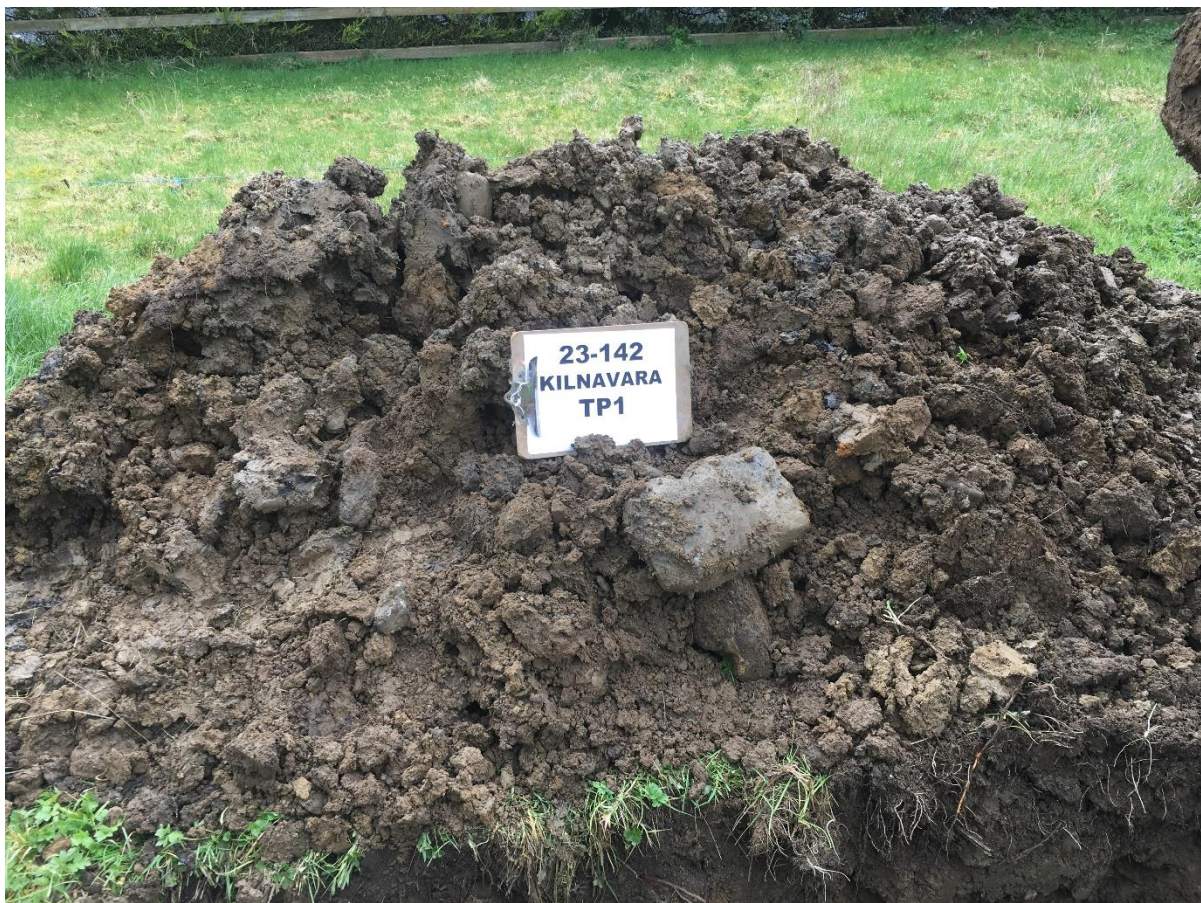
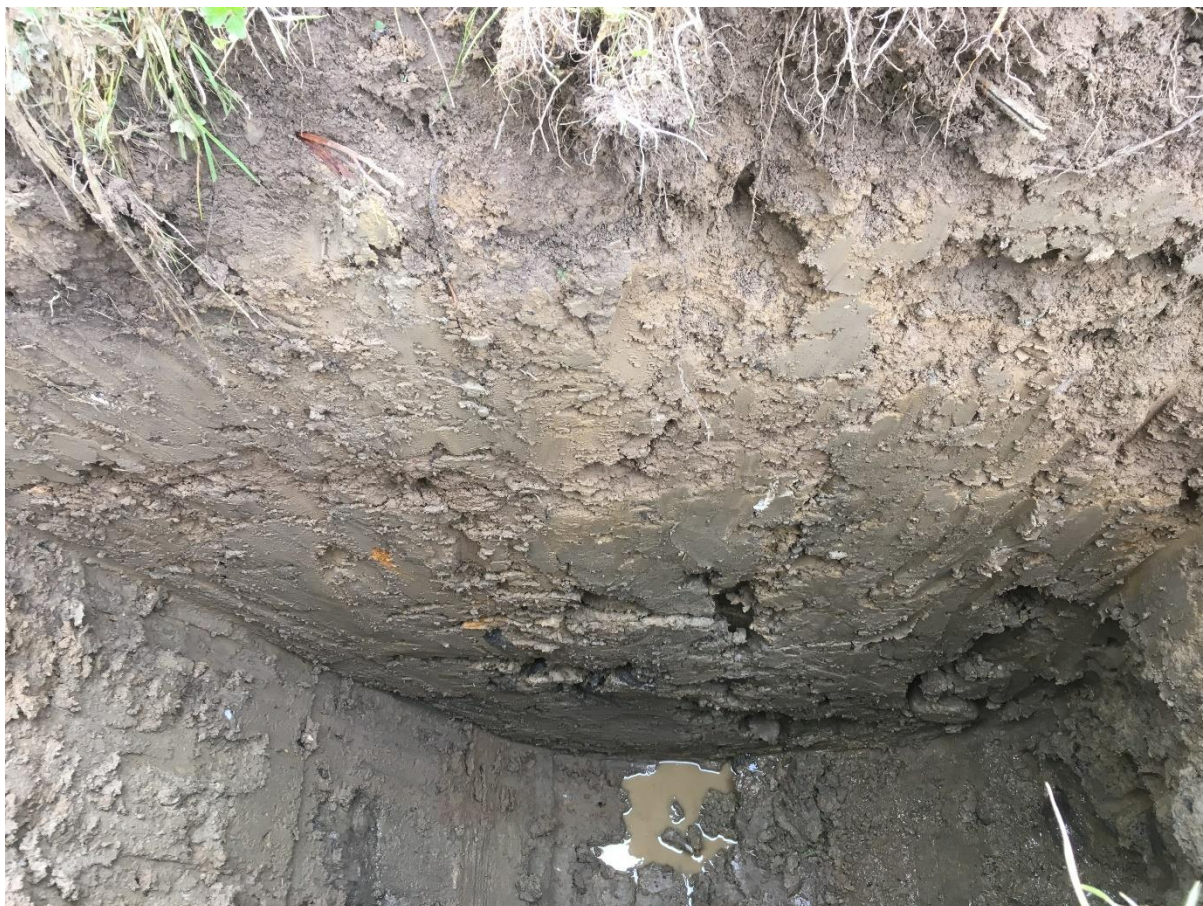
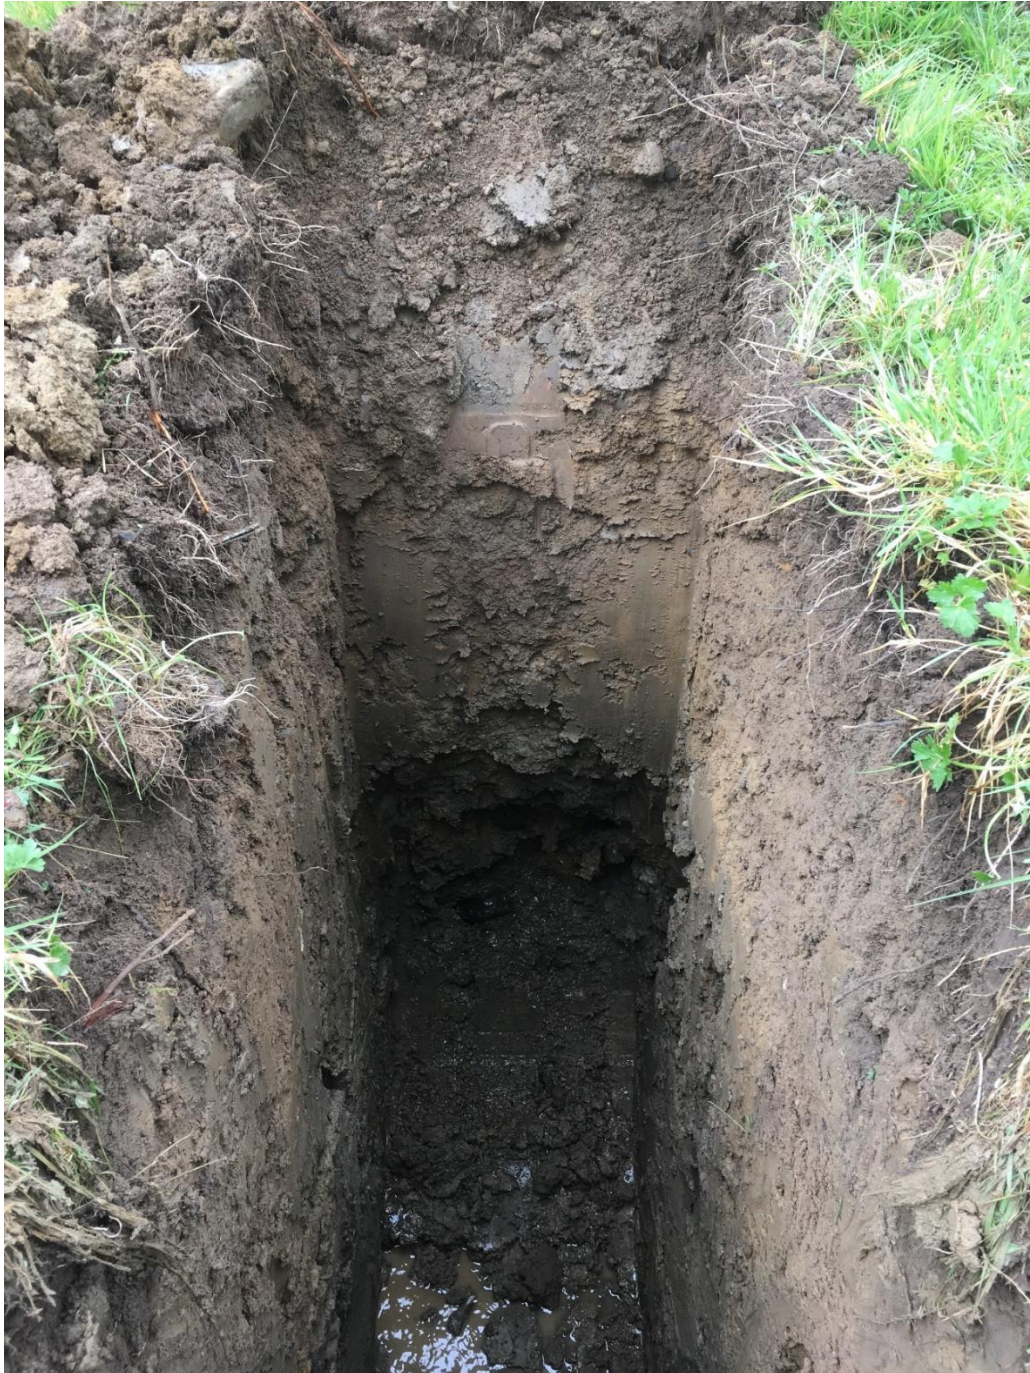
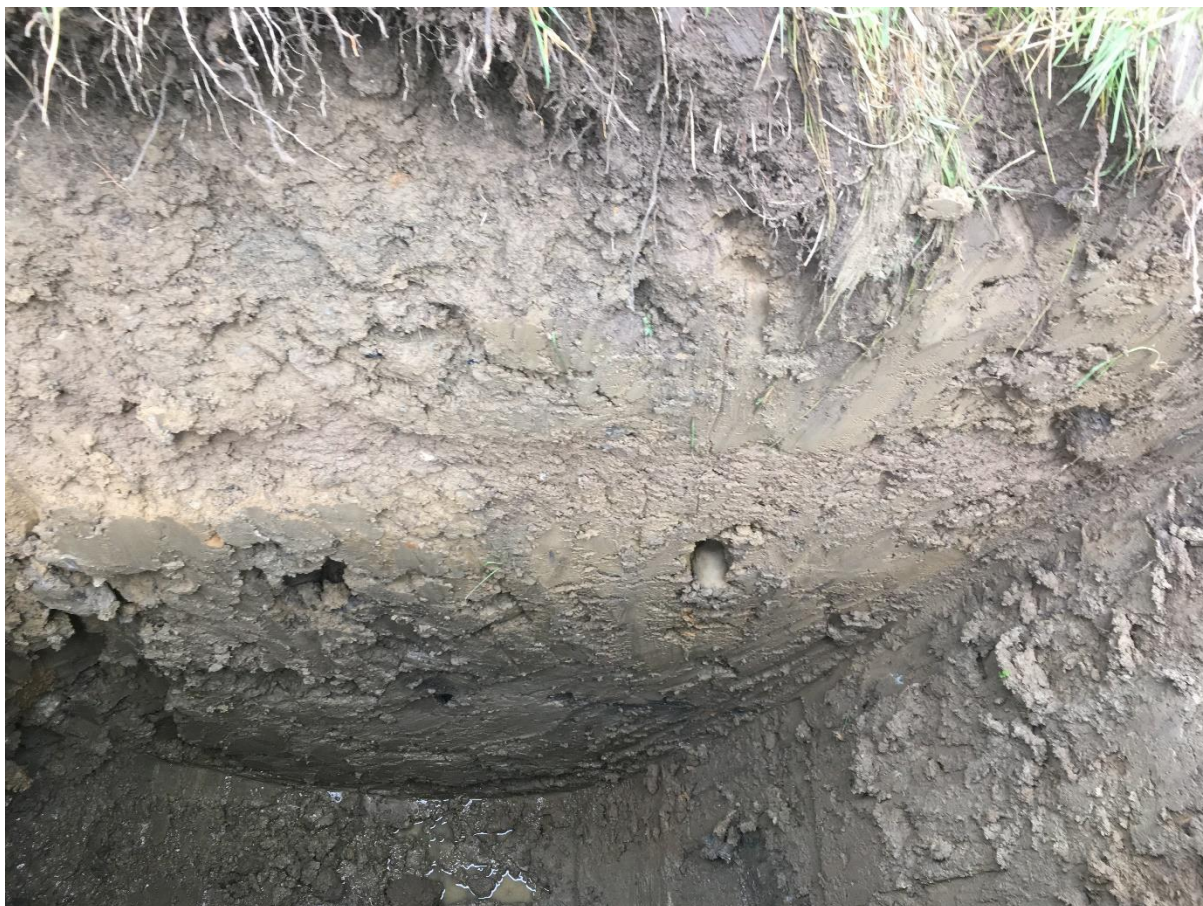
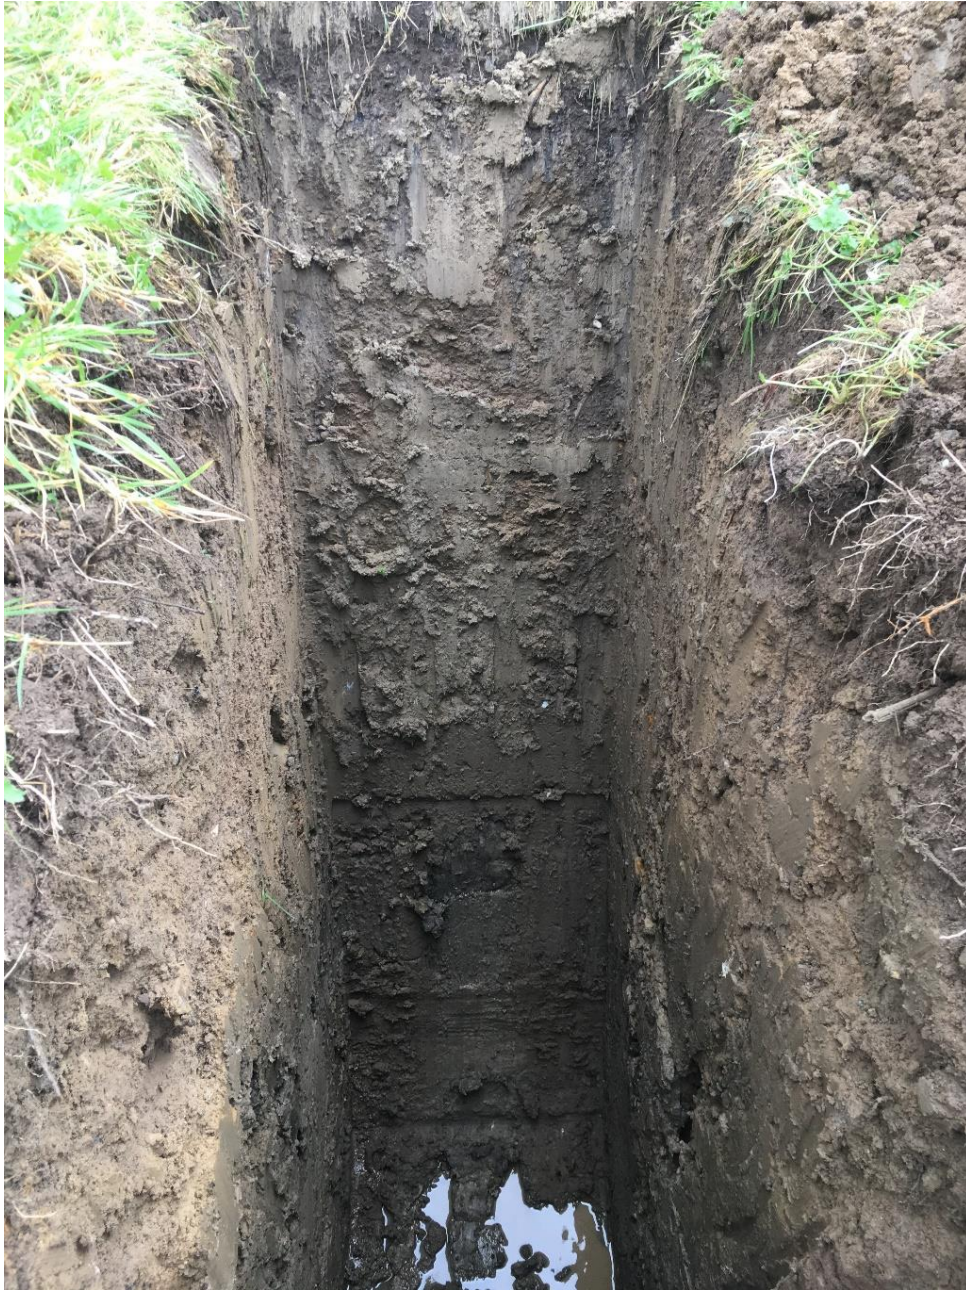
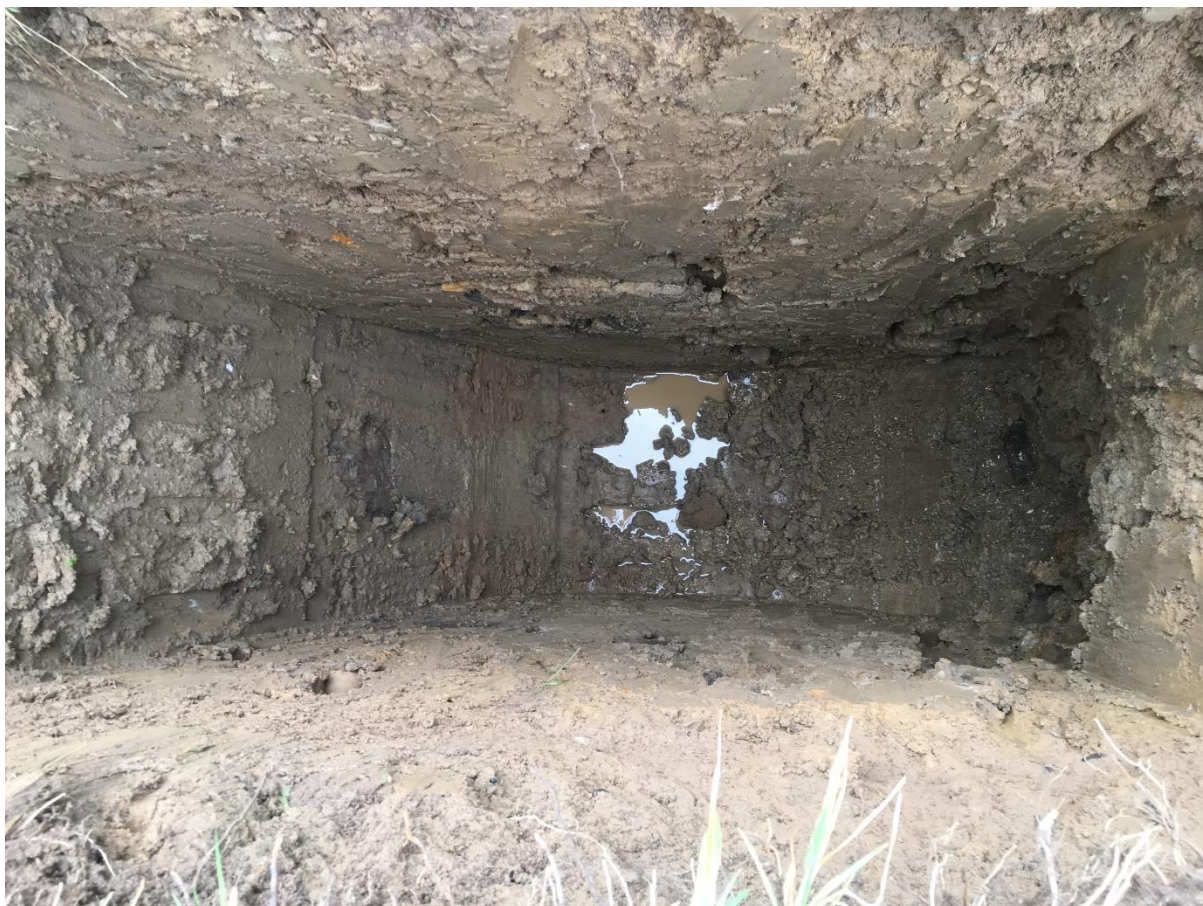
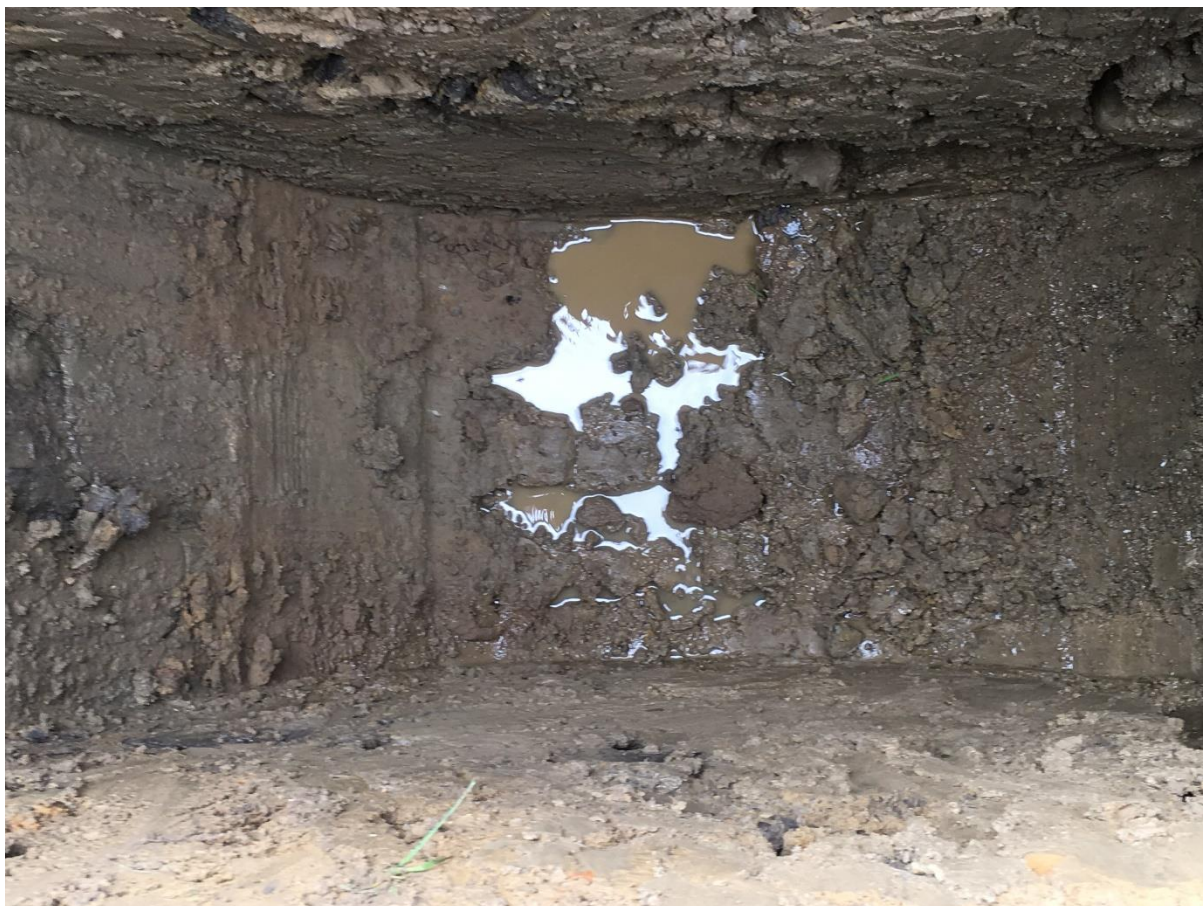
**TP3-1**

One (1) trial pit (TP3-1) was excavated at the bungalow garden at the south end of the site on 28<sup>th</sup> March 2024 using a 3-tonne Kubota U27-4 excavator, fitted with 600mm wide bucket, to a depth of 2.4m BGL.

Appendix D presents the trial pit log with photographs of the pit and arisings provided in Appendix E.

Groundwater was observed trickling from the sides and pooling at the base of trial pit TP3-1 at the southern portion of the Kilnavarra site.
