## **Kildangan National School, Co. Kildare Site Investigation**

Client: Dooley Cummins Architects + Engineers

Report No.: OCB24-033

Project title: Kildangan National School, Kildangan, Co. Kildare

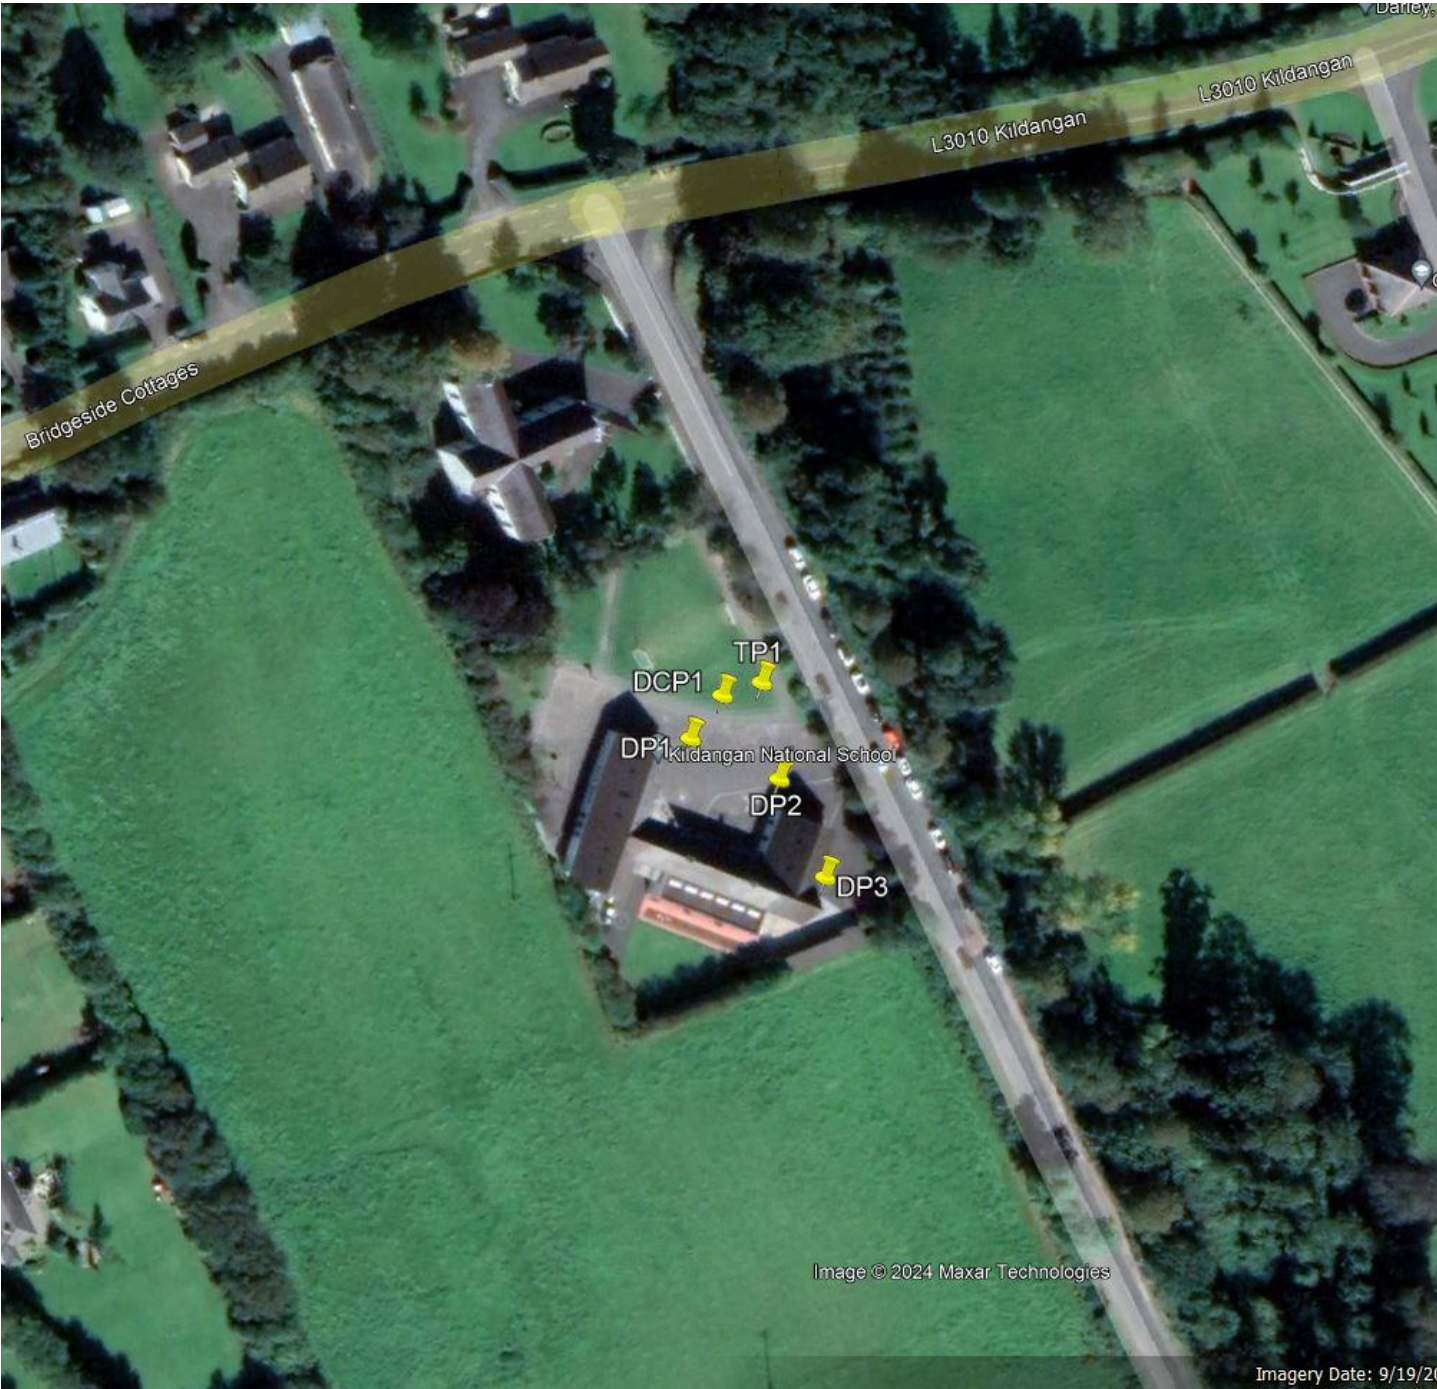
| Exploratory Hole Locations Plan | |

The exploratory holes and in situ tests were located as instructed by the Dooley Cummins Architects + Engineers as shown on the exploratory hole location plan in Appendix A.

The as-built exploratory hole positions were surveyed following completion of site operations by a Site Engineer from OCB Geotechnical. Surveying was carried out using a Trimble R6 GPS system employing VRS and real time kinetic (RTK) techniques.

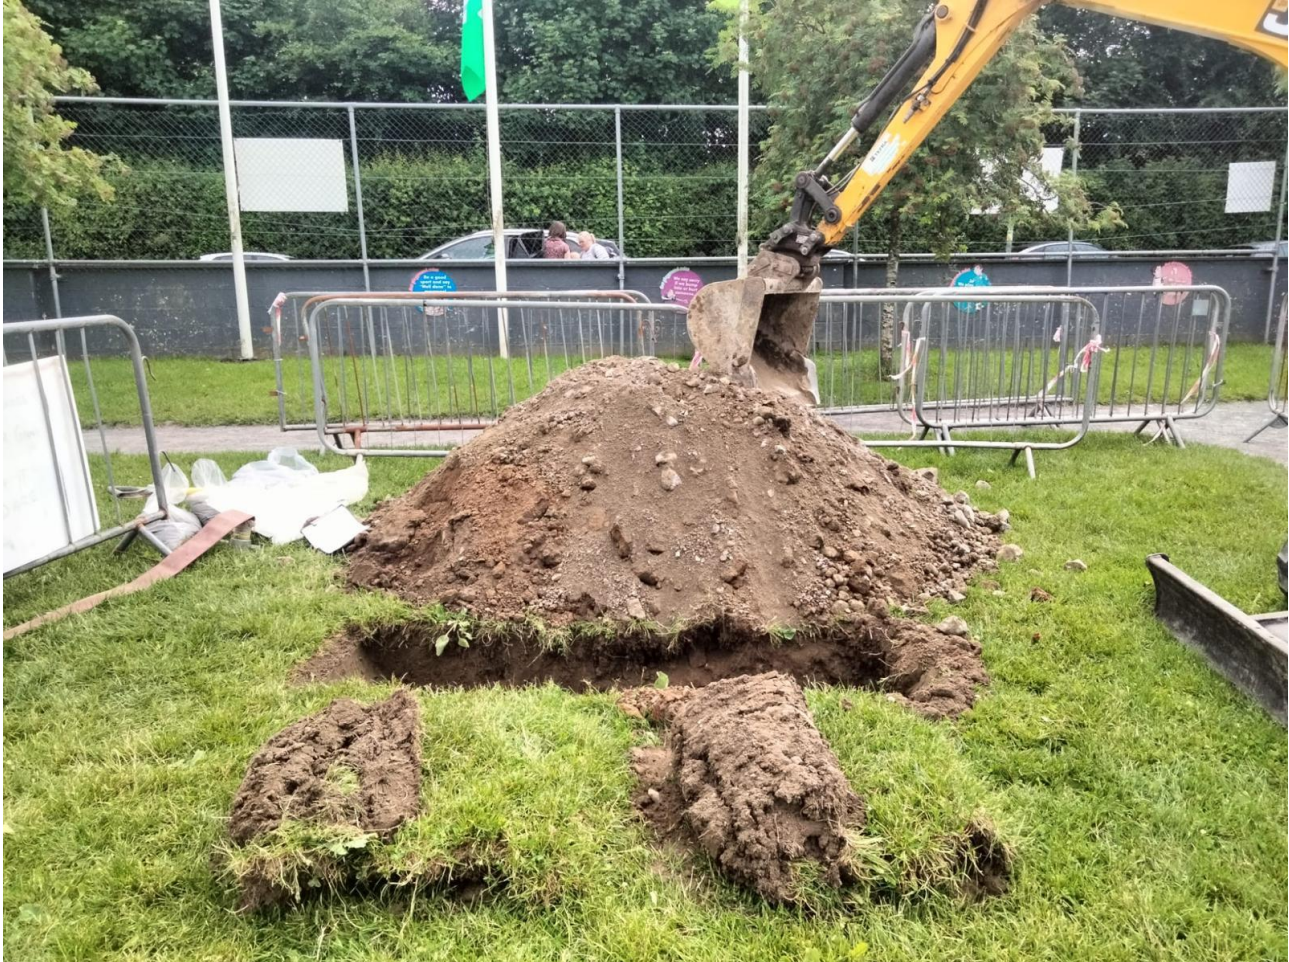
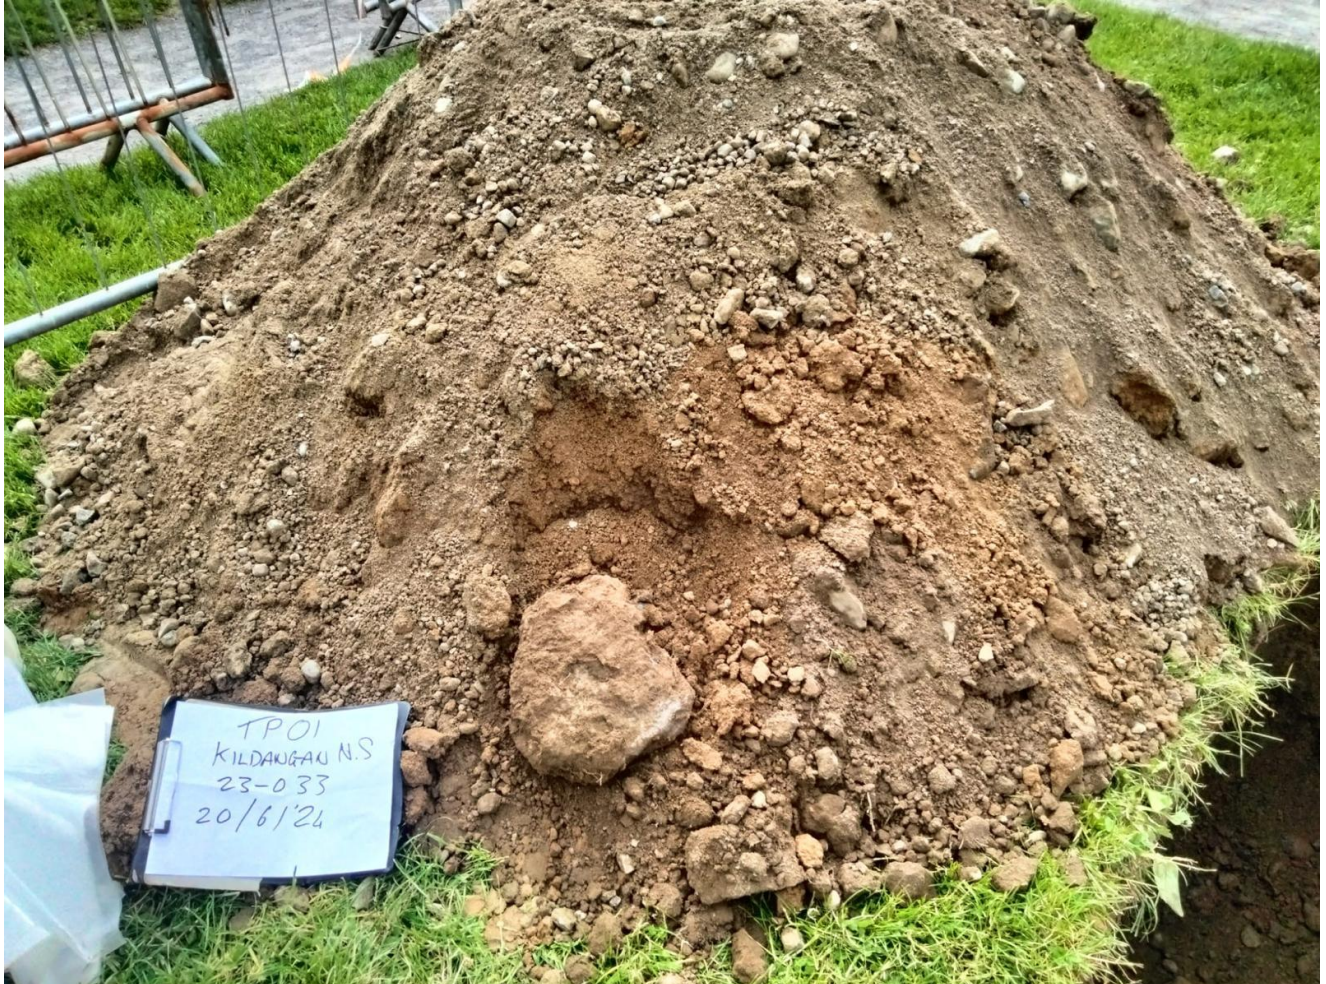
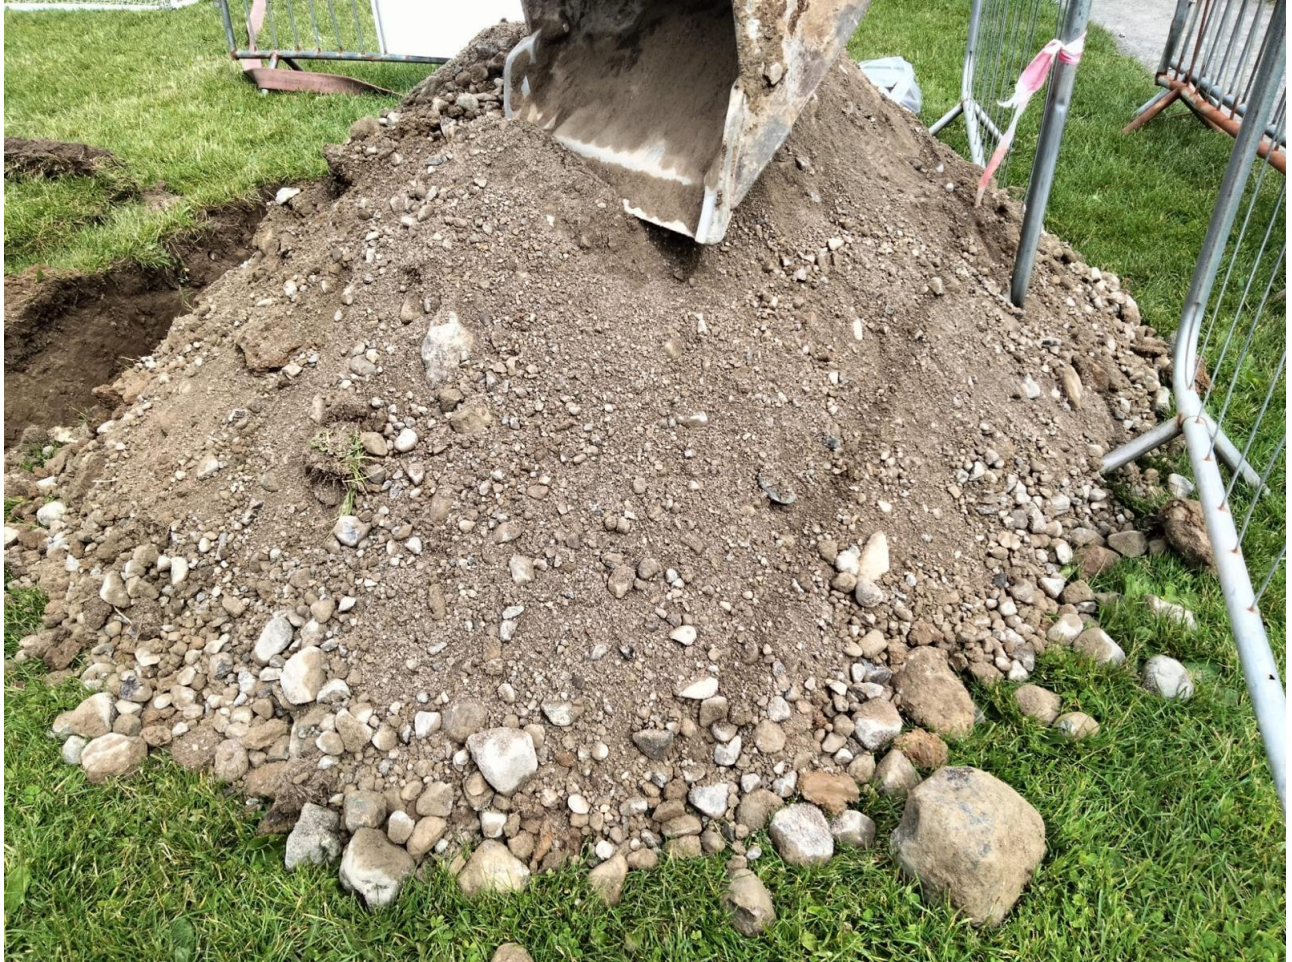
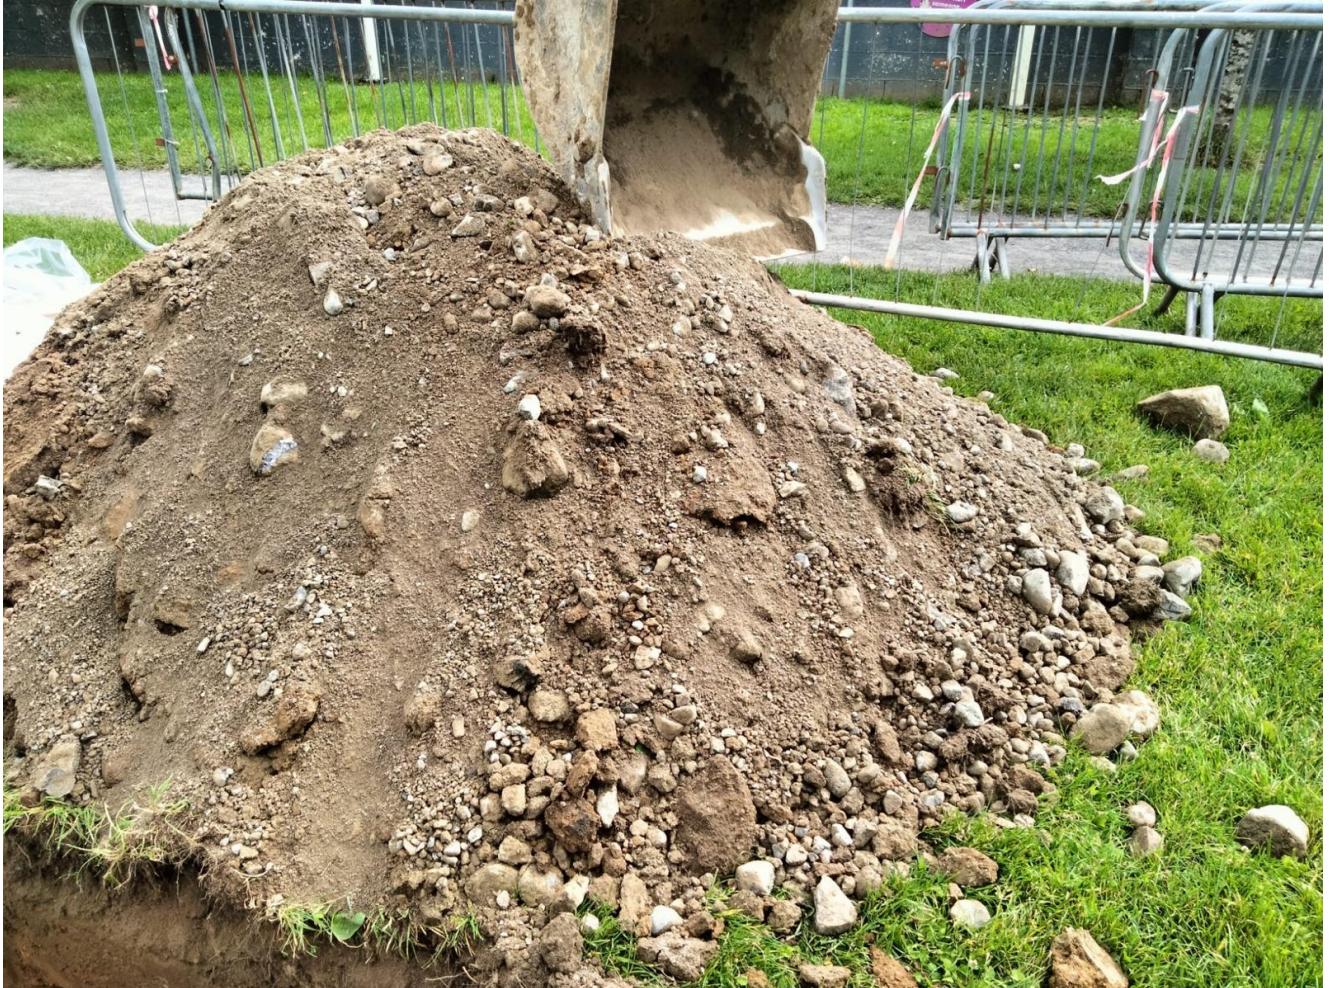
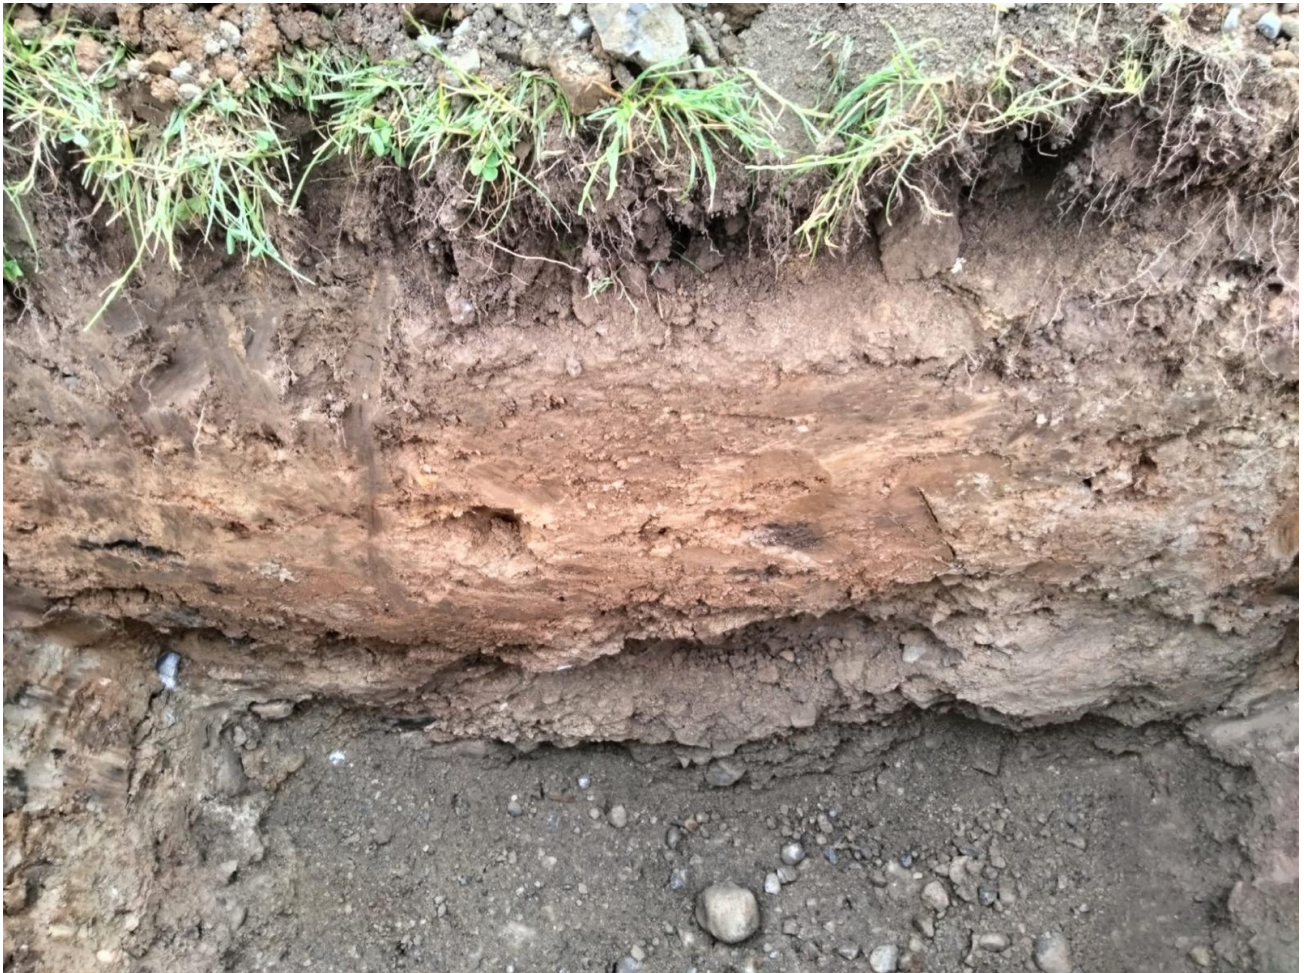
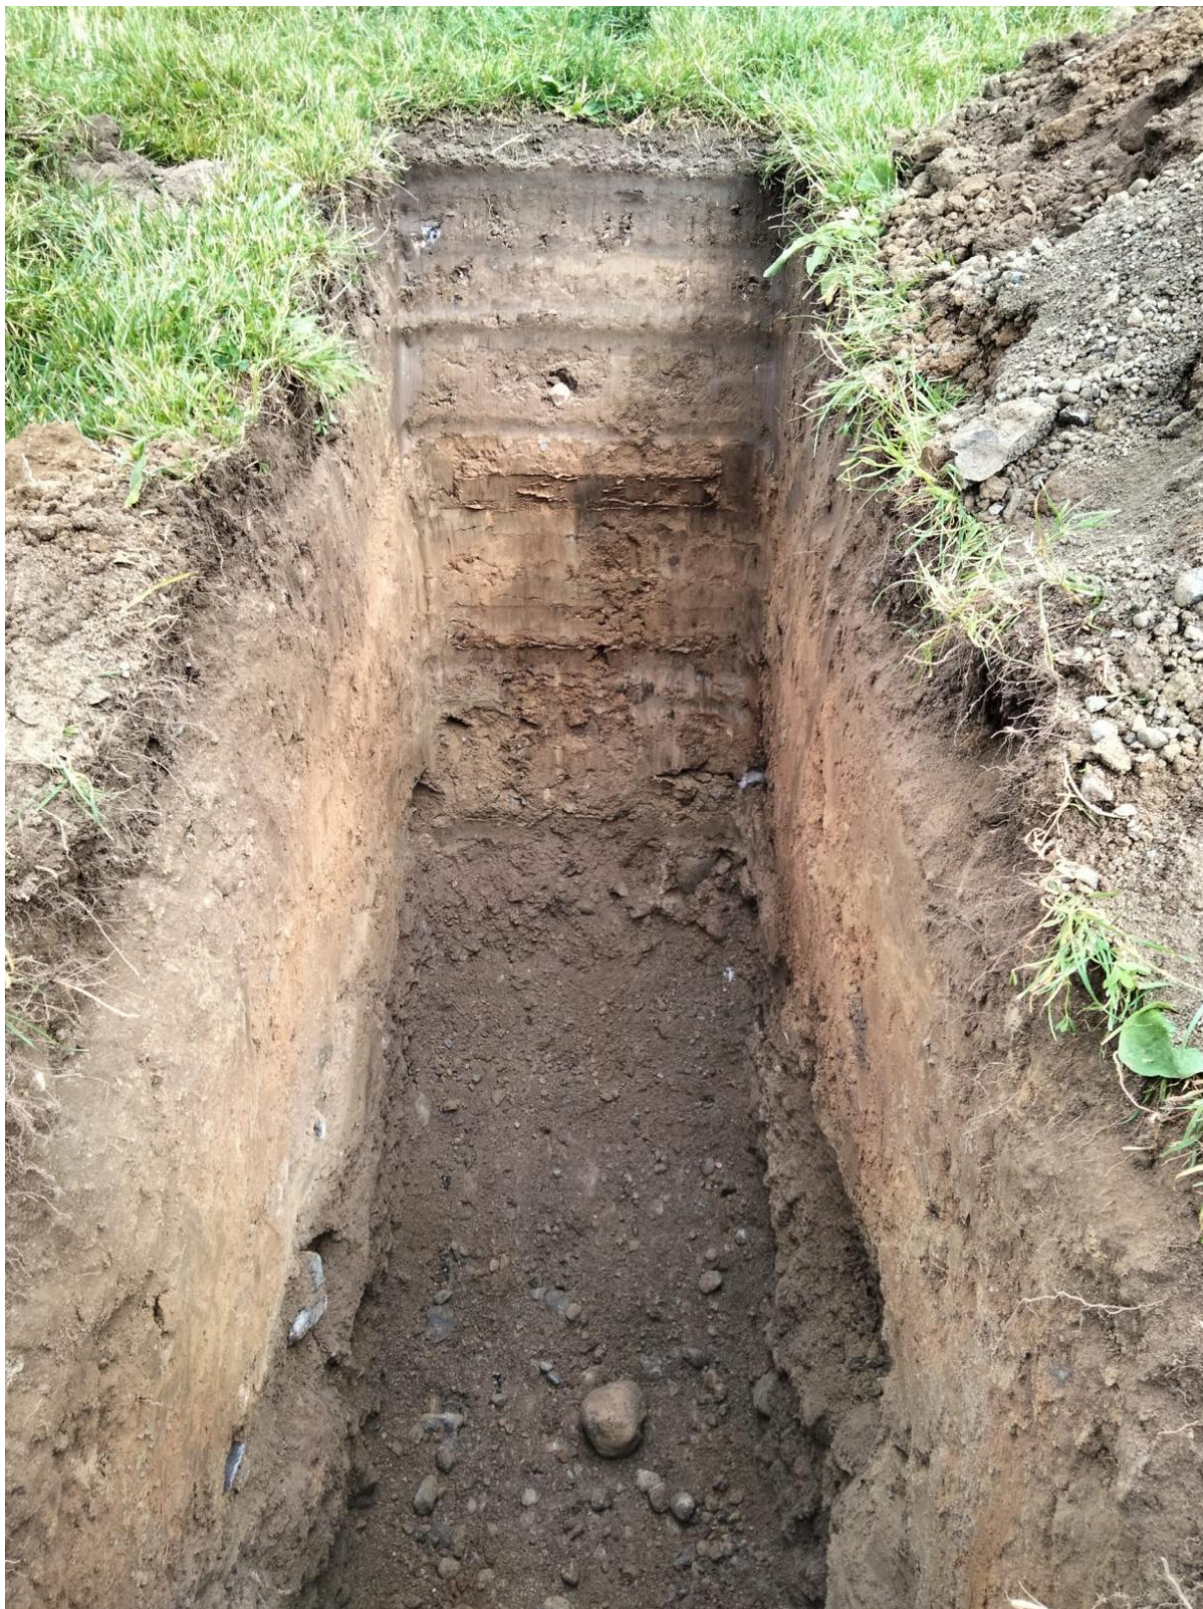
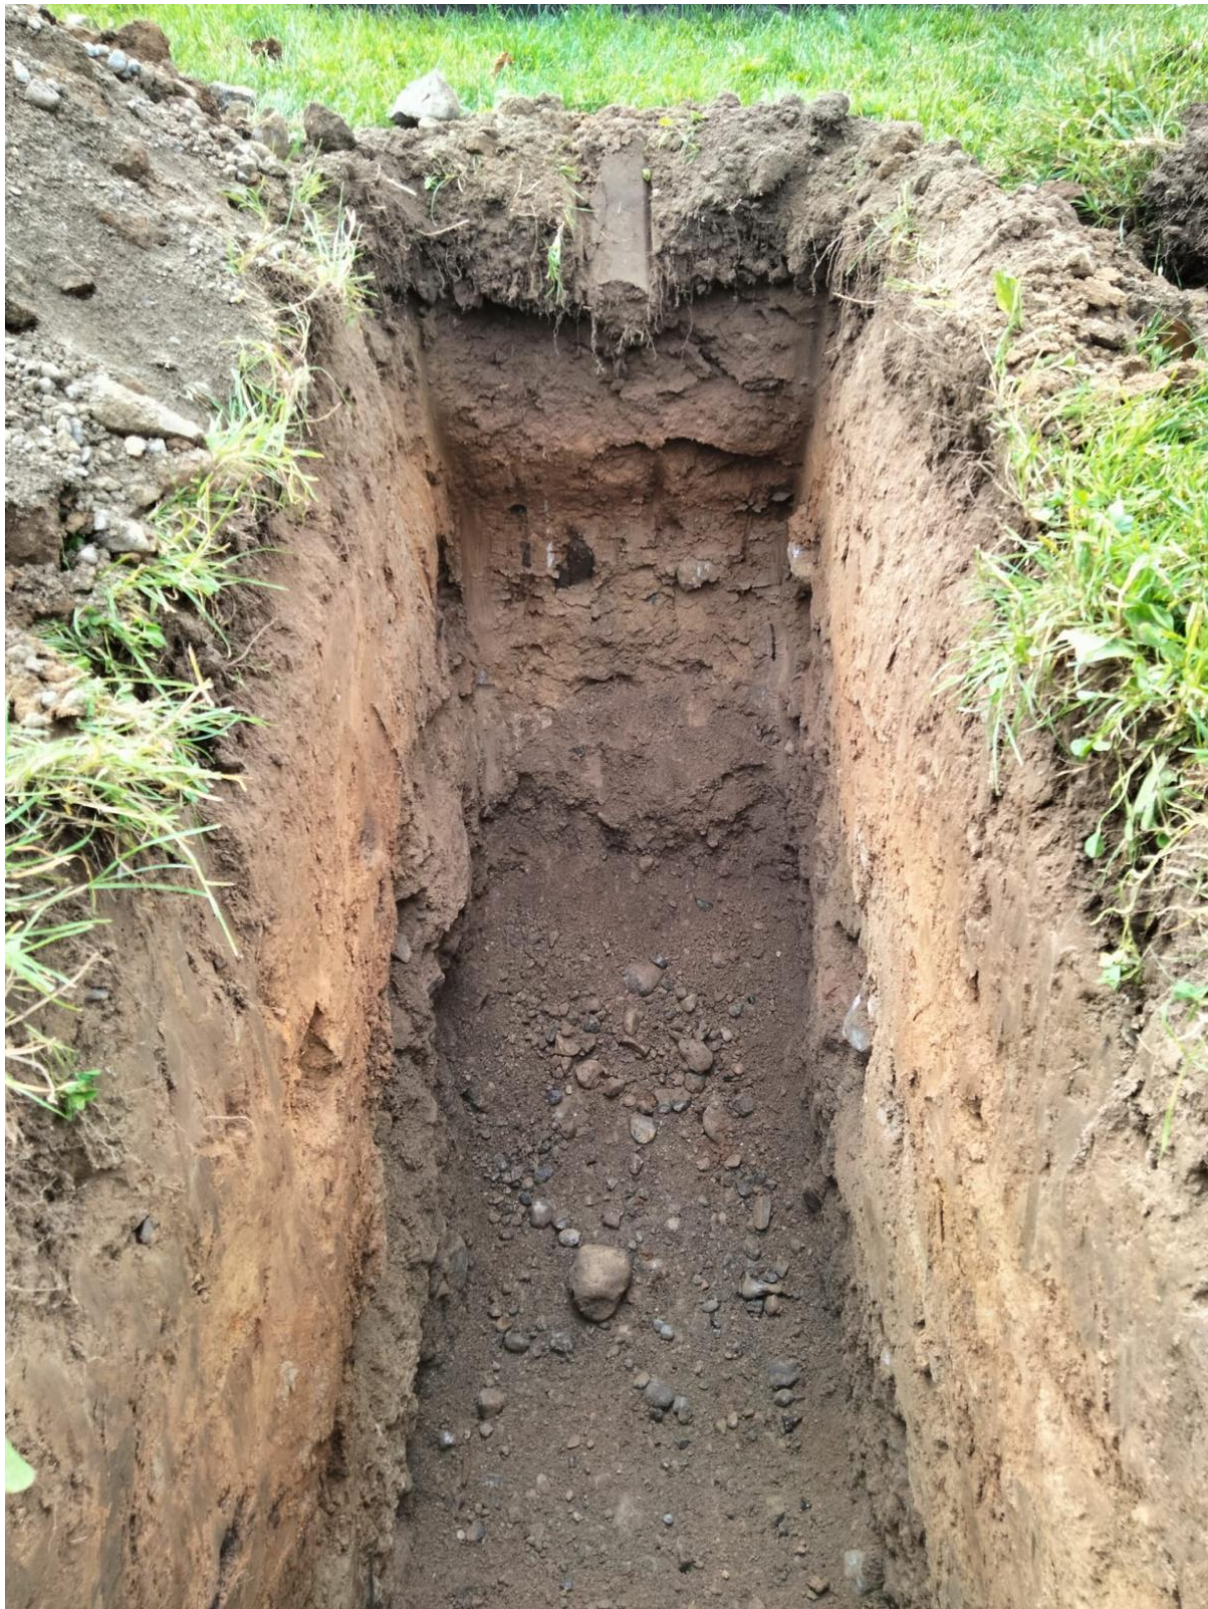
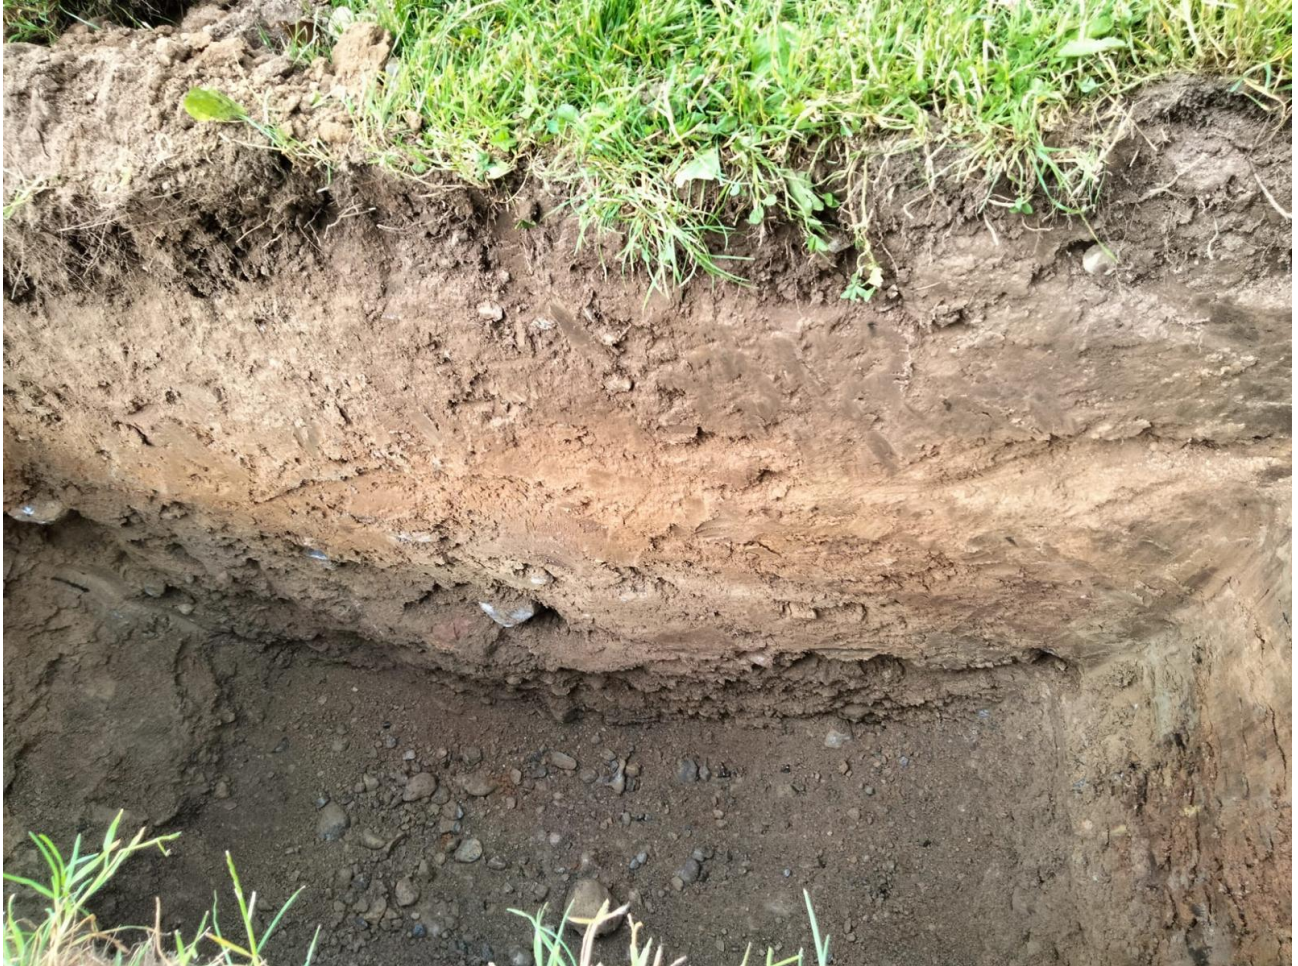
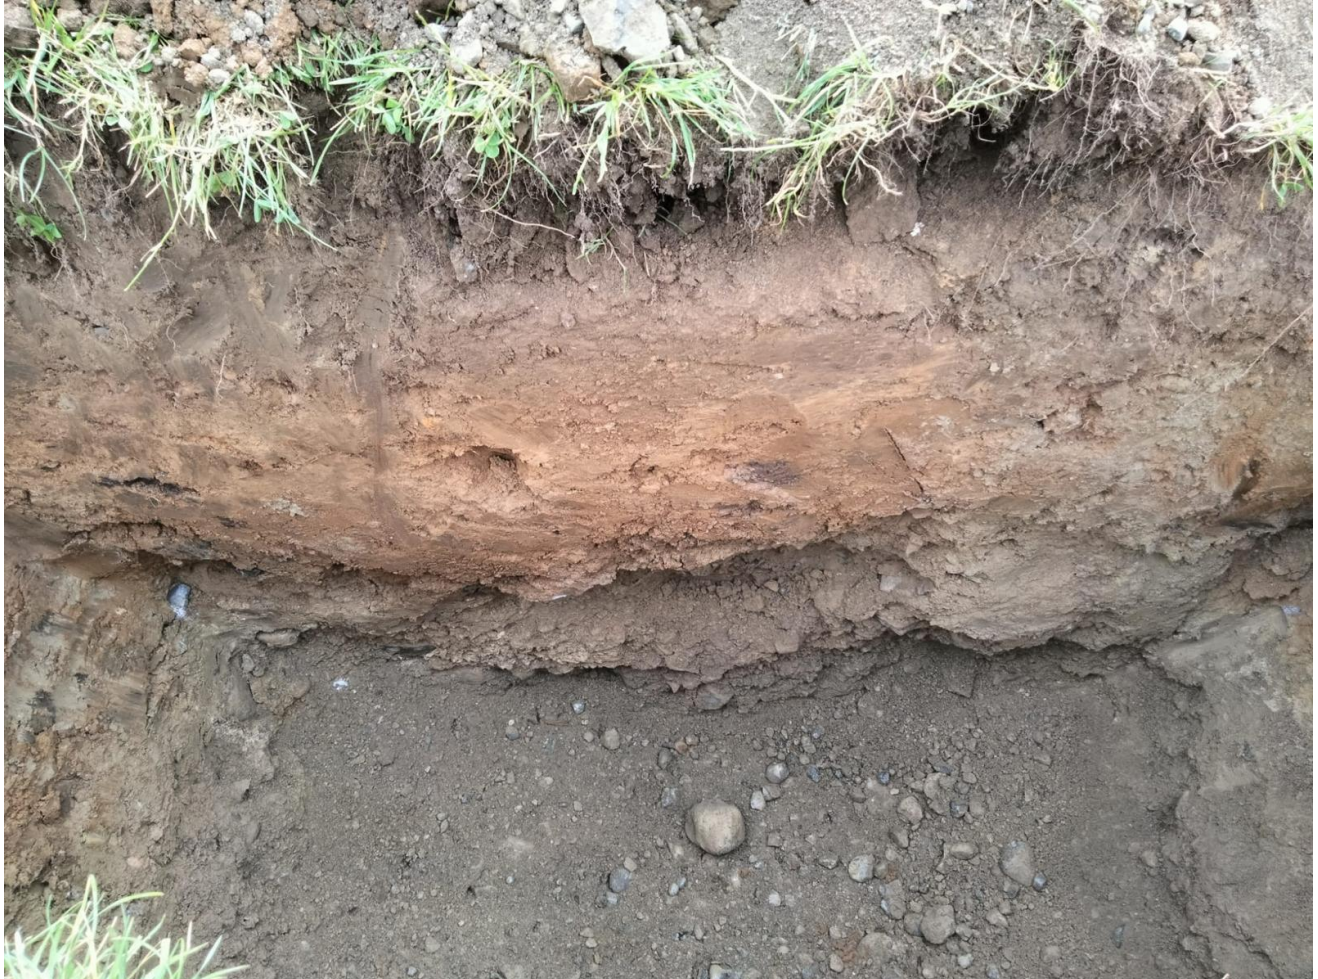
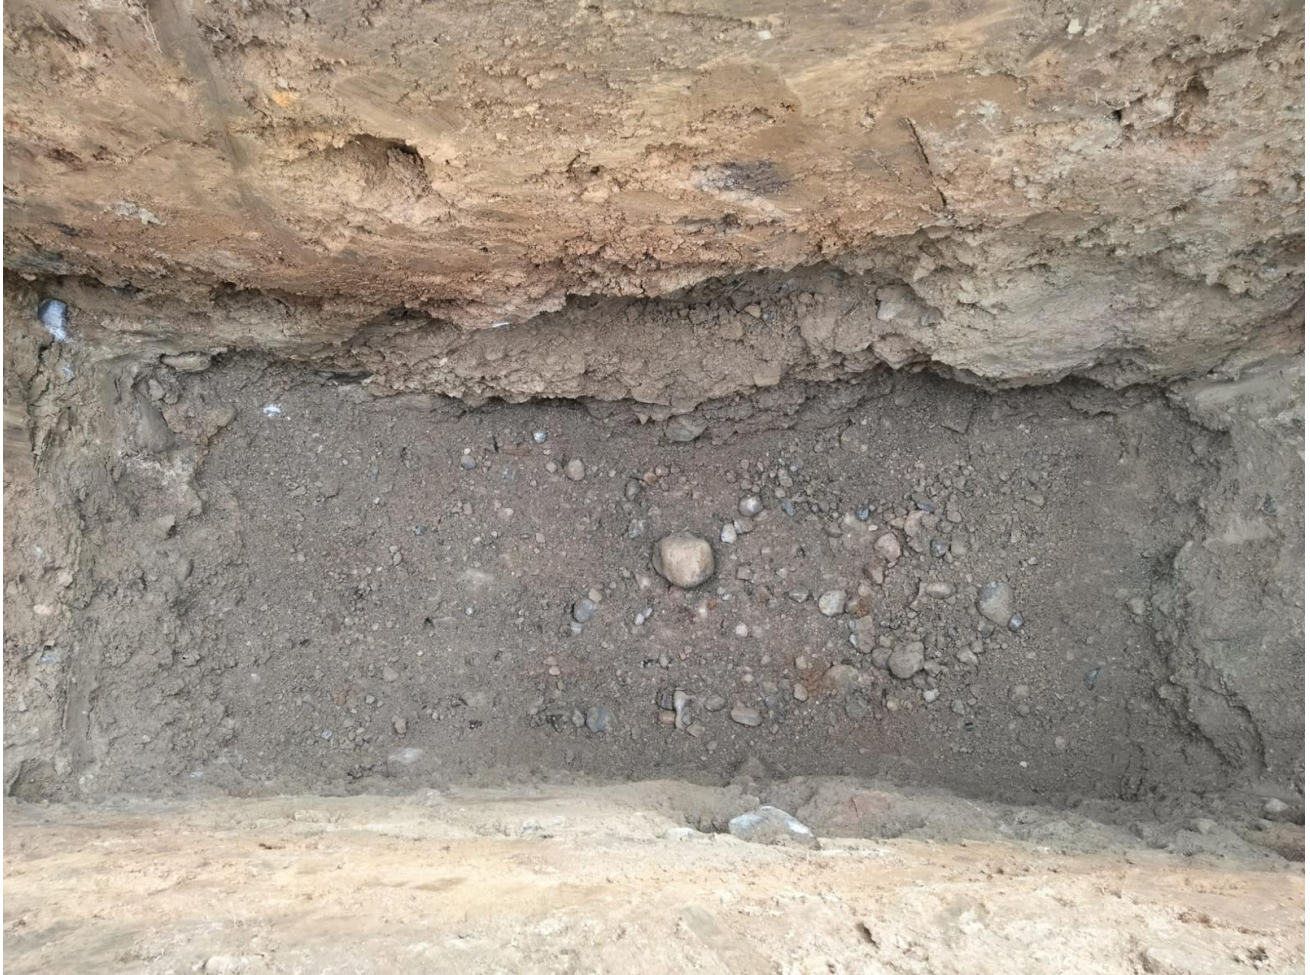
**TP1**

A trial pit (TP1) was excavated for infiltration testing at the grass lawn area to the northeast of the existing school building on 20<sup>th</sup> June 2024. The pit was excavated using a 3-tonne excavator, fitted with a 600mm wide bucket, to depths between 1.5m and 1.7m BGL.

Disturbed (small tub and bulk bag) samples were also taken at standard depth intervals and at change of strata. Groundwater was not encountered in the trial pit.

Appendix D presents the trial pit log with photographs of the pit and arisings provided in Appendix E.

| 0.00 - 0.20<br>0.00 - 0.20 | B1<br>D2 | | 74.36 | (0.20) | | TOPSOIL: Darker brown slightly sandy to sandy silty CLAY with occasional gravel and frequent rootlets, moist. | | |
| 0.20 - 0.80<br>0.20 - 0.80 | B3<br>ES4 | | | (0.60) | | Brown slightly gravelly sandy silty CLAY with occasional cobbles and small boulders and occasional rootlets, moist. Sand fine to coarse. Gravel fine to coarse. Gravel and cobbles subangular to subrounded predominantly grey to dark grey limestone. | | 0.5 |
| 0.80 - 1.30<br>0.80 - 1.30 | B5<br>D6 | | 73.76 | 0.80<br><br>(0.55) | | Yellowish brown slightly gravelly to gravelly sandy silty CLAY with medium to high cobble content and low small boulder content, moist. Sand fine to coarse. Gravel fine to coarse. Gravel and cobbles subangular to subrounded predominantly grey to dark grey limestone. | | 1.0 |
| 1.30 - 1.70<br>1.30 - 1.70 | B7<br>D8 | | 73.21 | 1.35<br><br>(0.35) | | Greyish brown slightly silty very sandy GRAVEL with high cobble content and low small boulder content, moist. Sand fine to coarse. Gravel fine to coarse. Gravel and cobbles subangular to subrounded predominantly grey to dark grey limestone and occasional black chert. | | 1.5 |
