# **Preliminary Report on Source Protection**

## **Kilmovee Urlaur Group Water Scheme County Mayo**

**Dr Elizabeth Ryder and Dr Alec Rolston**

**Centre for Freshwater and Environmental Studies  
Dundalk Institute of Technology**

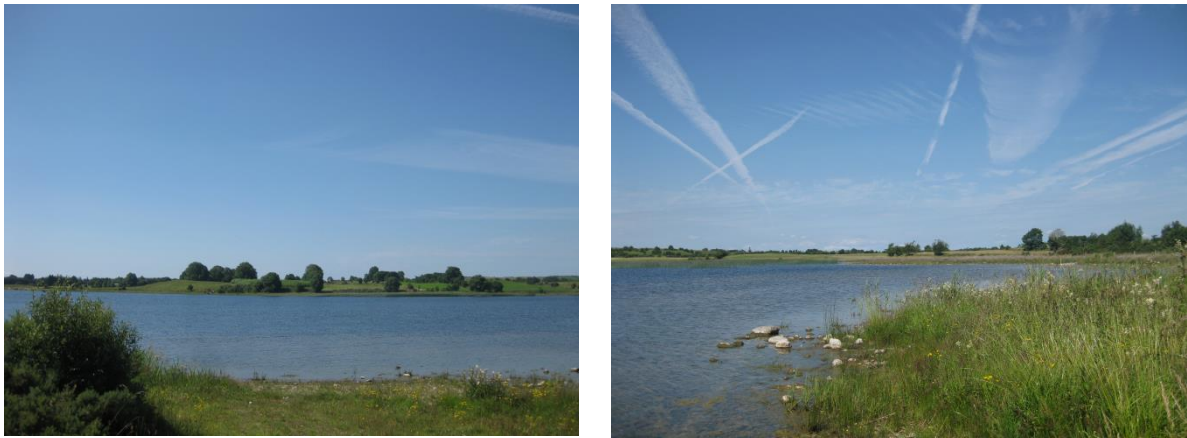
**Figure 1:** Site Location: Urlaur Lough.

Kilmovee Urlaur Group Water Scheme is a large scheme serving a population of approximately 1900 and is located in County Mayo, approximately 11 km south of Ballyhaunis, Co Mayo. The scheme extracts its water from the south of Urlaur Lough (Figure 1) beside Kilmovee Urlaur water treatment plant and reservoir. Urlaur Lough has a catchment area of 13.6 km<sup>2</sup> (Figure 2) and within the catchment there two are inflowing lakes into Urlaur Lough, Lough Roe and Lough Nanoge. The EPA Water Framework lake waterbody status 2010-2015 for Lough Roe and Lough Nanoge is unassigned and the lake waterbody status for Urlaur Lough is 'Bad' (<http://gis.epa.ie/Envision>). There is one main out flowing river from Urlaur Lough, which joins the Lung River before joining Lough Gara. Pressures within the catchment are primarily agricultural; particularly surrounding Urlaur Lough. Other pressures within the Kilmovee Urlaur catchment may include domestic wastewater treatment systems in areas High groundwater vulnerability.

Urlaur Lough has a surface area of 1.15 km<sup>2</sup>, with a mean depth of 4 m and a maximum depth of 11 m. Water is abstract from Lough Urlaur (10 m from the water treatment plant) from the intake pipe at a depth of approximately 1.5 m. The lake is categorised as typology type 10 (as designated by the EPA for the purposes of the Water Framework Directive), i.e. shallow (<4 m), less than 50 ha and high alkalinity (>100 mg/l CaCO<sub>3</sub>). Urlaur Lough is an Annex I list of the EU Habitats Directive as a

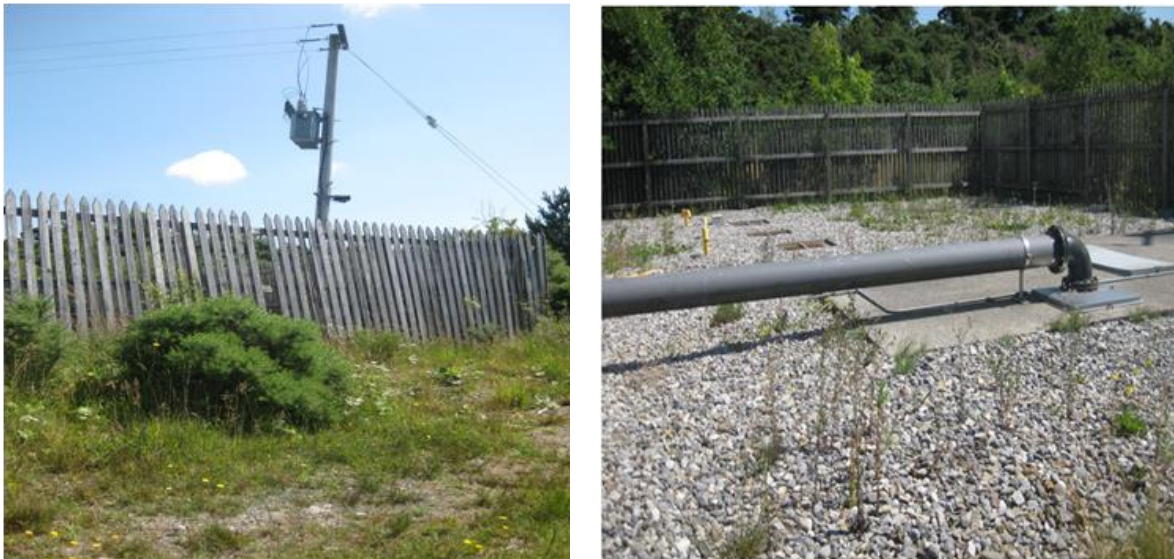
The dilapidated fencing surround the Kilmovee Urlaur water treatment plant and grounds, including the area over the underground water storage tanks is not adequate to ensure site security and needs immediate attention. Kilmovee Urlaur GWS raised concern of the potential public access to the grounds water treatment plant.

Figure 35: The dilapidated timber fencing surrounding the Kilmovee Urlaur water treatment plant.

Immediate attention is required to ensure on site security. It is recommended that palisade fencing replaces the existing dilapidated timber fencing currently surrounding the Kilmovee water treatment plant and grounds.
