# Tender Information Memorandum for Procurement of a Consultancy Team:

## Kildare County Council (KCC) Former Newbridge Machinery Yard Phase 2 Site Remediation Assessment and Remediation Project Enablement Services

## PHASE 1 ENVIRONMENTAL SITE ASSESSMENT

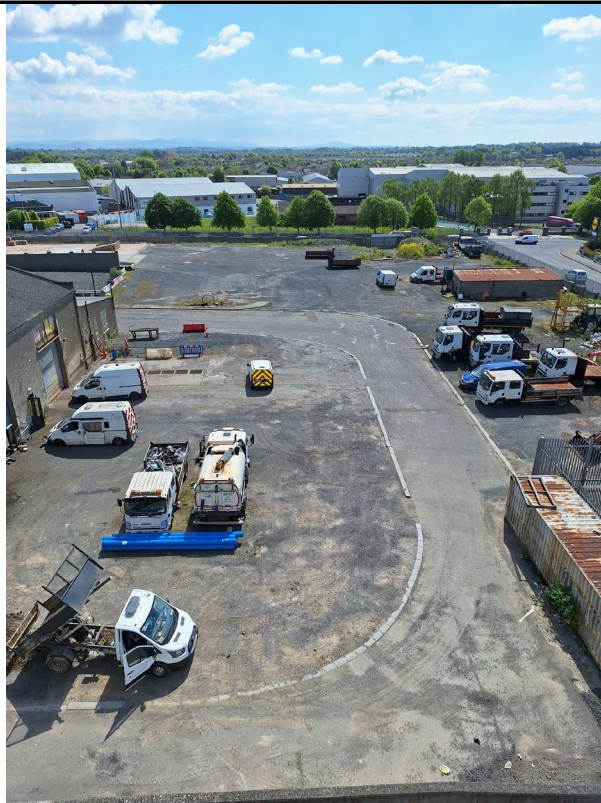
Image 1: View of central, south and western areas of the site, from northern boundary, facing south. Workshop building visible on left, Athgarvan road visible in

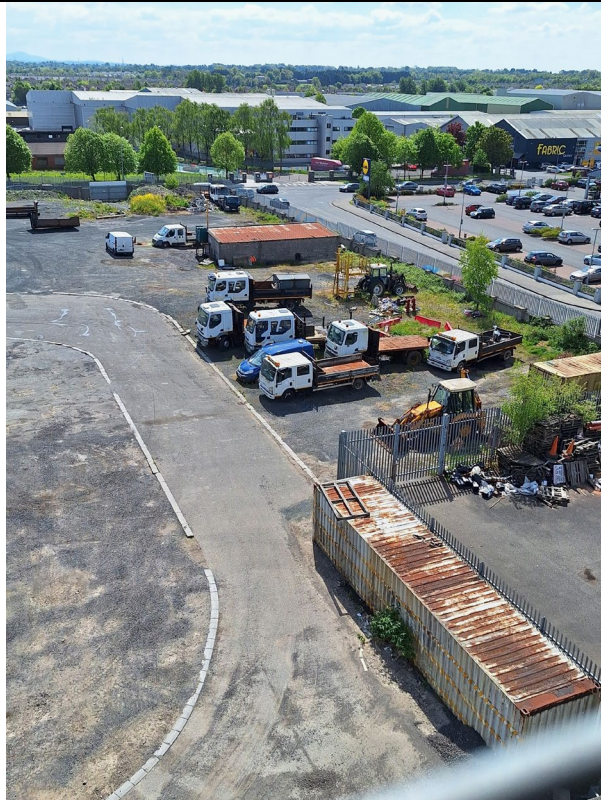
Image 2: View of western portion of site, from northern boundary, facing south. External storage yard and vehicle storage visible on right, commercial property beyond.

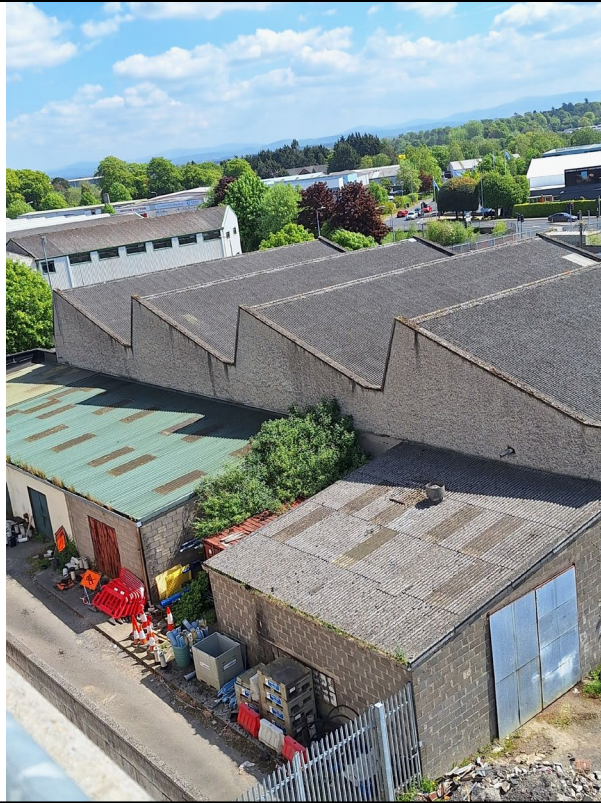
Image 3: View of main workshop building at northeast of site, from northern boundary, facing southeast. External Water Dept. storage yard visible in foreground.

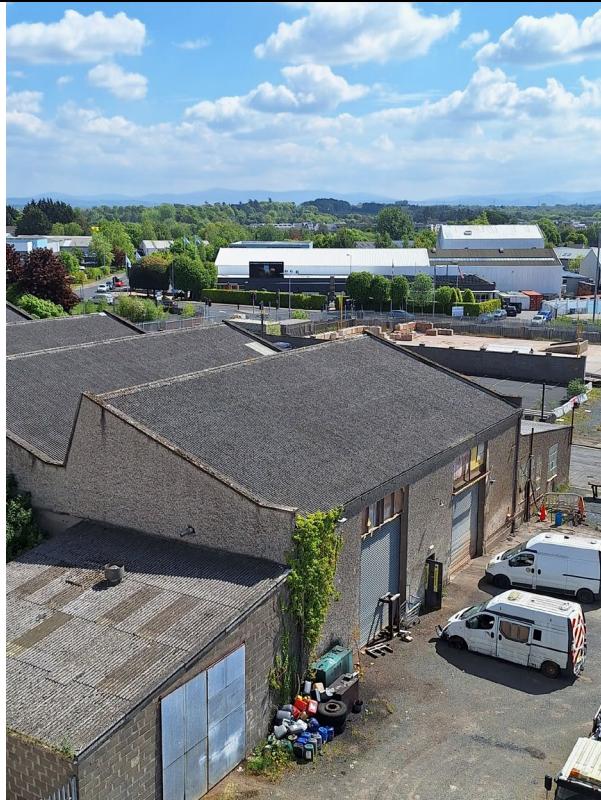
Image 4: View of west of main workshop building, from northern boundary, facing southeast. Waste oil tanks and drums visible in foreground.

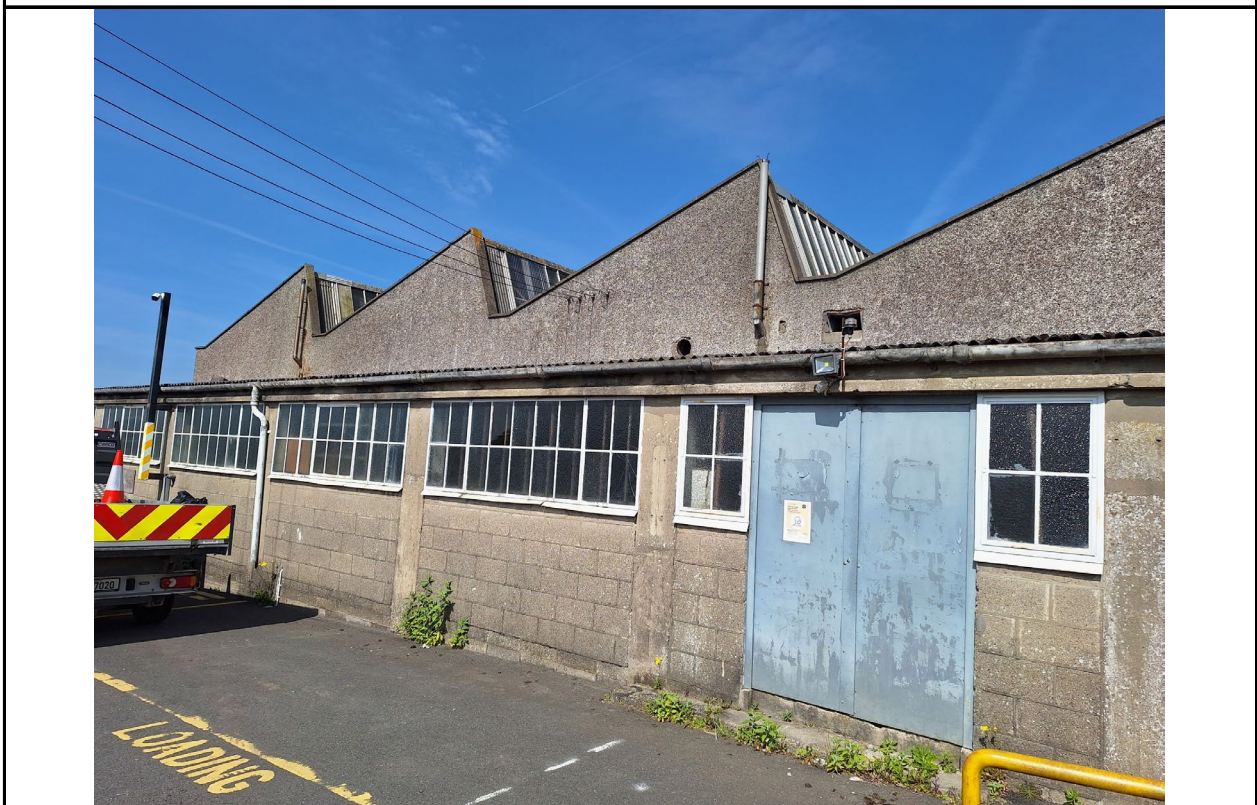
Image 8: View of southeast of workshop building, from entrance road, facing northwest. Concrete block wall construction and sawtooth corrugated roofing visible.

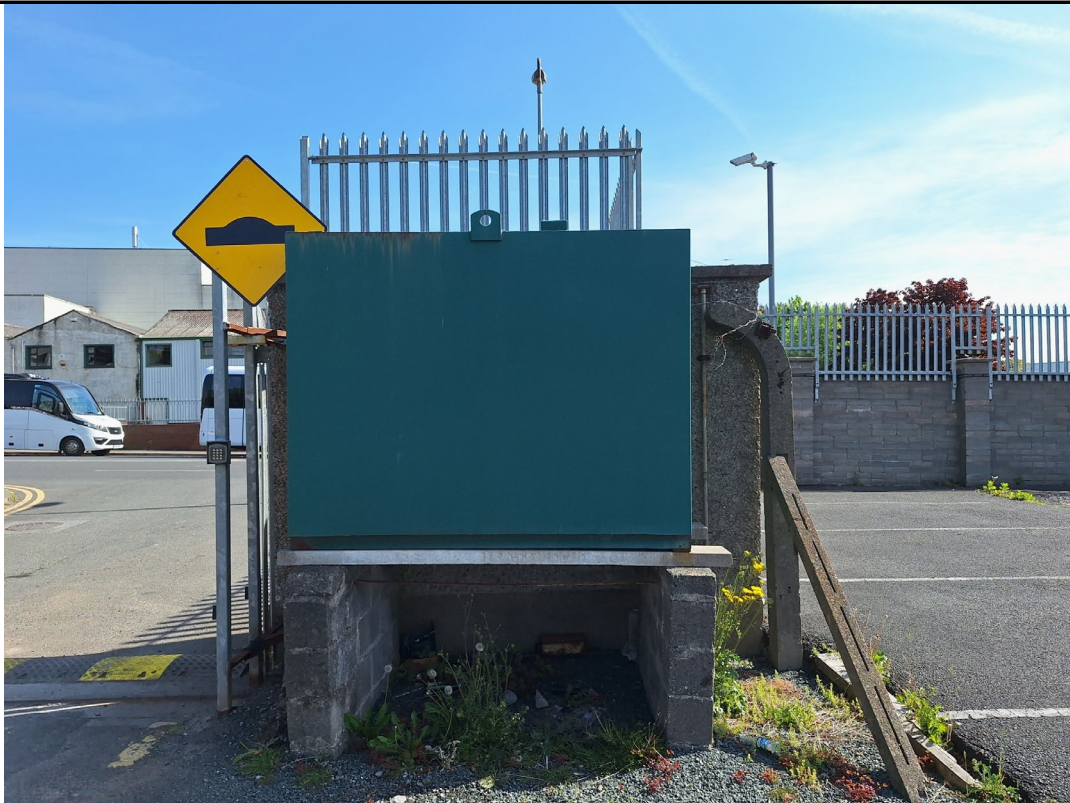
Image 9: View of heating oil aboveground storage tank (AST) adjacent to main site entrance gate, approx. 1,200-litre volume, steel construction.

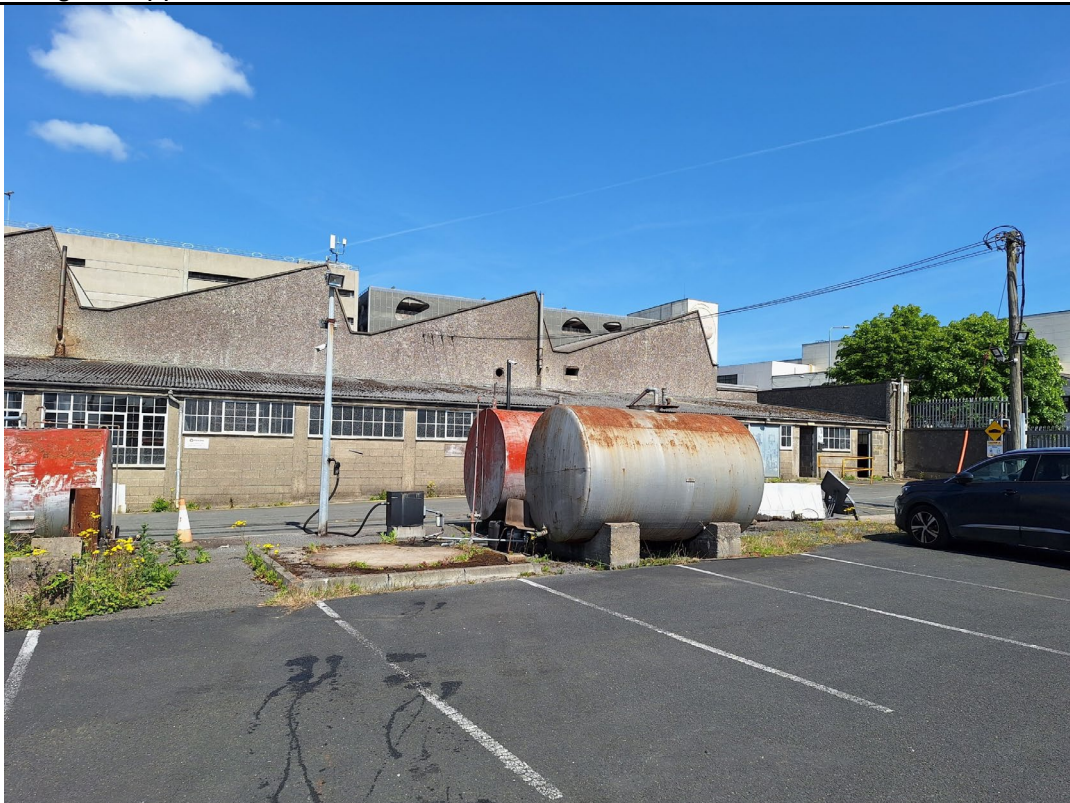
Image 10: View of southeast of workshop building with 3 No. aboveground storage tanks and fuel pump visible. Tanks each approx. 5,000-litre, 2 No. diesel (right), 1 No. green diesel.

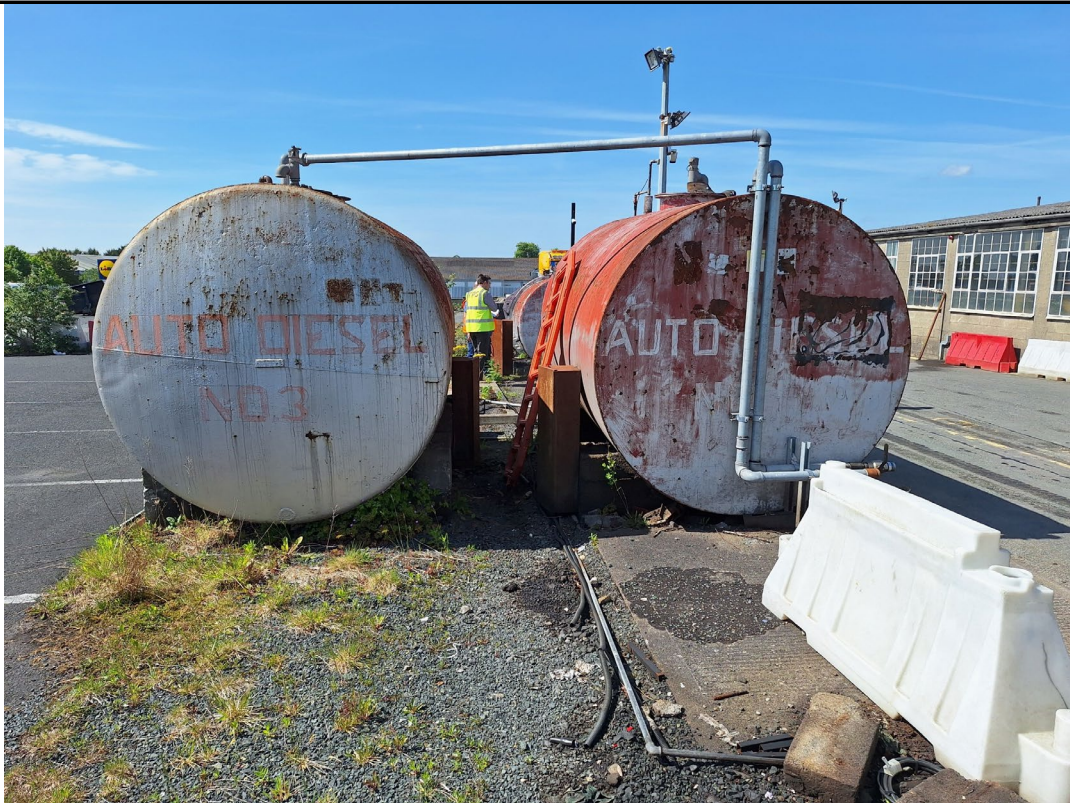
| Area No. | Description/Main Activity | Notes |
|---|---|---|
| 11 | Fuel Storage | Three steel aboveground storage tanks (ASTs) two diesel and one green diesel are located inside the entrance gate. The tank farm is in poor condition with no bunds, staining present, no interceptors, and no protective measures. Pumps and tubing are exposed at ground level. |

Image 11: View of 2 No. diesel AST (5,000-litre approx) south of workshop building, facing west. Tanks of steel construction, un-bunded, un-protected, ground staining evident.

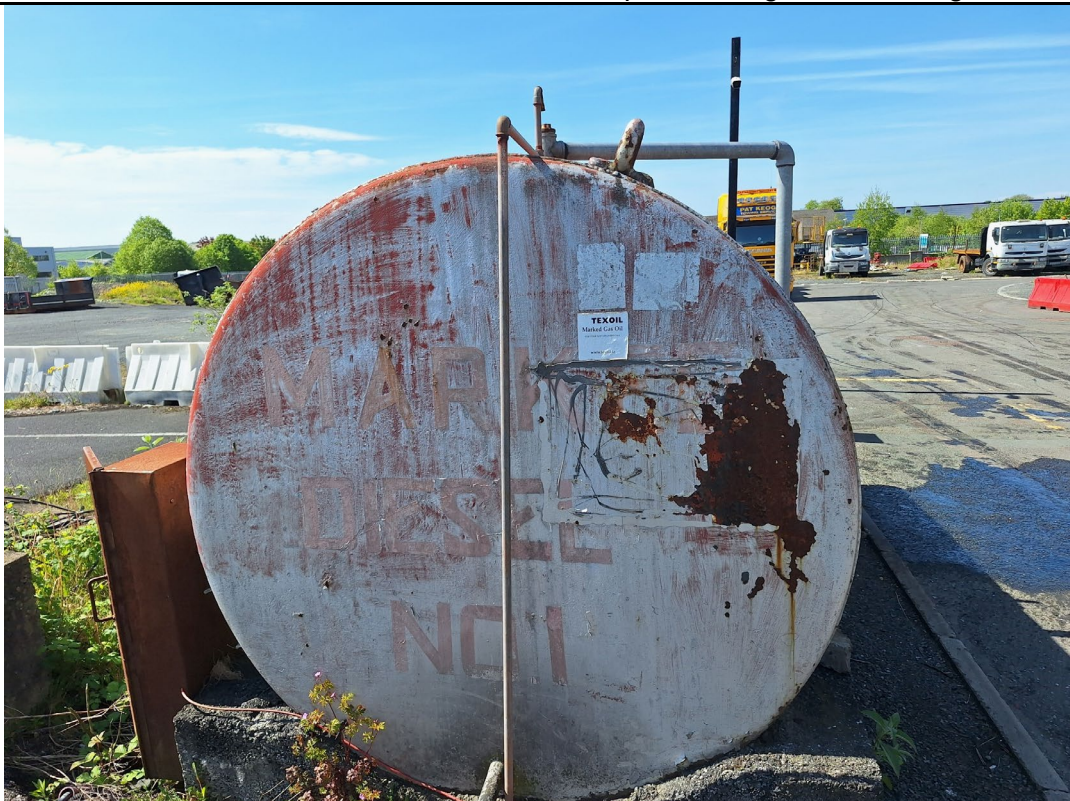
Image 12: View of green diesel AST (5,000-litre approx.) located south of workshop, facing west. Concrete plinth visible at base, un-bunded, ground staining observed.

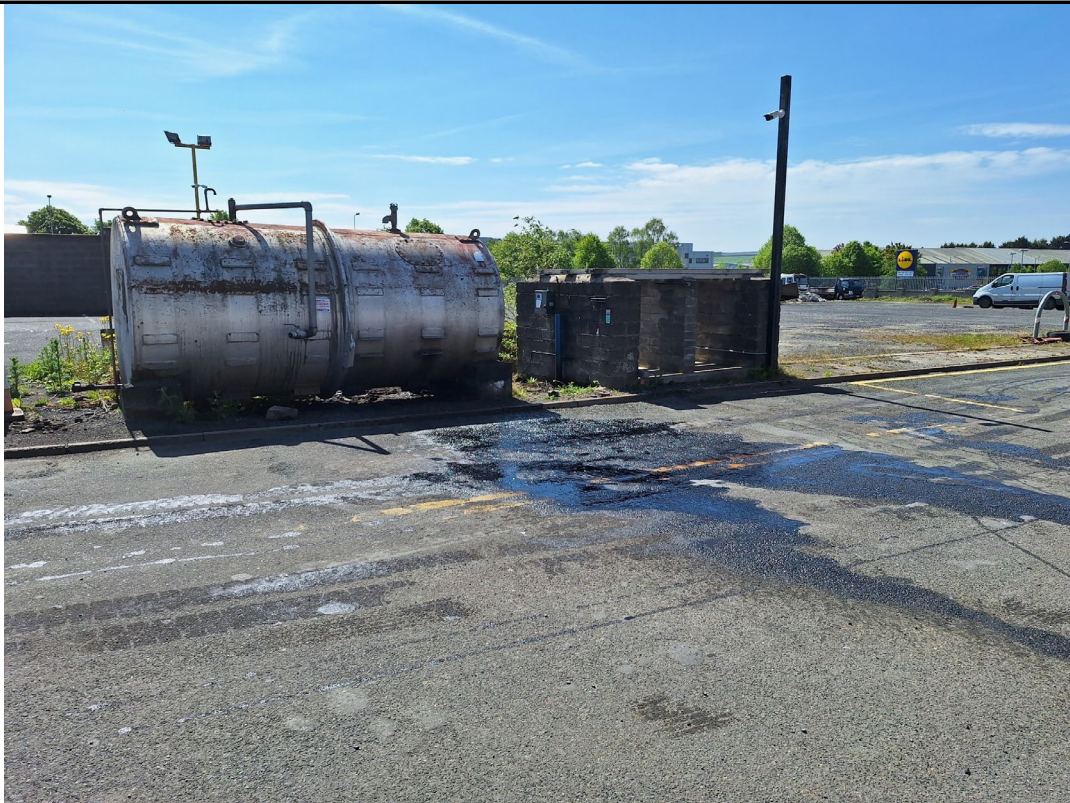
Image 13: View of green diesel AST and concrete block tank plinth south of workshop, facing south. 1 No. 4,500-litre approx. AST (diesel) removed from plinth during audit.

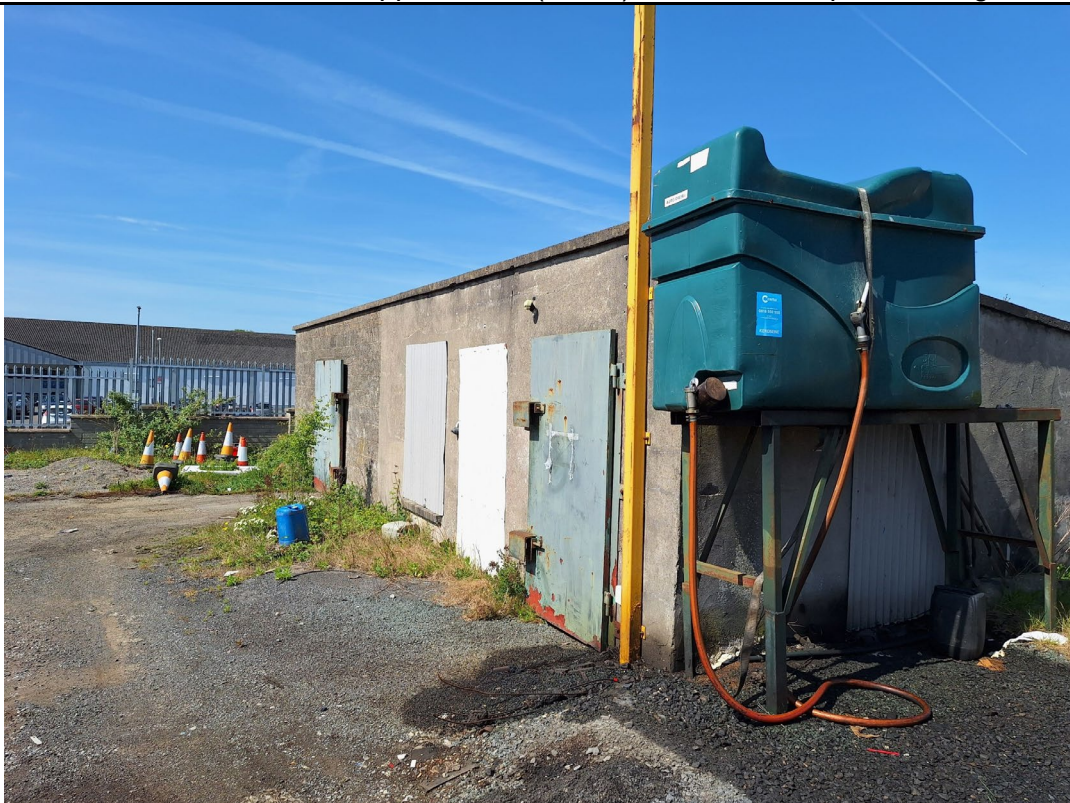
Image 14: View of 1 No. 1,200-litre approx. AST (diesel) adjacent to storage shed at western site boundary, facing west. No bunding, ground staining observed.

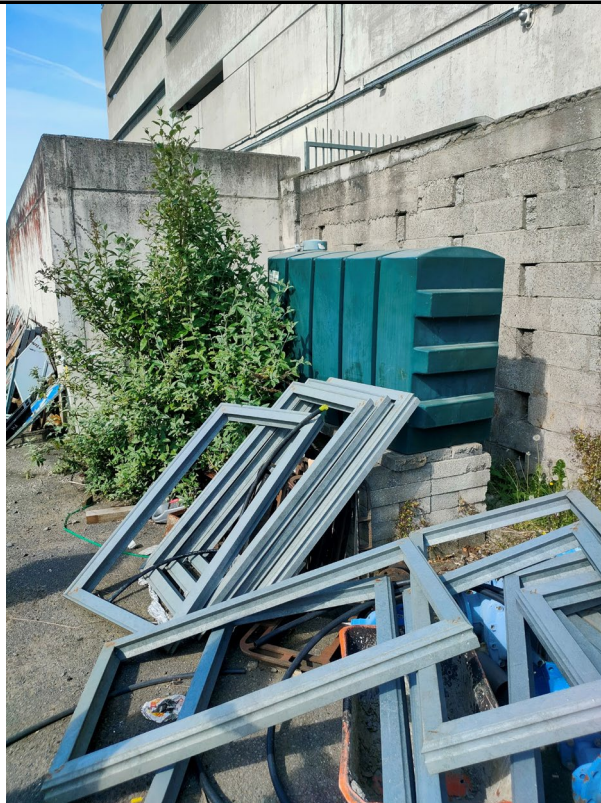
Image 15: View of 1 No. 1,200-litre approx. AST (heating oil) located in Water Dept exterior yard, northern site boundary, facing northwest. Un-banded, on concrete block base.

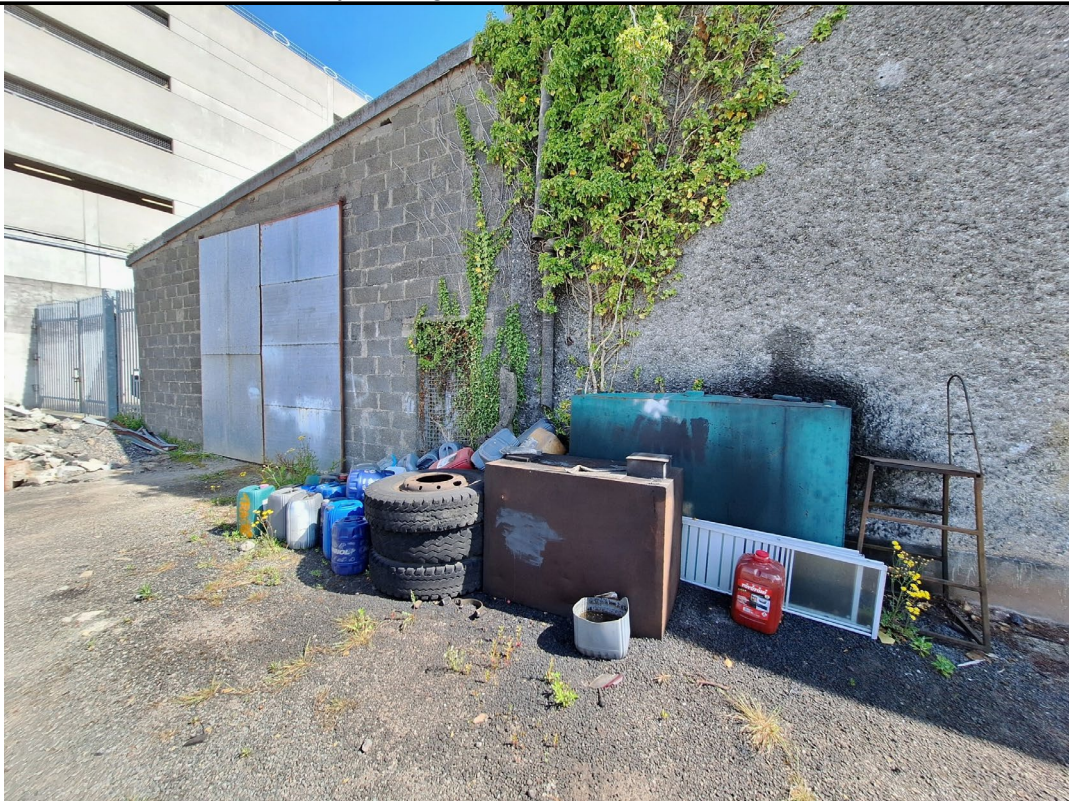
Image 16: View of waste material located adjacent to northwest of workshop. 2 No. disused oil storage tanks and various 20-litre oil containers observed.

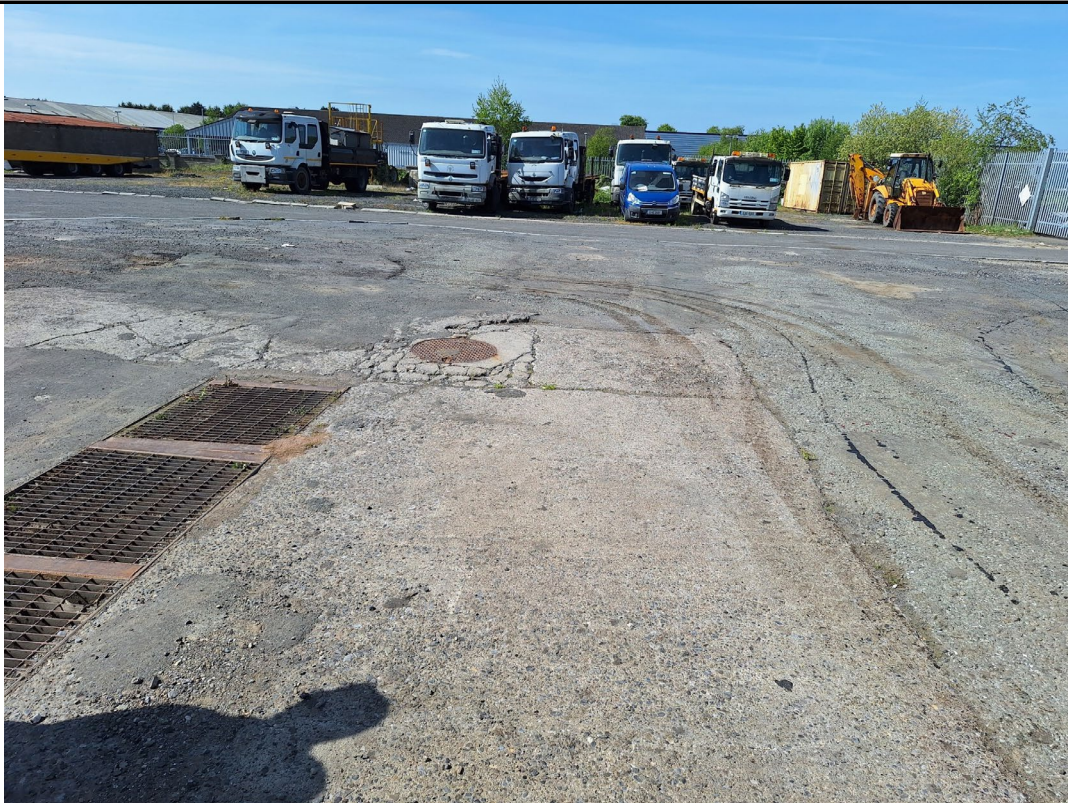
Image 17: View of northwest of site, facing southwest. Catch-pit visible on left in former wash-down area. Broken concrete and asphalt ground surface typical of site exterior.

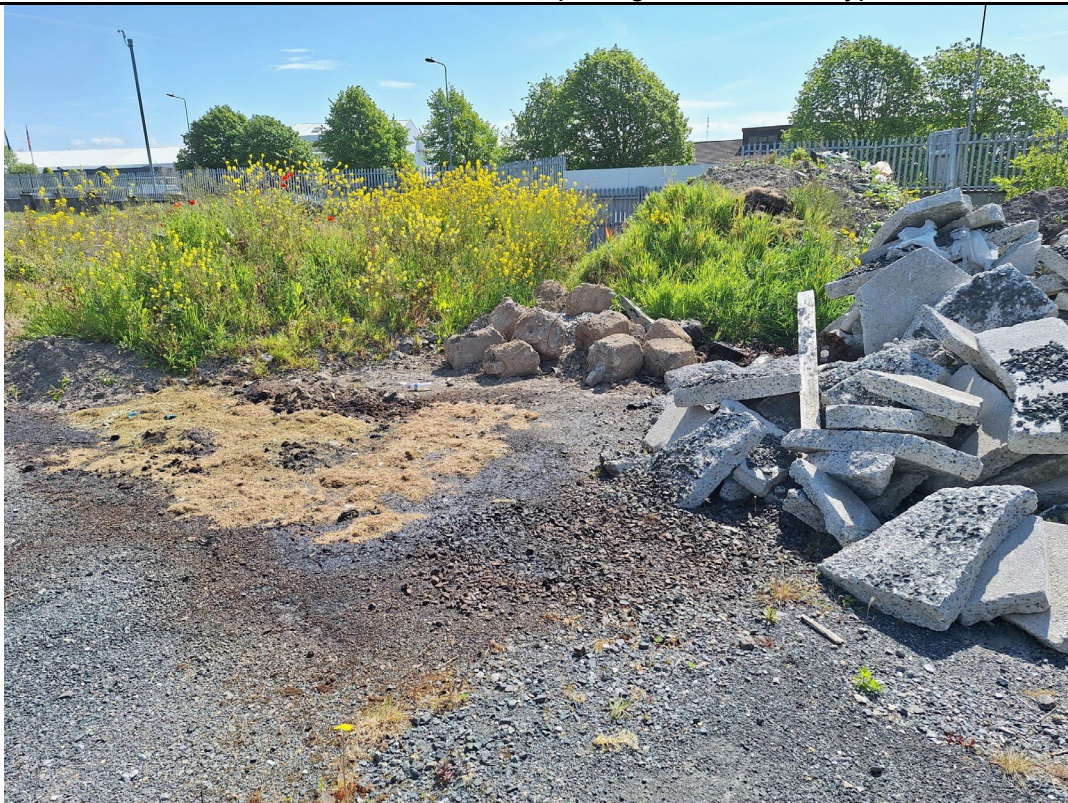
Image 18: View of waste material stockpiled at southern corner of site, facing south. Soil, stone, concrete, aggregate, sand, plastic piping and metal visible.

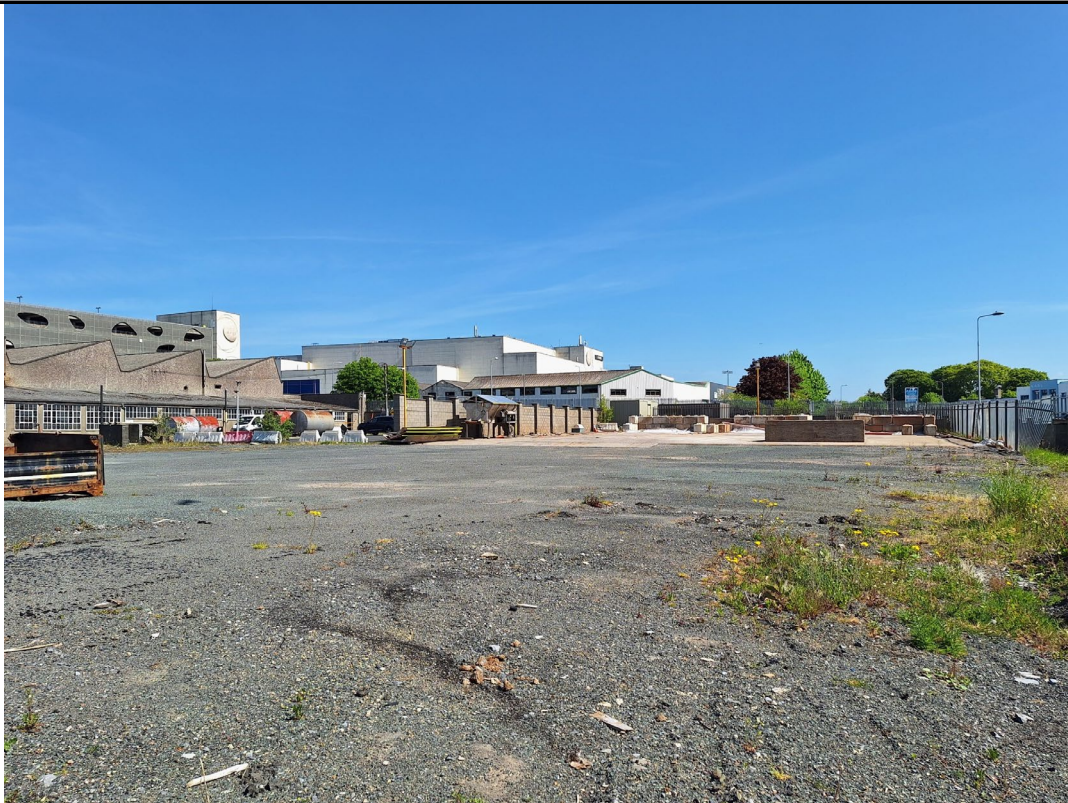
Image 19: View of southern portion of site, from southwest corner, facing northeast. Gravel/broken asphalt yard in foreground, salt storage area in background.

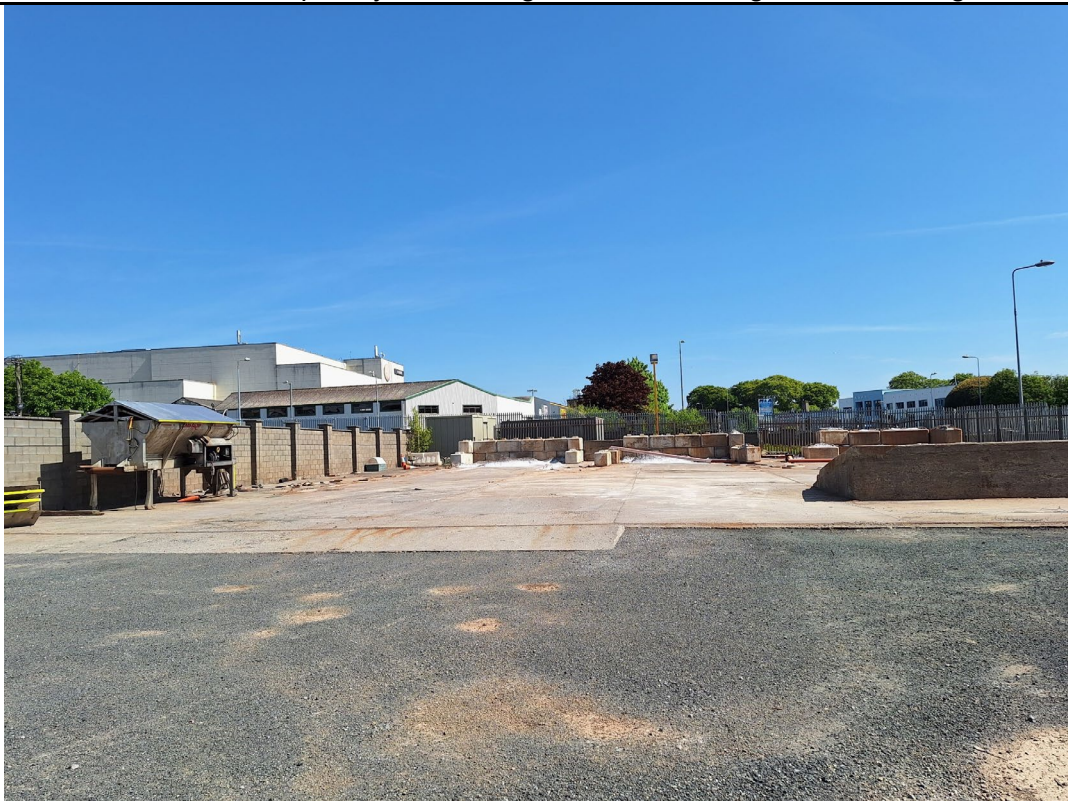
Image 20: View of former salt storage area at southeast of site, facing east. 3 No. empty uncovered storage bays visible in background on concrete hardstanding.

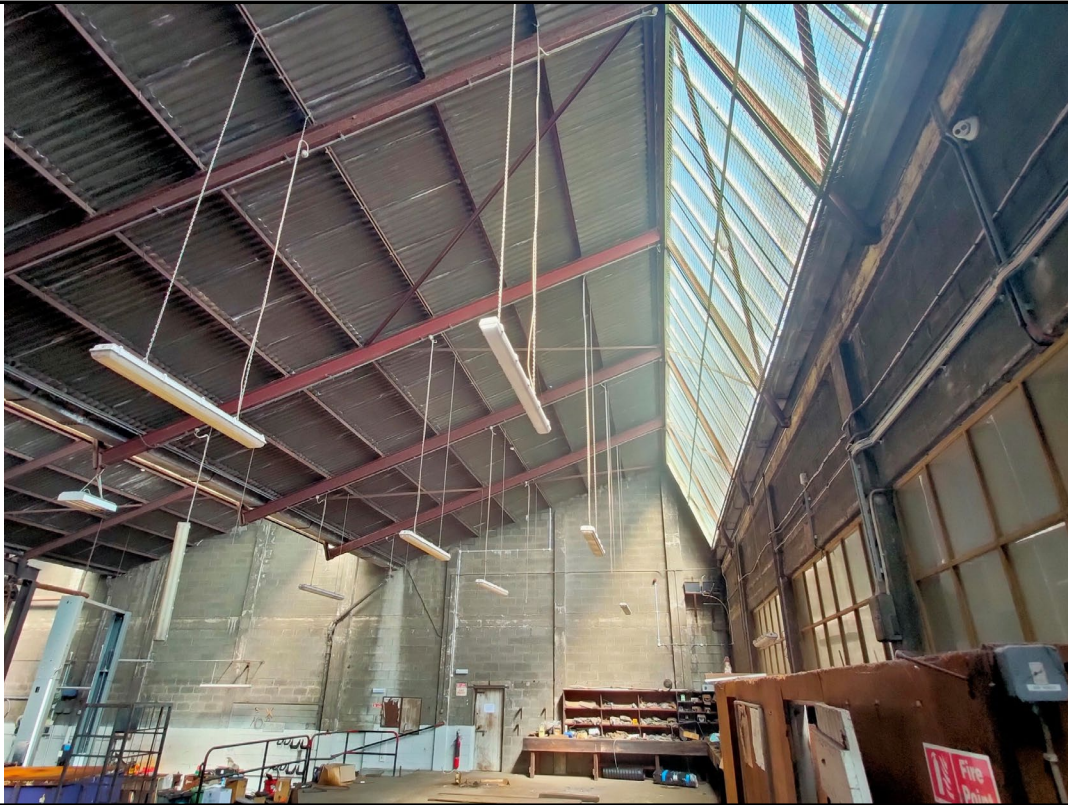
Image 21: View of interior of workshop building, facing north. Offices visible on right. Previous machining work area visible in centre.

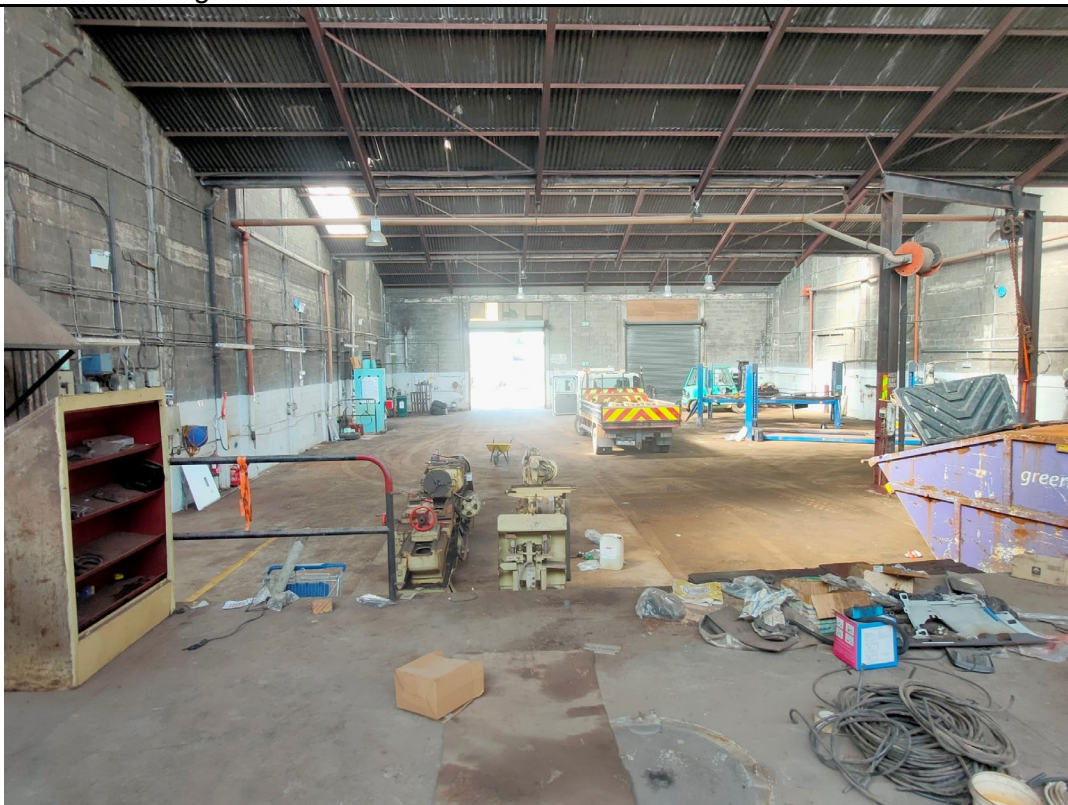
Image 22: View of interior of workshop, facing east. Roller shutter doors visible in background, disused lathes in centre awaiting removal, waste skip visible on right.

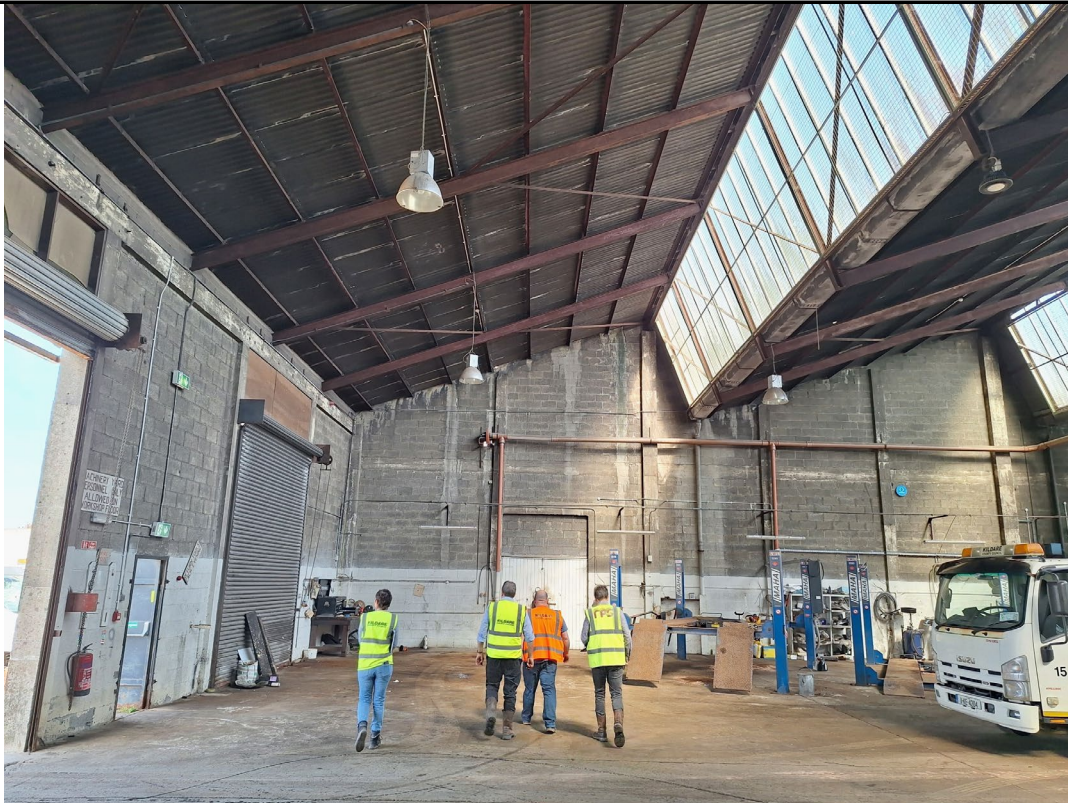
Image 23: View of workshop interior, eastern side, facing north. Roller shutter doors visible on left, 2 No. hydraulic vehicle inspection lifts visible on right, concrete floor

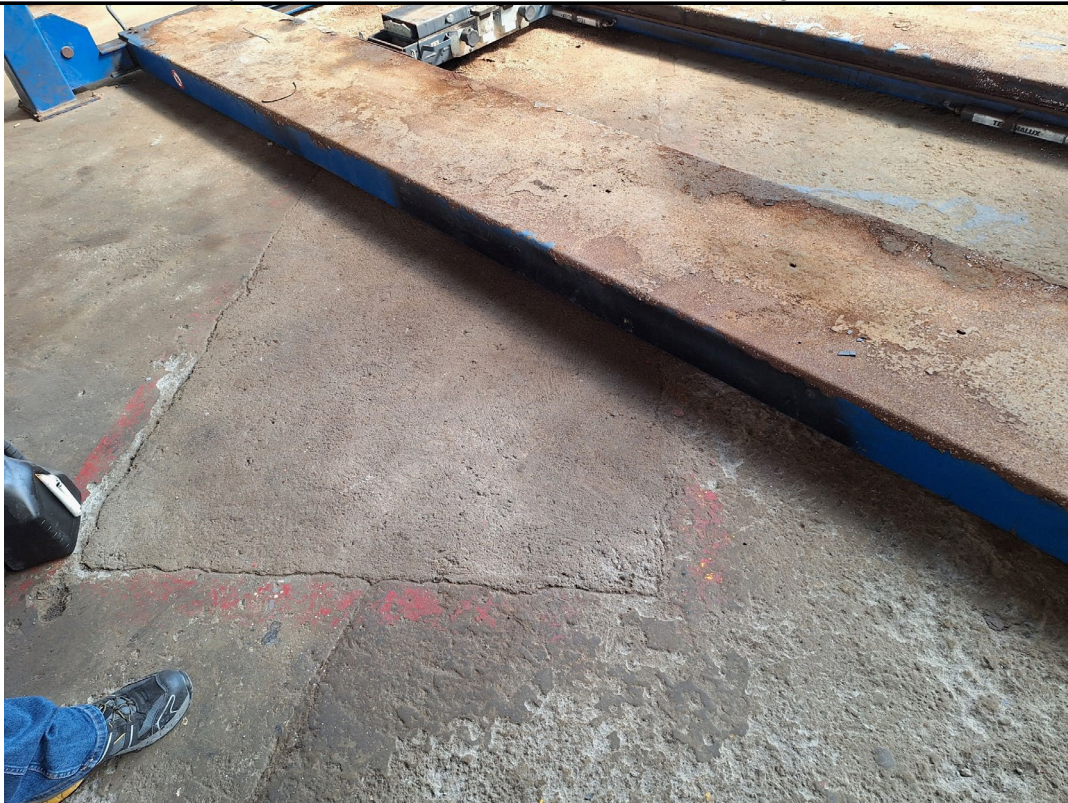
Image 24: View of concrete scar at location of infilled former inspection pit in workshop. 3 No. infilled inspection pits are located within workshop.

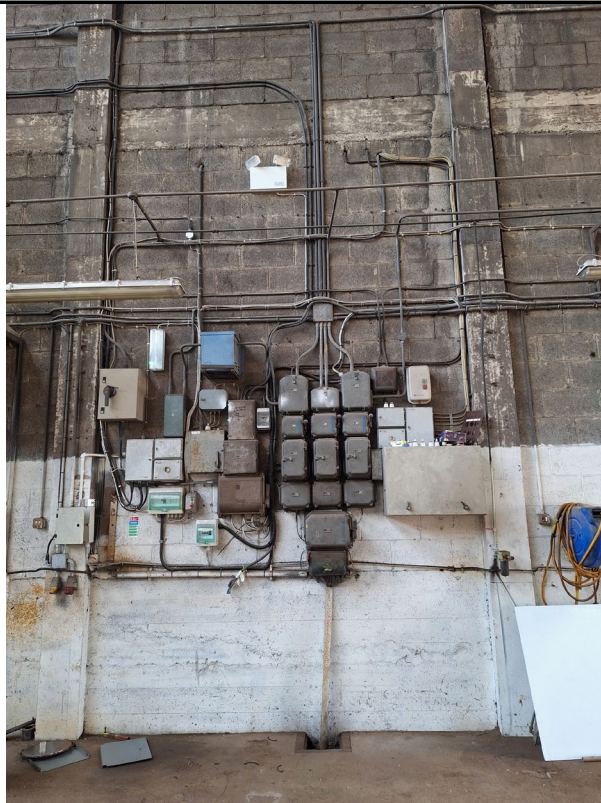
Image 25: View of electrical fuse boxes and circuit breaker panels on south interior wall of workshop building.

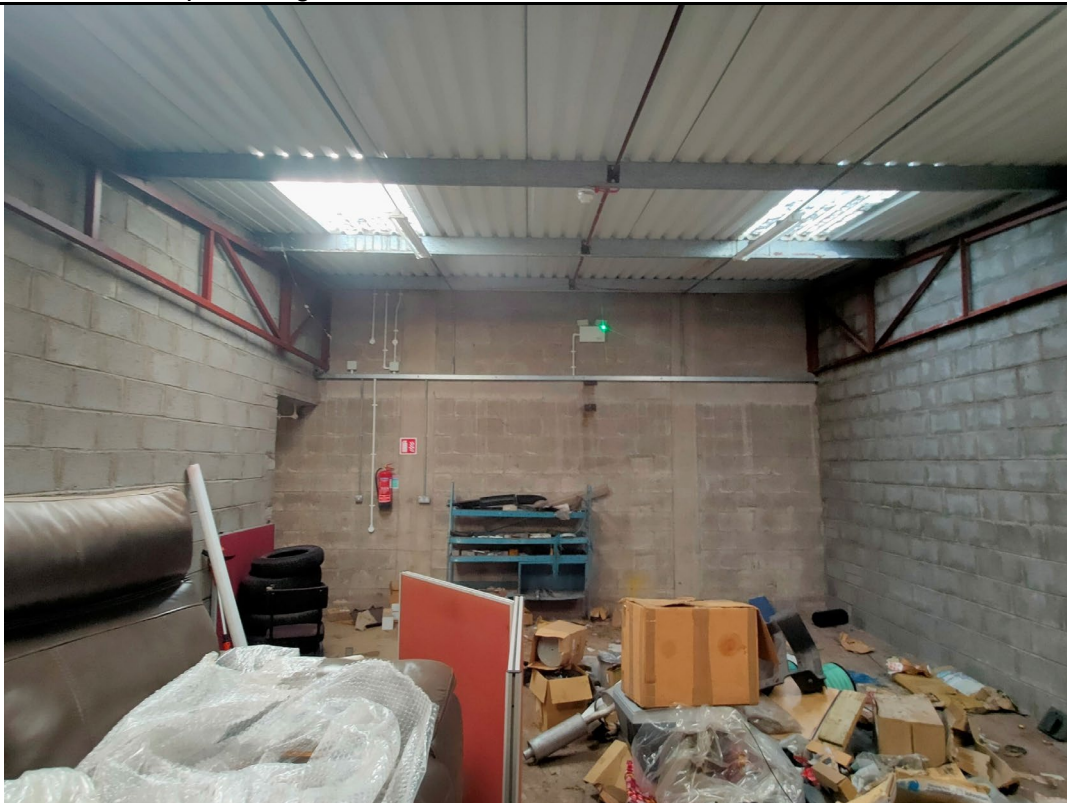
Image 26: View of store room located to north side of main workshop area, block walls, steel framed roof with corrugated aluminium sheeting.

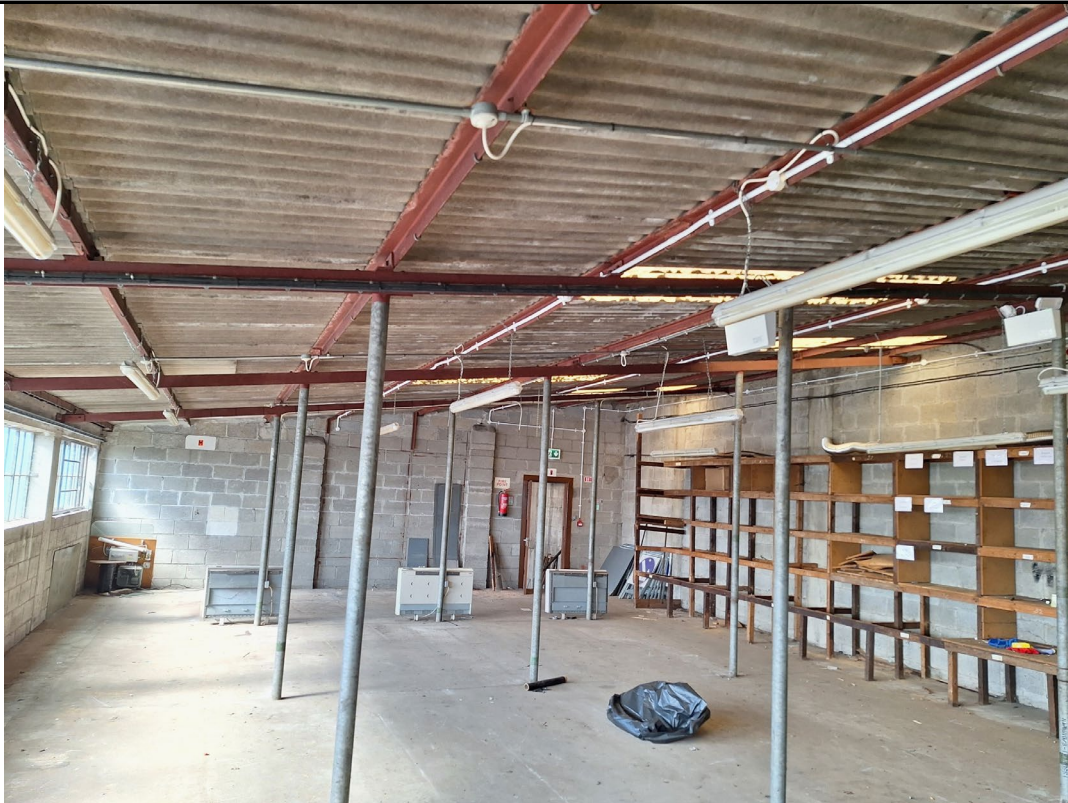
Image 27: View of small stores room located on south side of main workshop, concrete flooring, block walls, steel roof beams supported by narrow diameter circular metal

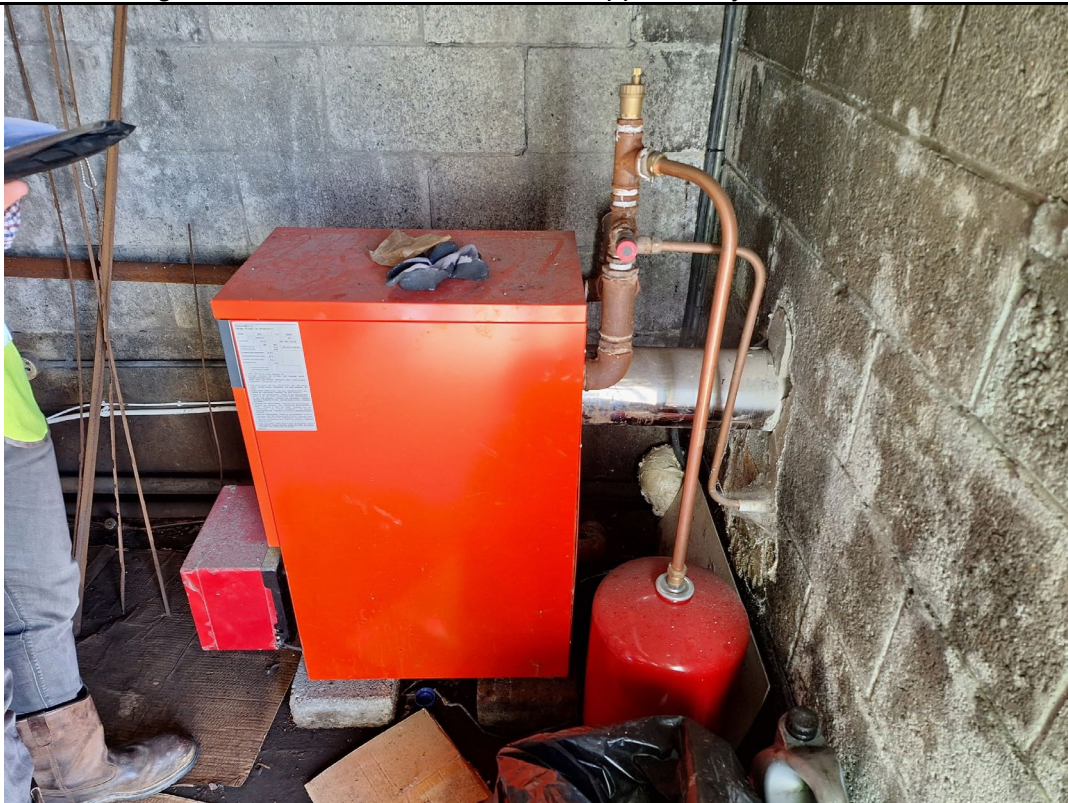
Image 28: View of oil-fired boiler in separate boiler room located at northeast of main workshop.

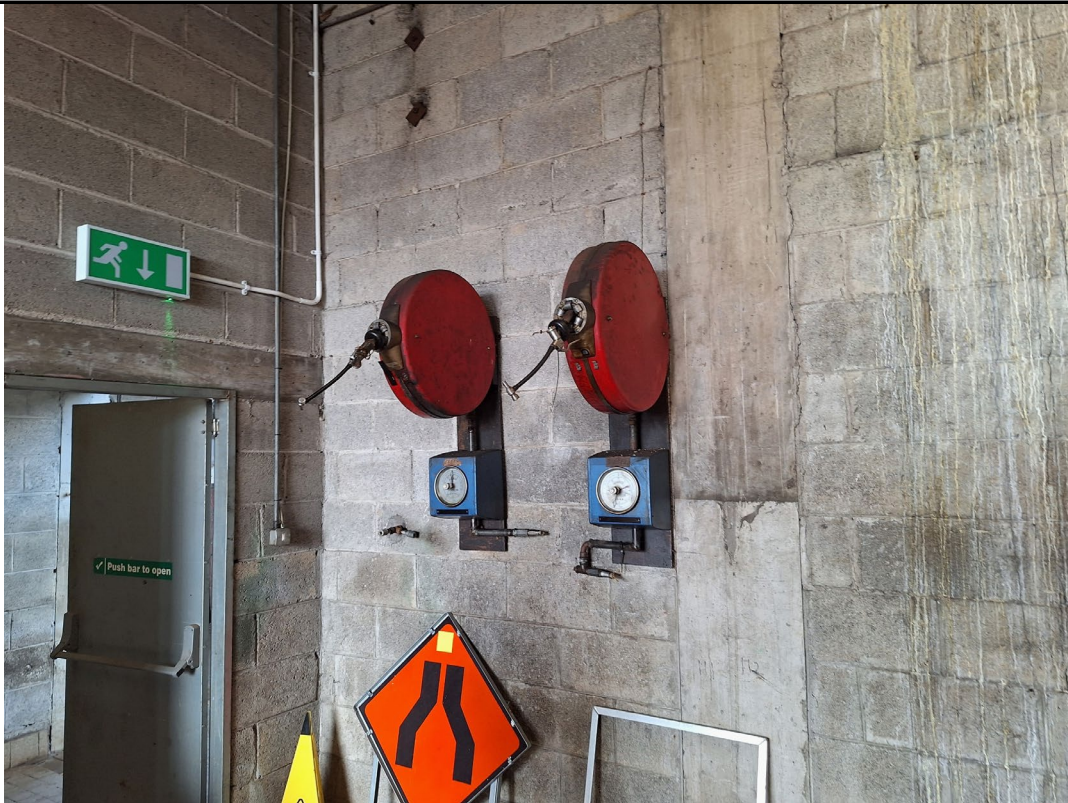
Image 29: View of interior wall mounted oil / fuel dispensers and gauges located on east side of workshop.

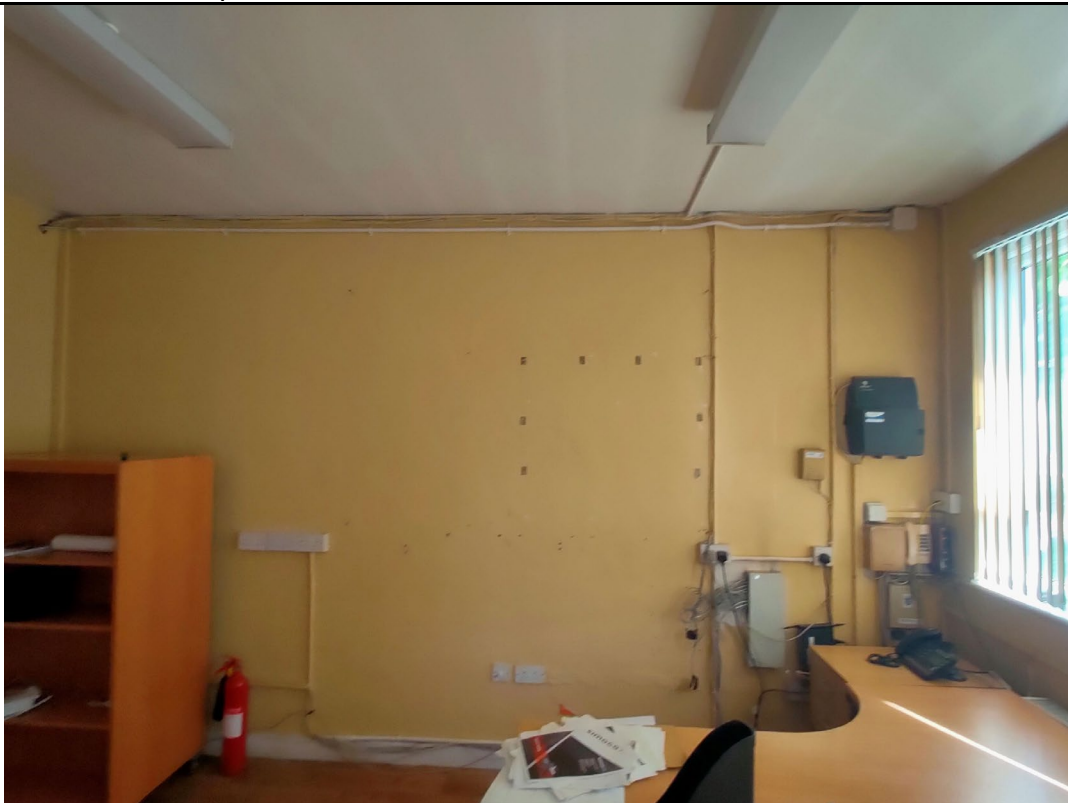
Image 30: View of typical office space on eastern side of main building. Laminate wood flooring, plastered block walls and ceiling, fluorescent lighting throughout.

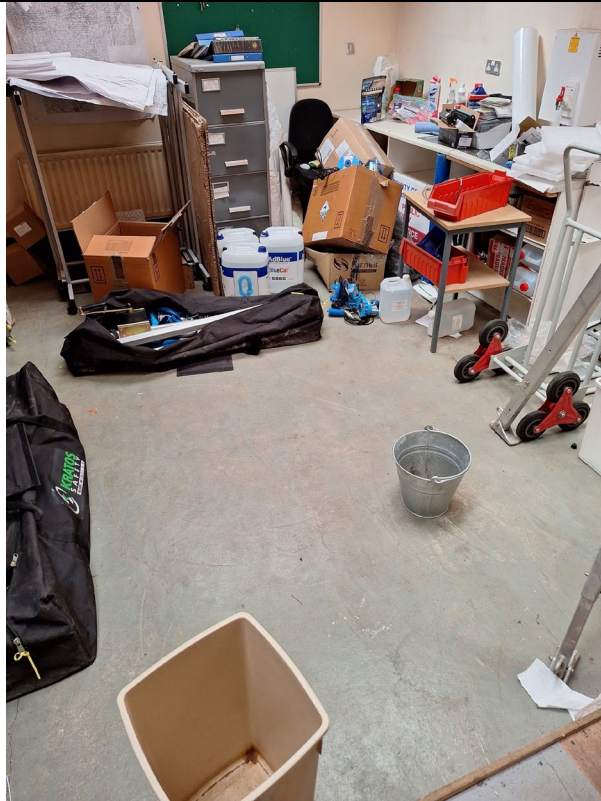
Image 31: View of Uisce Eireann interior store room, adjacent to UE offices at north of site. Painted concrete/screen flooring, plastered block walls, wood panel ceilings.
