# Tender Information Memorandum for Procurement of a Consultancy Team:

## Kildare County Council (KCC) Former Newbridge Machinery Yard Phase 2 Site Remediation Assessment and Remediation Project Enablement Services

## PHASE 1 ENVIRONMENTAL SITE ASSESSMENT

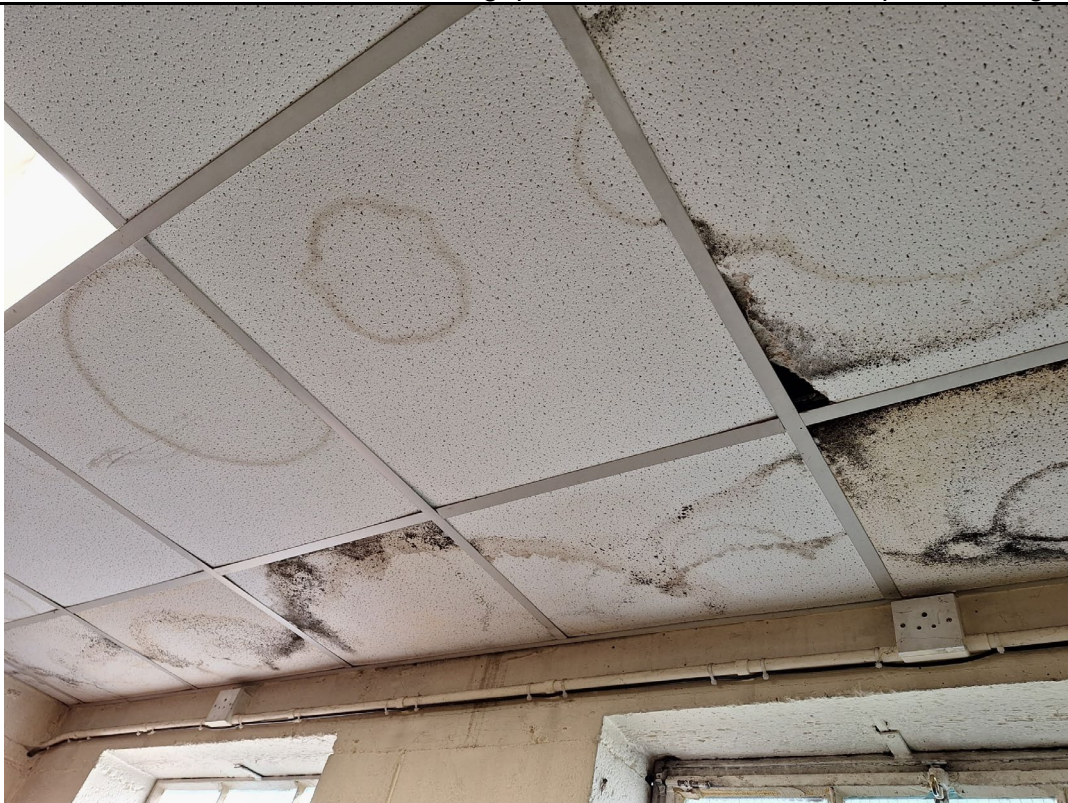
Image 32: View of ceiling in workshop kitchen / canteen, with water damage and mold visible on drop ceiling tiles and painted block walls.

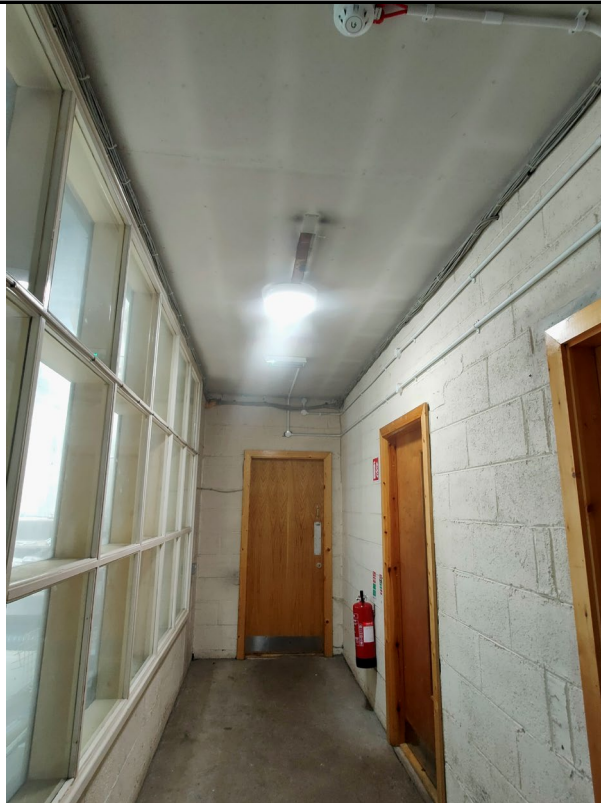
Image 33: View of interior corridor between workshop (left side) and Kildare County Council offices (right side). Polished concrete flooring, painted block walls, glass partition.

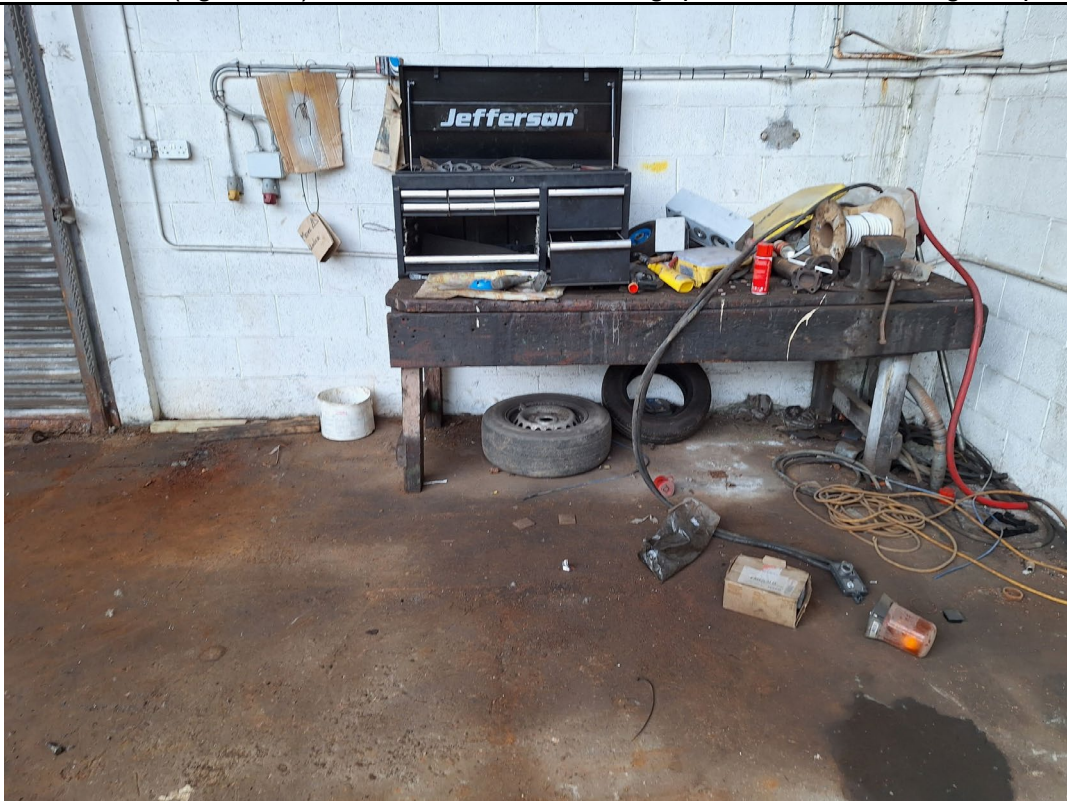
Image 34: View of disused workbench in main workshop with staining of concrete ground surface visible.

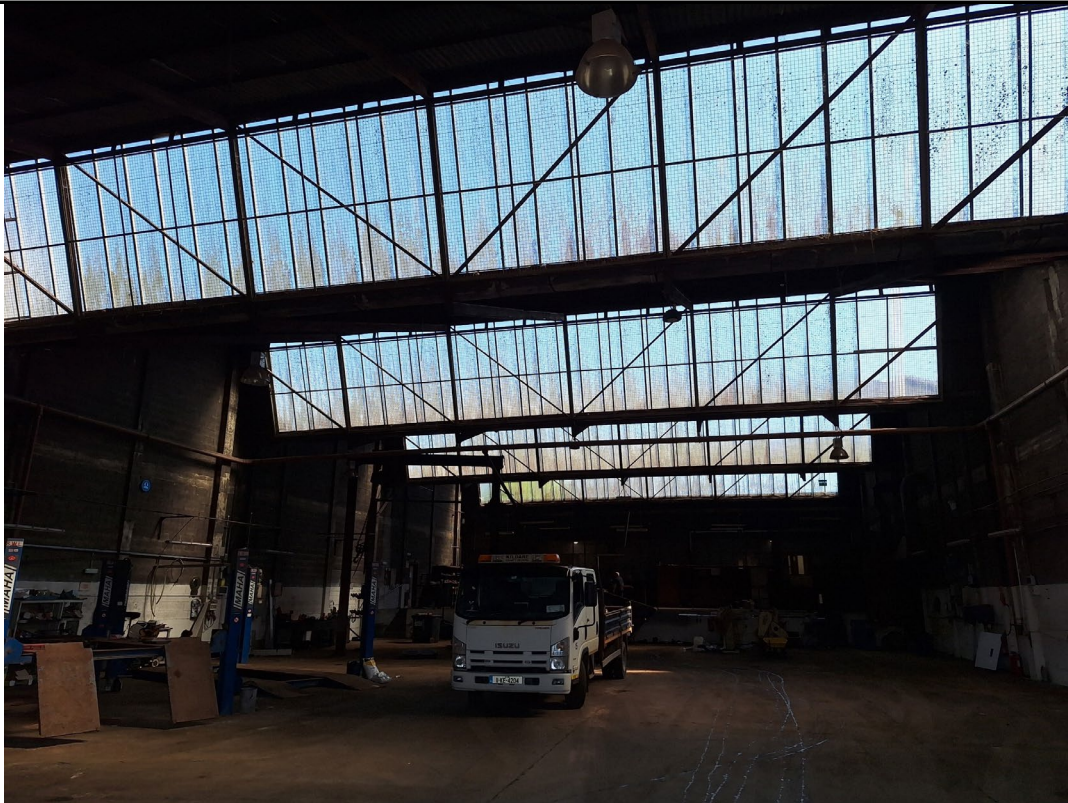
Image 35: View of main workshop, from western side, facing northeast. Hydraulic lifts visible on left, clear roofing panels and steel cross-beams also visible.

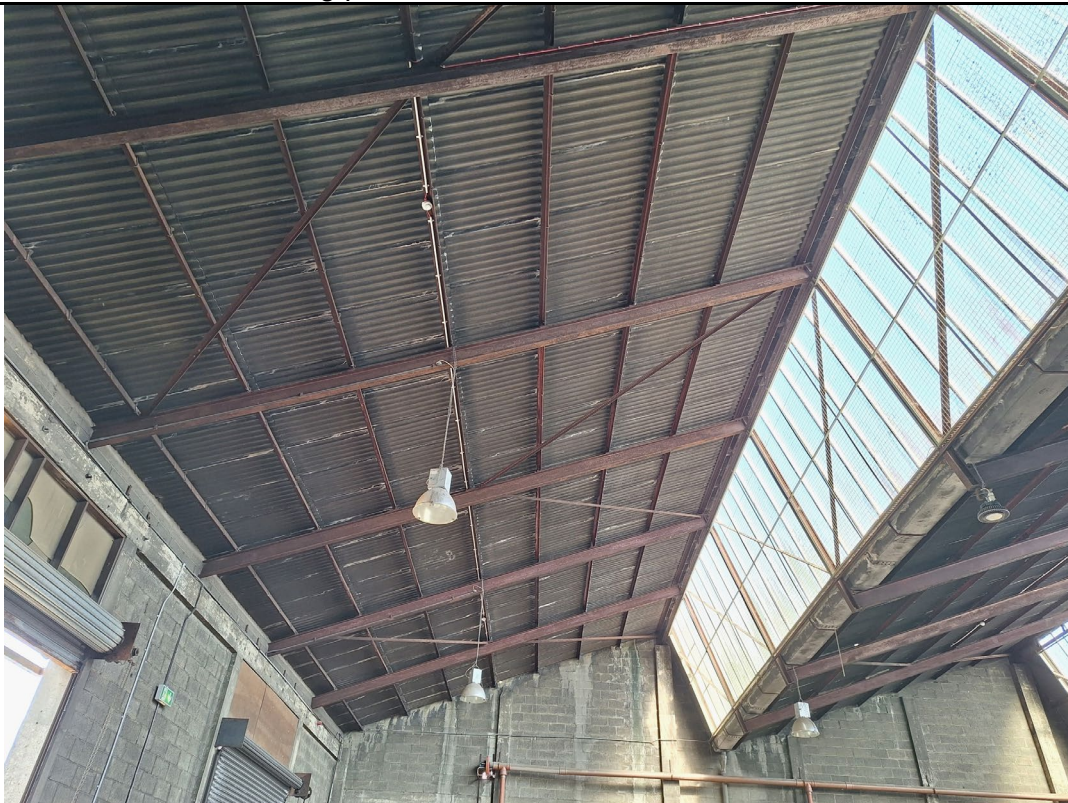
Image 36: View of roof of workshop building, from western entrance, facing north. Roof construction consists of steel beams supported on concrete columns.
