SURVEY, SAMPLING AND ASSESSMENT FOR ASBESTOS CONTAINING MATERIALS

Castlejordan Central National School

LMETB

Report Date: October 2025

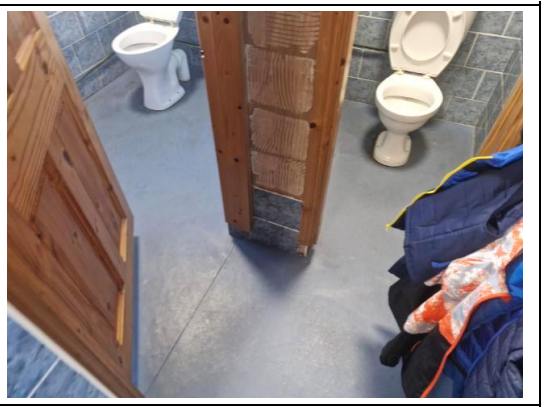
Type	Chrysotile
Material	Mastic and vinyl floor tiles beneath lino Bituminous Product
Location	Castlejordan Central National School Ground Floor Classrooms 002
Quantity	Non quantifiable
Sample No.	Strongly Presumed
Date	06/10/2025
Condition	Low Damage
Recommendation	Remove under controlled conditions if the works will interfere with the material.
Risk	Very Low
Lead Surveyor	Niall Keating

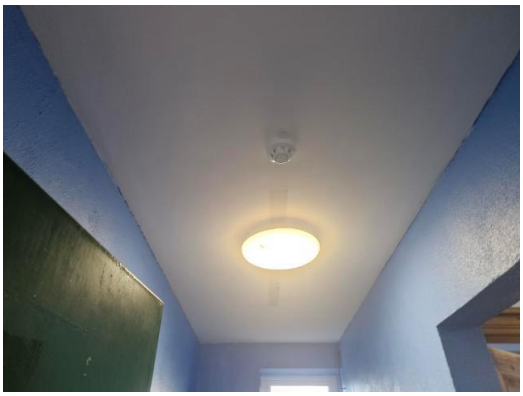
Type	NAD
Material	Plasterboard ceiling
Location	Castlejordan Central National School Ground Floor Toilets 004
Quantity	
Sample No.	No Asbestos Suspected

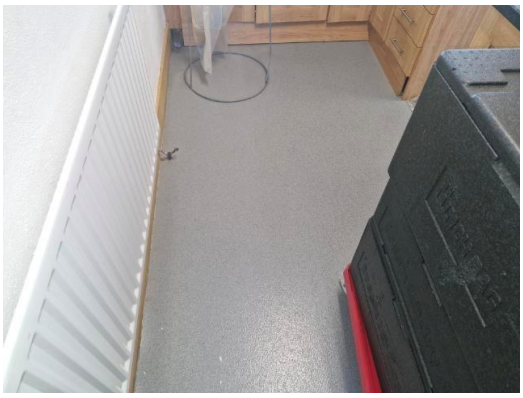
Type	NAD
Material	Lino
Location	Castlejordan Central National School Ground Floor Kitchen/hall 008
Quantity	
Sample No.	No Asbestos Suspected

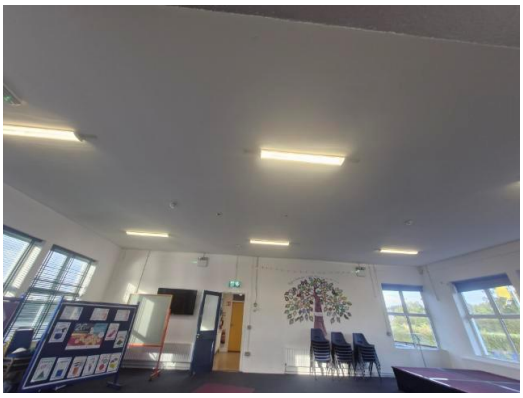
Type	NAD
Material	Plasterboard ceiling
Location	Castlejordan Central National School Ground Floor Kitchen/hall 008
Quantity	
Sample No.	No Asbestos Suspected

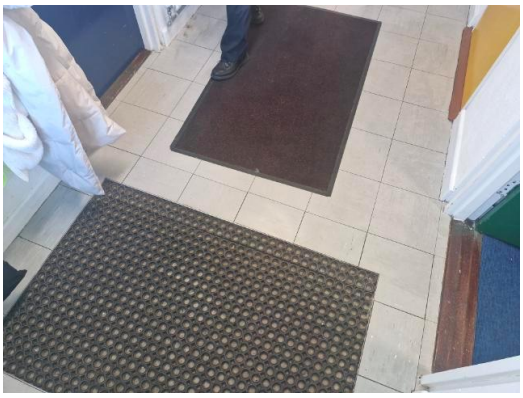
Type	NAD
Material	Vinyl floor tiles Vinyl Products
Location	Castlejordan Central National School Ground Floor Extension 009
Quantity	Non quantifiable
Sample No.	S004

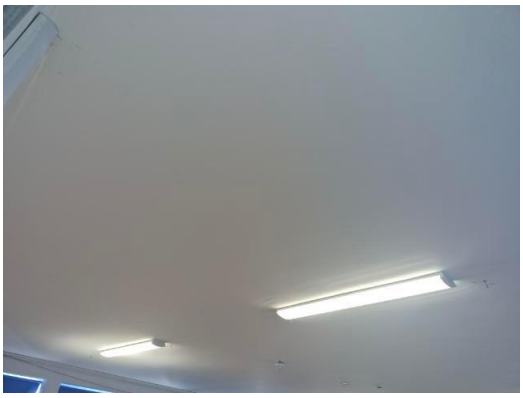
Type	NAD
Material	Plasterboard ceiling
Location	Castlejordan Central National School Ground Floor Extension 009
Quantity	
Sample No.	No Asbestos Suspected
