Energy Pathfinder Meath

8.2 Our Lady Of Mercy NS

Preliminary Safety and Health Plan

Ref.: 3232/KC/DMcD

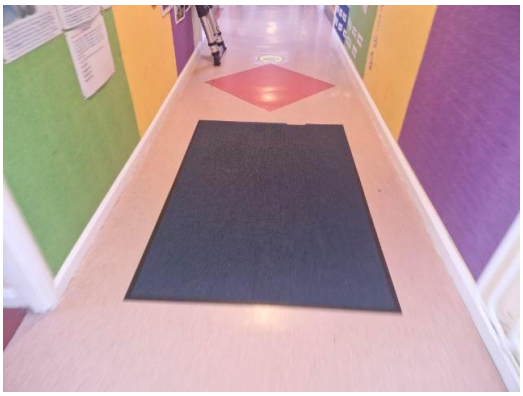
Type	NAD
Material	Lino
Location	Our Lady of Mercy NS Ground Floor Corridors 001
Quantity	
Sample No.	No Asbestos Suspected

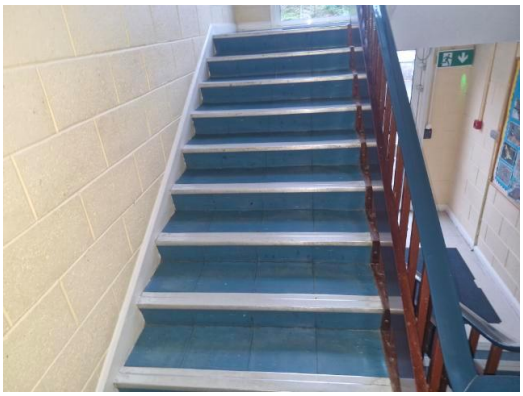
Type	NAD
Material	Vinyl floor tiles Vinyl Products
Location	Our Lady of Mercy NS Ground Floor Staircase 003
Quantity	35 m²
Sample No.	S005

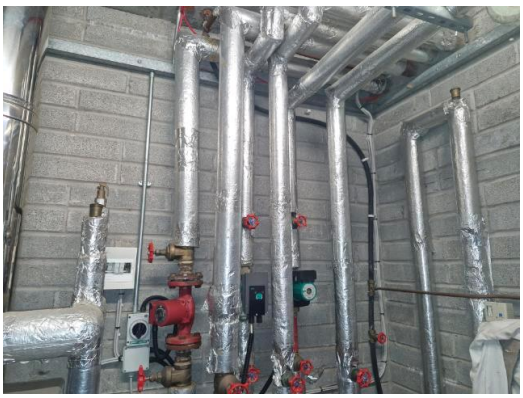
Type	NAD
Material	Pipe insulation
Location	Our Lady of Mercy NS Ground Floor Boiler room 1 009
Quantity	
Sample No.	S008
