Energy Pathfinder Meath

8.4 S N CUL AN MHUILIN

Preliminary Safety and Health Plan

Date: April 2026

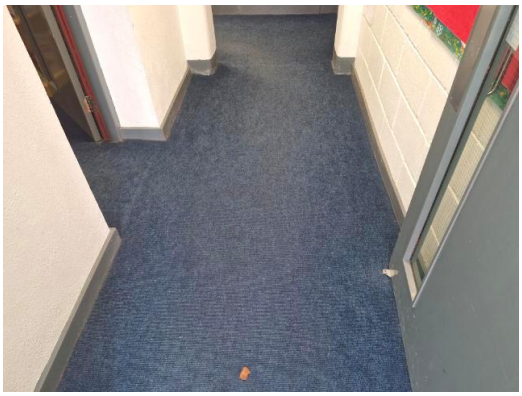
Type	Chrysotile	
Material	Textured coating on a mass concrete ceiling Textured Coating	
Location	1946 building Ground Floor Electrical room 003	
Quantity	3 m²	
Sample No.	Strongly Presumed	
Date	06/10/2025	
Condition	Low Damage	
Recommendation	Remove under controlled conditions if the works will interfere with the material.	
Risk	Very Low	
Lead Surveyor	Niall Keating

Type	Chrysotile	
Material	Mastic beneath carpet and screed Bituminous Product	
Location	1946 building Ground Floor Adjoining corridors 004	
Quantity	Non quantifiable	
Sample No.	S003	
Date	06/10/2025	
Condition	Medium Damage	
Recommendation	Remove under controlled conditions if the works will interfere with the material.	
Risk	Low	
Lead Surveyor	Niall Keating

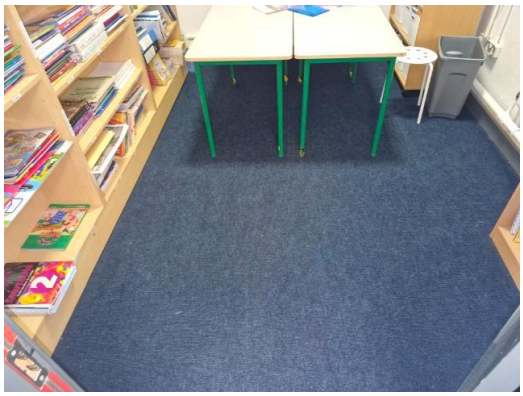
Type	Chrysotile	
Material	Mastic on the floors beneath carpet and screed Bituminous Product	
Location	1946 building Ground Floor Offices and classrooms 005	
Quantity	Non quantifiable	
Sample No.	Strongly Presumed	
Date	06/10/2025	
Condition	Low Damage	
Recommendation	Remove under controlled conditions if the works will interfere with the material.	
Risk	Very Low	
Lead Surveyor	Niall Keating

Type	Chrysotile	
Material	Mastic and vinyl floor tiles beneath lino Bituminous Product	
Location	1946 building Ground Floor Classroom toilets 009	
Quantity	Non quantifiable	
Sample No.	Strongly Presumed	
Date	06/10/2025	
Condition	Low Damage	
Recommendation	Remove under controlled conditions if the works will interfere with the material.	
Risk	Very Low	
Lead Surveyor	Niall Keating

Type	Chrysotile	
Material	Mastic and vinyl floor tiles beneath lino Bituminous Product	
Location	1946 building Ground Floor Classroom 010	
Quantity	Non quantifiable	
Sample No.	Strongly Presumed	
Date	06/10/2025	
Condition	Low Damage	
Recommendation	Remove under controlled conditions if the works will interfere with the material.	
Risk	Very Low	
Lead Surveyor	Niall Keating

Type	Chrysotile	
Material	Mastic and vinyl floor tiles beneath lino and screed Bituminous Product	
Location	Extension building Ground Floor Classrooms, corridors and toilets 008	
Quantity	Non quantifiable	
Sample No.	Strongly Presumed	
Date	06/10/2025	
Condition	Low Damage	
Recommendation	Remove under controlled conditions if the works will interfere with the material.	
Risk	Very Low	
Lead Surveyor	Niall Keating

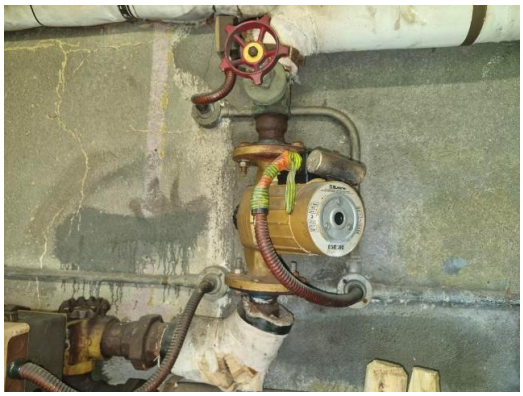
Type	Chrysotile	
Material	Pump gaskets Gaskets (compressed)	
Location	1946 building Ground Floor Boiler room 001	
Quantity	2 no.	
Sample No.	Strongly Presumed	
Date	06/10/2025	
Condition	Low Damage	
Recommendation	Remove under controlled conditions if the works will interfere with the material.	
Risk	Very Low	
Lead Surveyor	Niall Keating

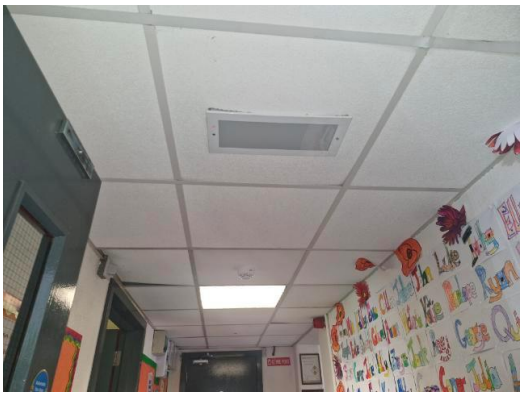
Type	NAD
Material	Ceiling tiles
Location	1946 building Ground Floor Corridors 002
Quantity	
Sample No.	No Asbestos Suspected

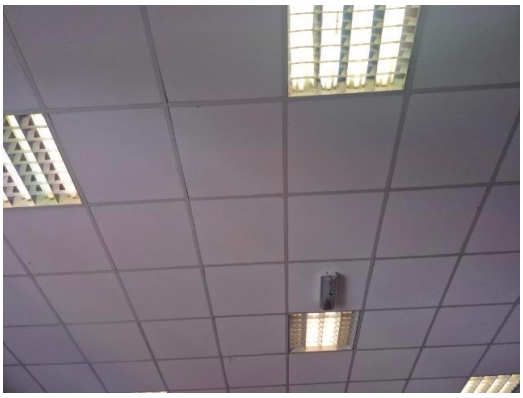
Type	NAD
Material	Ceiling tiles
Location	1946 building Ground Floor Classroom 010
Quantity	
Sample No.	No Asbestos Suspected

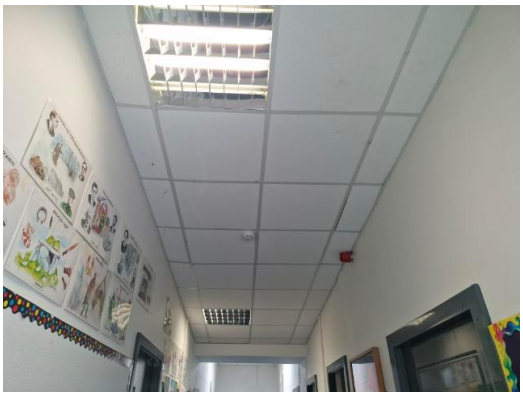
Type	NAD
Material	Ceiling tiles
Location	Extension building Ground Floor Corridors 007
Quantity	
Sample No.	No Asbestos Suspected

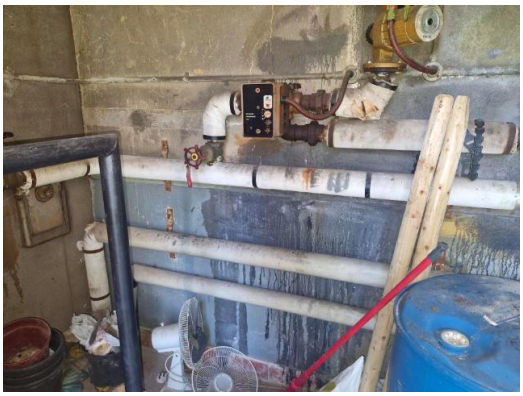
Type	NAD
Material	Pipe insulation
Location	S N CUL AN MHUILINN Ground Floor Boiler room 001
Quantity	
Sample No.	S002
