ASBESTOS REFURBISHMENT SURVEY REPORT

Moyne

Project Number
44153

Client	Rogerson Reddan & Associates
Project Title	44153 Moyne Community School 91436D
Document Title	Asbestos Refurbishment Report
Report No.	44153

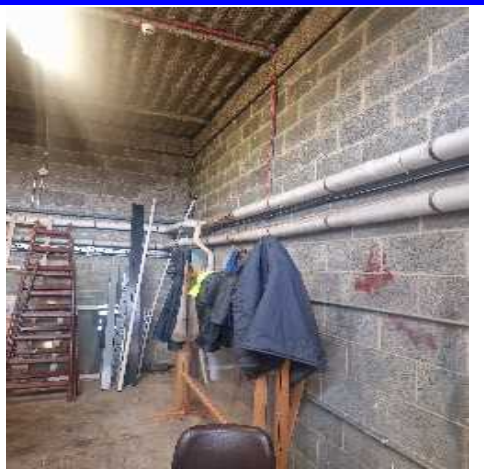
Location Details : 143971 No Asbestos Found

Building/Area :
Room/Section : Boiler room
Location : Pipe work
Description : Mmmf insulation
Sample No. :
Confirmation :
Access : Full Access
Normal Use :
Recommendations :
Notes :

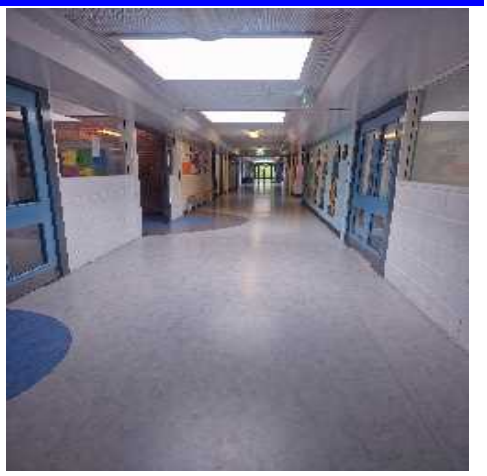
Location Details : 143973 No Asbestos Found

Building/Area :
Room/Section : Throughout
Location : Walls floor ceiling
Description : Modern lino blocks metal
Sample No. :
Confirmation :
Access : Full Access
Normal Use :
Recommendations :
Notes :

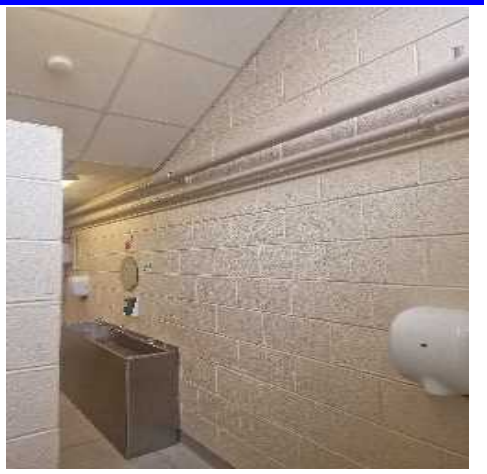
Location Details : 143974 No Asbestos Found

Building/Area :
Room/Section : Throughout
Location : Heating pipes
Description : Metal pipes
Sample No. :
Confirmation :
Access : Full Access
Normal Use :
Recommendations :
Notes :

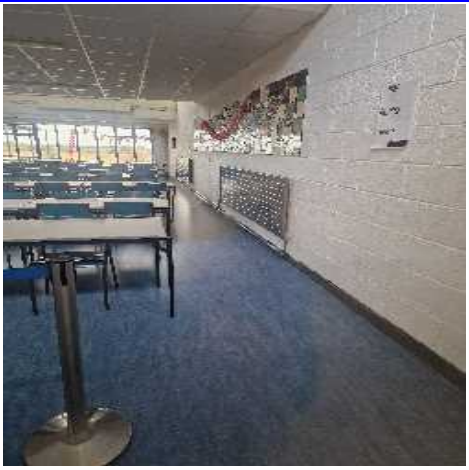
Location Details : 143975 No Asbestos Found

Building/Area :
Room/Section : Throughout
Location : Heating pipes
Description : Metal pipes
Sample No. :
Confirmation :
Access : Full Access
Normal Use :
Recommendations :
Notes :

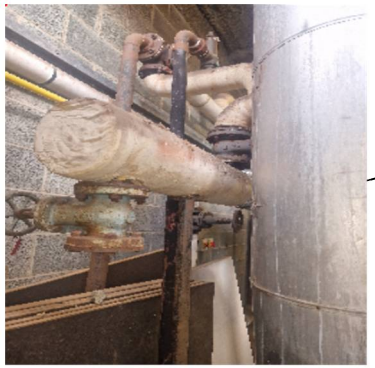
ASB20251028004

- Gaskets containing asbestos chrysotile were identified in the pipework flanges in the boiler house, these items should be removed and disposed of by a competent asbestos removal contractor prior to refurbishment works carried out.

Score
Asbestos Type :	Chrysotile	1
Type Of Product :	Textiles & Paper	2
Condition :	Good Condition	0
Surface Treatment :	Gasket	2
Quantity :		
	Material Assessment Score :	5

Gaskets

Priority 1 : Remove ACM's Prior to Refurbishment or Demolition.
