ASBESTOS REFURBISHMENT SURVEY REPORT

Our Lady's Bower 63210P

Project Number
44149

Client	Longford Westmeath Education & Training Board
Project Title	44149 Our Lady's Bower 63210P
Document Title	Asbestos Refurbishment Report
Report No.	44149

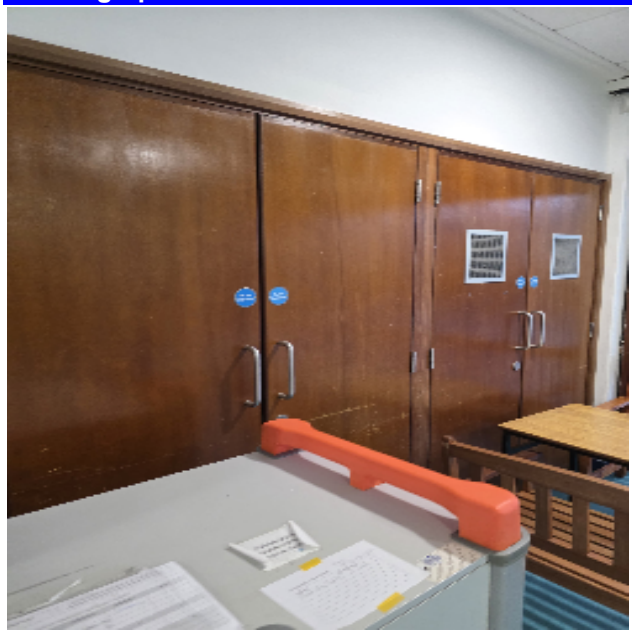
Score
Asbestos Type :	Presumed ACM Present	6
Type Of Product :	Textiles & Paper	2
Condition :	Low Damage	1
Surface Treatment :	Composite Materials Containing Asbestos	0
Quantity :		
	Material Assessment Score :	9

Priority 1 : Investigate prior to disturbing

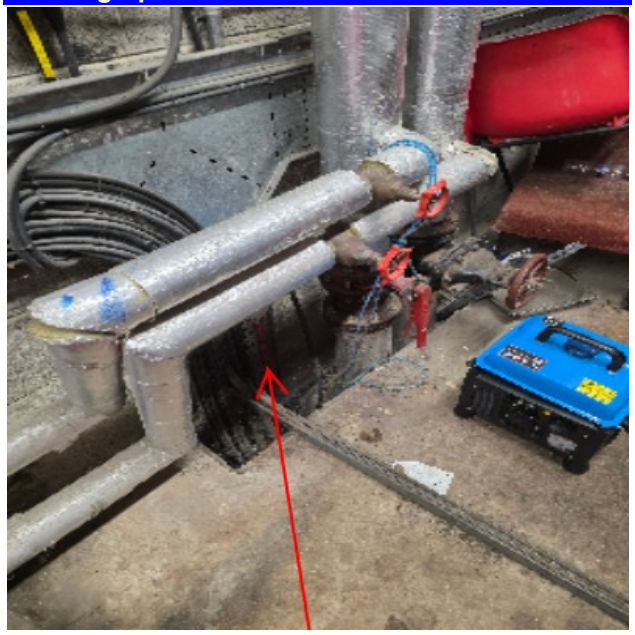
Score
Asbestos Type :	Presumed ACM Present	6
Type Of Product :		0
Condition :		0
Surface Treatment :		0
Quantity :		
	Material Assessment Score :	6

Evidence of previous removals. Request clearance certs.2 Floor voids. Asbestos may be present from old pipework. Unsafe to sample

Priority 1 : Investigate prior to disturbing

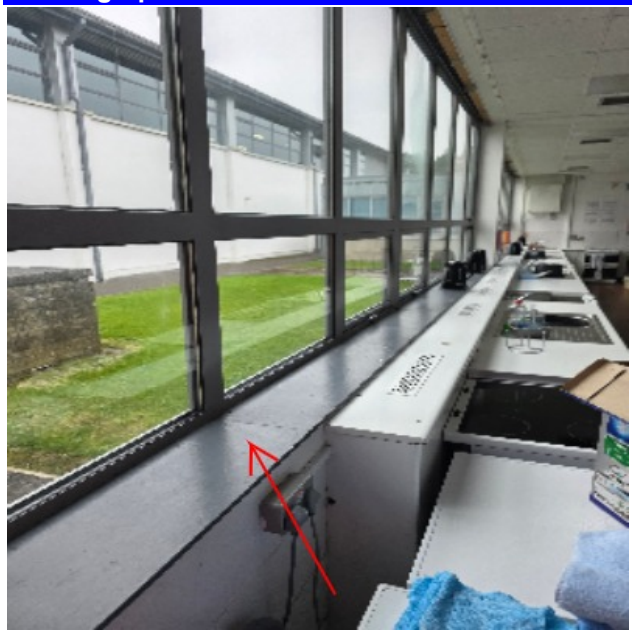
Score
Asbestos Type :	Chrysotile	1
Type Of Product :	Asbestos Cement	1
Condition :	Low Damage	1
Surface Treatment :	Asbestos Cement	1
Quantity :		
	Material Assessment Score :	4

Priority 1 : Remove ACM's Prior to Refurbishment or Demolition.

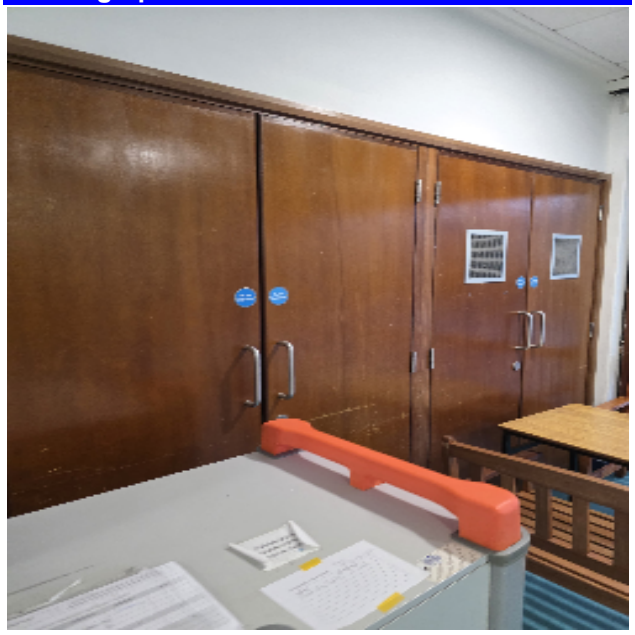
Score
Asbestos Type :	Presumed ACM Present	6
Type Of Product :		0
Condition :		0
Surface Treatment :		0
Quantity :		
	Material Assessment Score :	6

Priority 1 : Investigate prior to disturbing

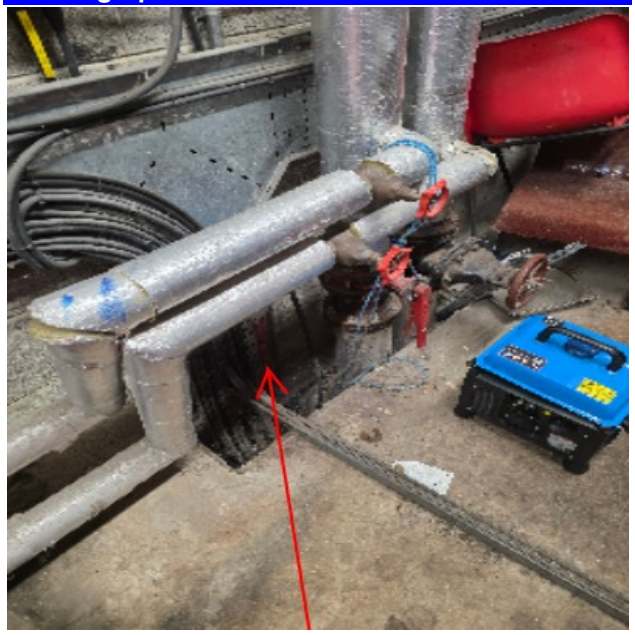
Score
Asbestos Type :	Chrysotile	1
Type Of Product :	Asbestos Insulation Board	2
Condition :	Medium Damage	2
Surface Treatment :	Composite Materials Containing Asbestos	0
Quantity :		
	Material Assessment Score :	5

Evidence of previous removals. Request clearance certs.2 Floor voids. Asbestos may be present from old pipework. Unsafe to sample

Priority 1 : Investigate prior to disturbing

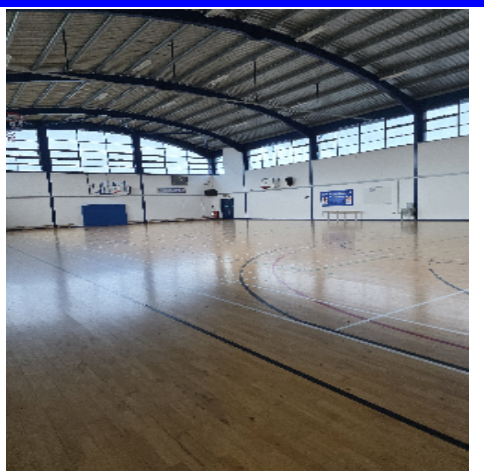
Location Details : 142400 No Asbestos Found

Building/Area : Our Ladys Bower
Room/Section : Sports Hall
Location : Heating equipment
Description : Built in 2008
Sample No. :
Confirmation :
Access : Full Access
Normal Use : School
Recommendations :
Notes :

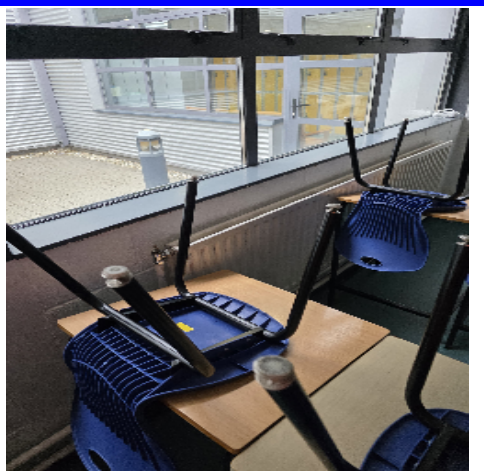
Location Details : 142406 No Asbestos Found

Building/Area : Our Ladys Bower
Room/Section : Rooms 18-22
Location : Heating equipment
Description : Block wall, concrete floor
Sample No. :
Confirmation :
Access : Full Access
Normal Use : School
Recommendations :
Notes : Fiberglass on pipework.

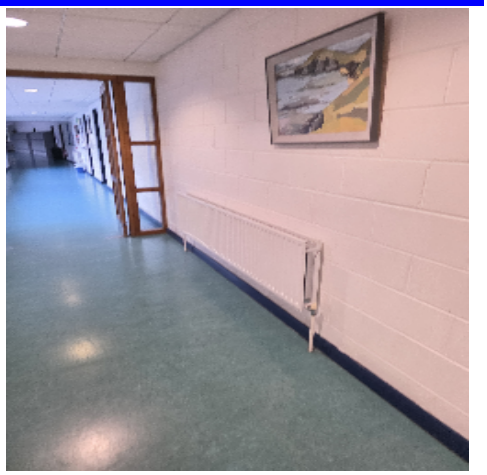
Location Details : 142419 No Asbestos Found

Building/Area :	Our Ladys Bower
Room/Section :	2008 Built section First floor
Location :	Heating equipment
Description :	Block wall, concrete floor
Sample No. :	
Confirmation :	
Access :	Full Access
Normal Use :	School
Recommendations :	
Notes :	Fiberglass on pipework.
