ASBESTOS REFURBISHMENT SURVEY REPORT

Templemichael

Project Number
44154

Client	Rogerson Reddan & Associates
Project Title	44154 Templemichael College 71730O
Document Title	Asbestos Refurbishment Report
Report No.	44154

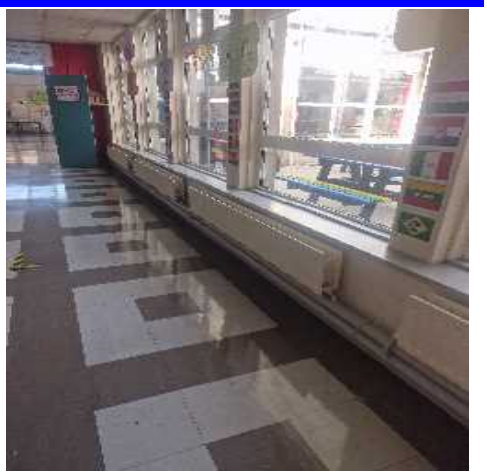
Location Details : 144315 No Asbestos Found

Building/Area :
Room/Section : Throughout
Location : Radiators
Description : Metal pipe work
Sample No. :
Confirmation :
Access : Full Access
Normal Use :
Recommendations :
Notes :
