ASBESTOS SURVEY REPORT

(Refurbishment / Demolition Survey)

Location: Youthreach Cappawhite (Selected Areas),
Old Vocational School, Cappawhite, Co. Tipperary E34 A320

Report No. PE24-1249

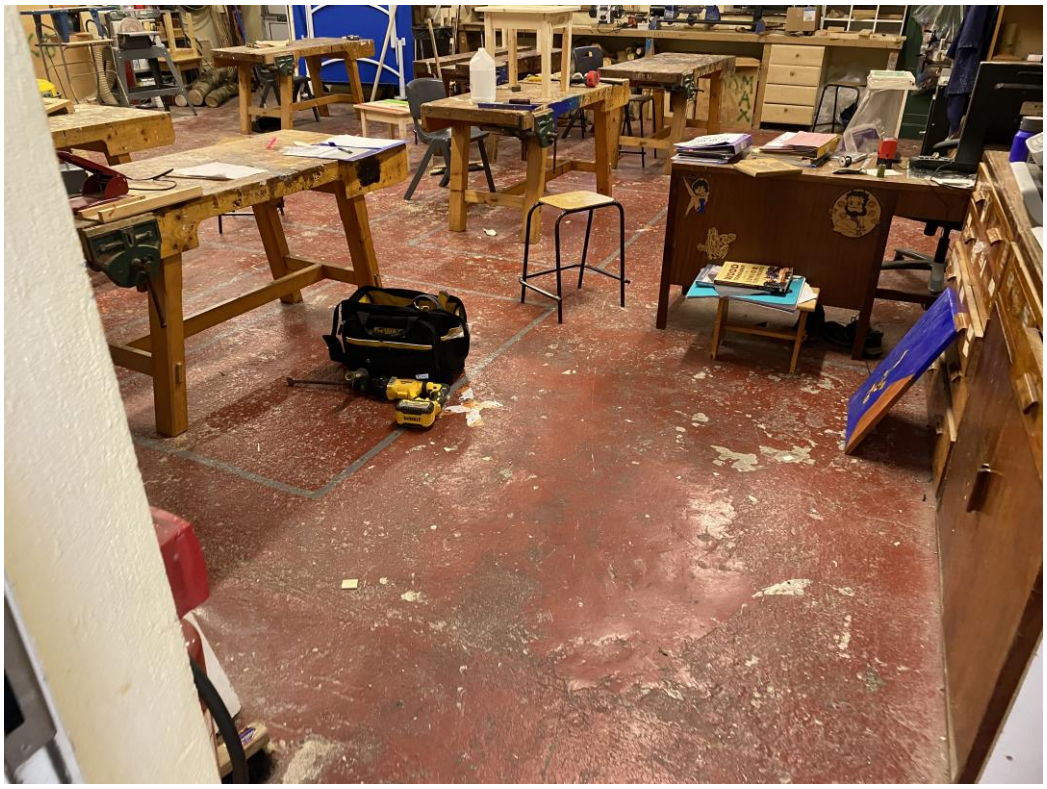
Painted concrete floor in the woodwork room
