# Management Asbestos Survey

| Site Address | Cappagh National Orthopaedic Hospital<br>Cappagh Road<br>Finglas West<br>Dublin 11 | | |
| Survey Dates | 2015, 2018 & 2024 | | |
| Issue Date | March, 2024 | | |

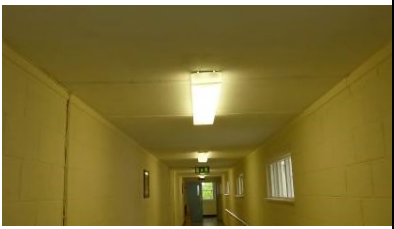
| Ref No. | Building/ Zone | Location Or Functional Space | Sample No. | Material Description, surface treatment and condition | Extent | Asbestos identified (presumed, strongly presumed or identified) | Product type | Condition | Surface treatment | Asbestos type | Material assessment score | Activity | Likelihood of disturbance | Exposure potential | Maintenance | Priority assessment score | Combined Assessment Score | Recommendation | Photo |
|---|---|---|---|---|---|---|---|---|---|---|---|---|---|---|---|---|---|---|---|
| 13. | Zone 1 | Link corridor | | Softboard to ceilings | | NAD | | | | | | | | | | | | | |

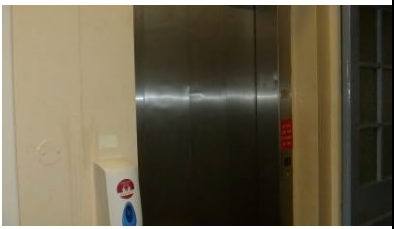
| Ref No. | Building/ Zone | Location Or Functional Space | Sample No. | Material Description, surface treatment and condition | Extent | Asbestos identified (presumed, strongly presumed or identified) | Product type | Condition | Surface treatment | Asbestos type | Material assessment score | Activity | Likelihood of disturbance | Exposure potential | Maintenance | Priority assessment score | Combined Assessment Score | Recommendation | Photo |
|---|---|---|---|---|---|---|---|---|---|---|---|---|---|---|---|---|---|---|---|
| 21. | Zone 1 | Ground floor Physio therapy Lift | | Concrete lift core | | NAD | | | | | | | | | | | | | |

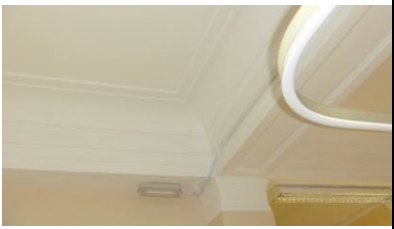
| Ref No. | Building/ Zone | Location Or Functional Space | Sample No. | Material Description, surface treatment and condition | Extent | Asbestos identified (presumed, strongly presumed or identified) | Product type | Condition | Surface treatment | Asbestos type | Material assessment score | Activity | Likelihood of disturbance | Exposure potential | Maintenance | Priority assessment score | Combined Assessment Score | Recommendation | Photo |
|---|---|---|---|---|---|---|---|---|---|---|---|---|---|---|---|---|---|---|---|
| 29. | Zone 1 | Ground floor Physio | | | | NAD | | | | | | | | | | | | | |

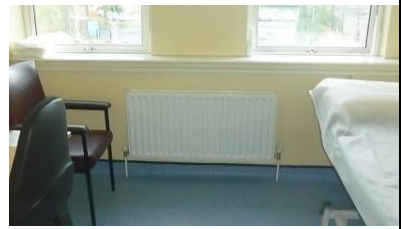
| Ref No. | Building/ Zone | Location Or Functional Space | Sample No. | Material Description, surface treatment and condition | Extent | Asbestos identified (presumed, strongly presumed or identified) | Product type | Condition | Surface treatment | Asbestos type | Material assessment score | Activity | Likelihood of disturbance | Exposure potential | Maintenance | Priority assessment score | Combined Assessment Score | Recommendation | Photo |
|---|---|---|---|---|---|---|---|---|---|---|---|---|---|---|---|---|---|---|---|
| 33. | Zone 1 | PAC Upper Ground Floor Exam Room 7 | | | | NAD | | | | | | | | | | | | | |

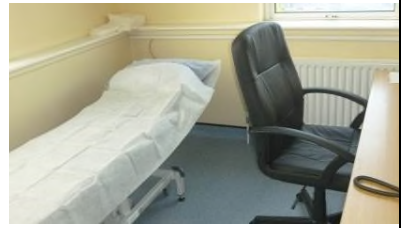
| Ref No. | Building/ Zone | Location Or Functional Space | Sample No. | Material Description, surface treatment and condition | Extent | Asbestos identified (presumed, strongly presumed or identified) | Product type | Condition | Surface treatment | Asbestos type | Material assessment score | Activity | Likelihood of disturbance | Exposure potential | Maintenance | Priority assessment score | Combined Assessment Score | Recommendation | Photo |
|---|---|---|---|---|---|---|---|---|---|---|---|---|---|---|---|---|---|---|---|
| 34. | Zone 1 | PAC Upper Ground Floor Exam Room 6 | | | | NAD | | | | | | | | | | | | | |

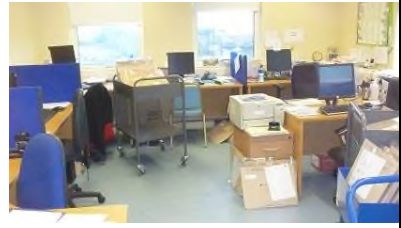
| Ref No. | Building/ Zone | Location Or Functional Space | Sample No. | Material Description, surface treatment and condition | Extent | Asbestos identified (presumed, strongly presumed or identified) | Product type | Condition | Surface treatment | Asbestos type | Material assessment score | Activity | Likelihood of disturbance | Exposure potential | Maintenance | Priority assessment score | Combined Assessment Score | Recommendation | Photo |
|---|---|---|---|---|---|---|---|---|---|---|---|---|---|---|---|---|---|---|---|
| 35. | Zone 1 | PAC Upper Ground Floor 7 person office | | | | NAD | | | | | | | | | | | | | |

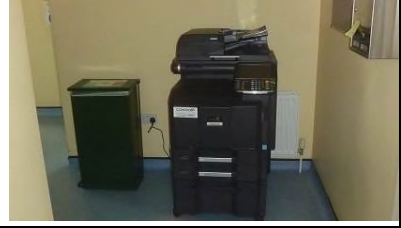
| Ref No. | Building/ Zone | Location Or Functional Space | Sample No. | Material Description, surface treatment and condition | Extent | Asbestos identified (presumed, strongly presumed or identified) | Product type | Condition | Surface treatment | Asbestos type | Material assessment score | Activity | Likelihood of disturbance | Exposure potential | Maintenance | Priority assessment score | Combined Assessment Score | Recommendation | Photo |
|---|---|---|---|---|---|---|---|---|---|---|---|---|---|---|---|---|---|---|---|
| 36. | Zone 1 | PAC Upper Ground Floor corridor | | | | NAD | | | | | | | | | | | | | |

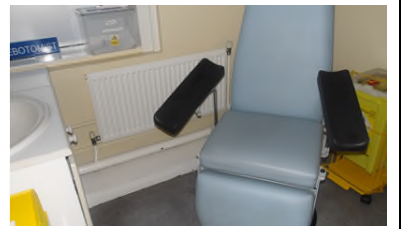
| Ref No. | Building/ Zone | Location Or Functional Space | Sample No. | Material Description, surface treatment and condition | Extent | Asbestos identified (presumed, strongly presumed or identified) | Product type | Condition | Surface treatment | Asbestos type | Material assessment score | Activity | Likelihood of disturbance | Exposure potential | Maintenance | Priority assessment score | Combined Assessment Score | Recommendation | Photo |
|---|---|---|---|---|---|---|---|---|---|---|---|---|---|---|---|---|---|---|---|
| 45. | Zone 1 | PAC Upper Ground Floor 164 | | | | NAD | | | | | | | | | | | | | |

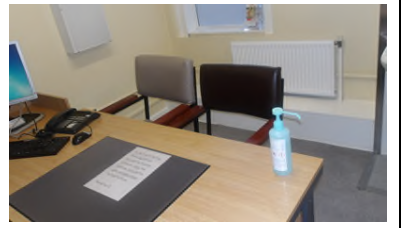
| Ref No. | Building/ Zone | Location Or Functional Space | Sample No. | Material Description, surface treatment and condition | Extent | Asbestos identified (presumed, strongly presumed or identified) | Product type | Condition | Surface treatment | Asbestos type | Material assessment score | Activity | Likelihood of disturbance | Exposure potential | Maintenance | Priority assessment score | Combined Assessment Score | Recommendation | Photo |
|---|---|---|---|---|---|---|---|---|---|---|---|---|---|---|---|---|---|---|---|
| 46. | Zone 1 | PAC Upper Ground Floor 163 | | | | NAD | | | | | | | | | | | | | |

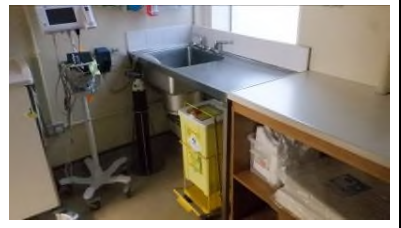
| Ref No. | Building/ Zone | Location Or Functional Space | Sample No. | Material Description, surface treatment and condition | Extent | Asbestos identified (presumed, strongly presumed or identified) | Product type | Condition | Surface treatment | Asbestos type | Material assessment score | Activity | Likelihood of disturbance | Exposure potential | Maintenance | Priority assessment score | Combined Assessment Score | Recommendation | Photo |
|---|---|---|---|---|---|---|---|---|---|---|---|---|---|---|---|---|---|---|---|
| 47. | Zone 1 | PAC Upper Ground Floor 162 | | | | NAD | | | | | | | | | | | | | |

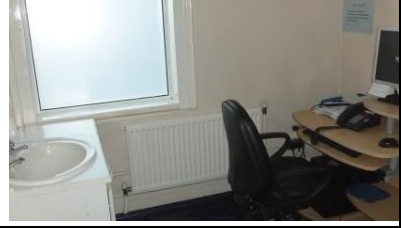
| Ref No. | Building/ Zone | Location Or Functional Space | Sample No. | Material Description, surface treatment and condition | Extent | Asbestos identified (presumed, strongly presumed or identified) | Product type | Condition | Surface treatment | Asbestos type | Material assessment score | Activity | Likelihood of disturbance | Exposure potential | Maintenance | Priority assessment score | Combined Assessment Score | Recommendation | Photo |
|---|---|---|---|---|---|---|---|---|---|---|---|---|---|---|---|---|---|---|---|
| 48. | Zone 1 | PAC Upper Ground Floor Office 3 | | | | NAD | | | | | | | | | | | | | |

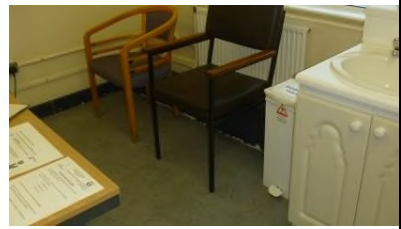
| Ref No. | Building/ Zone | Location Or Functional Space | Sample No. | Material Description, surface treatment and condition | Extent | Asbestos identified (presumed, strongly presumed or identified) | Product type | Condition | Surface treatment | Asbestos type | Material assessment score | Activity | Likelihood of disturbance | Exposure potential | Maintenance | Priority assessment score | Combined Assessment Score | Recommendation | Photo |
|---|---|---|---|---|---|---|---|---|---|---|---|---|---|---|---|---|---|---|---|
| 49. | Zone 1 | PAC Upper Ground Floor Examination room | | | | NAD | | | | | | | | | | | | | |

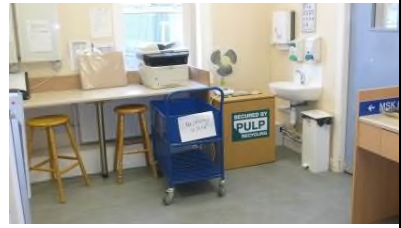
| Ref No. | Building/ Zone | Location Or Functional Space | Sample No. | Material Description, surface treatment and condition | Extent | Asbestos identified (presumed, strongly presumed or identified) | Product type | Condition | Surface treatment | Asbestos type | Material assessment score | Activity | Likelihood of disturbance | Exposure potential | Maintenance | Priority assessment score | Combined Assessment Score | Recommendation | Photo |
|---|---|---|---|---|---|---|---|---|---|---|---|---|---|---|---|---|---|---|---|
| 50. | Zone 1 | PAC Upper Ground Floor Clinic No. 3 166/167 | | | | NAD | | | | | | | | | | | | | |

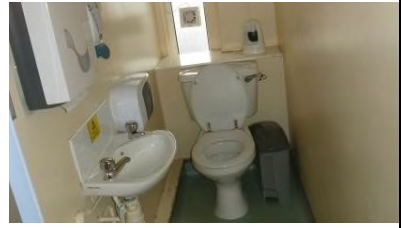
| Ref No. | Building/ Zone | Location Or Functional Space | Sample No. | Material Description, surface treatment and condition | Extent | Asbestos identified (presumed, strongly presumed or identified) | Product type | Condition | Surface treatment | Asbestos type | Material assessment score | Activity | Likelihood of disturbance | Exposure potential | Maintenance | Priority assessment score | Combined Assessment Score | Recommendation | Photo |
|---|---|---|---|---|---|---|---|---|---|---|---|---|---|---|---|---|---|---|---|
| 51. | Zone 1 | PAC Upper Ground Floor WC 161 | | | | NAD | | | | | | | | | | | | | |

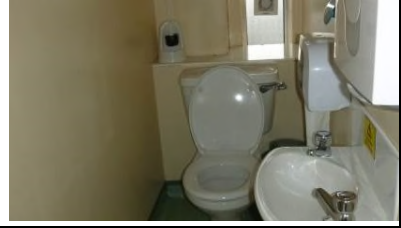
| Ref No. | Building/ Zone | Location Or Functional Space | Sample No. | Material Description, surface treatment and condition | Extent | Asbestos identified (presumed, strongly presumed or identified) | Product type | Condition | Surface treatment | Asbestos type | Material assessment score | Activity | Likelihood of disturbance | Exposure potential | Maintenance | Priority assessment score | Combined Assessment Score | Recommendation | Photo |
|---|---|---|---|---|---|---|---|---|---|---|---|---|---|---|---|---|---|---|---|
| 52. | Zone 1 | PAC Upper Ground Floor WC 162 | | | | NAD | | | | | | | | | | | | | |

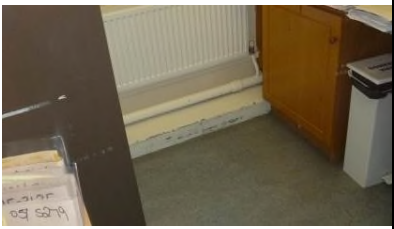
| Ref No. | Building/ Zone | Location Or Functional Space | Sample No. | Material Description, surface treatment and condition | Extent | Asbestos identified (presumed, strongly presumed or identified) | Product type | Condition | Surface treatment | Asbestos type | Material assessment score | Activity | Likelihood of disturbance | Exposure potential | Maintenance | Priority assessment score | Combined Assessment Score | Recommendation | Photo |
|---|---|---|---|---|---|---|---|---|---|---|---|---|---|---|---|---|---|---|---|
| 57. | Zone 1 | PAC Upper Ground Floor Office 1 153 | | | | NAD | | | | | | | | | | | | | |

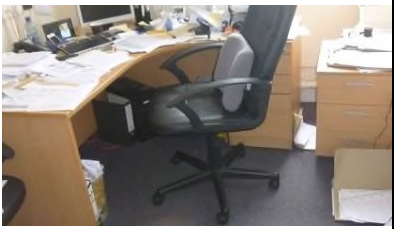
| Ref No. | Building/ Zone | Location Or Functional Space | Sample No. | Material Description, surface treatment and condition | Extent | Asbestos identified (presumed, strongly presumed or identified) | Product type | Condition | Surface treatment | Asbestos type | Material assessment score | Activity | Likelihood of disturbance | Exposure potential | Maintenance | Priority assessment score | Combined Assessment Score | Recommendation | Photo |
|---|---|---|---|---|---|---|---|---|---|---|---|---|---|---|---|---|---|---|---|
| 65. | Zone 1 | PAC 1 <sup>st</sup> floor Ass. To Dir of Nursing, 189 | | | | NAD | | | | | | | | | | | | | |

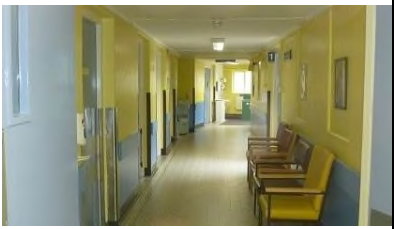
| Ref No. | Building/ Zone | Location Or Functional Space | Sample No. | Material Description, surface treatment and condition | Extent | Asbestos identified (presumed, strongly presumed or identified) | Product type | Condition | Surface treatment | Asbestos type | Material assessment score | Activity | Likelihood of disturbance | Exposure potential | Maintenance | Priority assessment score | Combined Assessment Score | Recommendation | Photo |
|---|---|---|---|---|---|---|---|---|---|---|---|---|---|---|---|---|---|---|---|
| 121. | Zone 1 | Ground floor St. Josephs Ward | | | | NAD | | | | | | | | | | | | | |

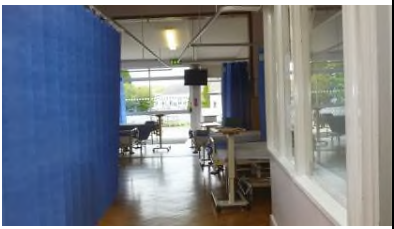
| Ref No. | Building/ Zone | Location Or Functional Space | Sample No. | Material Description, surface treatment and condition | Extent | Asbestos identified (presumed, strongly presumed or identified) | Product type | Condition | Surface treatment | Asbestos type | Material assessment score | Activity | Likelihood of disturbance | Exposure potential | Maintenance | Priority assessment score | Combined Assessment Score | Recommendation | Photo |
|---|---|---|---|---|---|---|---|---|---|---|---|---|---|---|---|---|---|---|---|
| 125. | Zone 1 | Ground floor St. Josephs Ward 074 | | | | NAD | | | | | | | | | | | | | |

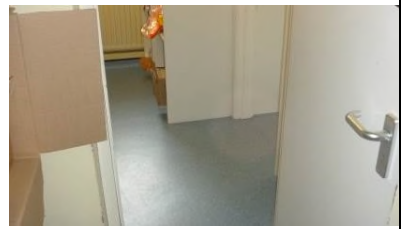
| Ref No. | Building/ Zone | Location Or Functional Space | Sample No. | Material Description, surface treatment and condition | Extent | Asbestos identified (presumed, strongly presumed or identified) | Product type | Condition | Surface treatment | Asbestos type | Material assessment score | Activity | Likelihood of disturbance | Exposure potential | Maintenance | Priority assessment score | Combined Assessment Score | Recommendation | Photo |
|---|---|---|---|---|---|---|---|---|---|---|---|---|---|---|---|---|---|---|---|
| 129. | Zone 1 | Ground floor St. Josephs HDU Stores 032-035 | | | | NAD | | | | | | | | | | | | | |

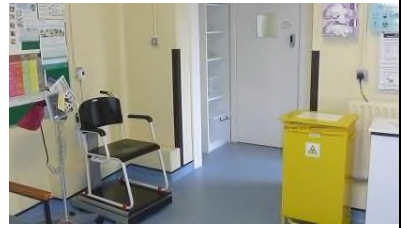
| Ref No. | Building/ Zone | Location Or Functional Space | Sample No. | Material Description, surface treatment and condition | Extent | Asbestos identified (presumed, strongly presumed or identified) | Product type | Condition | Surface treatment | Asbestos type | Material assessment score | Activity | Likelihood of disturbance | Exposure potential | Maintenance | Priority assessment score | Combined Assessment Score | Recommendation | Photo |
|---|---|---|---|---|---|---|---|---|---|---|---|---|---|---|---|---|---|---|---|
| 130. | Zone 1 | Ground floor St. Josephs Treatment room 036 | | | | NAD | | | | | | | | | | | | | |

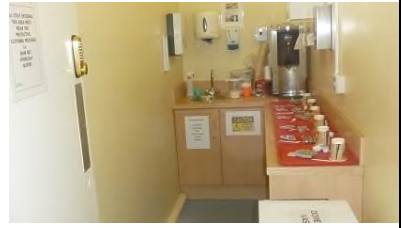
| Ref No. | Building/ Zone | Location Or Functional Space | Sample No. | Material Description, surface treatment and condition | Extent | Asbestos identified (presumed, strongly presumed or identified) | Product type | Condition | Surface treatment | Asbestos type | Material assessment score | Activity | Likelihood of disturbance | Exposure potential | Maintenance | Priority assessment score | Combined Assessment Score | Recommendation | Photo |
|---|---|---|---|---|---|---|---|---|---|---|---|---|---|---|---|---|---|---|---|
| 131. | Zone 1 | Ground floor St. Josephs Coffee stn. 040 | | | | NAD | | | | | | | | | | | | | |

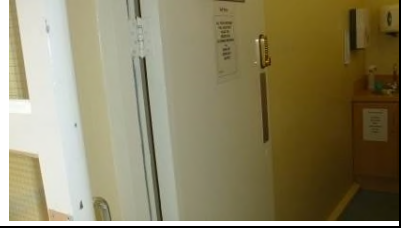
| Ref No. | Building/ Zone | Location Or Functional Space | Sample No. | Material Description, surface treatment and condition | Extent | Asbestos identified (presumed, strongly presumed or identified) | Product type | Condition | Surface treatment | Asbestos type | Material assessment score | Activity | Likelihood of disturbance | Exposure potential | Maintenance | Priority assessment score | Combined Assessment Score | Recommendation | Photo |
|---|---|---|---|---|---|---|---|---|---|---|---|---|---|---|---|---|---|---|---|
| 132. | Zone 1 | Ground floor St. Josephs | | | | NAD | | | | | | | | | | | | | |

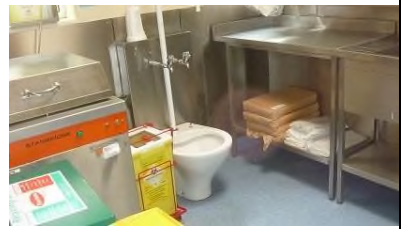
| Ref No. | Building/ Zone | Location Or Functional Space | Sample No. | Material Description, surface treatment and condition | Extent | Asbestos identified (presumed, strongly presumed or identified) | Product type | Condition | Surface treatment | Asbestos type | Material assessment score | Activity | Likelihood of disturbance | Exposure potential | Maintenance | Priority assessment score | Combined Assessment Score | Recommendation | Photo |
|---|---|---|---|---|---|---|---|---|---|---|---|---|---|---|---|---|---|---|---|
| 133. | Zone 1 | Ground floor St. Josephs Sluice room | | | | NAD | | | | | | | | | | | | | |

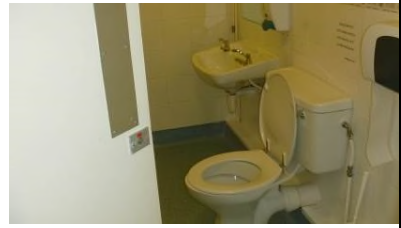
| Ref No. | Building/ Zone | Location Or Functional Space | Sample No. | Material Description, surface treatment and condition | Extent | Asbestos identified (presumed, strongly presumed or identified) | Product type | Condition | Surface treatment | Asbestos type | Material assessment score | Activity | Likelihood of disturbance | Exposure potential | Maintenance | Priority assessment score | Combined Assessment Score | Recommendation | Photo |
|---|---|---|---|---|---|---|---|---|---|---|---|---|---|---|---|---|---|---|---|
| 134. | Zone 1 | Ground floor St. Josephs Pediatric patients WC | | | | NAD | | | | | | | | | | | | | |

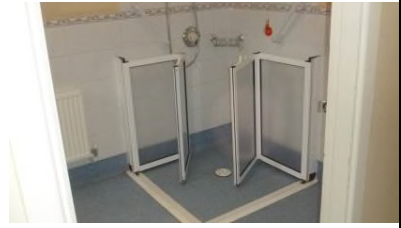
| Ref No. | Building/ Zone | Location Or Functional Space | Sample No. | Material Description, surface treatment and condition | Extent | Asbestos identified (presumed, strongly presumed or identified) | Product type | Condition | Surface treatment | Asbestos type | Material assessment score | Activity | Likelihood of disturbance | Exposure potential | Maintenance | Priority assessment score | Combined Assessment Score | Recommendation | Photo |
|---|---|---|---|---|---|---|---|---|---|---|---|---|---|---|---|---|---|---|---|
| 135. | Zone 1 | Ground floor St. Josephs Shower | | | | NAD | | | | | | | | | | | | | |

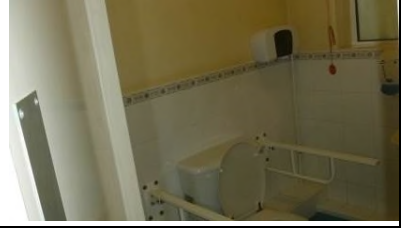
| Ref No. | Building/ Zone | Location Or Functional Space | Sample No. | Material Description, surface treatment and condition | Extent | Asbestos identified (presumed, strongly presumed or identified) | Product type | Condition | Surface treatment | Asbestos type | Material assessment score | Activity | Likelihood of disturbance | Exposure potential | Maintenance | Priority assessment score | Combined Assessment Score | Recommendation | Photo |
|---|---|---|---|---|---|---|---|---|---|---|---|---|---|---|---|---|---|---|---|
| 136. | Zone 1 | Ground floor St. Josephs Disabled WC | | | | NAD | | | | | | | | | | | | | |

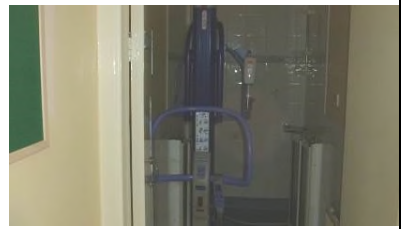
| Ref No. | Building/ Zone | Location Or Functional Space | Sample No. | Material Description, surface treatment and condition | Extent | Asbestos identified (presumed, strongly presumed or identified) | Product type | Condition | Surface treatment | Asbestos type | Material assessment score | Activity | Likelihood of disturbance | Exposure potential | Maintenance | Priority assessment score | Combined Assessment Score | Recommendation | Photo |
|---|---|---|---|---|---|---|---|---|---|---|---|---|---|---|---|---|---|---|---|
| 141. | Zone 1 | Ground floor St. Josephs Store room 4 | | | | NAD | | | | | | | | | | | | | |

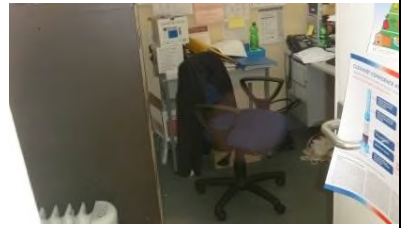
| Ref No. | Building/ Zone | Location Or Functional Space | Sample No. | Material Description, surface treatment and condition | Extent | Asbestos identified (presumed, strongly presumed or identified) | Product type | Condition | Surface treatment | Asbestos type | Material assessment score | Activity | Likelihood of disturbance | Exposure potential | Maintenance | Priority assessment score | Combined Assessment Score | Recommendation | Photo |
|---|---|---|---|---|---|---|---|---|---|---|---|---|---|---|---|---|---|---|---|
| 142. | Zone 1 | Ground floor St. Josephs Occupation health. 055 | | | | NAD | | | | | | | | | | | | | |

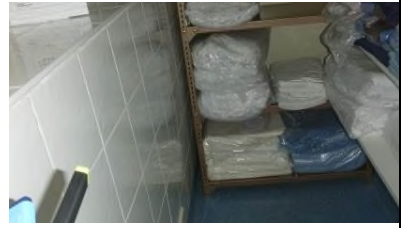
| Ref No. | Building/ Zone | Location Or Functional Space | Sample No. | Material Description, surface treatment and condition | Extent | Asbestos identified (presumed, strongly presumed or identified) | Product type | Condition | Surface treatment | Asbestos type | Material assessment score | Activity | Likelihood of disturbance | Exposure potential | Maintenance | Priority assessment score | Combined Assessment Score | Recommendation | Photo |
|---|---|---|---|---|---|---|---|---|---|---|---|---|---|---|---|---|---|---|---|
| 143. | Zone 1 | Ground floor St. Josephs Clean linen room | | | | NAD | | | | | | | | | | | | | |

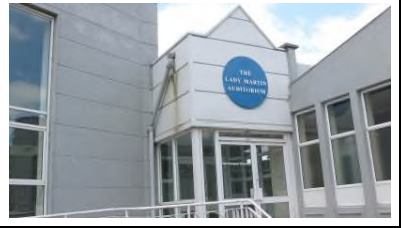
| Ref No. | Building/ Zone | Location Or Functional Space | Sample No. | Material Description, surface treatment and condition | Extent | Asbestos identified (presumed, strongly presumed or identified) | Product type | Condition | Surface treatment | Asbestos type | Material assessment score | Activity | Likelihood of disturbance | Exposure potential | Maintenance | Priority assessment score | Combined Assessment Score | Recommendation | Photo |
|---|---|---|---|---|---|---|---|---|---|---|---|---|---|---|---|---|---|---|---|
| 144. | Zone 1 | Auditorium External Facade Built 1998 | | | | NAD | | | | | | | | | | | | | |

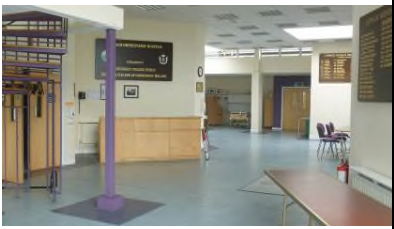
| Ref No. | Building/ Zone | Location Or Functional Space | Sample No. | Material Description, surface treatment and condition | Extent | Asbestos identified (presumed, strongly presumed or identified) | Product type | Condition | Surface treatment | Asbestos type | Material assessment score | Activity | Likelihood of disturbance | Exposure potential | Maintenance | Priority assessment score | Combined Assessment Score | Recommendation | Photo |
|---|---|---|---|---|---|---|---|---|---|---|---|---|---|---|---|---|---|---|---|
| 145. | Zone 1 | Ground floor Auditorium Lobby Built 1998 | | | | NAD | | | | | | | | | | | | | |

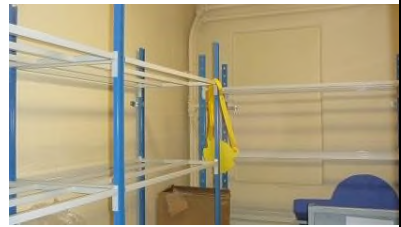
| Ref No. | Building/ Zone | Location Or Functional Space | Sample No. | Material Description, surface treatment and condition | Extent | Asbestos identified (presumed, strongly presumed or identified) | Product type | Condition | Surface treatment | Asbestos type | Material assessment score | Activity | Likelihood of disturbance | Exposure potential | Maintenance | Priority assessment score | Combined Assessment Score | Recommendation | Photo |
|---|---|---|---|---|---|---|---|---|---|---|---|---|---|---|---|---|---|---|---|
| 155. | Zone 1 | Ground floor St. Catherine's Clean linen room 091 | | | | NAD | | | | | | | | | | | | | |

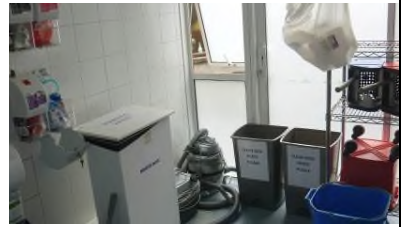
| Ref No. | Building/ Zone | Location Or Functional Space | Sample No. | Material Description, surface treatment and condition | Extent | Asbestos identified (presumed, strongly presumed or identified) | Product type | Condition | Surface treatment | Asbestos type | Material assessment score | Activity | Likelihood of disturbance | Exposure potential | Maintenance | Priority assessment score | Combined Assessment Score | Recommendation | Photo |
|---|---|---|---|---|---|---|---|---|---|---|---|---|---|---|---|---|---|---|---|
| 156. | Zone 1 | Ground floor St. Catherine's Cleaner room 092 | | | | NAD | | | | | | | | | | | | | |

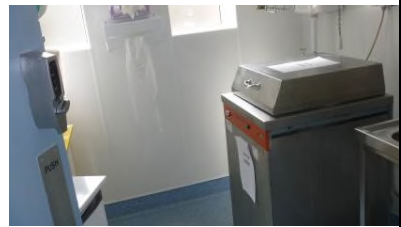
| Ref No. | Building/ Zone | Location Or Functional Space | Sample No. | Material Description, surface treatment and condition | Extent | Asbestos identified (presumed, strongly presumed or identified) | Product type | Condition | Surface treatment | Asbestos type | Material assessment score | Activity | Likelihood of disturbance | Exposure potential | Maintenance | Priority assessment score | Combined Assessment Score | Recommendation | Photo |
|---|---|---|---|---|---|---|---|---|---|---|---|---|---|---|---|---|---|---|---|
| 157. | Zone 1 | Ground floor St. Catherine's Sluice room 093 | | | | NAD | | | | | | | | | | | | | |

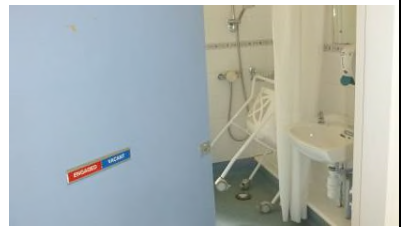
| Ref No. | Building/ Zone | Location Or Functional Space | Sample No. | Material Description, surface treatment and condition | Extent | Asbestos identified (presumed, strongly presumed or identified) | Product type | Condition | Surface treatment | Asbestos type | Material assessment score | Activity | Likelihood of disturbance | Exposure potential | Maintenance | Priority assessment score | Combined Assessment Score | Recommendation | Photo |
|---|---|---|---|---|---|---|---|---|---|---|---|---|---|---|---|---|---|---|---|
| 158. | Zone 1 | Ground floor St. Catherine's Shower WC's | | | | NAD | | | | | | | | | | | | | |

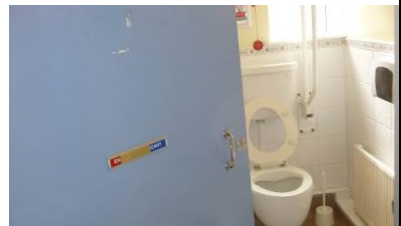
| Ref No. | Building/ Zone | Location Or Functional Space | Sample No. | Material Description, surface treatment and condition | Extent | Asbestos identified (presumed, strongly presumed or identified) | Product type | Condition | Surface treatment | Asbestos type | Material assessment score | Activity | Likelihood of disturbance | Exposure potential | Maintenance | Priority assessment score | Combined Assessment Score | Recommendation | Photo |
|---|---|---|---|---|---|---|---|---|---|---|---|---|---|---|---|---|---|---|---|
| 159. | Zone 1 | Ground floor St. Catherine's Shower WC's | | | | NAD | | | | | | | | | | | | | |

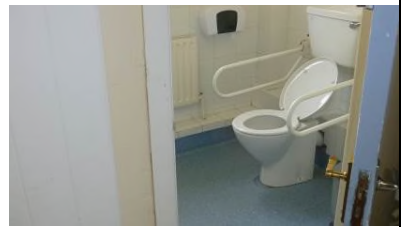
| Ref No. | Building/ Zone | Location Or Functional Space | Sample No. | Material Description, surface treatment and condition | Extent | Asbestos identified (presumed, strongly presumed or identified) | Product type | Condition | Surface treatment | Asbestos type | Material assessment score | Activity | Likelihood of disturbance | Exposure potential | Maintenance | Priority assessment score | Combined Assessment Score | Recommendation | Photo |
|---|---|---|---|---|---|---|---|---|---|---|---|---|---|---|---|---|---|---|---|
| 160. | Zone 1 | Ground floor St. Catherine's Shower WC's | | | | NAD | | | | | | | | | | | | | |

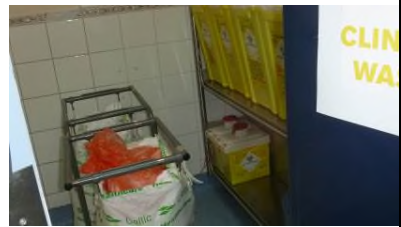
| Ref No. | Building/ Zone | Location Or Functional Space | Sample No. | Material Description, surface treatment and condition | Extent | Asbestos identified (presumed, strongly presumed or identified) | Product type | Condition | Surface treatment | Asbestos type | Material assessment score | Activity | Likelihood of disturbance | Exposure potential | Maintenance | Priority assessment score | Combined Assessment Score | Recommendation | Photo |
|---|---|---|---|---|---|---|---|---|---|---|---|---|---|---|---|---|---|---|---|
| 161. | Zone 1 | Ground floor St. Catherine's Clinical waste | | | | NAD | | | | | | | | | | | | | |

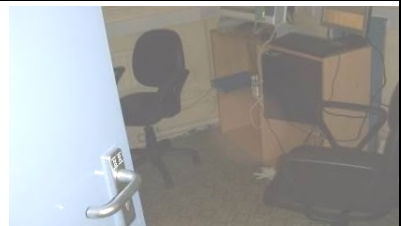
| Ref No. | Building/ Zone | Location Or Functional Space | Sample No. | Material Description, surface treatment and condition | Extent | Asbestos identified (presumed, strongly presumed or identified) | Product type | Condition | Surface treatment | Asbestos type | Material assessment score | Activity | Likelihood of disturbance | Exposure potential | Maintenance | Priority assessment score | Combined Assessment Score | Recommendation | Photo |
|---|---|---|---|---|---|---|---|---|---|---|---|---|---|---|---|---|---|---|---|
| 164. | Zone 1 | Ground floor St. Catherine's Main corridor Room 101 | | | | NAD | | | | | | | | | | | | | |

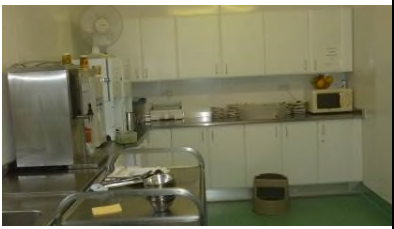
| Ref No. | Building/ Zone | Location Or Functional Space | Sample No. | Material Description, surface treatment and condition | Extent | Asbestos identified (presumed, strongly presumed or identified) | Product type | Condition | Surface treatment | Asbestos type | Material assessment score | Activity | Likelihood of disturbance | Exposure potential | Maintenance | Priority assessment score | Combined Assessment Score | Recommendation | Photo |
|---|---|---|---|---|---|---|---|---|---|---|---|---|---|---|---|---|---|---|---|
| 165. | Zone 1 | Ground floor St. Catherine's Main corridor Kitchen 102 | | | | NAD | | | | | | | | | | | | | |

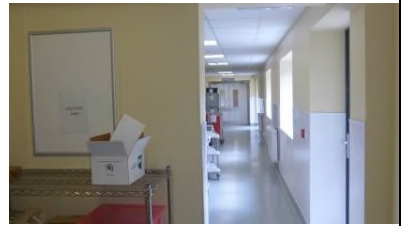
| Ref No. | Building/ Zone | Location Or Functional Space | Sample No. | Material Description, surface treatment and condition | Extent | Asbestos identified (presumed, strongly presumed or identified) | Product type | Condition | Surface treatment | Asbestos type | Material assessment score | Activity | Likelihood of disturbance | Exposure potential | Maintenance | Priority assessment score | Combined Assessment Score | Recommendation | Photo |
|---|---|---|---|---|---|---|---|---|---|---|---|---|---|---|---|---|---|---|---|
| 170. | Zone 1 | Ground floor St. Theresa's Ward Loan instrument. | | New Build | | NAD | | | | | | | | | | | | | |

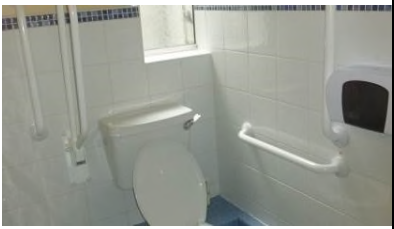
| Ref No. | Building/ Zone | Location Or Functional Space | Sample No. | Material Description, surface treatment and condition | Extent | Asbestos identified (presumed, strongly presumed or identified) | Product type | Condition | Surface treatment | Asbestos type | Material assessment score | Activity | Likelihood of disturbance | Exposure potential | Maintenance | Priority assessment score | Combined Assessment Score | Recommendation/ Comments | Photo |
|---|---|---|---|---|---|---|---|---|---|---|---|---|---|---|---|---|---|---|---|
| 9. | Zone 2 | Pharmacy Corridor WC 028 | | | | NAD | | | | | | | | | | | | | |

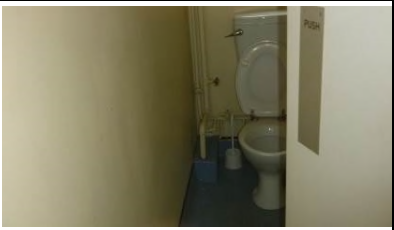
| Ref No. | Building/ Zone | Location Or Functional Space | Sample No. | Material Description, surface treatment and condition | Extent | Asbestos identified (presumed, strongly presumed or identified) | Product type | Condition | Surface treatment | Asbestos type | Material assessment score | Activity | Likelihood of disturbance | Exposure potential | Maintenance | Priority assessment score | Combined Assessment Score | Recommendation/ Comments | Photo |
|---|---|---|---|---|---|---|---|---|---|---|---|---|---|---|---|---|---|---|---|
| 12. | Zone 2 | Main corridor WC | | | | NAD | | | | | | | | | | | | | |

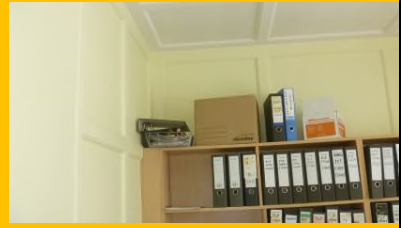
| Ref No. | Building/ Zone | Location Or Functional Space | Sample No. | Material Description, surface treatment and condition | Extent | Asbestos identified (presumed, strongly presumed or identified) | Product type | Condition | Surface treatment | Asbestos type | Material assessment score | Activity | Likelihood of disturbance | Exposure potential | Maintenance | Priority assessment score | Combined Assessment Score | Recommendation/ Comments | Photo |
|---|---|---|---|---|---|---|---|---|---|---|---|---|---|---|---|---|---|---|---|
| 31. | Zone 2 | Admin 1 <sup>st</sup> floor Account Payable Officer | | AC sheeting to ceiling and walls | | Chrysotile | 1 | 0 | 1 | 1 | 3 | 1 | 1 | 3 | 0 | 5 | 8 | Manage Label Monitor | |

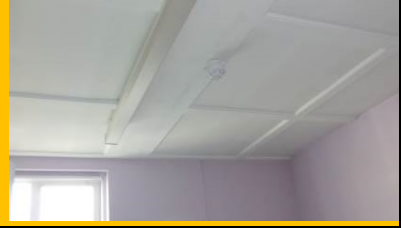
| Ref No. | Building/ Zone | Location Or Functional Space | Sample No. | Material Description, surface treatment and condition | Extent | Asbestos identified (presumed, strongly presumed or identified) | Product type | Condition | Surface treatment | Asbestos type | Material assessment score | Activity | Likelihood of disturbance | Exposure potential | Maintenance | Priority assessment score | Combined Assessment Score | Recommendation/ Comments | Photo |
|---|---|---|---|---|---|---|---|---|---|---|---|---|---|---|---|---|---|---|---|
| 32. | Zone 2 | Admin 1 <sup>st</sup> floor | | AC sheeting to ceiling and walls | | Chrysotile | 1 | 0 | 1 | 1 | 3 | 1 | 1 | 3 | 0 | 5 | 8 | Manage Label Monitor | |

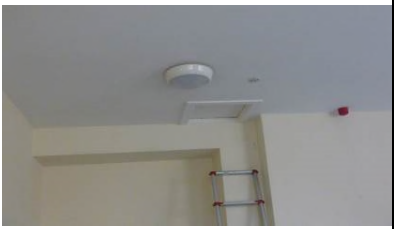
| Ref No. | Building/ Zone | Location Or Functional Space | Sample No. | Material Description, surface treatment and condition | Extent | Asbestos identified (presumed, strongly presumed or identified) | Product type | Condition | Surface treatment | Asbestos type | Material assessment score | Activity | Likelihood of disturbance | Exposure potential | Maintenance | Priority assessment score | Combined Assessment Score | Recommendation/ Comments | Photo |
|---|---|---|---|---|---|---|---|---|---|---|---|---|---|---|---|---|---|---|---|
| 37. | Zone 2 | Admin 1 <sup>st</sup> floor Theatre Staff Restroom | | | | NAD | | | | | | | | | | | | | |

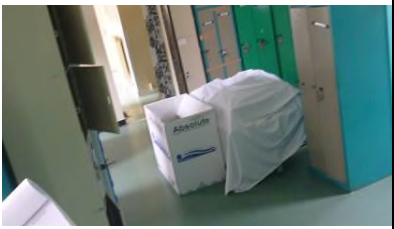
| Ref No. | Building/ Zone | Location Or Functional Space | Sample No. | Material Description, surface treatment and condition | Extent | Asbestos identified (presumed, strongly presumed or identified) | Product type | Condition | Surface treatment | Asbestos type | Material assessment score | Activity | Likelihood of disturbance | Exposure potential | Maintenance | Priority assessment score | Combined Assessment Score | Recommendation/ Comments | Photo |
|---|---|---|---|---|---|---|---|---|---|---|---|---|---|---|---|---|---|---|---|
| 41. | Zone 2 | Admin 1 <sup>st</sup> floor Female Locker room 080 | | | | NAD | | | | | | | | | | | | | |

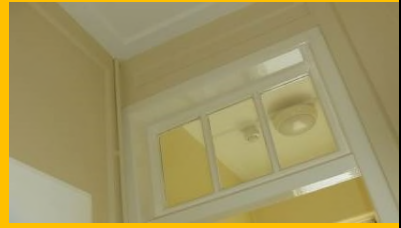
| Ref No. | Building/ Zone | Location Or Functional Space | Sample No. | Material Description, surface treatment and condition | Extent | Asbestos identified (presumed, strongly presumed or identified) | Product type | Condition | Surface treatment | Asbestos type | Material assessment score | Activity | Likelihood of disturbance | Exposure potential | Maintenance | Priority assessment score | Combined Assessment Score | Recommendation/ Comments | Photo |
|---|---|---|---|---|---|---|---|---|---|---|---|---|---|---|---|---|---|---|---|
| 55. | Zone 2 | Admin 1 <sup>st</sup> floor WC 222 | | AC sheeting to ceiling and walls | NQ | Chrysotile | 1 | 0 | 1 | 1 | 3 | 1 | 1 | 3 | 0 | 5 | 8 | Manage Label Monitor | |

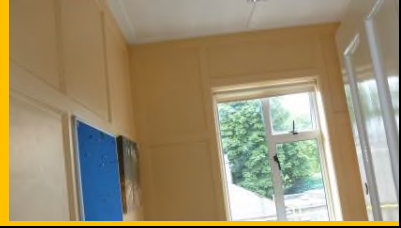
| Ref No. | Building/ Zone | Location Or Functional Space | Sample No. | Material Description, surface treatment and condition | Extent | Asbestos identified (presumed, strongly presumed or identified) | Product type | Condition | Surface treatment | Asbestos type | Material assessment score | Activity | Likelihood of disturbance | Exposure potential | Maintenance | Priority assessment score | Combined Assessment Score | Recommendation/ Comments | Photo |
|---|---|---|---|---|---|---|---|---|---|---|---|---|---|---|---|---|---|---|---|
| 56. | Zone 2 | Admin 1 <sup>st</sup> floor Office 225 | | AC sheeting to ceiling and walls | NQ | Chrysotile | 1 | 0 | 1 | 1 | 3 | 1 | 1 | 3 | 0 | 5 | 8 | Manage Label Monitor | |

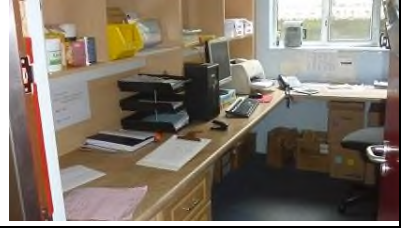
| Ref No. | Building/ Zone | Location Or Functional Space | Sample No. | Material Description, surface treatment and condition | Extent | Asbestos identified (presumed, strongly presumed or identified) | Product type | Condition | Surface treatment | Asbestos type | Material assessment score | Activity | Likelihood of disturbance | Exposure potential | Maintenance | Priority assessment score | Combined Assessment Score | Recommendation/ Comments | Photo |
|---|---|---|---|---|---|---|---|---|---|---|---|---|---|---|---|---|---|---|---|
| 72. | Zone 2 | Ground Floor Kitchen Catering office 146 | | | | NAD | | | | | | | | | | | | | |

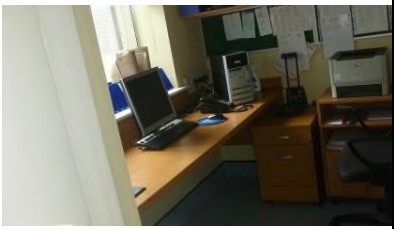
| Ref No. | Building/ Zone | Location Or Functional Space | Sample No. | Material Description, surface treatment and condition | Extent | Asbestos identified (presumed, strongly presumed or identified) | Product type | Condition | Surface treatment | Asbestos type | Material assessment score | Activity | Likelihood of disturbance | Exposure potential | Maintenance | Priority assessment score | Combined Assessment Score | Recommendation/ Comments | Photo |
|---|---|---|---|---|---|---|---|---|---|---|---|---|---|---|---|---|---|---|---|
| 97. | Zone 2 | Ground floor Occ. Therapy Treatment room | | | | NAD | | | | | | | | | | | | | |

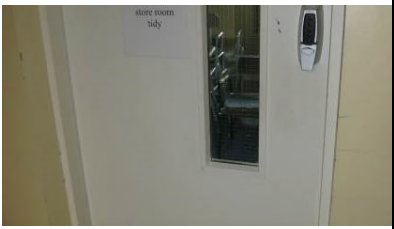
| Ref No. | Building/ Zone | Location Or Functional Space | Sample No. | Material Description, surface treatment and condition | Extent | Asbestos identified (presumed, strongly presumed or identified) | Product type | Condition | Surface treatment | Asbestos type | Material assessment score | Activity | Likelihood of disturbance | Exposure potential | Maintenance | Priority assessment score | Combined Assessment Score | Recommendation/ Comments | Photo |
|---|---|---|---|---|---|---|---|---|---|---|---|---|---|---|---|---|---|---|---|
| 101. | Zone 2 | Ground floor Occ. Therapy Store room | | | | NAD | | | | | | | | | | | | | |

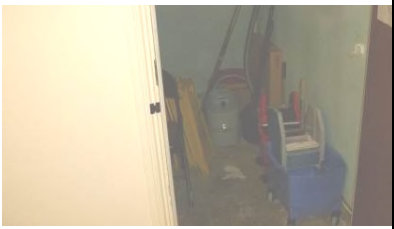
| Ref No. | Building/ Zone | Location Or Functional Space | Sample No. | Material Description, surface treatment and condition | Extent | Asbestos identified (presumed, strongly presumed or identified) | Product type | Condition | Surface treatment | Asbestos type | Material assessment score | Activity | Likelihood of disturbance | Exposure potential | Maintenance | Priority assessment score | Combined Assessment Score | Recommendation/ Comments | Photo |
|---|---|---|---|---|---|---|---|---|---|---|---|---|---|---|---|---|---|---|---|
| 105. | Zone 2 | Ground floor Bone Bank | | | | NAD | | | | | | | | | | | | | |

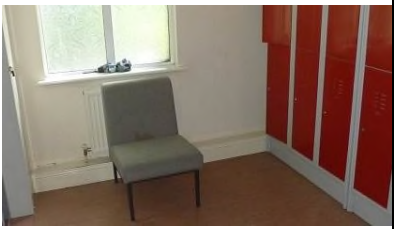
| Ref No. | Building/ Zone | Location Or Functional Space | Sample No. | Material Description, surface treatment and condition | Extent | Asbestos identified (presumed, strongly presumed or identified) | Product type | Condition | Surface treatment | Asbestos type | Material assessment score | Activity | Likelihood of disturbance | Exposure potential | Maintenance | Priority assessment score | Combined Assessment Score | Recommendation/ Comments | Photo |
|---|---|---|---|---|---|---|---|---|---|---|---|---|---|---|---|---|---|---|---|
| 109. | Zone 2 | Ladies changing room 191 | | | | NAD | | | | | | | | | | | | | |

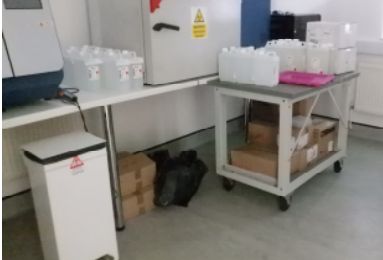
| Ref No. | Building/ Zone | Location Or Functional Space | Sample No. | Material Description, surface treatment and condition | Extent | Asbestos identified (presumed, strongly presumed or identified) | Product type | Condition | Surface treatment | Asbestos type | Material assessment score | Activity | Likelihood of disturbance | Exposure potential | Maintenance | Priority assessment score | Combined Assessment Score | Recommendation | Photo |
|---|---|---|---|---|---|---|---|---|---|---|---|---|---|---|---|---|---|---|---|
| 24. | Zone 6 | Cappagh Hospital Foundation Biological Hazard rooms. | | Plaster board ceilings | | NAD | | | | | | | | | | | | | |
