# COMMISSIONERS OF IRISH LIGHTS

18<sup>th</sup> June 2019

## **Muglins Boat Landing Inspection Report**

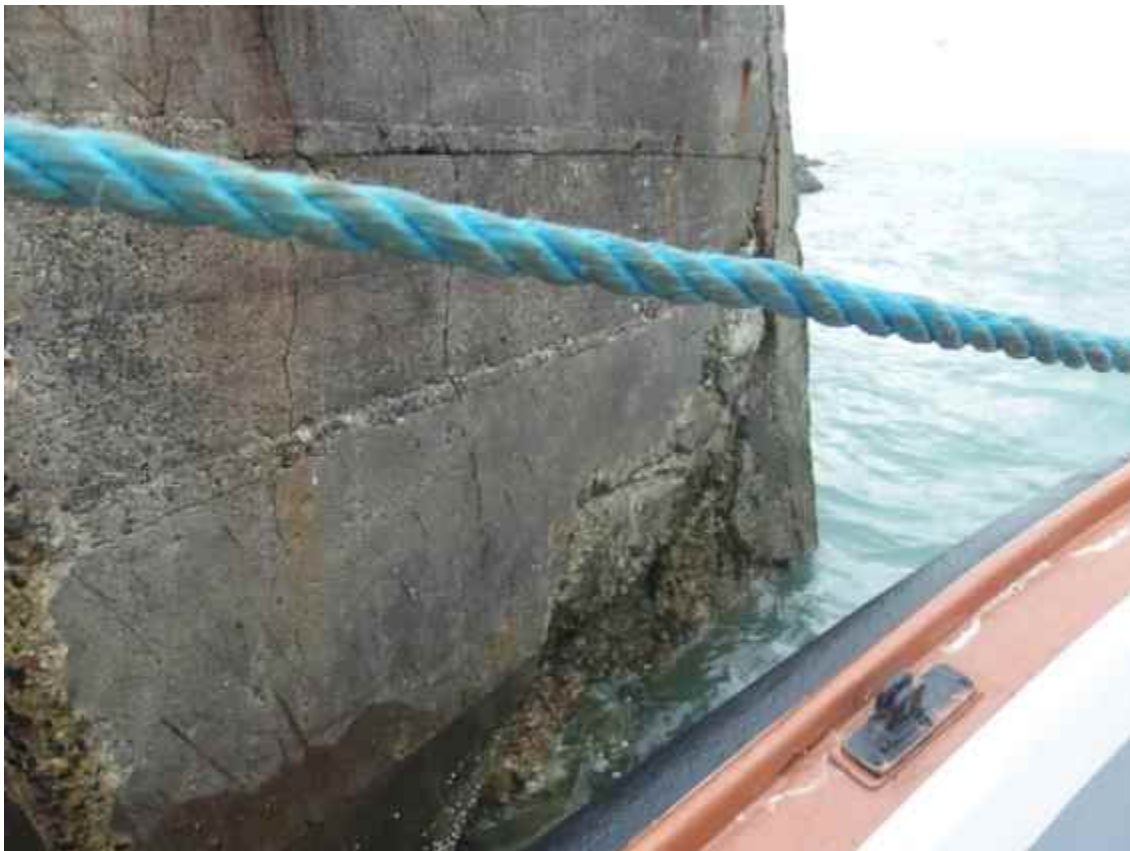
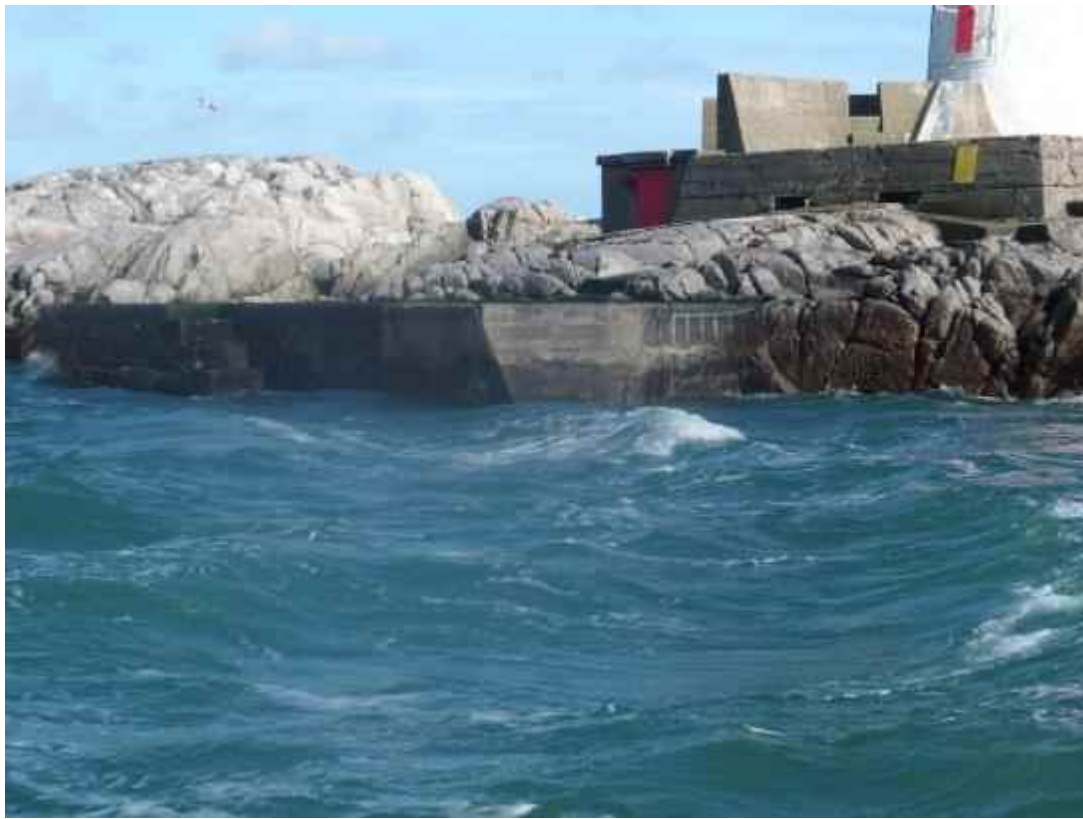
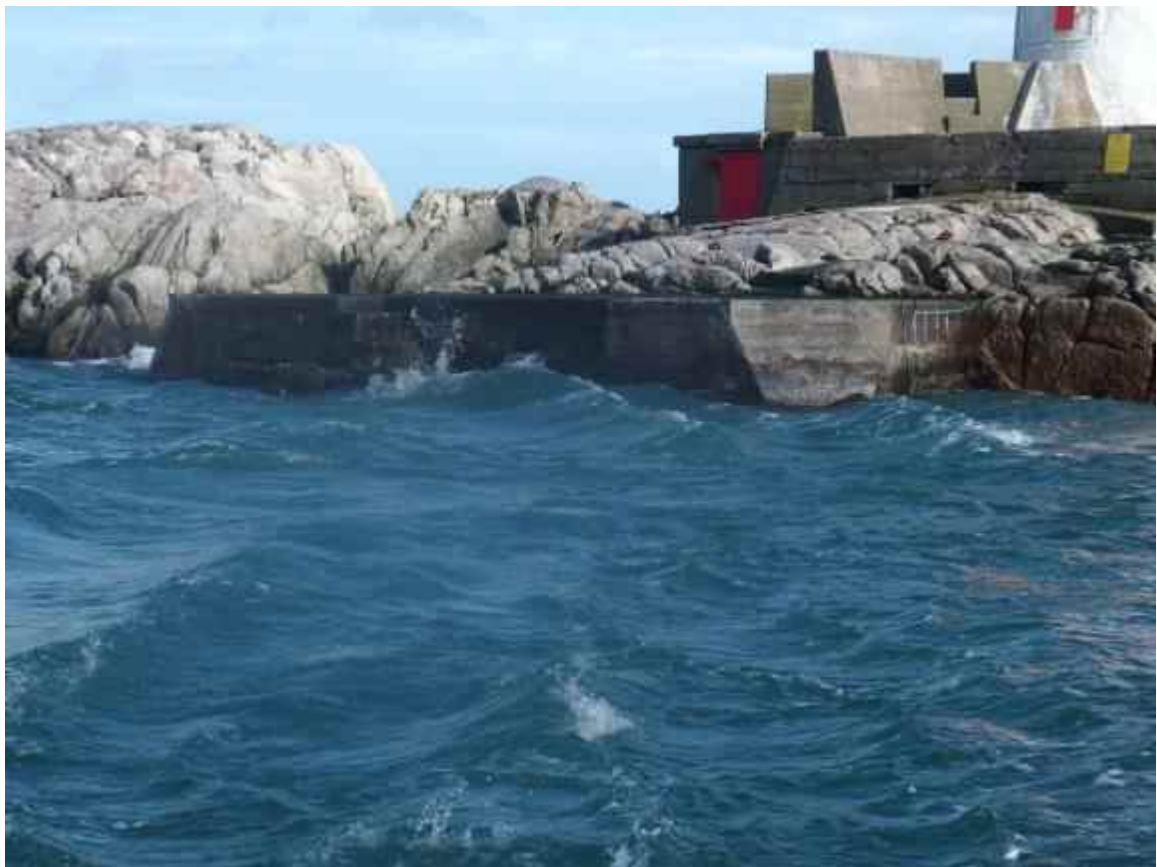
- Concrete repairs made to side of landing below the water line (This has got worse since the reports made in 2016 & 2017)
- Handrail in need of replacement (Outstanding from last report) – Handrail gone entirely

Concrete cracking and missing on side of landing below waterline
