# Model Project

Framework Agreement for Construction Design  
Professional Services for Pyrite Remediation Scheme

Project  
**Inspection of  
Notional Building 1,  
Dublin 15.**

Report Title  
**BUILDING CONDITION  
ASSESSMENT IN ACCORDANCE  
WITH IS 398-1:2013**

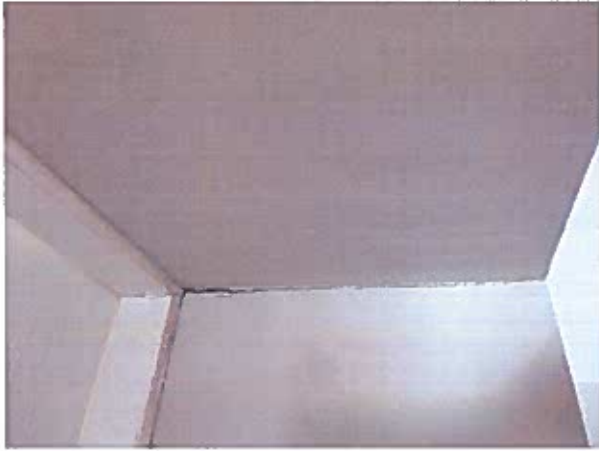
Photo 17

| ELEMENT GROUP | PHOTO REFERENCE | ATTRIBUTE VALUE | OBSERVATION IN ANY ROOM | LOCATION(S) IDENTITY /COMMENTS |
|---|---|---|---|---|
| Walls / Partitions on Ground Floor | 16, 17 | 1 | Horizontal cracking at top lh and top rh corners of reveal to door leading to study. | Hallway |

| Summary Conclusions and sign off template (To be read in accordance with the Table 3.2 – Evaluation of damage and associated sketches and photographs) | | | | |
|---|---|---|---|---|
| A | 16, 17 | Horizontal cracking at top lh and top rh corners of reveal to door leading to study. | Walls / Partitions on Ground Floor Level | 1 |

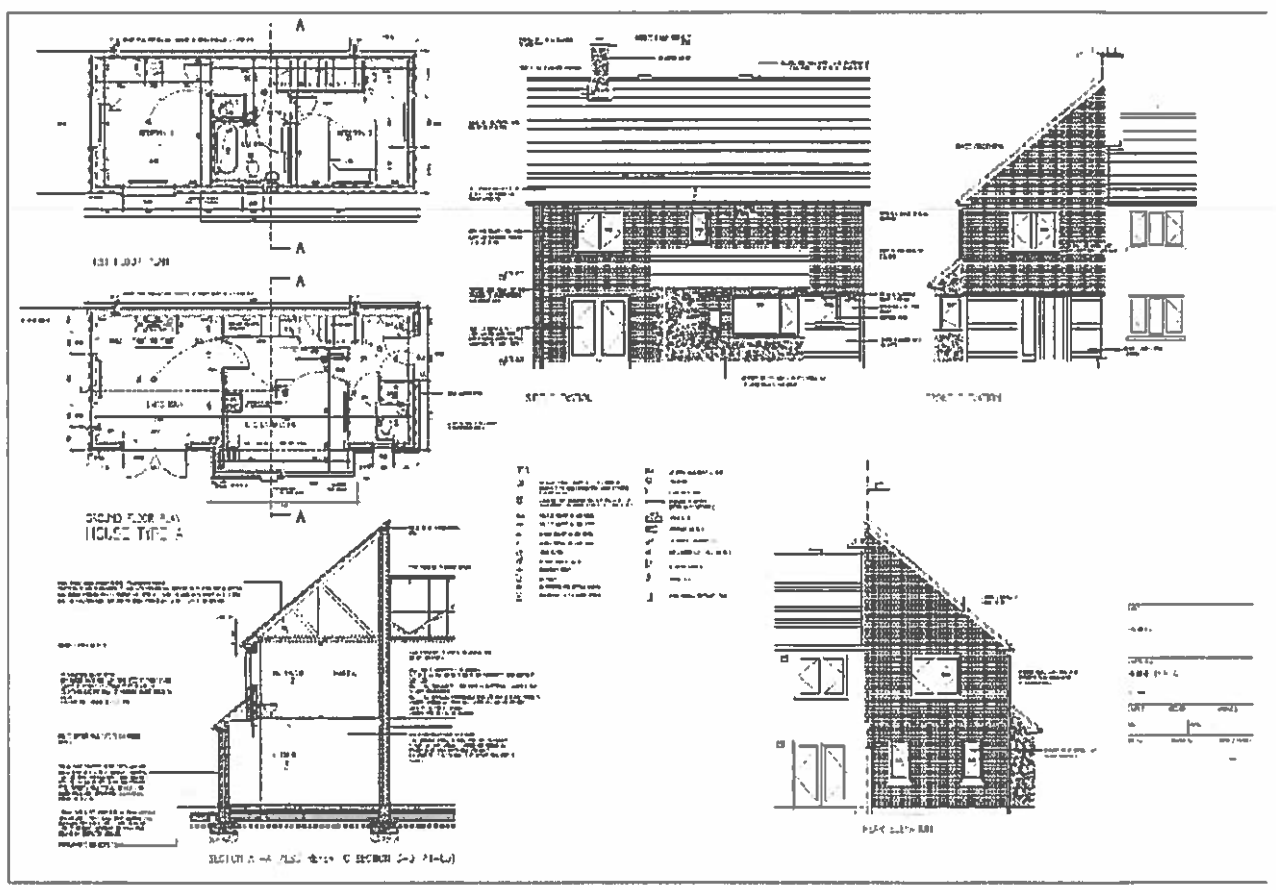
### Floor plan sketch

- 3.1.1 Please refer to attached drawings and referenced photographs for instances of recorded damage.

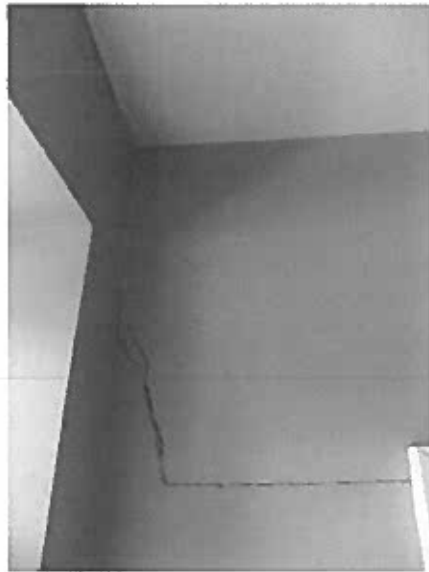
Photo 2

| ELEMENT GROUP | PHOTO REFERENCE | ATTRIBUTE VALUE | OBSERVATION IN ANY ROOM | LOCATION(S) IDENTITY /COMMENTS |
|---|---|---|---|---|
| Walls / Partitions on Ground Floor | 2 | 6 | Diagonal 4.5mm crack at left hand side of door to living room, reduces to approx. 1mm at top of door. | Hallway |

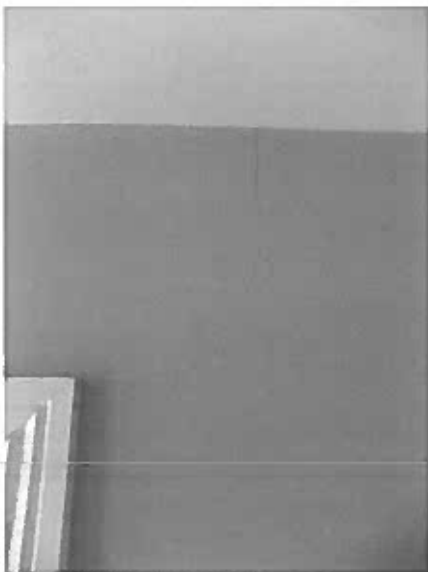
Photo 3

| ELEMENT GROUP | PHOTO REFERENCE | ATTRIBUTE VALUE | OBSERVATION IN ANY ROOM | LOCATION(S) IDENTITY /COMMENTS |
|---|---|---|---|---|
| | 3 | 4 | Diagonal 0.5mm crack at right hand side of door to living room. Crack reduces to hairline at top of door. | Hallway |

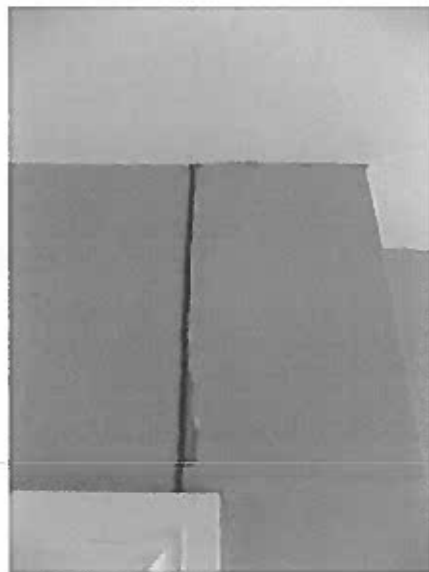
Photo 4

| ELEMENT GROUP | PHOTO REFERENCE | ATTRIBUTE VALUE | OBSERVATION IN ANY ROOM | LOCATION(S) IDENTITY /COMMENTS |
|---|---|---|---|---|
| | 4 | 6 | Vertical 6.5mm crack at right hand side of door to store. | Hallway |

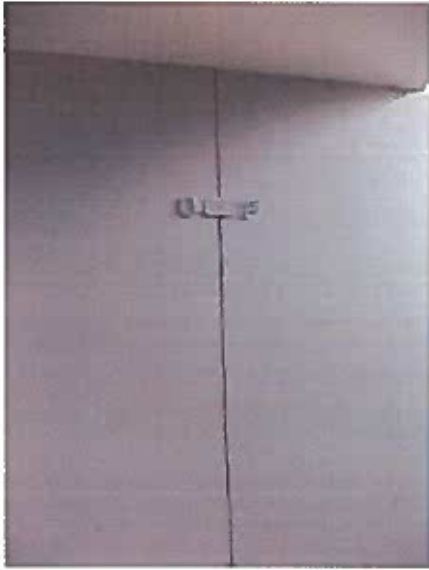
Photo 5

| ELEMENT GROUP | PHOTO REFERENCE | ATTRIBUTE VALUE | OBSERVATION IN ANY ROOM | LOCATION(S) IDENTITY /COMMENTS |
|---|---|---|---|---|
| | 5, 6 | 6 | Vertical 3.5mm crack at ceiling at junction of stud partition. Crack reduces to hairline at skirting. | Hallway |

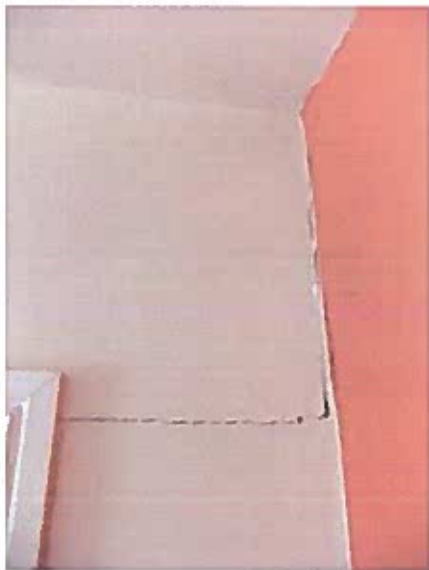
Photo 7

| ELEMENT GROUP | PHOTO REFERENCE | ATTRIBUTE VALUE | OBSERVATION IN ANY ROOM | LOCATION(S) IDENTITY /COMMENTS |
|---|---|---|---|---|
| | 7 | 6 | Horizontal 4mm crack at right hand side of door to hall, crack reduces to 1mm at top of door. | Living Room |

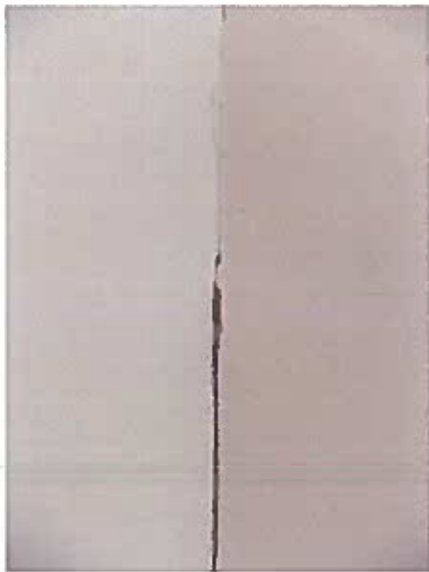
Photo 10

| Summary Conclusions and sign off template (To be read in accordance with the Table 3.2 – Evaluation of damage and associated sketches and photographs) | | | | |
|---|---|---|---|---|
| A | 10, 11 | Stud partition party wall with No. 17A is pushed up by 11mm, cracking at wall / wall junction for full height. | Ground Floor Ceiling(s) | 10 |

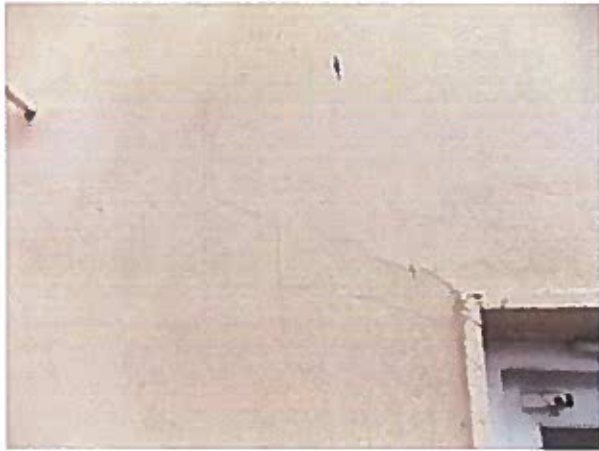
Photo 12

| ELEMENT GROUP | PHOTO REFERENCE | ATTRIBUTE VALUE | OBSERVATION IN ANY ROOM | LOCATION(S) IDENTITY /COMMENTS |
|---|---|---|---|---|
| | 12 | 10 | Cracking at left hand side of door to hall, wall pushed by max of 6mm. | W.C. |
