**Project Name:** Shannon Valley House Connections 08-01-25  
**Project Description:** CCTV Survey  
**Project Number:** CES 11740  
**Project Status:** Complete  
**Project Date:** 08/01/2026

Project Name Shannon Valley House Connections 08-01-25 Project Number CES 11740 Project Date 08/01/2026

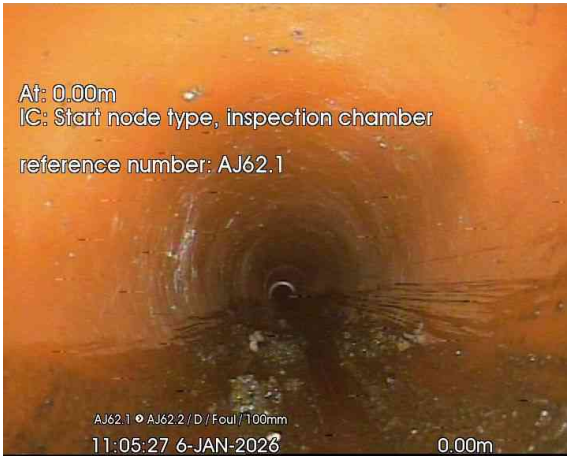
1, 00:00:00, 0.00 m  
 Start node, inspection chamber, reference: AJ62.1

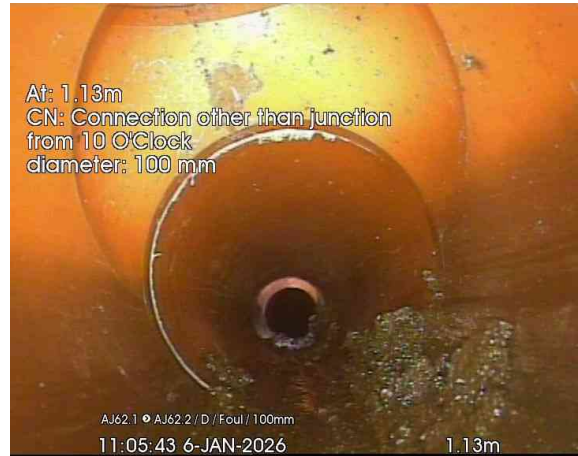
2, 00:00:07, 1.13 m  
 Connection other than junction at 10 o'clock, 100mm dia

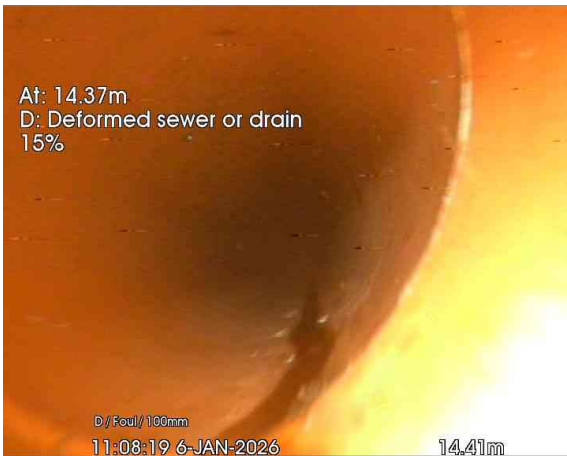
3, 00:00:28, 14.41 m  
 Deformed sewer or drain, 15%

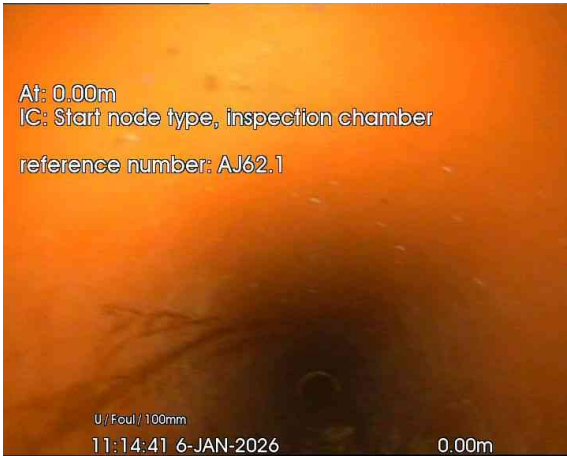
1, 00:00:01, 0.00 m  
 Start node, inspection chamber, reference: AJ62.1

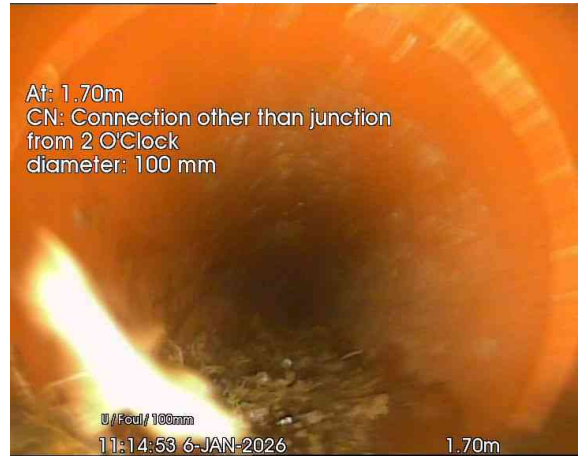
2, 00:00:06, 1.70 m  
 Connection other than junction at 2 o'clock, 100mm dia

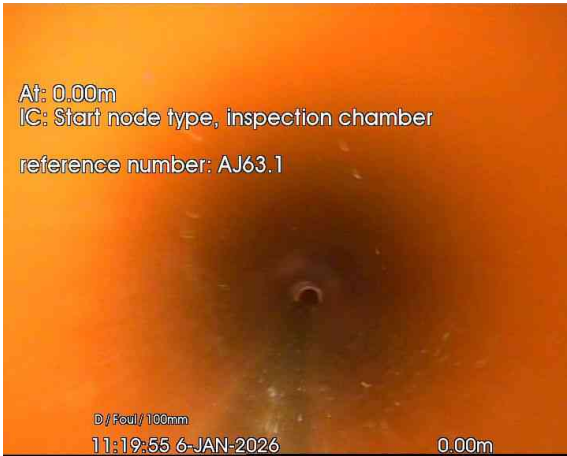
1, 00:00:01, 0.00 m  
 Start node, inspection chamber, reference: AJ63.1

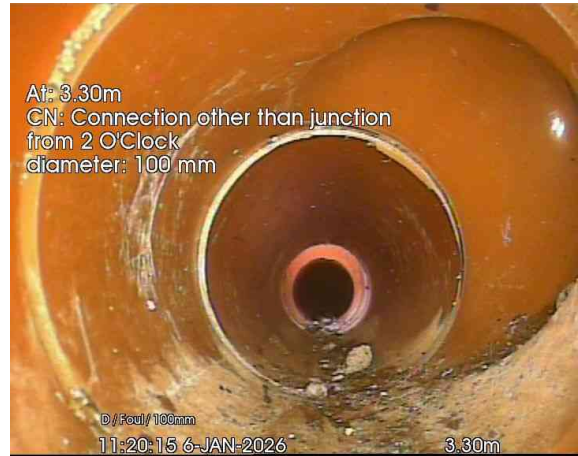
2, 00:00:12, 3.30 m  
 Connection other than junction at 2 o'clock, 100mm dia

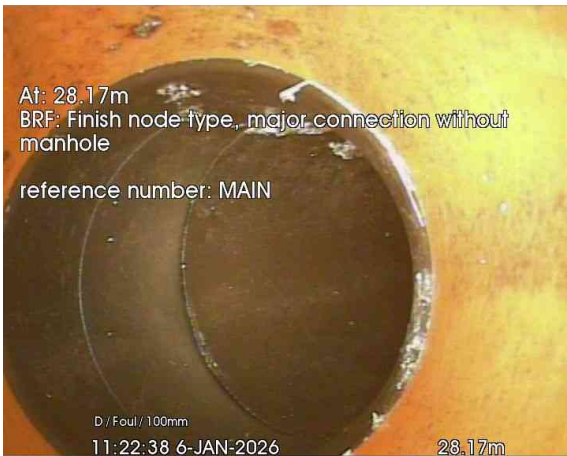
3, 00:01:06, 28.17 m  
 Finish node, major connection without manhole, reference: MAIN

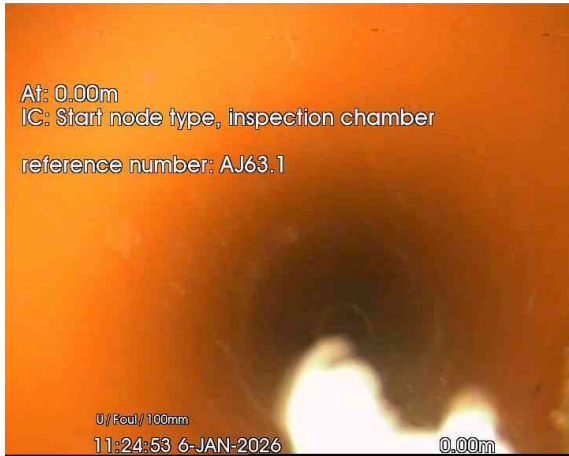
1, 00:00:01, 0.00 m  
 Start node, inspection chamber, reference: AJ63.1

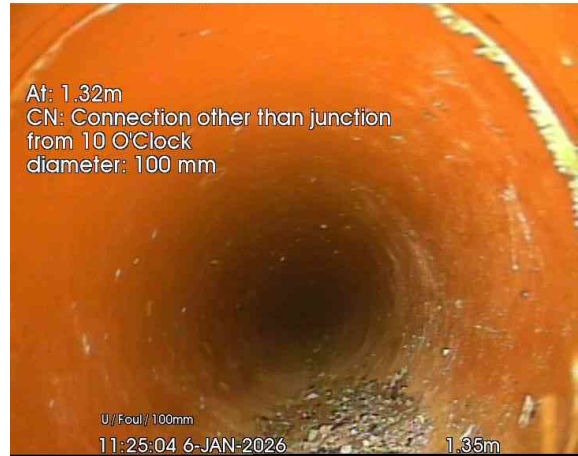
2, 00:00:04, 1.35 m  
 Connection other than junction at 10 o'clock, 100mm dia

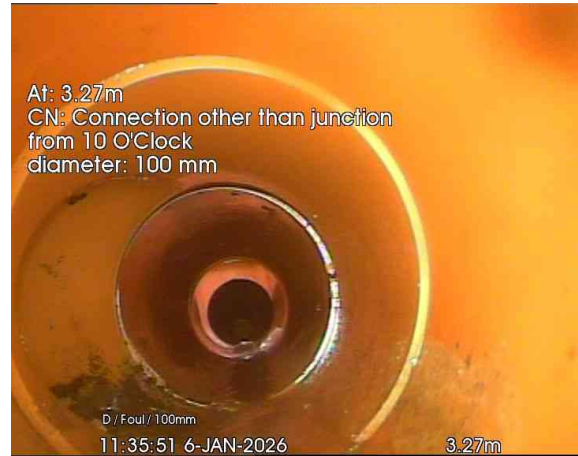
2, 00:00:14, 3.27 m  
Connection other than junction at 10 o'clock, 100mm dia

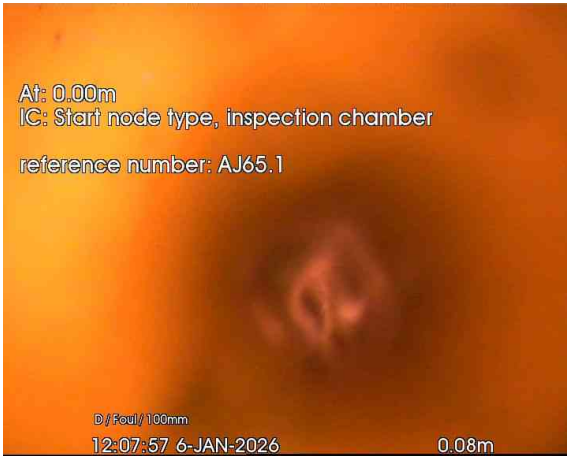
1, 00:00:01, 0.12 m  
Start node, inspection chamber, reference: AJ65.1

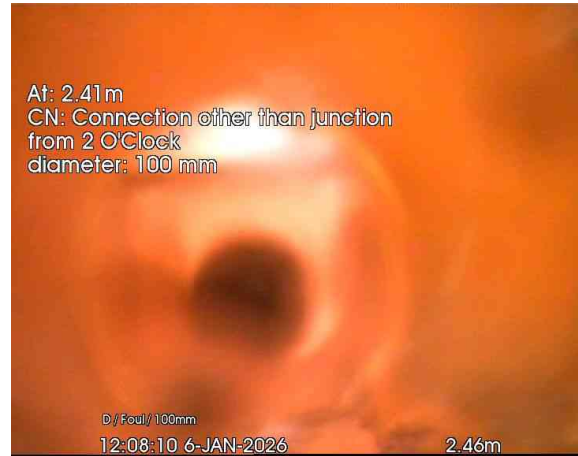
2, 00:00:06, 2.53 m  
Connection other than junction at 2 o'clock, 100mm dia

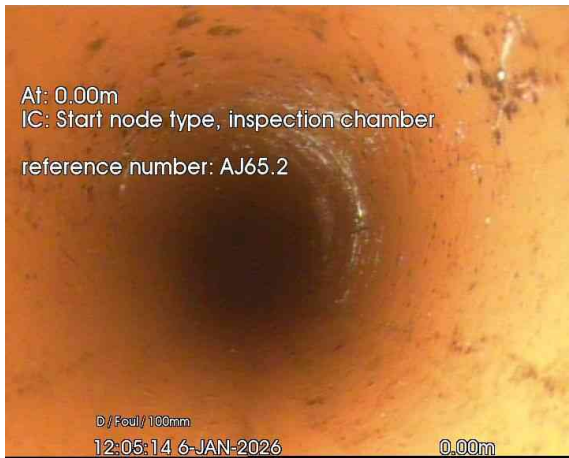
1, 00:00:01, 0.00 m  
 Start node, inspection chamber, reference: AJ65.2

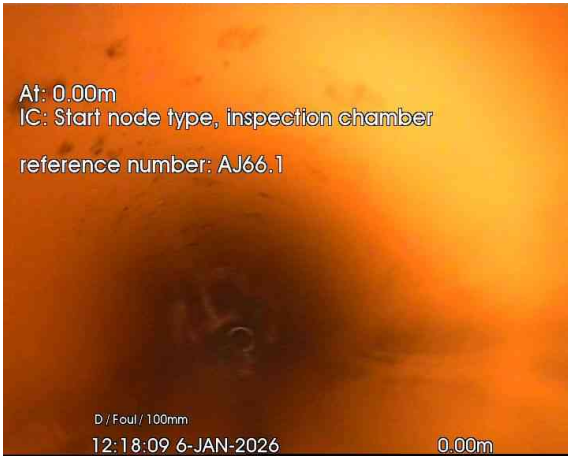
1, 00:00:01, 0.00 m  
 Start node, inspection chamber, reference: AJ66.1

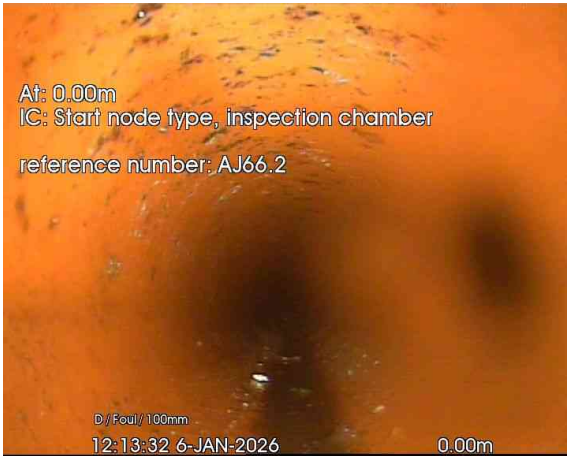
1, 00:00:01, 0.00 m  
Start node, inspection chamber, reference: AJ66.2

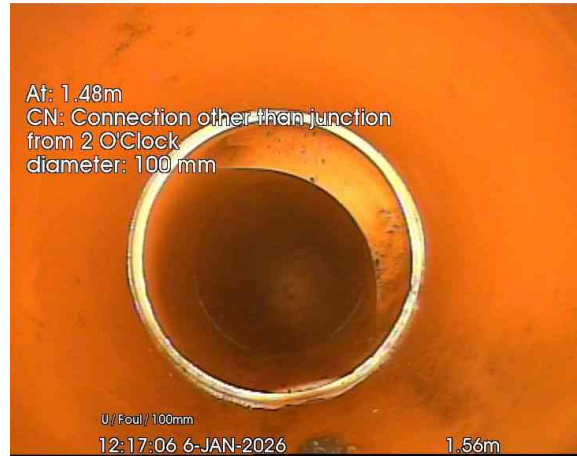
2, 00:00:04, 1.58 m  
 Connection other than junction at 2 o'clock, 100mm dia

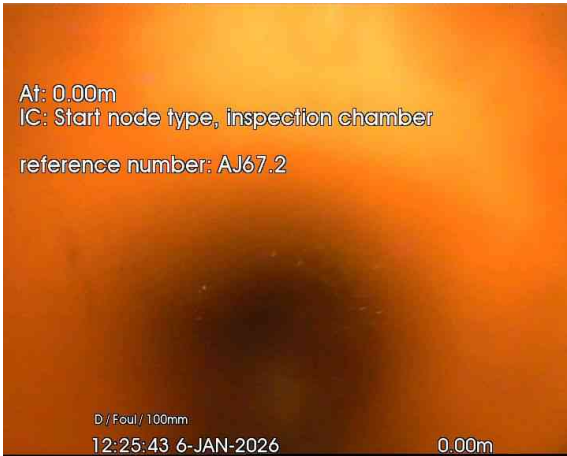
1, 00:00:01, 0.00 m  
Start node, inspection chamber, reference: AJ67.2

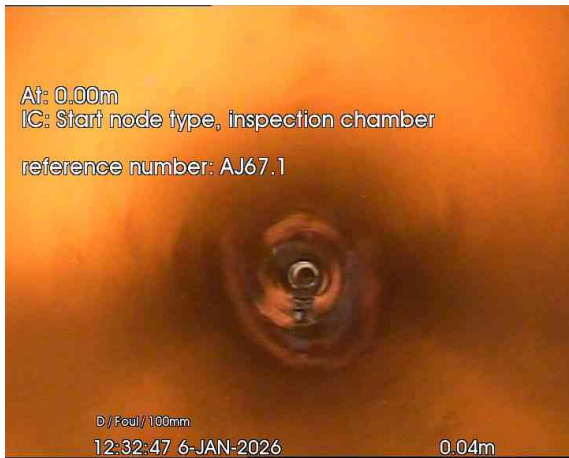
1, 00:00:01, 0.04 m  
 Start node, inspection chamber, reference: AJ67.1

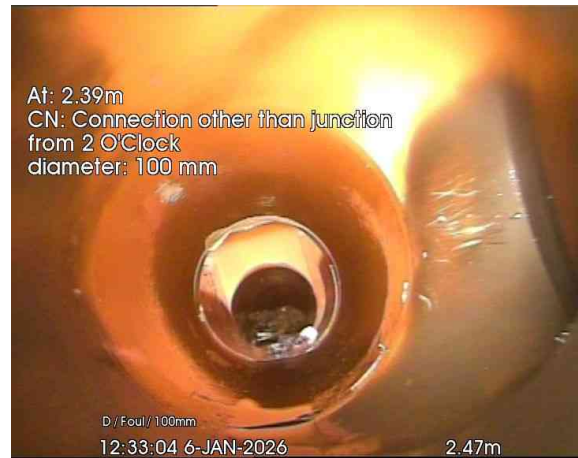
2, 00:00:09, 2.56 m  
 Connection other than junction at 2 o'clock, 100mm dia

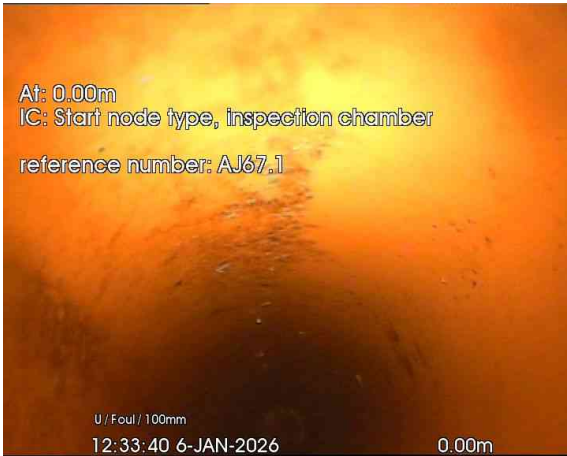
1, 00:00:01, 0.00 m  
 Start node, inspection chamber, reference: AJ67.1

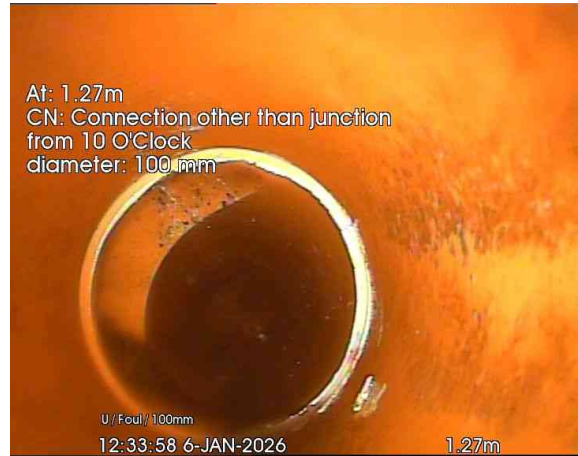
2, 00:00:08, 1.27 m  
 Connection other than junction at 10 o'clock, 100mm dia

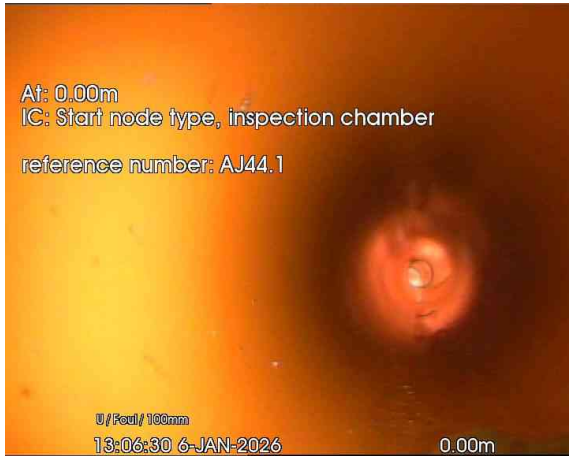
1, 00:00:01, 0.00 m  
 Start node, inspection chamber, reference: AJ44.1

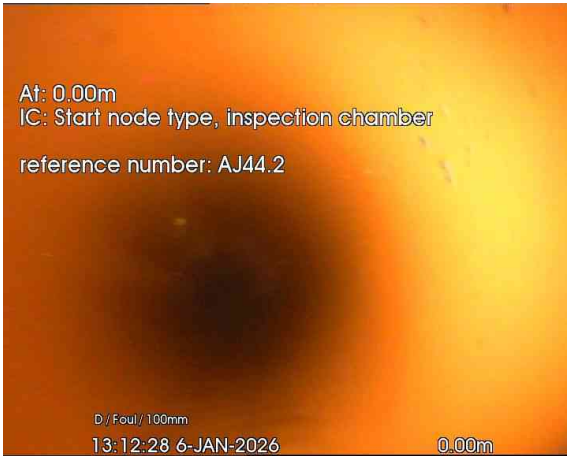
1, 00:00:01, 0.00 m  
 Start node, inspection chamber, reference: AJ44.2

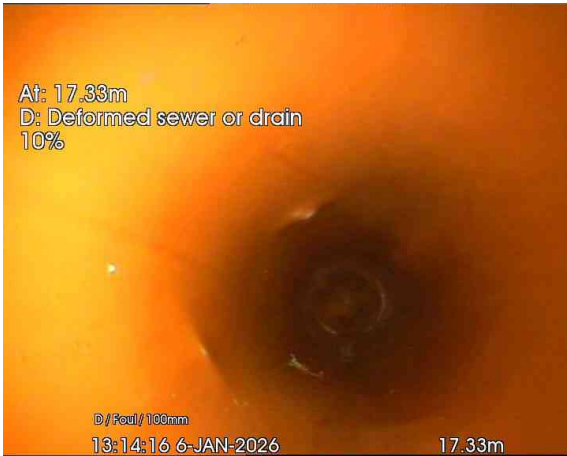
5, 00:01:10, 17.33 m  
 Deformed sewer or drain, 10%

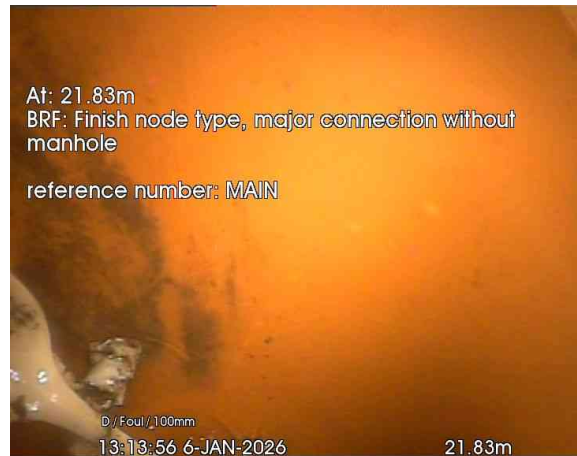
8, 00:00:55, 21.83 m  
 Finish node, major connection without manhole, reference: MAIN

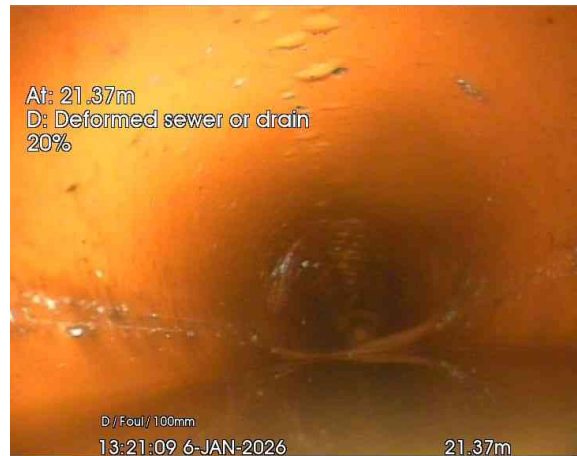
4, 00:01:01, 21.37 m  
 Deformed sewer or drain, 20%

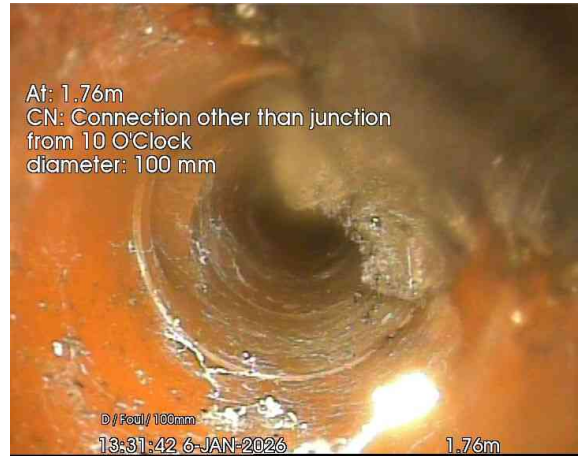
2, 00:00:12, 1.76 m  
 Connection other than junction at 10 o'clock, 100mm dia

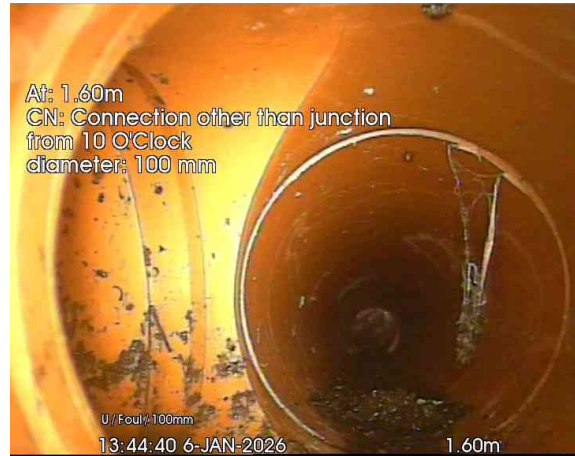
2, 00:00:08, 1.60 m  
 Connection other than junction at 10 o'clock, 100mm dia

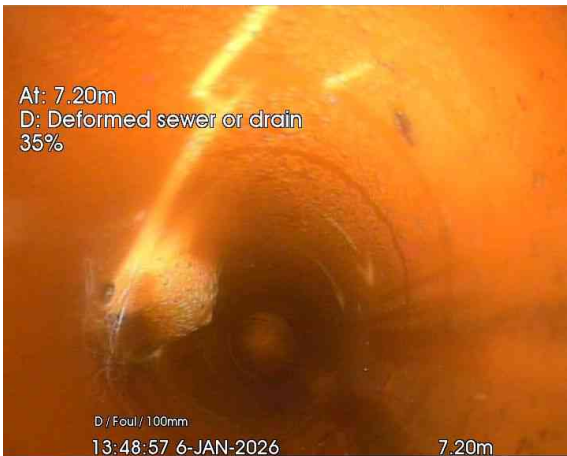
3, 00:00:18, 7.20 m  
 Deformed sewer or drain, 35%

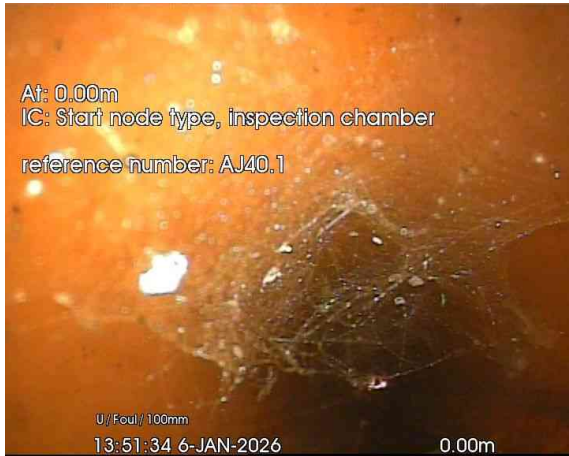
1, 00:00:03, 0.00 m  
Start node, inspection chamber, reference: AJ40.1

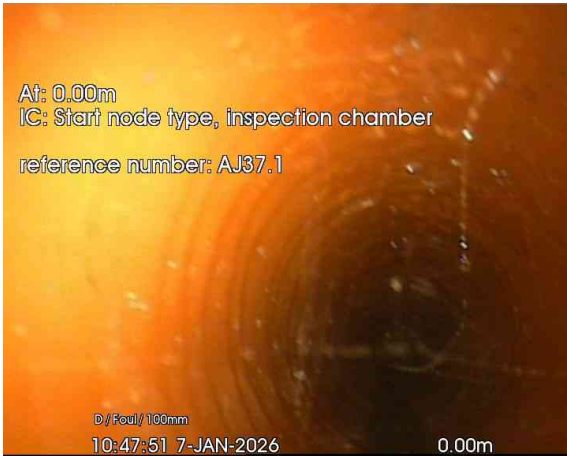
1, 00:00:01, 0.00 m  
Start node, inspection chamber, reference: AJ37.1

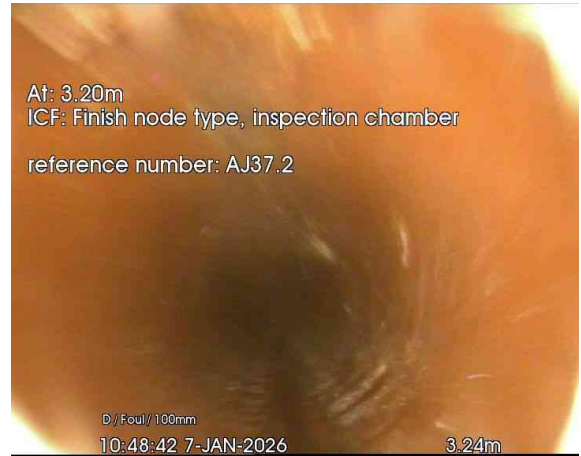
2, 00:00:17, 3.27 m  
Finish node, inspection chamber, reference: AJ37.2

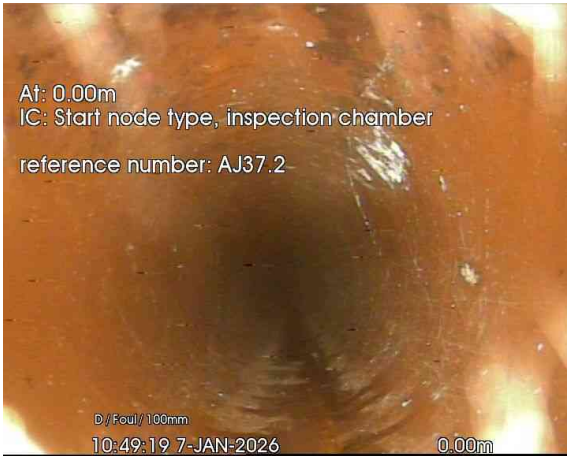
1, 00:00:00, 0.00 m  
 Start node, inspection chamber, reference: AJ37.2

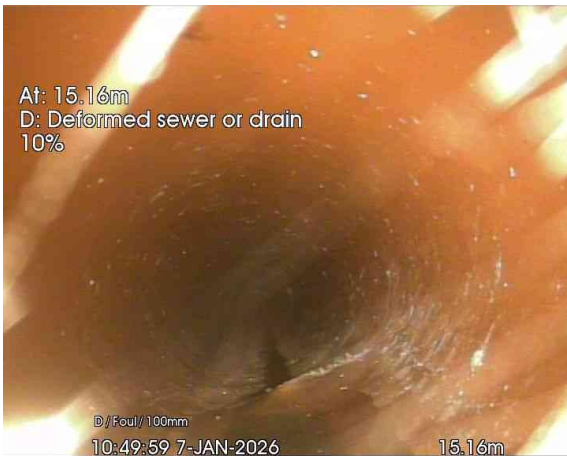
3, 00:00:31, 15.16 m  
 Deformed sewer or drain, 10%

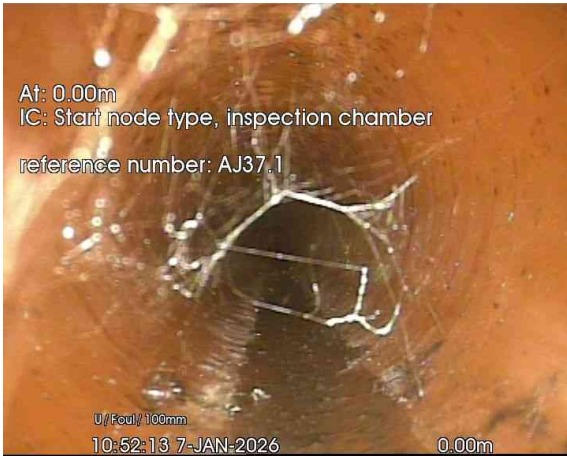
1, 00:00:01, 0.00 m  
 Start node, inspection chamber, reference: AJ37.1

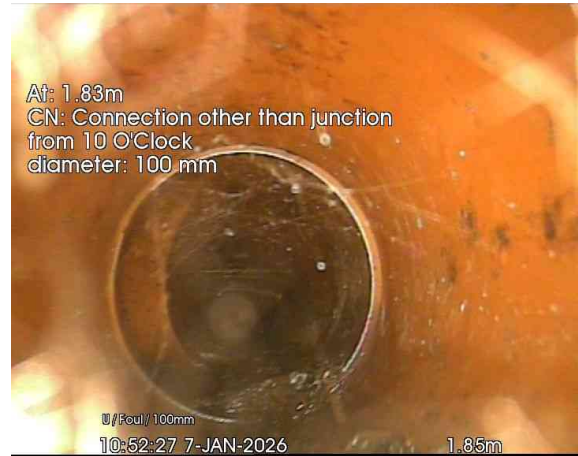
2, 00:00:07, 1.85 m  
 Connection other than junction at 10 o'clock, 100mm dia

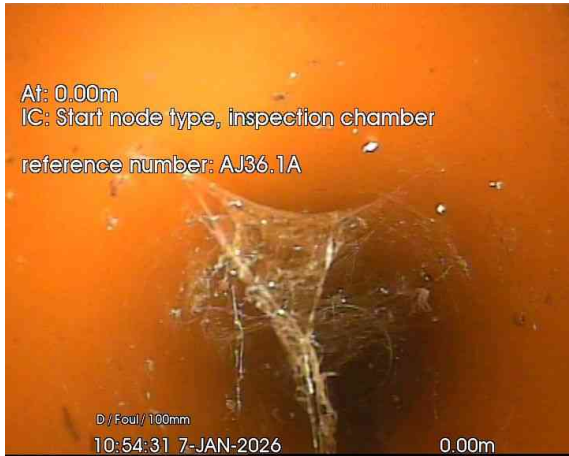
1, 00:00:01, 0.00 m  
 Start node, inspection chamber, reference: AJ36.1A

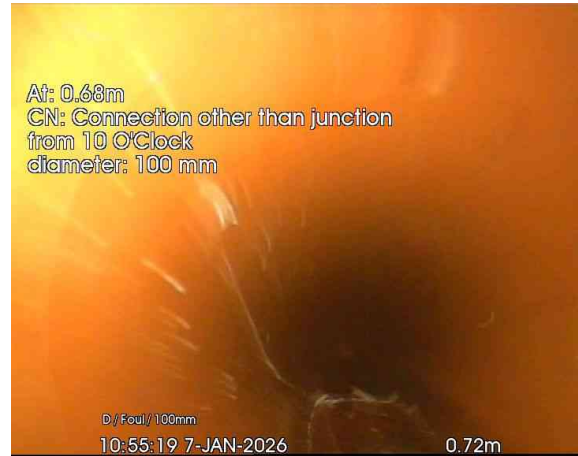
2, 00:00:10, 0.72 m  
 Connection other than junction at 10 o'clock, 100mm dia

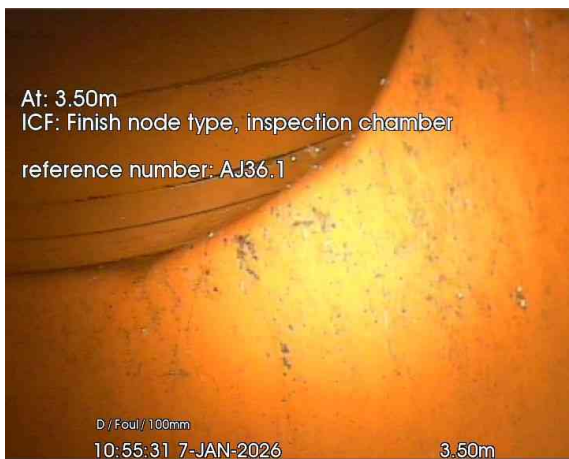
3, 00:00:15, 3.50 m  
 Finish node, inspection chamber, reference: AJ36.1

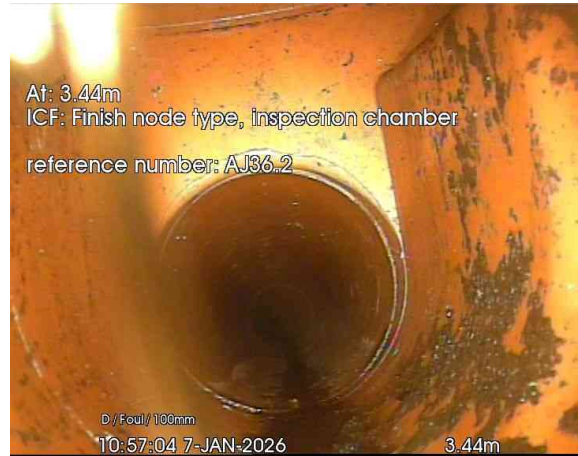
2, 00:00:10, 3.44 m  
 Finish node, inspection chamber, reference: AJ36.2

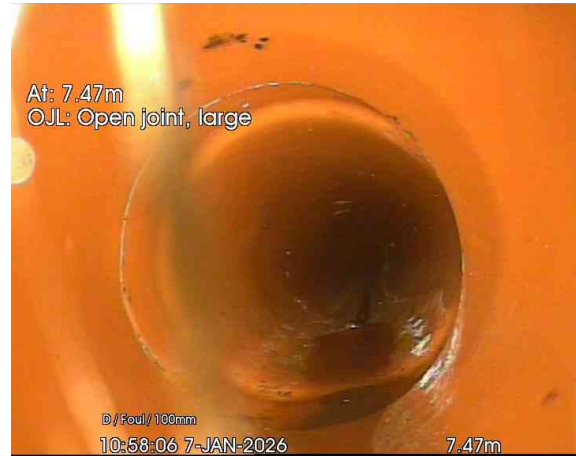
2, 00:00:17, 7.47 m  
 Open joint, large

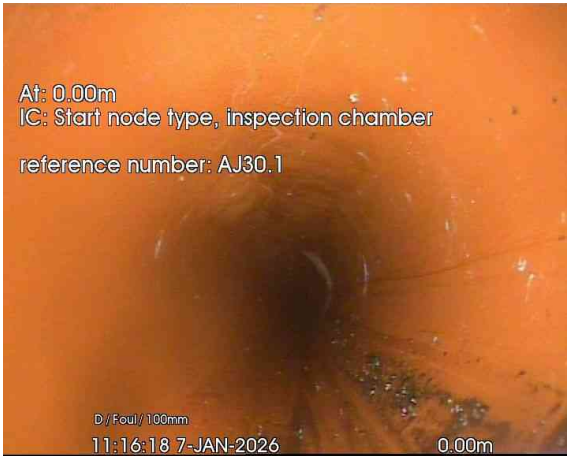
1, 00:00:01, 0.00 m  
 Start node, inspection chamber, reference: AJ30.1

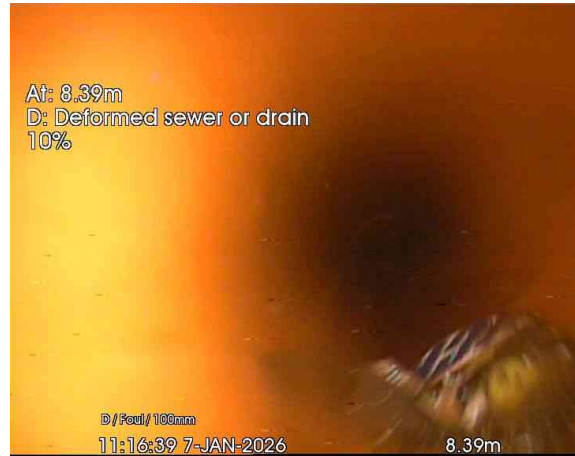
2, 00:00:17, 8.39 m  
 Deformed sewer or drain, 10%

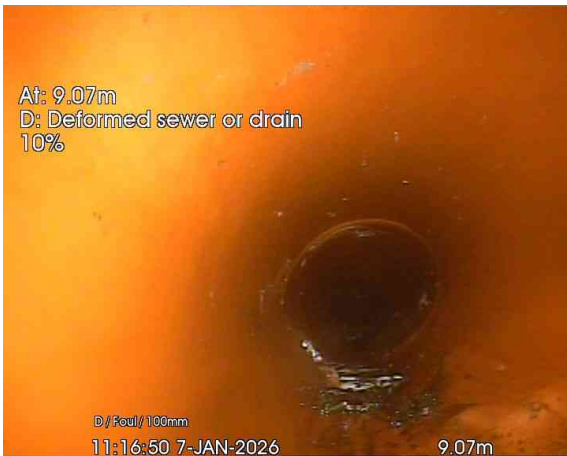
3, 00:00:23, 9.07 m  
 Deformed sewer or drain, 10%

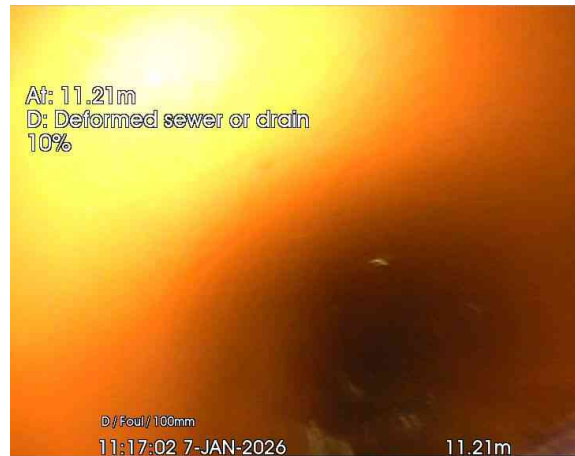
4, 00:00:30, 11.21 m  
 Deformed sewer or drain, 10%

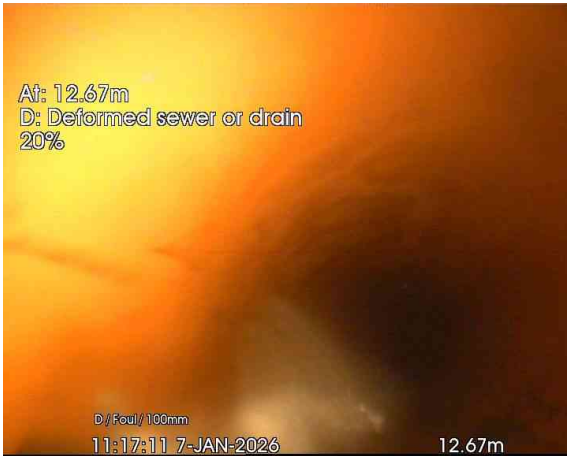
5, 00:00:35, 12.67 m  
Deformed sewer or drain, 20%

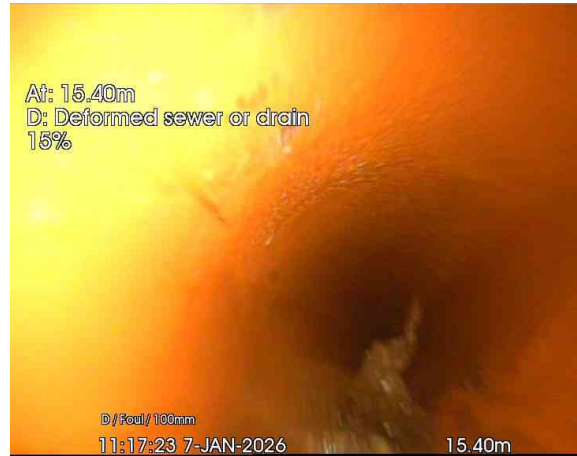
6, 00:00:43, 15.40 m  
Deformed sewer or drain, 15%

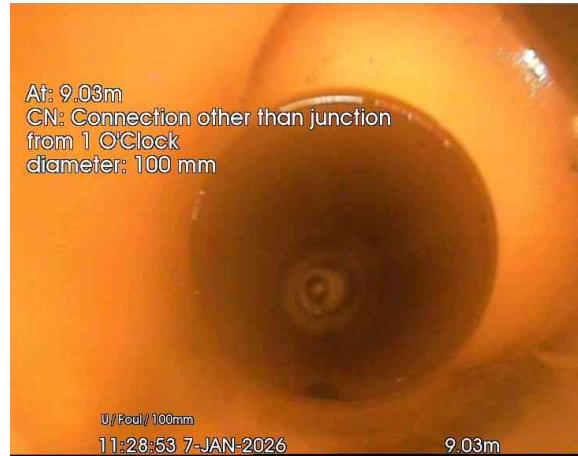
2, 00:00:19, 9.03 m  
 Connection other than junction at 1 o'clock, 100mm dia

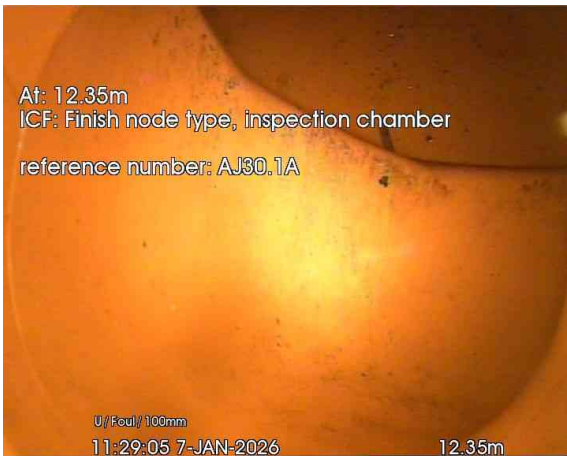
3, 00:00:25, 12.35 m  
 Finish node, inspection chamber, reference: AJ30.1A

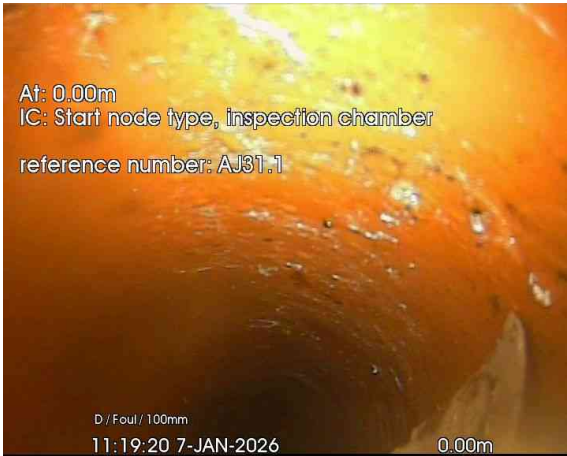
1, 00:00:01, 0.00 m  
 Start node, inspection chamber, reference: AJ31.1

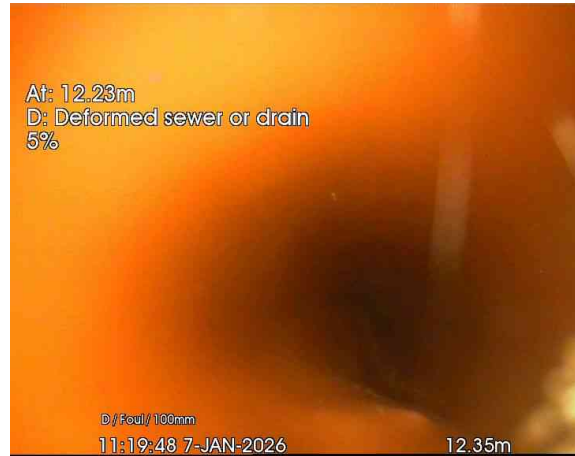
2, 00:00:24, 12.51 m  
 Deformed sewer or drain, 5%

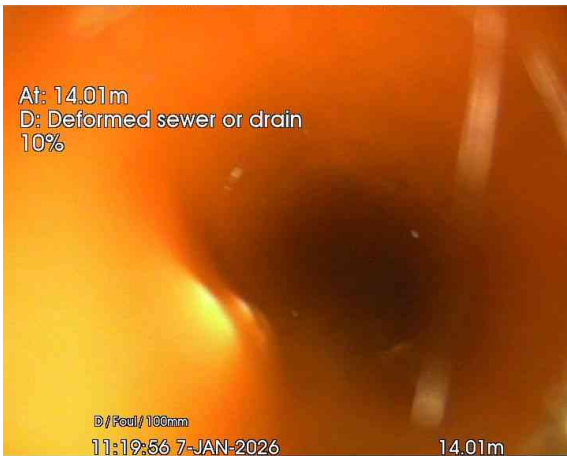
3, 00:00:28, 14.01 m  
 Deformed sewer or drain, 10%

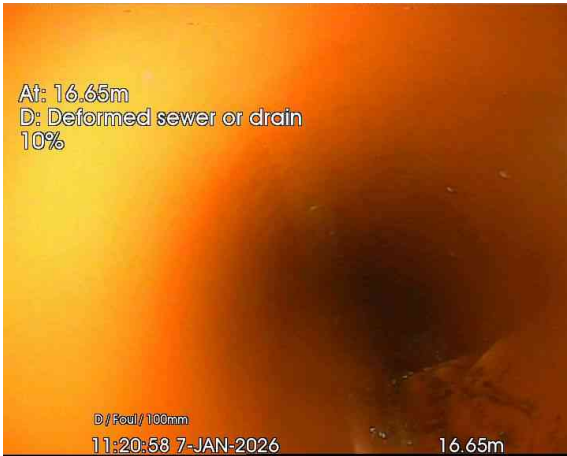
5, 00:01:16, 16.65 m  
Deformed sewer or drain, 10%
