Project Name: Shannon Valley Foul Water 10-11-25
Project Description: CCTV Survey
Project Number: CES 11659
Project Status: Complete
Project Date: 10/11/2025
Inspection Standard: MSCC5 Sewers & Drainage GB (SRM5 Scoring)

Project Name: Shannon Valley Foul Water 10-11-25
Project Number: CES 11659
Project Date: 10/11/2025

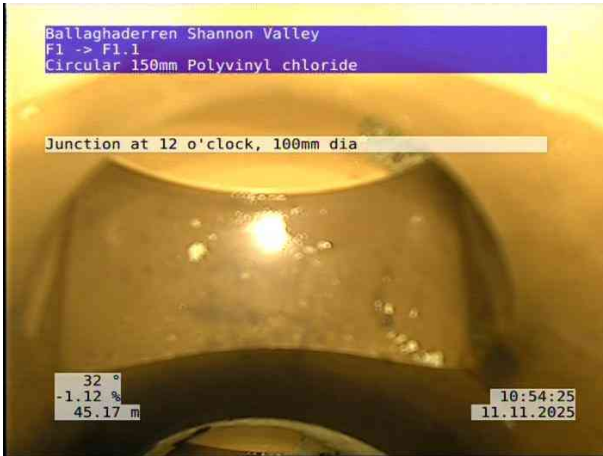
5, 00:04:53, 45.17 m
 Junction at 12 o'clock, 100mm dia

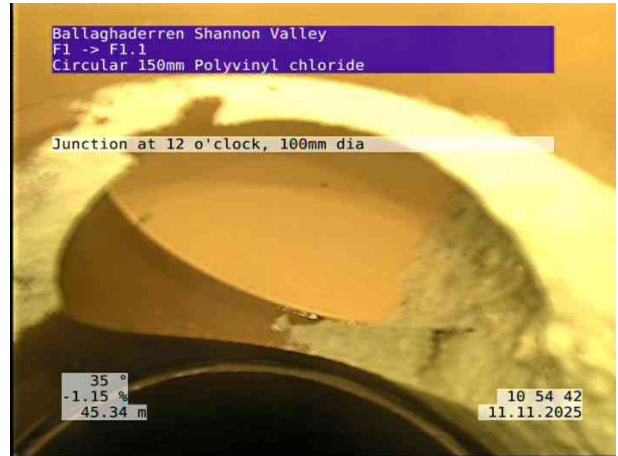
6, 00:05:06, 45.34 m
 Junction at 12 o'clock, 100mm dia

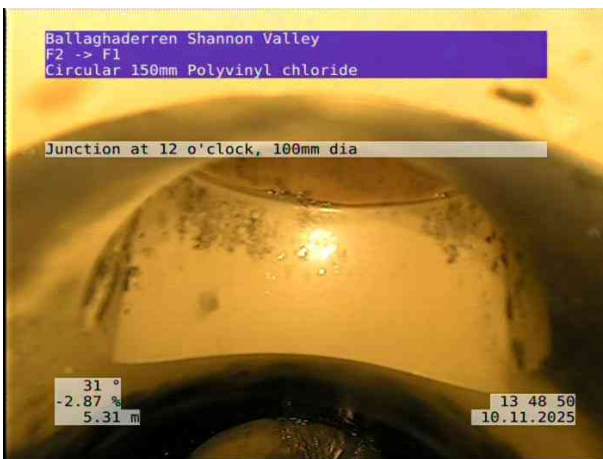
3, 00:00:58, 5.31 m
 Junction at 12 o'clock, 100mm dia

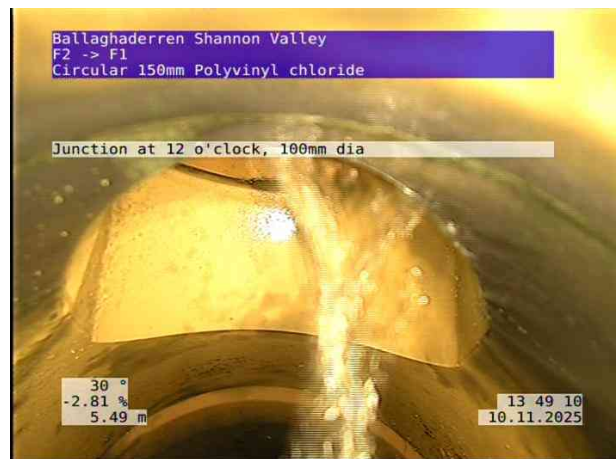
4, 00:01:12, 5.49 m
 Junction at 12 o'clock, 100mm dia

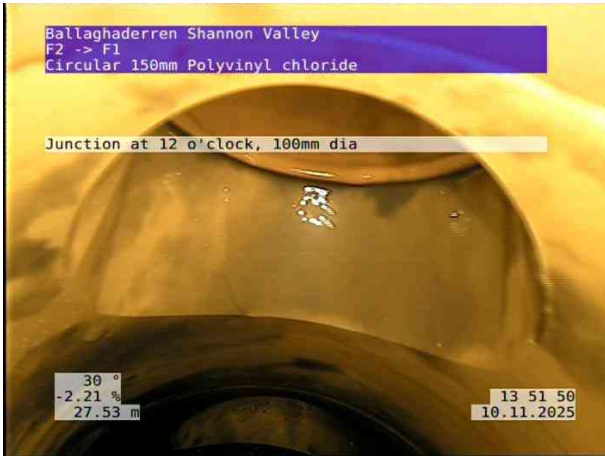
5, 00:03:44, 27.53 m
 Junction at 12 o'clock, 100mm dia

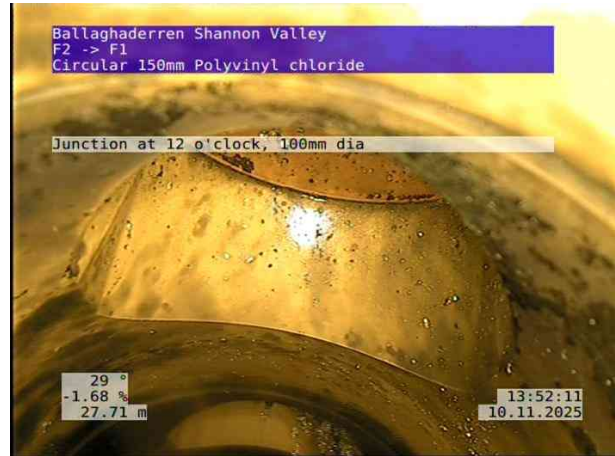
6, 00:04:01, 27.71 m
 Junction at 12 o'clock, 100mm dia

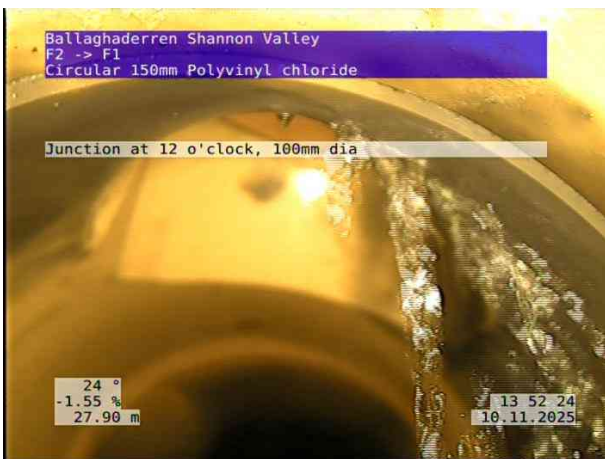
7, 00:04:10, 27.90 m
 Junction at 12 o'clock, 100mm dia

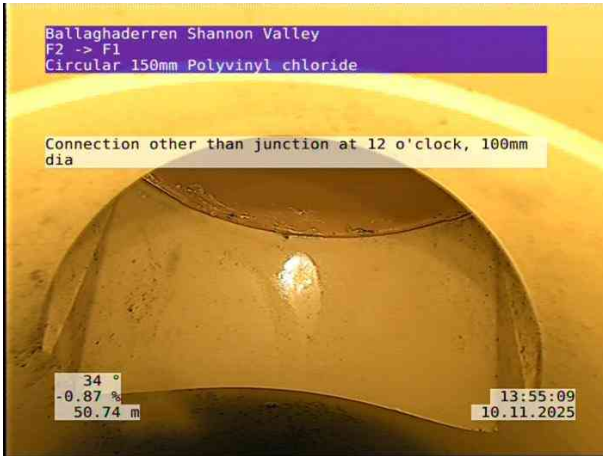
9, 00:06:42, 50.74 m
 Connection other than junction at 12 o'clock, 100mm dia

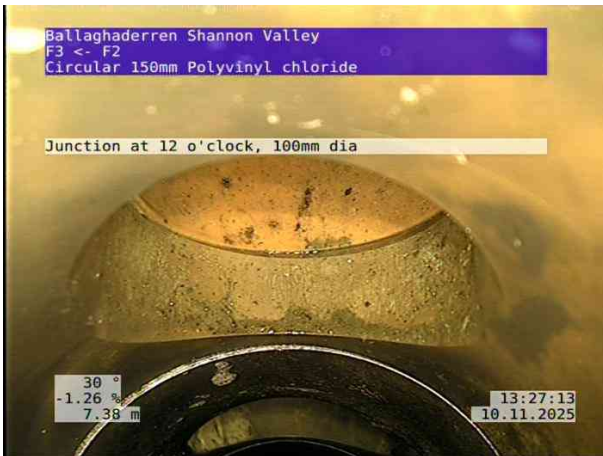
3, 00:01:17, 7.38 m
 Junction at 12 o'clock, 100mm dia

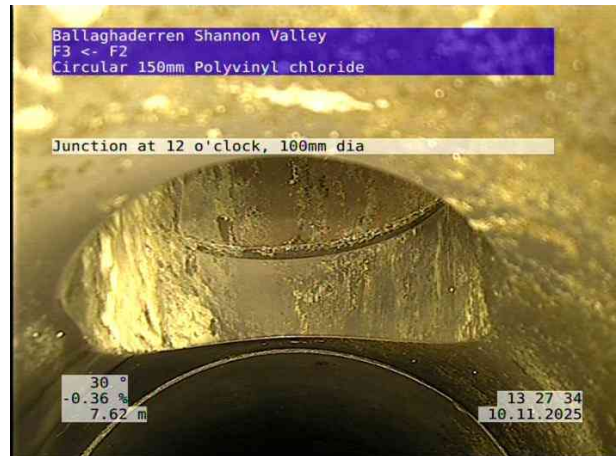
4, 00:01:33, 7.62 m
 Junction at 12 o'clock, 100mm dia

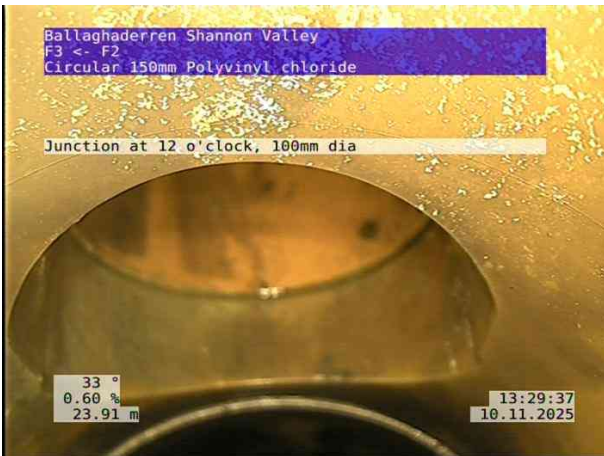
7, 00:03:24, 23.91 m
 Junction at 12 o'clock, 100mm dia

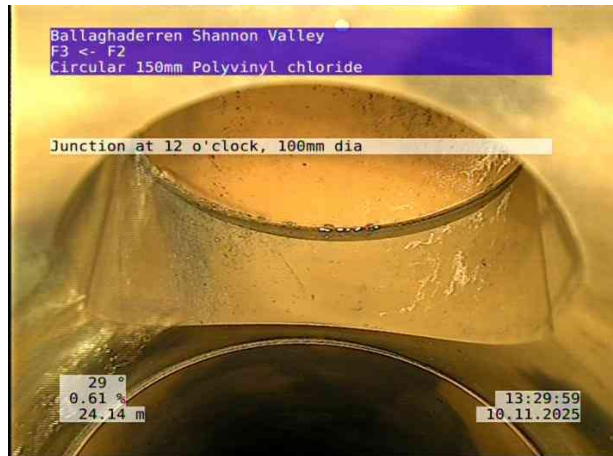
8, 00:03:41, 24.14 m
 Junction at 12 o'clock, 100mm dia

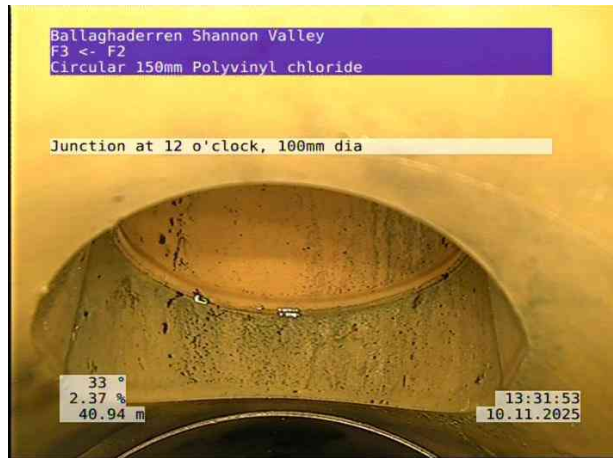
10, 00:05:27, 40.94 m
 Junction at 12 o'clock, 100mm dia

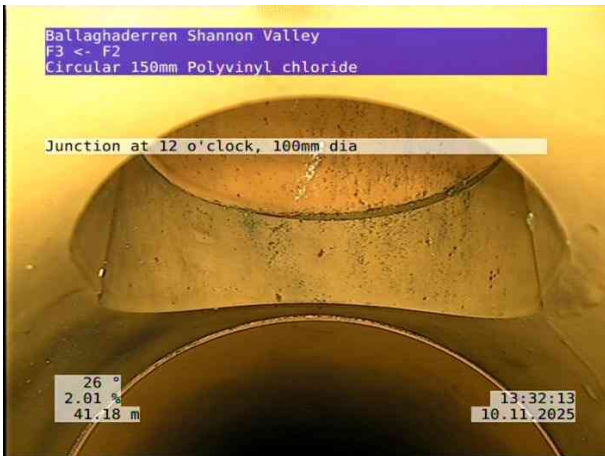
11, 00:05:42, 41.18 m
 Junction at 12 o'clock, 100mm dia

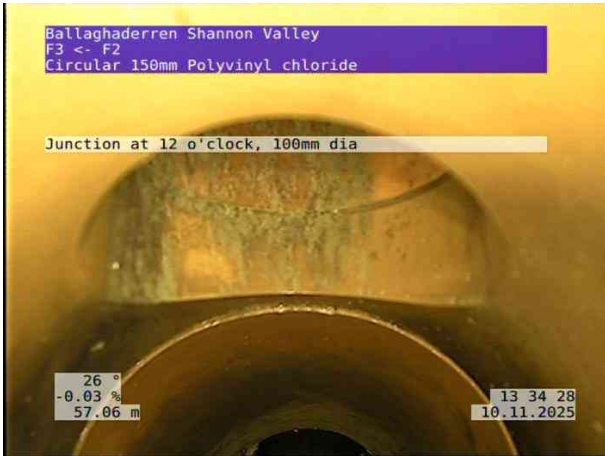
13, 00:07:48, 57.06 m
 Junction at 12 o'clock, 100mm dia

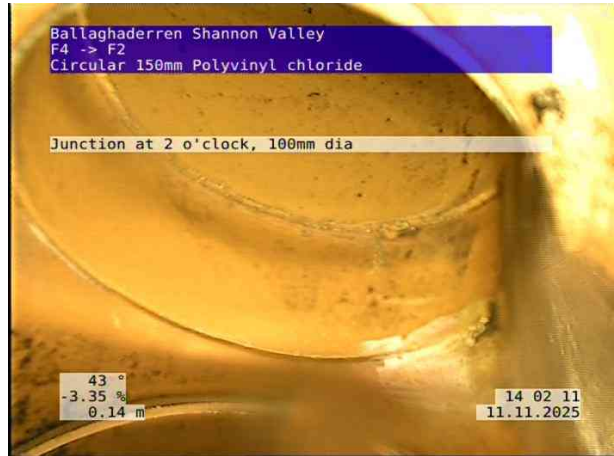
2, 00:00:18, 0.14 m
 Junction at 2 o'clock, 100mm dia

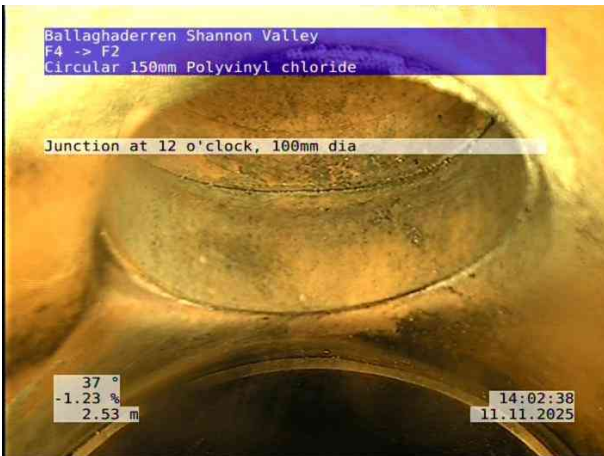
3, 00:00:40, 2.53 m
 Junction at 12 o'clock, 100mm dia

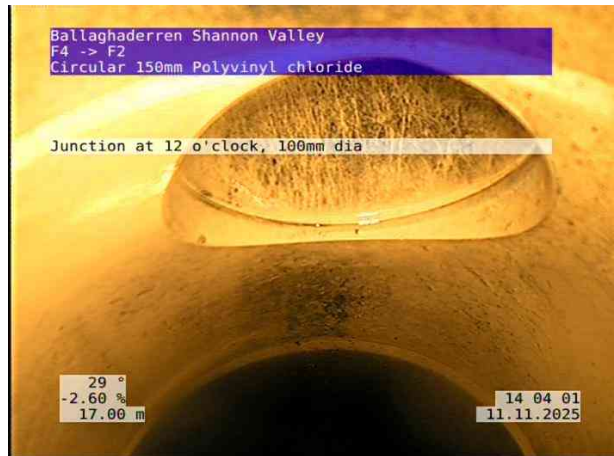
4, 00:02:01, 17.01 m
 Junction at 12 o'clock, 100mm dia

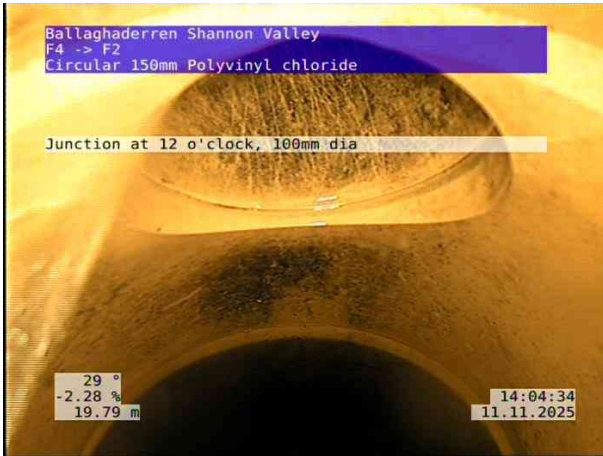
5, 00:02:29, 19.79 m
 Junction at 12 o'clock, 100mm dia

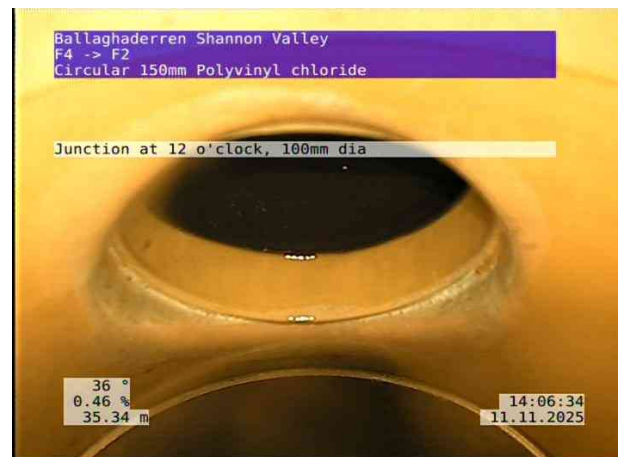
8, 00:04:11, 35.34 m
 Junction at 12 o'clock, 100mm dia

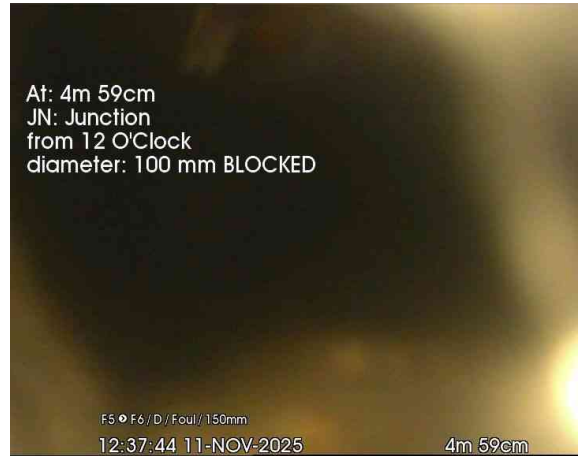
6, 00:00:55, 4.59 m
 Junction at 12 o'clock, 100mm dia, BLOCKED

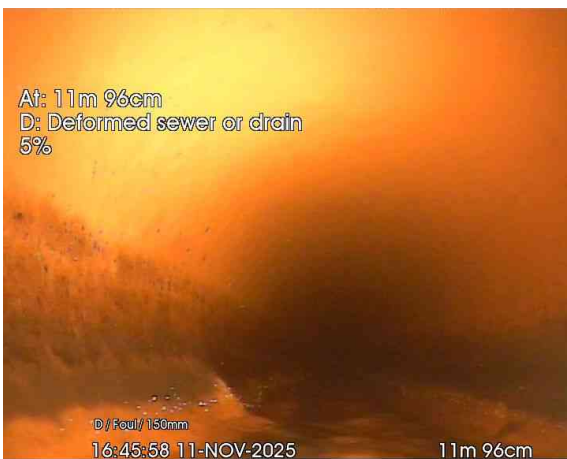
3, 00:00:38, 11.96 m
 Deformed sewer or drain, 5%
