Project Name: Shannon Valley Surface Water 10-11-25
Project Description: CCTV Survey
Project Number: CES 11659
Project Status: Complete
Project Date: 10/11/2025
Inspection Standard: MSCC5 Sewers & Drainage GB (SRM5 Scoring)

Section Inspection - 11/11/2025 - S1.1X

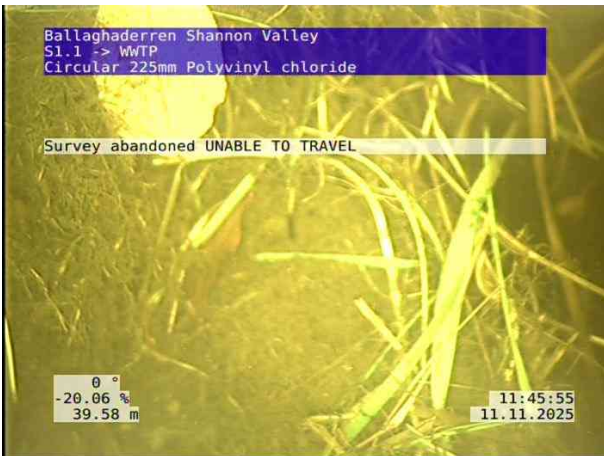
7, 00:11:02, 39.58 m
 Survey abandoned, UNABLE TO TRAVEL (OUTFALL) (REF CHANGE)

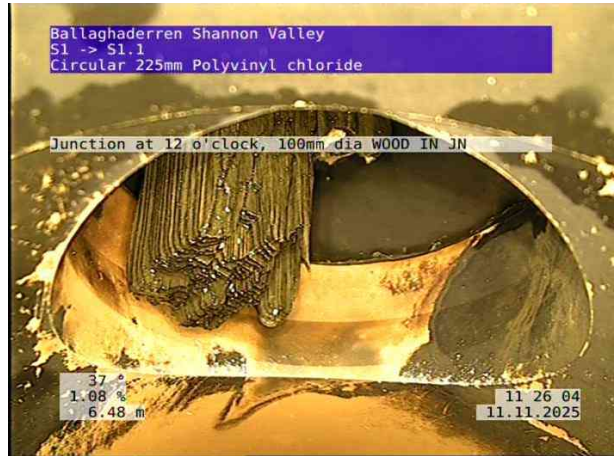
2, 00:01:03, 6.48 m
 Junction at 12 o'clock, 100mm dia, WOOD IN JN

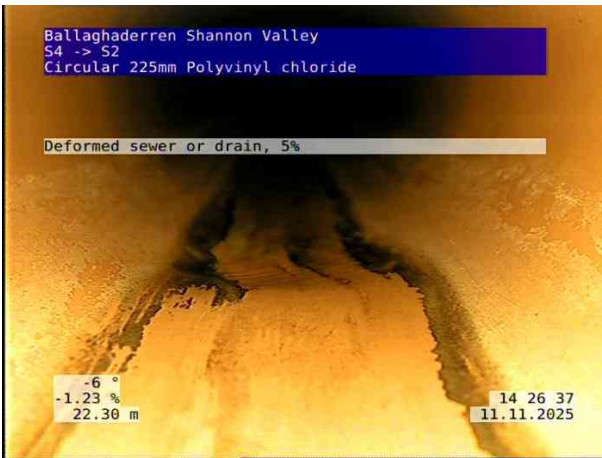
5, 00:02:58, 22.30 m
 Deformed sewer or drain, 5%

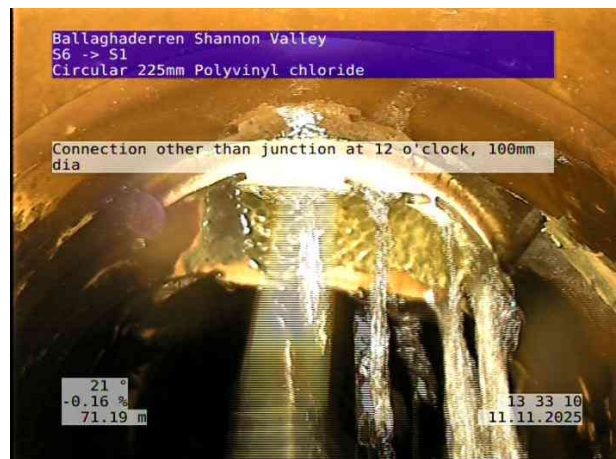
4, 00:06:57, 71.19 m
 Connection other than junction at 12 o'clock, 100mm dia

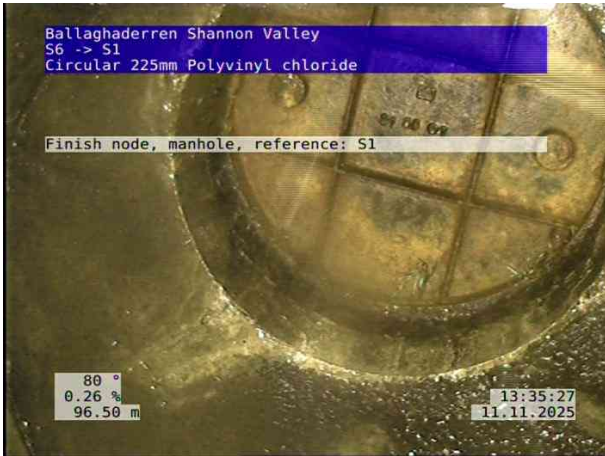
5, 00:09:07, 96.50 m
Finish node, manhole, reference: S1

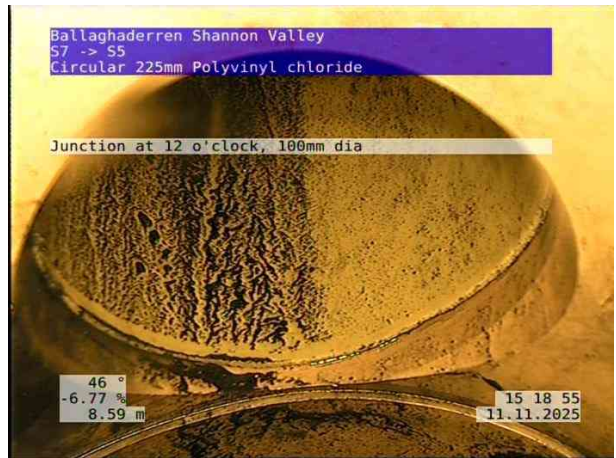
2, 00:01:06, 8.59 m
 Junction at 12 o'clock, 100mm dia

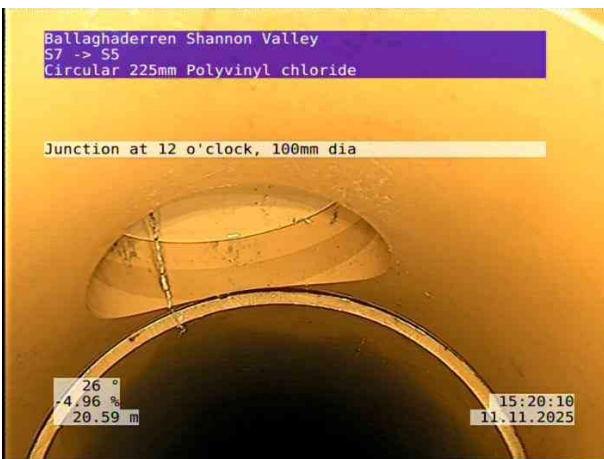
3, 00:02:13, 20.60 m
 Junction at 12 o'clock, 100mm dia

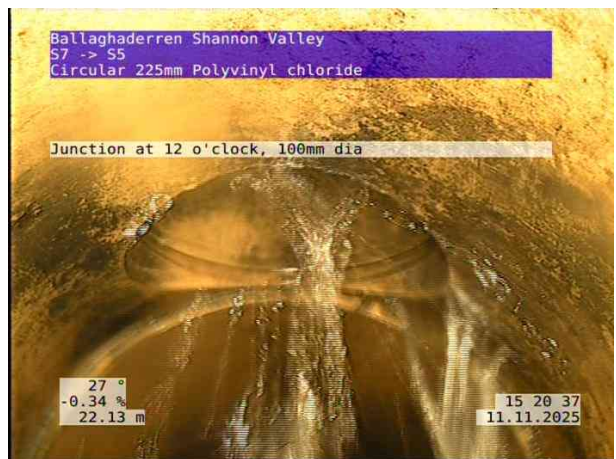
4, 00:02:34, 22.13 m
 Junction at 12 o'clock, 100mm dia

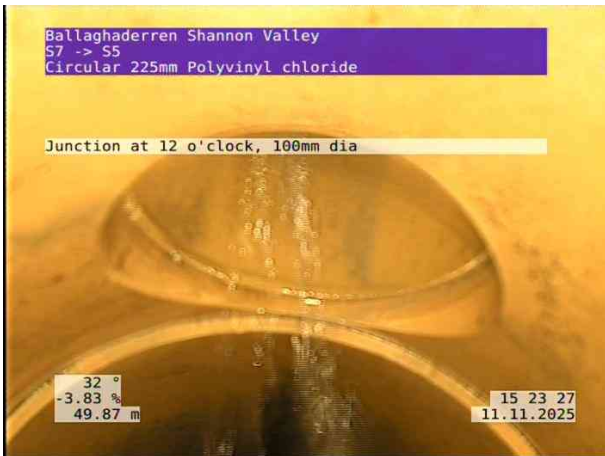
7, 00:05:06, 49.87 m
Junction at 12 o'clock, 100mm dia

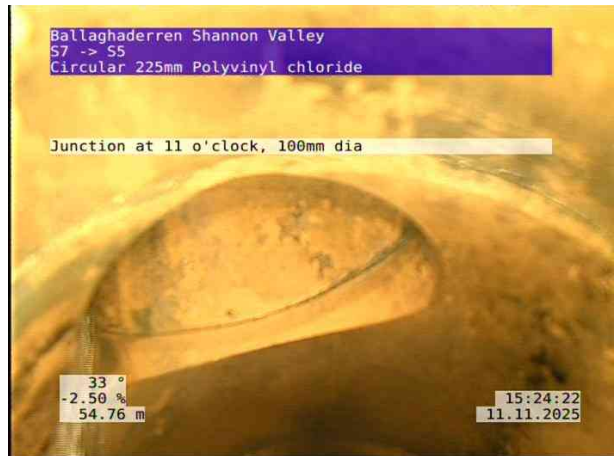
8, 00:05:48, 54.76 m
Junction at 11 o'clock, 100mm dia

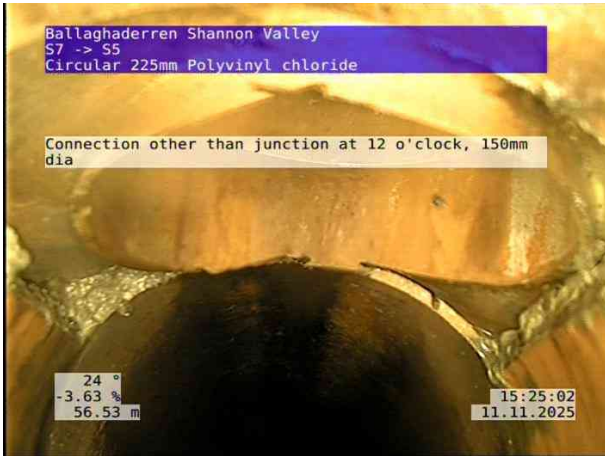
9, 00:06:20, 56.53 m
 Connection other than junction at 12 o'clock, 150mm dia

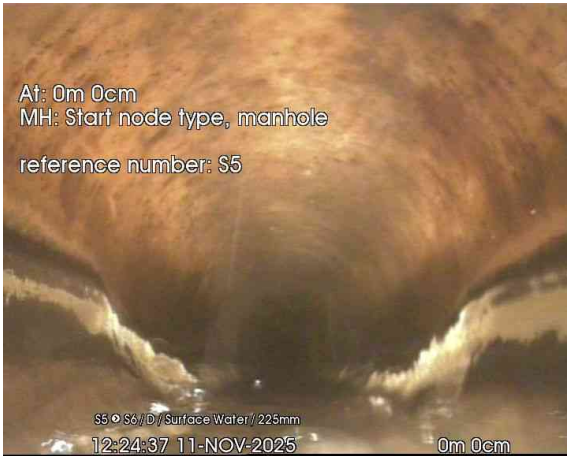
1, 00:00:02, 0.00 m
 Start node, manhole, reference: S5

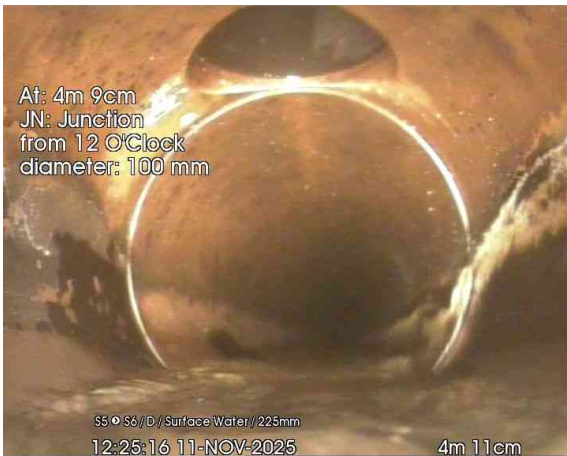
3, 00:00:24, 4.11 m
 Junction at 12 o'clock, 100mm dia

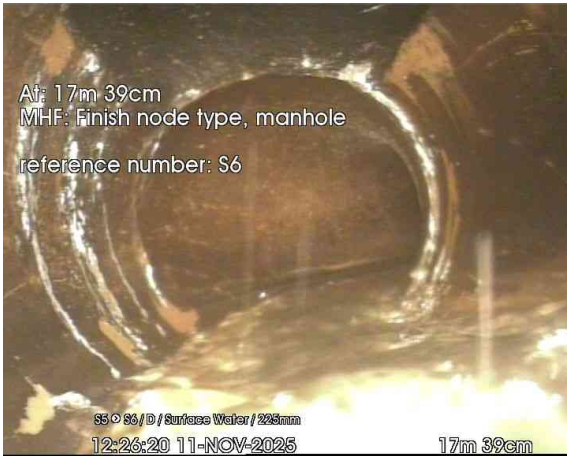
5, 00:01:13, 17.39 m
Finish node, manhole, reference: S6

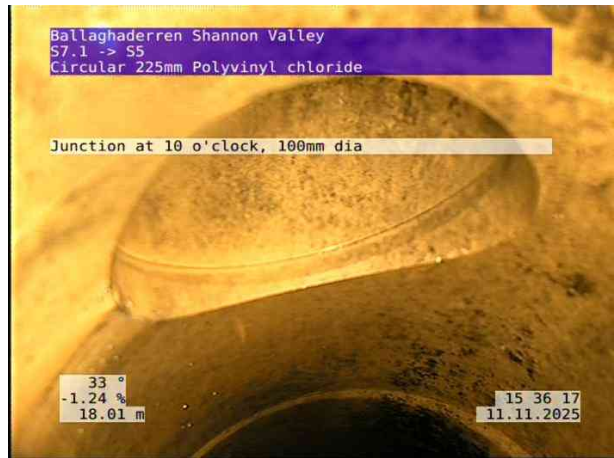
2, 00:02:39, 18.01 m
 Junction at 10 o'clock, 100mm dia

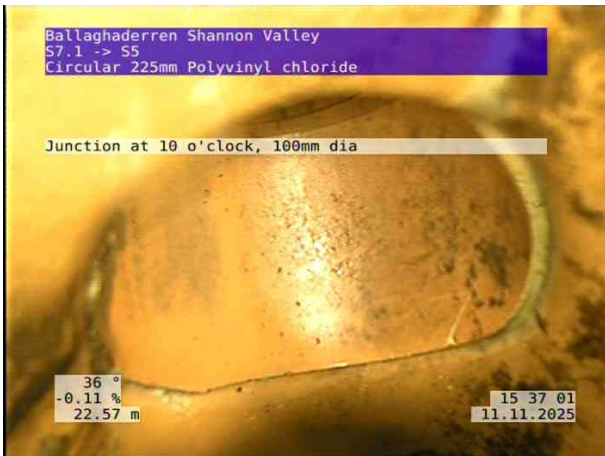
3, 00:03:14, 22.57 m
 Junction at 10 o'clock, 100mm dia

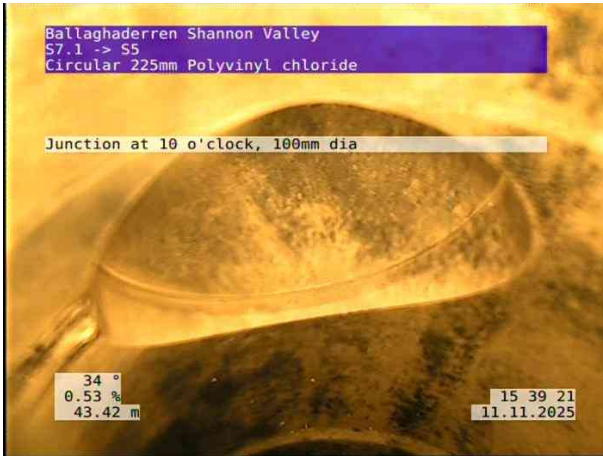
5, 00:05:13, 43.42 m
 Junction at 10 o'clock, 100mm dia

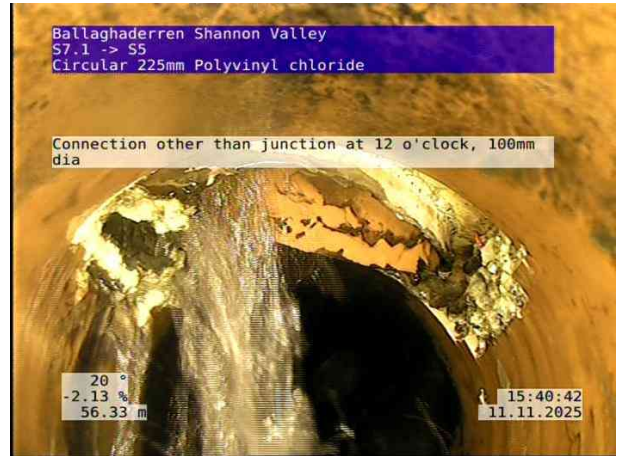
6, 00:06:25, 56.33 m
 Connection other than junction at 12 o'clock, 100mm dia

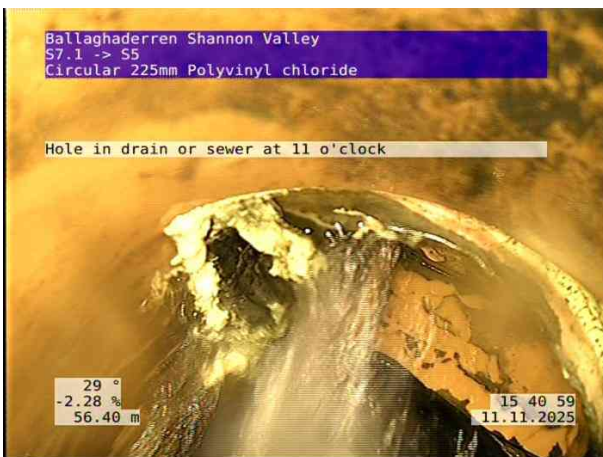
Item No.	PLR	Grade	Description
1	S1.1X	5	Hole in drain or sewer from 11 o'clock to 3 o'clock
4	S2X	3	Multiple defects
7	S7X	4	Hole in drain or sewer from 10 o'clock to 11 o'clock
9	S7.1X	4	Multiple defects

7, 00:06:32, 56.40 m
 Hole in drain or sewer at 11 o'clock

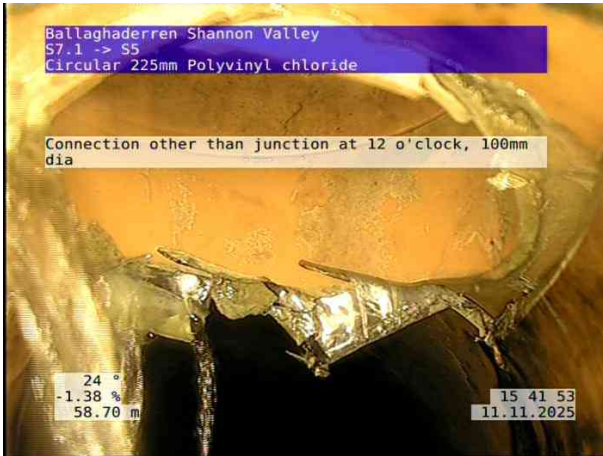
9, 00:07:08, 58.70 m
 Connection other than junction at 12 o'clock, 100mm dia

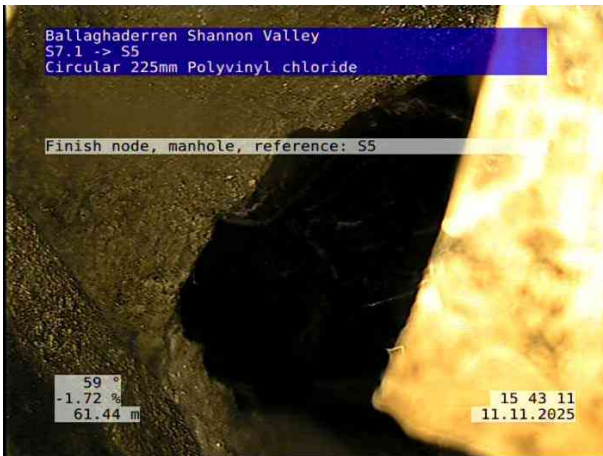
11, 00:07:54, 61.44 m
 Finish node, manhole, reference: S5

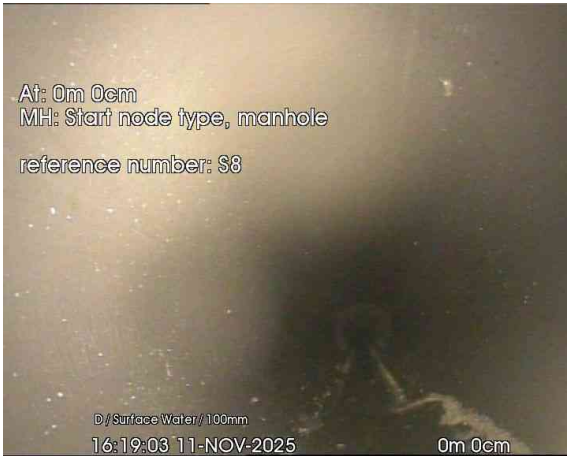
1, 00:00:00, 0.00 m
 Start node, manhole, reference: S8

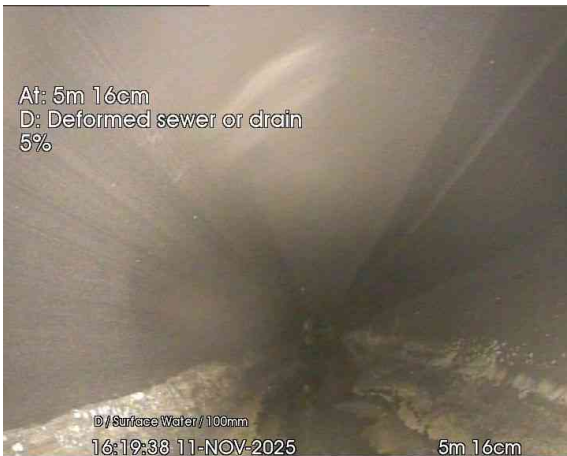
3, 00:00:24, 5.16 m
 Deformed sewer or drain, 5%

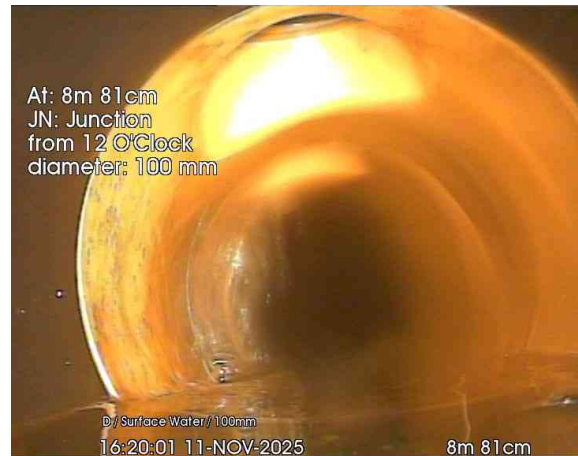
4, 00:00:37, 8.81 m
 Junction at 12 o'clock, 100mm dia

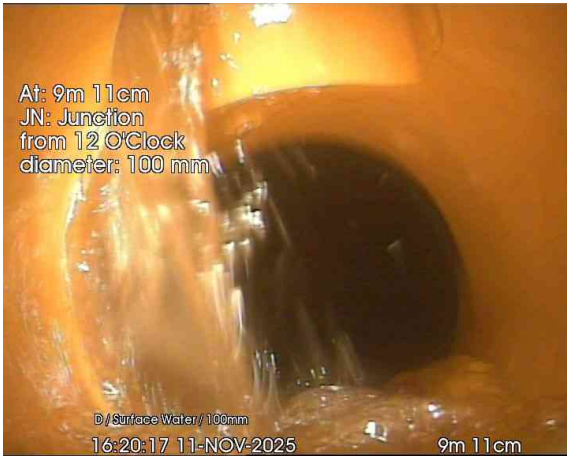
5, 00:00:43, 9.11 m
 Junction at 12 o'clock, 100mm dia

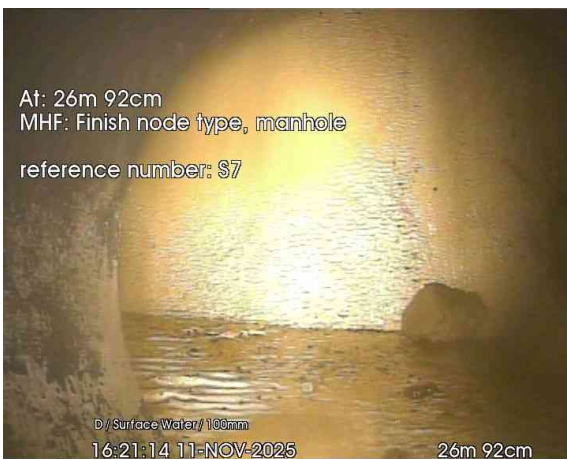
7, 00:01:29, 26.92 m
 Finish node, manhole, reference: S7

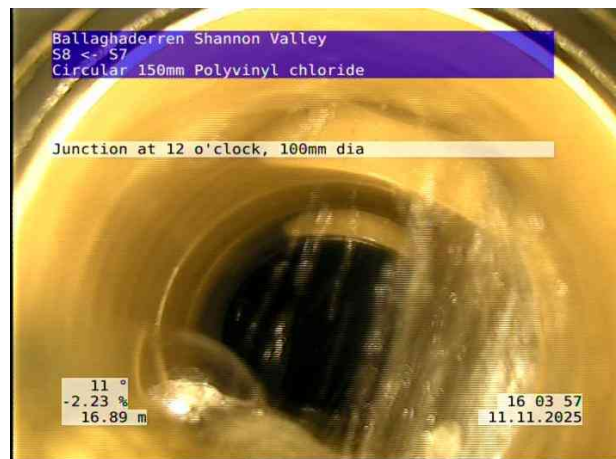
4, 00:03:01, 16.89 m
 Junction at 12 o'clock, 100mm dia

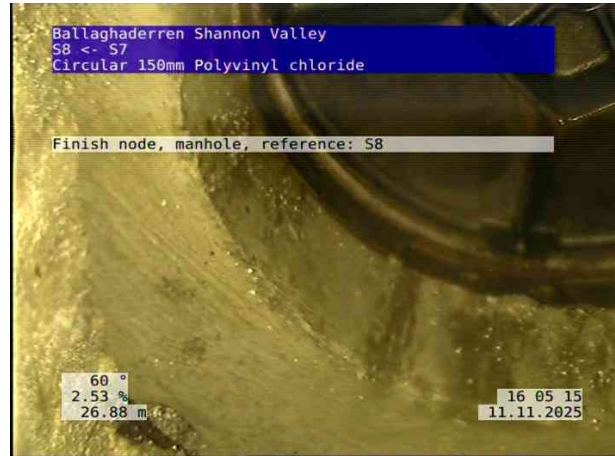
6, 00:04:11, 26.88 m
 Finish node, manhole, reference: S8
