# ASBESTOS MANAGEMENT SURVEY REPORT

Blood Science Facility,

Pathology Block 6,

Beaumont Hospital

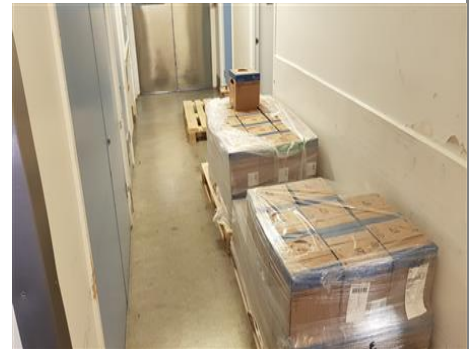
## Location Details 295912 No Asbestos Found

Building/Area : Pathology  
Room/Section : On Call room  
Location : Floor walls and ceilings  
Description :  
Sample No. :  
Confirmation : --N\A--  
Access : Full Access  
Normal Use : Laboratories

mushroom Floor tiles and bitumen adhesive; No ACM's identified in this area. A more detailed survey will be required prior to any refurbishment or demolition works.

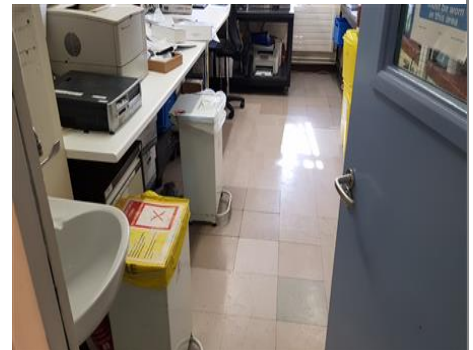
## Location Details 295913 No Asbestos Found

Building/Area : Pathology  
Room/Section : On Call room  
Location : Floor walls and ceilings  
Description :  
Sample No. :  
Confirmation : --N\A--  
Access : Full Access  
Normal Use : Laboratories

mushroom Floor tiles and bitumen adhesive; No ACM's identified in this area. A more detailed survey will be required prior to any refurbishment or demolition works.

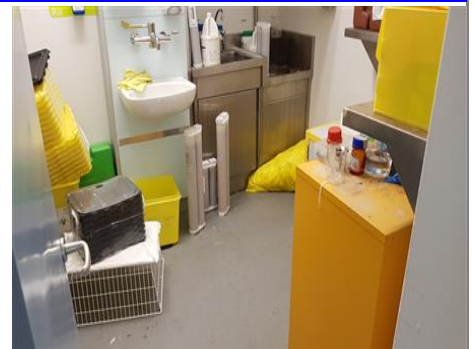
## Location Details 295914 No Asbestos Found

Building/Area : Pathology  
Room/Section : On Call room  
Location : Floor walls and ceilings  
Description :  
Sample No. :  
Confirmation : --N\A--  
Access : Full Access  
Normal Use : Laboratories

mushroom Floor tiles and bitumen adhesive; No ACM's identified in this area. A more detailed survey will be required prior to any refurbishment or demolition works.

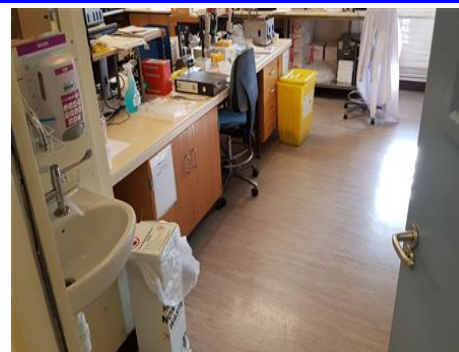
## Location Details 295915 No Asbestos Found

mushroom Floor tiles and bitumen adhesive; No ACM's identified in this area. A more detailed survey will be required prior to any refurbishment or demolition works.

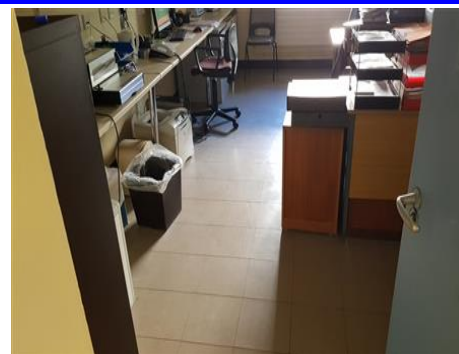
## Location Details 295916 No Asbestos Found

Building/Area : Pathology  
Room/Section : Chemical Pathology Office  
Location : Floor walls and ceilings  
Description :  
Sample No. :  
Confirmation : --N\A--  
Access : Full Access  
Normal Use : Laboratories

mushroom Floor tiles and bitumen adhesive; No ACM's identified in this area. A more detailed survey will be required prior to any refurbishment or demolition works.

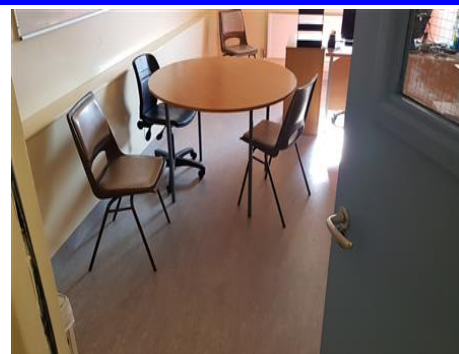
## Location Details 295917 No Asbestos Found

Building/Area : Pathology  
Room/Section : L1 CP6  
Location : Floor walls and ceilings  
Description :  
Sample No. :  
Confirmation : --N\A--  
Access : Full Access  
Normal Use : Laboratories

mushroom Floor tiles and bitumen adhesive; No ACM's identified in this area. A more detailed survey will be required prior to any refurbishment or demolition works.

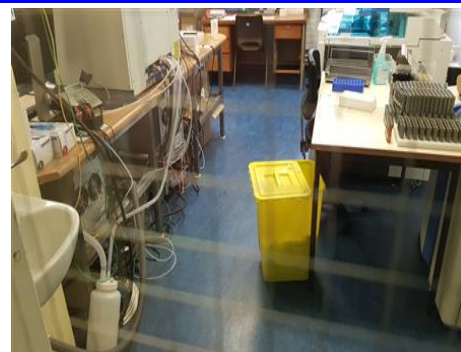
## Location Details 295918 No Asbestos Found

mushroom Floor tiles and bitumen adhesive; No ACM's identified in this area. A more detailed survey will be required prior to any refurbishment or demolition works.

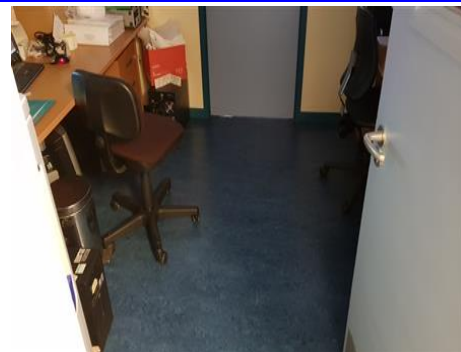
## Location Details 295919 No Asbestos Found

Building/Area : Pathology  
Room/Section : L1 CP22  
Location : Floor walls and ceilings  
Description :  
Sample No. :  
Confirmation : --N\A--  
Access : Full Access  
Normal Use : Laboratories

mushroom Floor tiles and bitumen adhesive; No ACM's identified in this area. A more detailed survey will be required prior to any refurbishment or demolition works.

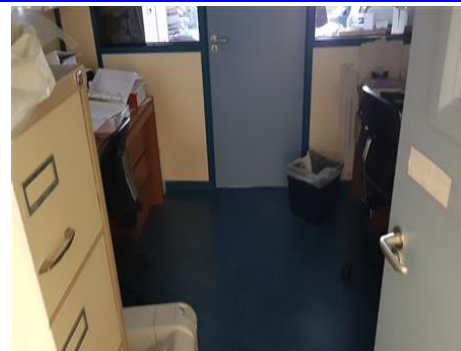
## Location Details 295920 No Asbestos Found

Building/Area : Pathology  
Room/Section : L1 CP23  
Location : Floor walls and ceilings  
Description :  
Sample No. :  
Confirmation : --N\A--  
Access : Full Access  
Normal Use : Laboratories

mushroom Floor tiles and bitumen adhesive; No ACM's identified in this area. A more detailed survey will be required prior to any refurbishment or demolition works.

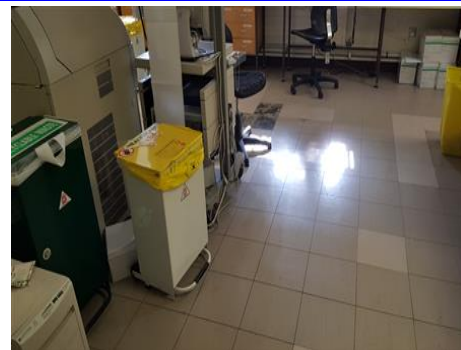
## Location Details 295921 No Asbestos Found

mushroom Floor tiles and bitumen adhesive; No ACM's identified in this area. A more detailed survey will be required prior to any refurbishment or demolition works.

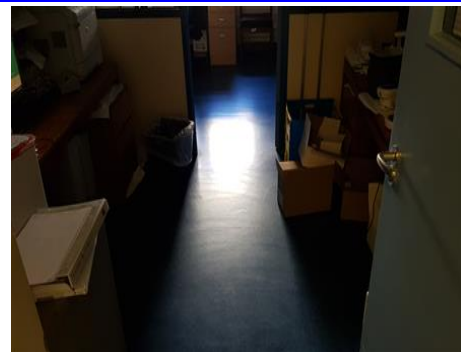
## Location Details 295922 No Asbestos Found

Building/Area : Pathology  
Room/Section : L1 CP24  
Location : Floor walls and ceilings  
Description :  
Sample No. :  
Confirmation : --N\A--  
Access : Full Access  
Normal Use : Laboratories

mushroom Floor tiles and bitumen adhesive; No ACM's identified in this area. A more detailed survey will be required prior to any refurbishment or demolition works.

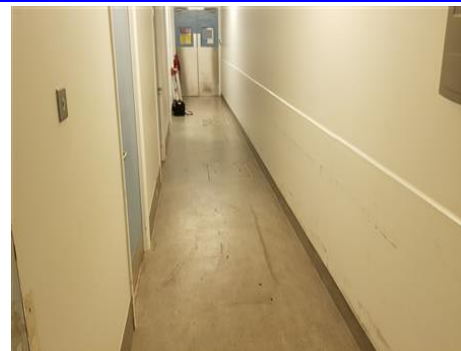
## Location Details 295924 No Asbestos Found

Building/Area : Pathology  
Room/Section : Corridor  
Location : Floor walls and ceilings  
Description :  
Sample No. :  
Confirmation : --N\A--  
Access : Full Access  
Normal Use : Laboratories

mushroom Floor tiles and bitumen adhesive; No ACM's identified in this area. A more detailed survey will be required prior to any refurbishment or demolition works.

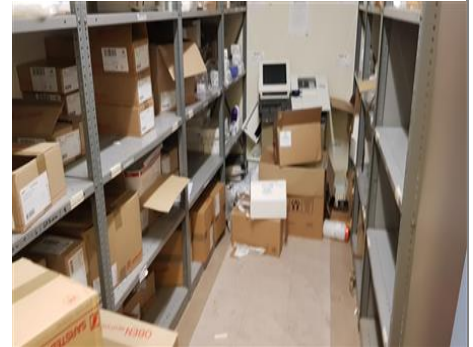
## Location Details 295925 No Asbestos Found

mushroom Floor tiles and bitumen adhesive; No ACM's identified in this area. A more detailed survey will be required prior to any refurbishment or demolition works.

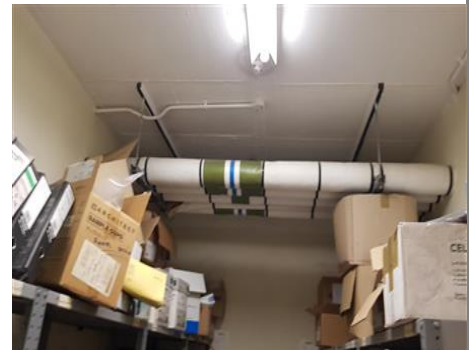
## Location Details 295926 No Asbestos Found

Building/Area : Pathology  
Room/Section : Store  
Location : Floor walls and ceilings  
Description :  
Sample No. :  
Confirmation : --N\A--  
Access : Full Access  
Normal Use : Laboratories

mushroom Floor tiles and bitumen adhesive; No ACM's identified in this area. A more detailed survey will be required prior to any refurbishment or demolition works.

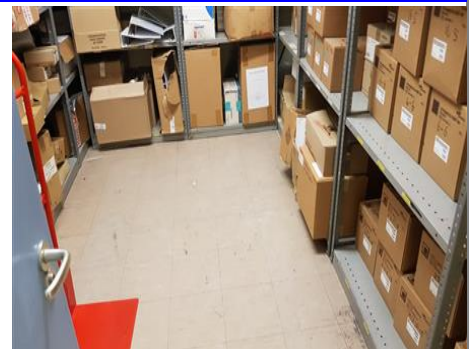
## Location Details 295927 No Asbestos Found

Building/Area : Pathology  
Room/Section : Store  
Location : Floor walls and ceilings  
Description :  
Sample No. :  
Confirmation : --N\A--  
Access : Full Access  
Normal Use : Laboratories

mushroom Floor tiles and bitumen adhesive; No ACM's identified in this area. A more detailed survey will be required prior to any refurbishment or demolition works.

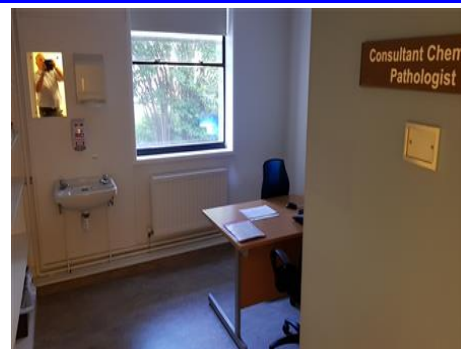
## Location Details 295928 No Asbestos Found

mushroom Floor tiles and bitumen adhesive; No ACM's identified in this area. A more detailed survey will be required prior to any refurbishment or demolition works.

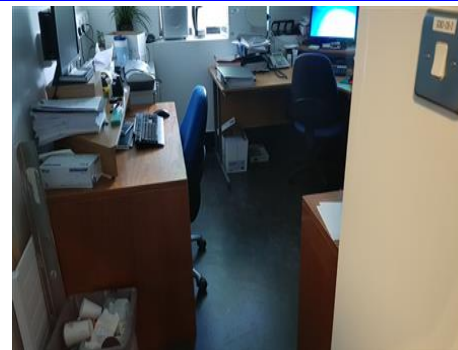
## Location Details 295931 No Asbestos Found

mushroom Floor tiles and bitumen adhesive; No ACM's identified in this area. A more detailed survey will be required prior to any refurbishment or demolition works.

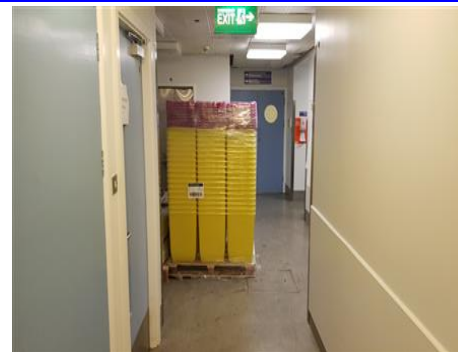
## Location Details 295932 No Asbestos Found

Building/Area : Pathology  
Room/Section : Store  
Location : Floor walls and ceilings  
Description :  
Sample No. :  
Confirmation : --N\A--  
Access : Full Access  
Normal Use : Laboratories

mushroom Floor tiles and bitumen adhesive; No ACM's identified in this area. A more detailed survey will be required prior to any refurbishment or demolition works.

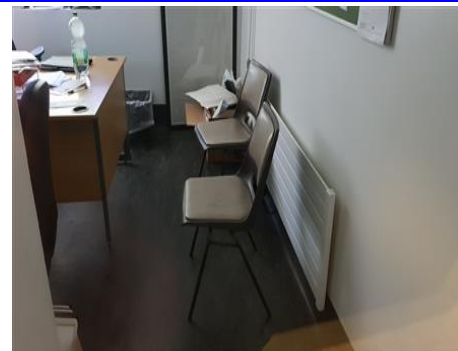
## Location Details 295933 No Asbestos Found

Building/Area : Pathology  
Room/Section : Store  
Location : Floor walls and ceilings  
Description :  
Sample No. :  
Confirmation : --N\A--  
Access : Full Access  
Normal Use : Laboratories

mushroom Floor tiles and bitumen adhesive; No ACM's identified in this area. A more detailed survey will be required prior to any refurbishment or demolition works.

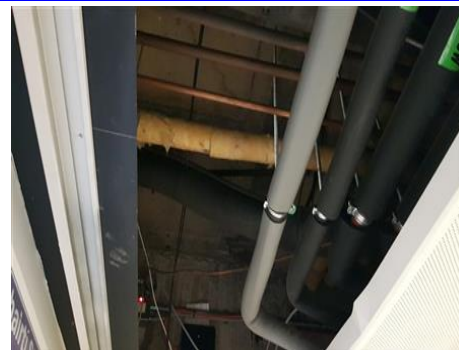
## Location Details 295934 No Asbestos Found

mushroom Floor tiles and bitumen adhesive; No ACM's identified in this area. A more detailed survey will be required prior to any refurbishment or demolition works.

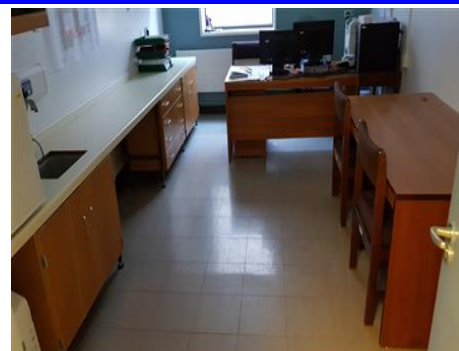
## Location Details 295935 No Asbestos Found

Building/Area : Pathology  
Room/Section : Office  
Location : Floor walls and ceilings  
Description :  
Sample No. :  
Confirmation : --N\A--  
Access : Full Access  
Normal Use : Laboratories

mushroom Floor tiles and bitumen adhesive; No ACM's identified in this area. A more detailed survey will be required prior to any refurbishment or demolition works.

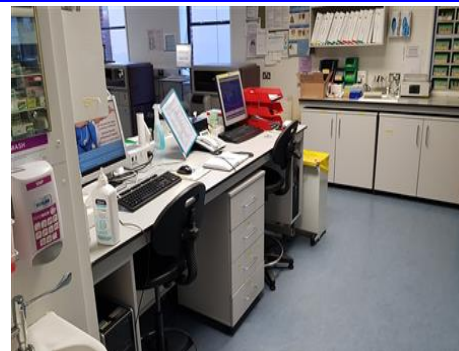
## Location Details 295936 No Asbestos Found

Building/Area : Pathology  
Room/Section : Office  
Location : Floor walls and ceilings  
Description :  
Sample No. :  
Confirmation : --N\A--  
Access : Full Access  
Normal Use : Laboratories

mushroom Floor tiles and bitumen adhesive; No ACM's identified in this area. A more detailed survey will be required prior to any refurbishment or demolition works.

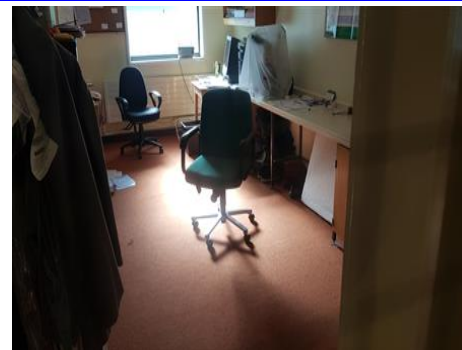
## Location Details 295937 No Asbestos Found

mushroom Floor tiles and bitumen adhesive; No ACM's identified in this area. A more detailed survey will be required prior to any refurbishment or demolition works.

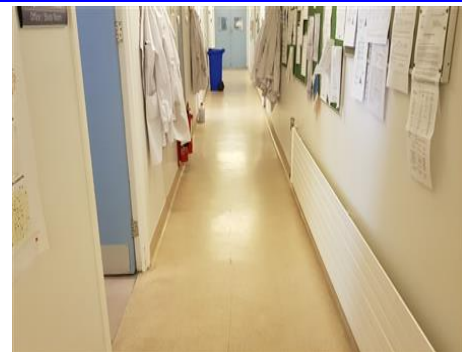
## Location Details 295938 No Asbestos Found

Building/Area : Pathology  
Room/Section : Office  
Location : Floor walls and ceilings  
Description :  
Sample No. :  
Confirmation : --N\A--  
Access : Full Access  
Normal Use : Laboratories

mushroom Floor tiles and bitumen adhesive; No ACM's identified in this area. A more detailed survey will be required prior to any refurbishment or demolition works.

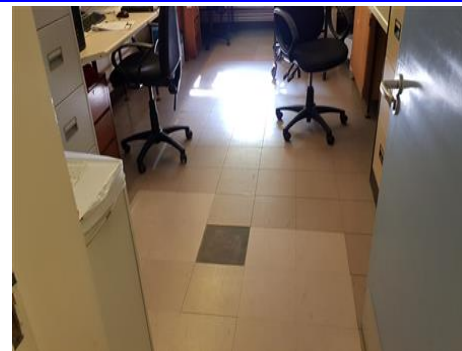
## Location Details 295939 No Asbestos Found

Building/Area : Pathology  
Room/Section : Office  
Location : Floor walls and ceilings  
Description :  
Sample No. :  
Confirmation : --N\A--  
Access : Full Access  
Normal Use : Laboratories

mushroom Floor tiles and bitumen adhesive; No ACM's identified in this area. A more detailed survey will be required prior to any refurbishment or demolition works.

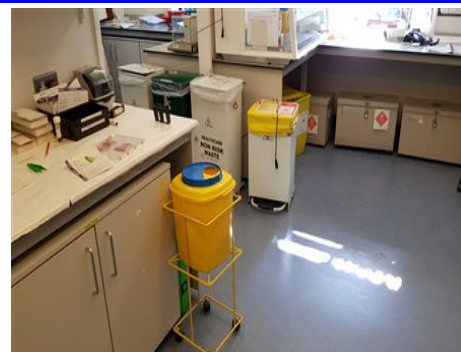
## Location Details 295940 No Asbestos Found

mushroom Floor tiles and bitumen adhesive; No ACM's identified in this area. A more detailed survey will be required prior to any refurbishment or demolition works.

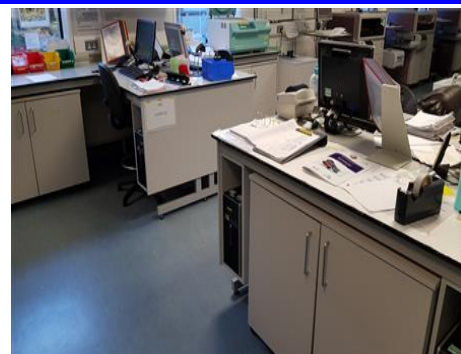
## Location Details 295941 No Asbestos Found

Building/Area : Pathology  
Room/Section : Office  
Location : Floor walls and ceilings  
Description :  
Sample No. :  
Confirmation : --N\A--  
Access : Full Access  
Normal Use : Laboratories

mushroom Floor tiles and bitumen adhesive; No ACM's identified in this area. A more detailed survey will be required prior to any refurbishment or demolition works.

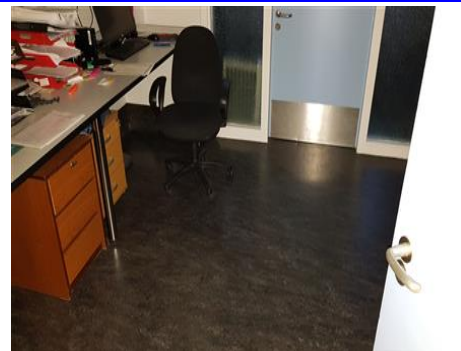
## Location Details 295942 No Asbestos Found

Building/Area : Pathology  
Room/Section : Office  
Location : Floor walls and ceilings  
Description :  
Sample No. :  
Confirmation : --N\A--  
Access : Full Access  
Normal Use : Laboratories

mushroom Floor tiles and bitumen adhesive; No ACM's identified in this area. A more detailed survey will be required prior to any refurbishment or demolition works.

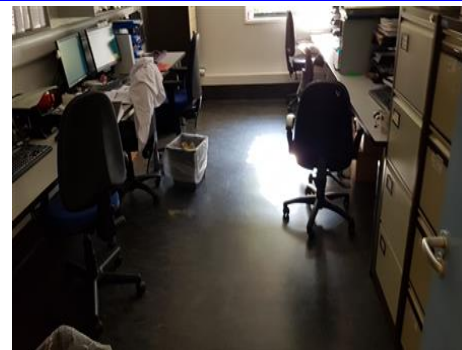
## Location Details 295943 No Asbestos Found

Building/Area : Pathology  
Room/Section : Office  
Location : Floor walls and ceilings  
Description :  
Sample No. :  
Confirmation : --N\A--  
Access : Full Access  
Normal Use : Laboratories

mushroom Floor tiles and bitumen adhesive; No ACM's identified in this area. A more detailed survey will be required prior to any refurbishment or demolition works.

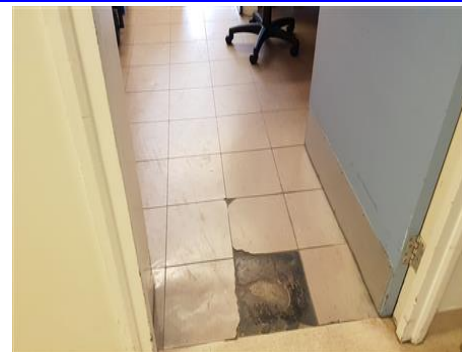
## Location Details 295944 No Asbestos Found

Building/Area : Pathology  
Room/Section : Office  
Location : Floor walls and ceilings  
Description :  
Sample No. :  
Confirmation : --N\A--  
Access : Full Access  
Normal Use : Laboratories

mushroom Floor tiles and bitumen adhesive; No ACM's identified in this area. A more detailed survey will be required prior to any refurbishment or demolition works.

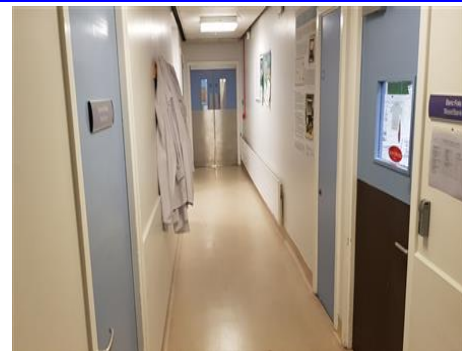
## Location Details 295945 No Asbestos Found

Building/Area : Pathology  
Room/Section : Office  
Location : Floor walls and ceilings  
Description :  
Sample No. :  
Confirmation : --N\A--  
Access : Full Access  
Normal Use : Laboratories

mushroom Floor tiles and bitumen adhesive; No ACM's identified in this area. A more detailed survey will be required prior to any refurbishment or demolition works.

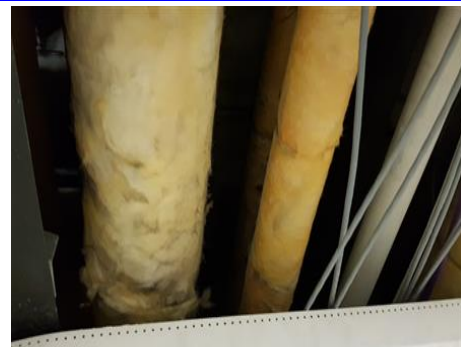
## Location Details 295946 No Asbestos Found

mushroom Floor tiles and bitumen adhesive; No ACM's identified in this area. A more detailed survey will be required prior to any refurbishment or demolition works.

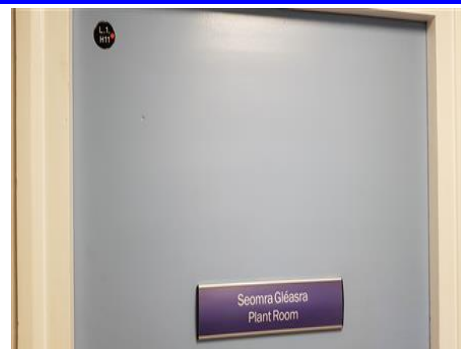
## Location Details 295947 No Asbestos Found

Building/Area : Pathology  
Room/Section : Office  
Location : Floor walls and ceilings  
Description :  
Sample No. : BFB20180609001  
Confirmation : --N\A--  
Access : Full Access  
Normal Use : Laboratories

mushroom Floor tiles and bitumen adhesive; No ACM's identified in this area. A more detailed survey will be required prior to any refurbishment or demolition works.

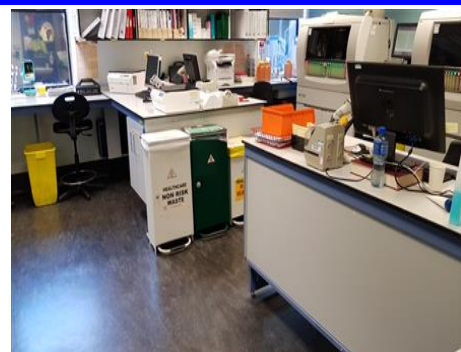
## Location Details 295948 No Asbestos Found

Building/Area : Pathology  
Room/Section : Office  
Location : Floor walls and ceilings  
Description :  
Sample No. :  
Confirmation : --N\A--  
Access : Full Access  
Normal Use : Laboratories

mushroom Floor tiles and bitumen adhesive; No ACM's identified in this area. A more detailed survey will be required prior to any refurbishment or demolition works.

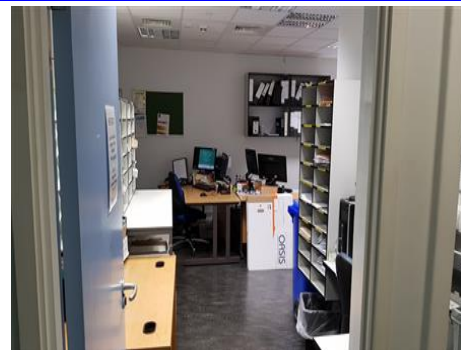
## Location Details 295949 No Asbestos Found

mushroom Floor tiles and bitumen adhesive; No ACM's identified in this area. A more detailed survey will be required prior to any refurbishment or demolition works.

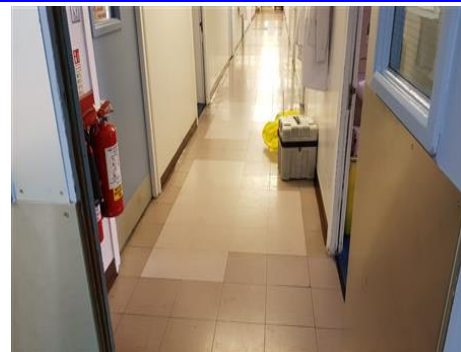
## Location Details 295951 No Asbestos Found

Building/Area : Pathology  
Room/Section : Pathology reception  
Location : Floor walls and ceilings  
Description :  
Sample No. :  
Confirmation : --N\A--  
Access : Full Access  
Normal Use : Laboratories

mushroom Floor tiles and bitumen adhesive; No ACM's identified in this area. A more detailed survey will be required prior to any refurbishment or demolition works.

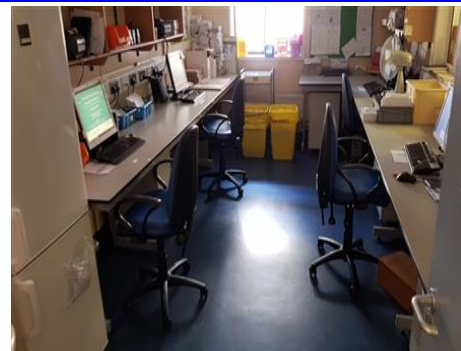
## Location Details 295952 No Asbestos Found

Building/Area : Pathology  
Room/Section : Pathology reception  
Location : Floor walls and ceilings  
Description :  
Sample No. :  
Confirmation : --N\A--  
Access : Full Access  
Normal Use : Laboratories

mushroom Floor tiles and bitumen adhesive; No ACM's identified in this area. A more detailed survey will be required prior to any refurbishment or demolition works.

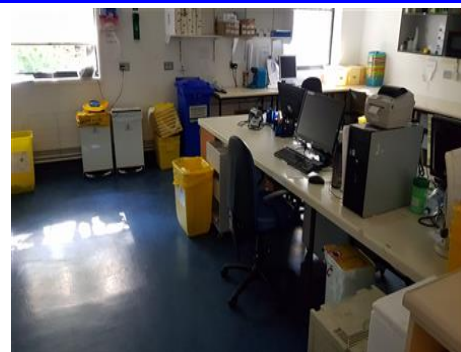
## Location Details 295953 No Asbestos Found

mushroom Floor tiles and bitumen adhesive; No ACM's identified in this area. A more detailed survey will be required prior to any refurbishment or demolition works.

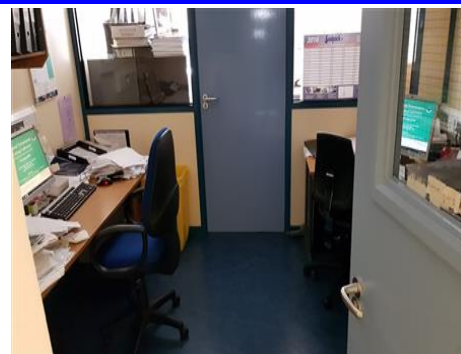
## Location Details 295955 No Asbestos Found

Building/Area : Pathology  
Room/Section : Pathology reception  
Location : Floor walls and ceilings  
Description :  
Sample No. :  
Confirmation : --N\A--  
Access : Full Access  
Normal Use : Laboratories

mushroom Floor tiles and bitumen adhesive; No ACM's identified in this area. A more detailed survey will be required prior to any refurbishment or demolition works.

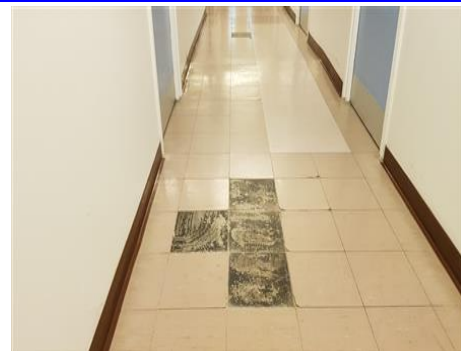
## Location Details 295956 No Asbestos Found

Building/Area : Pathology  
Room/Section : Pathology reception  
Location : Floor walls and ceilings  
Description :  
Sample No. :  
Confirmation : --N\A--  
Access : Full Access  
Normal Use : Laboratories

mushroom Floor tiles and bitumen adhesive; No ACM's identified in this area. A more detailed survey will be required prior to any refurbishment or demolition works.

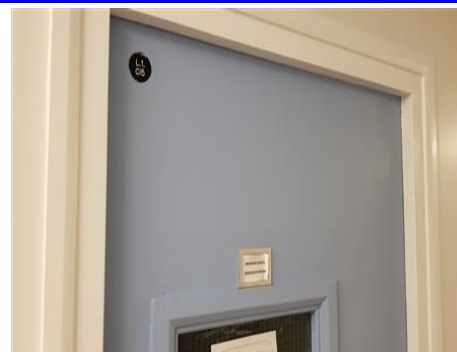
## Location Details 295957 No Asbestos Found

mushroom Floor tiles and bitumen adhesive; No ACM's identified in this area. A more detailed survey will be required prior to any refurbishment or demolition works.

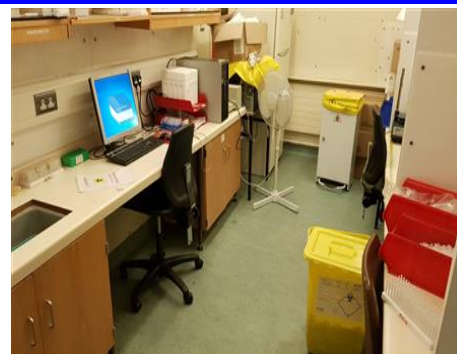
## Location Details 295958 No Asbestos Found

Building/Area : Pathology  
Room/Section : Pathology reception  
Location : Floor walls and ceilings  
Description :  
Sample No. :  
Confirmation : --N\A--  
Access : Full Access  
Normal Use : Laboratories

mushroom Floor tiles and bitumen adhesive; No ACM's identified in this area. A more detailed survey will be required prior to any refurbishment or demolition works.

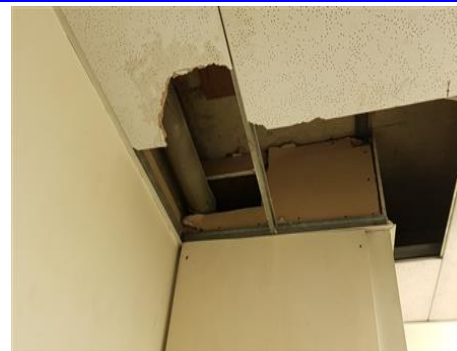
## Location Details 295959 No Asbestos Found

Building/Area : Pathology  
Room/Section : Pathology reception  
Location : Floor walls and ceilings  
Description :  
Sample No. :  
Confirmation : --N\A--  
Access : Full Access  
Normal Use : Laboratories

mushroom Floor tiles and bitumen adhesive; No ACM's identified in this area. A more detailed survey will be required prior to any refurbishment or demolition works.

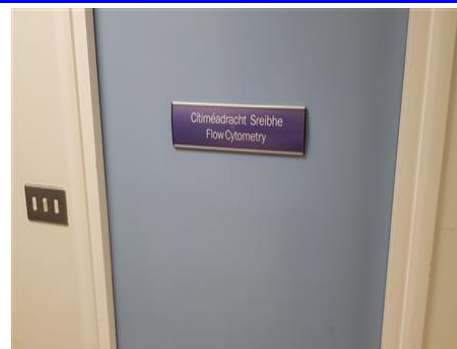
## Location Details 295960 No Asbestos Found

mushroom Floor tiles and bitumen adhesive; No ACM's identified in this area. A more detailed survey will be required prior to any refurbishment or demolition works.

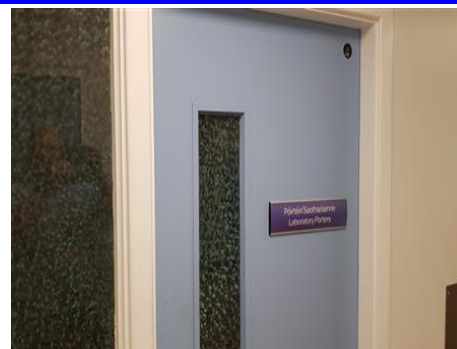
## Location Details 295961 No Asbestos Found

Building/Area : Pathology  
Room/Section : Pathology reception  
Location : Floor walls and ceilings  
Description :  
Sample No. :  
Confirmation : --N\A--  
Access : Full Access  
Normal Use : Laboratories

mushroom Floor tiles and bitumen adhesive; No ACM's identified in this area. A more detailed survey will be required prior to any refurbishment or demolition works.

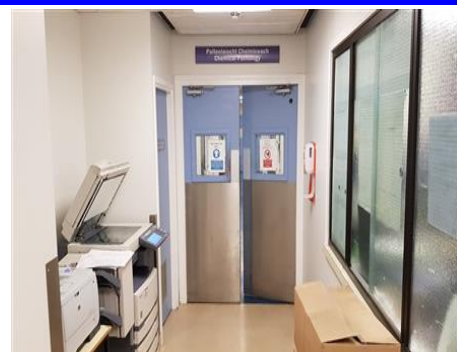
## Location Details 295962 No Asbestos Found

Building/Area : Pathology  
Room/Section : Pathology reception  
Location : Floor walls and ceilings  
Description :  
Sample No. :  
Confirmation : --N\A--  
Access : Full Access  
Normal Use : Laboratories

mushroom Floor tiles and bitumen adhesive; No ACM's identified in this area. A more detailed survey will be required prior to any refurbishment or demolition works.

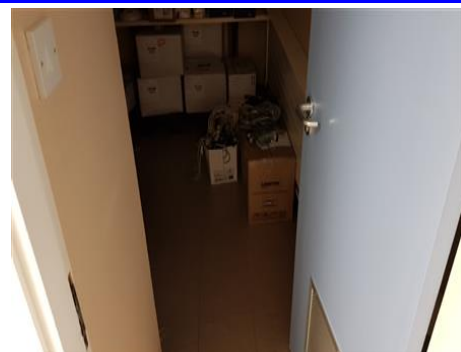
## Location Details 295963 No Asbestos Found

mushroom Floor tiles and bitumen adhesive; No ACM's identified in this area. A more detailed survey will be required prior to any refurbishment or demolition works.

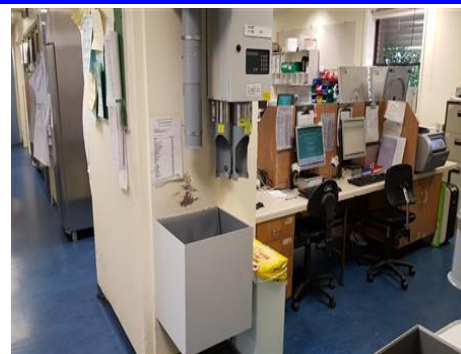
## Location Details 295964 No Asbestos Found

Building/Area : Pathology  
Room/Section : Pathology reception  
Location : Floor walls and ceilings  
Description :  
Sample No. :  
Confirmation : --N\A--  
Access : Full Access  
Normal Use : Laboratories

mushroom Floor tiles and bitumen adhesive; No ACM's identified in this area. A more detailed survey will be required prior to any refurbishment or demolition works.

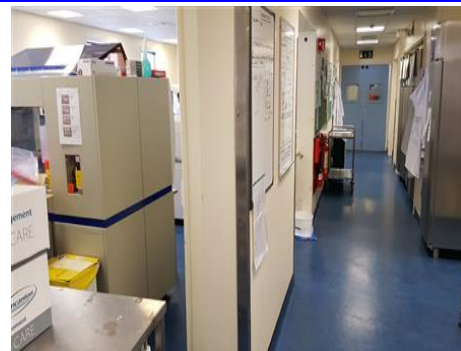
## Location Details 295965 No Asbestos Found

Building/Area : Pathology  
Room/Section : Pathology reception  
Location : Floor walls and ceilings  
Description :  
Sample No. :  
Confirmation : --N\A--  
Access : Full Access  
Normal Use : Laboratories

mushroom Floor tiles and bitumen adhesive; No ACM's identified in this area. A more detailed survey will be required prior to any refurbishment or demolition works.

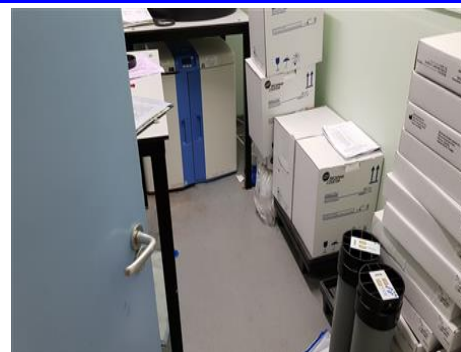
## Location Details 295966 No Asbestos Found

mushroom Floor tiles and bitumen adhesive; No ACM's identified in this area. A more detailed survey will be required prior to any refurbishment or demolition works.

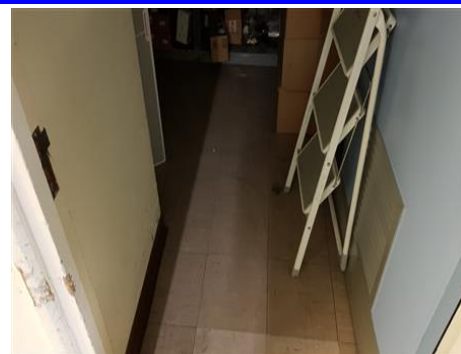
## Location Details 295967 No Asbestos Found

Building/Area : Pathology  
Room/Section : Pathology reception  
Location : Floor walls and ceilings  
Description :  
Sample No. :  
Confirmation : --N\A--  
Access : Full Access  
Normal Use : Laboratories

mushroom Floor tiles and bitumen adhesive; No ACM's identified in this area. A more detailed survey will be required prior to any refurbishment or demolition works.

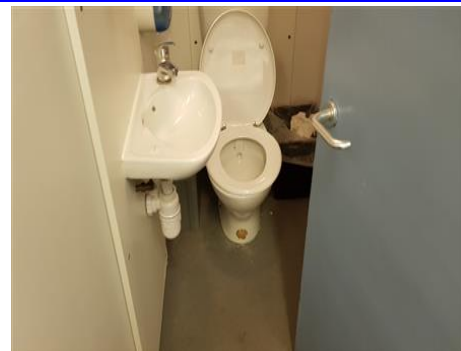
## Location Details 295968 No Asbestos Found

Building/Area : Pathology  
Room/Section : Toilet  
Location : Floor walls and ceilings  
Description :  
Sample No. :  
Confirmation : --N\A--  
Access : Full Access  
Normal Use : Laboratories

mushroom Floor tiles and bitumen adhesive; No ACM's identified in this area. A more detailed survey will be required prior to any refurbishment or demolition works.

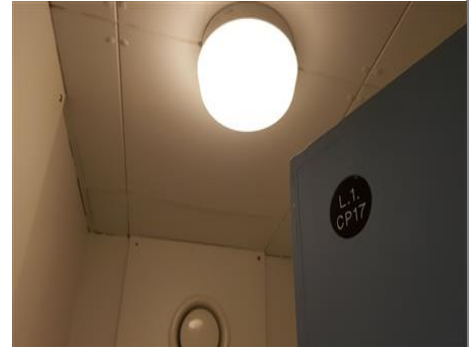
## Location Details 295969 No Asbestos Found

Building/Area : Pathology  
Room/Section : Toilet  
Location : Floor walls and ceilings  
Description : Tiles  
Sample No. : BFB20180609.03  
Confirmation : --N\A--  
Access : Full Access  
Normal Use : Laboratories

mushroom Floor tiles and bitumen adhesive. Ceiling tiles sampled; No ACM's identified in this area. A more detailed survey will be required prior to any refurbishment or demolition works.

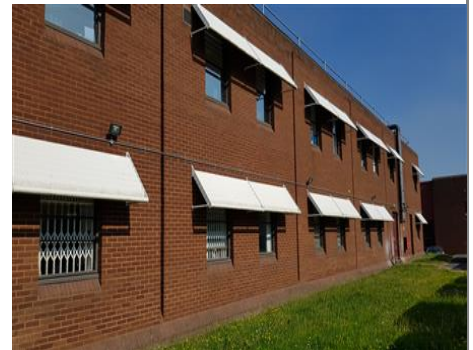
## Location Details 295973 No Asbestos Found

Building/Area : Pathology  
Room/Section : Court Yard  
Location : Floor walls and ceilings  
Description :  
Sample No. :  
Confirmation : --N\A--  
Access : Full Access  
Normal Use : Laboratories

; No ACM's identified in this area. A more detailed survey will be required prior to any refurbishment or demolition works.

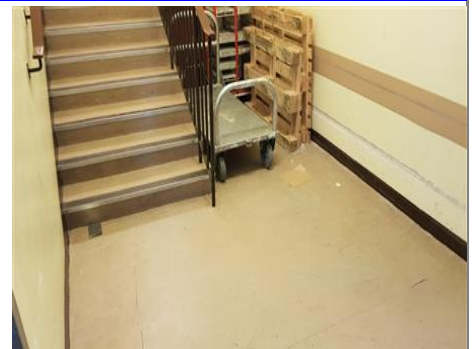
## Location Details 295906 No Asbestos Found

Building/Area : Pathology  
Room/Section : Corridor  
Location : Floor walls and ceilings  
Description :  
Sample No. :  
Confirmation : --N\A--  
Access : Full Access  
Normal Use : Laboratories

; No ACM's identified in this area. A more detailed survey will be required prior to any refurbishment or demolition works.

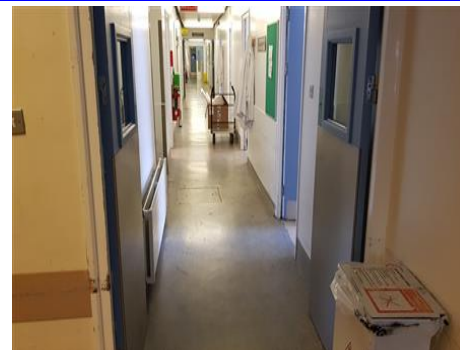
## Location Details 295907 No Asbestos Found

Building/Area : Pathology  
Room/Section : Corridor  
Location : Floor walls and ceilings  
Description :  
Sample No. :  
Confirmation : --N\A--  
Access : Full Access  
Normal Use : Laboratories

; No ACM's identified in this area. A more detailed survey will be required prior to any refurbishment or demolition works.
