# SKIBBEREEN STEAM MILL

## INFORMATION PACK

## INSPECTION REPORT

### Re: The Old Steam Mill, Skibbereen, Co. Cork.

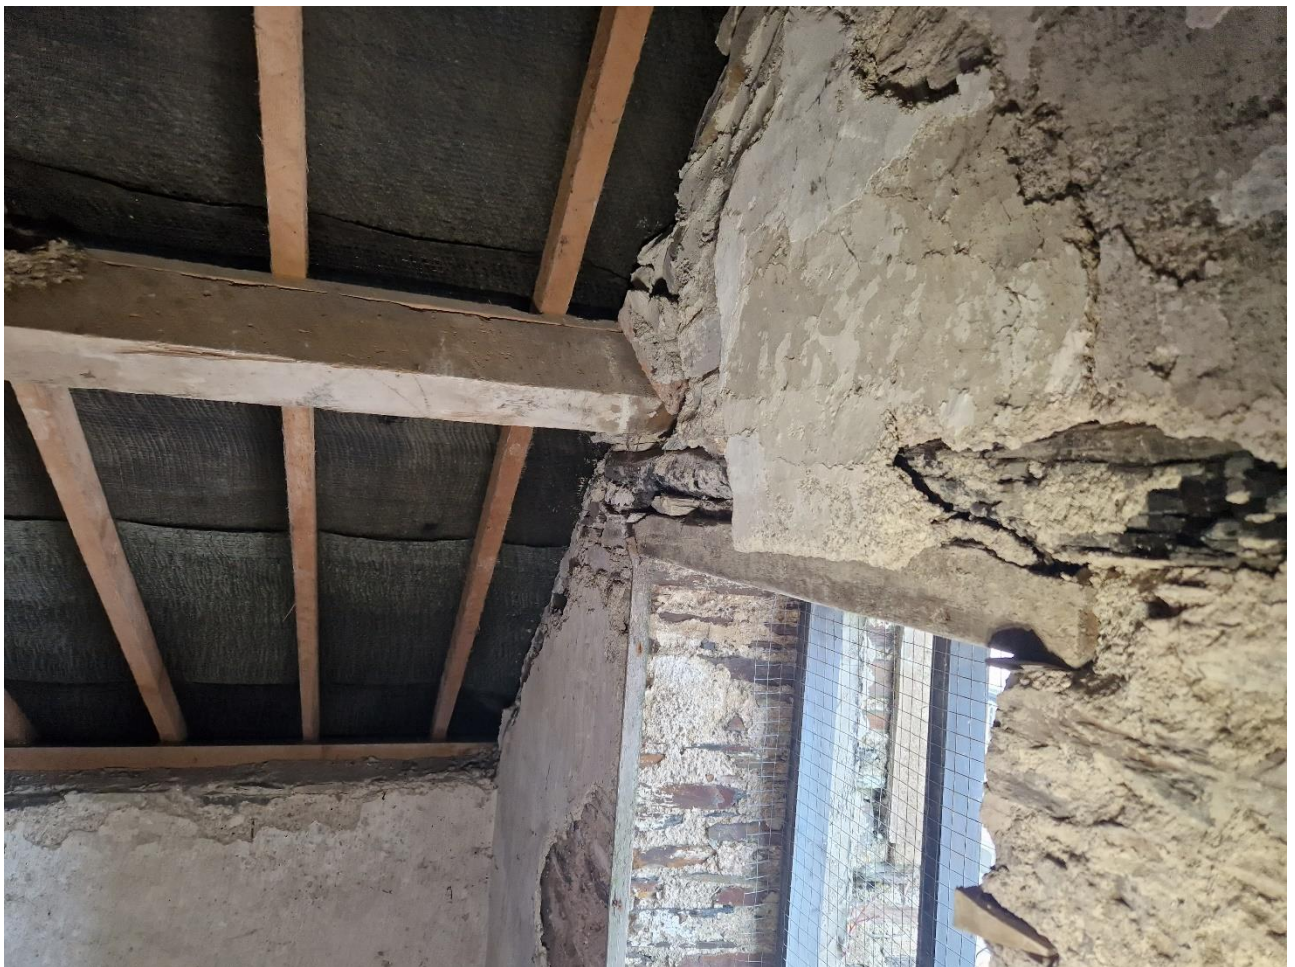
*Figure 10. Shows displacement of the masonry around the purlin end.*

You might review the ironwork as part of any roofing upgrade work.

We suggest that as the south annexe is poor, the original trusses are retained but that the new cut roof can support itself without support from these trusses.

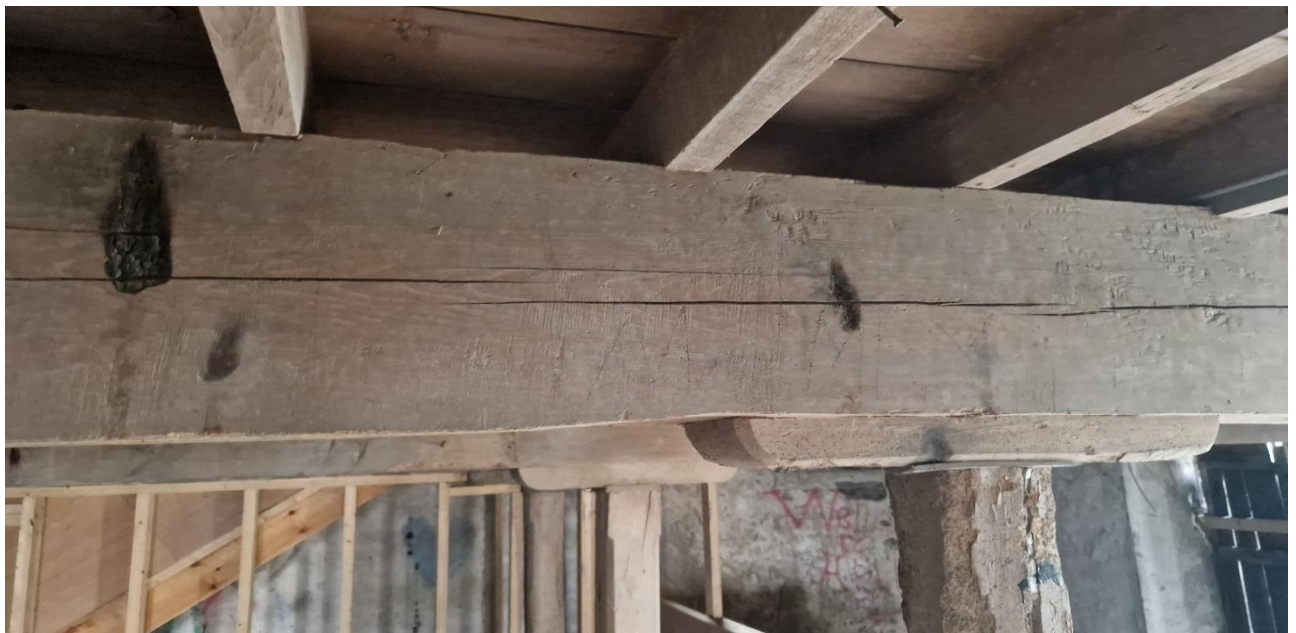
We have recorded several burn marks on some timbers throughout the building. This marking was carried out to ward off fire in buildings. This practice is quite common in the UK but is rare in Ireland.

*Figure 13. Shows two of several burn marks present in the building.*

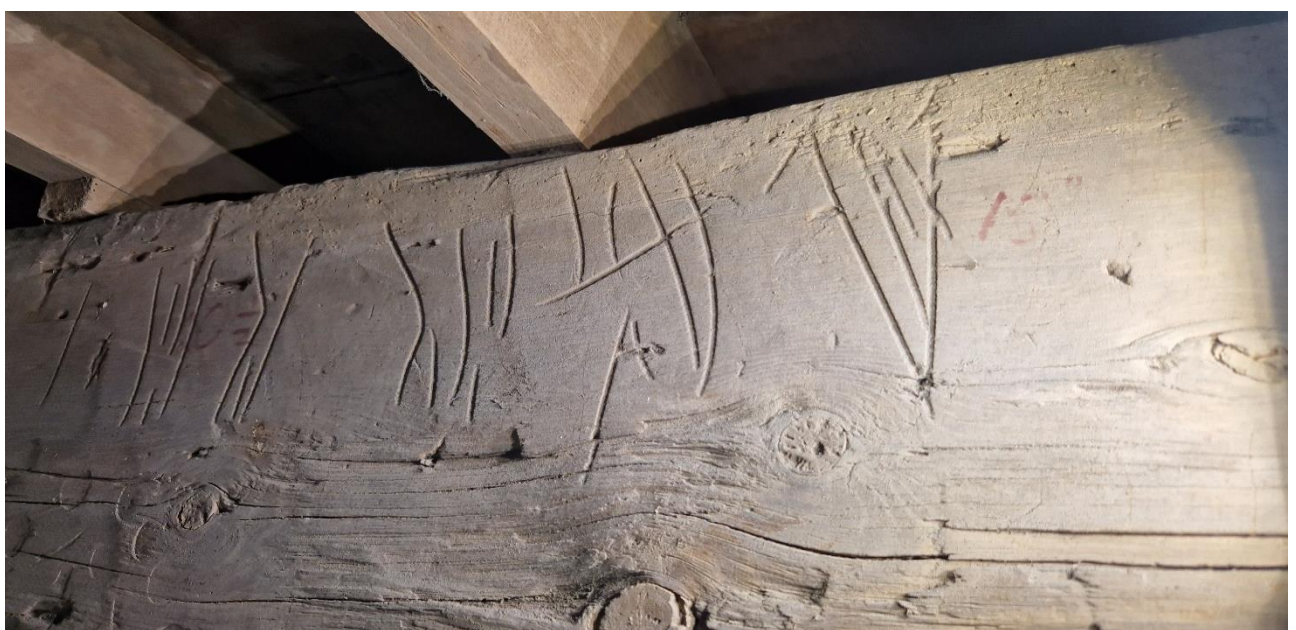
We also recorded shipping marks on a number of the timber girders. The marks appear to be of 'Baltic' origin, which is typical of early nineteenth-century timber.

*Figure 14. Shows typical baltic marks visible on some timbers.*

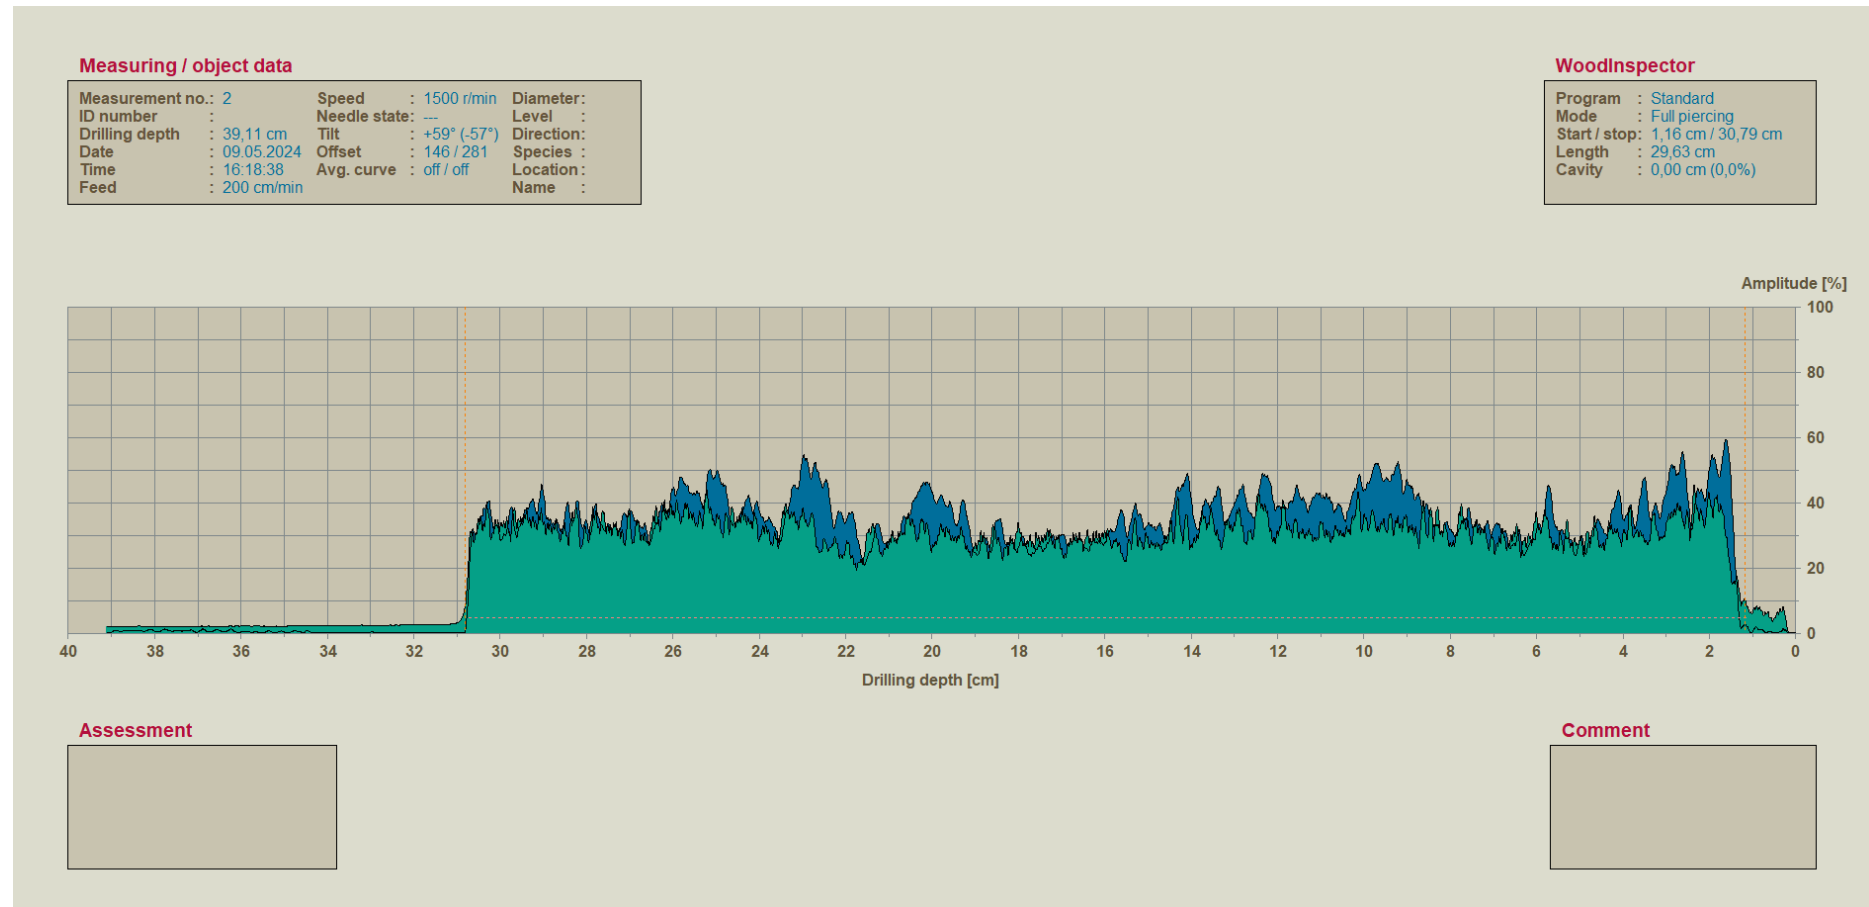
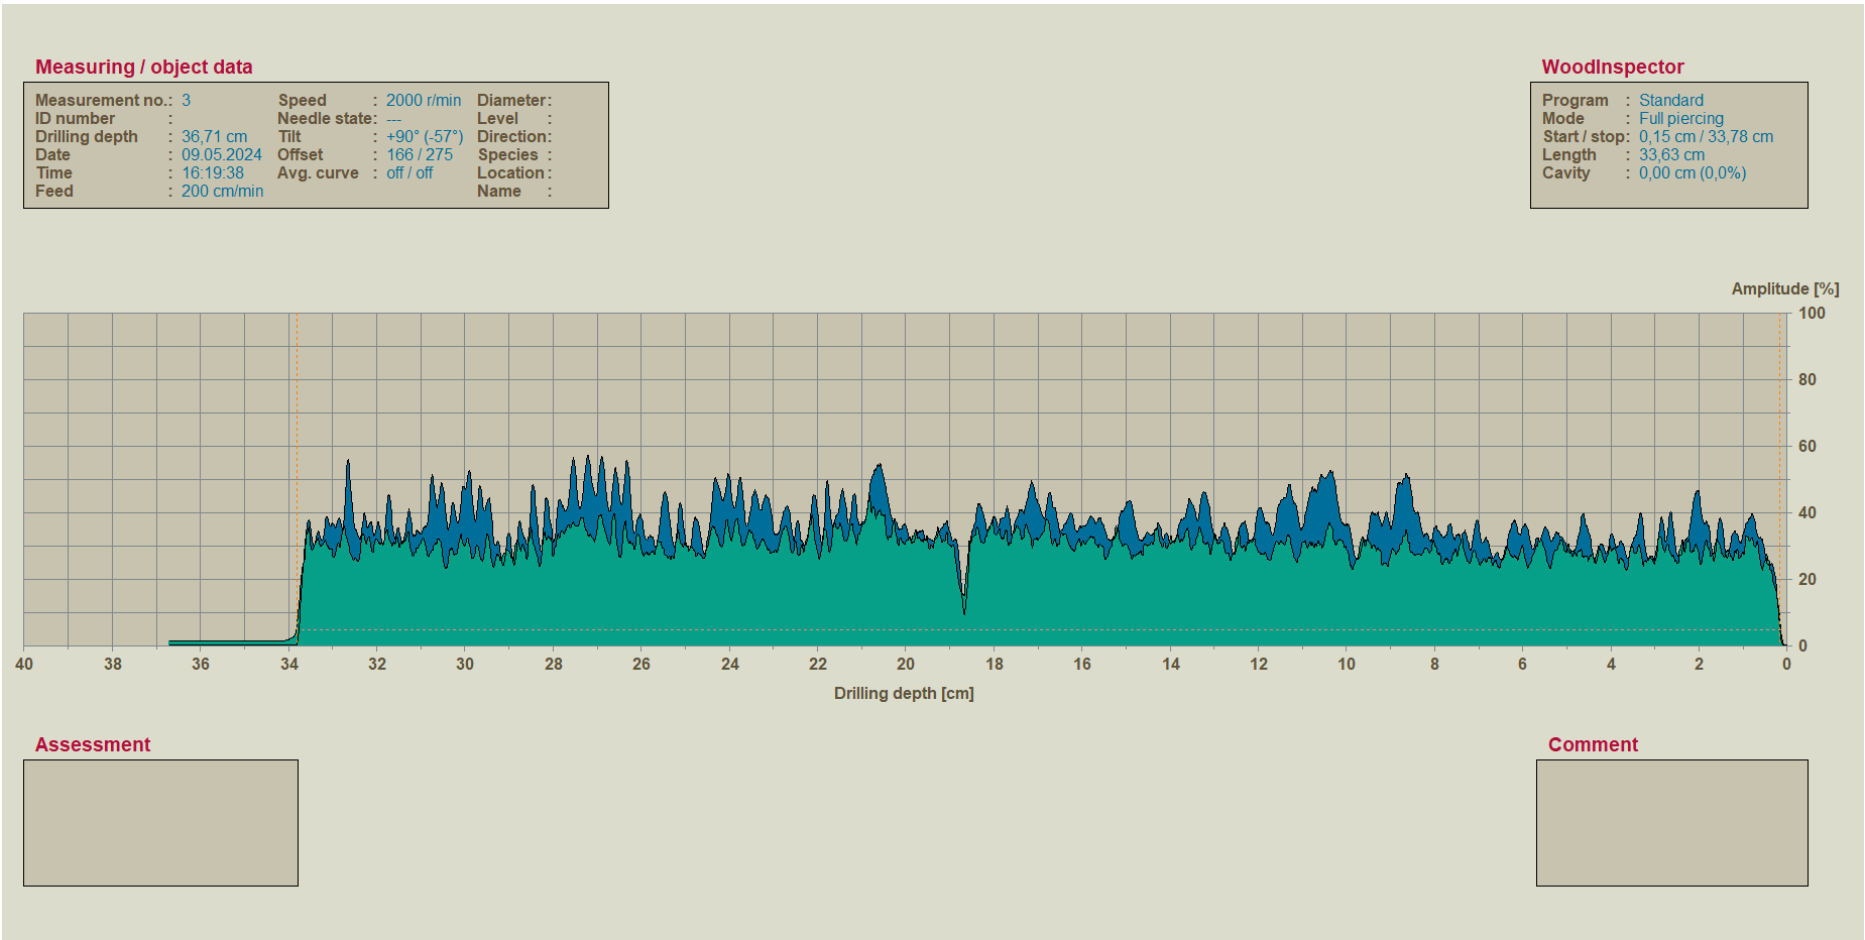
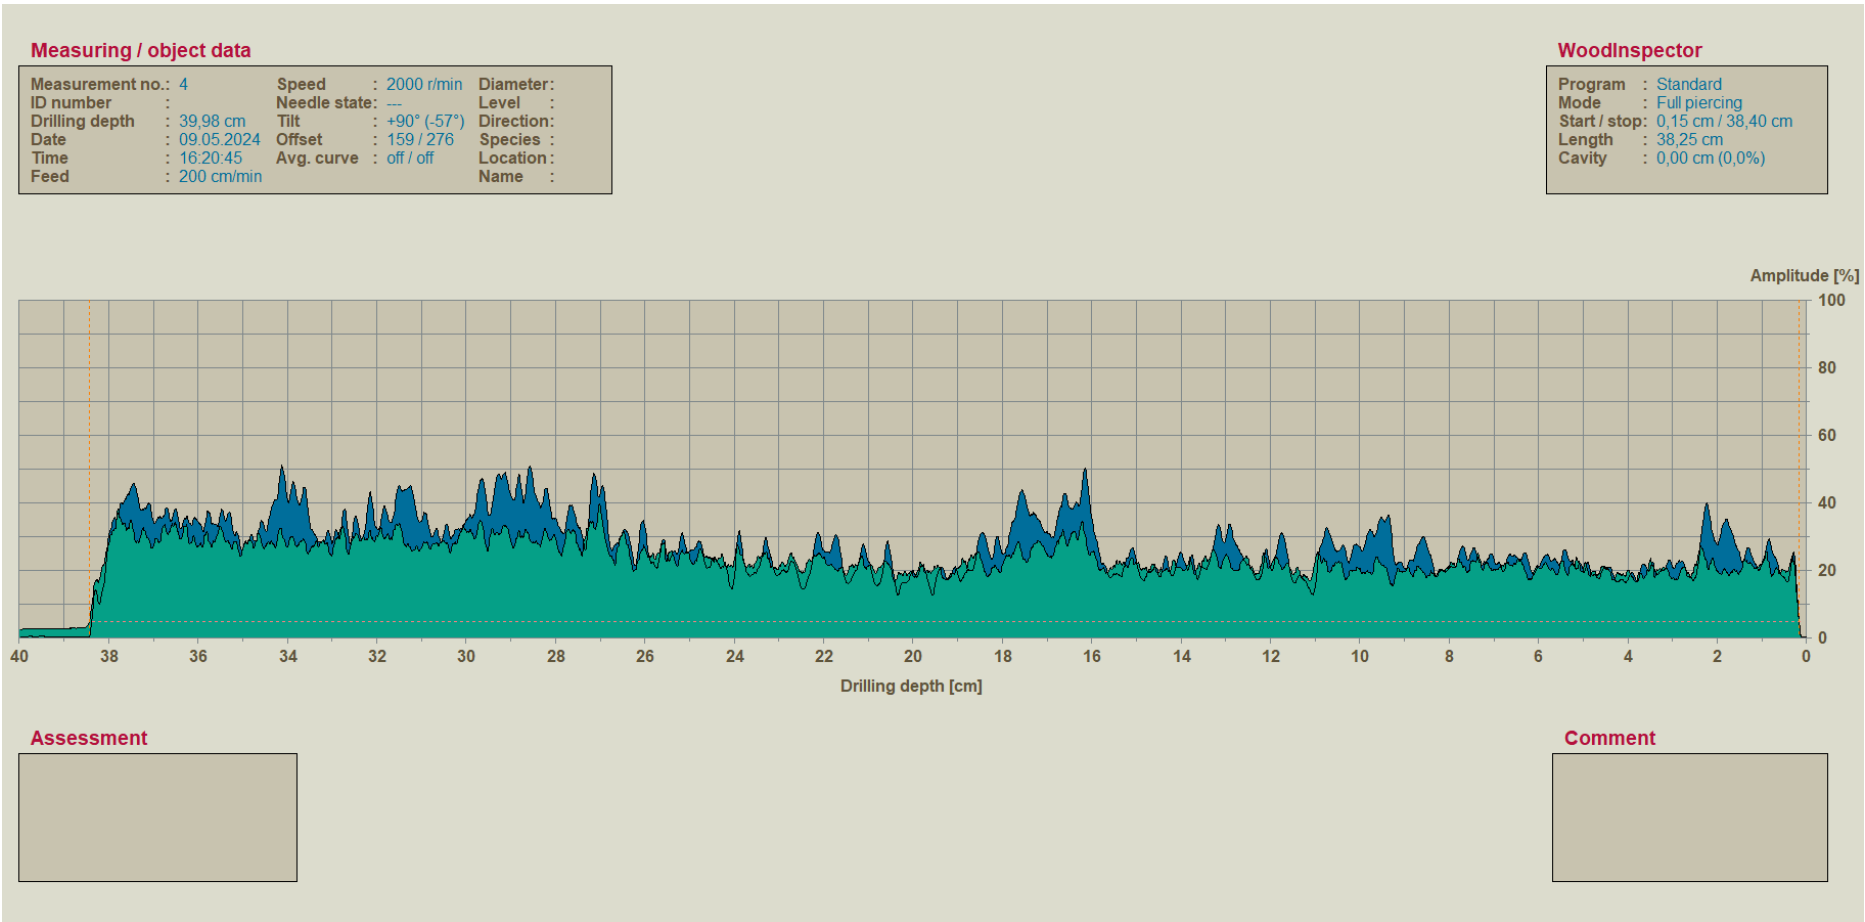
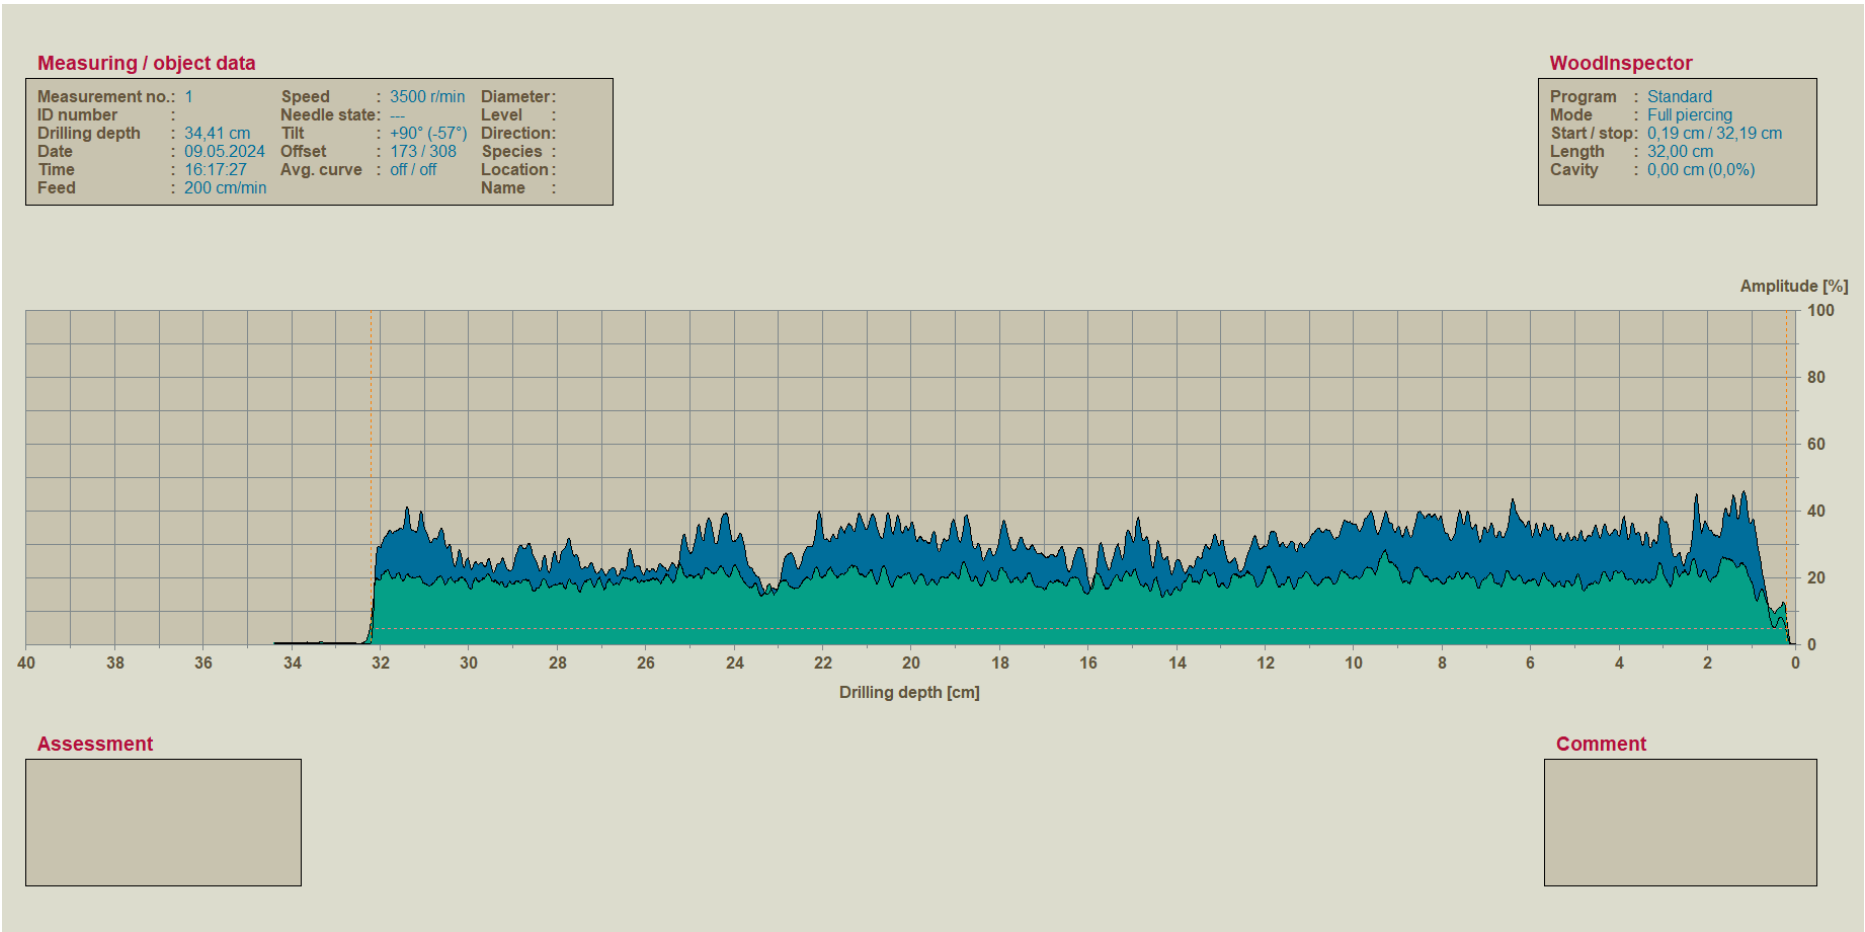
## Micro drilling

The below results show some beam ends that have decay present but have enough remaining healthy timber to be retained.

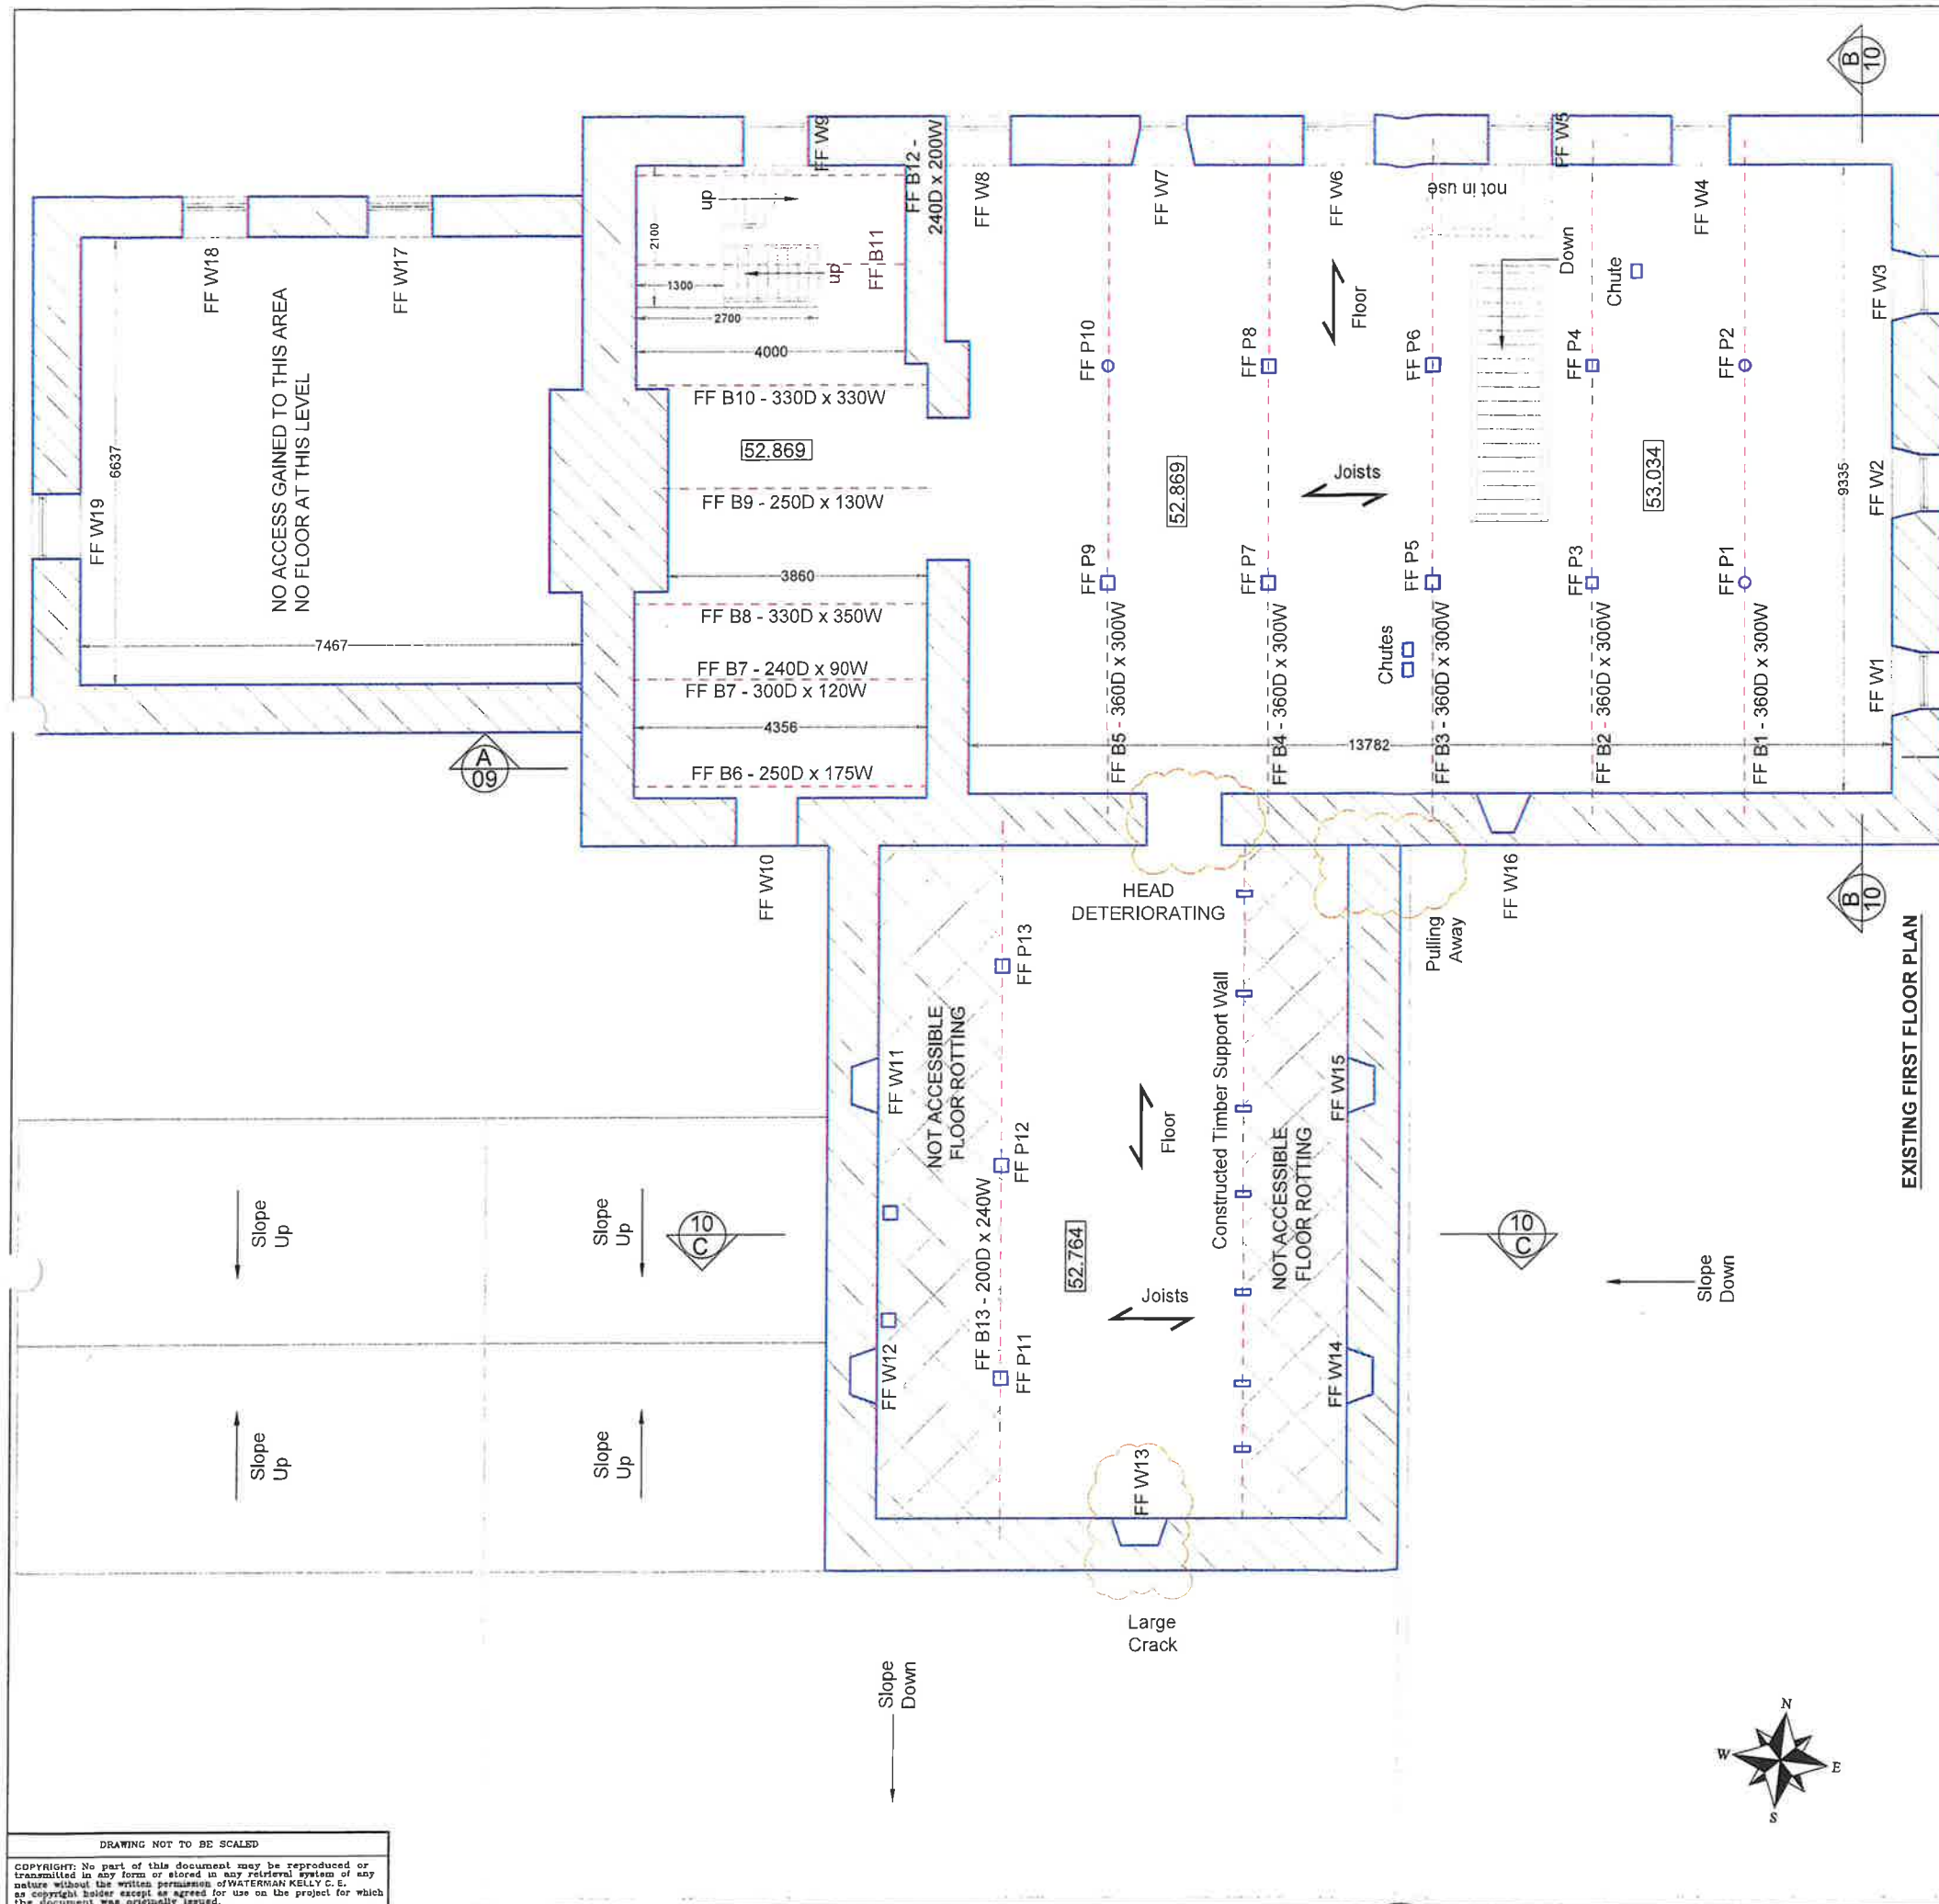
Drawing No: **WK10534-03** Revision: **0**

- Dimensions not to be scaled from drawing.
- Woodworm noted throughout First Floor.
- It is noted that many of the timber piers are placed on footings. Many also have timber blocks placed on top of the pier, under the beam to spread load.

- Many of the timber piers are not original and have been replaced throughout the years.
- Main Mill Warehouse joists spanning North/South are 150 x 50mm @ 400mm C/C.

- Beam on the South Annex has been replaced with a timber wall construction.
- South Annex pulling from main building.
- It is noted that the East wall of the Main Mill Warehouse may be pulling away.

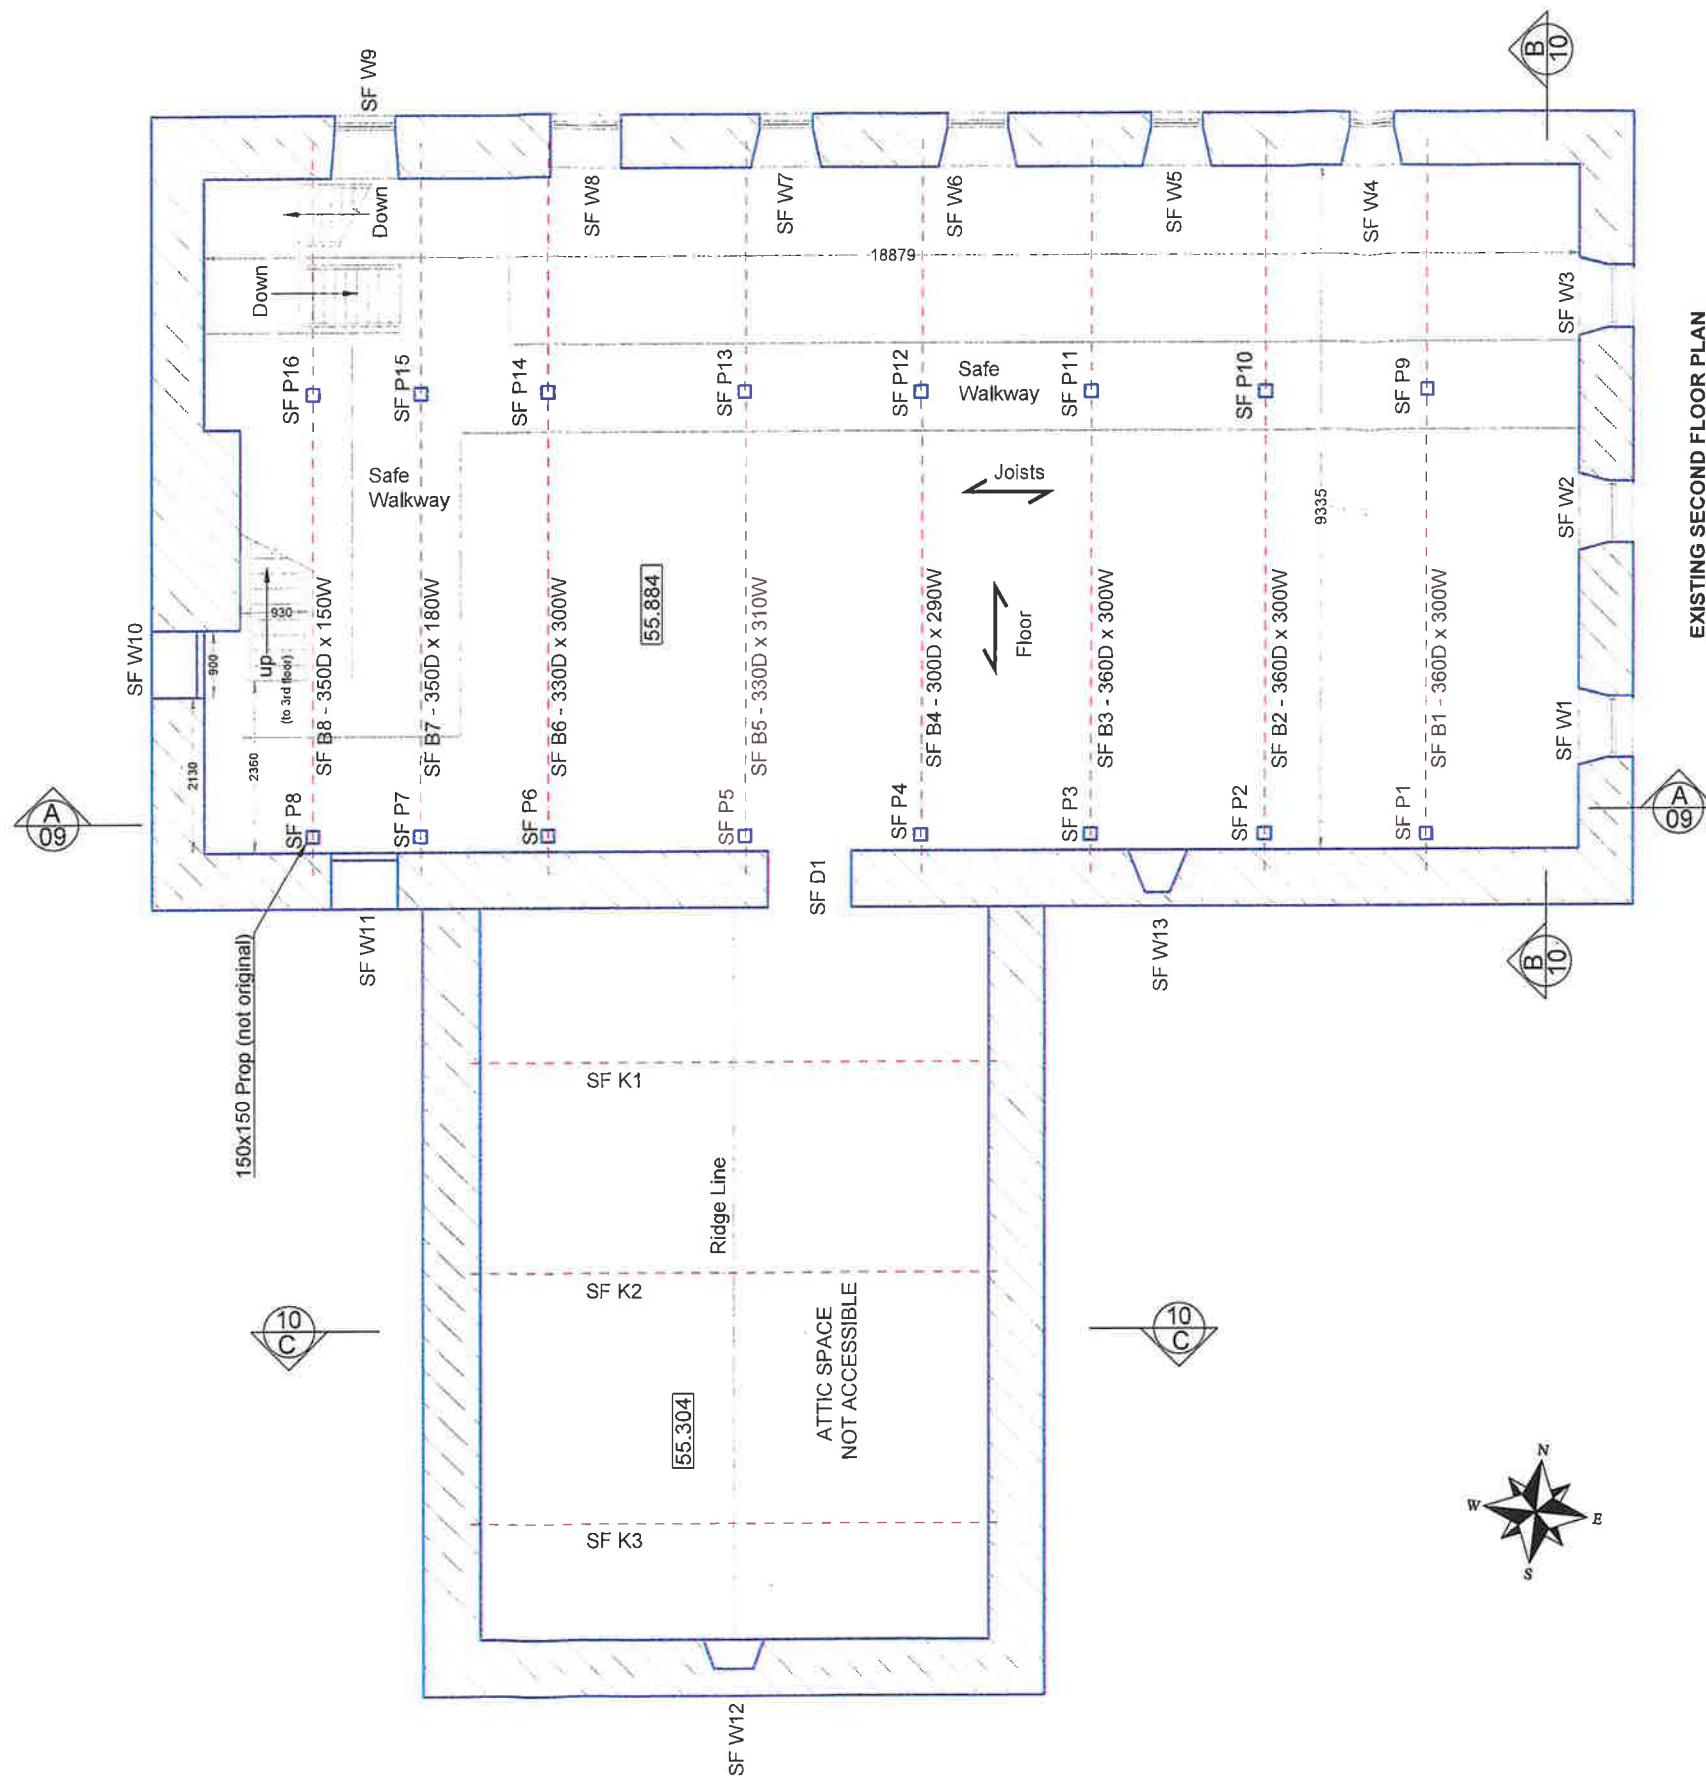
Drawing No: **WK10534-04** Revision: **0**

- Dimensions not to be scaled from drawing.
- Woodworm noted throughout Second Floor.
- It is noted that many of the timber piers are placed on footings. Many also have timber blocks placed on top of the pier, under the beam to spread load.

- Timber piers on the South wall of the Main Mill Warehouse are not original and have been placed under beams due to the end of the beams deteriorating.

- Main Mill Warehouse joists spanning North/South are 150 x 50mm @ 400mm C/C.
- Main Mill Warehouse floorboards spanning East/West are 30 x 200mm. Floorboards in poor condition with plywood covering much of the floorboards. There is a general safe walkway marked.

- South Annex contains King Truss structures supporting the roof. Two look to have been replaced in years gone by. Trusses are deteriorating in condition with woodworm present.

- South Annex purlins are in poor condition with many rotting/contain woodworm.
- South Annex walls are in poor condition with a crack under SF W12 Cill.

- It is noted that the East wall of the Main Mill Warehouse may be pulling away.

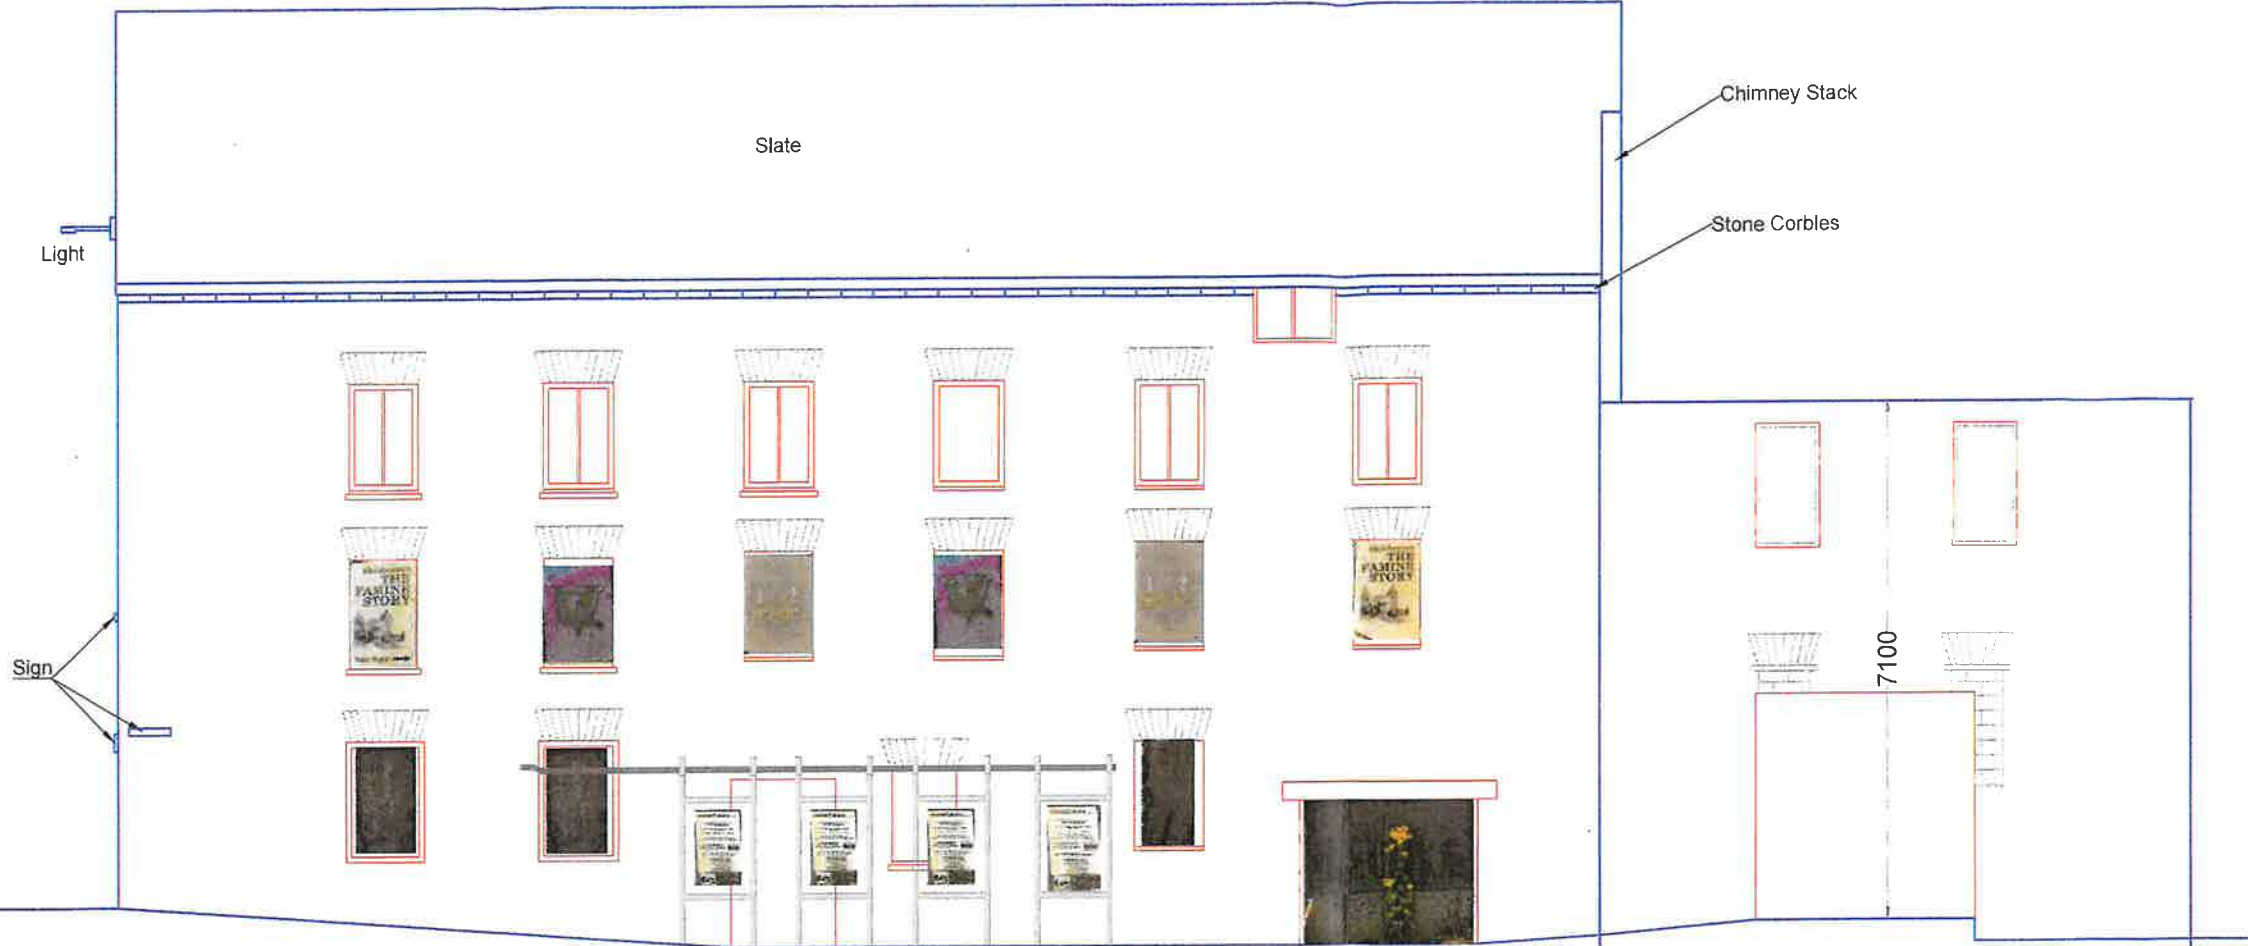
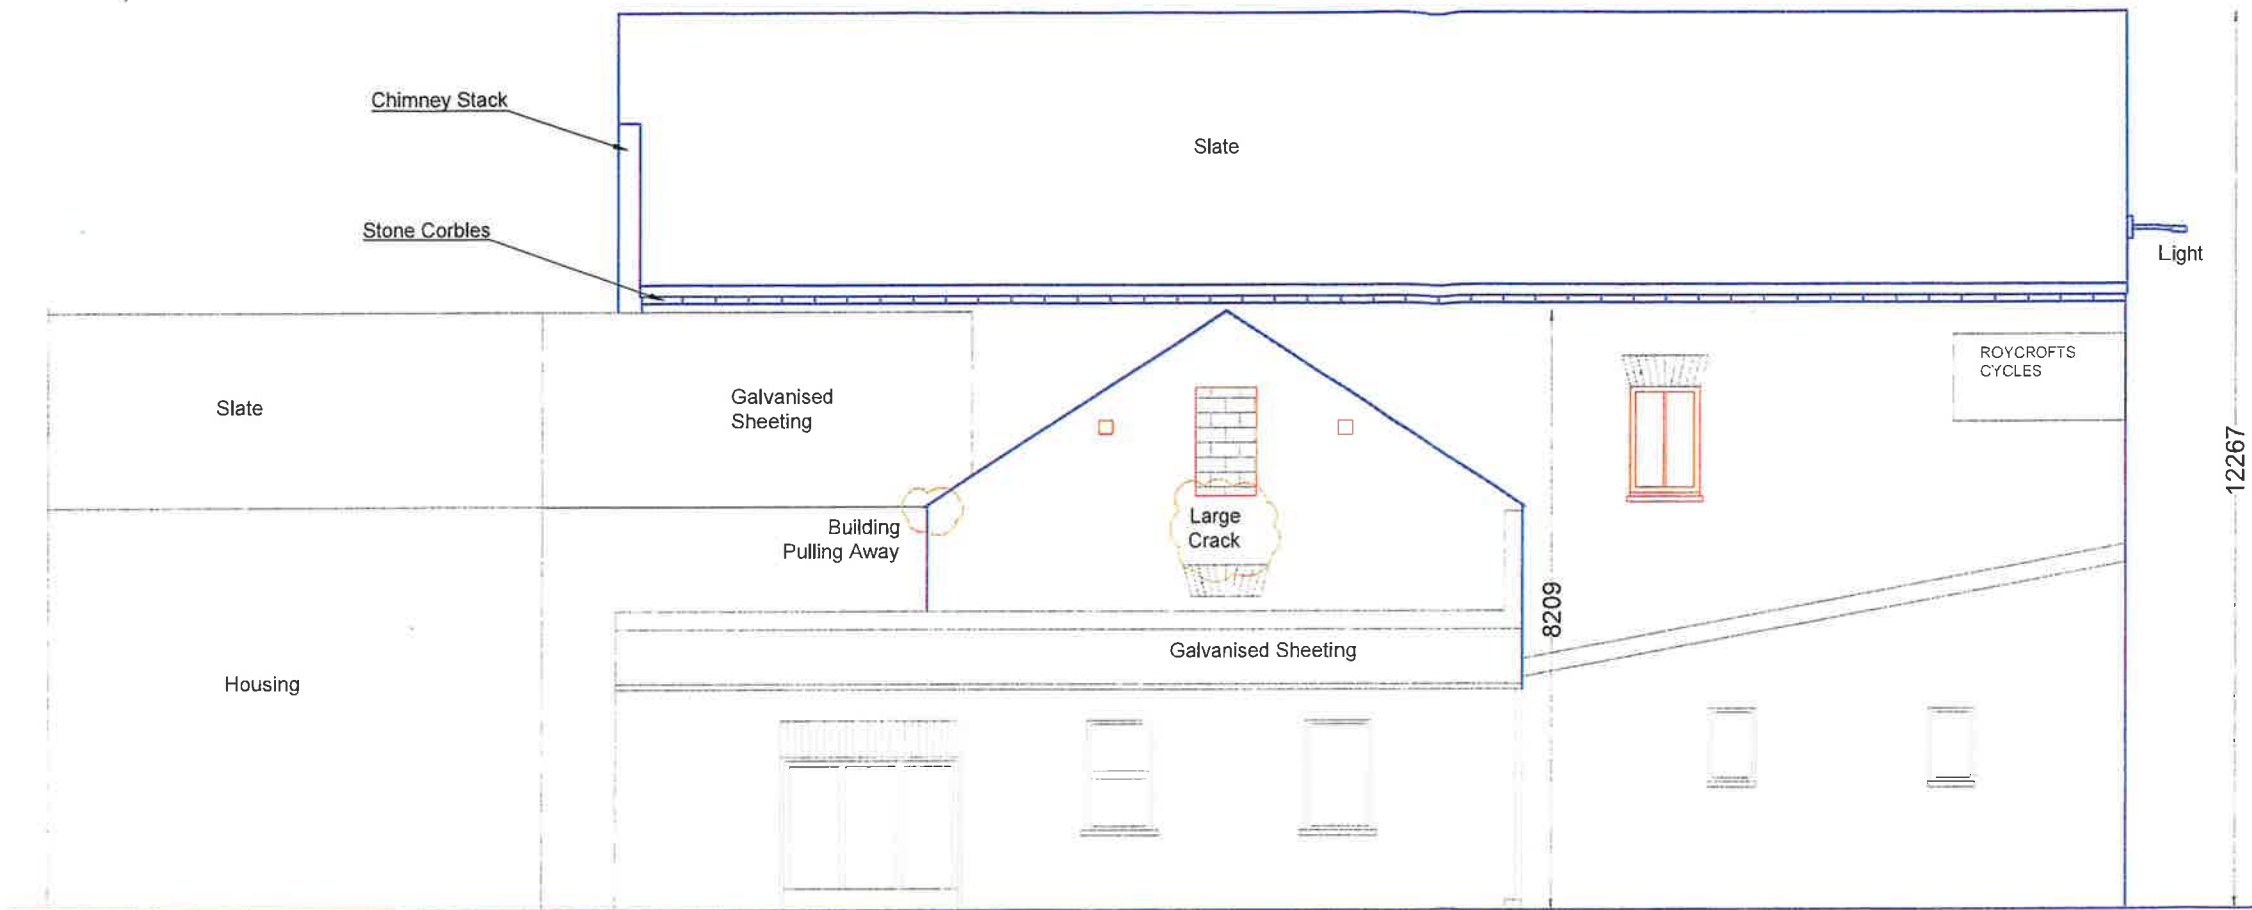
- Dimensions not to be scaled from drawing.
- See corresponding plans for door, window, beam and pier schedules.
- Some of the Stone Corbles are missing in places on the Main Mill Warehouse.

- The majority of the South Annex walls has buildings on each side.
- The buildings surrounding the South Annex and Main Mill Warehouse are in reasonable condition.

- The building to the East with the roof sloping from East to West has a gutter located against the Main Mill Warehouse and South Annex which may be causing excess water infiltration.

- There is a crack visible under the window cill of SF W12 where the window itself has been blocked up on the South Annex.
- To the West corner of the South Annex roof where the neighbouring building roof connects, there is some stone work missing resulting in a hole. There is also a large plant growing from this corner.

- The neighbouring buildings galvanised roof at Second Floor level is in poor condition connecting to the South Annex.
