# SKIBBEREEN STEAM MILL

## INFORMATION PACK

## INSPECTION REPORT

### Re: The Old Steam Mill, Skibbereen, Co. Cork.

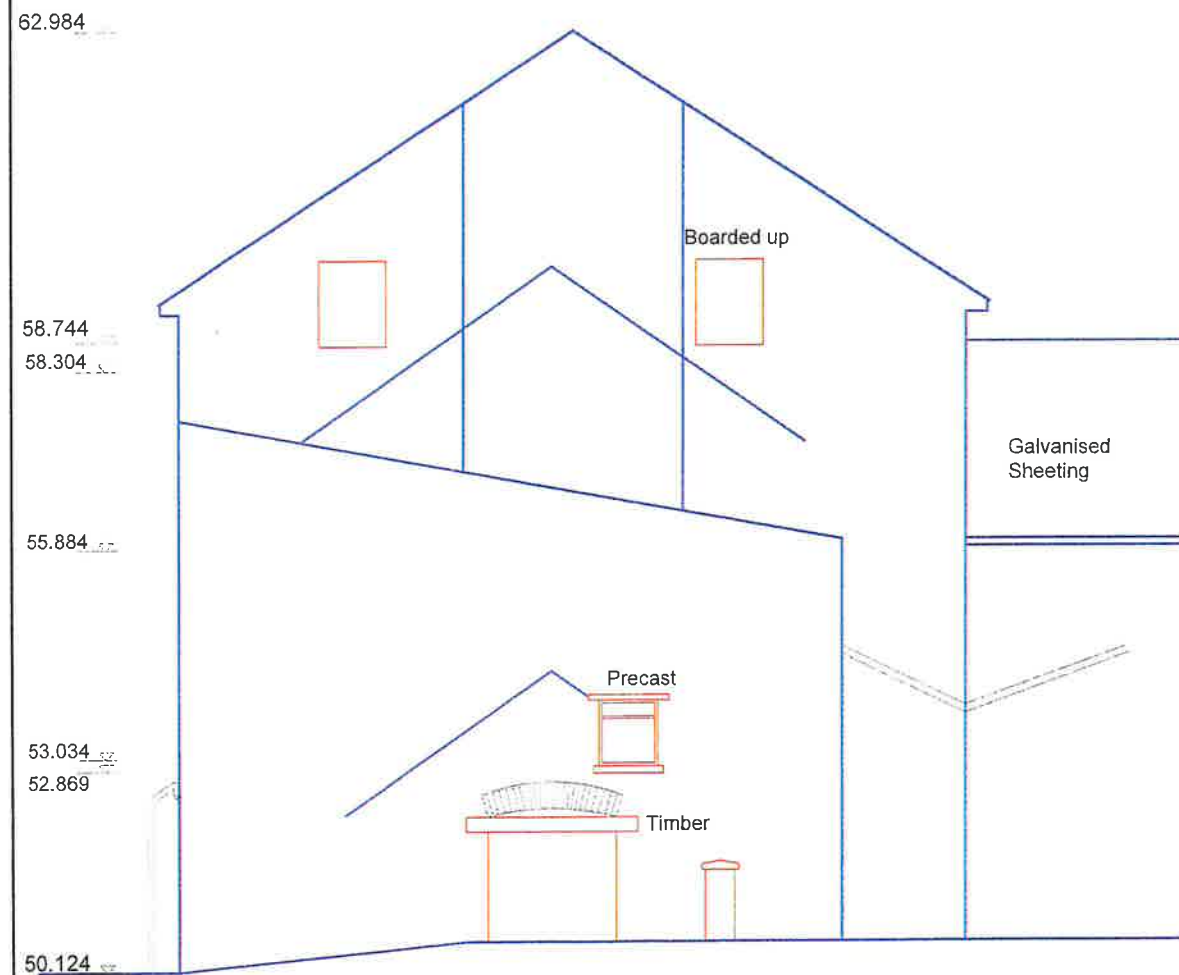
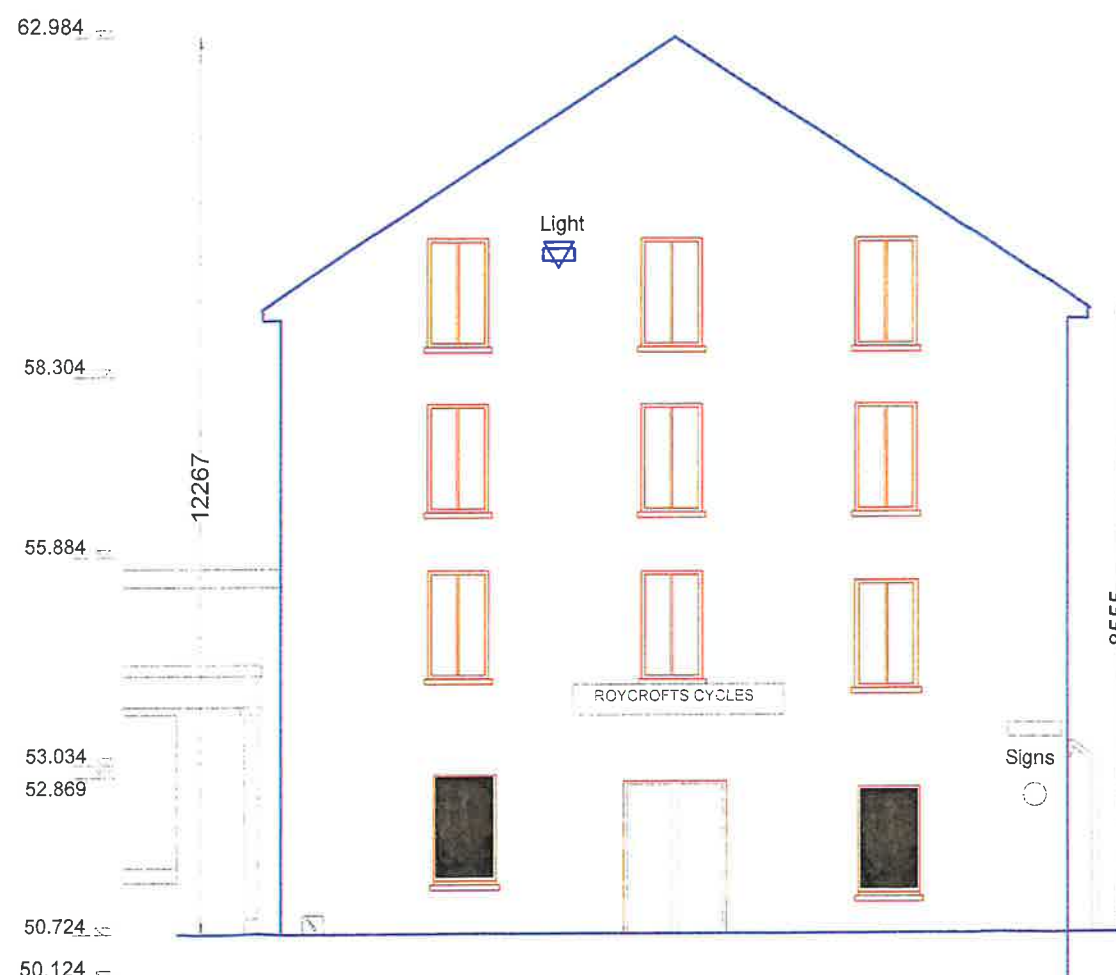
- The neighbouring building has roof level up to the First Floor of the Main Mill Warehouse.
- There is some cracking and deterioration around the doorway.

- There is some vegetation growing from the window openings.
- There is some cracking noted on the left hand side at Roof level.

- There was a building previously located at the end of the Main Mill Warehouse building at Ground Floor level with the roof line visible.
- The large head on the possible fire place on the West Annex is timber and deteriorating. There is a slight arch with vertical stone construction following the arch.
- There is a window above the possible fire place in poor condition with a precast head and cill on the West Annex.
- The West Annex was not accessible. There is currently no roof on the West Annex.
- There is a roof line visible of the previous building structure with two windows located above this roof line at Third Floor level of the Main Mill Warehouse.
- One of those windows is boarded with the other window metal framed with a mesh covering the opening.
- The chimney line is visible on the centre of the West elevation.

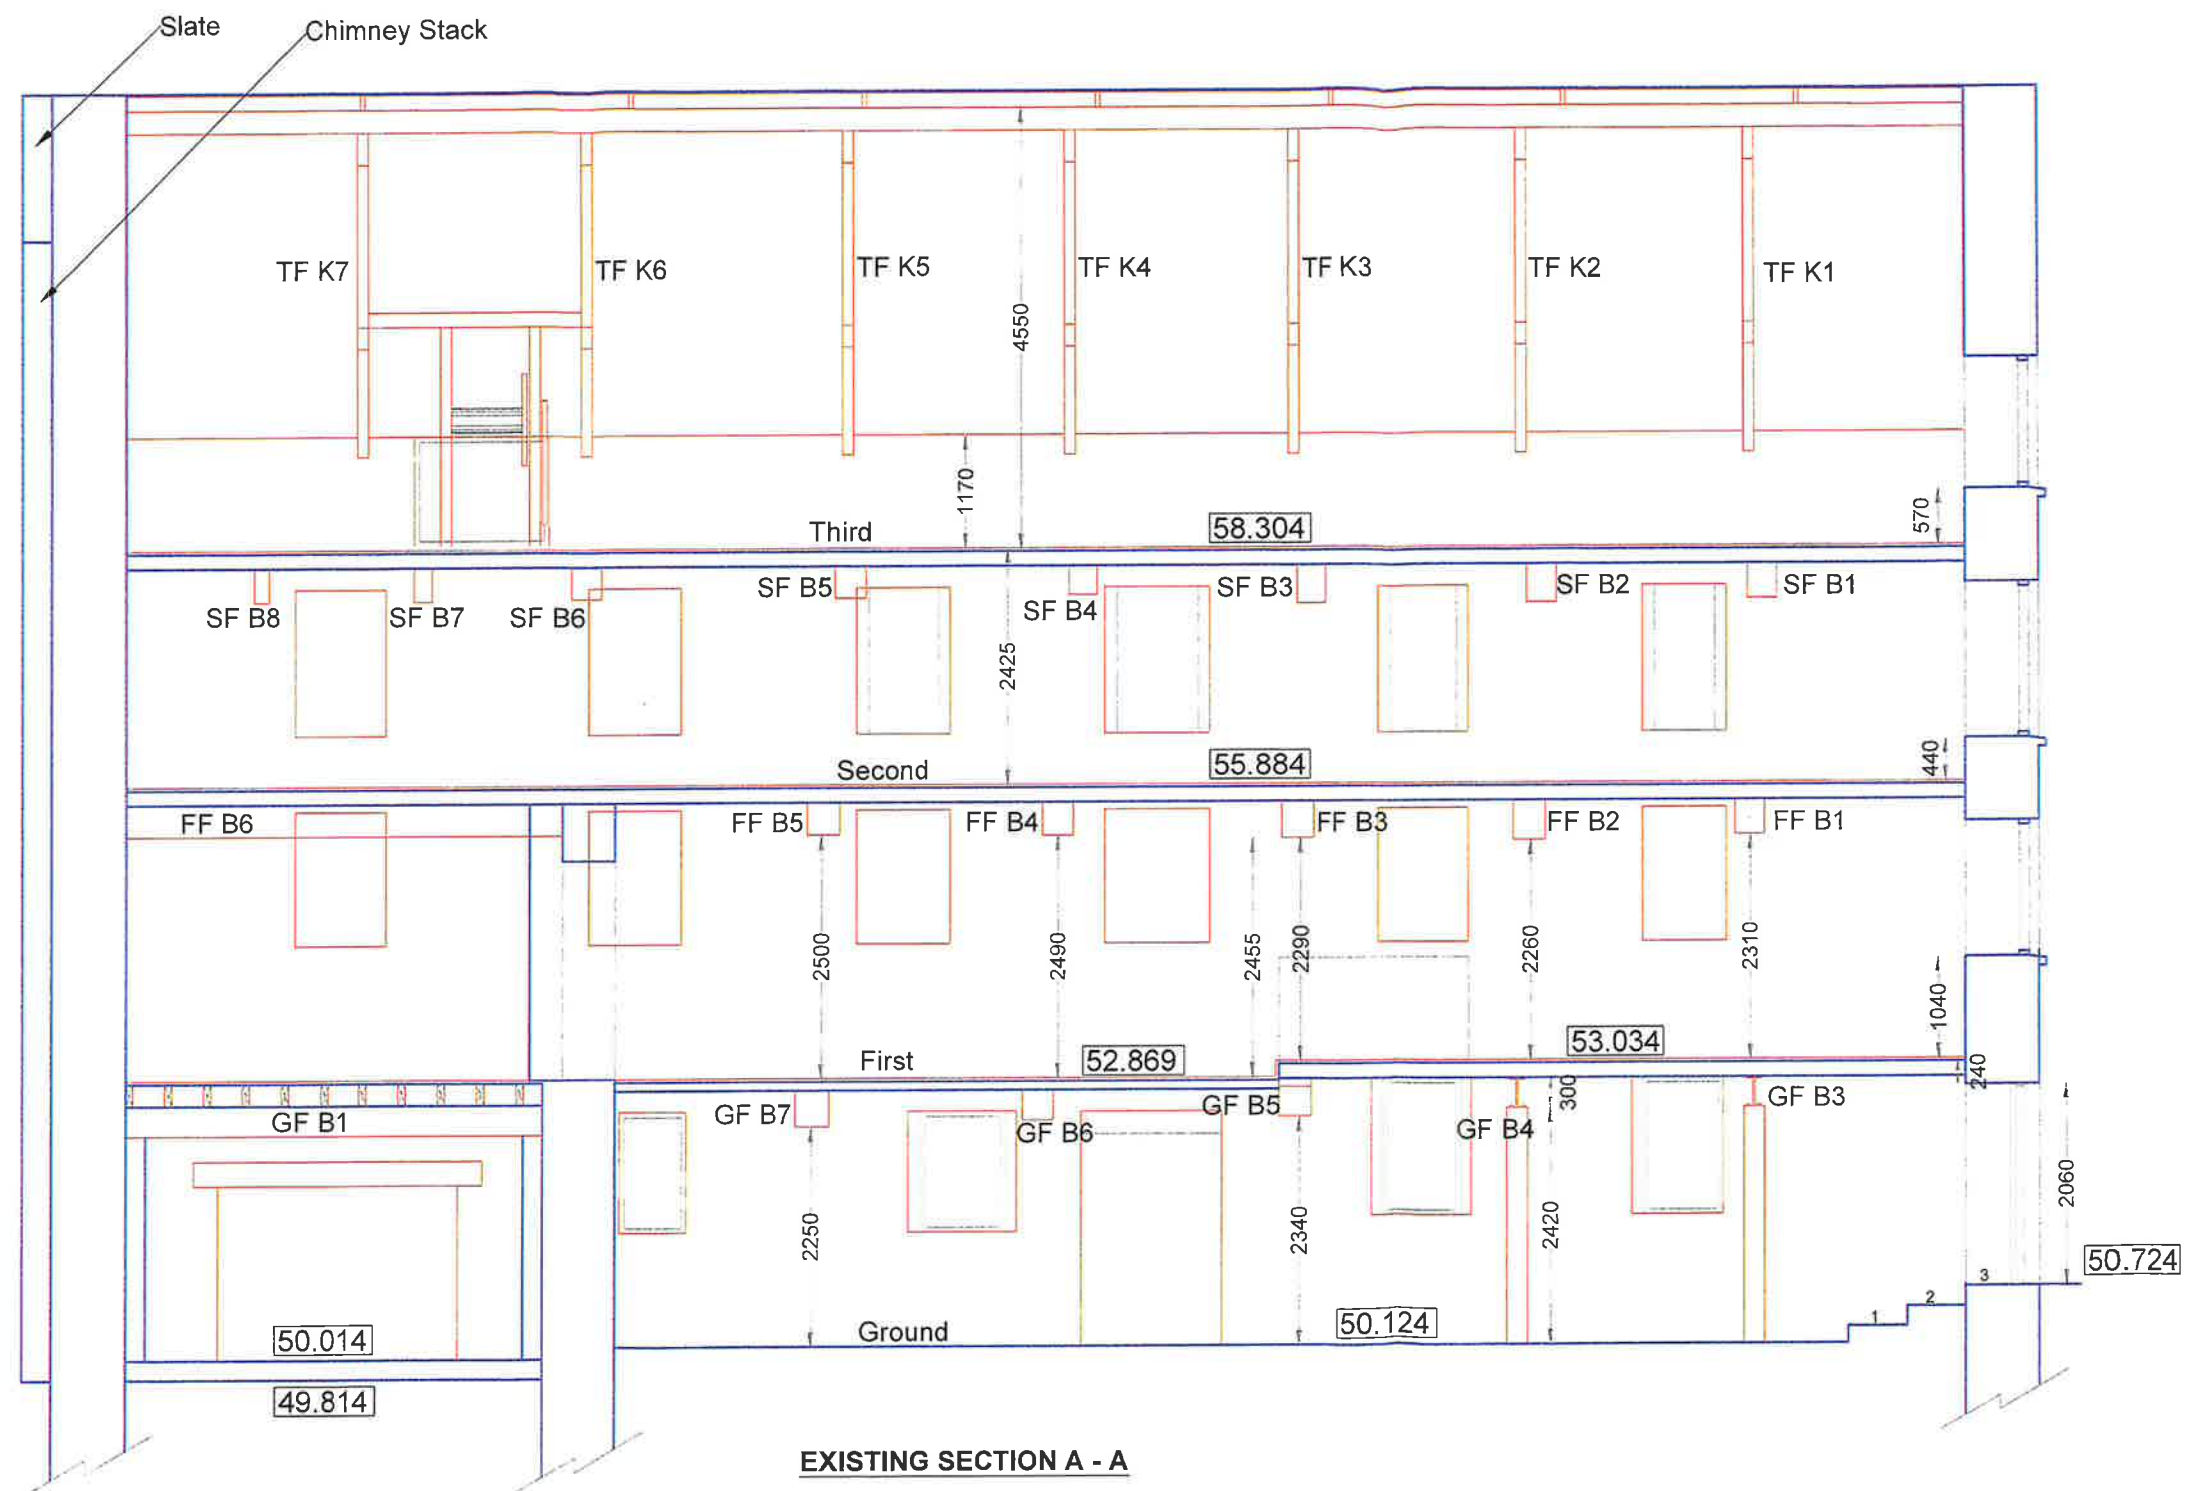
- Dimensions not to be scaled from drawing.
- See corresponding plans for door, window, beam and pier schedules.
- The two beams closest to the door on the East at Ground Floor level have been replaced with steel I beams and placed on brick pier.

- Many of the piers through the floors have a footing placed under the pier along with a block placed under the beam on the pier to spread load.
- The timber floor at First Floor, Second Floor and Third Floor levels are in poor condition with many areas rotting and plywood placed on top.

- Note the Step down on the First Floor of 165mm.
- Woodworm has been noted in most areas on timber beams, piers and floorboards.
- The Third Floor level contains a walkway put in place for safe passage along the length of the floor level.

- Many of the King Truss connections to the wall have been spliced due to cracking occurring from the connection points.
- The East wall (Front of building) may be pulling away from the rest of the Main Mill Warehouse.

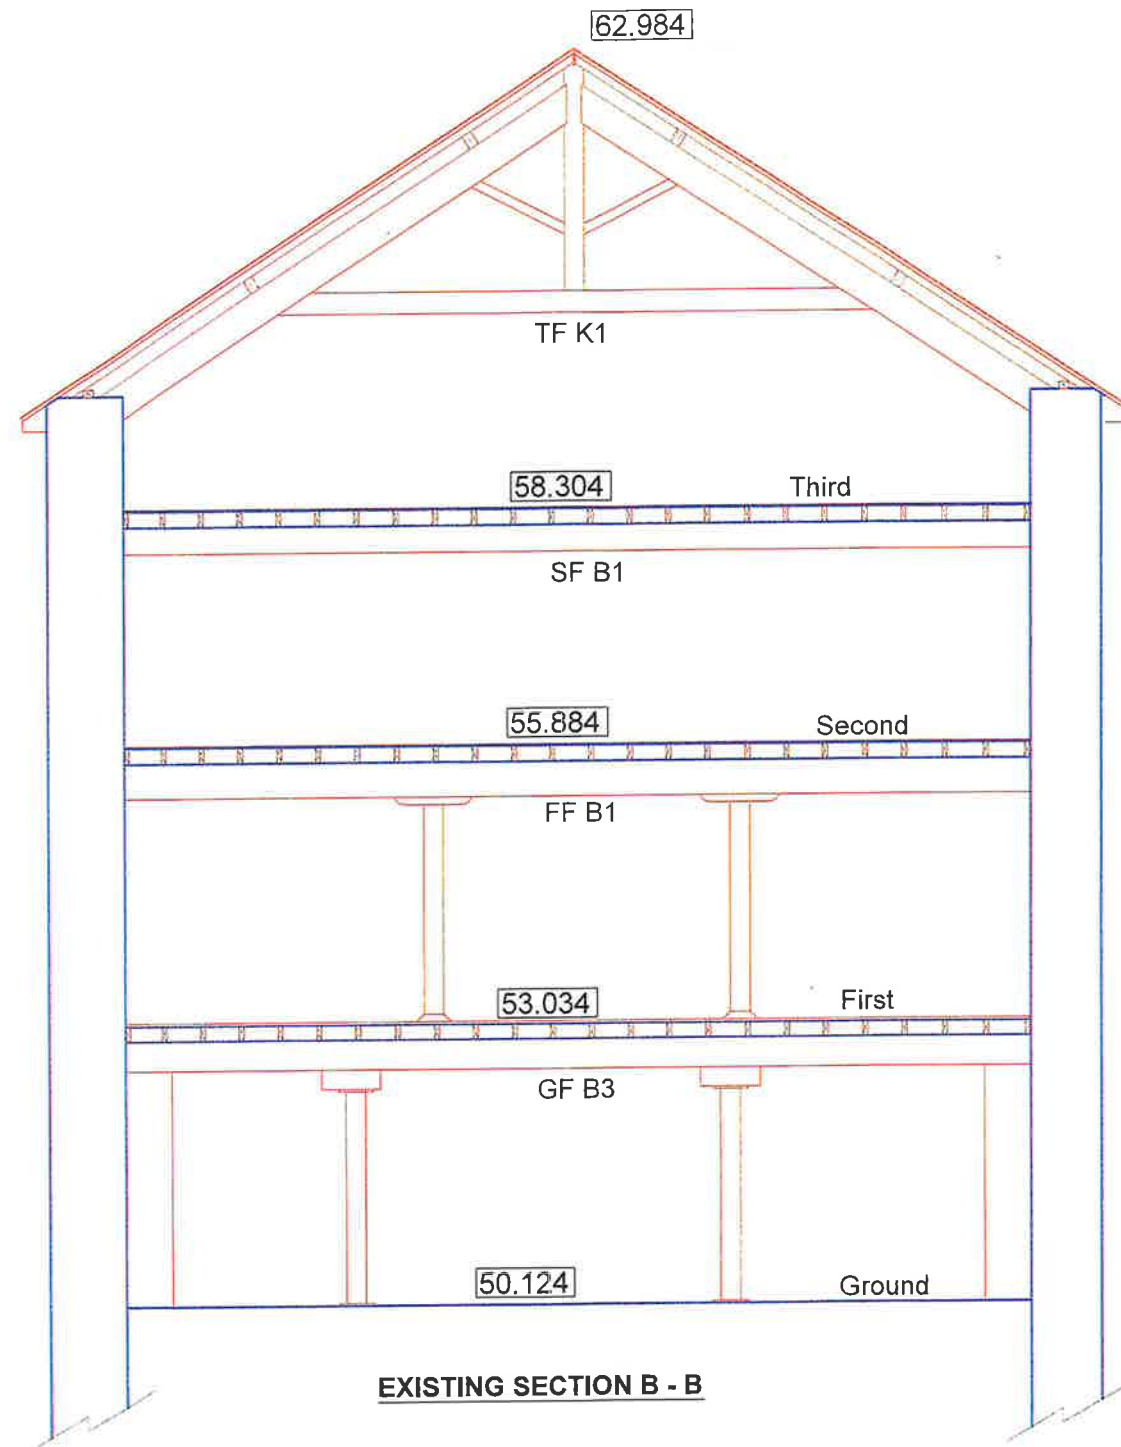
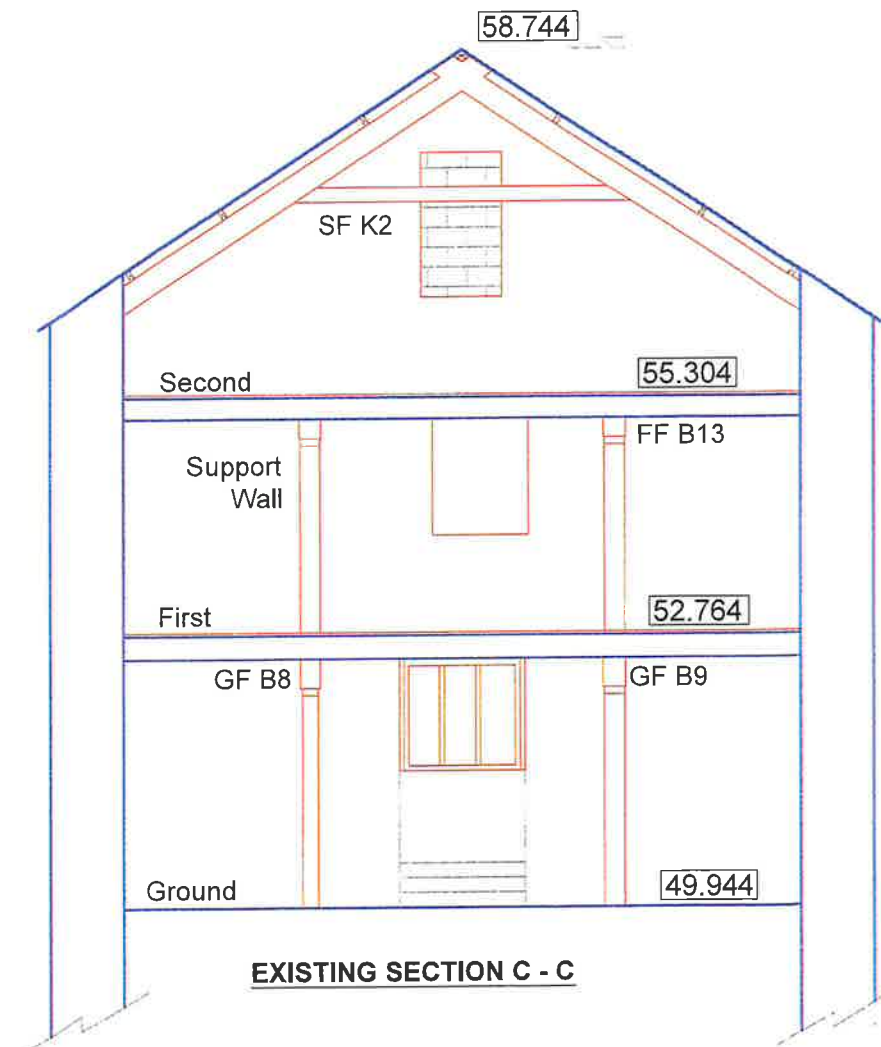
- Displays a section of the Main Mill Warehouse.
- The two beams closest to the door on the East at Ground Floor level have been replaced with steel I beam and placed on brick pier.

- Many of the piers through the floors have a footing placed under the pier along with a block placed under the beam on the pier to spread load.
- The timber floor at First Floor, Second Floor and Third Floor levels are in poor condition with many areas rotting and plywood placed on top.

- Note there is a Step down on the First Floor of 165mm.
- Woodworm has been noted in most areas on timber beams, piers and floorboards.
- The Third Floor level contains a walkway put in place for safe passage along the length of the floor level.

- Many of the King Truss connections to the wall have been spliced due to cracking occurring from the connection points.
- The East wall (Front of building) may be pulling away from the rest of the building.

- Displays a section of the South Annex off the main building.
- The Beams, Piers and Floorboards are in very poor condition with much of the First Floor inaccessible.
- The Third Floor is not accessible and is blocked from entry.
- The King Trusses are in poor condition with two of the three replaced in previous years. Evidence of woodworm present on the trusses.
- Many of the purlins are in poor condition.
- The galvanised roof is in poor condition.
- Many of the windows have been blocked up or boarded.
- There is a fall of 180mm through to the Ground Floor from the Main Mill Warehouse to the South Annex.

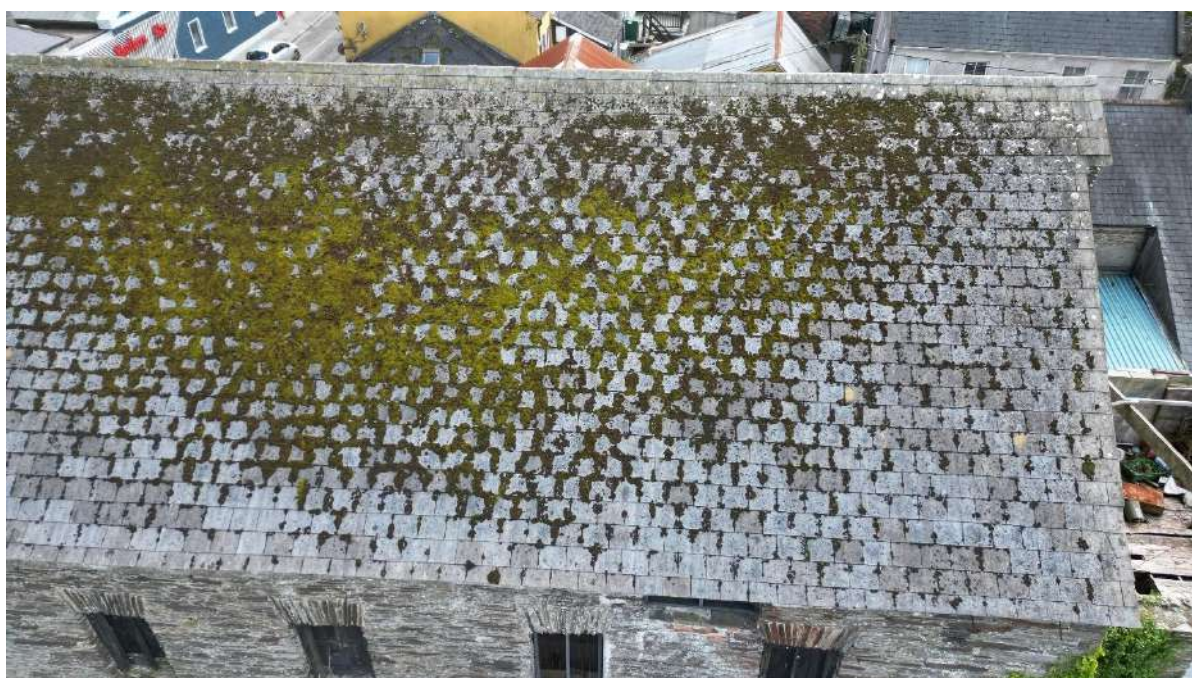
The pitched roof does not have even line or gauge, but the finish is in a reasonable condition throughout, with no obvious signs of failure present. There is a lot of moss growth visible, especially to the north face of the roof.

*Fig 3.04: North face of roof of mill.*

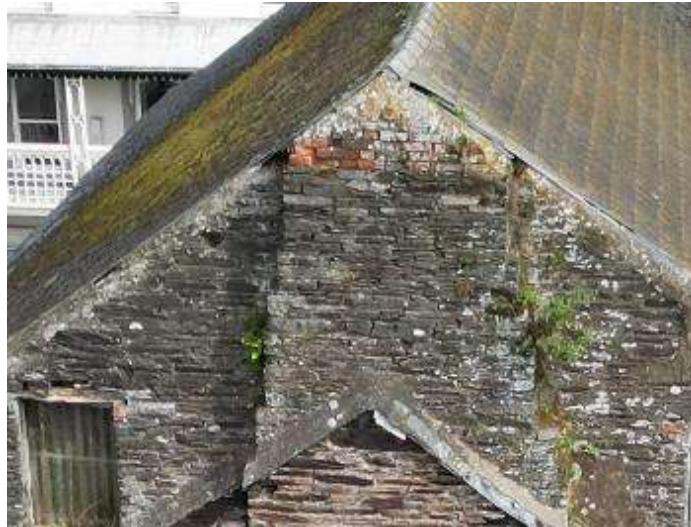
The west gable wall has the remnants of a projecting chimney present, which has been cut back to ridgel level, and the roof finish projects out over this structure. There are gaps visible at the verge along this elevation; the detailing involved the gap between the slates and top of the wall being filled in with mortar, but this has failed in places which is allowing for water penetration through the building fabric.

*Fig 3.05: View of verge to west gable- note gaps visible between roof finish and walls.*

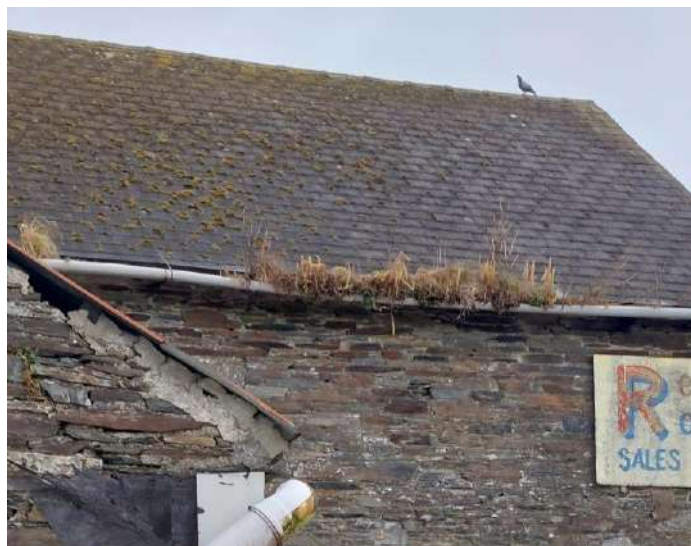
The roof has a projecting stone eaves detail. The rainwater goods should be thought of in conjunction with the roof, and there are no rainwater goods present to the front (north) elevation. There are gutters present to the south, and a significant amount of vegetation was visible which was causing them to sag. No downpipes were visible. The rainwater goods are therefore largely missing at present, allowing for large volumes of water from the roof to flow down the walls of the building as a result and leading to a saturated building fabric.

*Fig 3.06: Gutters to south elevation. Significant vegetation and sagging visible.*

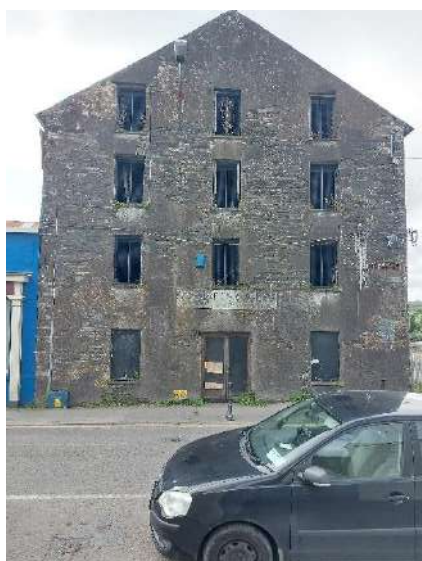
*Fig 3.07: East elevation*

The structural engineer's report for the east facing gable shows that this wall is out of plumb. While this type of lateral failure is typically due to failure of the lintels of some of the windows, the inspection of the internal wall showed no particular movement. This would suggest that the out of plumbness was part of the original construction of the premises.

Cracking and deterioration of the wall was noted around the doorway at ground level, centrally above the ground floor window to the rhs, and the lhs at roof level. It is anticipated that this localised cracking can be dealt with without major structural intervention with the wall.

The neighbouring building has roof level adjoining the first floor of the mill, and there is a vertical crack visible between the two buildings.

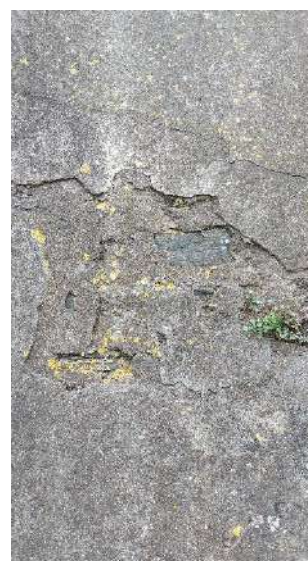
*Fig 3.09: Failure of render finish*

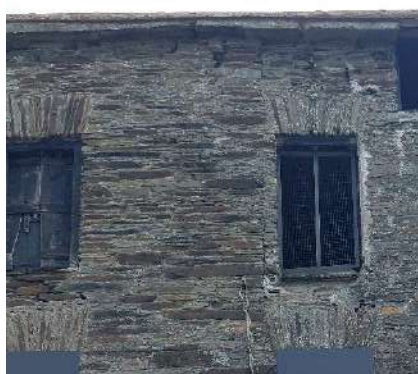
Fig 3.11 Detail of stonework- eroded joints and cracking visible, especially at eaves level

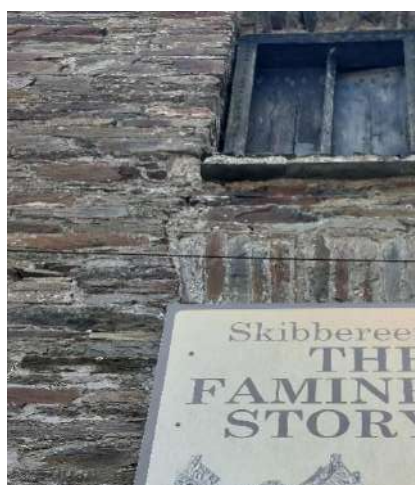
Fig 3.12: Cracking above window

The north facing wall is reasonably good condition. The wall is rough coursed exposed masonry throughout. There is evidence from historic photos that the east corner of the elevation would once have been rendered, but this render finish has now been lost to the face of the wall. Some render is present around window reveals. The masonry appears to be in a good condition generally, with no significant cracking or bowing noted. There was some erosion of the joints noted, as well as minor cracking above four of the window heads and to the top east corner of the building.

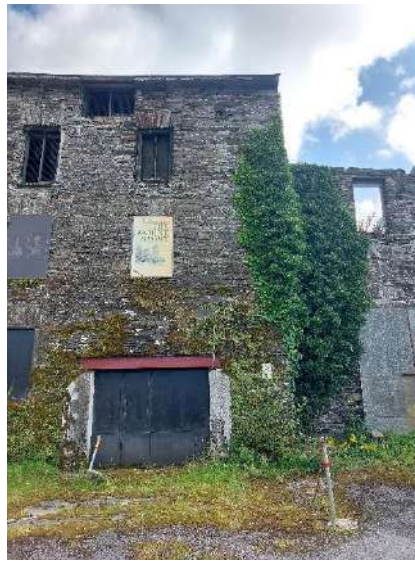
There is significant vegetative growth visible on the north wall. There is ivy growth at ground-first floor level and reaching almost eaves level to the west corner. The ivy has the potential to damage masonry walls if not controlled. There is moss and fern growth to the ground floor wall generally, and especially around the double door opening to the west end, indicating dampness of the building structure behind.

*Fig 3.14: View of north west corner of building – significant ivy growth visible*

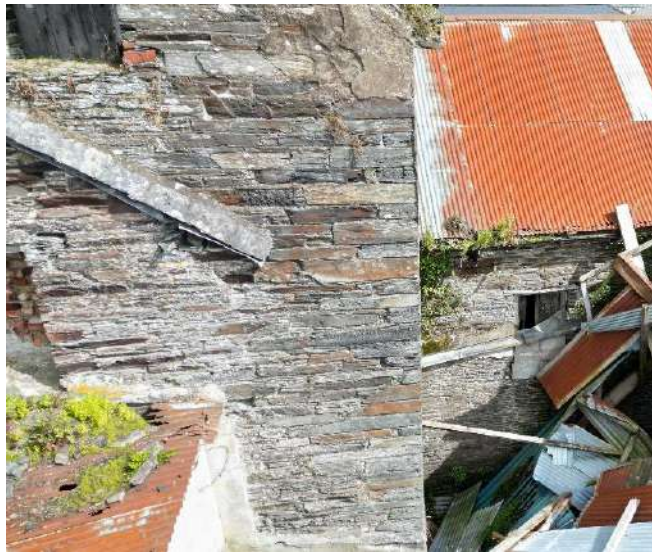
*Fig 3.16: Southwest corner. Some render visible at eaves level. Lead flashing to former roofline visible.*

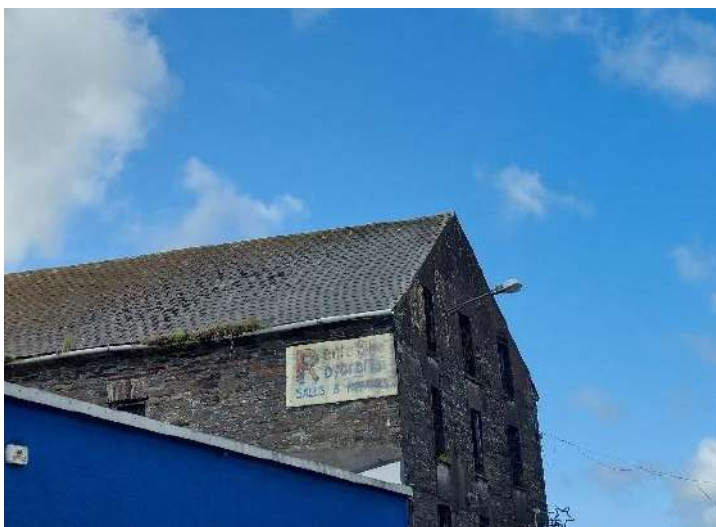
*Fig 3.17: South elevation of main volume towards east corner.*

The wall is exposed stone generally, but a cement-based render is present above the roof line of the adjoining volume to the east side of the annex. This render may be causing issues with breathability and moisture levels in the walls.

There are issues present with the rainwater goods as previously described, with a considerable amount of vegetative growth visible.

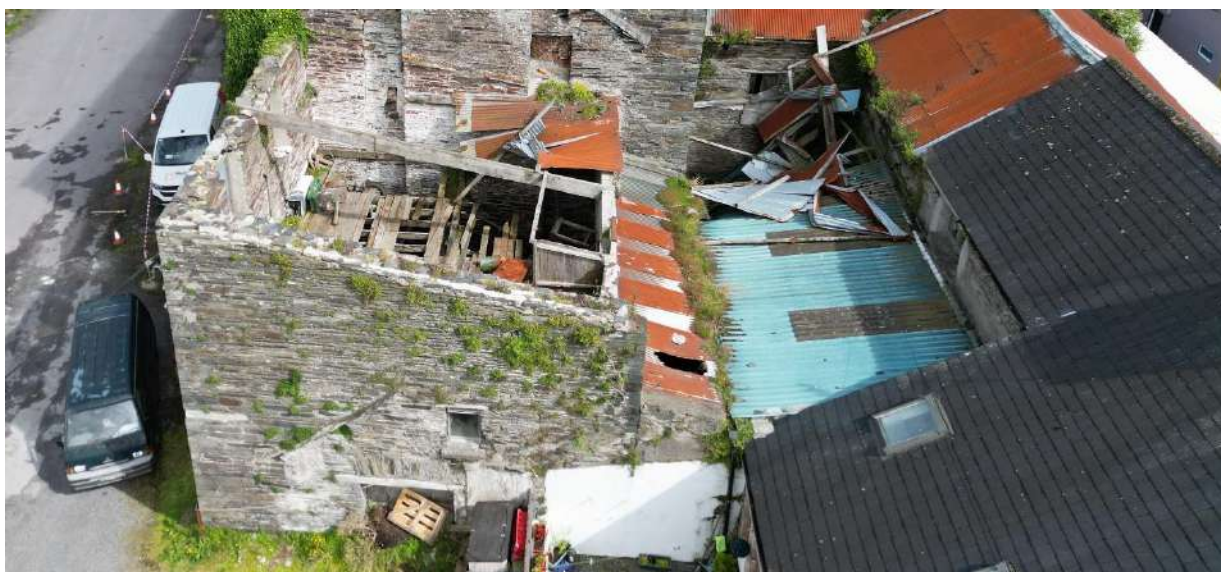
Fig 3.18: View of west annex

The north and west walls of the west annex are rubblestone masonry and generally in good condition with no significant bowing or cracking noted. However, they are deteriorating due to damp penetration. The south wall visible from drone footage is modern concrete block construction. There are cut stones quoins present to the northwest corner with rough coursed masonry present to elsewhere. A concrete lintel has replaced one of the quoins. There is some erosion of joints visible, especially to the west gable.

There were formerly four window openings to the north elevation with square headed openings with flat stone arches to the ground floor and plain heads above. The windows to the upper floor have plain timber frames fitted with perspex or similar. The flat stone head of the one towards the west appears to have deflected, and the masonry above is loose. The masonry to the top of the walls generally is in a poor condition. There is no capping present leaving the structure vulnerable to damage, and there are sections of very loose masonry visible which represents a threat to passers-by.

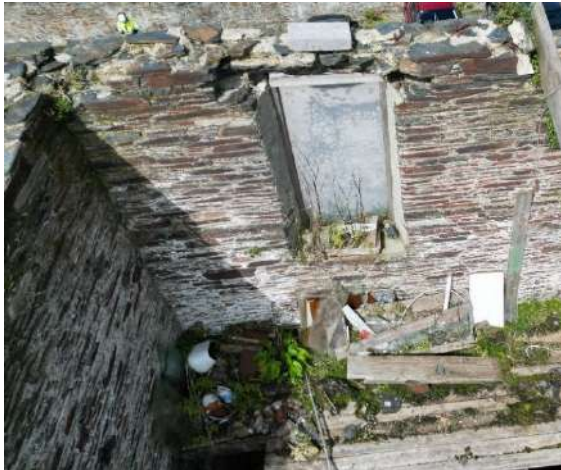
*Fig 3.19: Loose masonry to top of walls*

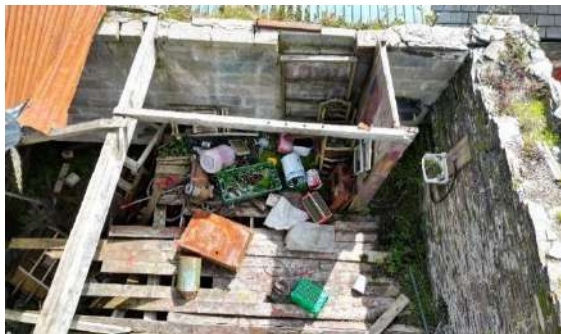
*Fig 3.20: Concrete block wall to south elevation*

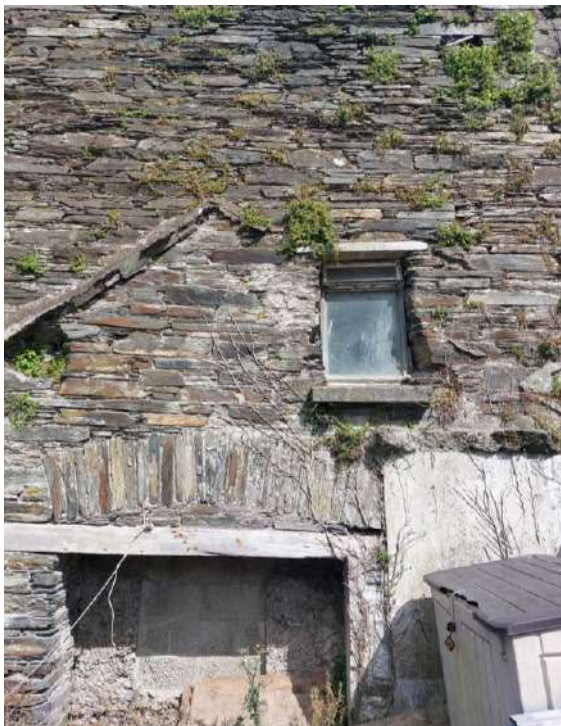
*Fig 3.21: View of west elevation with former roof line, former opening and modern window opening.*

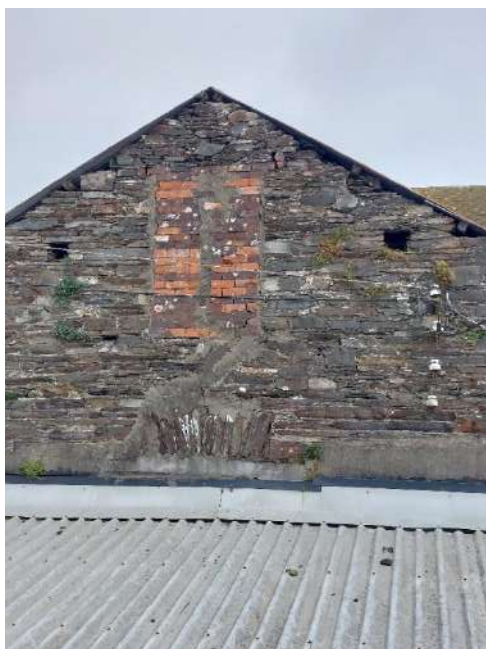
*Fig 3.22: South gable wall of south annex*

The south gable wall of the annex has an adjoining building up to first floor level. The top of a former opening is visible above the ridge line, which has a flat headed stone arch. There is moderate cracking visible centrally above this, with poorly installed cement over, possibly as an earlier attempt at a repair. There is a bricked up opening above this located centrally on the gable wall. There are bricks to the window head, with no visible lintel present. There is cracking visible above this, and the very top section of the gable appears to be unstable. There are two small openings to either side of this. The corrugated roof was added later and there is significant damage visible around the verges, with the masonry loose / missing in places and large gaps present between the stones and roof covering.

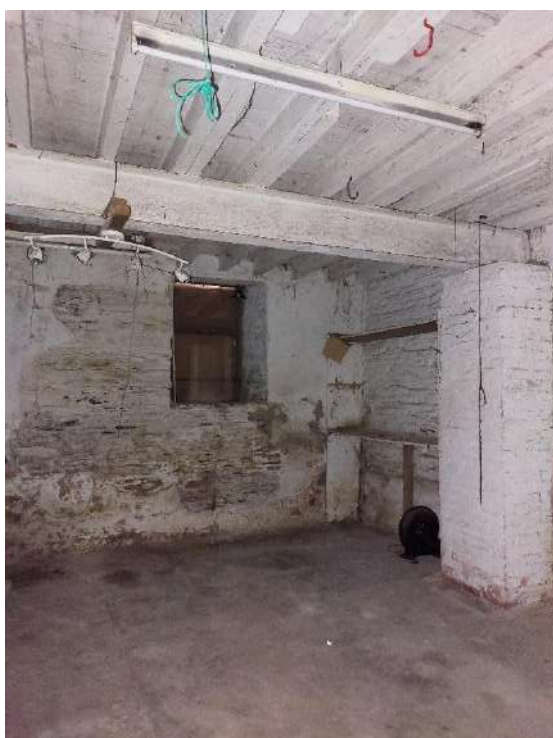
*Fig 3.26: Northeast corner of ground floor. Modern floor structure above supported on brick piers. Damp visible to walls.*

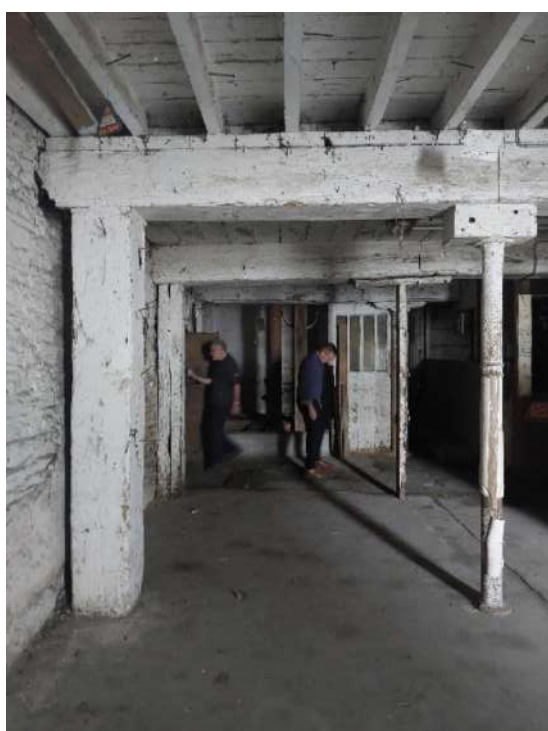
*Fig 3.28: View towards west. Original timber structure visible.*

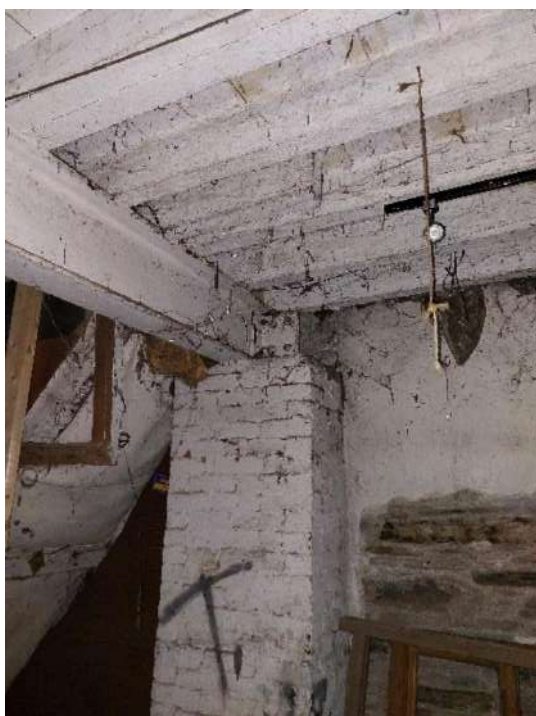
*Fig 3.30: Steel structure on brick piers to east end of ground floor*

The steel beams are supported by brick piers as previously described and do not have any additional support mid-span. The brick piers are in good condition. The timber beams are supported by a combination of timber, steel, and cast-iron posts, both along the span and adjoining the external walls. There is decay and woodworm visible to the timber sections, with one post (GF P13) being significantly eroded as a result of woodworm damage. While some surface corrosion is visible on the metal posts, they seem to be structurally sound.

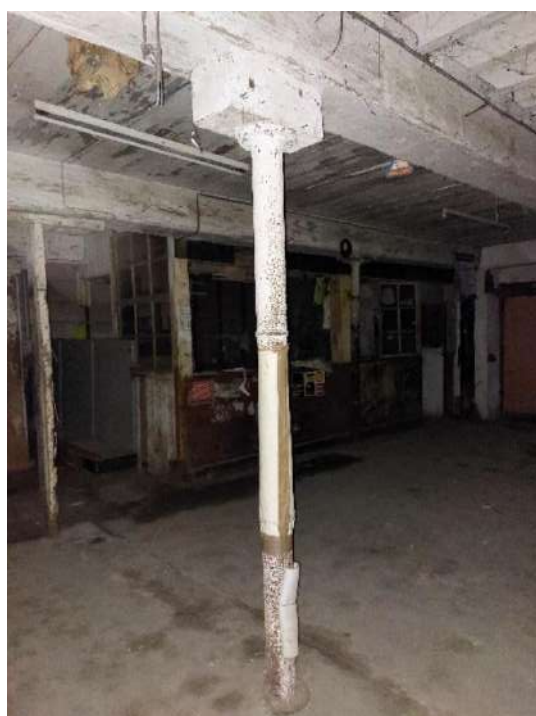
*Fig 3.31: Metal post supporting timber structure to west end of building.*

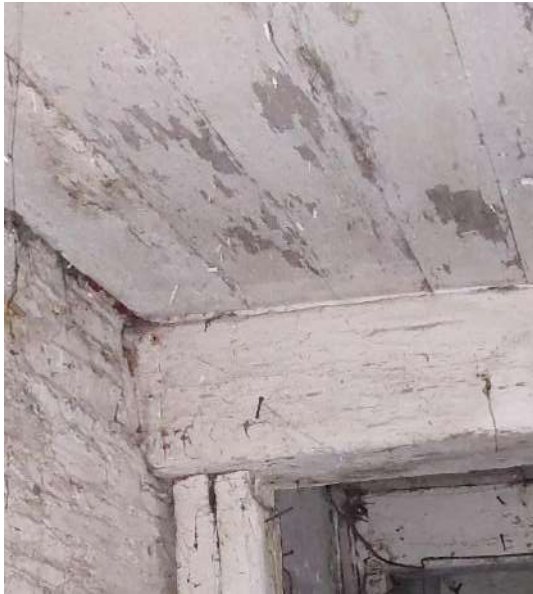
*Fig 3.32: Timber beam embedded in damp external walls to south side of main volume.*

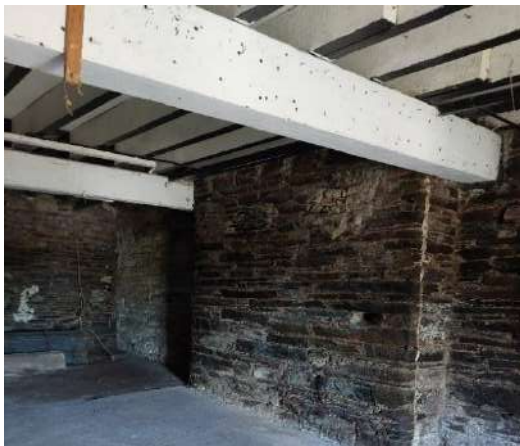
*Fig 3.33: View of chimney breast to west room with timber structure above.*

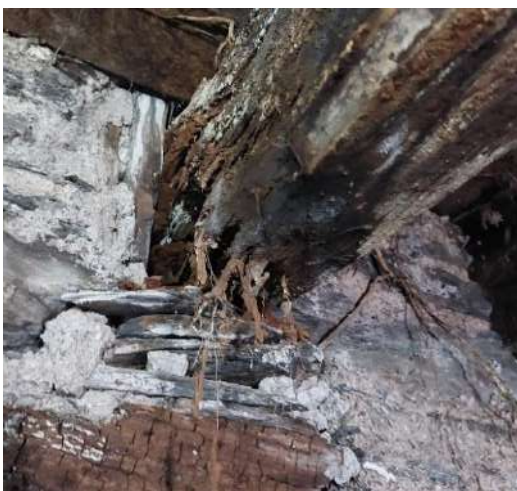
*Fig 3.34: Decayed joist ends in west room*

There are two timber beams spanning east-west in the west room of the ground floor (GF B1, B2). The structural engineer has indicated that these are in good condition. There are timber joists above this spanning north-south which measure approximately 275x75mm at 400 centres. The joist ends in this volume are in poor condition as a result of prolonged contact with damp walls and associated decay of the structure, especially to the south wall.

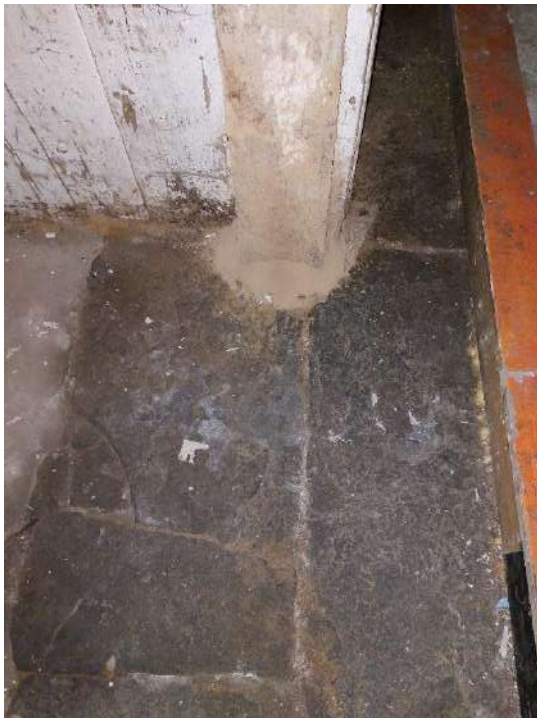
There is a section of floor towards the west of the main room centrally where flagstones are visible, and these are likely original. Slabs are also visible around the front door and in the former shop area.

*Fig 3.35: Flagstone to west and of main volume ground floor*

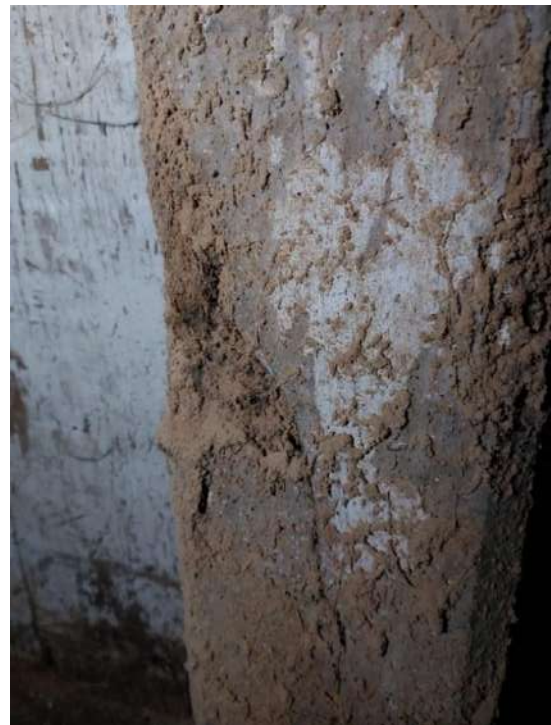
*Fig 3.36: Significant woodworm infestation to timber column*

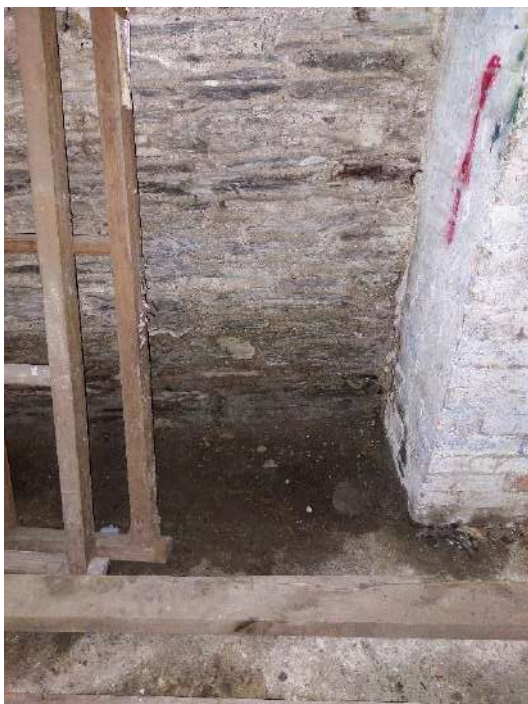
There is a concrete ground floor slab to the majority of the building, and this is in good condition, true and level and no sign of failure. There are signs of damp around floor level, especially along the north / east elevations and to the northeast corner where external ground levels are high. While no core was taken through the floor for analysis it is noted that it is very unlikely that a damp-proof membrane, radon barrier, or insulation is present in the floor. There is a similar floor present in the west room, and this finish slopes down towards the north doorway.

*Fig 3.37: Damp visible to ground floor slab and base of external walls*

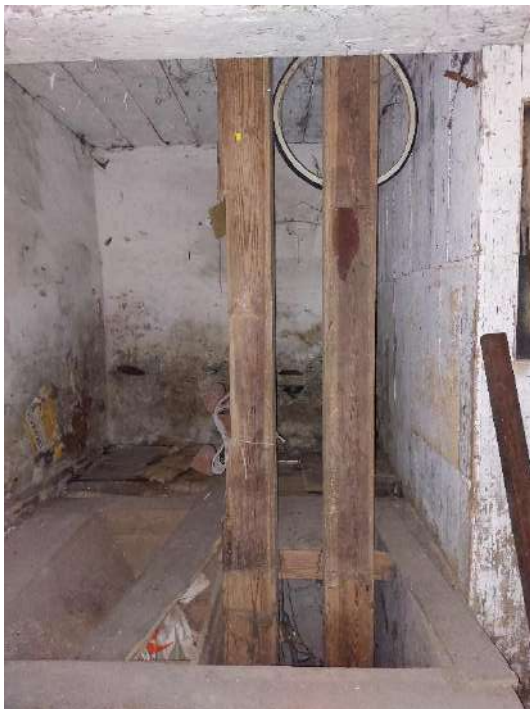
*Fig 3.40: Chutes to southwest corner of main volume. Damp to walls behind with mould visible.*

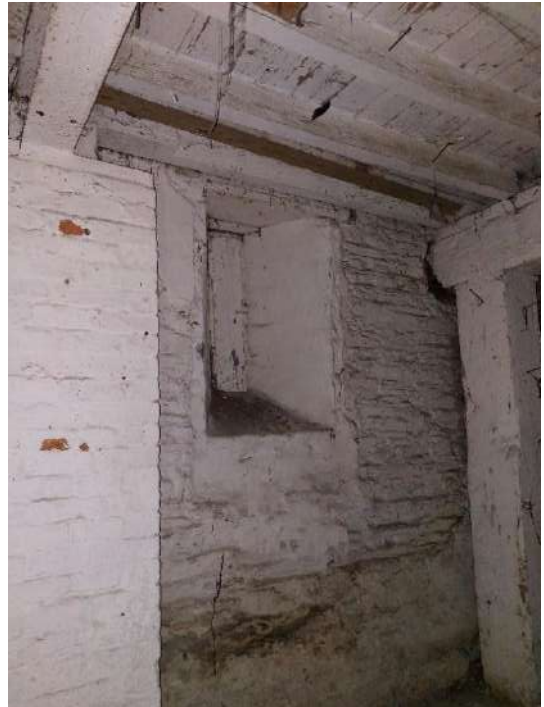
*Fig 3.42: Closed up window opening to south wall.*

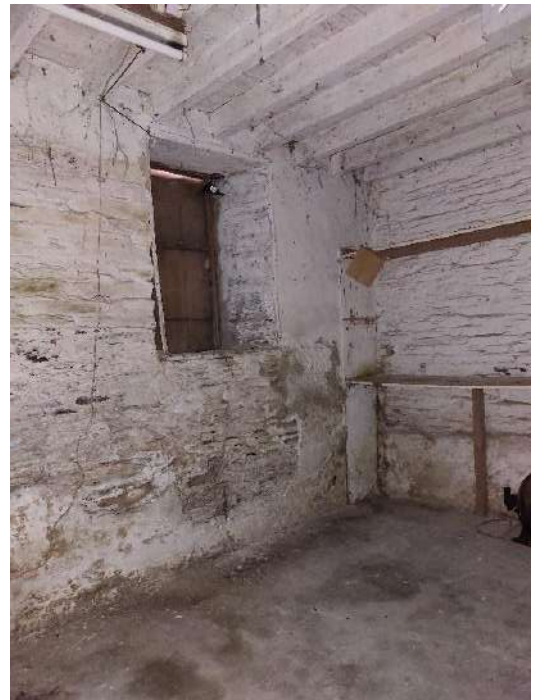
*Fig 3.44: Window opening to east wall. Damp visible to lower section of wall.*

The window and door lintels appear to be in reasonable structural condition, with no obvious signs of failure. The window towards the south (W1) has stone reveals and timber to the head and cill of the openings. The opening is boarded up externally. A window frame is present internally, which appears to be relatively modern. There is no glazing present. There is render intact to either side of the door, with the reveals likewise having a render finish. The door is a timber door with glazed panels and is relatively modern. The steps are concrete, with timber handrail with relatively chunky bannisters, curved volute, and swan neck detailing. The window to the north (W2) is covered in plastic sheeting internally. The cill and reveals are stone.

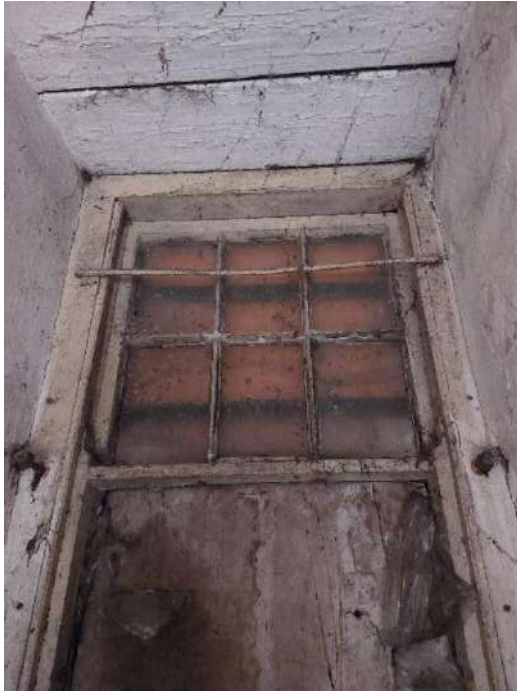
The windows to the north wall are boarded up externally. Internally, the three visible openings have window frames intact, with the window towards the east (W13) having a sash window. The bottom sash has horn details present, but has lost its glazing bars. The glazing bars are intact in the upper sash, subdividing it into six panes. It is noted that while the historic photographs of the building show vertically divided windows on the upper floors, the ground floor does appear to have sliding sash windows, and this window likely dates from the 1900s. The window reveal is splayed to the west side only, with the reveal to the east possibly being altered as part of the installation of the brick pier adjacent to this.

*Fig 3.47: Sliding sash window to north elevation towards east of building.*

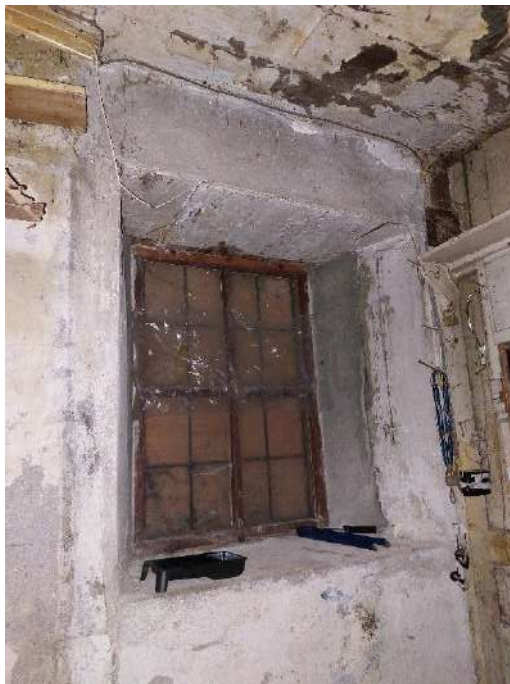
*Fig 3.48: Timber window to shop area (west of building) with concrete construction visible around opening.*

Elsewhere, the two windows to the west of the building have more modern sections present. These are four pane fixed windows fitted with bars externally. The lintels to all windows to the north elevation are timber. The one in the window towards the west (W6) is in a poor condition, with decay visible. The three other lintels appear to be in reasonable condition. The section of wall below W5 has been filled using concrete construction.
