# SKIBBEREEN STEAM MILL

## INFORMATION PACK

## INSPECTION REPORT

### Re: The Old Steam Mill, Skibbereen, Co. Cork.

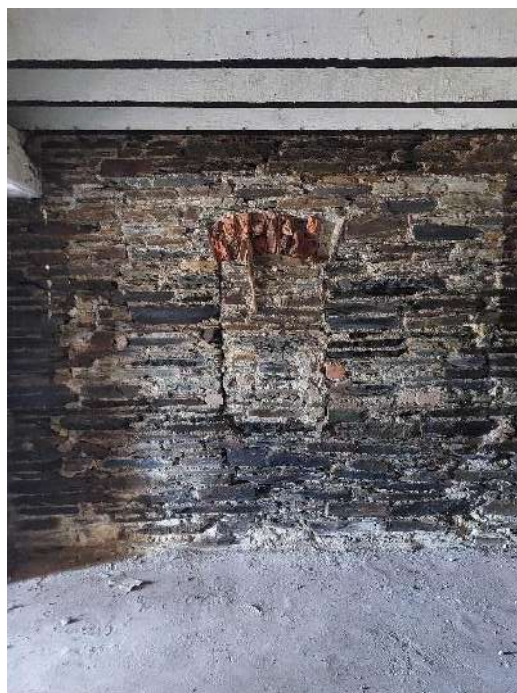
*Fig 3.511: Former window opening into main volume now filled in. Brick arch above with significant spalling visible.*

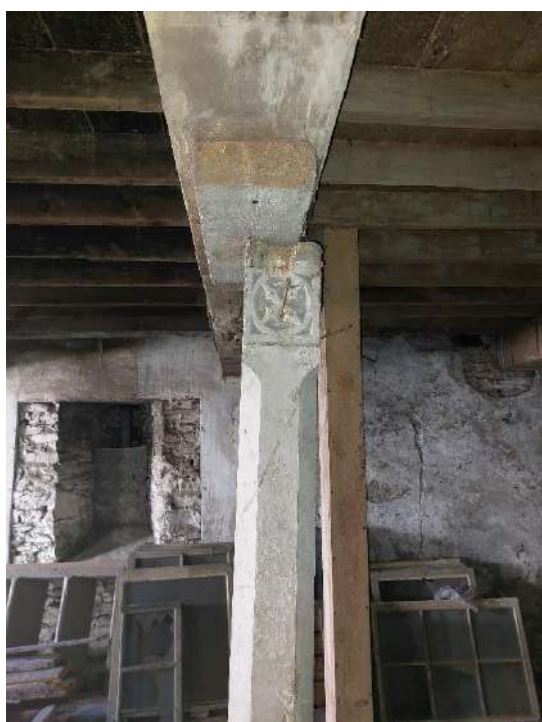
Fig 3.57: Misaligned column possibly from a church.

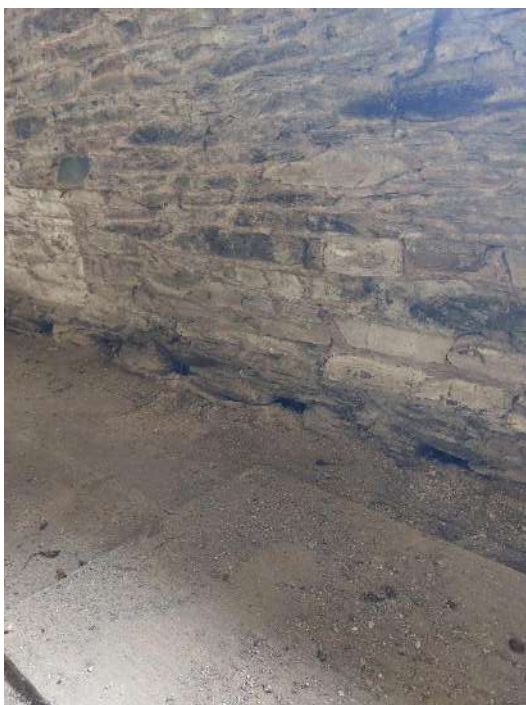
*Fig 3.58: Top of former putlog holes visible to east wall at floor level.*

The putlogs holes of a previous floor structure are visible in the east wall, providing evidence that this was slightly higher than the existing one. There is some cracking visible over these holes towards the north side of the east gable.

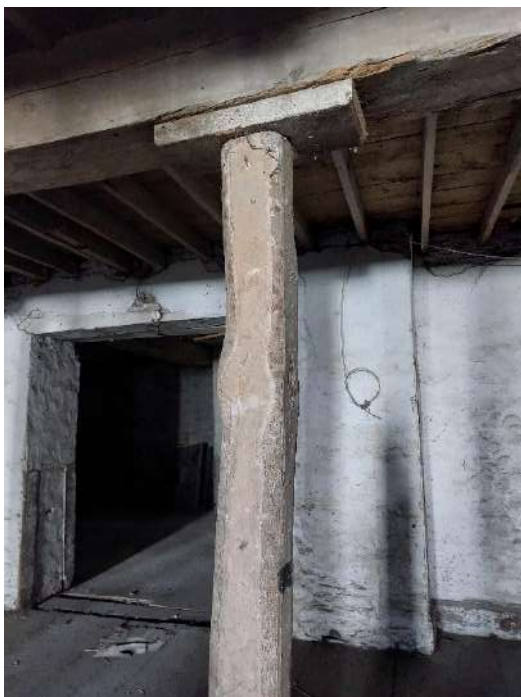
Each of the primary beams is supported by a two timber columns (SF P1-P10). There are a mixture of profiles present. Most of the columns match the size and detailing of those found on the upper floors, as described later in this report. It is assumed that these are original. Three columns (P1, P2, P10) are formed from simple tree trunks, one of which retains its rough bark finish (P1). One column (P3) has a decorative carved head, and it appears that it may have been taken from a church. This column is misaligned and not fully supporting the beam above. The columns generally have blocks placed at their heads and bases to spread the load. Many of the columns are affected by woodworm, and most have large vertical cracks, presumably associated with heavy loading of the structure.

*Fig 3.59: Column towards west formed by roughly hewn tree trunk with plate above visible.*

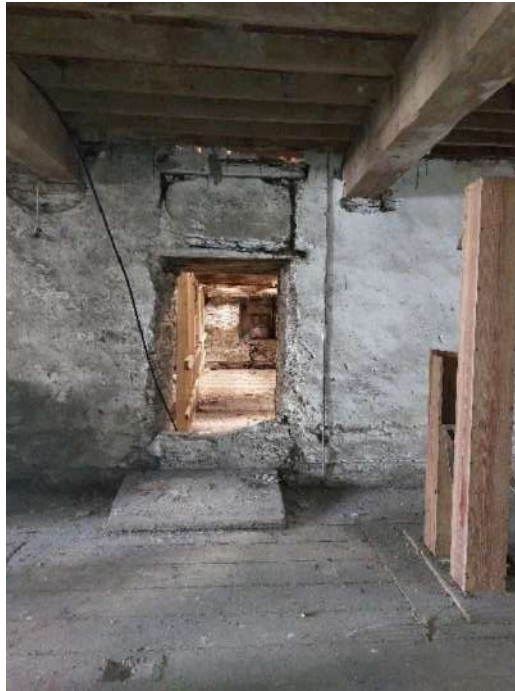
The walls to the south of the main room are painted plaster generally. The plaster finish is more intact toward the west of the building, with exposed stone present towards the east. There are two openings on this wall and a doorway provides access to the south annex second floor. This doorway has a timber lintel above, with an infill section of masonry between this and a higher imbedded lintel. The timber lintels have failed, and the infill section appears to be unstable. The opening does not extend to floor level, with a ramp present to provide access to the opening and the cill being formed with rough masonry. The former window opening to the south wall (FF W16) was a very narrow opening with plaster reveals and cill. It has been partially blocked up internally. It has a large timber lintel which is recorded by the structural engineer as being in poor condition.

*Fig 3.60: Door opening into south annex with failed lintel above.*

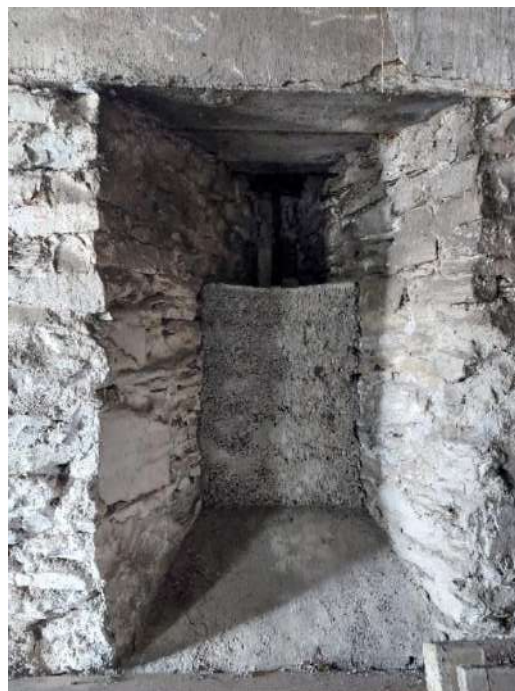
*Fig 3.61: Blocked up window opening to south wall.*

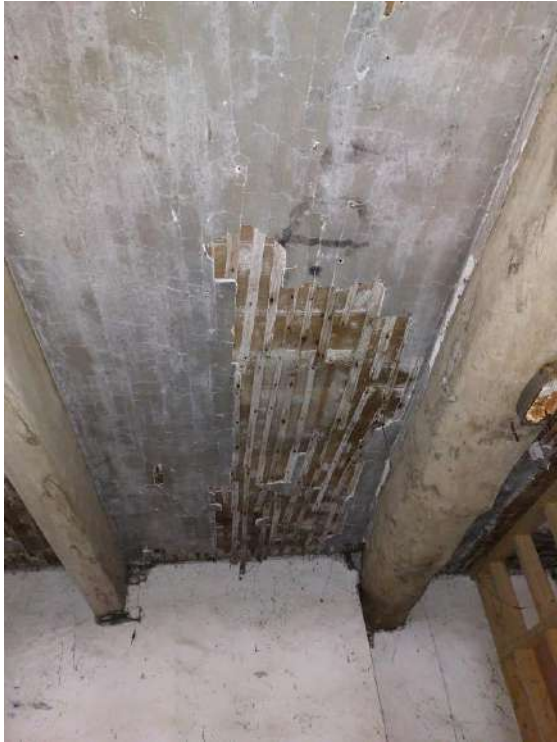
*Fig 3.64: View of ceiling in west room with lath and plaster visible.*

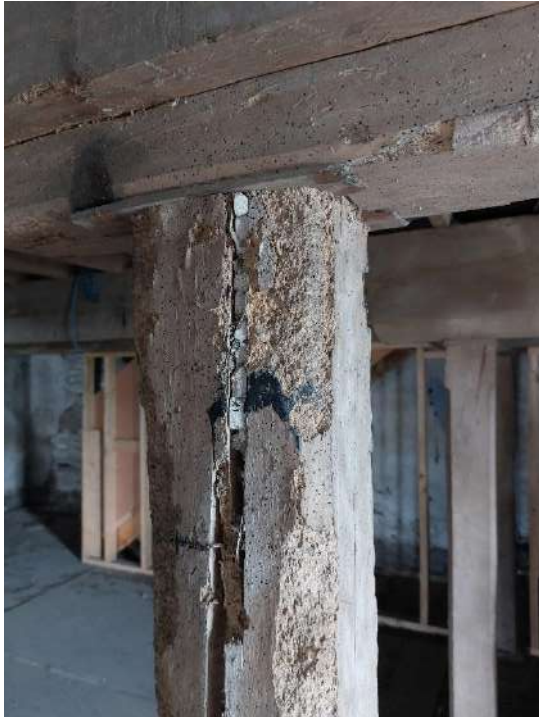
*Fig 3.69: Timber beam and column with woodworm damage visible*

The beams appear to be generally sound, although there are signs of woodworm visible throughout. Decay was noted in the B1 where it is embedded in the south wall. Significant woodworm was present in B2, significant woodworm and signs of decay where embedded in north wall noted in B5, very significant woodworm infestation in B6, with the outer edge having been eaten away in large parts. Notwithstanding issues with woodworm and decay, the structural engineer's written report has indicated that the beams and columns are in good condition on this floor.

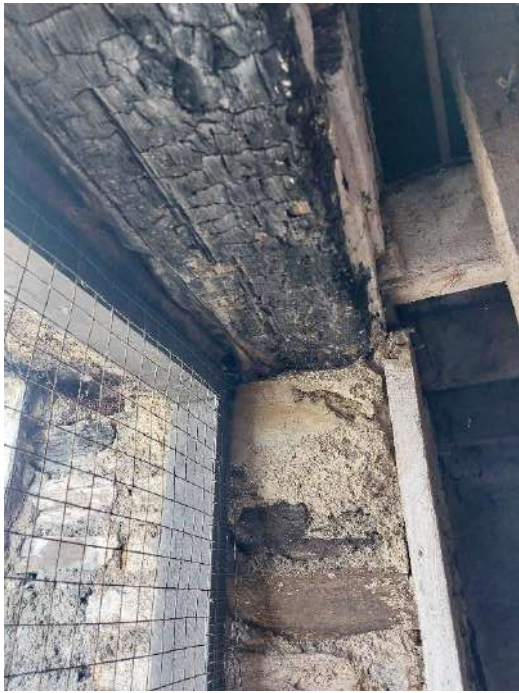
*Fig 3.72: Charred timber lintel in east wall*

The east gable wall has some patches of lime plaster intact, but it has failed to a large extent. There are three east facing windows. The one towards the south (SF W1) has a charred timber lintol internally, possibly evidence of an earlier fire in the building. The central window has a timber lintol in good condition (SF W2). The lintol to the northern most window (SF W3) is again badly charred, especially in the central section. However, the engineer's report has indicated that the lintol is in a good condition structurally. All three windows have a concrete render to the cill and masonry reveals.

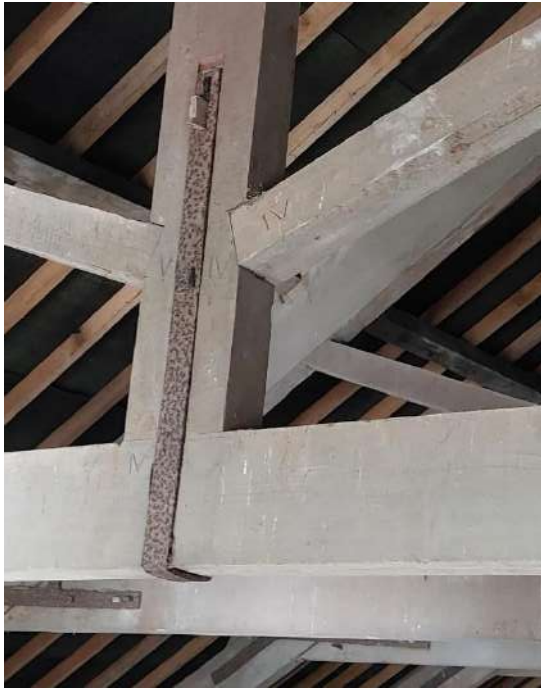
Fig 3.78: Timber truss with carpenter marks visible

The roof is supported by 7no. king post trusses which are original. The roof trusses are of a through bolted pitch pine construction. The structural engineer's report noted that the trusses appear to be in remarkably good condition for their age. They are suffering from some decay near external walls as a result of the original detailing here whereby the roof truss was embedded directly into the wall at the eaves and not constructed on a wall plate. On occasion the roof truss has been replaced and repaired in this area with the addition of a second roof truss base. Where it has been replaced shows no further signs of damage. There is evidence of woodworm, and one king truss in particular shows signs of deterioration. However, overall, the timber structure on this level appears to be less affected than the lower floors.

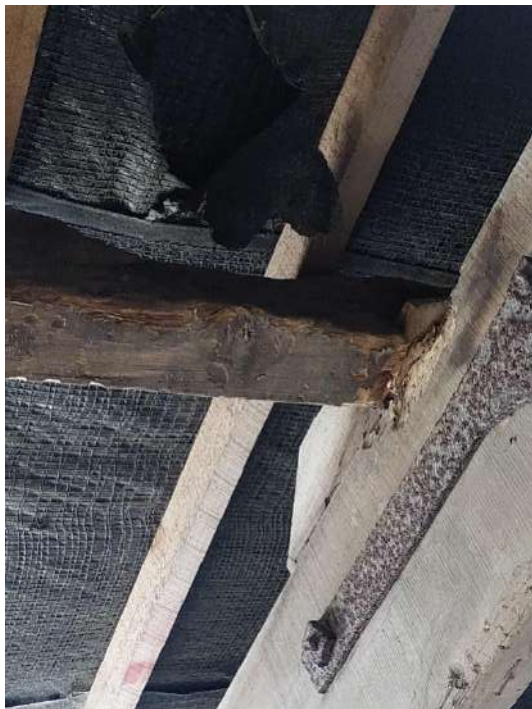
Fig 3.79: Decay visible to roof purlin

The trusses are in good condition and show no real sign of deterioration as a result of damp generally. Some decay was noted on truss reference 6, around the metal support bracket to the north side of the building. Decay of the roof purlin above was also visible in this location, possibly as a result of an earlier leak in this area. Decay was also noted to truss reference 3 where it met the south wall.

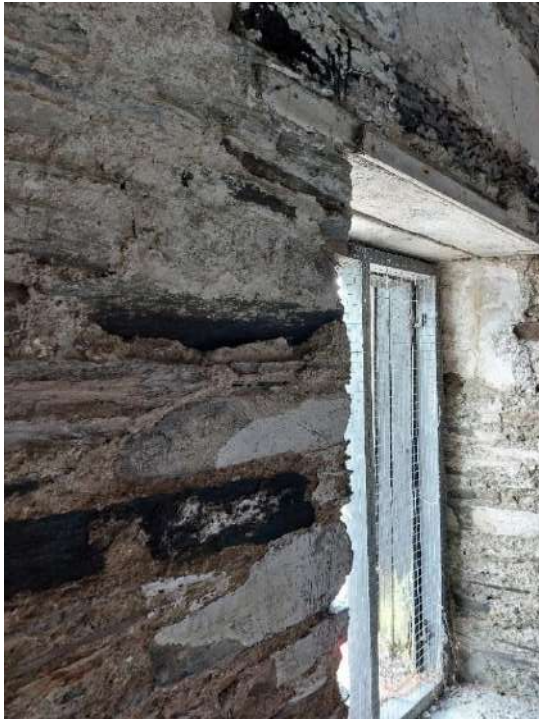
*Fig 3.82: View of east wall window opening*

The east gable wall has some patches of lime plaster intact, but it has failed to a large extent. The plaster has a large, visible aggregate. No major cracks were noted in this wall. There are three east facing windows (TF W1, W2, W3). With concrete cills and plaster reveals internally and stone cills externally. On the window towards the north (W3) and centrally (W2) there are narrow timber lintels present with larger sections above, and charring is visible to the higher ones. These lintels appear to be in reasonable condition. The window to the south was not accessible, but no charred section could be seen, and this lintel was recorded as being in poor condition by the structural engineer.

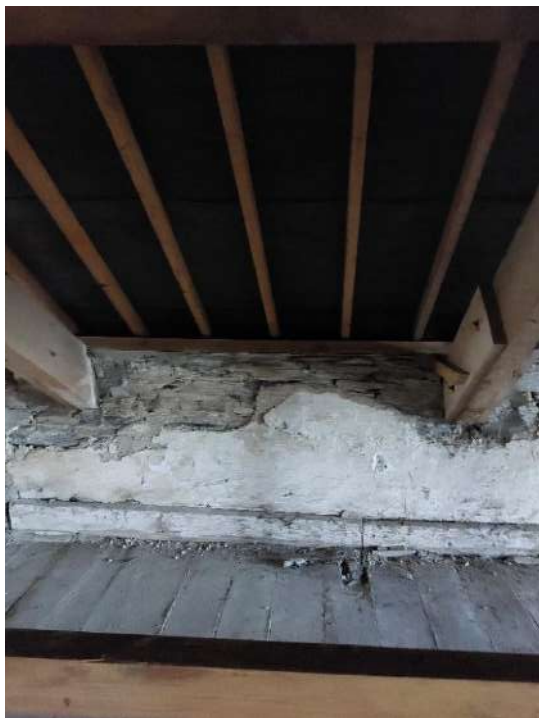
*Fig 3.83: View of north wall*

The north wall has quite a lot of the lime plaster intact although this is most likely damaged as a result of high moisture content in the walls. The plaster has been lost generally just below wall plate. The is more intact towards the east side of the building, with less present towards the west gable wall. There is a timber skirting present to the east side of the building, running from the east wall to truss 2.

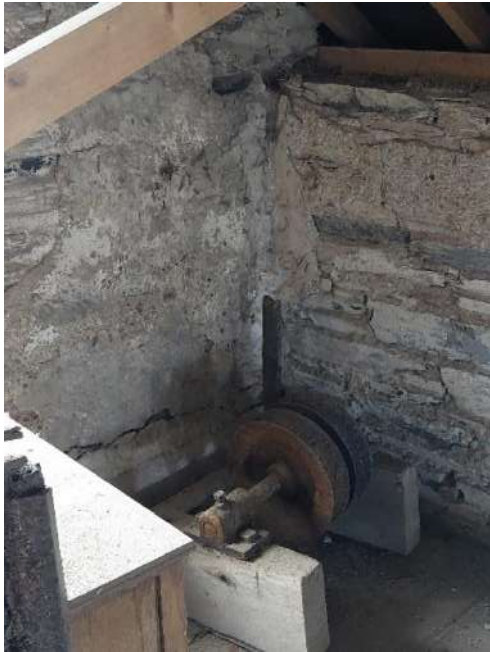
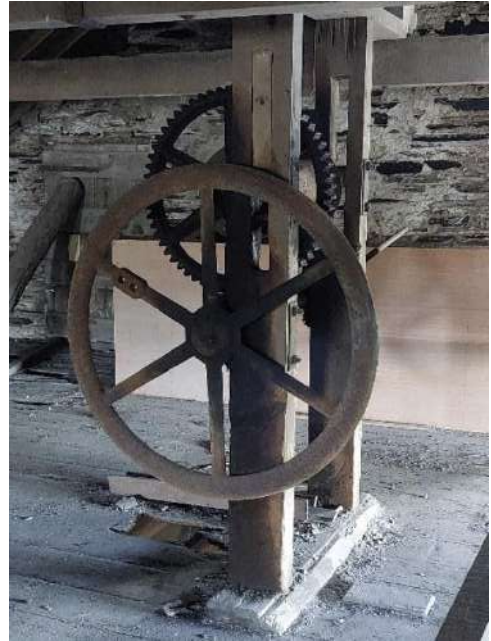
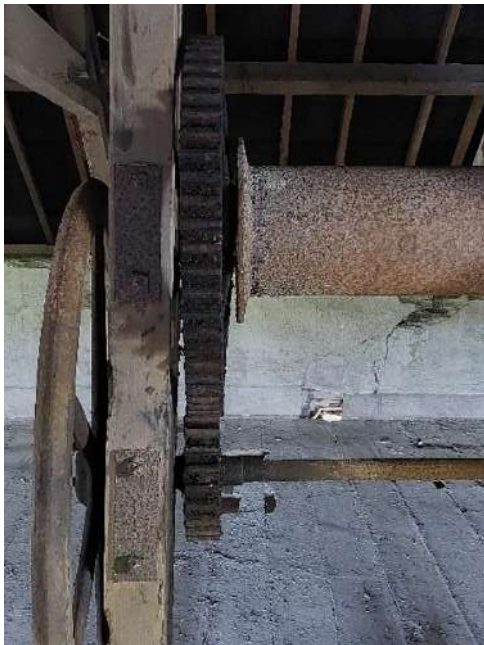
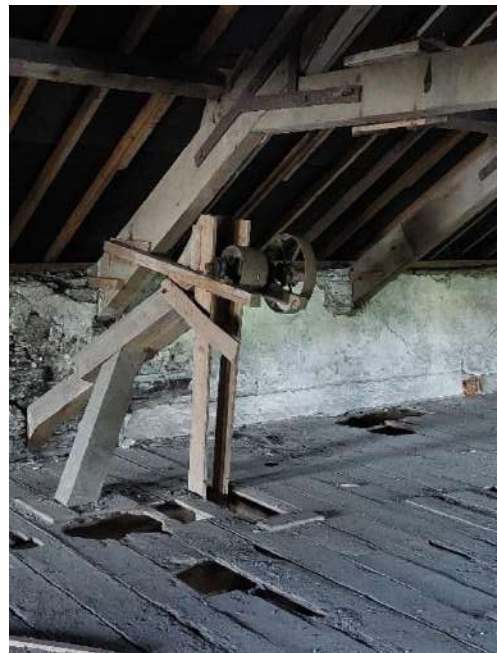
There are a number of items on the third floor (wheels, winches, belts etc) associated with the buildings former use as a mill. They form a part of the story of the building, referencing its industrial heritage. Their retention in situ should be considered as part of the proposed works.

*Fig 3.84-3.87: Photos of various items of machinery in the mill*

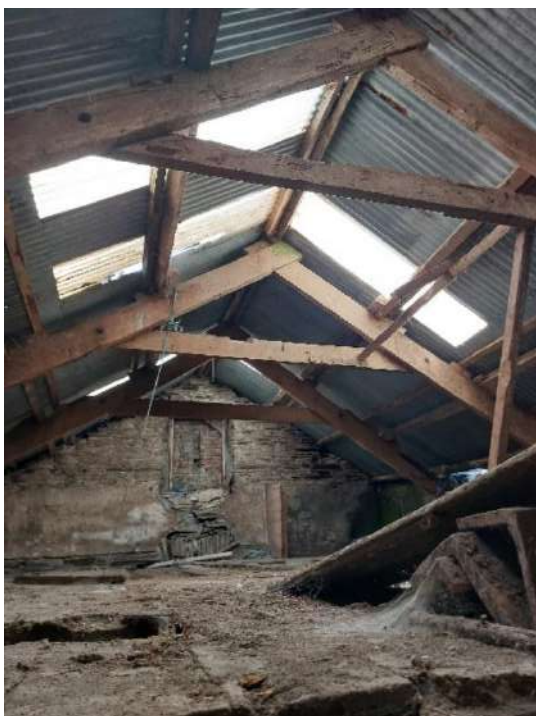
*Fig 3.89: Roof structure of south annex*

The roof trusses appear to be historic, and the structural engineer's report has indicated that approximately 50% of the truss is in poor condition due to damp and decay and will need to be replaced. The trusses are simple collar tie trusses with overlapping notched timbers to the apex. There are purlins running the length of the roof above, and again decay is visible to these sections. The corrugated finish sits directly above this. The finish is in poor condition and is allowing for some water ingress through the roof and should be replaced in its entirety. There is a modern steel support post running from roof to ground adjacent to the west wall.

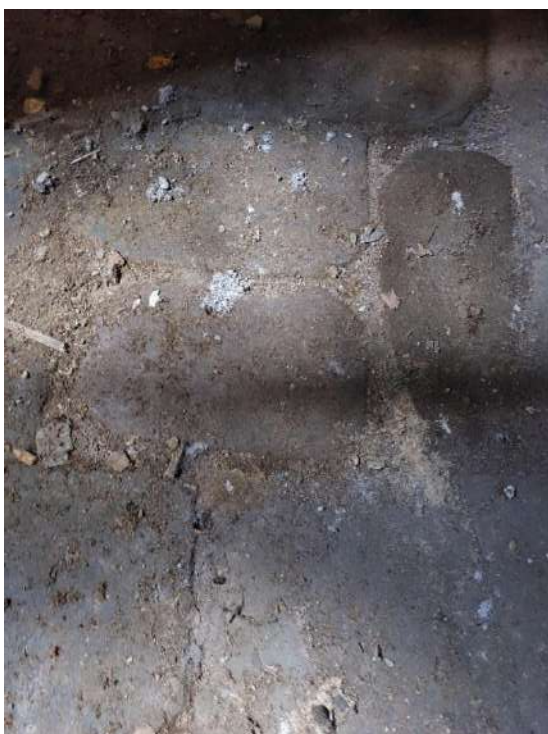
*Fig 3.90. Flagstone floor to south annex*

The ground floor covering consists of large flagstones which are most likely original to the building. There is a significant amount of damp visible at ground floor in the annex, and to the base of the external walls. Staining is visible to the floor and lower portion of the walls throughout. The external areas were not accessible around the annex, but it seems that they are higher than internal ones, with three steps up from ground floor to the external doorway (now blocked up) on the south gable wall.

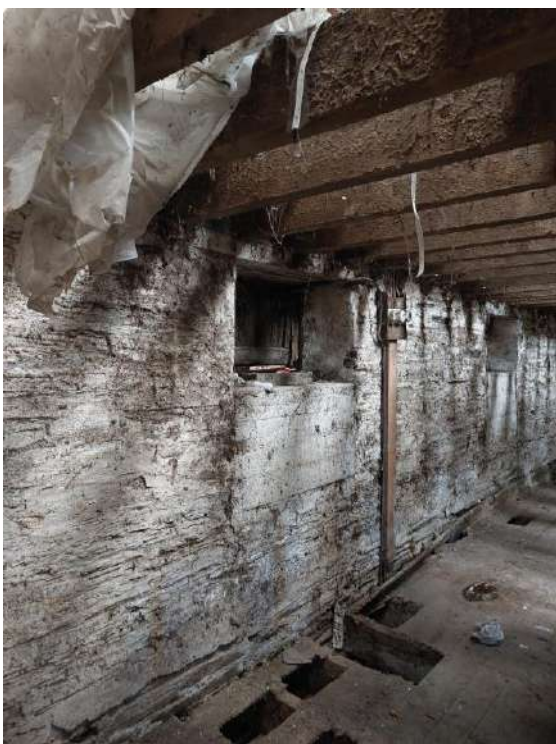
*Fig 3.94: View of east wall*

The east wall appears to be in better condition generally. The most notable issue visible on this wall is where it adjoins the main volume of the mill, with a gap visible between the two volumes which widens as it goes up, indicating that the annex is pulling away from the main volume. There are no ties between the two buildings, with the walls having been built independently of each other.

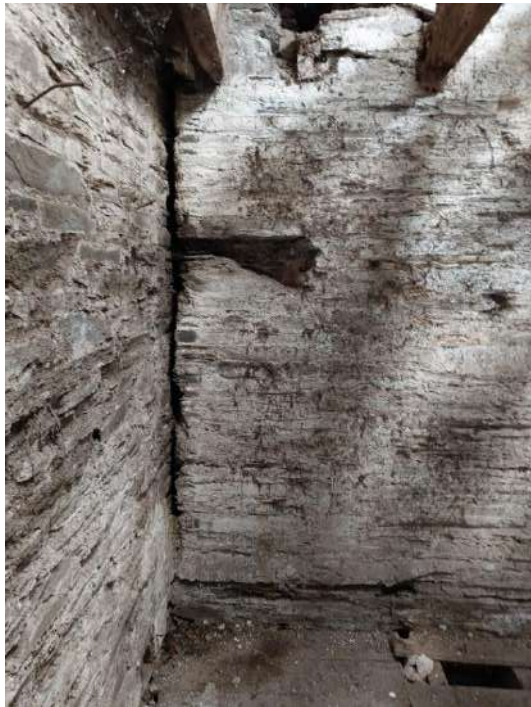
*Fig 3.95: Crack at first floor level between main volume and south annex*

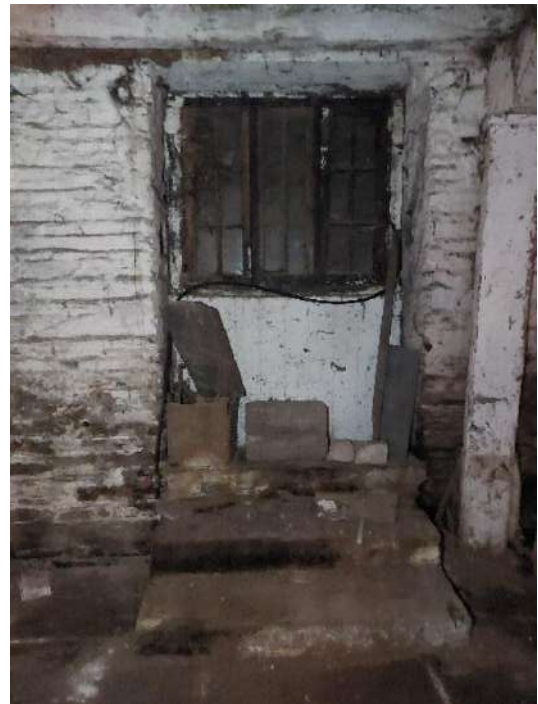
The south wall is rubble stone masonry throughout. Plaster is present to eaves level on the upper floor, but the stone is generally exposed elsewhere. There are three openings in the south wall, one centrally on each of the levels. There are steps up to the ground floor opening, which is blocked up at lower level with timber casement windows present above. There is a large timber lintel present which is in poor condition. The opening on the first floor has been closed up in blockwork to its external face. This timber lintel has failed entirely and broken along its span. There is significant cracking between the openings on both levels, with the masonry between the openings appearing to be unstable. The opening on the upper floor has been bricked up. The timber lintel to this opening has failed, and there is significant cracking visible to the apex of the gable wall above this, with loose masonry along the verge.

*Fig 3.96: Door opening in south gable wall of annex*

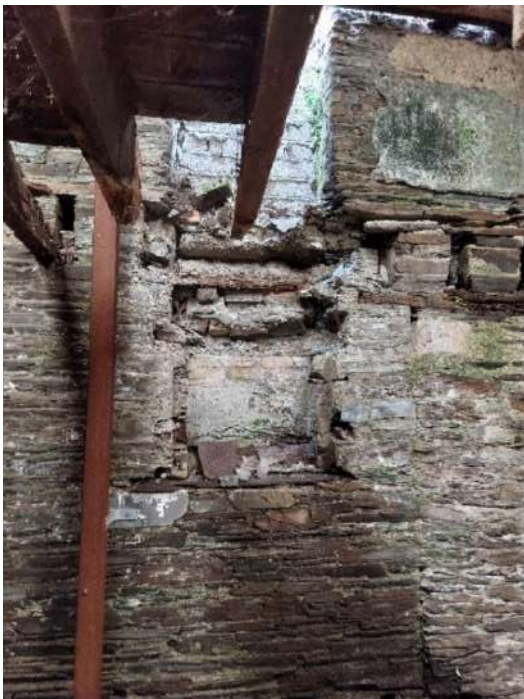
The opening towards the south side of the upper floor (W12) has been altered over the years, and there is a section of infill blockwork above this opening extending to eaves level. The window towards the main volume on this level (W11) has been partially blocked up internally, with the remnants of badly decayed shutters present internally. Significant deflection is visible to the timber lintel above, with cracking to the wall above the head. There is a significant amount of algae growth along the upper section of the west wall, especially adjacent to the south gable. While some lime render is intact it is badly deteriorated as a result of saturation of the building fabric. There are a number of putlog holes visible in the wall where the joist ends have failed. Overall the west wall is in a poor condition, and the structural engineer has suggested that consideration should be given to replacing it in its entirety.

*Fig 3.97: Opening / infill section in west wall with steel post visible*

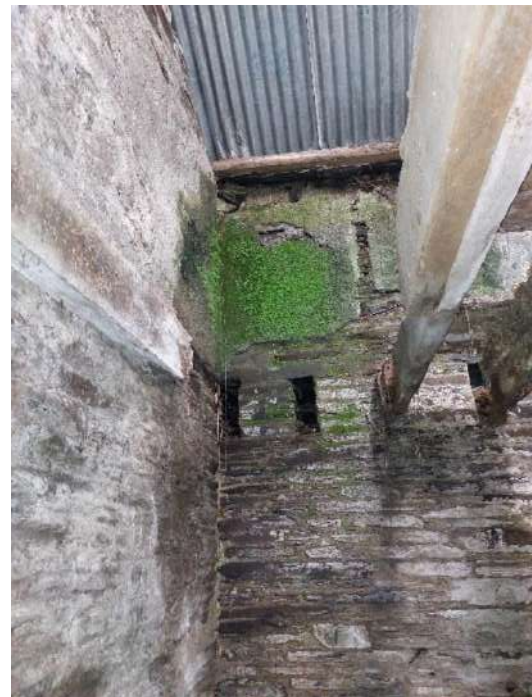
*Fig 3.98 Mould and algae growth visible on west wall*

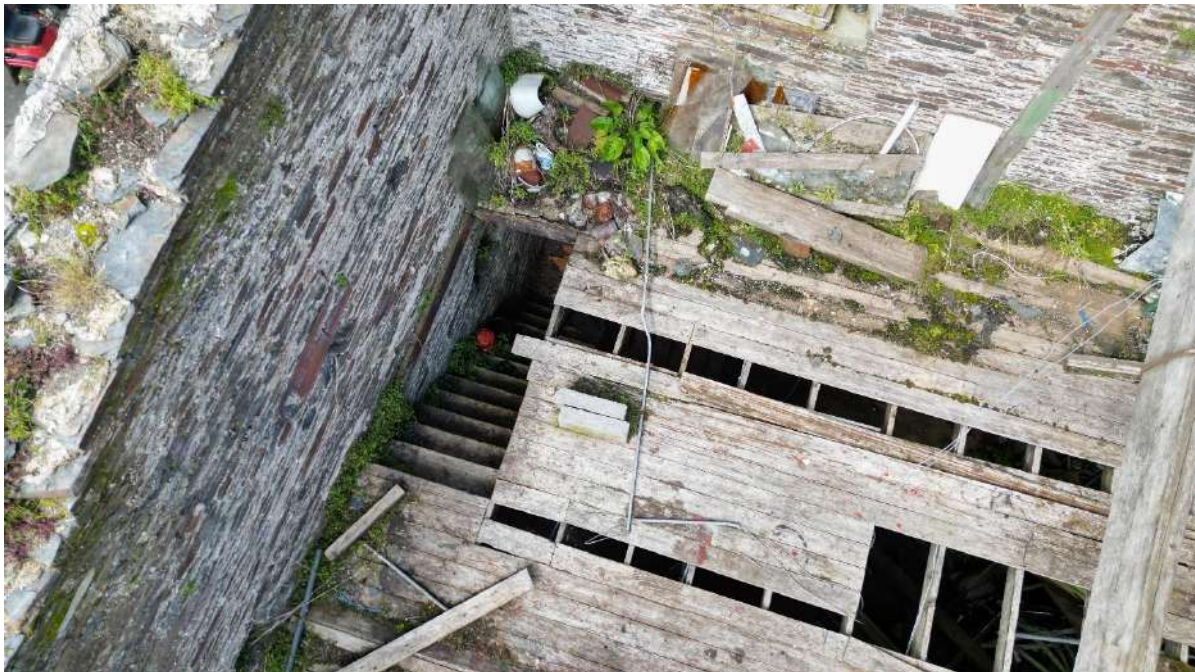
The interior of the west annex was inaccessible. The roof of this volume has failed, and it has been open to the elements to a prolonged period of time, resulting in the complete degradation of the interior fabric. This could be seen from drone footage, with a timber floor structure with joists spanning east-west visible, along with timber floorboards and a timber stair to the north-west corner. It is assumed that this building will be stripped in its entirety as it is unlikely that any original floor structure etc. will be in a fit condition for retention.

*Fig 3.99. Northwest corner with stairs visible*

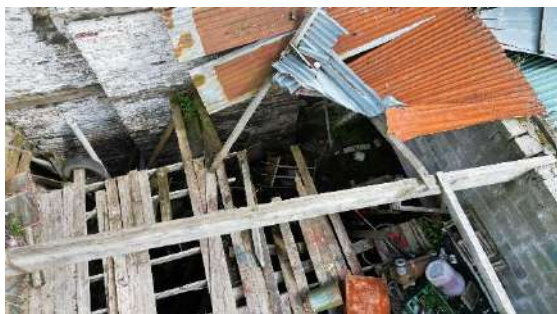
*Fig 3.100. South east corner with remains of corrugated roof structure*

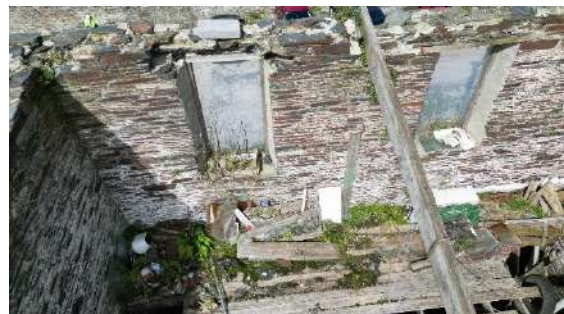
*Fig 3.101: Window opening to north wall*

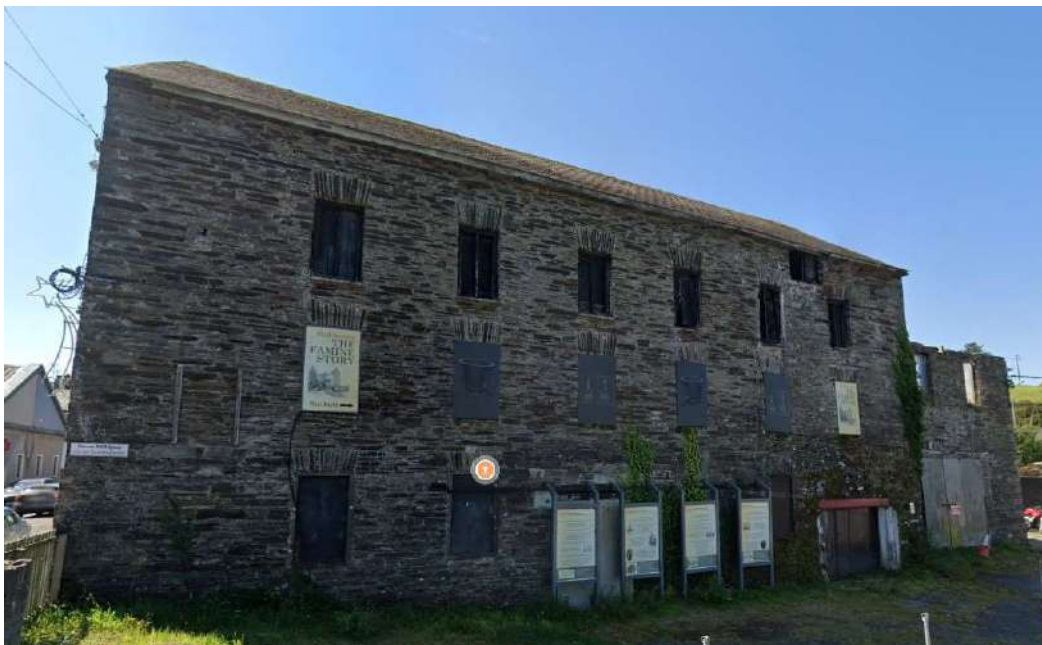
*Photo 2 – Main mill warehouse north elevation*

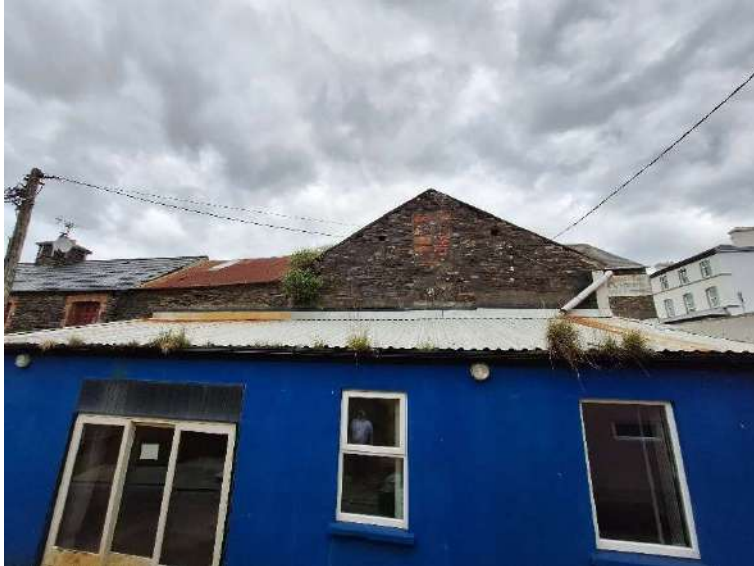
*Photo 3 – Gable of southern annex behind blue building*

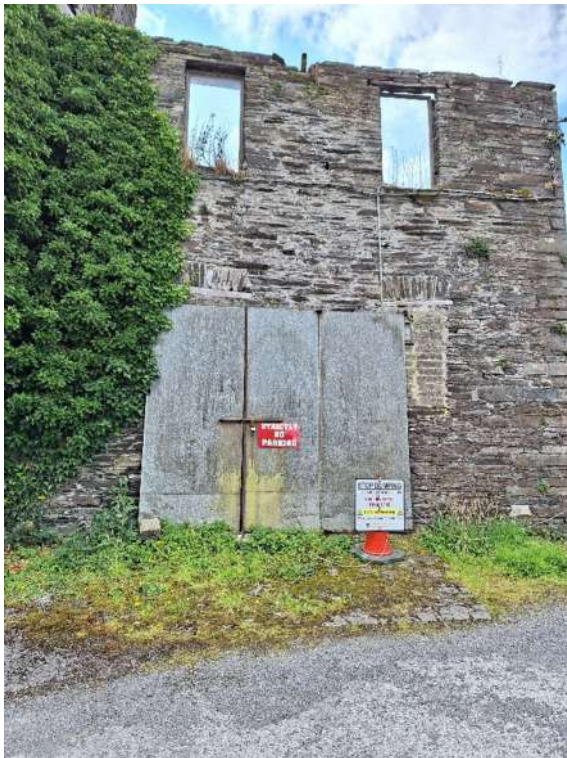
There is an annex to the west, of which only part of the external walls remain and is effectively derelict.

*Photo 4 – West Annex*

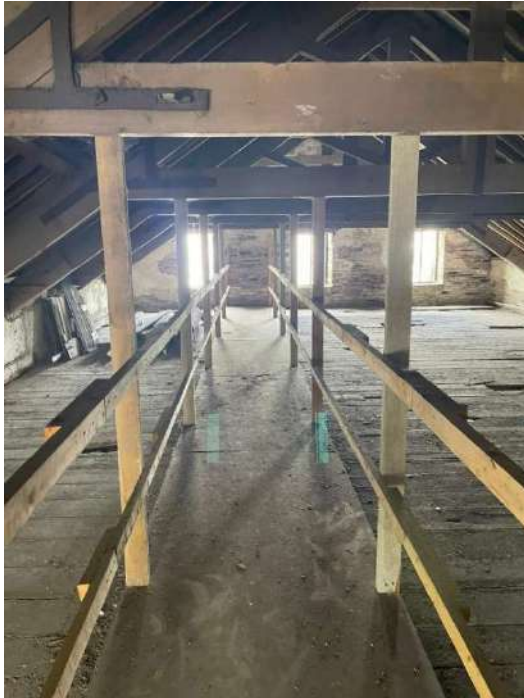
On the third floor the floorboards are in extremely poor condition suffering from damp and dry rot and need to be replaced in their entirety. The joists beneath the floorboards wall are in extremely poor condition need to be replaced in their entirety.

*Photo 15 – Third floor*

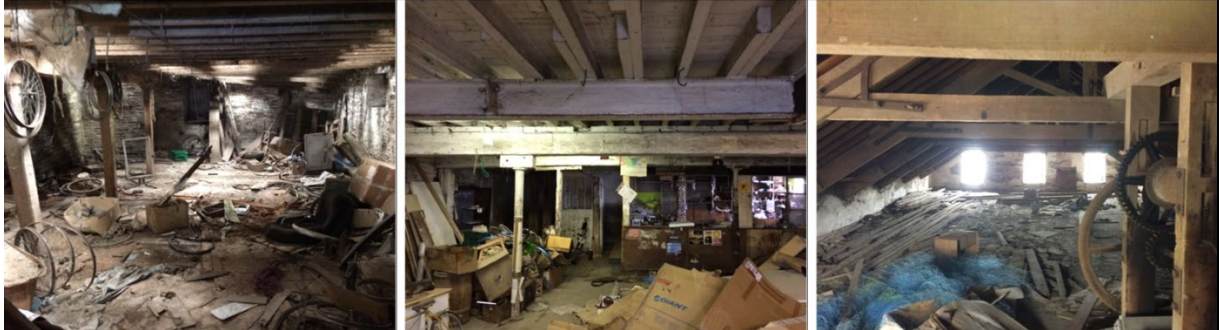
Internally, the building is of solid construction, with large thick stone and concrete rendered painted walls. A mix of large wooden pillars and metal and wooden joists were noted. Ceilings are largely exposed, with wooden rafters supporting the next storey floor boards. The top floor of the structure offers some bat roosting potential. The roof structure is a king post roof with large exposed wooden braces, rafters and purlins. Slate tiles are largely underlain with felt. (**Photographs 2 - 4**).

**Photograph 2 – 4: Internal view of the building. Note the large amount of waste material and the natural light penetrating the top floor.**

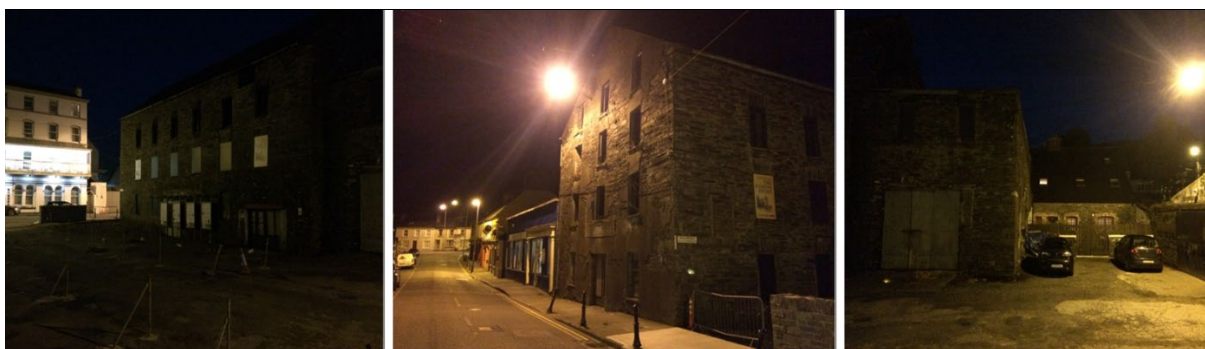
It is noted that due to the location of the development site, which is situated within a urbanised area, is lit by street lighting, security lighting, amenity lights and passing vehicle head lights (**Photograph 5 - 7**).

**Photograph 5 - 7: Shows street lighting including attached to the building, resulting in illumination and light spill of the proposed development site.**

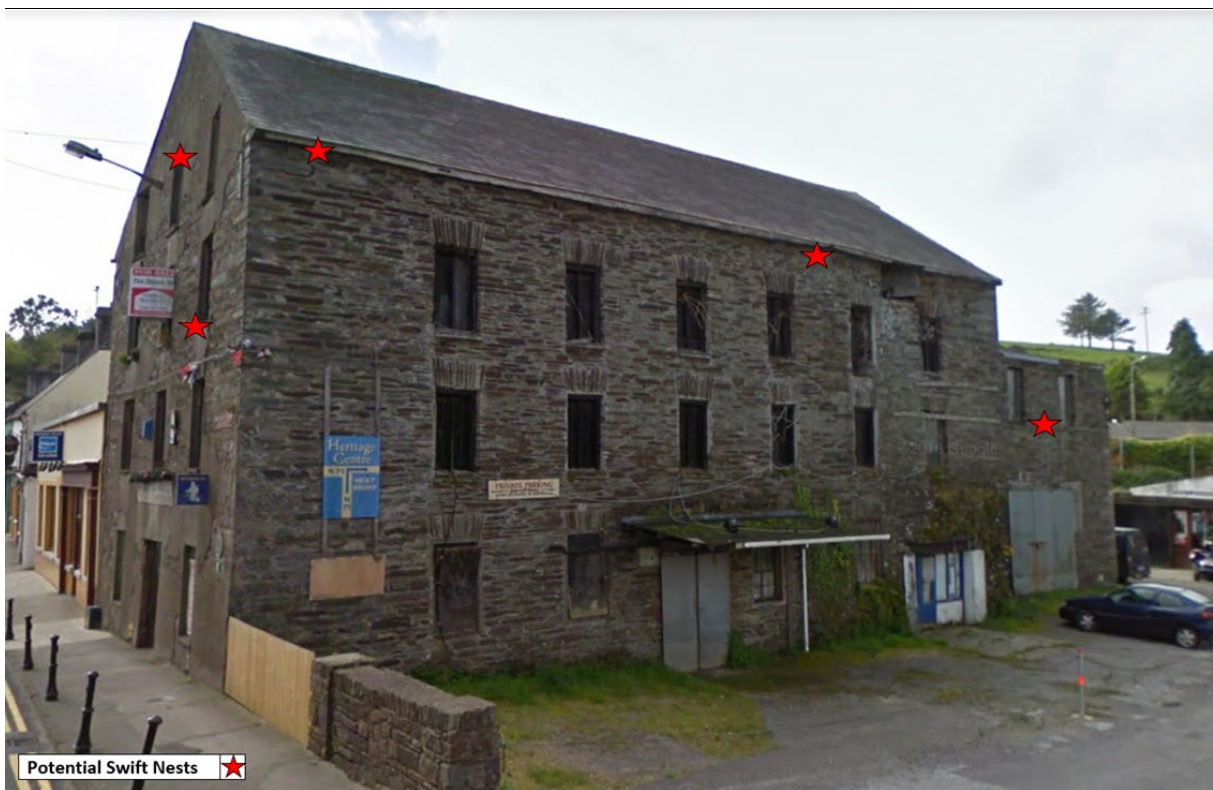
A total of fourteen Swifts were noted at any one time, forming screaming parties. Based on observations it was determined that 5 to 6 nests exist within the building (**Figure 3**). These nests are concentrated along the northern and eastern face of the building. Potential nests were noted within gaps in stone work near the eaves of the building and within the main wall structure. Further nests were noted within the gaps in a window frame to the east of the building and within a gap in the stone work below a window frame. A dead swift was also found within the building.

**Figure 3: Location of potential Swift nests.**
