**Windows Restoration Works at Ormonde College,  
Ormonde Road, Kilkenny for Kilkenny and Carlow Education and  
Training Board**

**WINDOW CONDITION SURVEY AND SCHEDULE OF  
WORKS**

**August 2024**

**Job No. 23085**

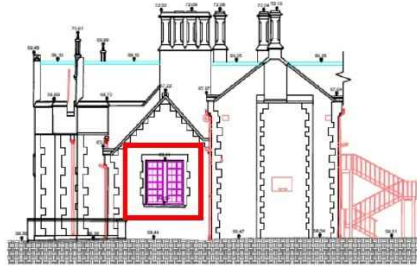
G01 (1no window)

**Condition:** Glazing putty is cracked; paint to frame and sashes is flaking/missing in areas; decay in frame and sash at cill; gaps around frame.

**Recommendations:** Replace decayed sections of timber cill and bottom rail; re-use existing glazing and re-putty all glazing; strip, prime, undercoat and repaint frame and sashes, internally and externally; re-draught-proof with new draught seals; adjust sash cords & weights and replace where necessary; maintain and clean all ironmongery, reinstate lime mortar seal to gap around window frame.

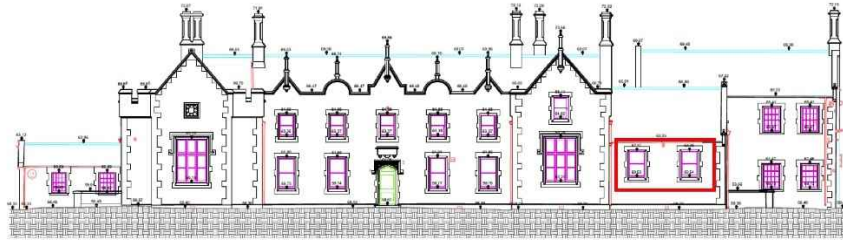
G02 and G03 (2no windows)

**Condition:** Glazing putty is cracked; paint to frame and sashes is flaking/missing in areas; previously repaired with decay in frame and sash at cill; lime mortar pointing around frames poor.

**Recommendations:** Replace decayed sections of timber cill and bottom rail; re-use existing glazing and re-putty all glazing; strip, prime, undercoat and repaint frame and sashes, internally and externally; re-draught-proof with new draught seals; adjust sash cords & weights and replace where necessary; maintain and clean all ironmongery, reinstate with new lime mortar seal to gap around window frame.

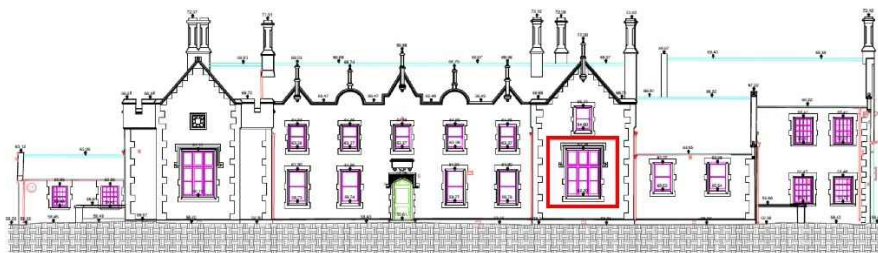
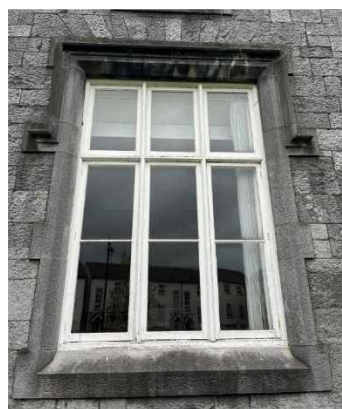
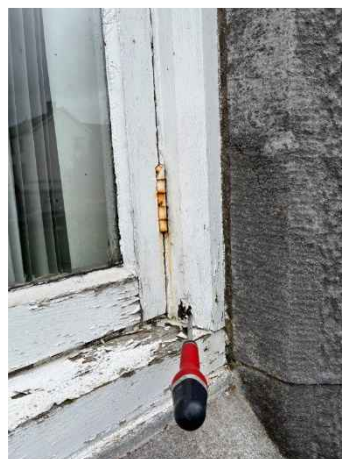
Window G04

**Condition:** Wind-blown water ingress causing damage to interior; glazing putty is cracked; paint to frame and sashes is flaking/missing in areas; decay in frame and sash at cill; corrosion of hinges to opening sashes; large gaps around frame.

**Recommendations:** Replace decayed sections of timber cill and bottom rail; re-use existing glazing and re-putty all glazing; strip, prime, undercoat and repaint frame and sashes, internally and externally; re-seal and draught-proof with new seals; replace corroding hinges; maintain and clean all ironmongery, reinstate lime mortar seal to gap around window frame.

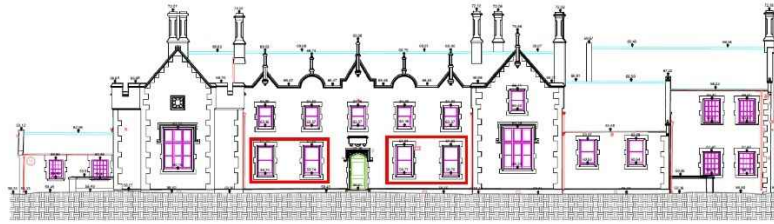
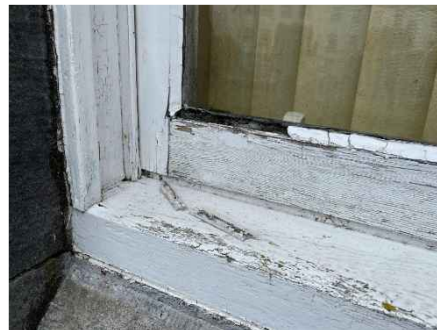
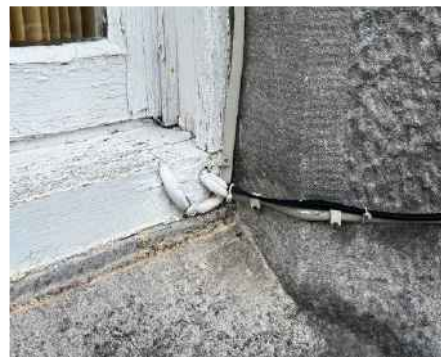
G05, G06, G07 and G08 (4no windows)

**Condition:** Glazing putty is cracked and missing in areas; paint to frame and sashes is flaking/missing in areas; significant decay in some frames and sashes at cill; ironmongery poor in some areas.

**Note:** Electrical cables penetrate corner of window frame.

**Recommendations:** Replace decayed sections of timber cill and frame; re-use existing glazing and re-putty all glazing; strip, prime, undercoat and repaint frame and sashes, internally and externally; re-draught-proof with new draught seals; adjust sash cords & weights and replace where necessary; maintain and clean all ironmongery and replace where damaged; reinstate with new lime mortar seal to gap around window frame.

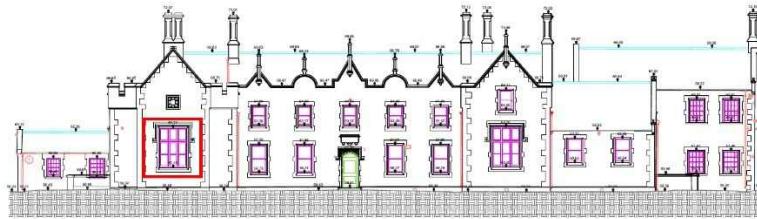
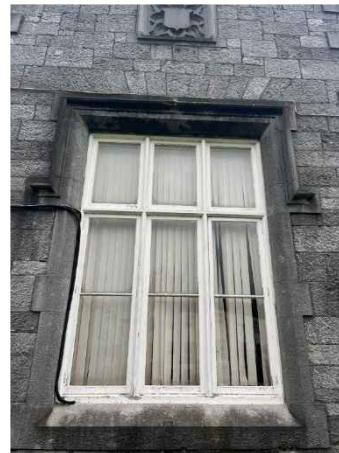
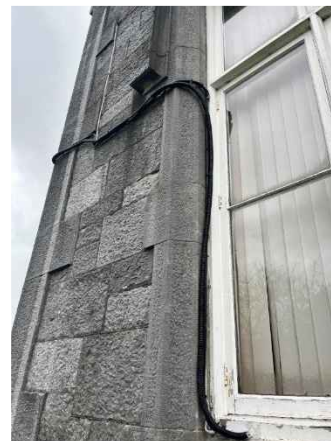
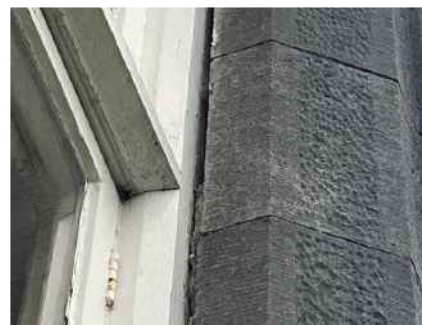
Window G10

**Condition:** Glazing putty is cracked; paint to frame and sashes is flaking/missing in areas; slight decay in frame at cill; corrosion of hinges to opening sashes; large gaps around frame.

**Note:** Electrical cables penetrate corner of window frame.

**Recommendations:** Repair or replace decayed sections of timber frame, as necessary; re-use existing glazing and re-putty all glazing; strip, prime, undercoat and repaint frame and sashes, internally and externally; re-seal and draught-proof with new seals; replace corroding hinges; maintain and clean all ironmongery, reinstate lime mortar seal to gap around window frame.

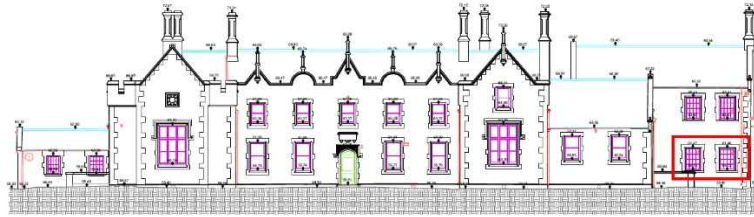
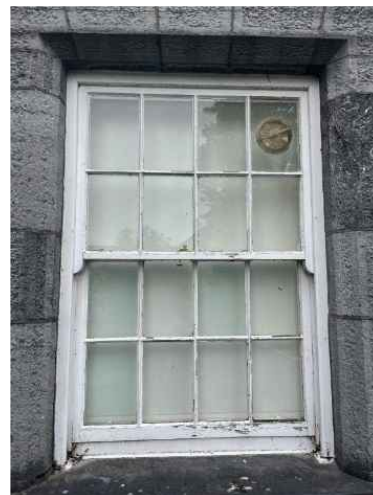
G46 and G47 (2no windows)

**Condition:** Glazing putty is cracked; paint to frame and sashes is flaking/missing; decay in frame and sash at cill; corrosion of nails to frame cover slips (G47), gaps around frame.

**Recommendations:** Replace decayed sections of timber cill and bottom rail; re-use existing glazing and re-putty all glazing; strip, prime, undercoat and repaint frame and sashes, internally and externally; re-seal and draught-proof with new draught seals; adjust sash cords & weights and replace where necessary; maintain and clean all ironmongery, reinstate lime mortar seal to gap around window frame.

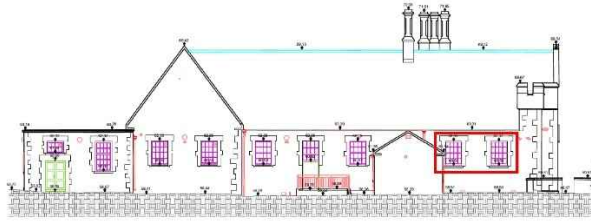
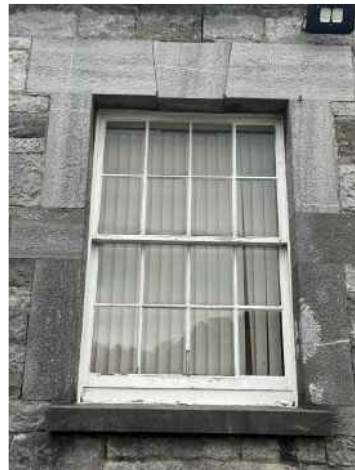
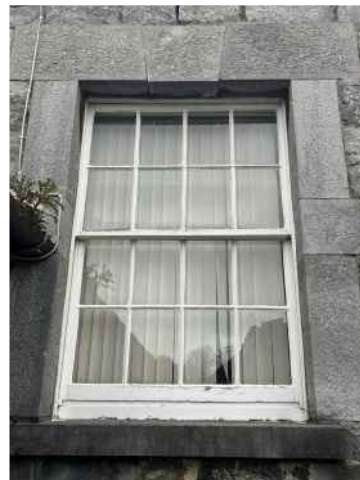
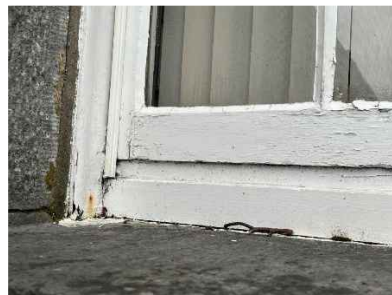
G11 and G12 (2no windows)

**Type:** 8 over 8 timber-framed, single-glazed, vertical sliding sashes, painted white.**Condition:** Glazing putty is cracked and missing in areas; paint to frame and sashes is flaking/missing; decay in frame and sash at cill; corrosion of nails to frame cover slips, lime mortar seal around frame cracked.**Recommendations:** Replace decayed sections of timber cill and bottom rail; re-use existing glazing and re-putty all glazing; strip, prime, undercoat and repaint frame and sashes, internally and externally; re-draught-proof with new draught seals; adjust sash cords & weights and replace where necessary; maintain and clean all ironmongery, reinstate lime mortar seal to gap around window frame.

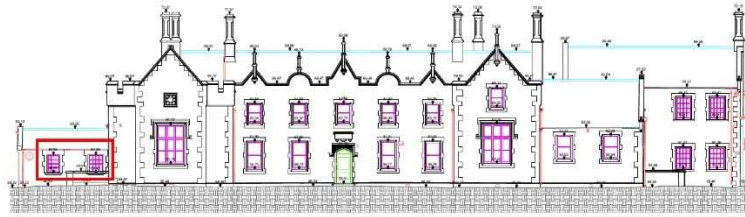
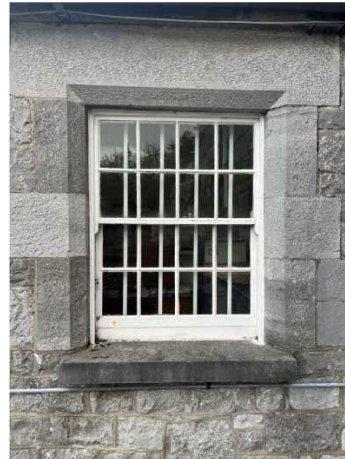
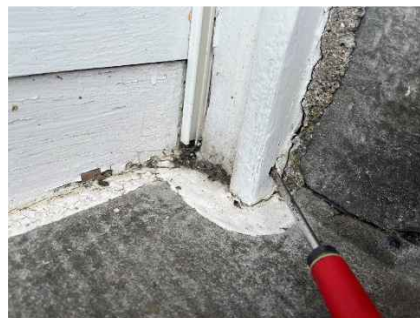
G13 and G14 (2no windows)

**Condition:** Glazing putty is cracked and missing in areas; paint to frame and sashes is flaking/missing; decay in frame and sash at cill; mid-rail detaching from frame; lime mortar seal around frame cracked.

**Note:** Electrical cable penetrates corner of G14 window frame.

**Recommendations:** Replace decayed sections of timber cill and bottom rail; re-use existing glazing and re-putty all glazing; strip, prime, undercoat and repaint frame and sashes, internally and externally; re-seal and draught-proof with new draught seals; adjust sash cords & weights and replace where necessary; maintain and clean all ironmongery, reinstate lime mortar seal to gap around window frame.

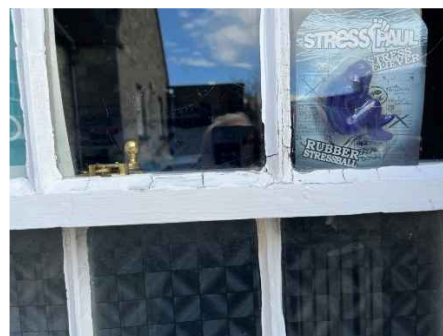
G15 (1no window)

**Condition:** Glazing putty is cracked and missing in areas; one damaged glass pane; paint to frame and sashes is flaking/missing; decay in frame and sash at cill; mid-rail detaching from frame; lime mortar seal around frame cracked.

**Note:** Electrical cables penetrate the two top corners of the window frame.

**Recommendations:** Replace decayed sections of timber cill and bottom rail; re-use existing glazing and re-putty all glazing; replace cracked glass pane; strip, prime, undercoat and repaint frame and sashes, internally and externally; re-seal and draught-proof with new draught seals; adjust sash cords & weights and replace where necessary; maintain and clean all ironmongery, reinstate lime mortar seal to gap around window frame.

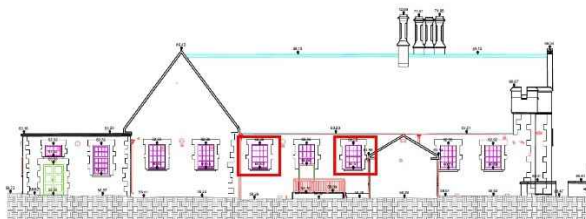
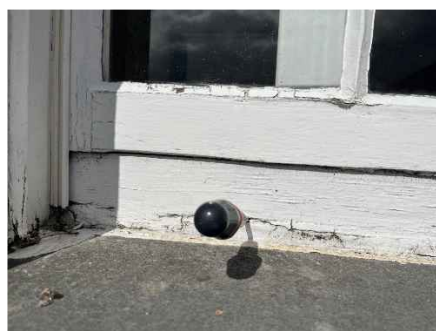
G16 and G18 (2no windows)

**Type:** 8 over 8 timber-frame, single-glazed, vertical sliding sashes, painted white.**Condition:** Glazing putty is cracked and missing in areas; cracked glass pane to G16; paint to frame and sashes is flaking/missing; decay in frame at cill (G16).**Recommendations:** Replace decayed sections of timber cill; replace cracked glass pane and re-using existing glazing, re-putty all glazing; strip, prime, undercoat and repaint frame and sashes, internally and externally; re-seal and draught-proof with new draught seals; adjust sash cords & weights and replace where necessary; maintain and clean all ironmongery, reinstate lime mortar seal to gap around window frame.**Note:** Electrical cable penetrates corner of G16 window frame.

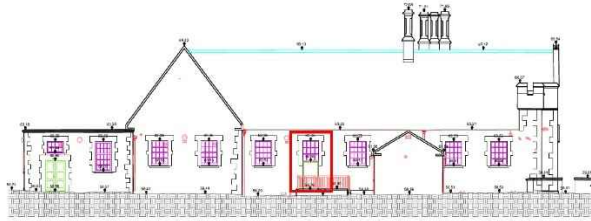
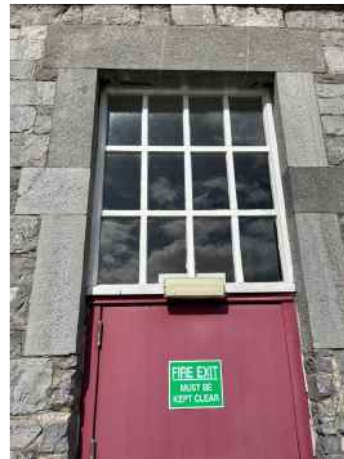
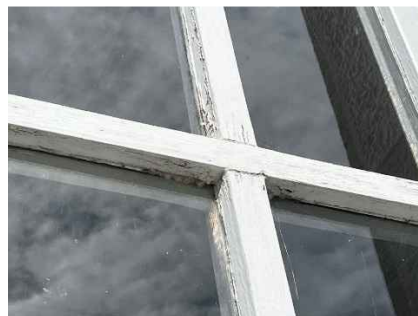
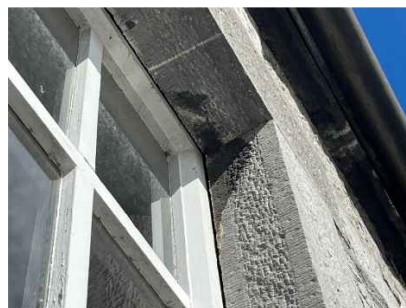
G17 (1no window over door)

**Type:** 12 pane, single-glazed, timber-frame, fixed pane over-door window, painted white.**Condition:** Relatively modern replacement of original window fitting when converted to door opening; poorly constructed; large gaps where lime mortar seal between window/door frame and wall is missing.**Recommendations:** Replace window with new 12 pane, timber-framed, fixed pane over-door window (possibly retaining frame); re-using existing glazing with new putty; painted with primer, undercoat and white finish coats, internally and externally; reinstated with lime mortar seal to gap around window and door frames.

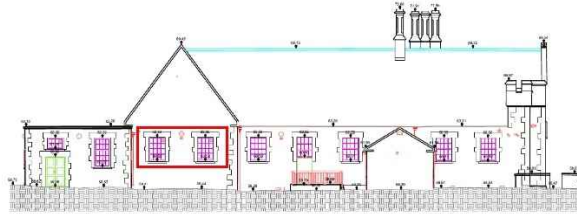
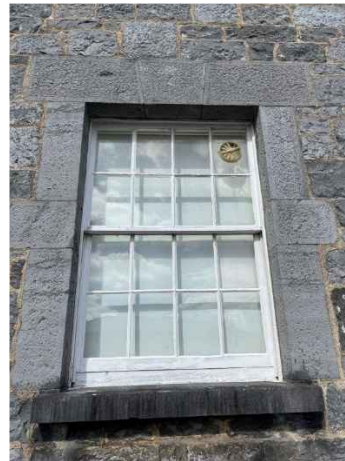
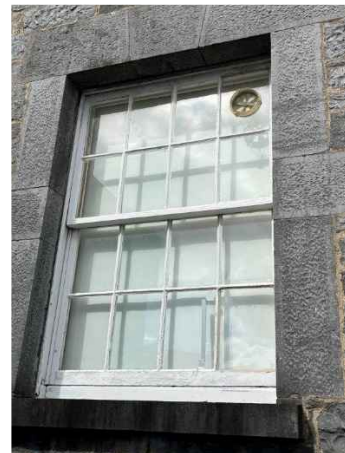
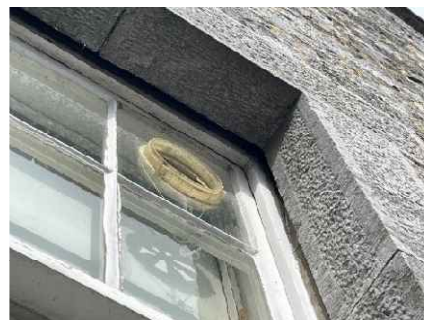
G19 and G20 (2no windows)

**Condition:** Glazing putty is cracked and missing in areas; cracked glass panes to both windows (3no total); paint to frame and sashes is flaking/missing; decay in frames at cill; lime mortar seal around frames cracked with large sections missing entirely.

**Recommendations:** Replace decayed sections of timber frame at cill; replace cracked glass panes and re-using existing glazing, re-putty all glazing; strip, prime, undercoat and repaint frame and sashes, internally and externally; re-seal and draught-proof with new draught seals; adjust sash cords & weights and replace where necessary; maintain and clean all ironmongery, reinstate lime mortar seal to gap around window frames.

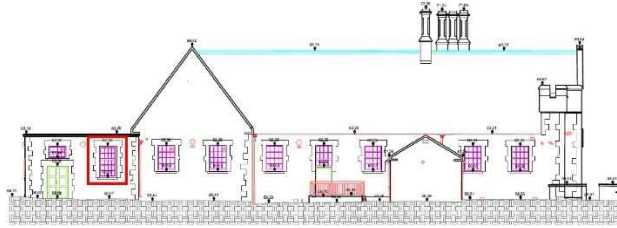
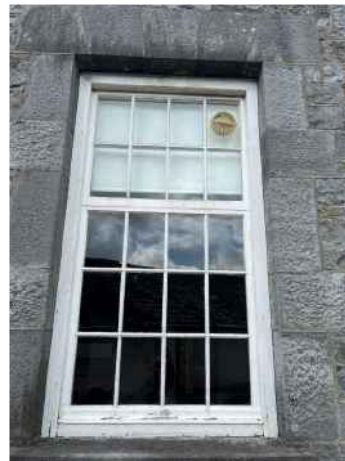
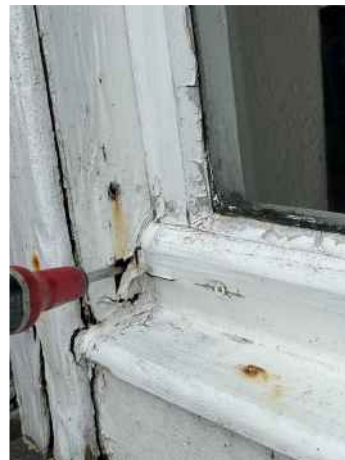
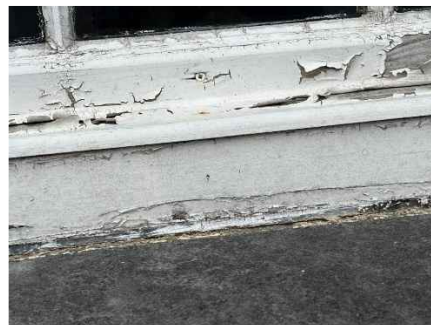
G21 (1no window)

**Condition:** Relatively modern replacement/reconfiguration of original window fitting, possibly with some original sashes; poorly constructed; in very poor condition with decay in frame and sash at cill level; glazing putty is cracked; paint to frame and sashes is flaking/missing; lime mortar seal around frame poor.

**Recommendations:** Replace window with new timber frame window to match original windows elsewhere in the building, retaining existing sashes, sash frames repaired as necessary, with new ironmongery, weights and chords; re-using existing glazing with new putty; painted with primer, undercoat and white finish coats, internally and externally; reinstated with lime mortar seal to gap around window frame.

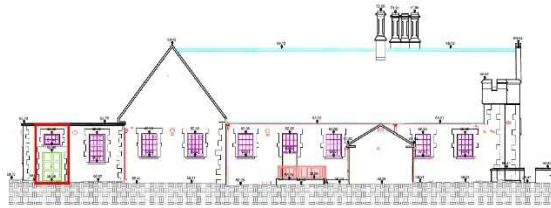
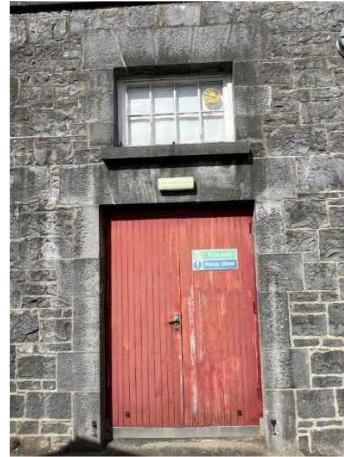
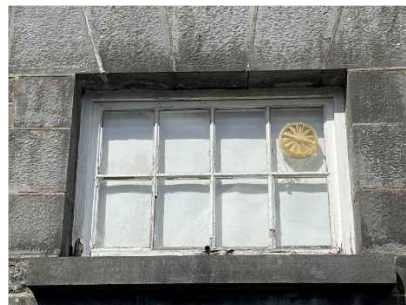
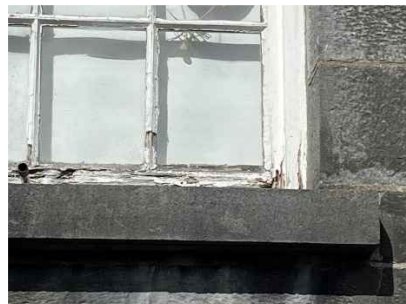
G22 (1no window)

**Condition:** Glazing putty is cracked and missing in areas; paint to frame and sashes is flaking/missing; significant decay in frame at cill.

**Note:** Pipe/duct penetration through bottom rail of window frame.

**Recommendations:** Replace decayed sections of timber frame; re-use existing glazing and re-putty all glazing; strip, prime, undercoat and repaint, internally and externally; maintain and clean all ironmongery; reinstate lime mortar seal to gap around window frame.

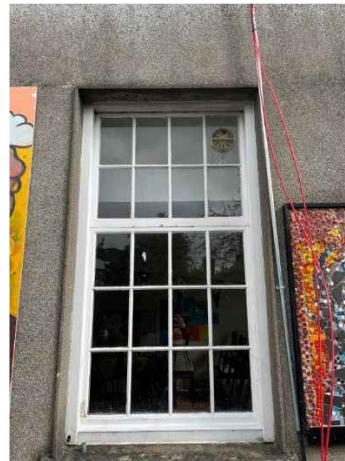
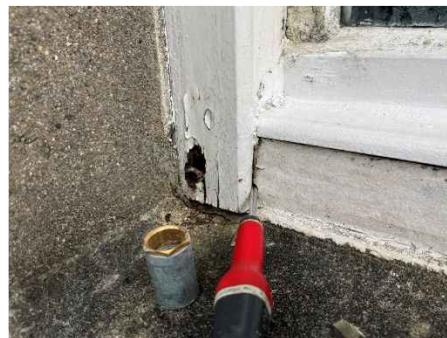
**Condition:** Relatively modern replacement/reconfiguration of original window fittings, possibly with some original sashes; poorly constructed; in very poor condition with decay in frame and sash at cill level and bottom rail of top sash; glazing putty is cracked; cracked glass panes to some windows (3no total); paint to frame and sashes is flaking/missing; lime mortar seal around frame poor.

**Recommendations:** Replace window with new timber frame window to match original windows elsewhere in the building, retaining existing sashes sash, frames repaired as necessary, with new ironmongery, weights and chords; re-using existing glazing with new putty; painted with primer, undercoat and white finish coats, internally and externally; reinstated with lime mortar seal to gap around window frame.

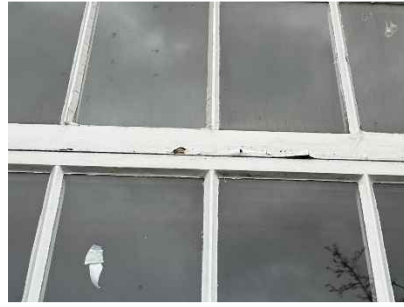
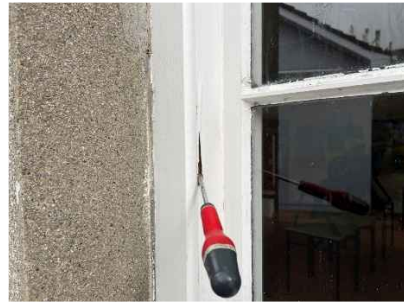
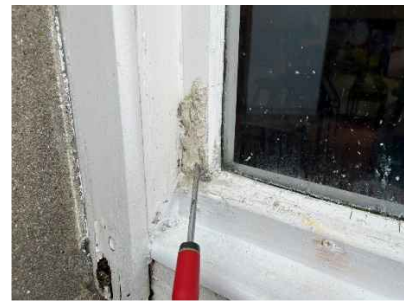
G28 and G29 (2no windows)

**Condition:** Relatively modern replacement/reconfiguration of original window fitting, possibly with some original sashes; poorly constructed; in very poor condition with decay in frame and sash at cill level; glazing putty is cracked; some cracked glazing panes; paint to frame and sashes is flaking/missing; lime mortar seal around frame poor.

**Recommendations:** Replace window with new timber frame window to match original windows elsewhere in the building, retaining existing sashes, sash frames repaired as necessary, with new ironmongery, weights and chords; re-using existing glazing with new putty; painted with primer, undercoat and white finish coats, internally and externally; reinstated with lime mortar seal to gap around window frame.

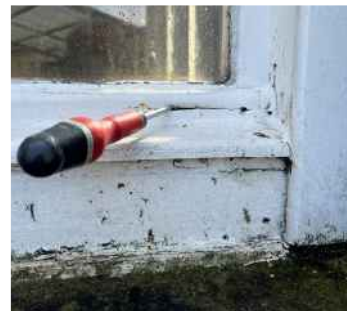
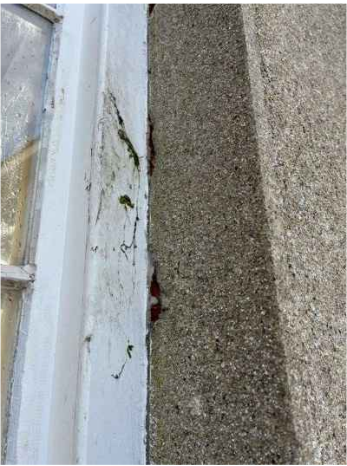
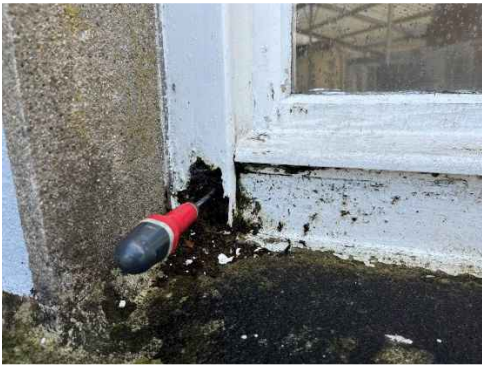
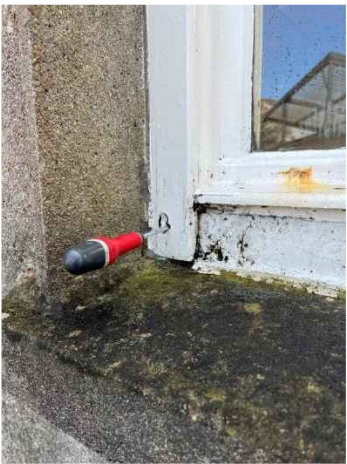
G30, G31, G32 and G33 (4no windows)

**Condition:** Relatively good condition with no obvious decay to frames; recent replacement of glazing with some poor putty placement; one cracked glazing pane; hinges stiff; paint to frame and sashes is flaking/missing in areas.

**Recommendations:** Replace cracked glazing pane with matching glass; otherwise re-use existing glazing and re-putty all glazing; strip, prime, undercoat and repaint frame and sashes, internally and externally; re-draught-proof with new draught seals; maintain and clean all ironmongery and replace where damaged; retain windows in-situ.

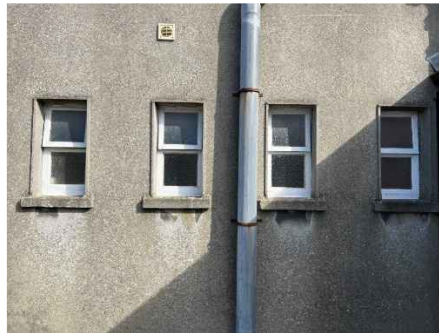
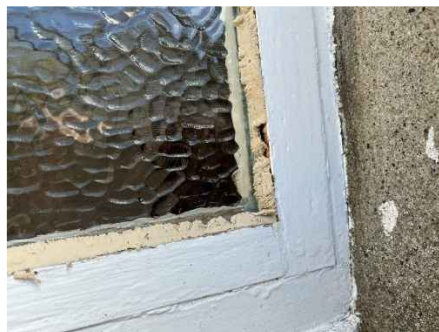
G34 and G35 (2no windows)

**Condition:** Relatively good condition with no obvious decay to frames; some cracking of putty; paint to frame and sashes in good condition.

**Recommendations:** Re-use existing glazing and re-putty all glazing; strip, prime, undercoat and repaint frame and sashes, internally and externally; re-seal and draught-proof with new draught seals; maintain and clean all ironmongery and replace where damaged; retain windows in-situ.

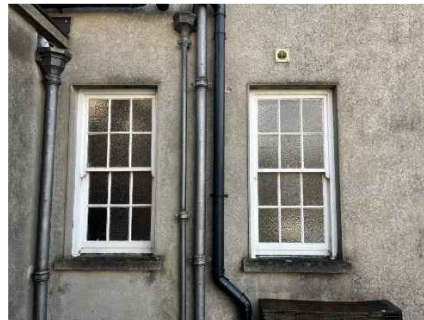
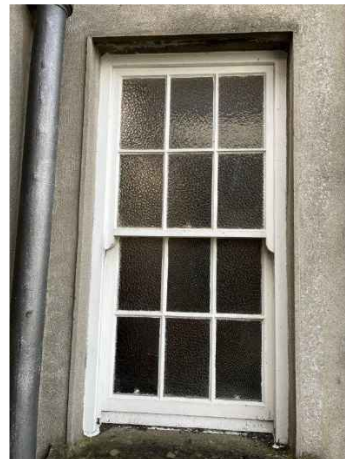
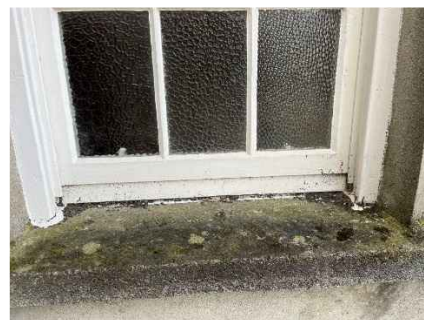
G36 (1no window)

**Type:** 8 over 8 timber-framed, single-glazed, vertical sliding sashes, painted white.**Condition:** Glazing putty is cracked in areas; paint to frame and sashes is flaking/missing; minor decay to frame and cover timbers to frame sides; small hole at top of frame from former service penetration.**Recommendations:** Repair decayed sections of timber frame and cover strips; seal hole in frame; re-use existing glazing and re-putty all glazing; strip, prime, undercoat and repaint frame and sashes, internally and externally; re-seal and draught-proof with new draught seals; adjust sash cords & weights and replace where necessary; maintain and clean all ironmongery.

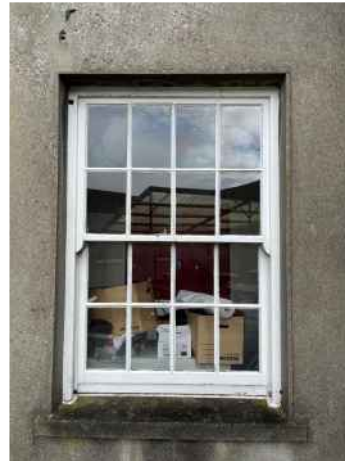
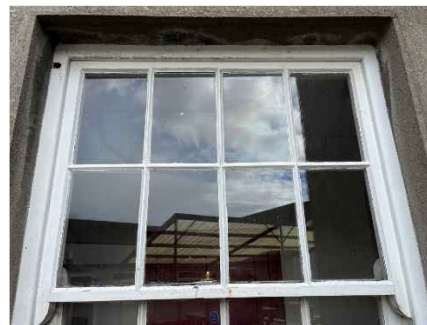
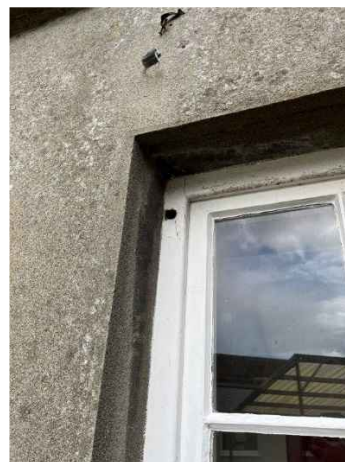
G37 (1no window)

**Condition:** Water ingress through window causing damage to interior finishes; significant decay to frame and sashes at cill level and mid-rail; some cracked glazing panes (2no); glazing putty is cracked; paint to frame and sashes is flaking/missing in areas; large gaps around frame.

**Recommendations:** Carry out extensive repairs to frame and sashes replacing decayed sections of timber cill and bottom rails; replace cracked glazing panes with similar, elsewhere, re-use existing glazing and re-putty all glazing; strip, prime, undercoat and repaint frame and sashes, internally and externally; re-seal and draught-proof with new seals; maintain and clean all ironmongery; reinstate lime mortar seal to gap around window frame.

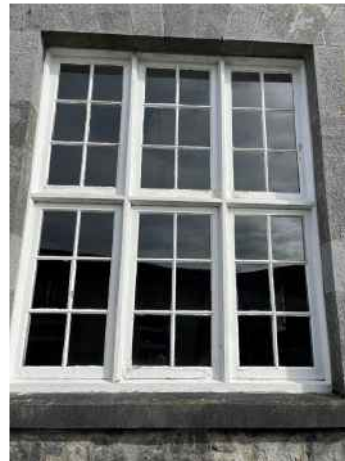
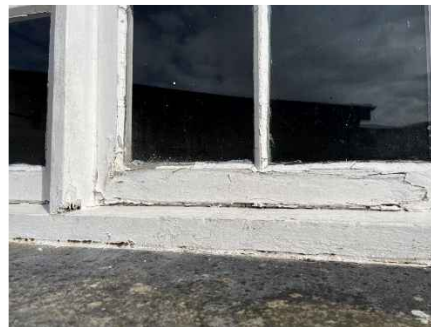
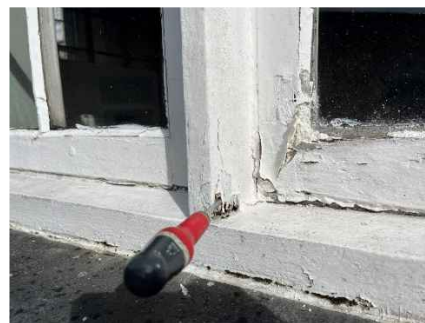
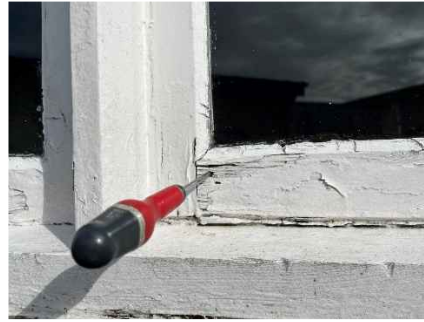
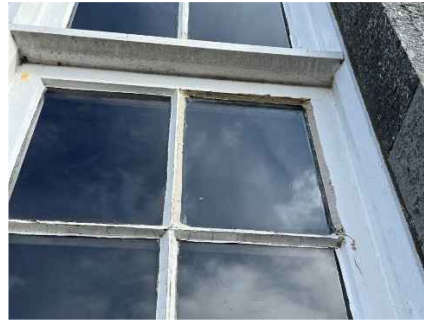
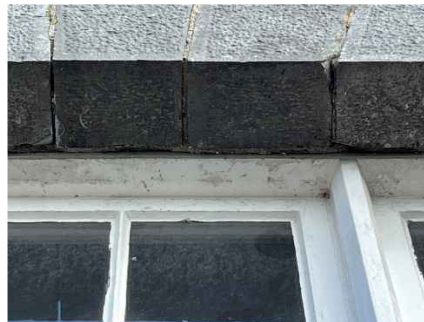
G38, G39 and G40 (3no windows)

**Condition:** Glazing putty is poor in areas of previous repairs with cracking to older putty; some cracked glass panes in all windows; paint to frame and sashes is flaking/missing; some decay to frame and bottom rail at cill level; small hole at base of one window frame from former service penetration; large gaps around frames.

**Recommendations:** Repair decayed sections of timber frame and sash rails; seal hole in frame; replace 4no broken glass panes and elsewhere re-use existing glazing and re-putty all glazing; strip, prime, undercoat and repaint frame and sashes, internally and externally; re-seal and draught-proof with new draught seals; adjust sash cords & weights and replace where necessary; maintain and clean all ironmongery; reinstate lime mortar seal to gap around window frame.

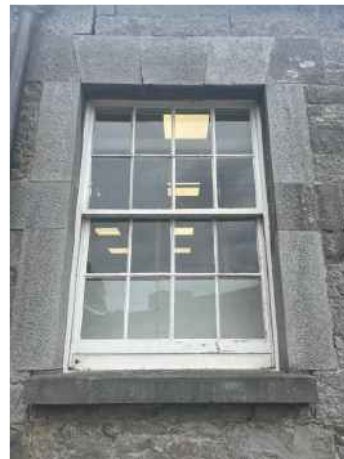
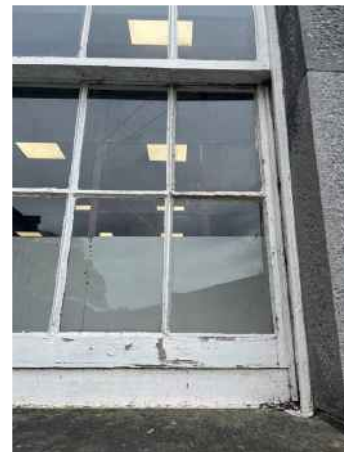
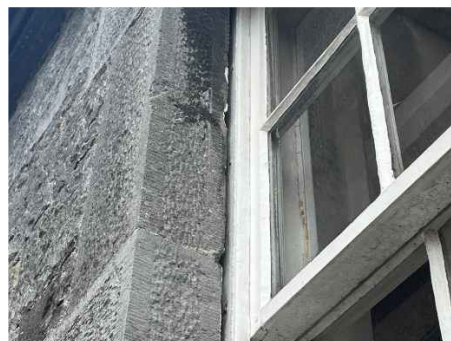
**Condition:** Glazing putty is poor in areas of previous repairs with cracking to older putty with sections missing; paint to frame and sashes is flaking/missing; some minor decay to frame and bottom rail at cill level.

**Recommendations:** Repair decayed sections of timber frame and sash rails where necessary; re-use existing glazing and re-putty all glazing; strip, prime, undercoat and repaint frame and sashes, internally and externally; re-seal and draught-proof with new draught seals; adjust sash cords & weights and replace where necessary; maintain and clean all ironmongery.

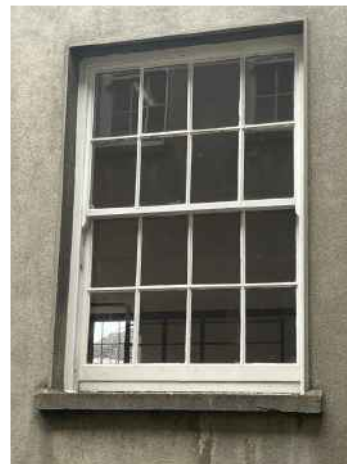
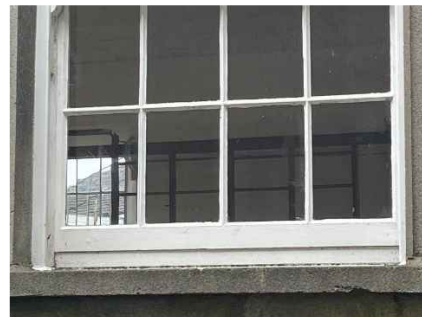
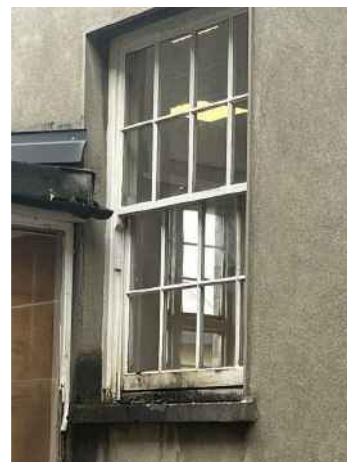
G50, G51 and G52 (3no windows)

**Condition:** Generally in good condition; glazing putty is cracking in areas; paint is good; no obvious decay to frame and bottom rail at cill level.

**Recommendations:** Re-use existing glazing and re-putty all glazing; strip, prime, undercoat and repaint frame and sashes, internally and externally; re-seal and draught-proof with new draught seals; adjust sash cords & weights and replace where necessary; maintain and clean all ironmongery and replace where damaged; retain windows in-situ.

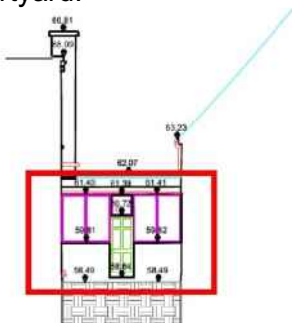
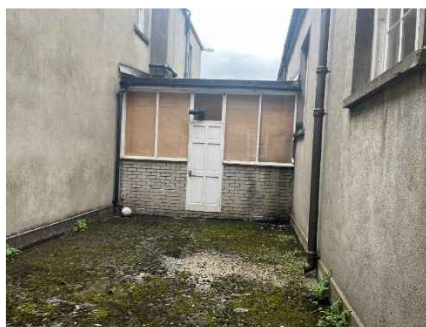
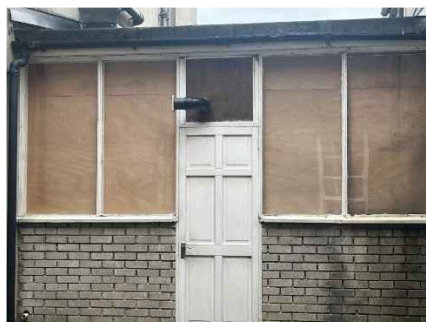
G54 (1no window)

**Condition:** Generally in very poor condition; significant decay of timber frame; glazing putty is cracking in areas; paint is poor with peeling/cracking in areas (leaking rainwater gutter over window causing significant wetting of window frame).

**Recommendations:** Repair decayed sections of timber frame; re-use existing glazing and re-putty all glazing; strip, prime, undercoat and repaint frame, internally and externally.

**Note:** Rainwater gutter over window to be repaired.

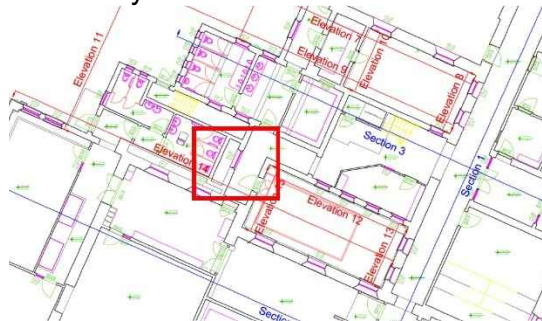
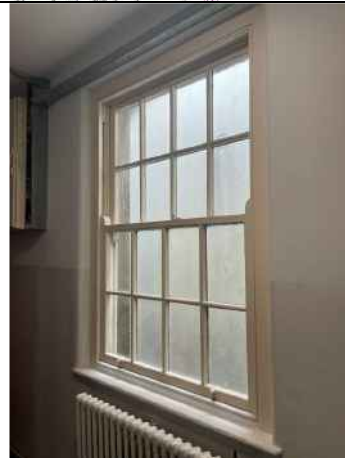
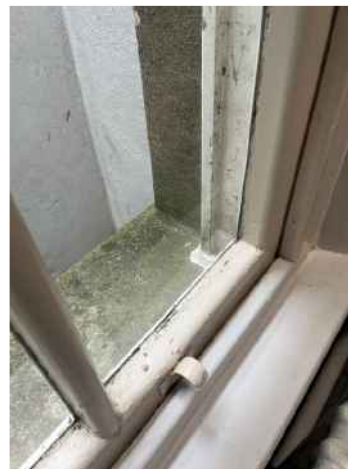
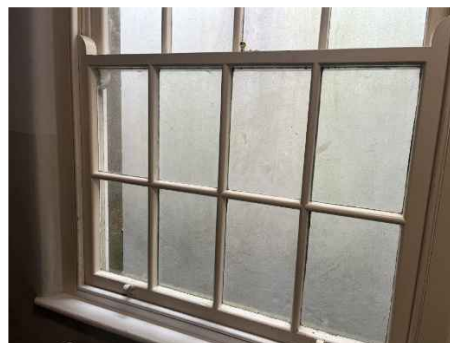
**Condition:** Generally in good condition; glazing putty is cracking in areas; paint is good; no obvious decay to frame and bottom rail at cill level.

**Recommendations:** Re-use existing glazing and re-putty all glazing; strip, prime, undercoat and repaint frame and sashes, internally and externally; re-seal and draught-proof with new draught seals; adjust sash cords & weights and replace where necessary; maintain and clean all ironmongery and replace where damaged; retain windows in-situ.

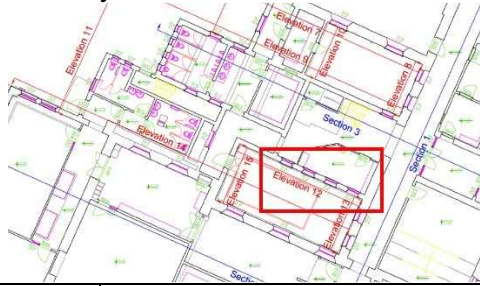
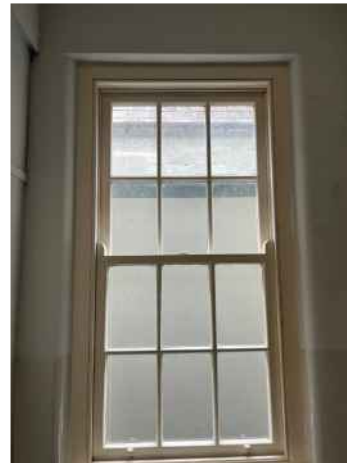
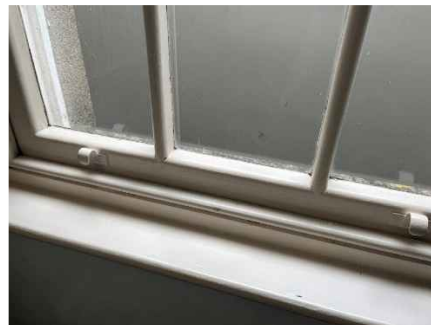
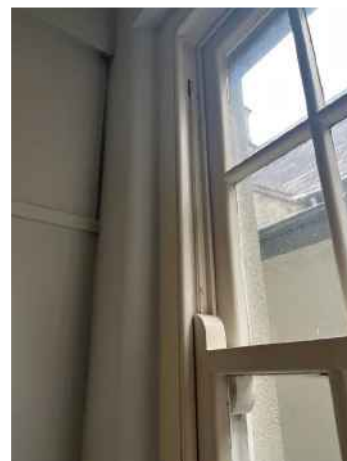
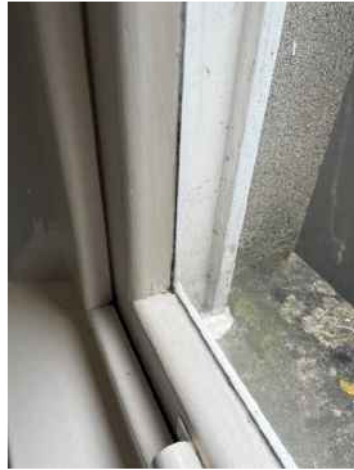
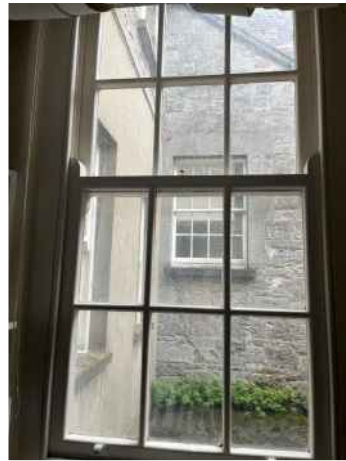
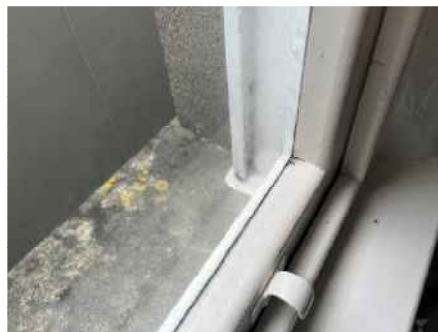
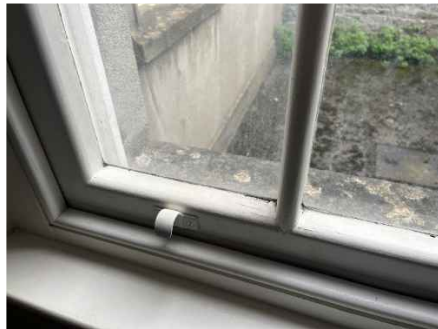
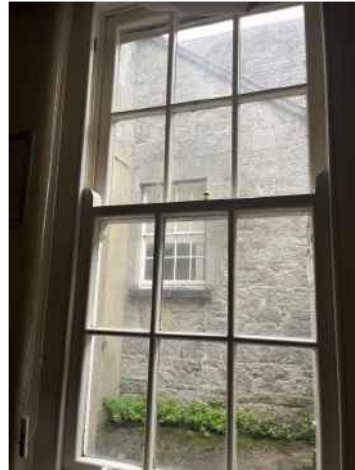
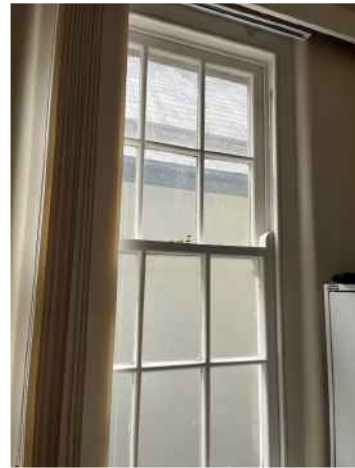
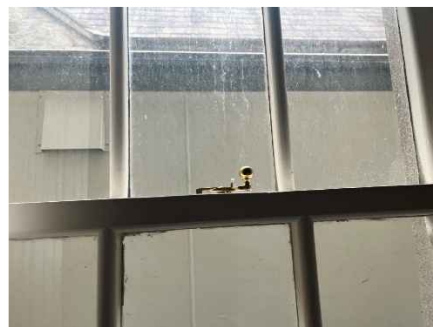
G55, G56, G57 and G58 (4no windows)

**Condition:** Generally in good condition; glazing putty is cracking in areas; paint is good; no obvious decay to frame and bottom rail at sill level.

**Recommendations:** Re-use existing glazing and re-putty all glazing; strip, prime, undercoat and repaint frame and sashes, internally and externally; re-seal and draught-proof with new draught seals; adjust sash cords & weights and replace where necessary; maintain and clean all ironmongery and replace where damaged; retain windows in-situ.

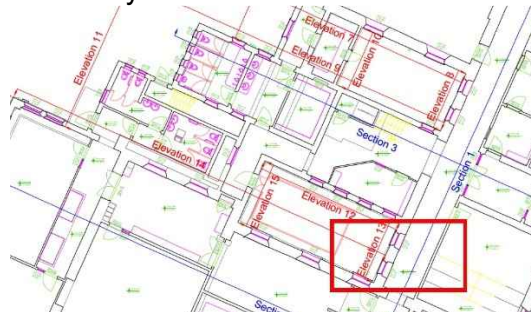
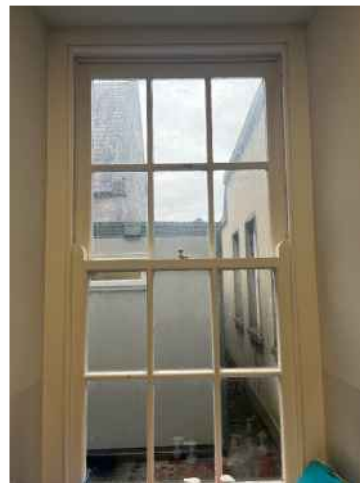
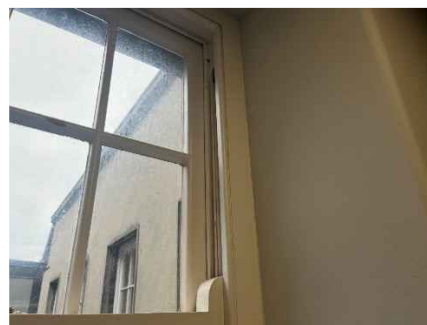
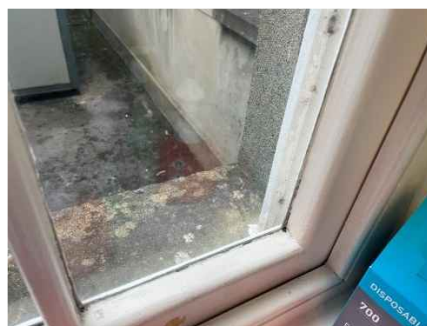
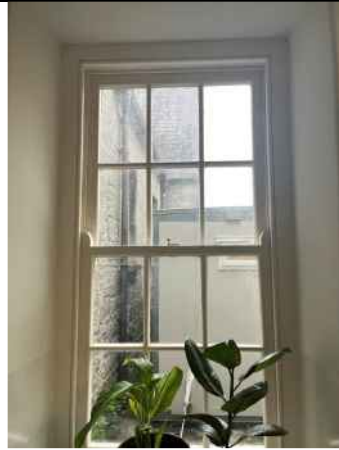
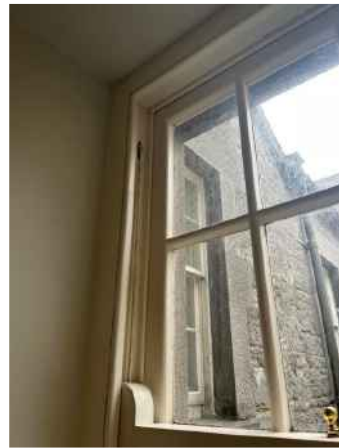
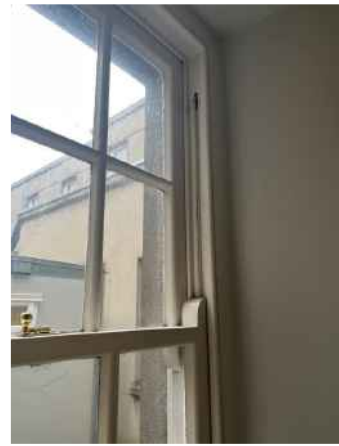
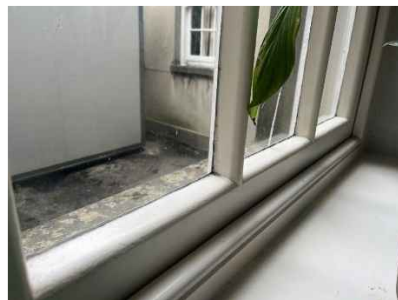
G59 and G60 (2no windows)

**Condition:** Generally in good condition; glazing putty is cracking in areas; paint is good; no obvious decay to frame and bottom rail at cill level.

**Recommendations:** Re-use existing glazing and re-putty all glazing; strip, prime, undercoat and repaint frame and sashes, internally and externally; re-seal and draught-proof with new draught seals; adjust sash cords & weights and replace where necessary; maintain and clean all ironmongery and replace where damaged; retain windows in-situ.

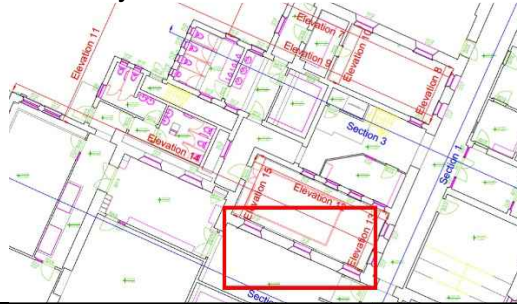
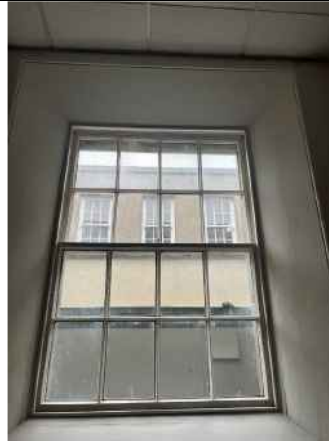
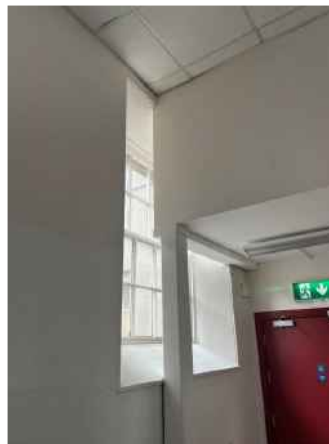
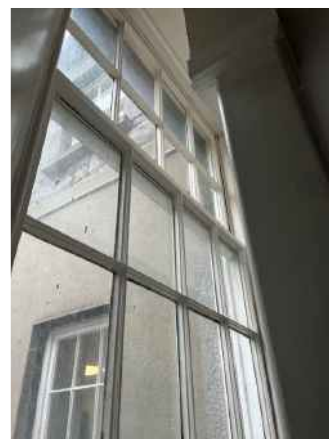
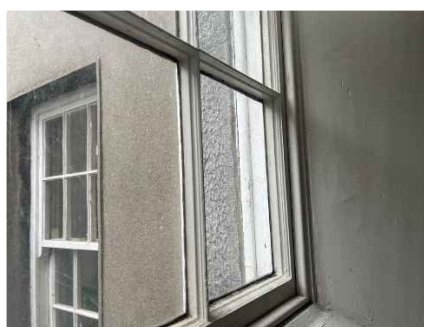
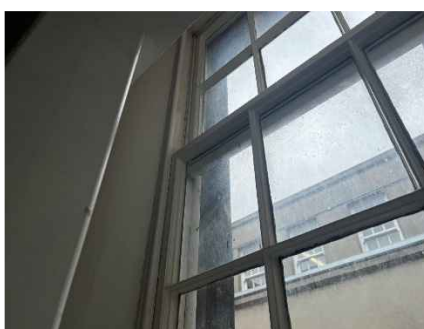
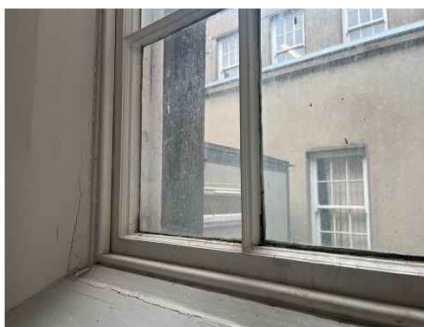
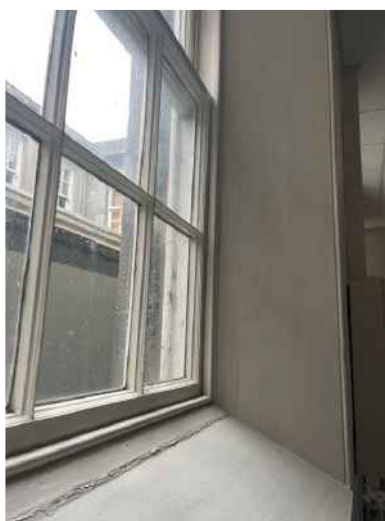
G61, G62 and G63 (3no windows)

**Condition:** Generally in good condition; glazing putty is cracking in areas; paint is good; no obvious decay to frame and bottom rail at cill level.

**Recommendations:** Re-use existing glazing and re-putty all glazing; strip, prime, undercoat and repaint frame and sashes, internally and externally; re-seal and draught-proof with new draught seals; adjust sash cords & weights and replace where necessary; maintain and clean all ironmongery and replace where damaged; retain windows in-situ.

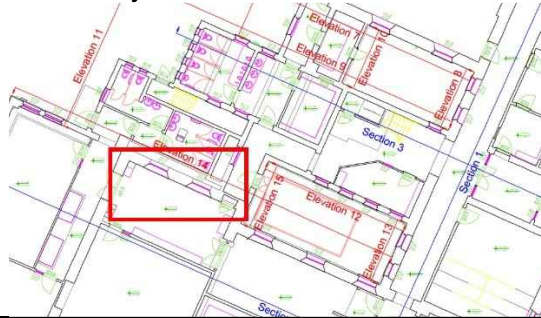
G64 and G65 (2no windows)

**Condition:** Generally in good condition; some opening of frame joints, glazing putty is cracking in areas; paint is good; no obvious decay to frame and bottom rail at cill level.

**Recommendations:** Repair timber frame joints where loose, re-use existing glazing and re-putty all glazing; strip, prime, undercoat and repaint frame and sashes, internally and externally; re-seal and draught-proof with new draught seals; adjust sash cords & weights and replace where necessary; maintain and clean all ironmongery and replace where damaged; retain windows in-situ.

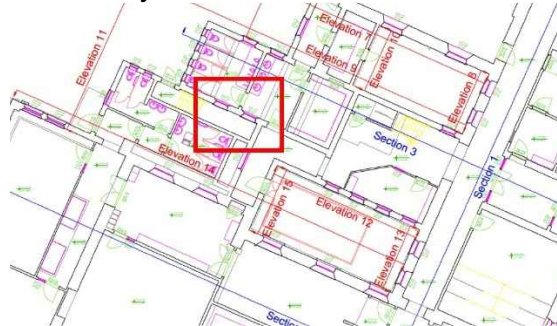
G66 and G67 (2no windows)

**Condition:** Generally in good condition; glazing putty is cracking in areas; paint is good; no obvious decay to frame and bottom rail at cill level.

**Recommendations:** Re-use existing glazing and re-putty all glazing; strip, prime, undercoat and repaint frame and sashes, internally and externally; re-seal and draught-proof with new draught seals; adjust sash cords & weights and replace where necessary; maintain and clean all ironmongery and replace where damaged; retain windows in-situ.

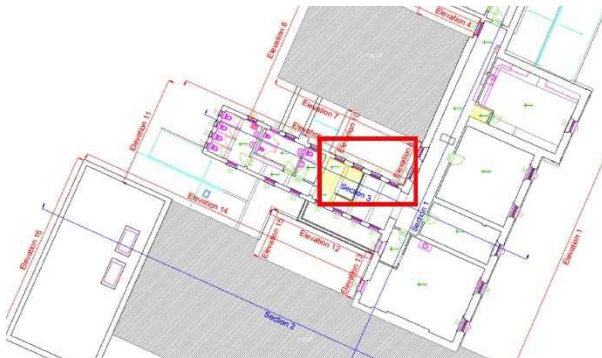
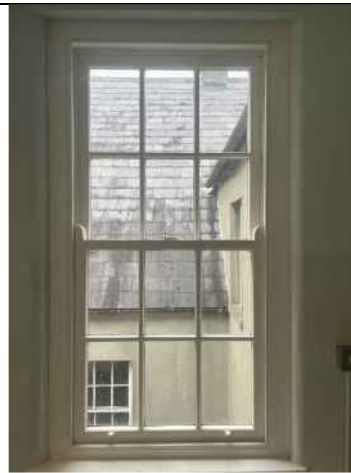
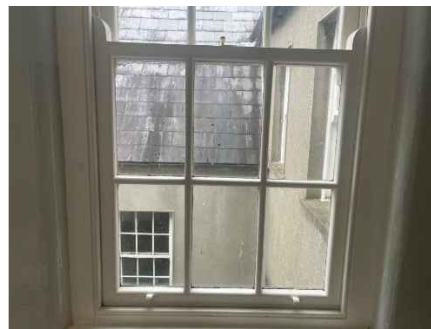
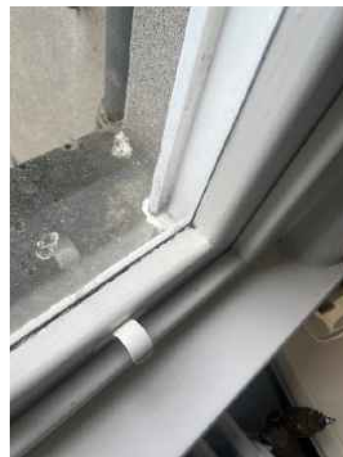
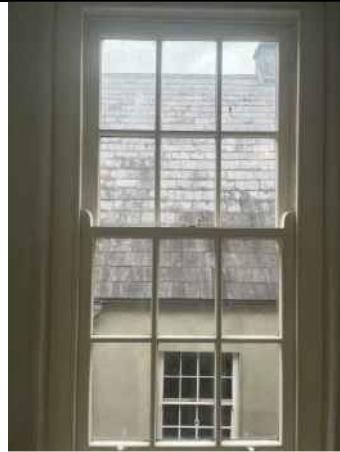
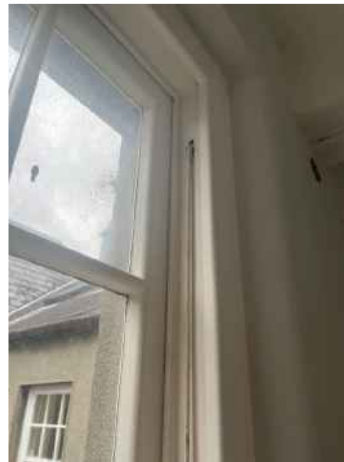
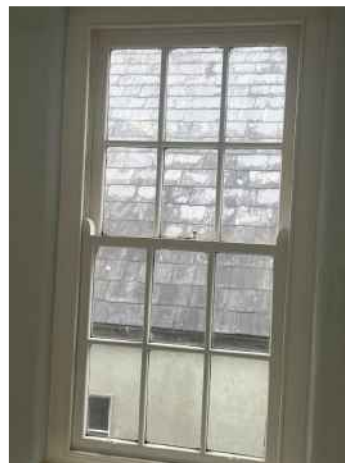
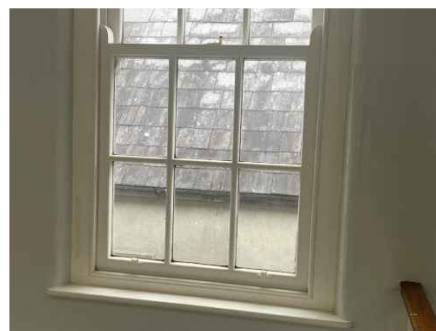
F01, F02, F03 and F04 (4no windows)

**Condition:** Generally in good condition; glazing putty is cracking in areas; paint is good; no obvious decay to frame and bottom rail at cill level.

**Recommendations:** Re-use existing glazing and re-putty all glazing; strip, prime, undercoat and repaint frame and sashes, internally and externally; re-seal and draught-proof with new draught seals; adjust sash cords & weights and replace where necessary; maintain and clean all ironmongery and replace where damaged; retain windows in-situ.
