**Windows Restoration Works at Ormonde College,  
Ormonde Road, Kilkenny for Kilkenny and Carlow Education and  
Training Board**

**WINDOW CONDITION SURVEY AND SCHEDULE OF  
WORKS**

**August 2024**

**Job No. 23085**

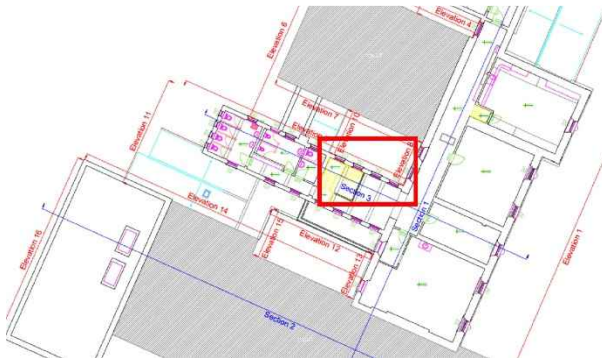
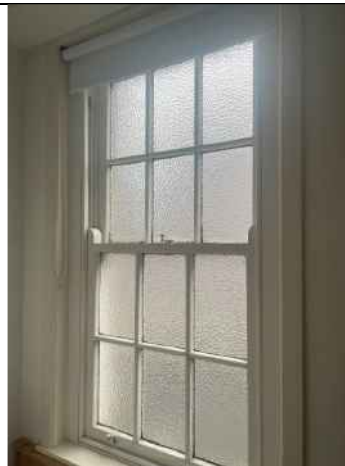
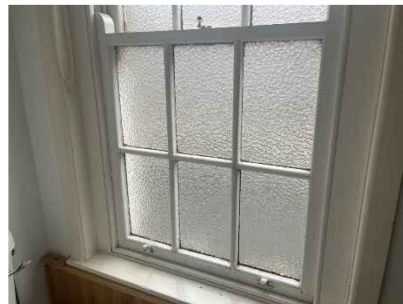
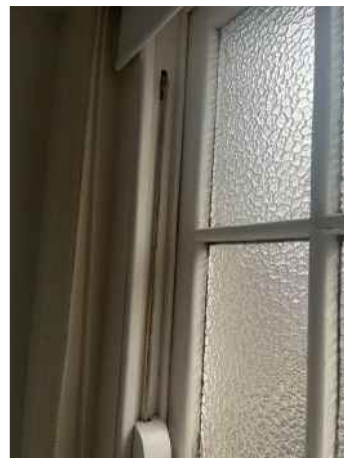
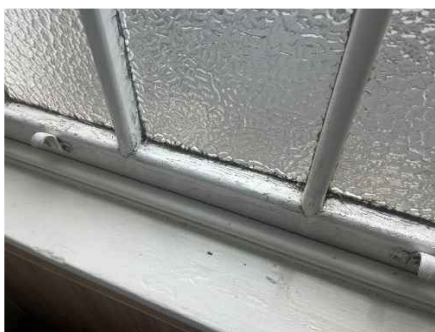
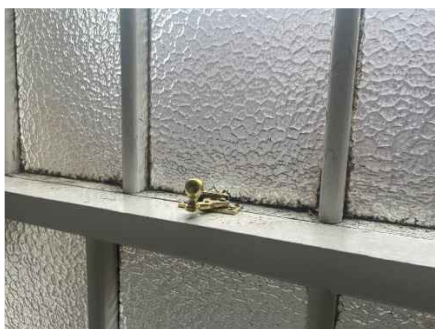
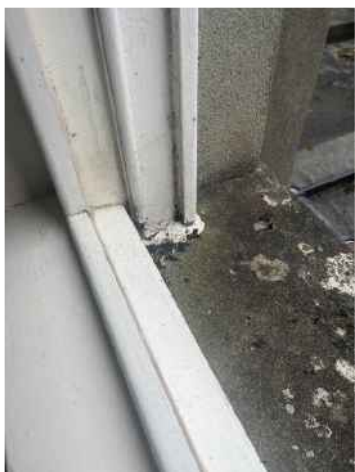
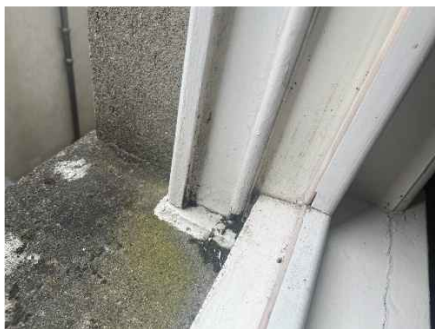
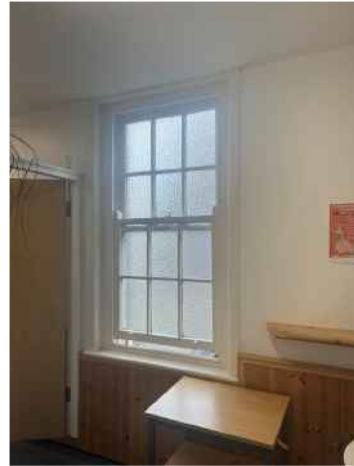
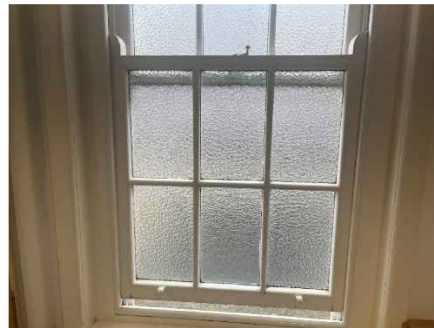
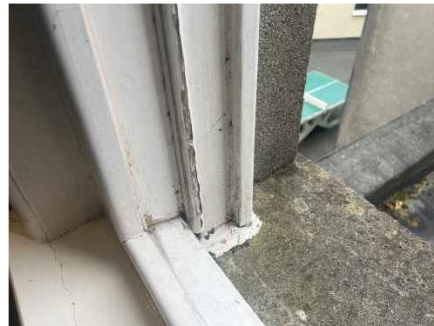
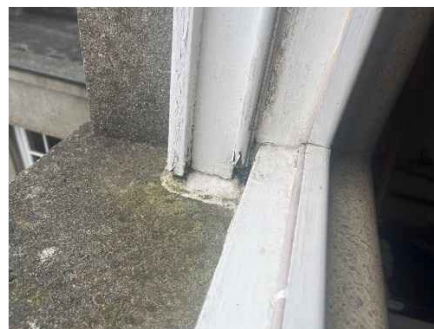
F05, F06 and F08 (3no windows – no window F07)

**Condition:** Generally in good condition; glazing putty is cracking in areas; paint is good, some deterioration; no obvious decay to frame and bottom rail at cill level, one cracked pane of glass.

**Recommendations:** Replace cracked glass pane with matching obscure glass pane, and elsewhere, re-use existing glazing and re-putty all glazing; strip, prime, undercoat and repaint frame and sashes, internally and externally; re-seal and draught-proof with new draught seals; adjust sash cords & weights and replace where necessary; maintain and clean all ironmongery and replace where damaged; retain windows in-situ.

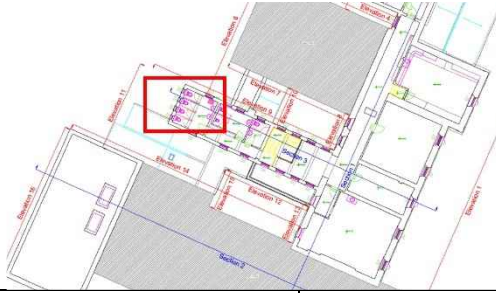
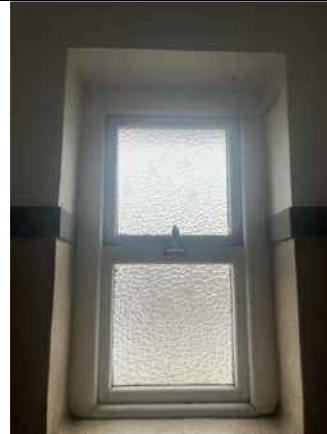
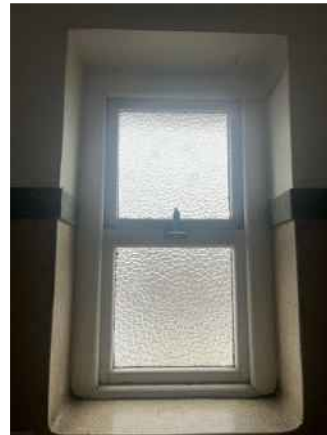
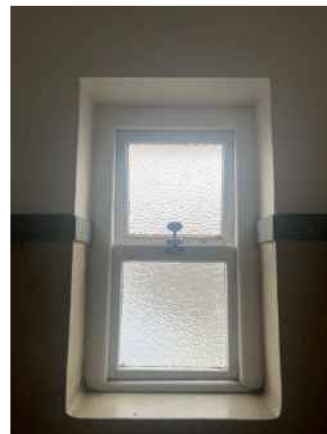
F09, F10, F11 and F12 (4no windows)

**Condition:** Relatively good condition with no obvious decay to frames; one replacement glass pane different pattern; hinges stiff; paint to frame and sashes is in reasonable condition.

**Recommendations:** Re-use existing glazing and re-putty all glazing; strip, prime, undercoat and repaint frame and sashes, internally and externally; re-draught-proof with new draught seals; maintain and clean all ironmongery and replace where damaged; retain windows in-situ.

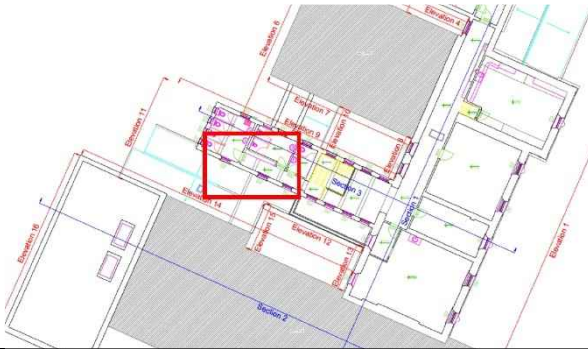
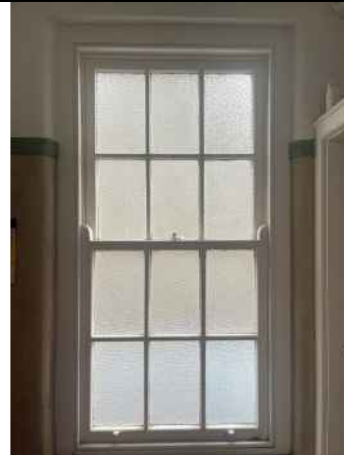
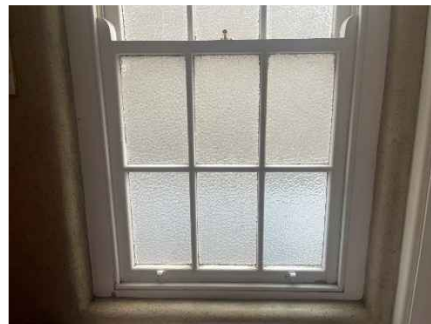
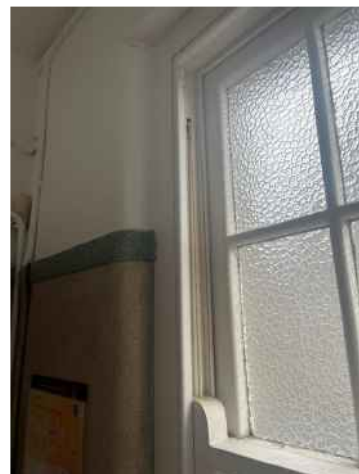
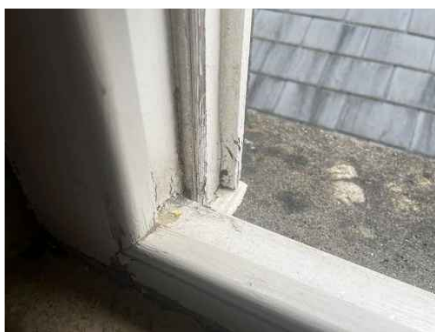
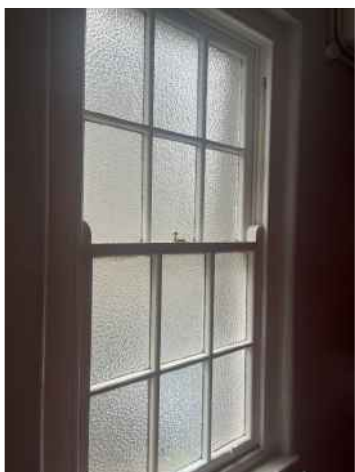
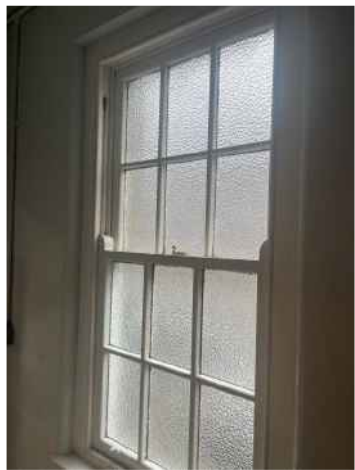
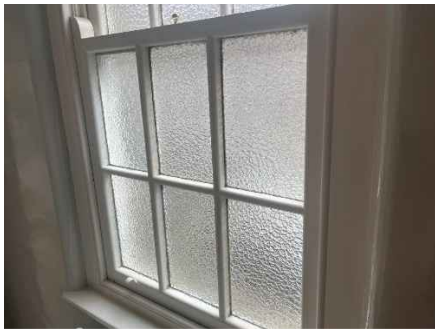
F13, F14 and F15 (3no windows)

**Condition:** Generally in good condition; glazing putty is cracking in areas; paint is good, some deterioration; no obvious decay to frame and bottom rail at cill level.

**Recommendations:** Re-use existing glazing and re-putty all glazing; strip, prime, undercoat and repaint frame and sashes, internally and externally; re-seal and draught-proof with new draught seals; adjust sash cords & weights and replace where necessary; maintain and clean all ironmongery and replace where damaged; retain windows in-situ.

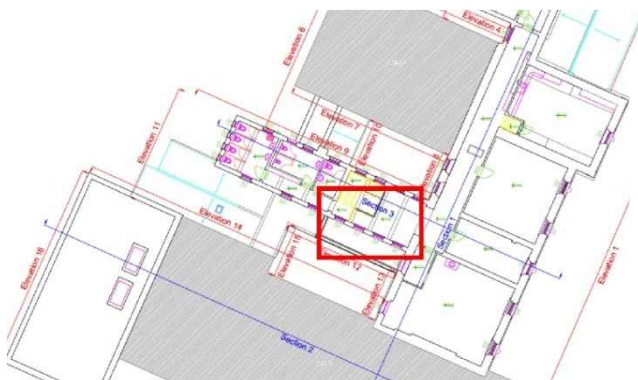
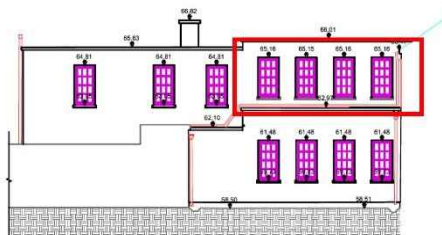
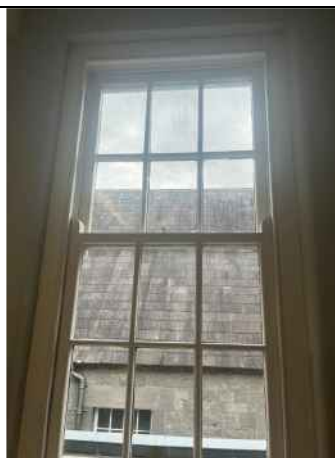
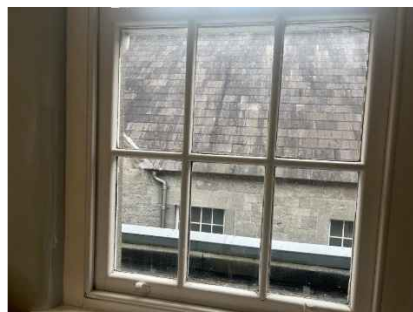
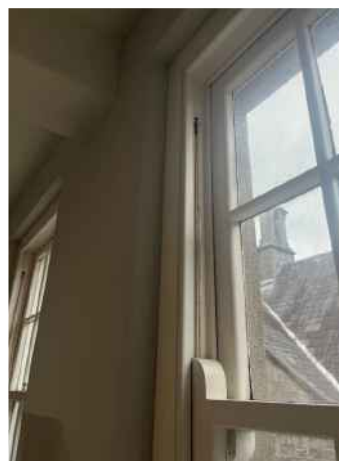
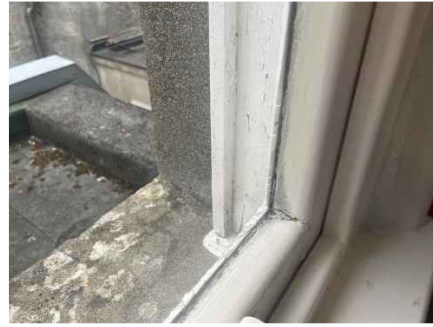
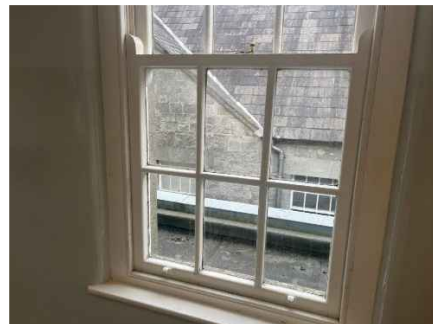
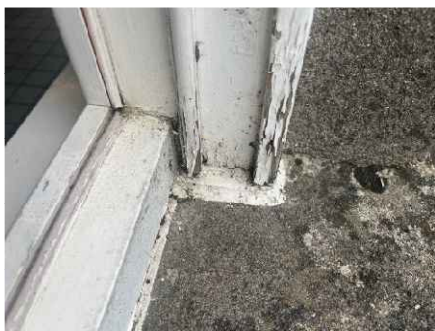
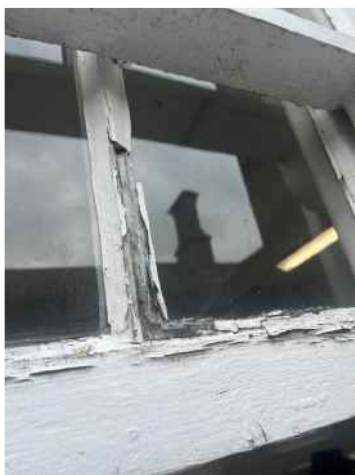
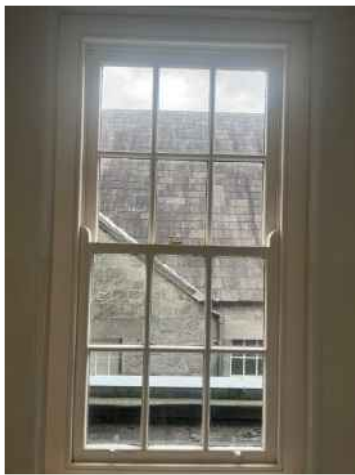
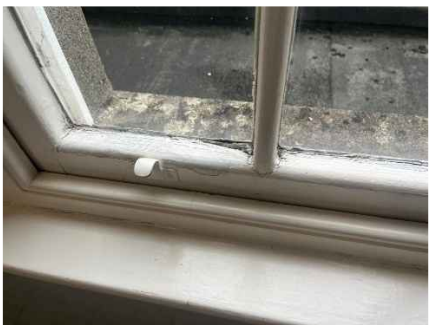
F16, F17, F18 and F19 (4no windows)

**Condition:** Generally in good condition; glazing putty is cracking in areas; paint is good; some minor decay to frames at cill level to some windows.

**Recommendations:** Repair timber frames where decayed; re-use existing glazing and re-putty all glazing; strip, prime, undercoat and repaint frame and sashes, internally and externally; re-seal and draught-proof with new draught seals; adjust sash cords & weights and replace where necessary; maintain and clean all ironmongery and replace where damaged; retain windows in-situ.

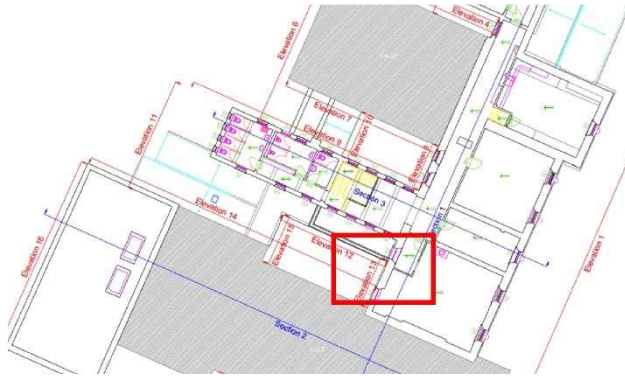
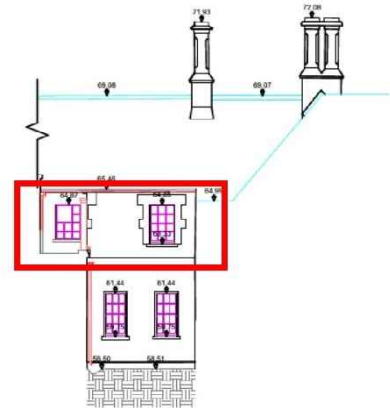
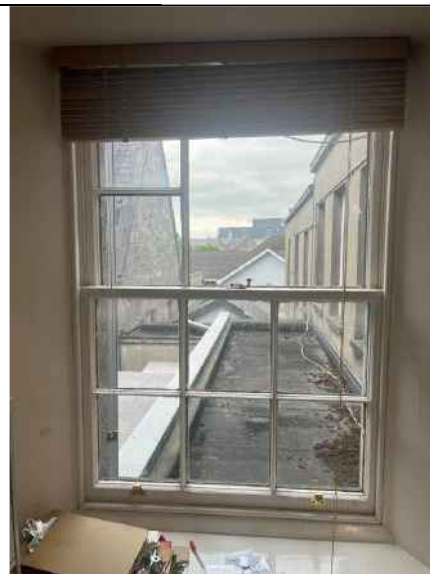
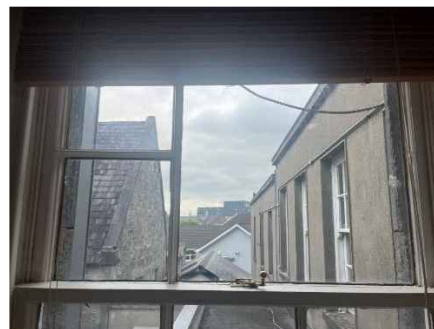
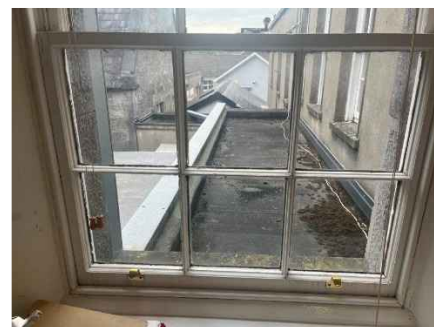
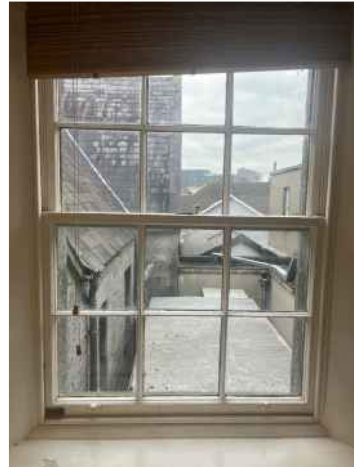
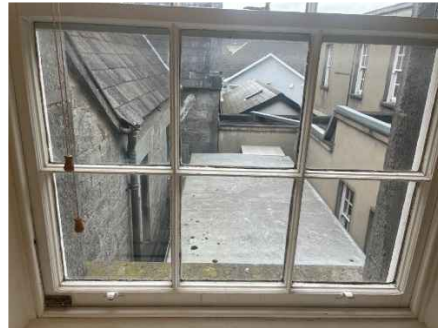
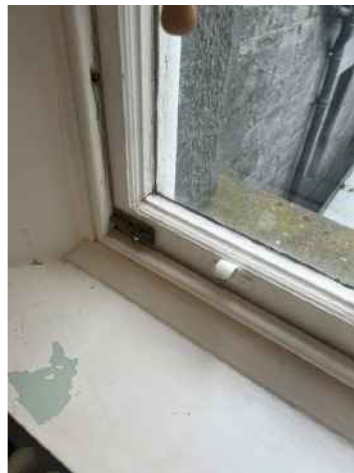
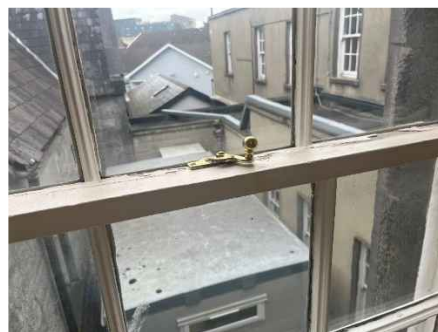
F20 and F21 (2no windows)

**Condition:** Generally in good condition; glazing putty is cracking in areas; paint is flaking and missing in areas; some minor deterioration to frames at cill level to some windows; top sash of F20 altered previously by removing glazing bars to combine four panes into one single larger pane.

**Recommendations:** Repair timber frames where decayed; repair altered top sash to window F20 to reinstate original 6no panes; re-use existing glazing with new as required and re-putty all glazing; strip, prime, undercoat and repaint frame and sashes, internally and externally; re-seal and draught-proof with new draught seals; adjust sash cords & weights and replace where necessary; maintain and clean all ironmongery and replace where damaged.

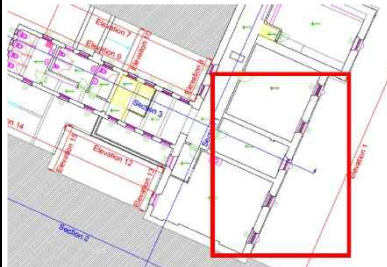
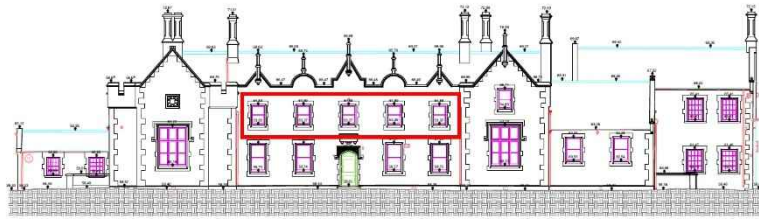
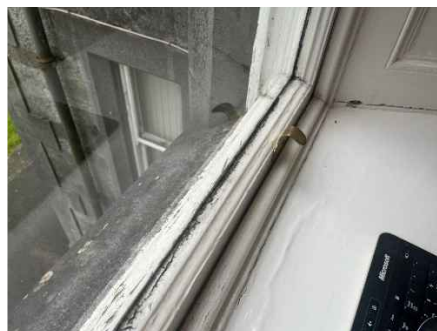
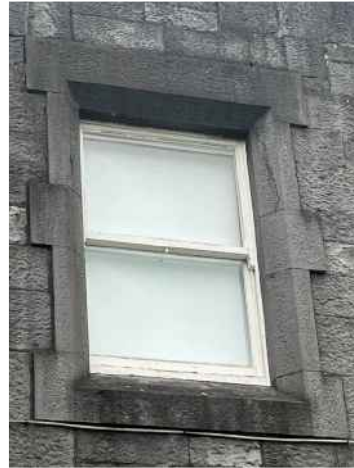
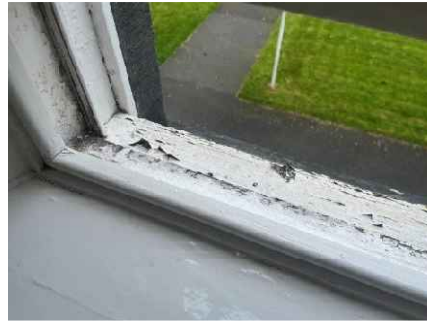
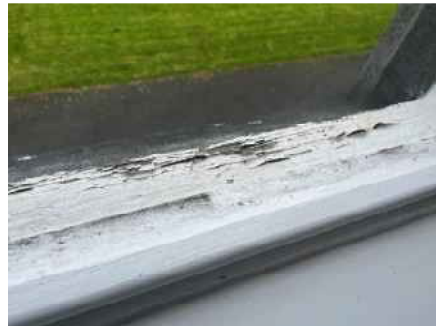
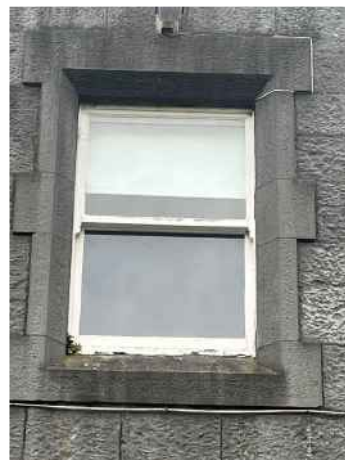
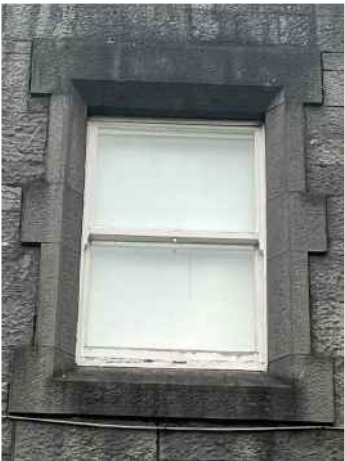
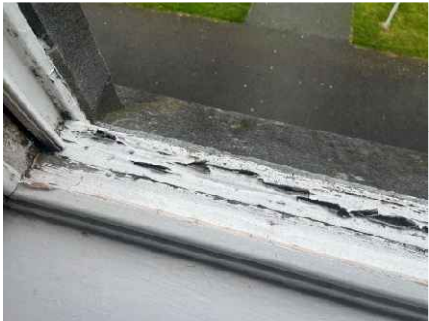
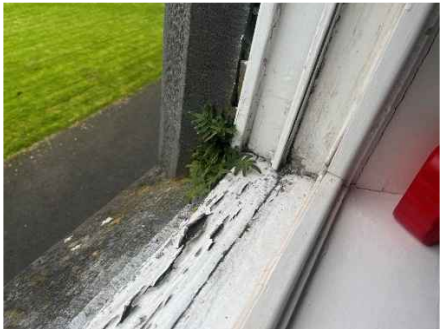
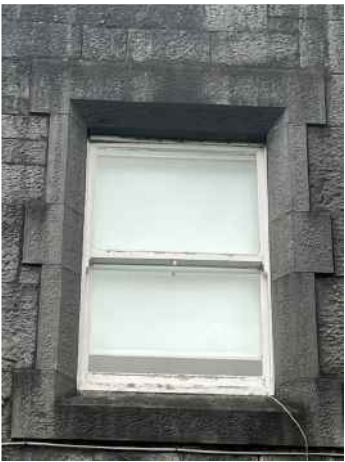
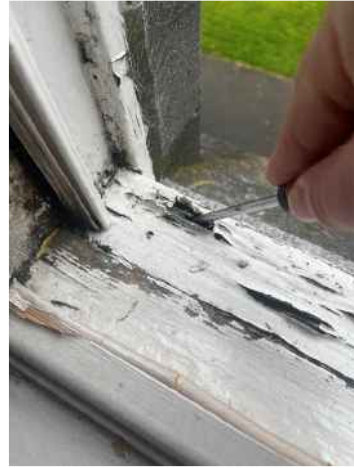
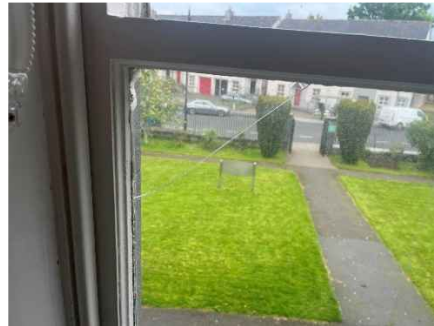
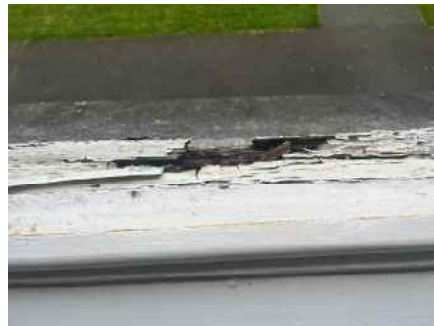
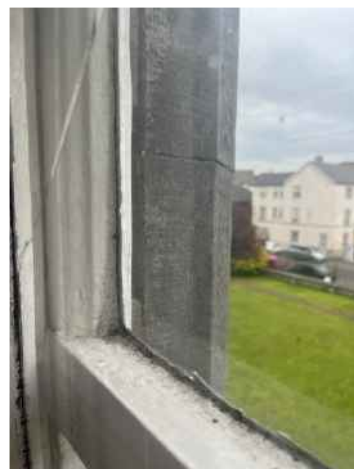
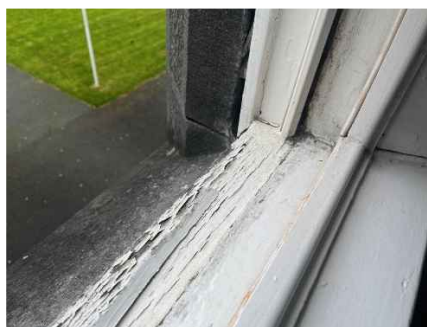
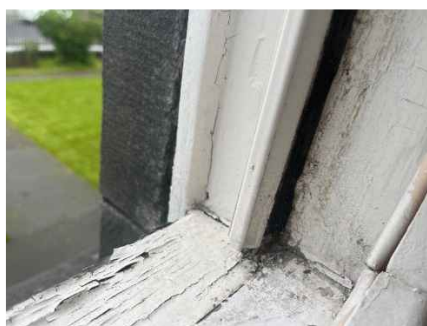
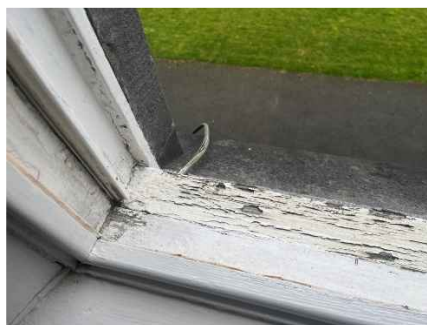
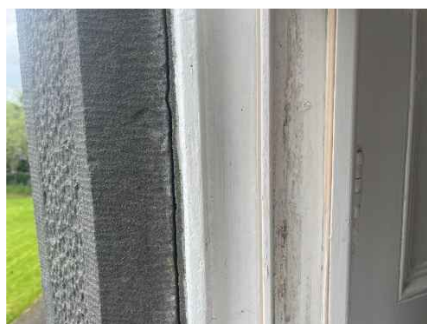
F22, F23, F24, F25 and F26 (5no windows)

**Condition:** Glazing putty is cracked; paint to frame and sashes is flaking/missing in areas; significant deterioration of frame with decay in frame and bottom sash rail at cill; lime mortar pointing around frames poor; one cracked glass pane.

**Recommendations:** Replace decayed sections of timber cill and bottom rail; replace cracked glass pane to one window and elsewhere, re-use existing glazing and re-putty all glazing; strip, prime, undercoat and repaint frame and sashes, internally and externally; re-seal and draught-proof with new draught seals; adjust sash cords & weights and replace where necessary; maintain and clean all ironmongery, reinstate with new lime mortar seal to gap around window frame.

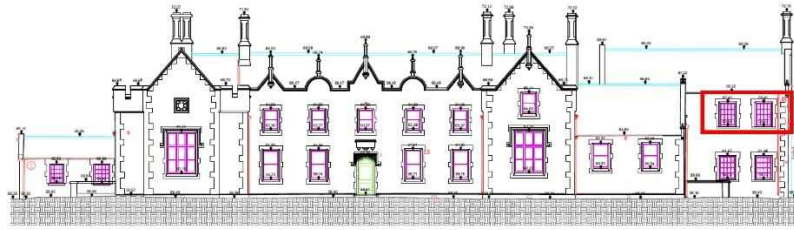
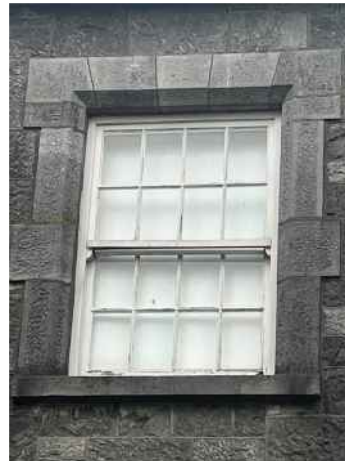
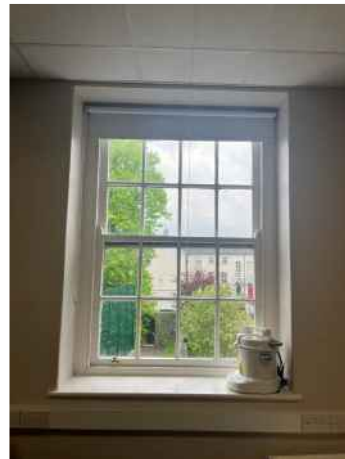
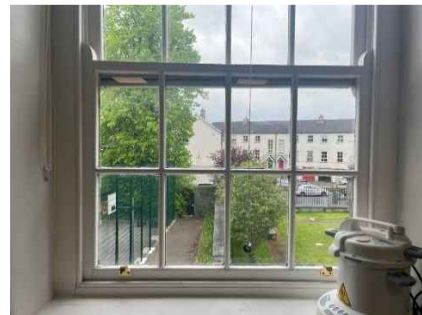
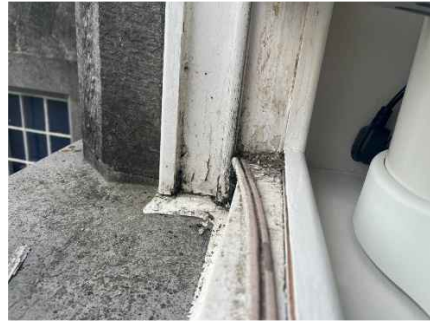
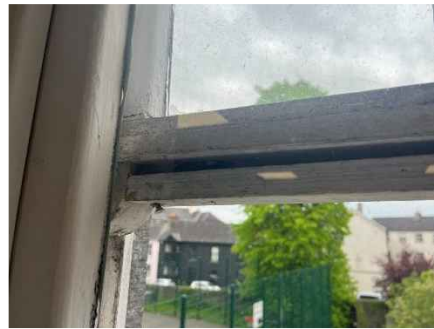
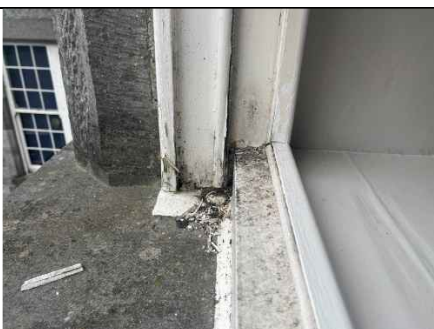
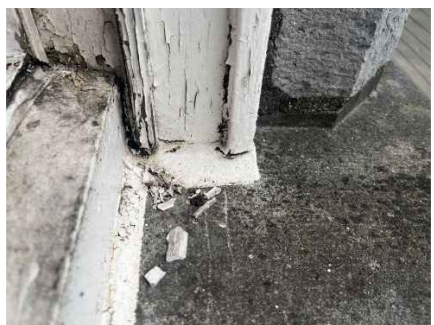
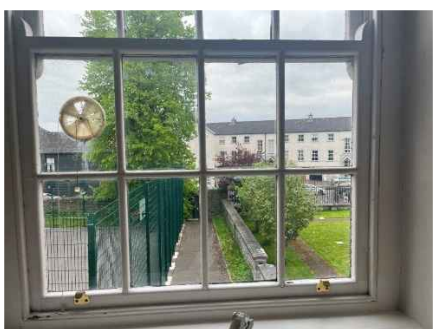
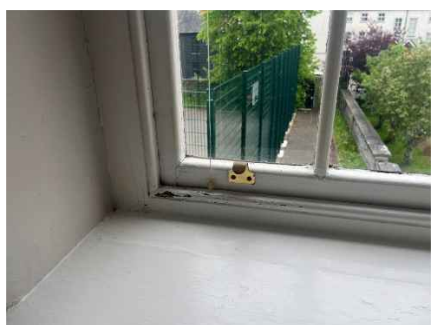
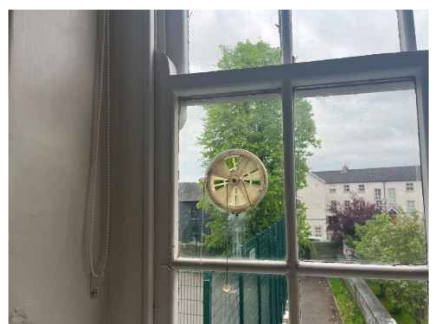
F28 and F29 (2no windows)

**Condition:** Glazing putty is cracked; paint to frame and sashes is flaking/missing; some slight deterioration of frame and sash at cill; previous repairs in poor condition.

**Recommendations:** Repair decayed sections of timber frames; re-use existing glazing and re-putty all glazing; strip, prime, undercoat and repaint frame and sashes, internally and externally; re-seal and draught-proof with new draught seals; adjust sash cords & weights and replace where necessary; maintain and clean all ironmongery.

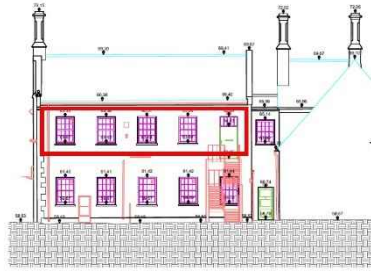
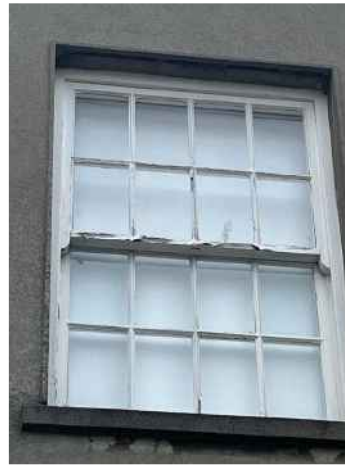
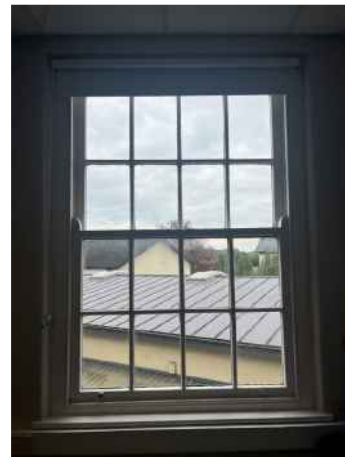
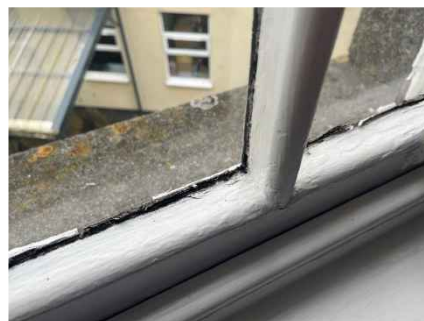
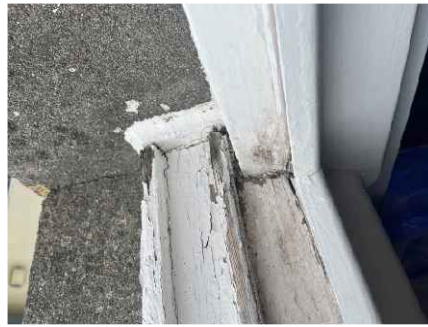
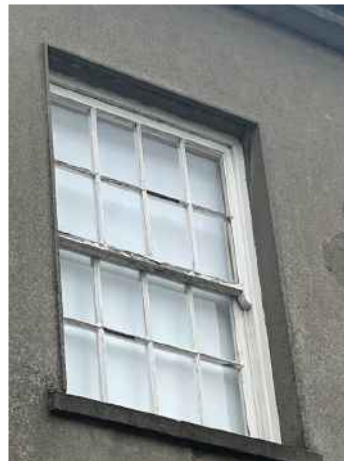
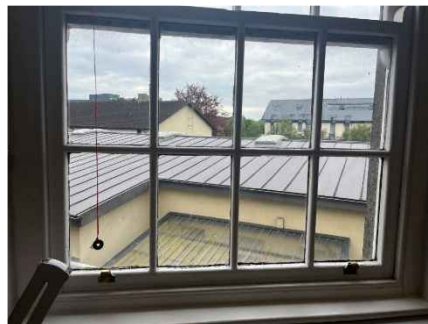
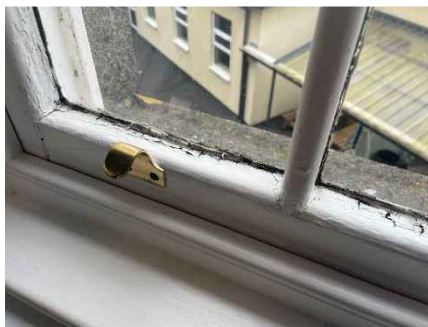
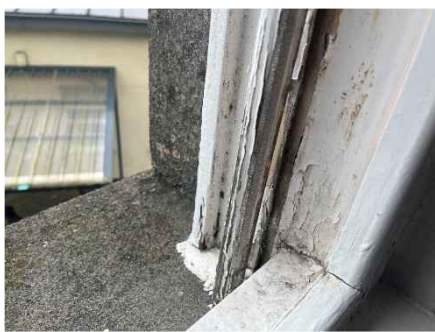
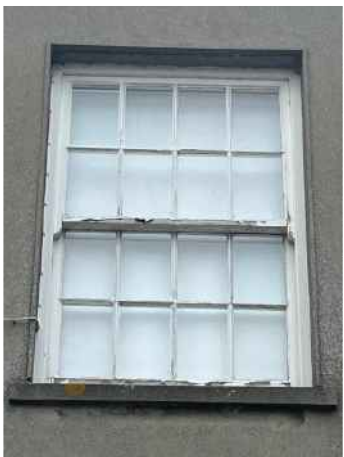
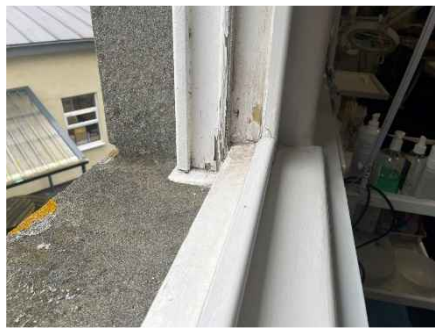
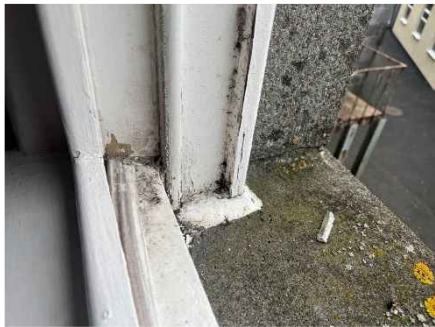
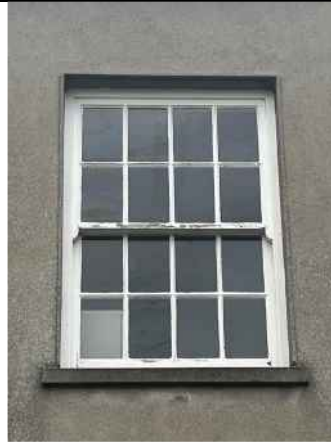
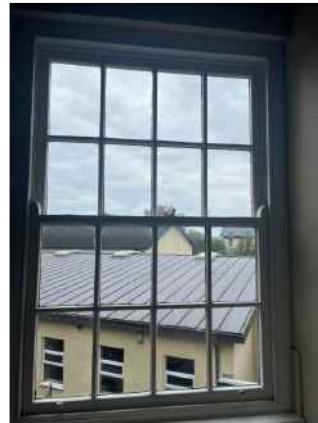
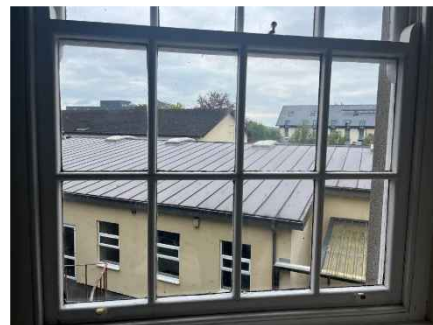
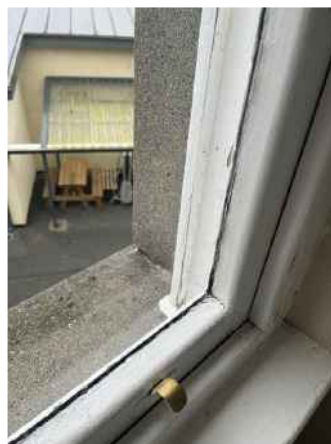
F30, F31, F32 and F33 (4no windows)

**Condition:** Glazing putty is cracked; paint to frame and sashes is flaking/missing; some slight deterioration of frame and sash at cill; dividing bead detaching on some frames; deterioration of draught proofing strips.

**Recommendations:** Repair decayed sections of timber frames; re-use existing glazing and re-putty all glazing; strip, prime, undercoat and repaint frame and sashes, internally and externally; re-seal and draught-proof with new draught seals; adjust sash cords & weights and replace where necessary; maintain and clean all ironmongery.

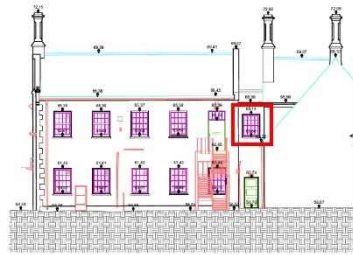
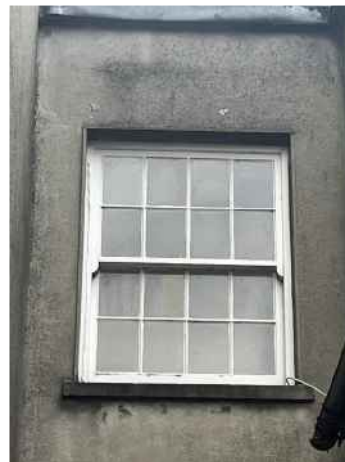
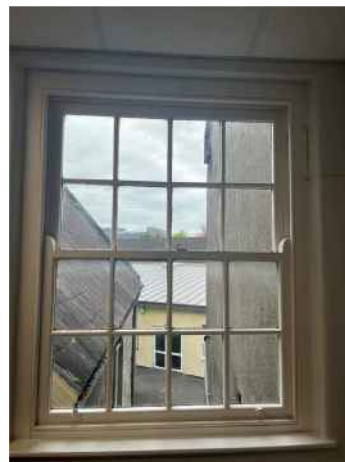
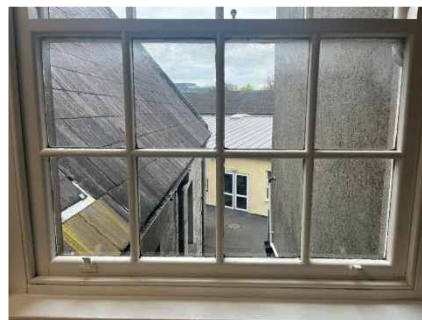
F34 (1no window)

**Condition:** Generally in good condition; glazing putty is cracked; paint to frame and sashes is flaking/missing.

**Note:** Electrical cable penetrating through top corner of window frame.

**Recommendations:** Re-use existing glazing and re-putty all glazing; strip, prime, undercoat and repaint frame and sashes, internally and externally; re-seal and draught-proof with new draught seals; adjust sash cords & weights and replace where necessary; maintain and clean all ironmongery.

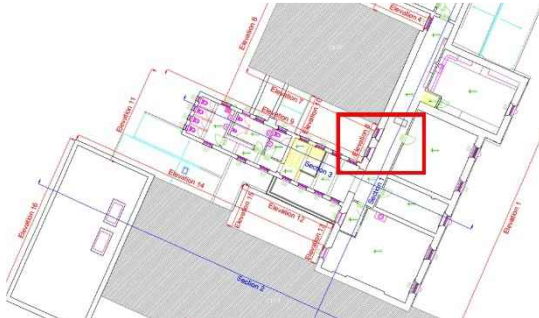
F35 and F36 (2no windows)

**Condition:** Generally in good condition; glazing putty is cracked; paint to frame and sashes is flaking/missing.

**Recommendations:** Re-use existing glazing and re-putty all glazing; strip, prime, undercoat and repaint frame and sashes, internally and externally; re-seal and draught-proof with new draught seals; adjust sash cords & weights and replace where necessary; maintain and clean all ironmongery.
